Preliminary Engineering Report Final Draft

Kongiganak, Alaska

June 12, 2018

**Preliminary Engineering Report
for Improvements to the
Community Sewage Lagoon,
Water Treatment Plant and
Laundry Facility**

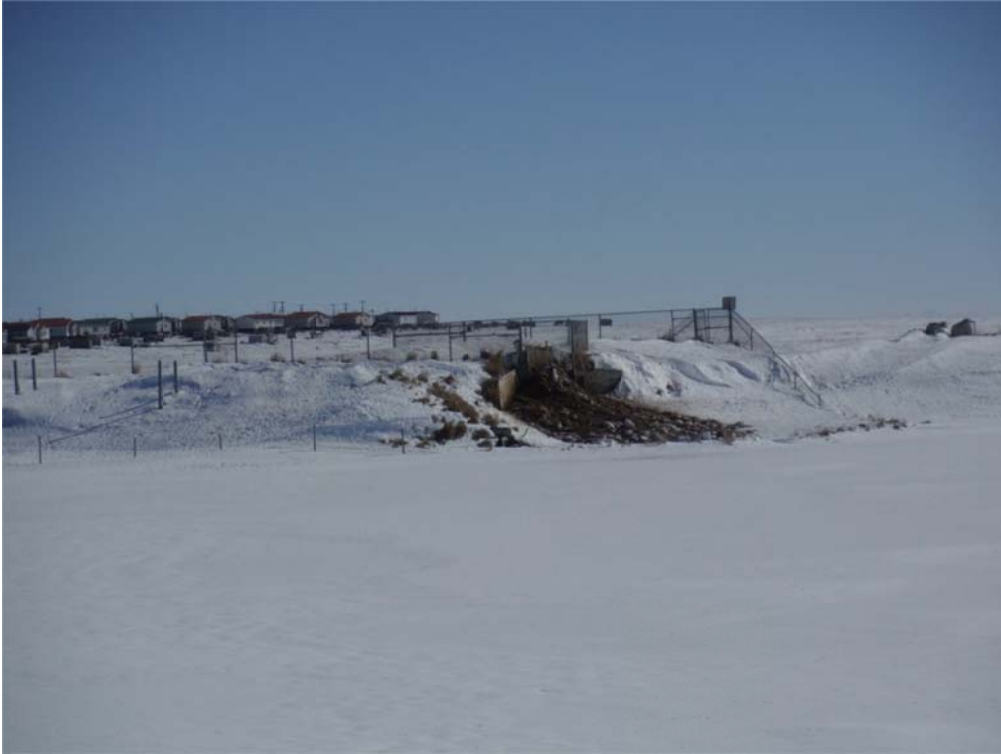
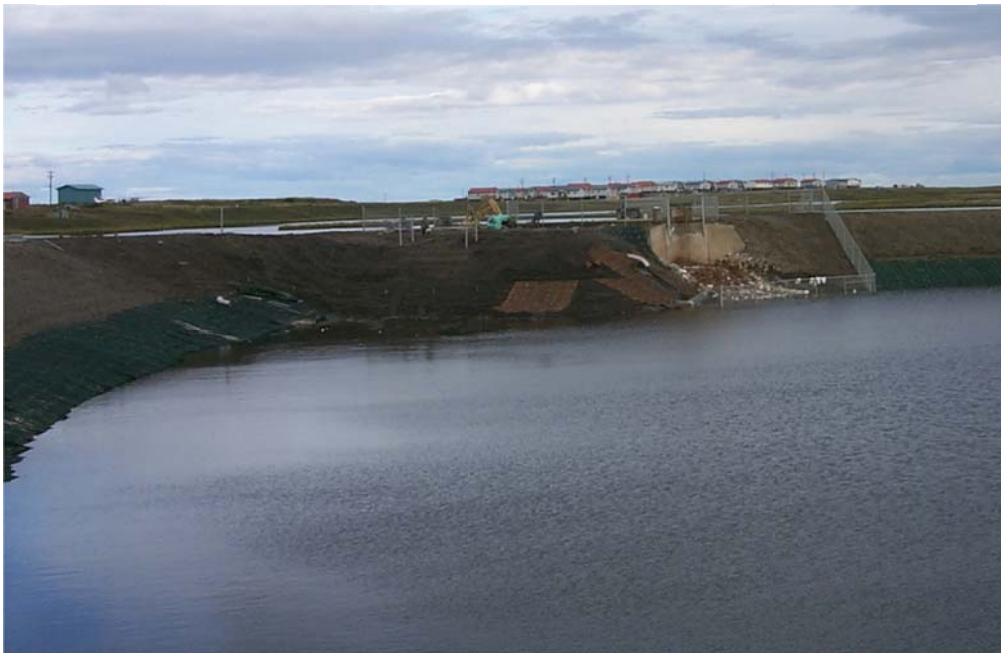
Photos of the existing condition of honeybucket facility (above) and during construction (below). Note that a second fence panel was added to the height of the facility from what is shown below. Accumulated waste and water level are now up to the top of the second fence panel height.

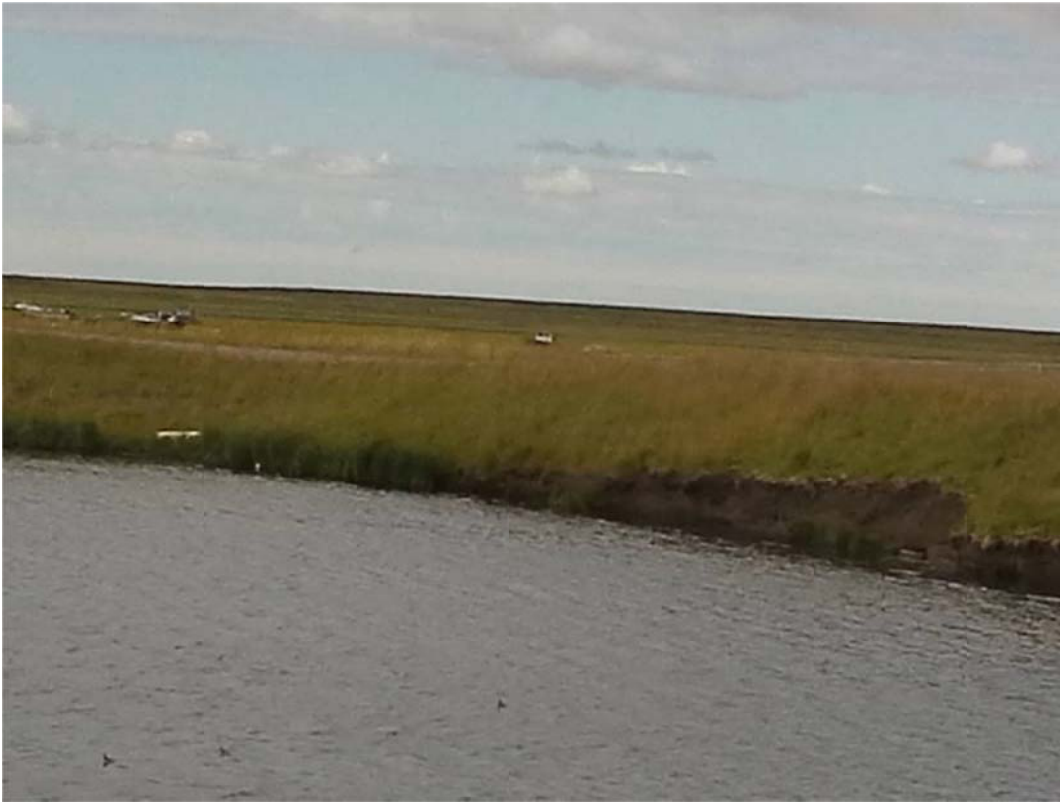
Photo of erosion during summer months. This erosion is exhibiting calving of the berms above the erosion blanket. Photo provided by Susan Randlett.

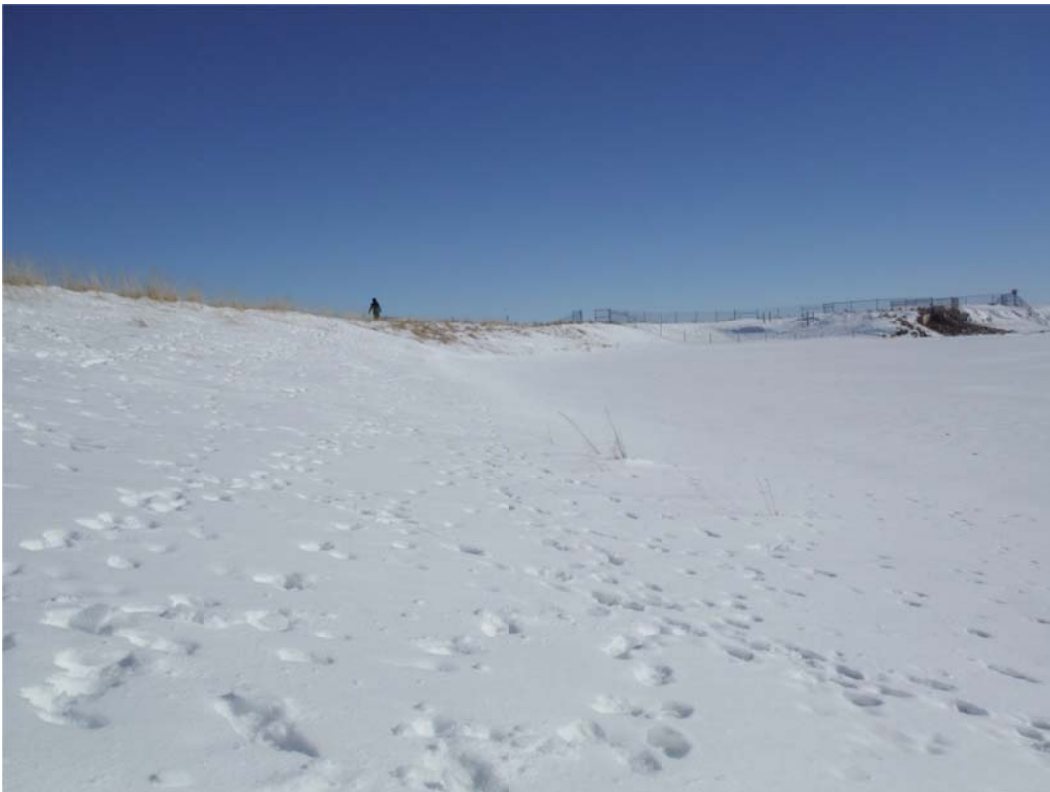
- Erosion is affecting an area of at least 100 feet in length and cutting into the berm itself 1 to 3 vertical feet. The area of worst visible erosion (above the water line) has cut into the berm up to 3 feet. The damage should be verified after break-up as a precise measurement could not be taken with the presence of drifting snow.

View of north berm from mid-berm at the northwest corner. The area below the figure standing on top of the berm is the area with the greatest erosion.

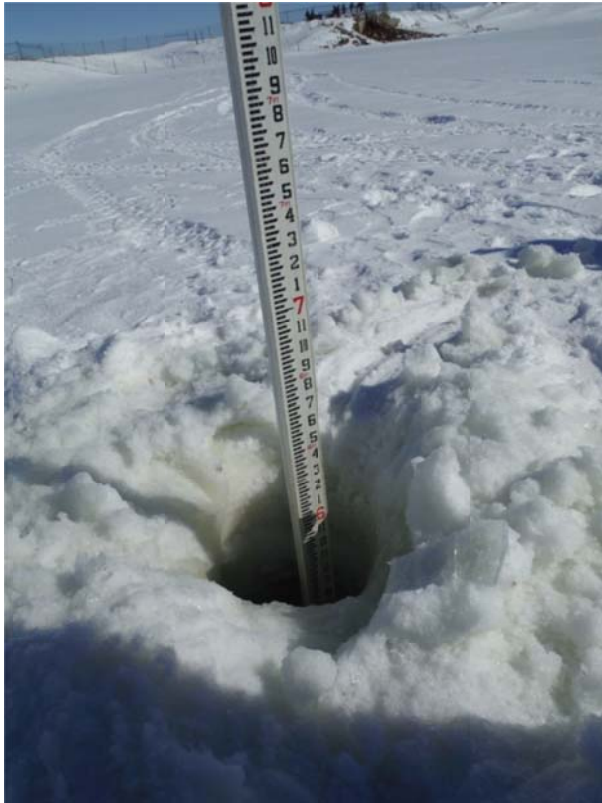
Measuring depth of ice, depth of water, and elevation of lagoon bottom (or berm wall).

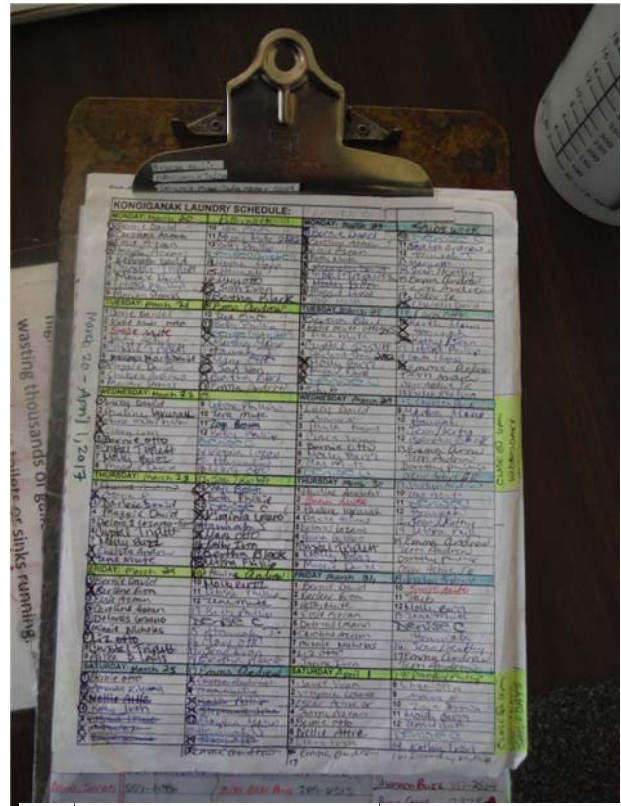
- A shortage of washer capacity and availability: only three of the 6 washers are working. One of the washers does not consistently fill properly and has to be filled with water manually. The laundry attendant operates a wait list for those who want to wash clothes and a limit of two bags per person is enforced. The community has not been successful in repairing the washers, nor has it received assistance from the RMW.

The waiting list for the laundromat.

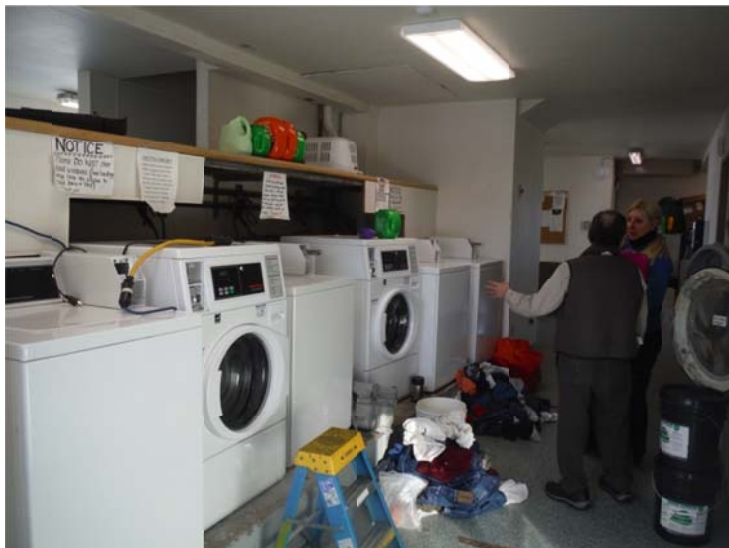
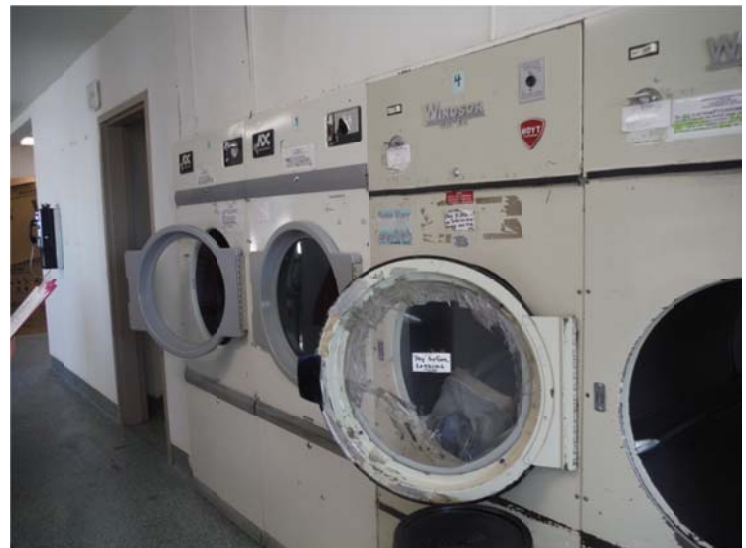
- A shortage of dryer capacity and availability: Dryers #2, 5, and 6 are working. Dryers #1 and #4 are cold air, and #3 is missing the door. The coin-operation does not work reliably on all of the dryers. The community has not been successful in repairing the dryers, nor has it received assistance from the RMW.

Washers (left picture) and dryers (right picture) in the washeteria.

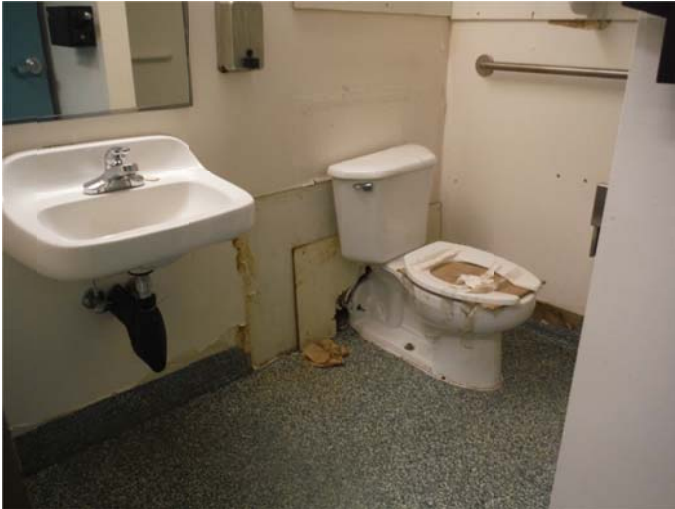
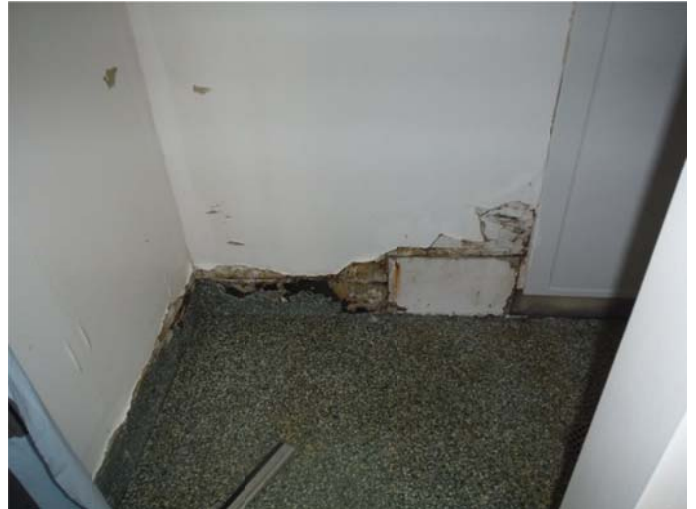
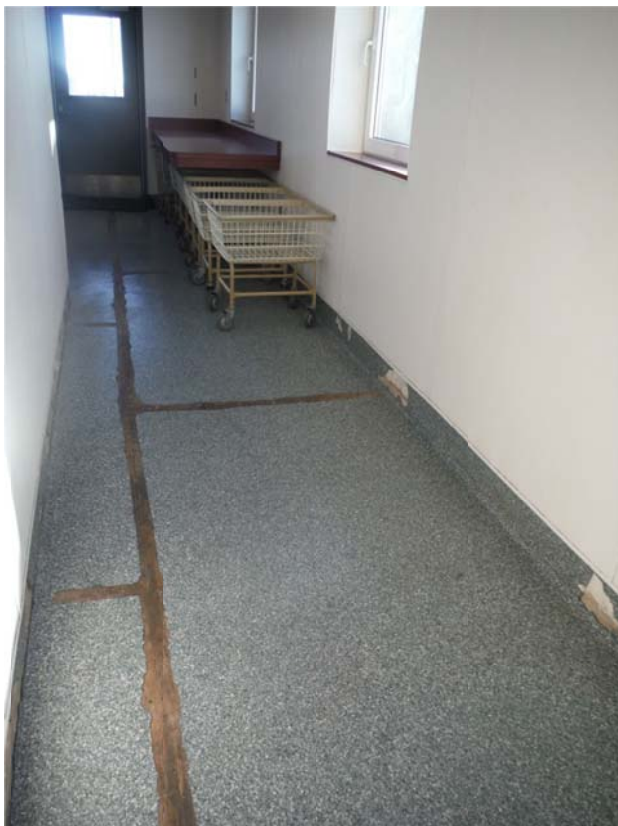
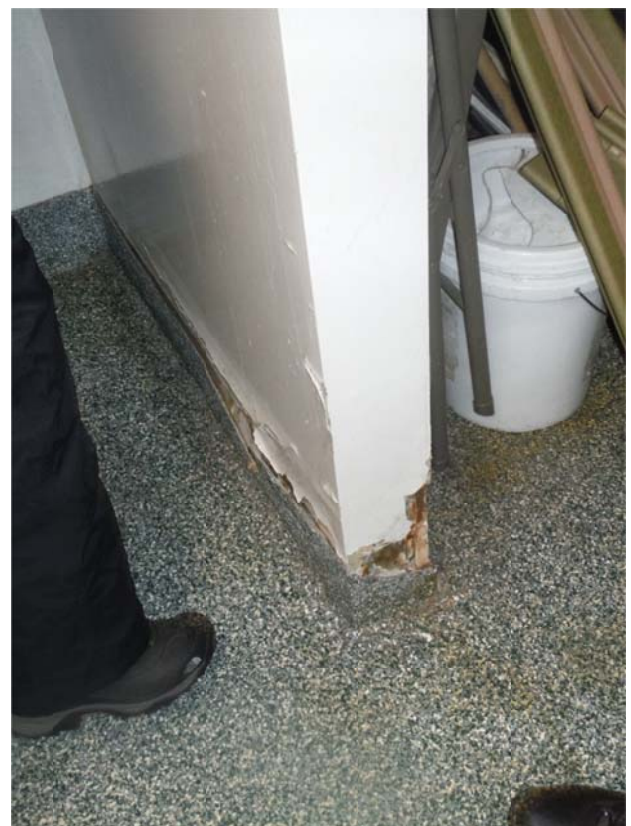
- Deteriorating flooring throughout the first floor. The resin flooring did not adhere sufficiently at the sheathing joints and the integral cove base.

- Shower pans or surrounds were not installed. The resin flooring was carried into the shower to form a pan. This has resulted in water damage, loss of sheetrock sheathing, and mold. Only one of the three showers is in use (refer to Table 1 and Attachment B, Figure 2).

Photos on this page show toilet out of operation, disintegrating walls in showers, and deteriorated condition of flooring in the washeteria.

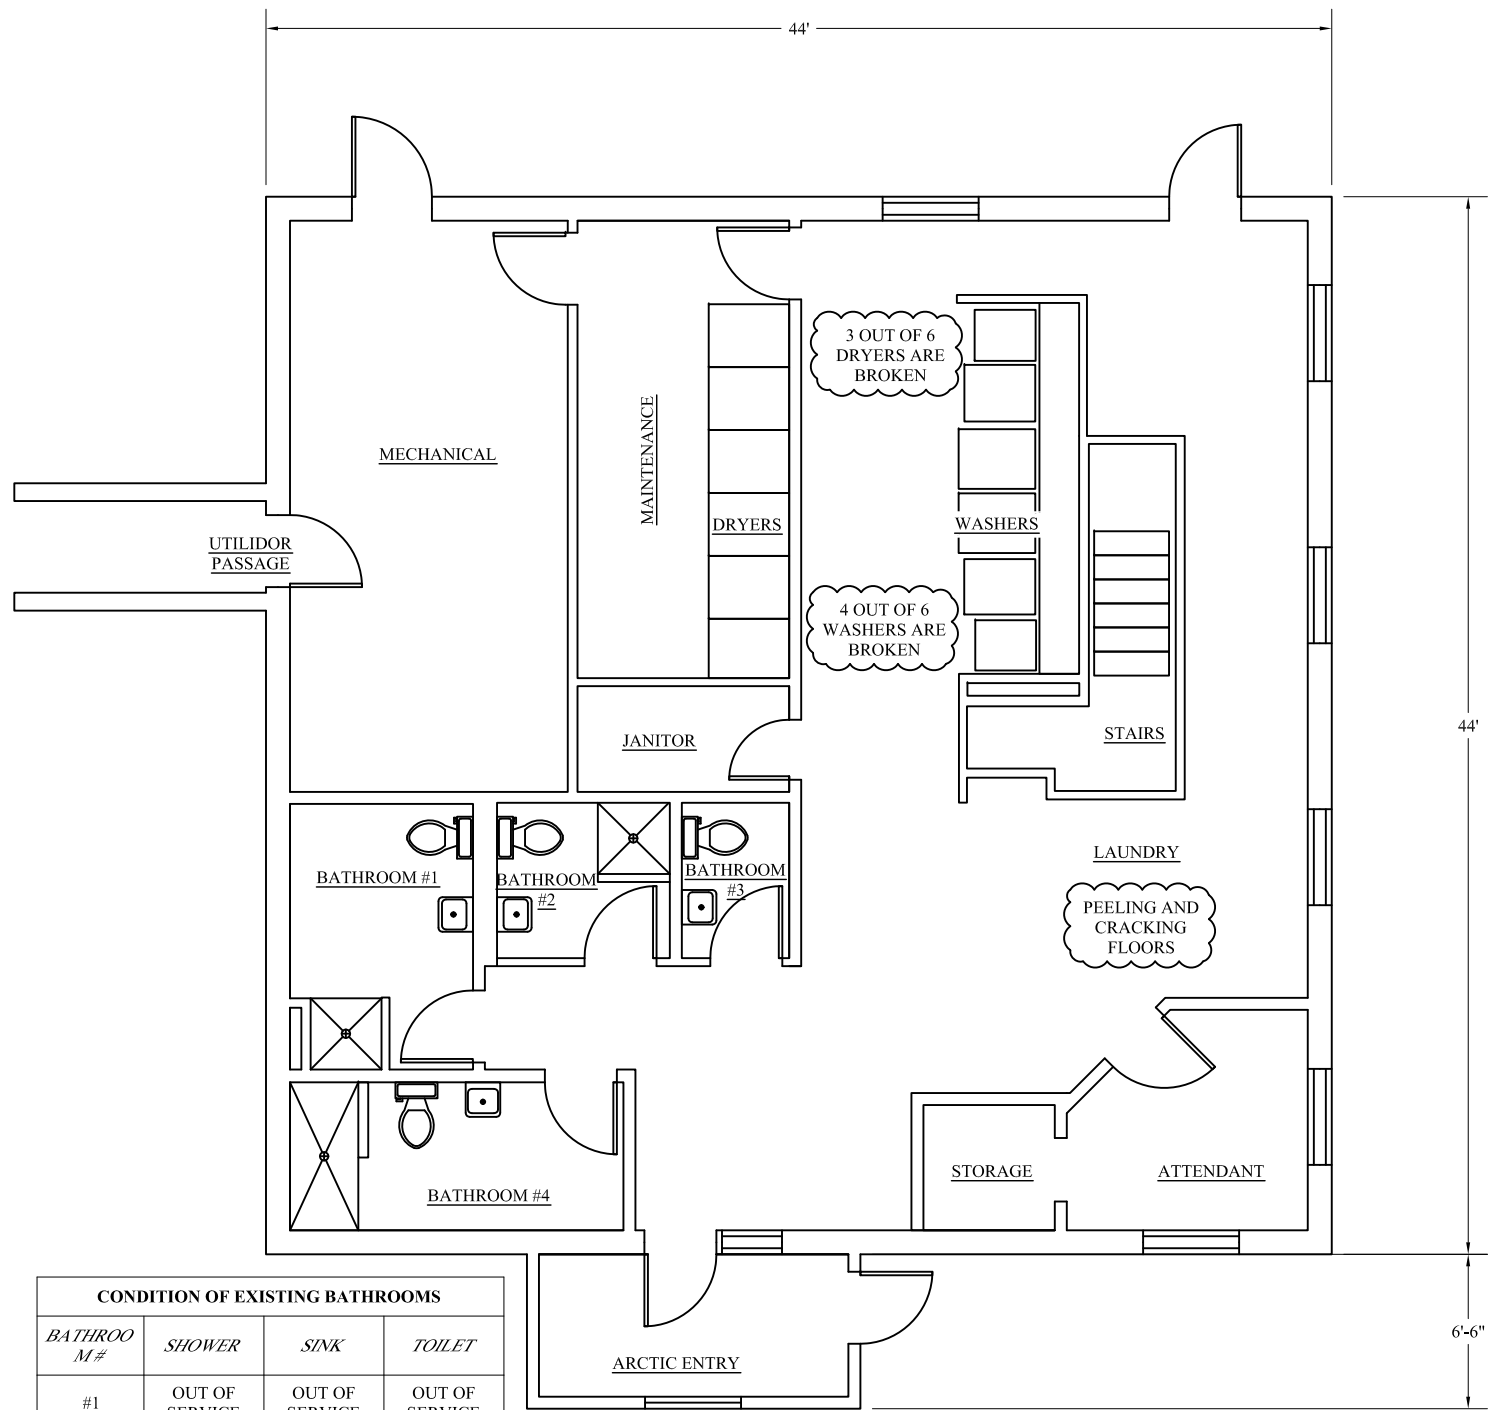
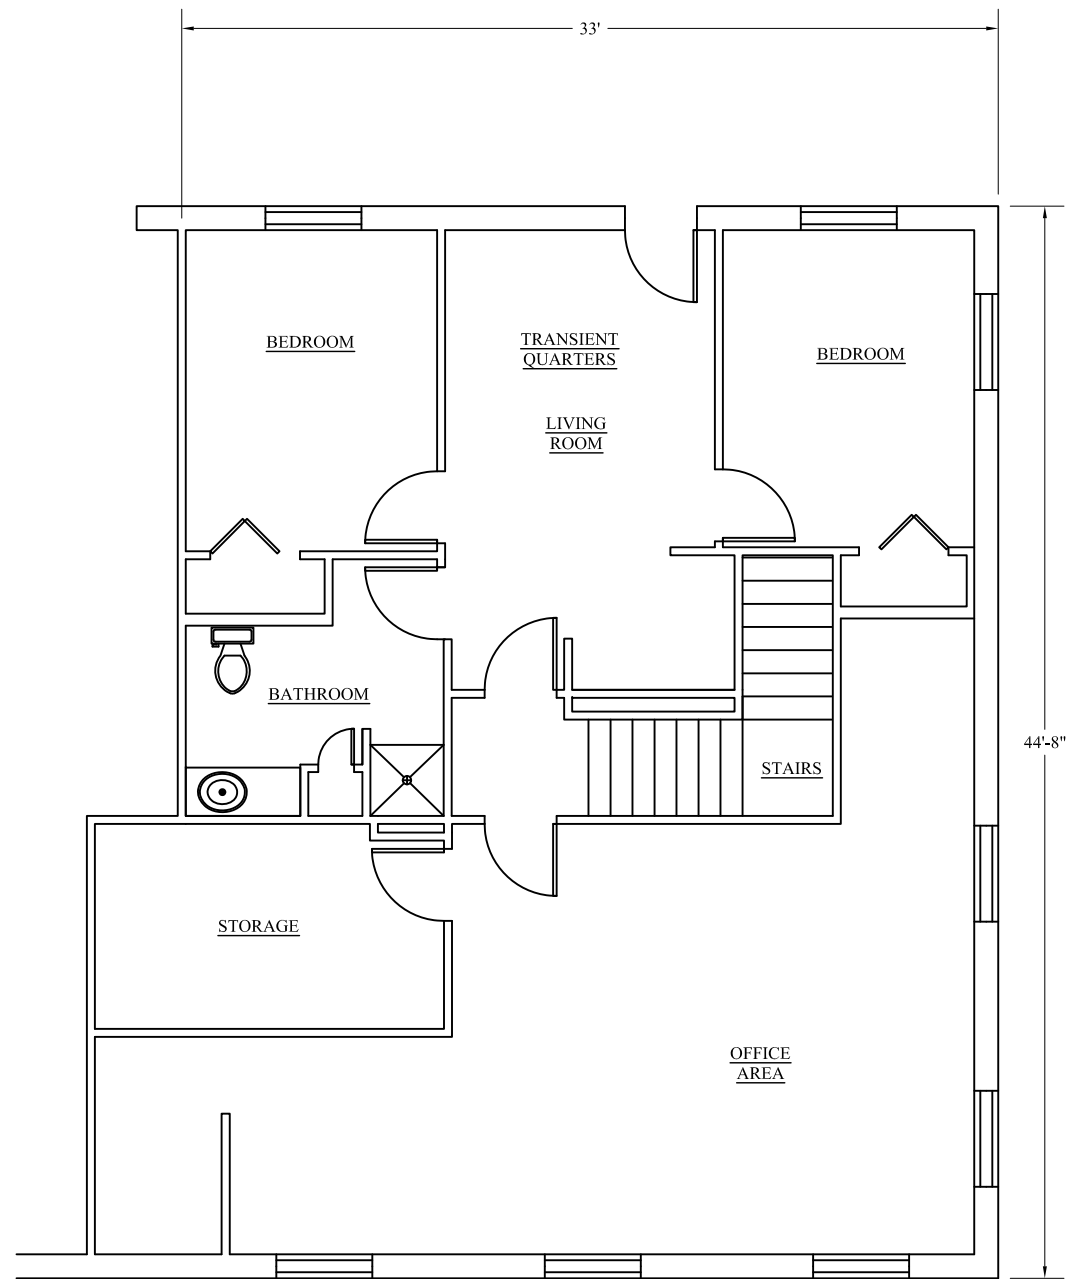
FIGURE 2
DATE: 04/16/2018
DRAWN BY: JK
CHECKED BY: HG
SCALE: AS NOTED

CONDITION OF EXISTING BATHROOMS			
BATHROOM #	SHOWER	SINK	TOILET
#1	OUT OF SERVICE	OUT OF SERVICE	OUT OF SERVICE
#2	OUT OF SERVICE	OUT OF SERVICE	OUT OF SERVICE
#3	N/A	OUT OF SERVICE	IN SERVICE
#4	OUT OF SERVICE	IN SERVICE	IN SERVICE

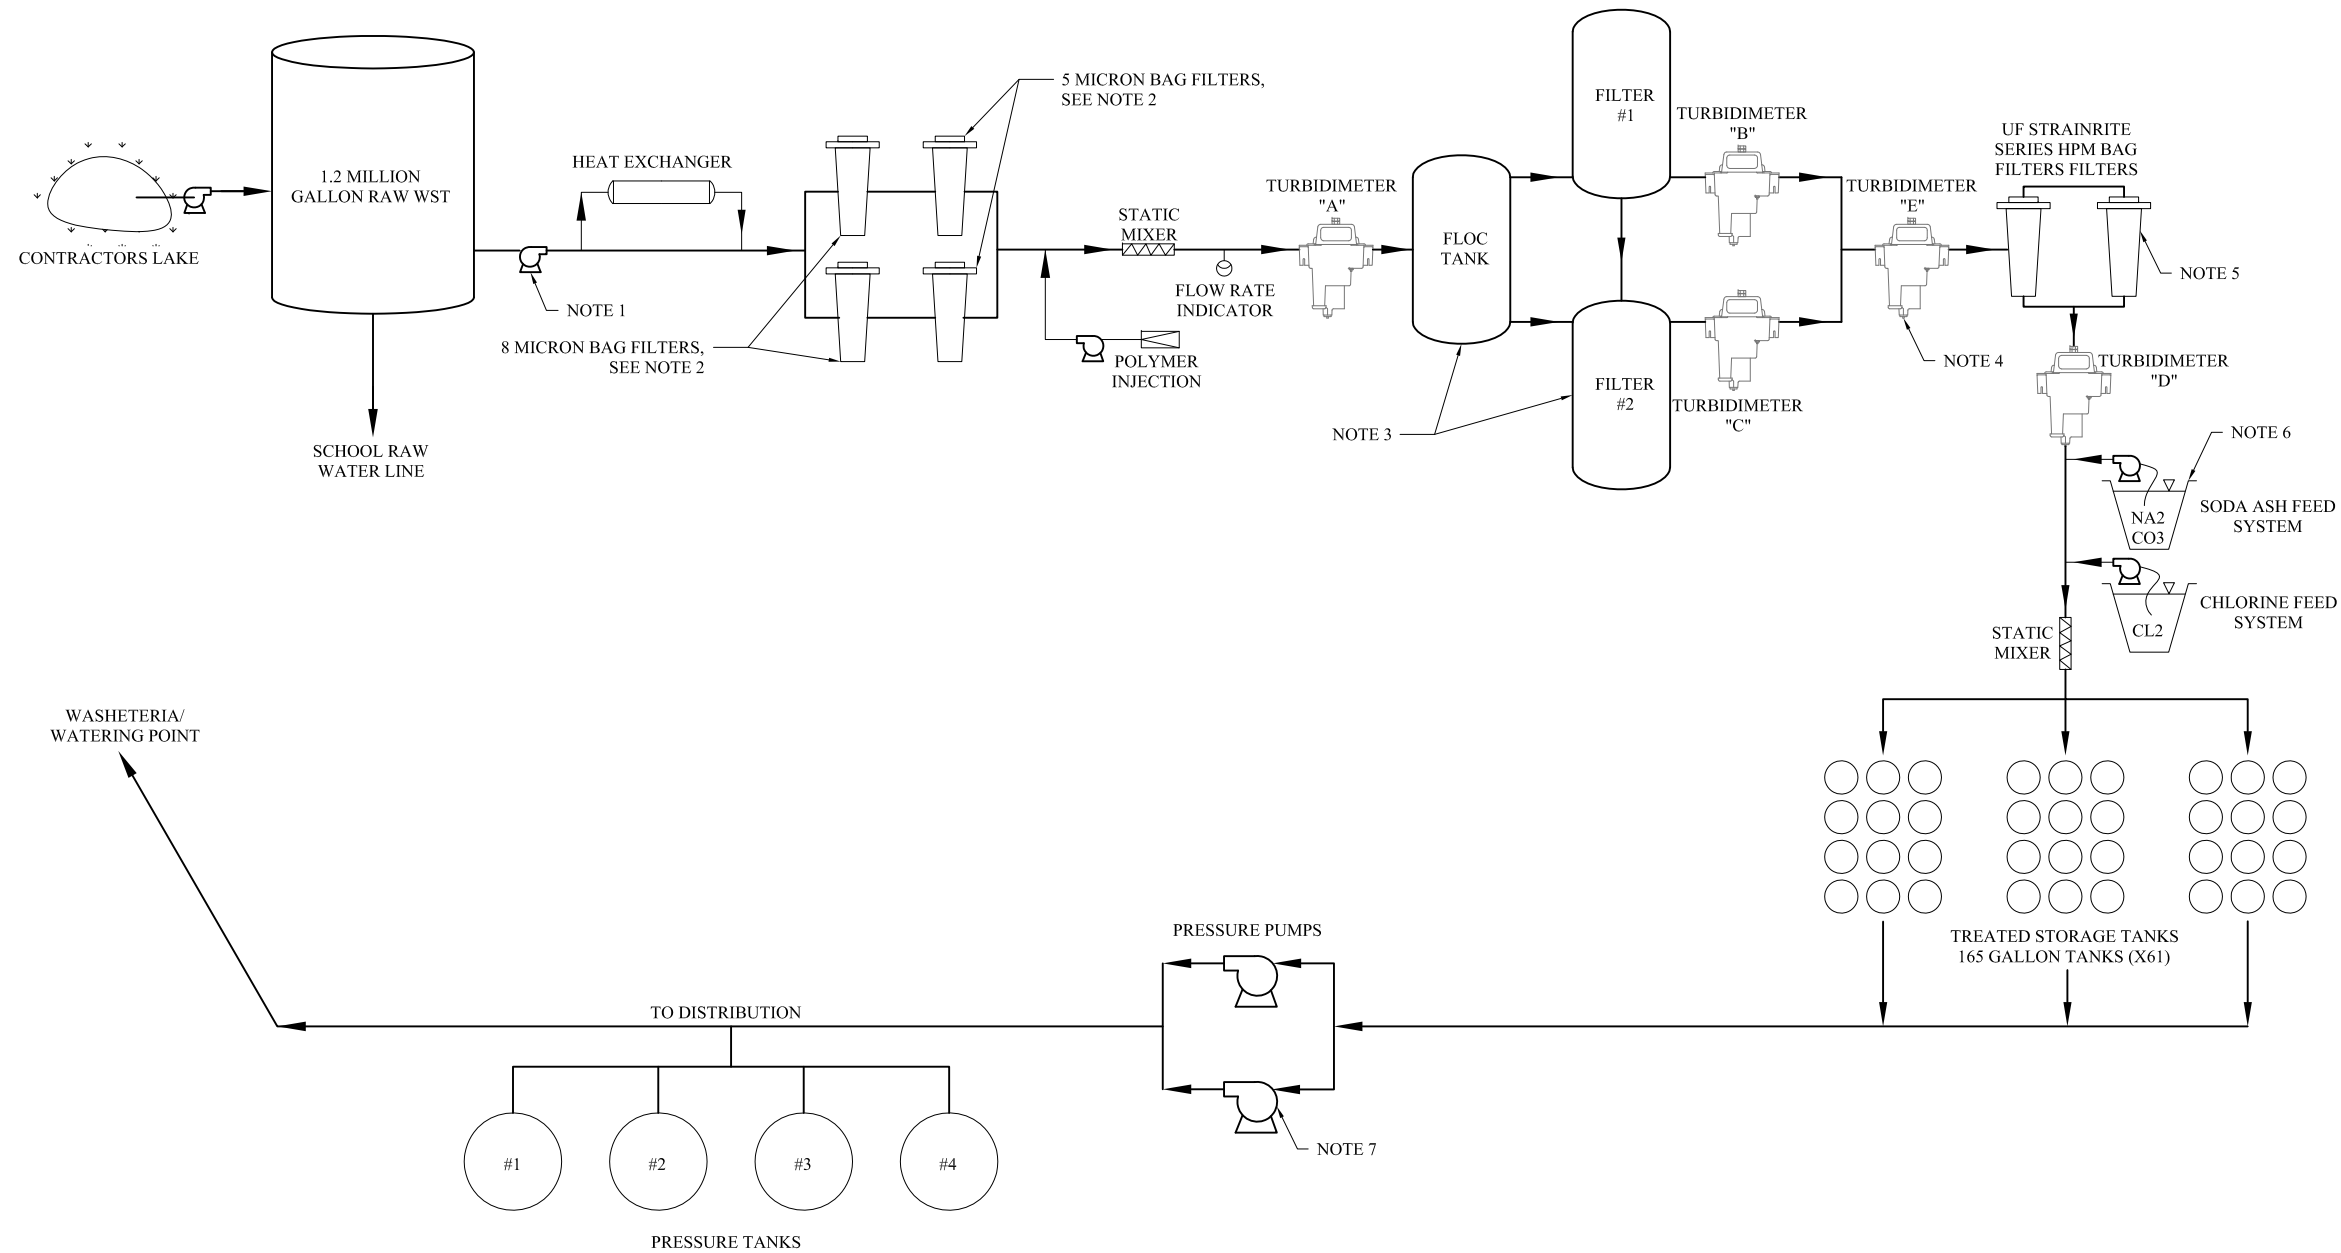
None of the bag filters are in use. Contact time was originally designed to be achieved in four 5,000 gallon tanks. Further design included a treated water contact tank of approximately 200,000 gallons that was to be adjacent to the raw water storage tank. As a temporary measure, banks of 165 gallon tanks were installed over 15 years ago. A tank replacement project did not proceed, and the community is still operating with the 165 gallon tanks in the water plant basement. Refer to Attachment B, Figure 6 for water treatment schematic.

1. TREATMENT PUMP IS A 2HP GOULDS PLACED ON THE FIRST FLOOR. PUMP HAS INSUFFICIENT NPSH TO OPERATE CORRECTLY AT LOWER TANK LEVELS, BELOW 7-8 FT.
2. NONE OF THE BAG FILTERS ARE IN USE.
3. FILTERS WERE BEING OPERATED IN SERIES.
4. HATCH 1720E TURBIDIMETERS IN USE BUT NOT SERVICED.
5. GIARDIA FILTER NOT IN USE.
6. SODA ASH SYSTEM NOT IN USE. OPERATOR NO LONGER HAS A HAND HELD PH METER.
7. ONE OF THE PRESSURE PUMPS IN INOPERABLE.
