Tuntutuliak Water Improvements

Preliminary Engineering Report

Tuntutuliak, Alaska

65% Draft Report (Revised)

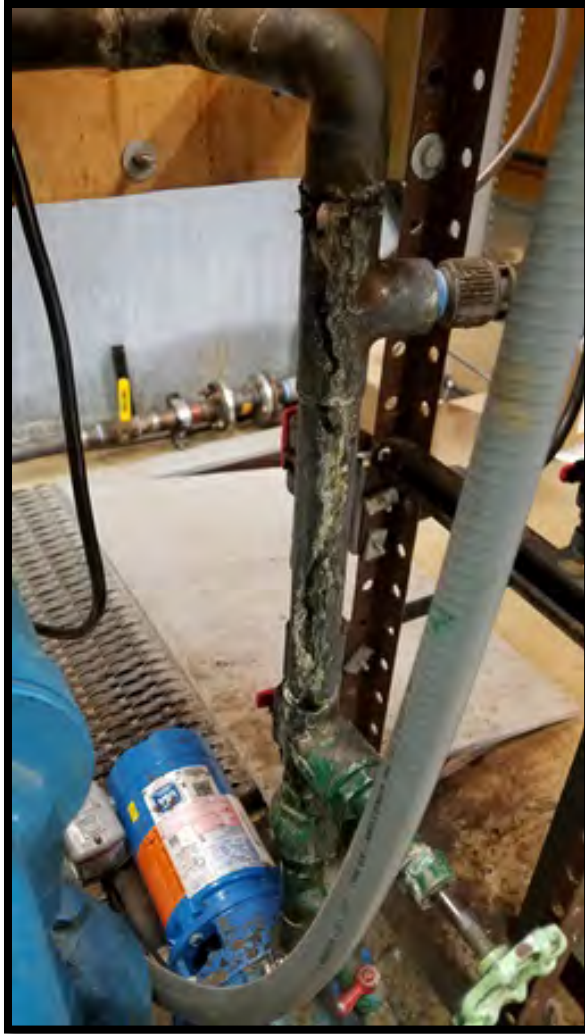
The WTP was also in poor condition. Only one of two boilers is functioning. There were small leaks and corroded glycol pipes observed throughout the building. There were numerous observed leaks and corrosion on many water pipes, valves, gauges, and pumps. The operator reports that a valve is replaced every month. In July 2018, a valve broke and flooded the WTP. The backwash air scour doesn't work due to a plugged filter. Operators have not been able to fix it. The raw water tank gauge doesn't work. Some of the piping has been replaced with PEX-style piping but it is inadequately supported and water hammering was observed. There was no ventilation in the WTP. The lift station doesn't have adequate venting pipe and the room fills with sewage smells. Doors have to be propped open to clear out the smell. The lift station and holding tanks were cleaned recently, but the problem has not improved. The operator reports that the backup generator has not been tested recently and it appears to be unreliable. The fire alarms and emergency lighting were expired and inoperative. There are no GFCI outlets or breakers in the WTP.

Figure 3 (left): Leaking pressure pump.
Figure 4 (right): Pile corrosion.

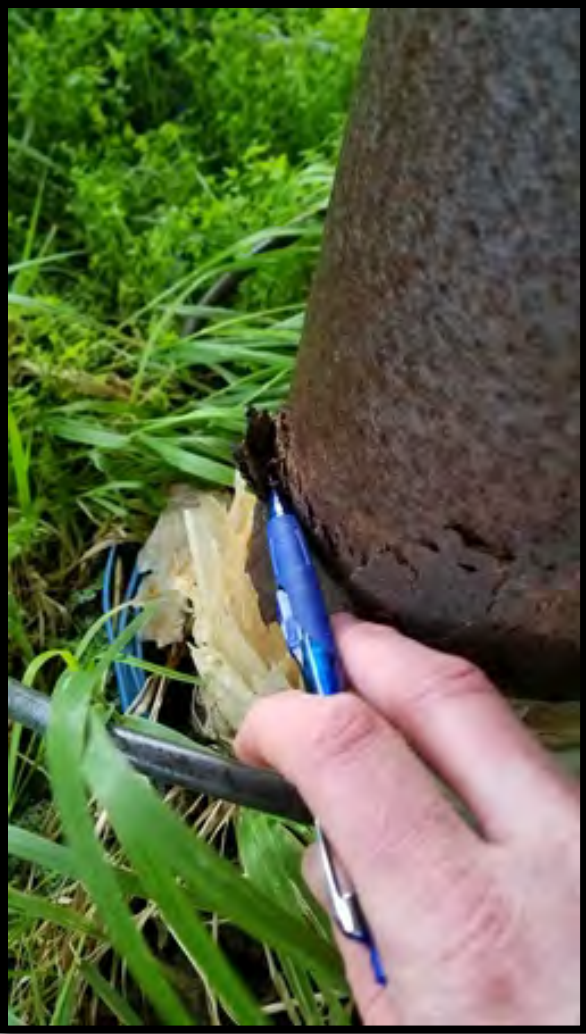
The facility is past its useful design life. The exterior of the building is in fair shape. There was no observed settling damage in the building. The foundation is on driven steel piles. There is significant corrosion on the piles. At least 1/8 inch of lost material was observed, which is 20% of the steel pipe's thickness. It appears the piles could start failing in the next 10 years. Additional studies are needed to confirm remaining life of piles. The outfall piping has moved significantly and needs to be releveled. Only one of the three exterior lights is working.

All windows and exterior doors will be replaced. New energy efficient exterior and interior lights. The whole building will be brought up to electrical, plumbing, fire, and safety codes. The pile foundation will be replaced or repaired.

- The piles need to be replaced. It is very difficult to replace piles without damaging the building or causing settling. The building structural components may need to be reinforced prior to replacing the foundation.

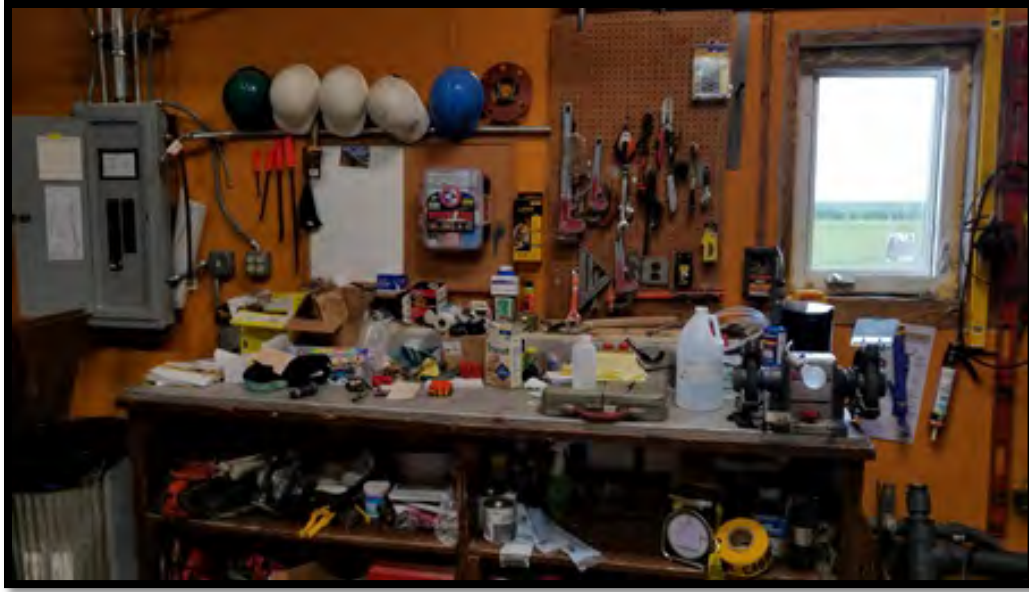
The WTP has no work space except a small work bench for repair work. There is no office space or laboratory space. The operators need an office with a desk, computer, testing space, and space for records keeping.

Figure 5: WTP work bench and record library.

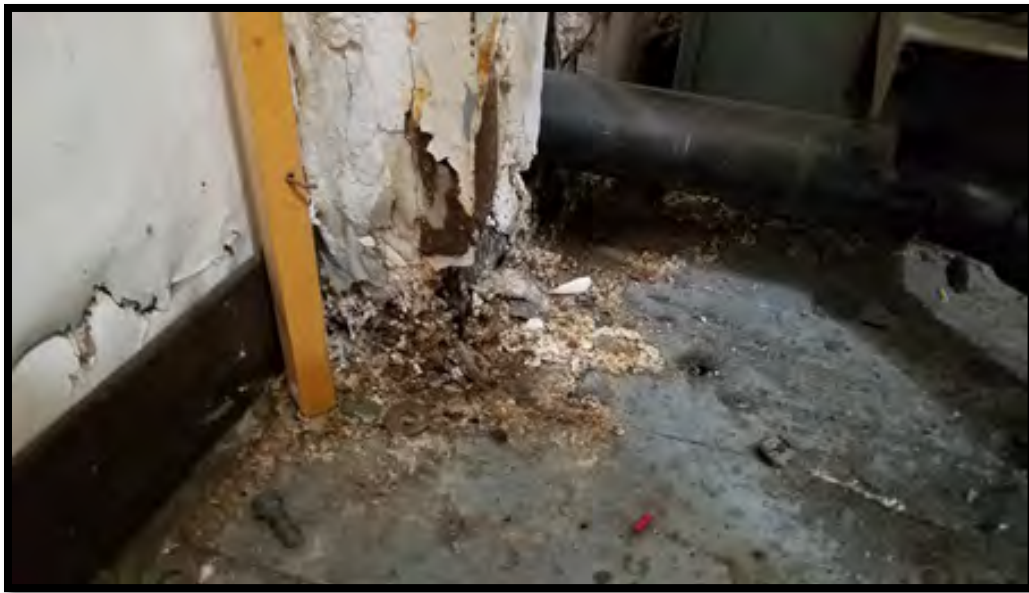
The floor louvers for the dryers were nonfunctional and it appears the dryers are sucking air from inside the building. This is a code violation and is hazardous. There are no ground fault circuit interrupter (GFCI) outlets or breakers in the washeteria.

Figure 6: Water damage behind dryers in washeteria

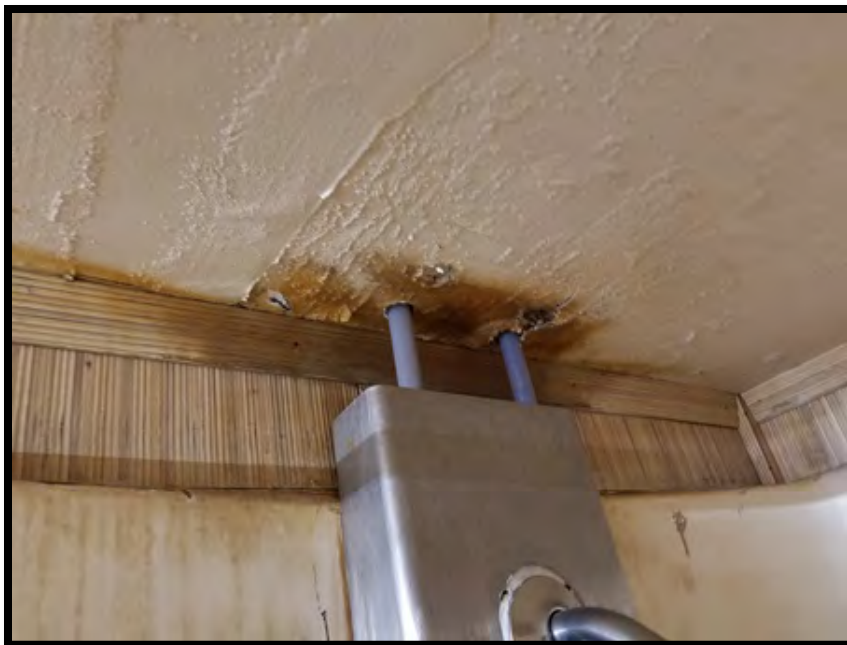
Figure 10: Women's shower, water damage and mold.

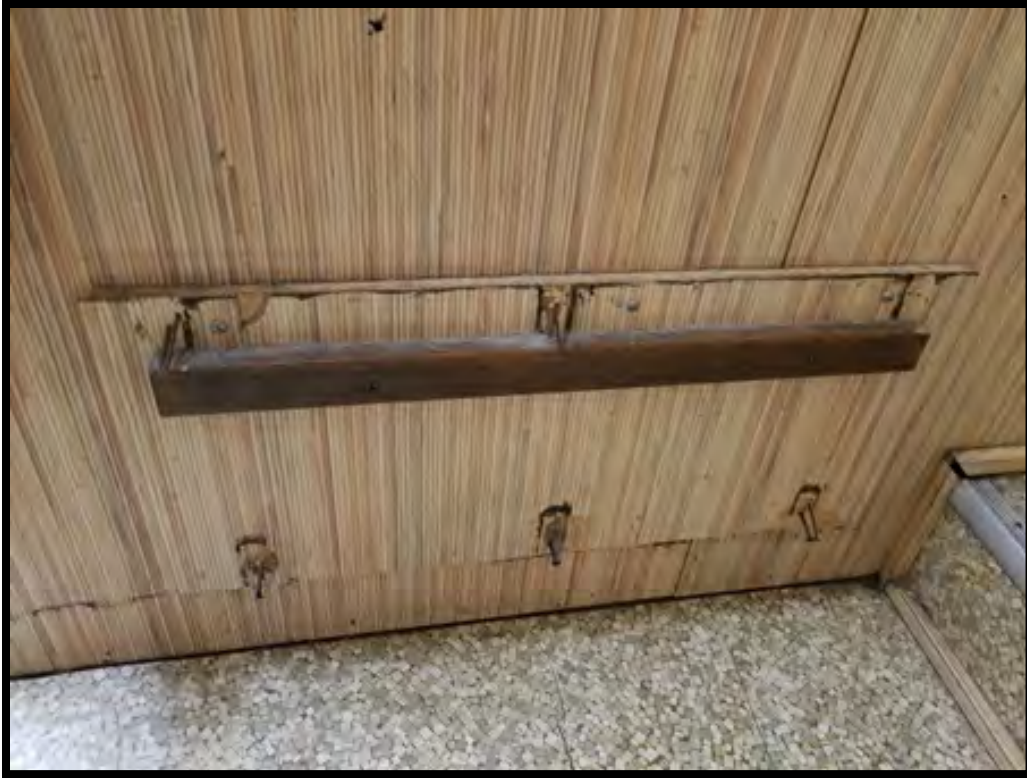
Figure 11: Women's shower, water damage along wall and floor.

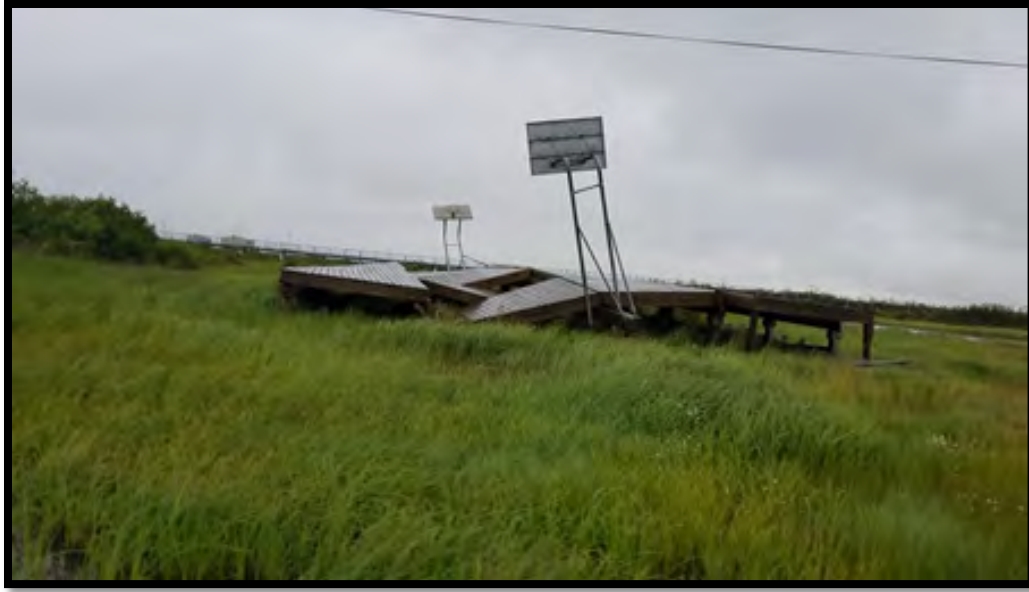
Figure 15: Basketball court, damaged from heavying and settling.

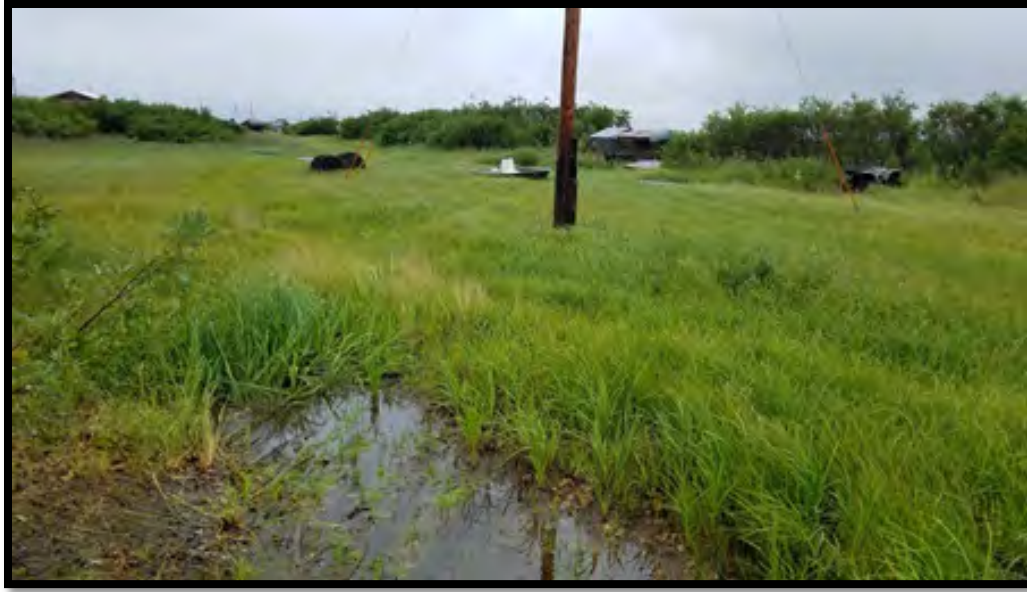
Figure 21: Potential new washeteria site by power plant, standing water

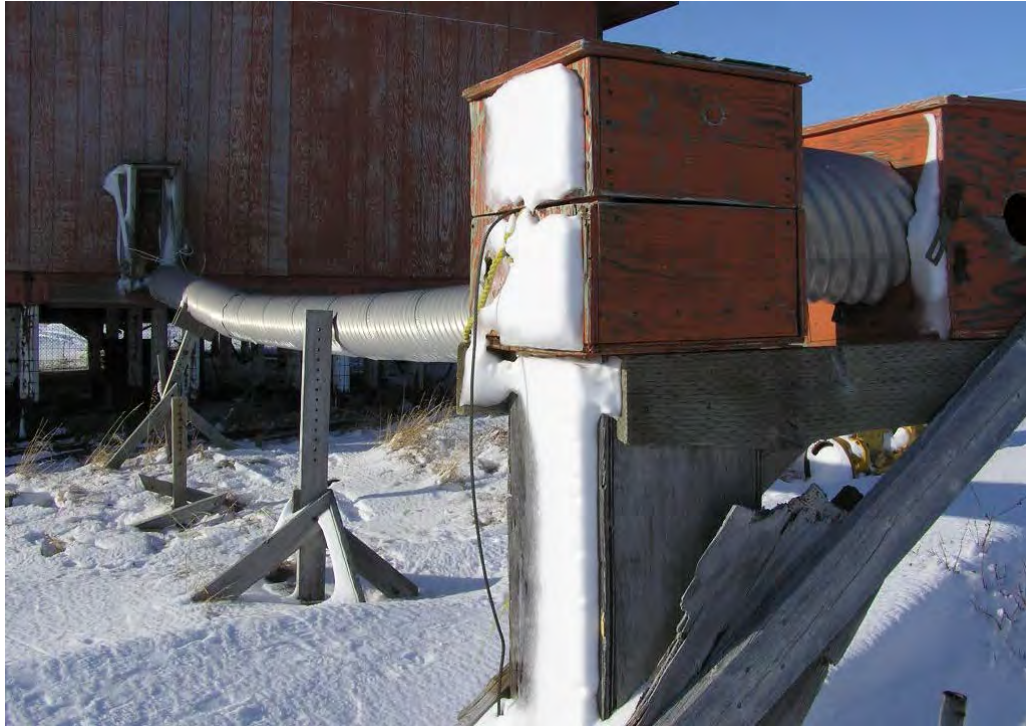
Figure 3 - Well System and Transmission Line

The arctic box on the well head is in need of replacement as it offers minimal thermal protection. The existing transmission line from the well is an approximately 20-foot long copper pipe equipped with heat trace inside an arctic insulated PVC pipe with a CMP jacket. This pipe was supported with 3-legged wooden assemblies with cradles. The supports are now in a state of disrepair, leaving the pipe rigidly supported only at the well end. This also places a strain on the rigid copper water piping. The arctic box at the connection of the raw water pipe to the WTP is partially disassembled resulting in the potential for damage due to freezing. Also, water in the raw water line is forced back into the well using compressed air after the well pump is turned off. This process can be made automatic by installing an air/vacuum valve on the raw water piping in the WTP as record drawings indicate that bleeder valve is already present on the well drop pipe. An air/vacuum valve in the WTP, new arctic boxes at the well head and connection to the WTP, and a new raw water transmission line consisting of a 1-inch or 1.5-inch HDPE carrier pipe with arctic insulation supported by wood cribs are recommended to address these deficiencies.

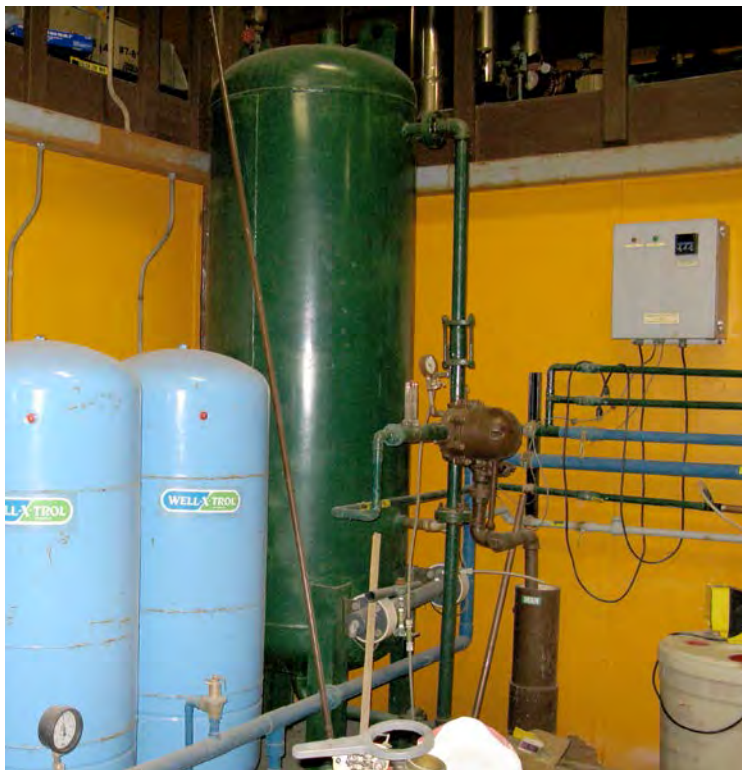
Figure 8 - Existing Greensand Filter and Piping

The existing greensand filter has deficiencies that which impair the operator's ability to produce the best possible water. The current underdrain is constructed of pvc of unknown condition and it is not screened. The filter is not equipped with a freeboard drain. No viewport window or illumination port is present to verify backwash performance or the condition of the media. The filter is equipped with a galvanized air scour header of unknown condition placed between the gravel support media and the greensand. The

lack of a freeboard drain impairs the air scour process resulting in poor filter efficiency and a potential for media fouling. A Solo Valve is used on the filter face piping that restricts backwash flow to the filter and may be responsible for shearing floc. A new filter equipped with a freeboard drain, viewport window, illumination port, and an underdrain properly equipped for air scour is recommended. New filter face piping is required to remove the existing Solo Valve. Costs and improvements related to the installation of a new greensand filter are provided in Table 7 below.

Several of the deficiencies above may be corrected with filter modifications and others cannot. Because of the limited construction funding, it may be desirable to retrofit the existing greensand filter instead of replacing it with a new one. At a minimum, new media should be installed, a drain down port added, and the face piping should be replaced. The service life of greensand media in Tuntutuliak is estimated to be 20 years assuming proper regeneration. Improvements to the existing filter are itemized in Table 8.

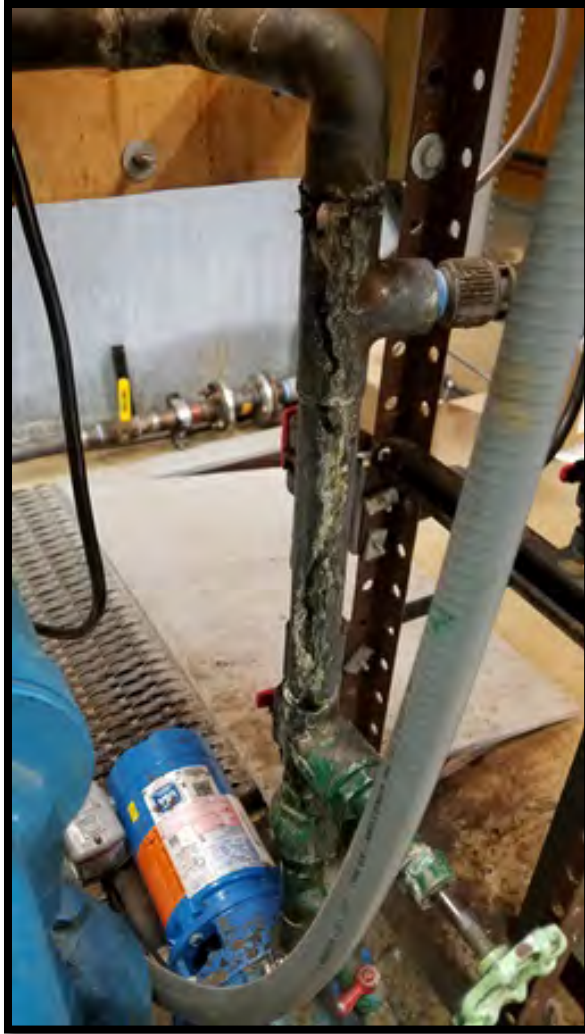
Figure 3 (left): Leaking pressure pump.
Figure 4 (right): Pile corrosion.

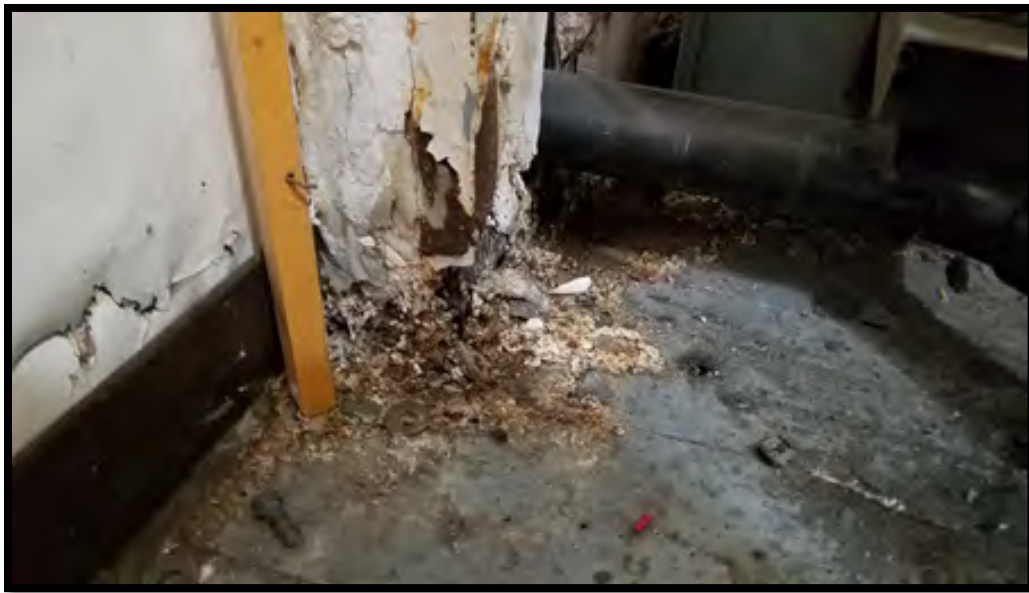
Figure 6: Water damage behind dryers in washeteria

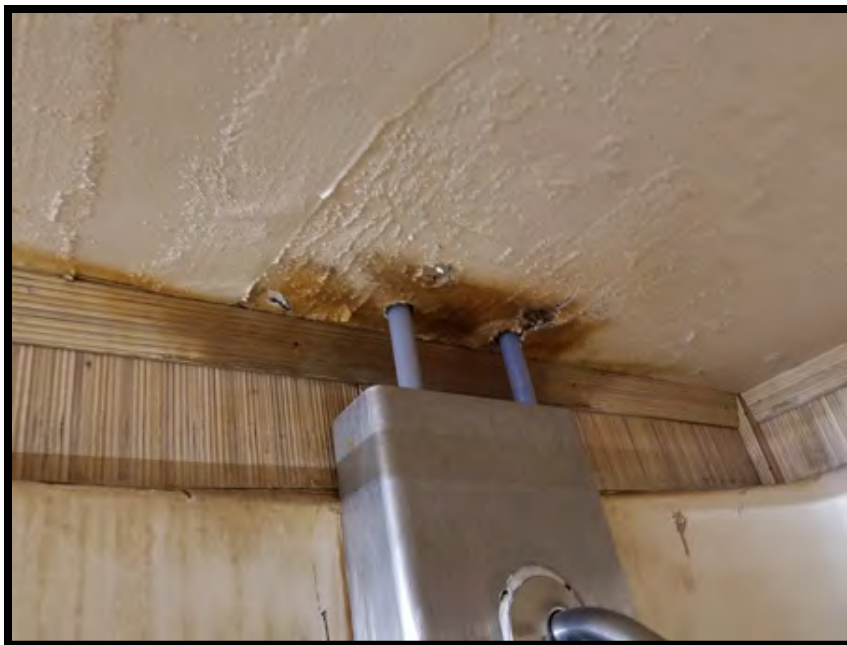
Figure 10: Women's shower, water damage and mold.

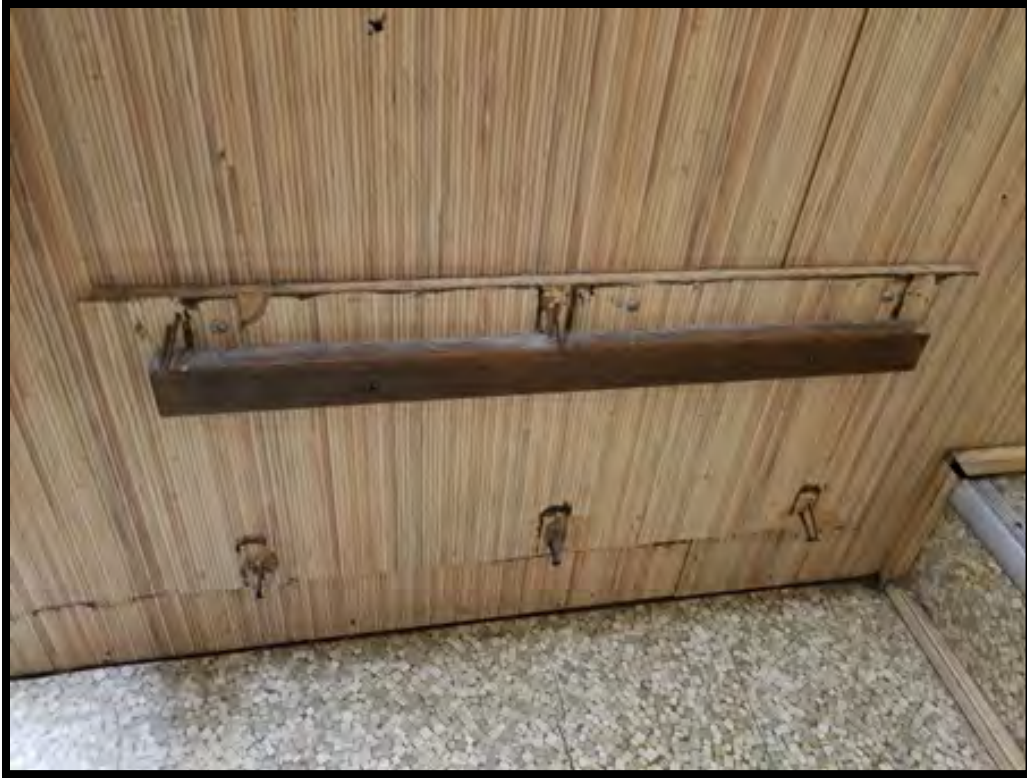
Figure 11: Women's shower, water damage along wall and floor.

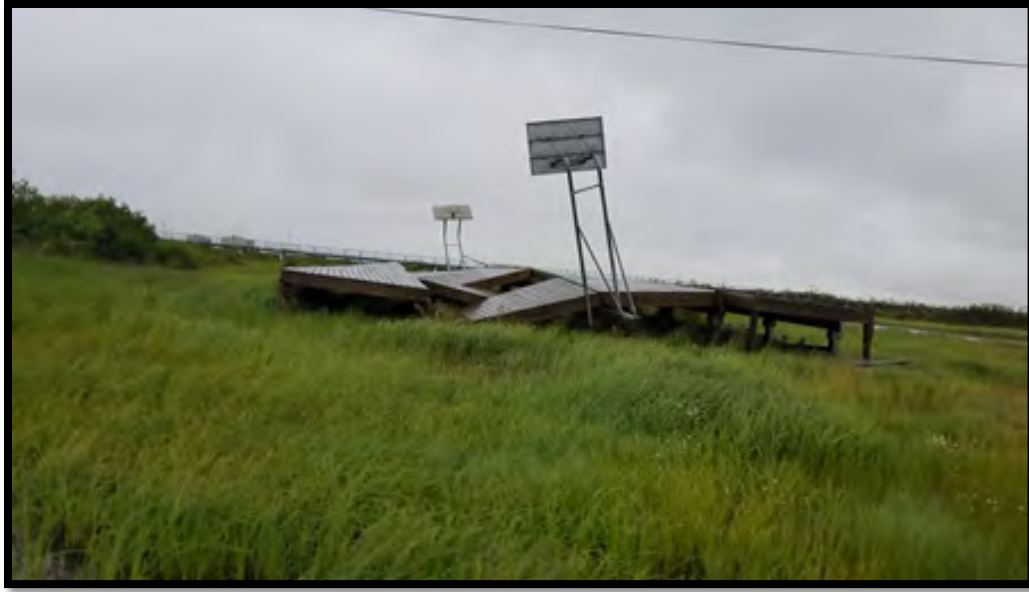
Figure 15: Basketball court, damaged from heavying and settling.

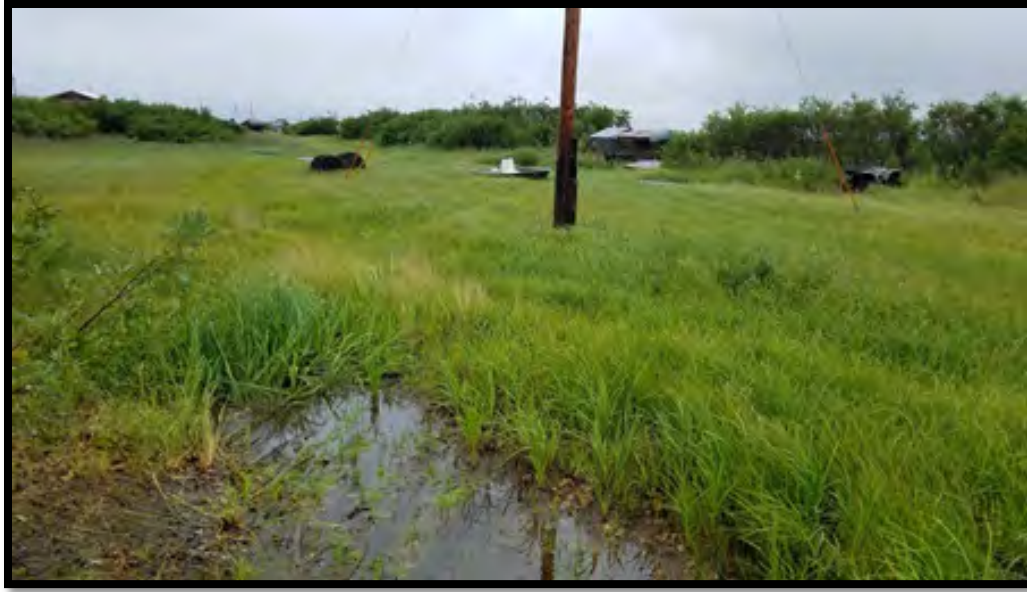
Figure 21: Potential new washeteria site by power plant, standing water
