TECHNICAL MEMORANDUM

Subject: City of North Pole – West of Old Richardson Highway Stormwater Drainage Study

A city-wide drainage integrity overview was desired by the city. By reviewing the major drainages throughout the city looking for blockages, failed/failing structures, and other readily visible items of concern, RESPEC identified items that might disrupt the flow of stormwater and potentially create future problems. After consultation with the city, RESPEC understood that there were no known issues outside of the recently completed “West of Old Richardson Highway Study”. So, it was decided to focus on the culverts under the 10 road crossings of Thirtymile slough since it provides the main drainage pathway through the city and receives flow from the ditches of adjacent neighborhoods.

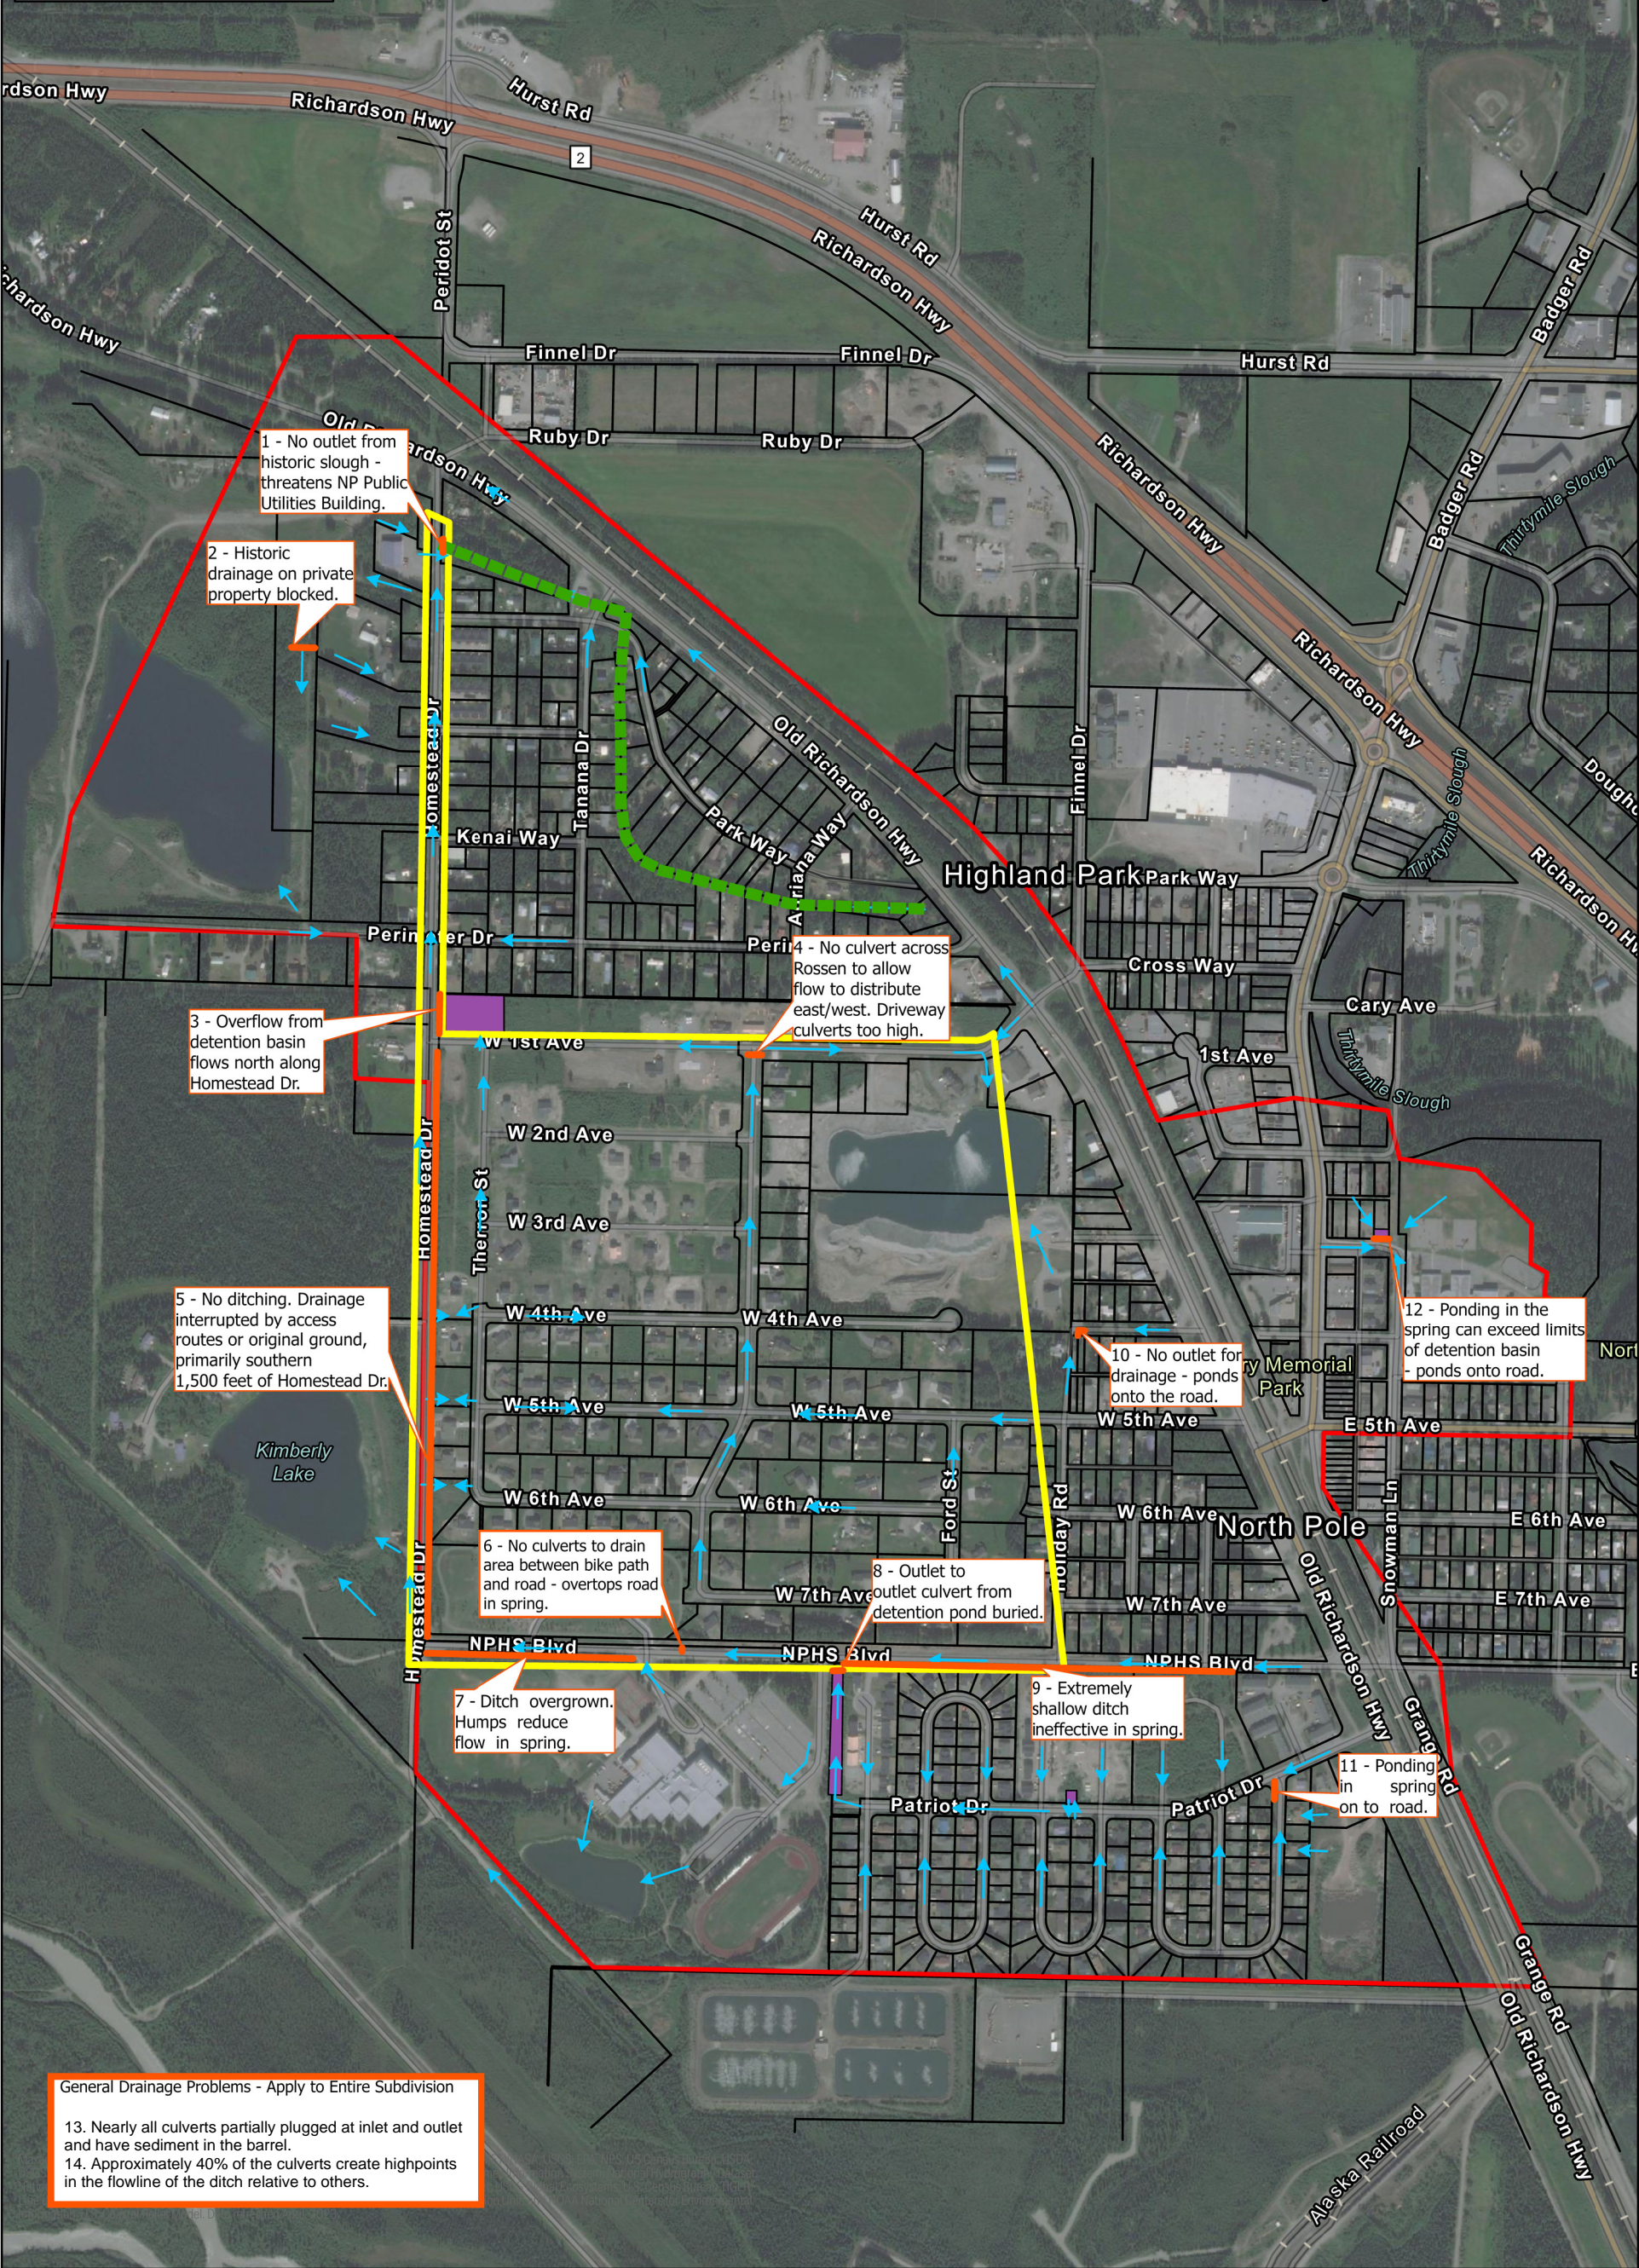
The key items are shown on the attached Fig 1 – Existing Drainage Conditions. The numbers indicate their relative importance of the problem and the associated impact of the solution on reducing the flooding:

13. Nearly all culverts partially plugged at inlet and outlet and have sediment in the barrel.

14. Approximately 40% of the culverts create highpoints in the flowline of the ditch relative to others.

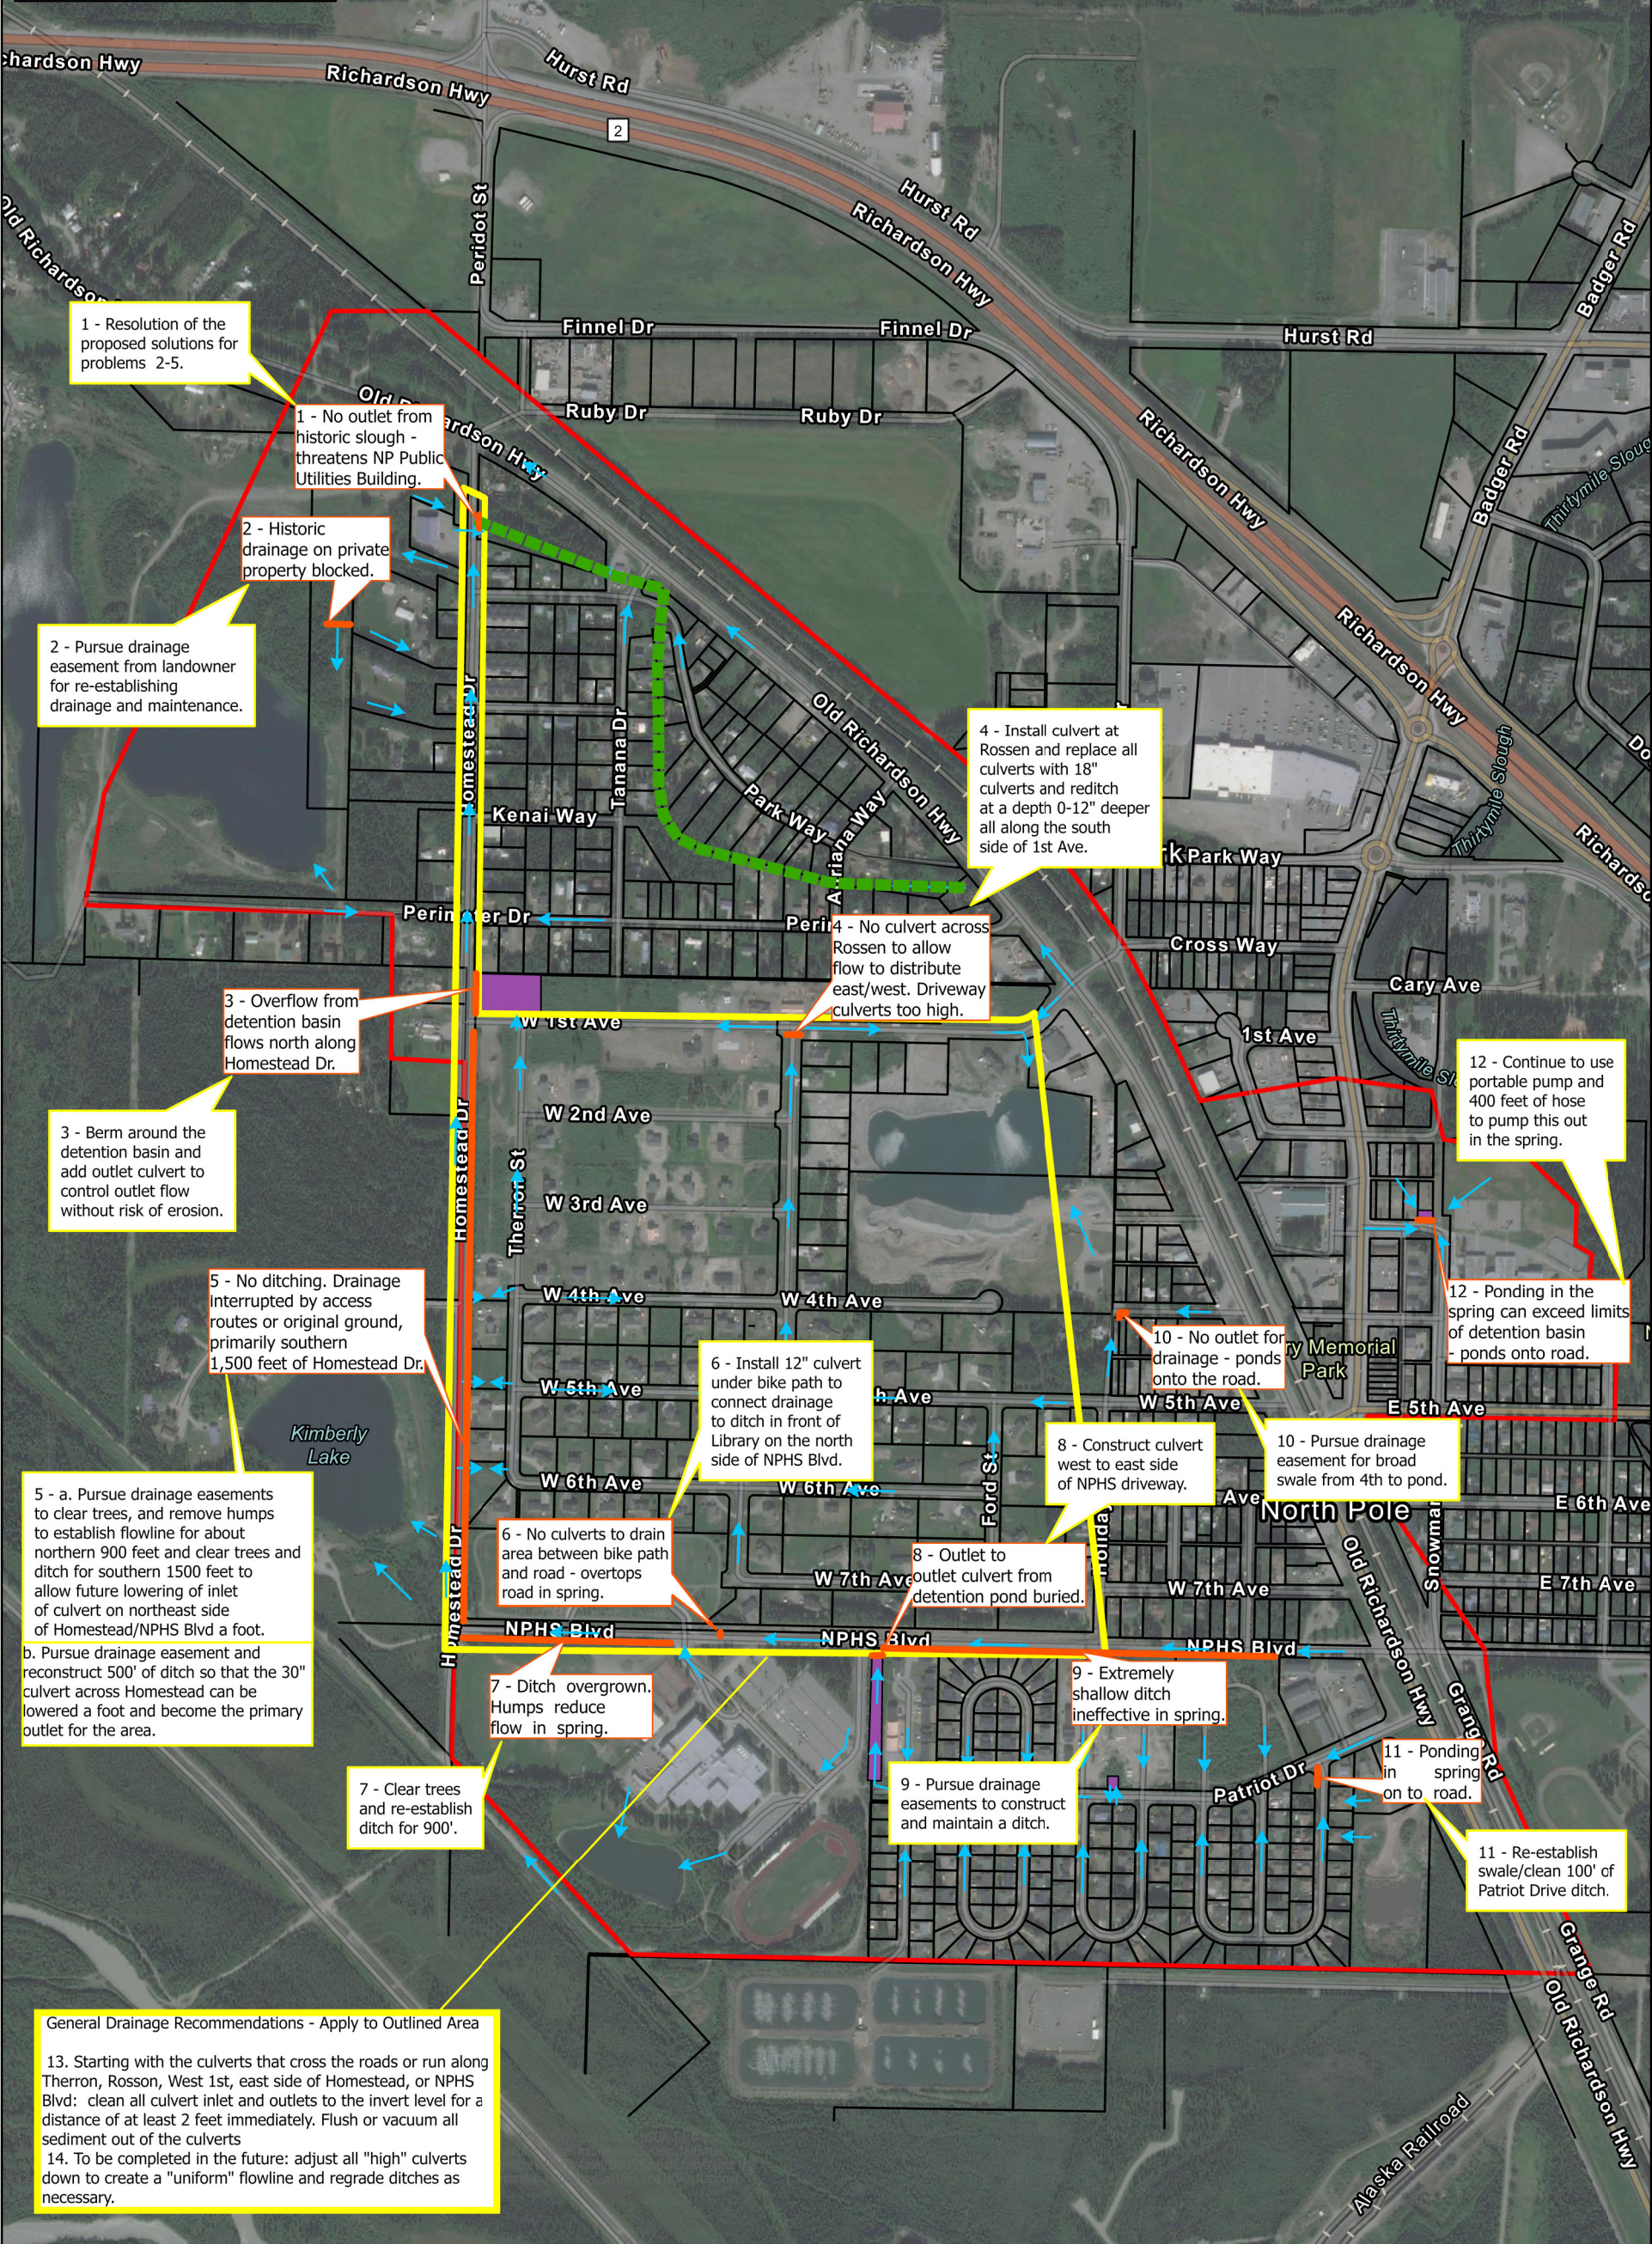
The proposed solutions to the problems are shown on Figure 2 along with the problem.

With these in mind, the following summarizes the goal of each solution for problems 1-5 to mitigate the overall issue:

1. Resolution of the proposed solutions for problems 2-5 is the ultimate goal but each individual one is really important and can be pursued independently if one is stalled or will take longer.

2. Establishing a pathway from the historic slough in Highway Park to the old gravel pit west of Homestead along a path that has a ditch that is now blocked would give the whole Highway Park/Ford Subdivision drainage system a relief point. A drainage easement would be required.

3. Providing a berm around the detention basin northeast of the intersection of Homestead and 1st and installing an outlet culvert would increase the storage and reduce the current erosion from overflow without increasing the flooding upstream.

4. Installing an equalization culvert across Rosson Cross Way would allow water to flow either to the detention pond or to Rosson's gravel pit along the existing drainage path. This spring the water elevation was 9"-12" higher on the west side than the east side.

5. For part a, establishing a clear drainage path on the east side of Homestead Drive that would allow flow south from 1st Ave to NPHS Blvd would connect the two existing outlets from this block. The southwest outlet invert is only 0.4 feet above the north outlet invert to the detention basin. We recommend digging the ditch with a profile that would allow (under part b) lowering the culvert at Homestead/NPHS Blvd a foot and lowering the existing drainage to Kimberly Lake. The toe of the existing embankment is tight to the existing property lines so drainage easements are likely needed for all of this work along Homestead and certainly for the portion to Kimberly Lake. As part of this, we also recommend obtaining drainage easements to preserve the existing drainage swales/pathways from Therron Street to Homestead Drive at 2nd, 3rd, 4th, 5th, and 6th avenues.

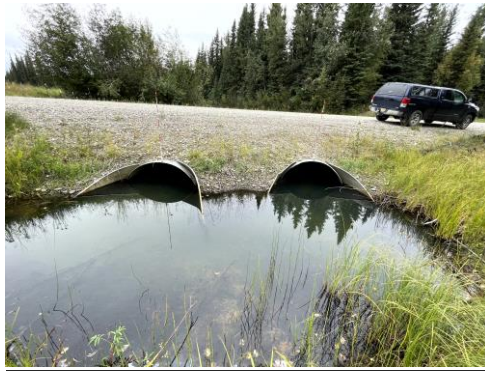
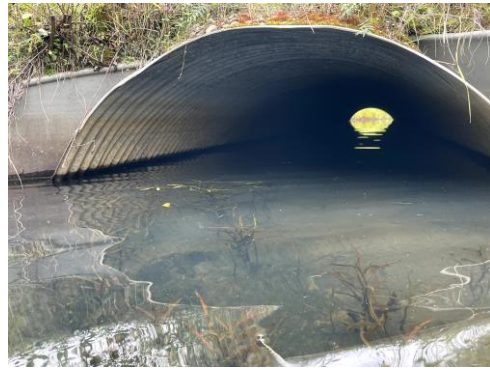
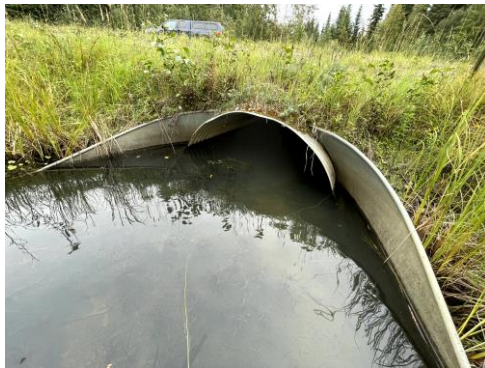
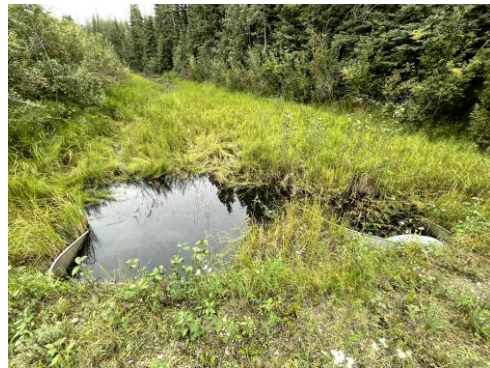
CULVERT 1: PSALMS BLVD NEAR BUZBY RD

Culverts are in good condition with no deformation or settlement observed.

Picture 1 – Culvert inlet

Picture 2 – Culvert inlet

Picture 3 – Culvert outlet

Picture 4 – Culvert outlet

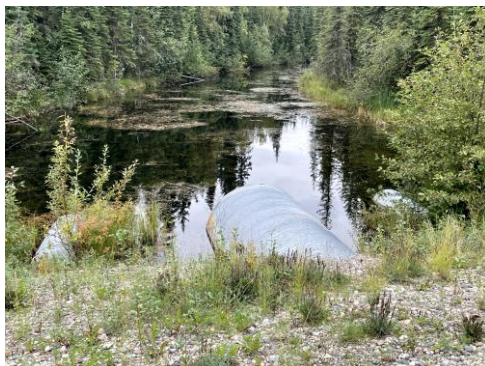
Picture 5 – Culvert outlets

Two 3' culverts and a 7' culvert are in good condition with a rust level to 1/3 the height of the 7' culvert

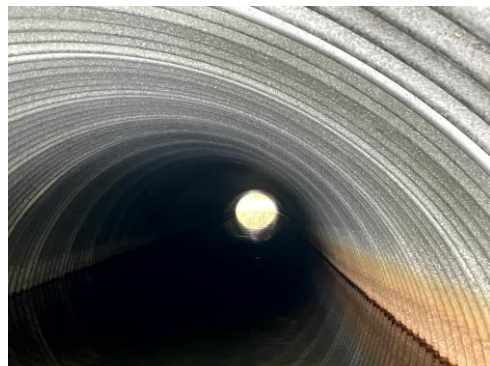
Picture 6 – Interior of 7' culvert demonstrates culvert's integrity

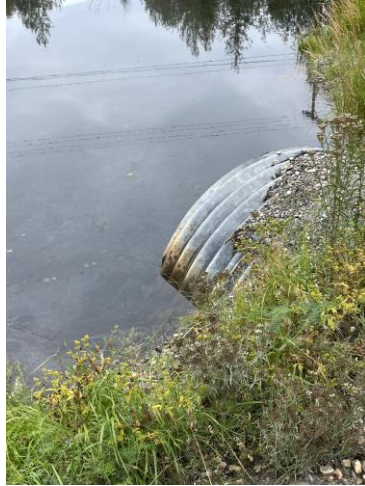
Picture 7 – Culvert outlet

This culvert is in good condition with little to no rust and only slight deformation.

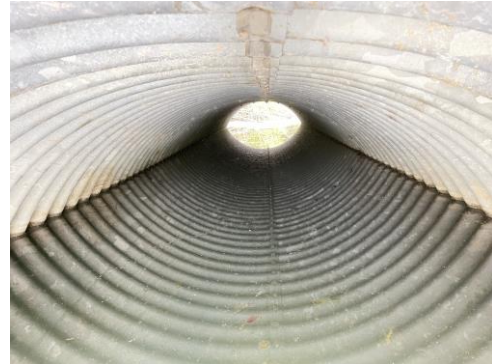
Picture 8 – Culvert interior shows minimal rust and deformation.

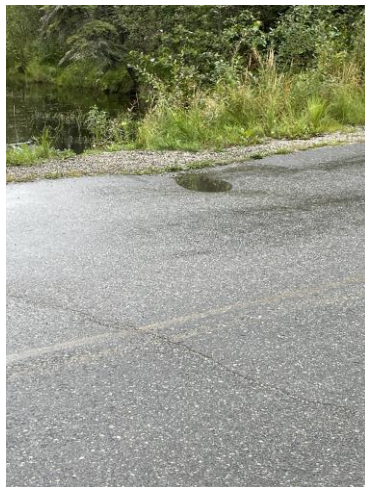
This culvert is deteriorating. As seen in the picture below, the culvert is rusted out near the inlet and the seams are separating at both ends of the culvert. 8th Avenue is settling over the south end of the culvert, where the culvert deterioration is the most severe.

Picture 9 – Road settlement occurring over culvert inlet

Replacement of the 6' diameter culvert at East 8th Avenue near Blanket Blvd is the top priority of this study. The culvert shows significant structural deficiencies. The culvert is rusting out near the water line and the seams are separating at the inlet and outlet. East 8th Avenue is also settling on the south side over top of the most severe culvert deterioration. Replacement is necessary to ensure drainage and roadway integrity. Replacing the culvert with a larger 8' diameter culvert will both match the upstream and downstream culvert sizes and likely be required to meet current fish passage requirements.

One culvert in particular, (East 8th Avenue near Blanket Boulevard) has significant structural damage and is recommended for timely replacement.

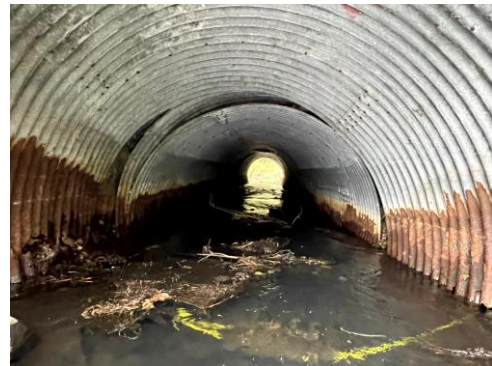
Picture 10 – Culvert seams separating at inlet

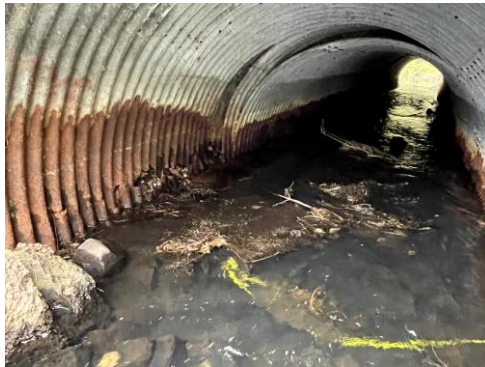
Picture 11 - Culvert rusted out and seams separating

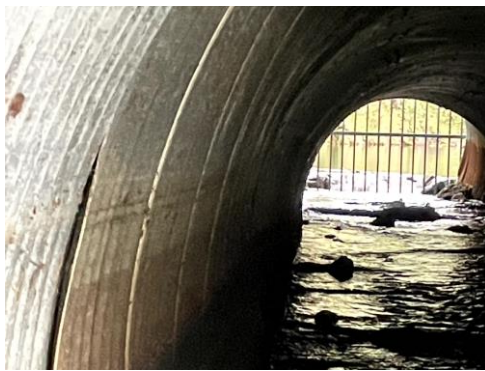
Picture 13 – Seams separating at outlet

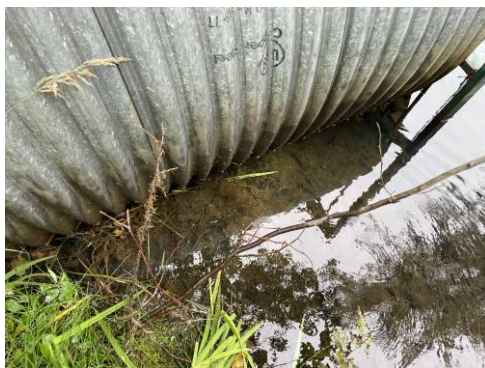
Picture 14 - Scouring along the exterior of the culvert

Replacement of the 6' diameter culvert at East 5th Avenue near Davis Road is the 3rd priority. This culvert is flattening which could lead to failure. Replacement of the culvert with a larger culvert to match the upstream and downstream 8' diameter culvert sizes will also likely be required to meet current fish passage requirements.

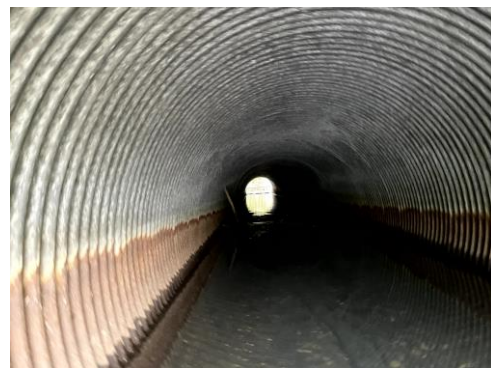
Replacement is needed for this culvert. Culvert is flattening on the upper quadrant on the east side which could lead to failure. Rust is present to ½ of its height.

Picture 15 – Flattening of culvert is evident in the middle section; rust is present to 1/3 of culvert height.

The third priority culvert is at East 5th Avenue near Davis Road which should be replaced because of the circular deformation occurring and be resized for fish passage. The 4th (Cary Avenue near North Santa Claus Lane) and 5th (Snowman Lane near City Hall) priority culvert replacements are to increase the size of the culverts to meet fish passage requirements and to match the size of upstream and downstream culvert sizes.

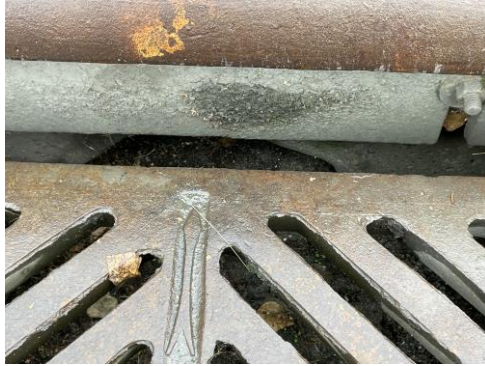
This storm drain is on the south side of east 5th Avenue and is not connected to the adjacent culverts. However, it was noted that the storm drain is not currently functional because it is 90% full of sediment, consequently providing little to no drainage.

Picture 16 - Storm drain is filled with sediment

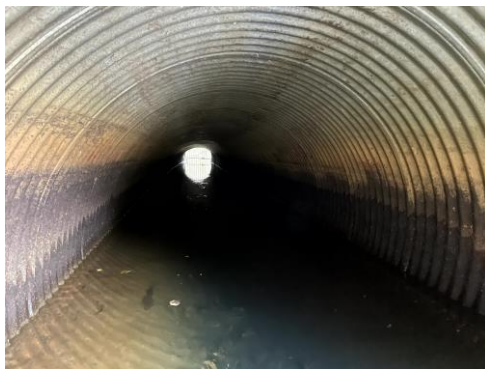
Culvert is in good condition with slight vertical settlement and slight circular deformation. Culvert is rusted to $\frac{2}{3}$ the interior height and some scour is present at the inlet and outlet.

Picture 17 - Interior rust to $\frac{2}{3}$ height of the culvert wall

The 5th priority, replacement of the 6' Snowman Lane culvert near City Hall will be the final culvert in the slough to be resized to an 8' or larger diameter to meet current fish passage requirements and to bring the culvert sizes along the slough into conformity with each other.

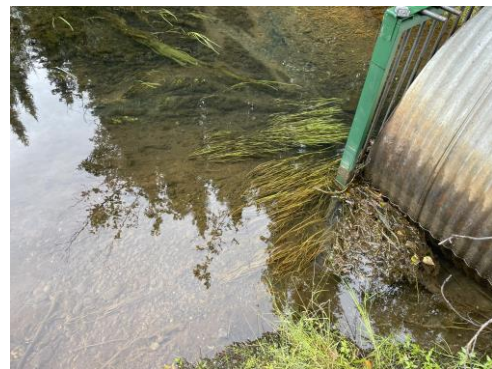
Picture 18 - Scour evident at culvert inlet and outlet

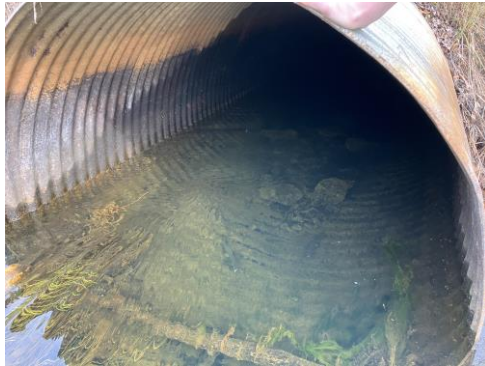
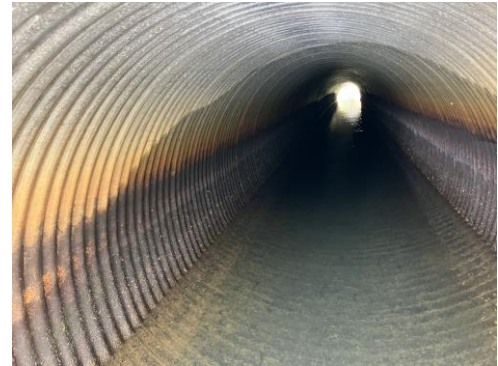
This culvert is undersized (5' diameter) compared to upstream and downstream culverts, which has a potential impact on fish passage under high flow conditions. The rust level is $\frac{2}{3}$ to $\frac{3}{4}$ of the culvert's interior height indicating the water level is regularly nearer to capacity than other culverts. Mild scour and bank erosion are present.

Picture 19 - Rust visible on sidewall with fish swimming in culvert Picture 20 - Culvert has maintained structural integrity

The 4th priority is the replacement of the Cary Avenue culvert near North Santa Claus Lane to ensure fish passage in high flow conditions and meet current fish passage requirements. Currently, it is the only 5' diameter culvert on the Thirtymile slough and shows signs that it often flows at near-capacity, which decreases the ability of fish to travel through the culvert.

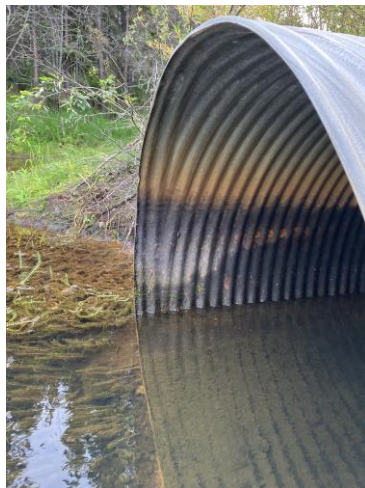
Picture 21 - Rust at culvert outlet

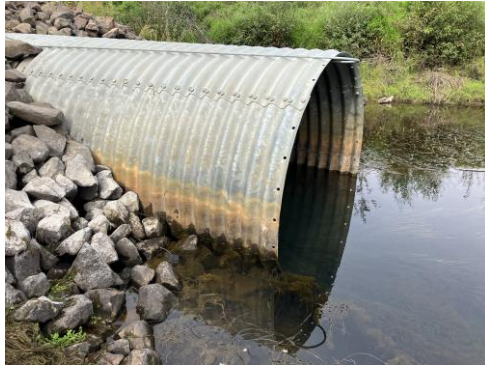
Culvert is in great condition with a rust level of $\frac{1}{4}$ the culvert height and no indication of deflection. The high-water mark on this culvert is near the crown of the culvert and likely comes from when the downstream Richardson Highway culverts were plugged, causing the slough to back-up. This culvert is maintained by DOT but is included in this study because its functioning affects the city of North Pole's drainage system.

Picture 22 - Rock at the inlet and outlet prevent bank scour

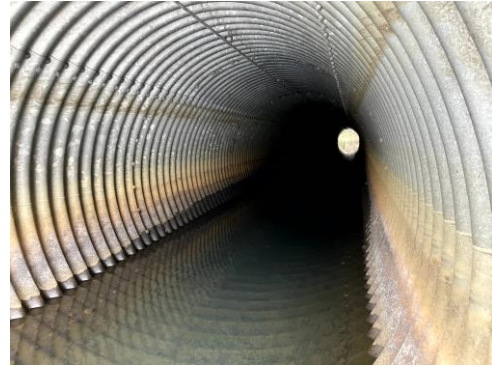
Picture 23 - Culvert integrity is evidenced by a lack of deflection; high-water mark is visible near the crown of the culvert.

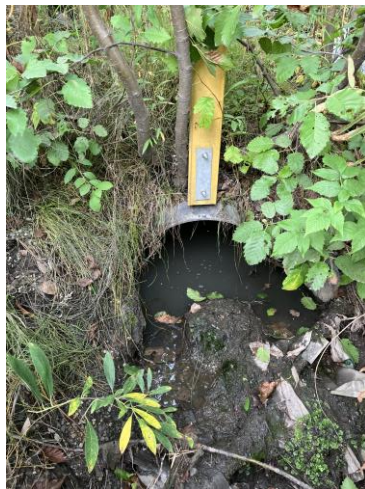
This storm drain outlet is near the outlet of the Saint Nicholas Drive culvert. The outlet is partially obscured and could affect drainage during high flow conditions. The pipe appears in fair condition at the outlet.

Picture 24 - Storm drain outlet is partially obscured

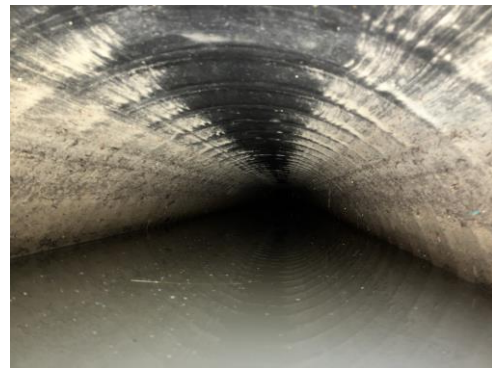
Picture 25 - Interior pipe wall appears in fair condition at the outlet

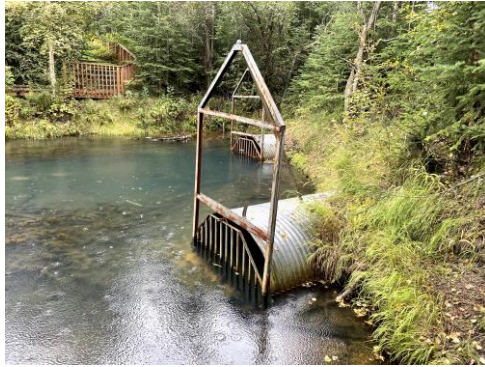
Maintenance is needed on these two approximately 400-foot-long culverts under the Richardson Highway near Santa Claus Lane. Continued cleaning is required to counteract vertical settlement and blockage due to beaver activity. Options for lining the culverts should be investigated to ensure the culverts maintain their integrity over the long-term.

Picture 26 - The outlet of east culvert is in the background and outlet of west culvert is in the foreground. The east culvert has been cleared of debris and is fully functional. The west culvert is partially blocked by both debris and culvert settlement.

The second priority is maintenance on the Richardson Highway culverts near North Santa Claus Lane to improve and maintain their performance in peak flow conditions and to maintain fish passage. Options for lining the culverts to provide long-term integrity should be investigated. Since these culverts are within the State of Alaska Department of Transportation right-of-way and not under the city's control we recommend continued coordination by the City with the State to help keep these a priority and reliable to pass the peak flows.

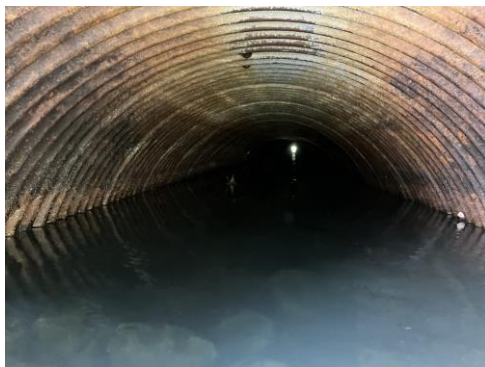
The east culvert was completely blocked by beaver debris and consequently submerged this past spring. DOT contracted with divers to completely clear the culvert and it is now fully operational, although it is experiencing minor settlement. The end of the culvert can be sighted with a sightline approximately 6" below the top of the culvert. Approximately 4 to 6 inches of sediment was measured in the culvert at the inlet and outlet.

Picture 27 - East culvert inlet, rust line shows that the culvert frequently ran full in the past (likely when plugged by beaver debris)

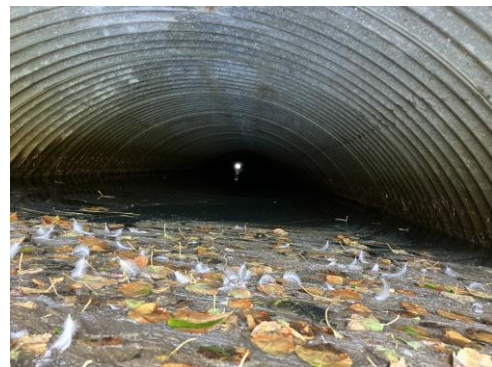
Picture 28 - East culvert outlet. Some settlement is evident.

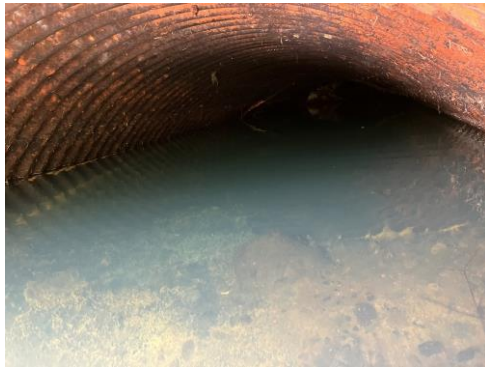
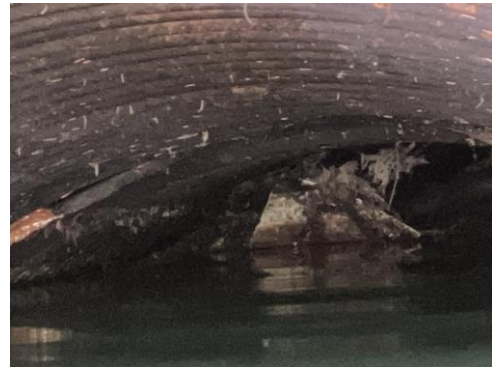
The west culvert is operating at a limited capacity. The settlement in this culvert is significant. The end can be sighted at a sight line approximately 18" below the culvert top and according to DOT, a significant amount of beaver debris is present. Approximately 6 to 8 inches of sediment was measured in the culvert at the inlet and outlet.

Picture 29 & 30 - West culvert inlet shows debris and significant rust accumulation.

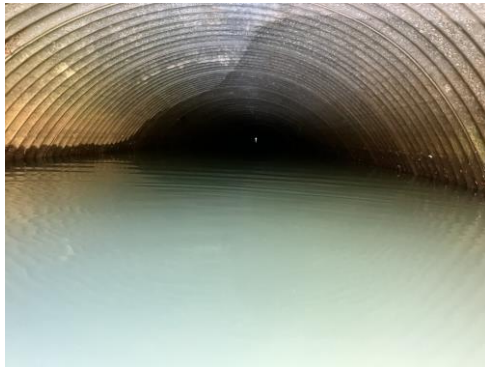
Picture 31 - West culvert outlet. Culvert settlement is occurring mid-culvert.

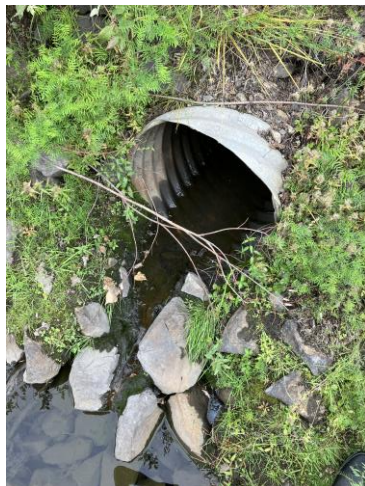
Picture 32 - Outlet of storm drain coming from McDonald's parking lot

The outlet of the storm drain shows rust over $\frac{3}{4}$ of the pipe height and sediment adhered to the top of the pipe. Pipe settlement is suspected but was not visible from the outlet. The storm drain serves the McDonald's parking lot, which is a known trouble spot for stormwater ponding.

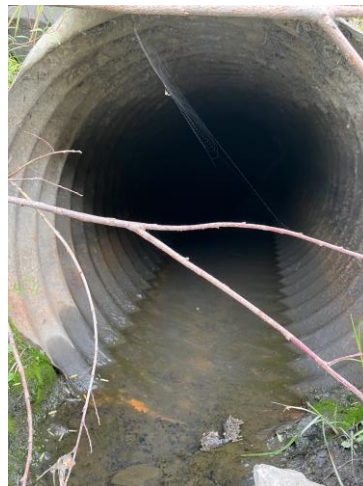
Picture 33 - Rust present to more than $\frac{3}{4}$ of pipe height and mud adhered to the top of the pipe

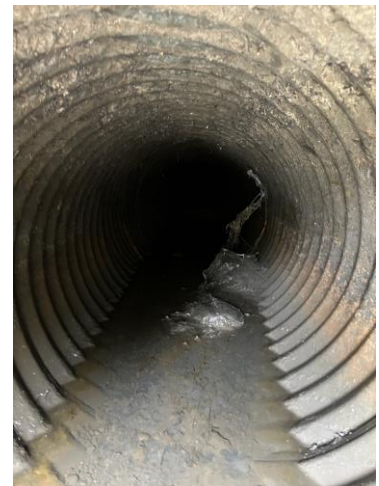
Picture 34 – Some debris was observed inside the pipe

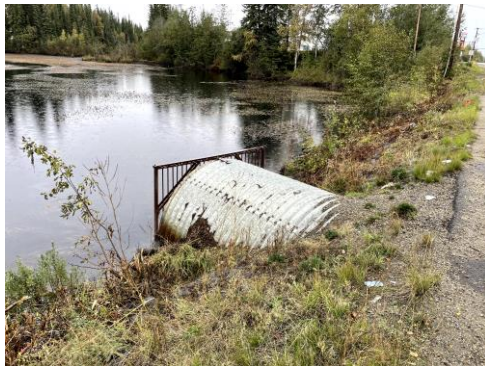
Picture 35 - Hurst Road culvert inlet

Culvert is well-sized with a 9' diameter and is in great condition. It has a rust height of only 1/3 of the pipe height and is not deforming or settling vertically. This culvert is maintained by DOT but is included in this study because its functioning affects the city of North Pole's drainage system.

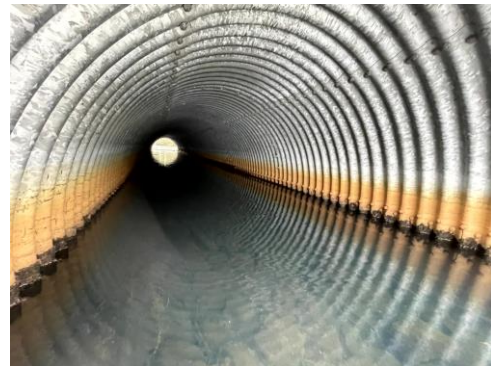
Picture 36 - Culvert is not settling or deforming
