VILLAGE SAFE WATER

BEAVER, ALASKA

WELL IMPROVEMENTS

Regarding: Beaver Well Modifications, PWS # 360230

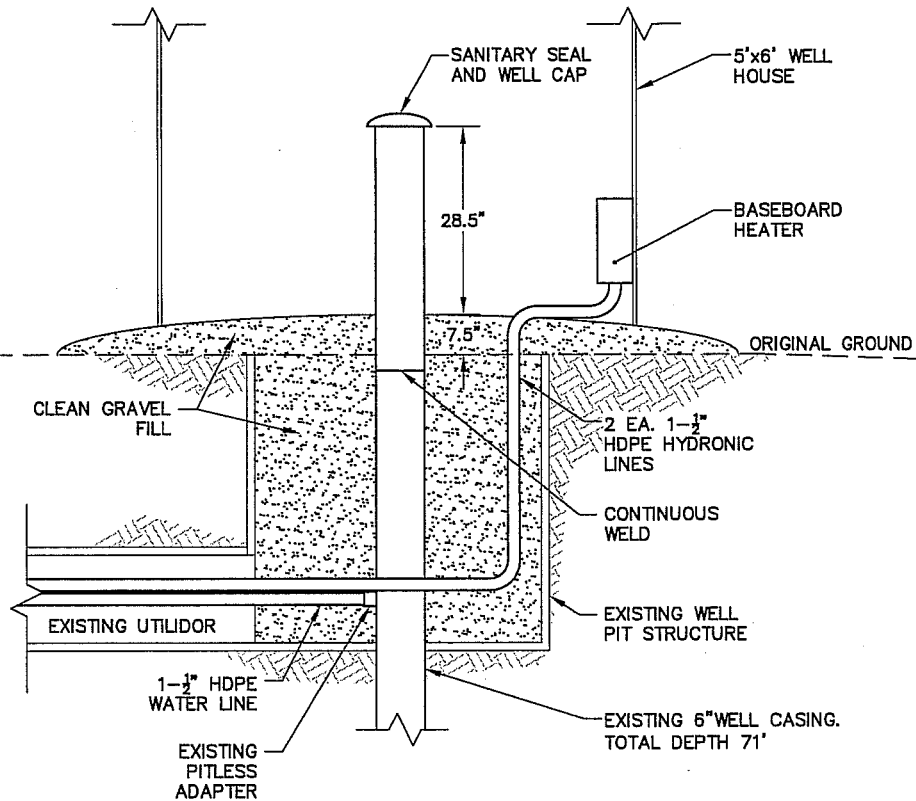
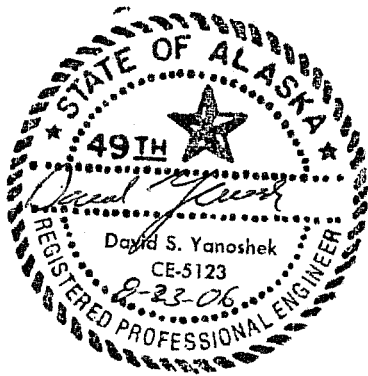
Figure: 2

1. SEE FIGURE 1 FOR WELL LOCATION.
2. SEE MEMO DATED 8-18-06 FOR ADDITIONAL INFORMATION.
3. SEE 11-6-95 WELL LOG FOR SUBSURFACE INFORMATION.
4. WELL IMPROVMENTS PERFORMED IN JULY, 2006.

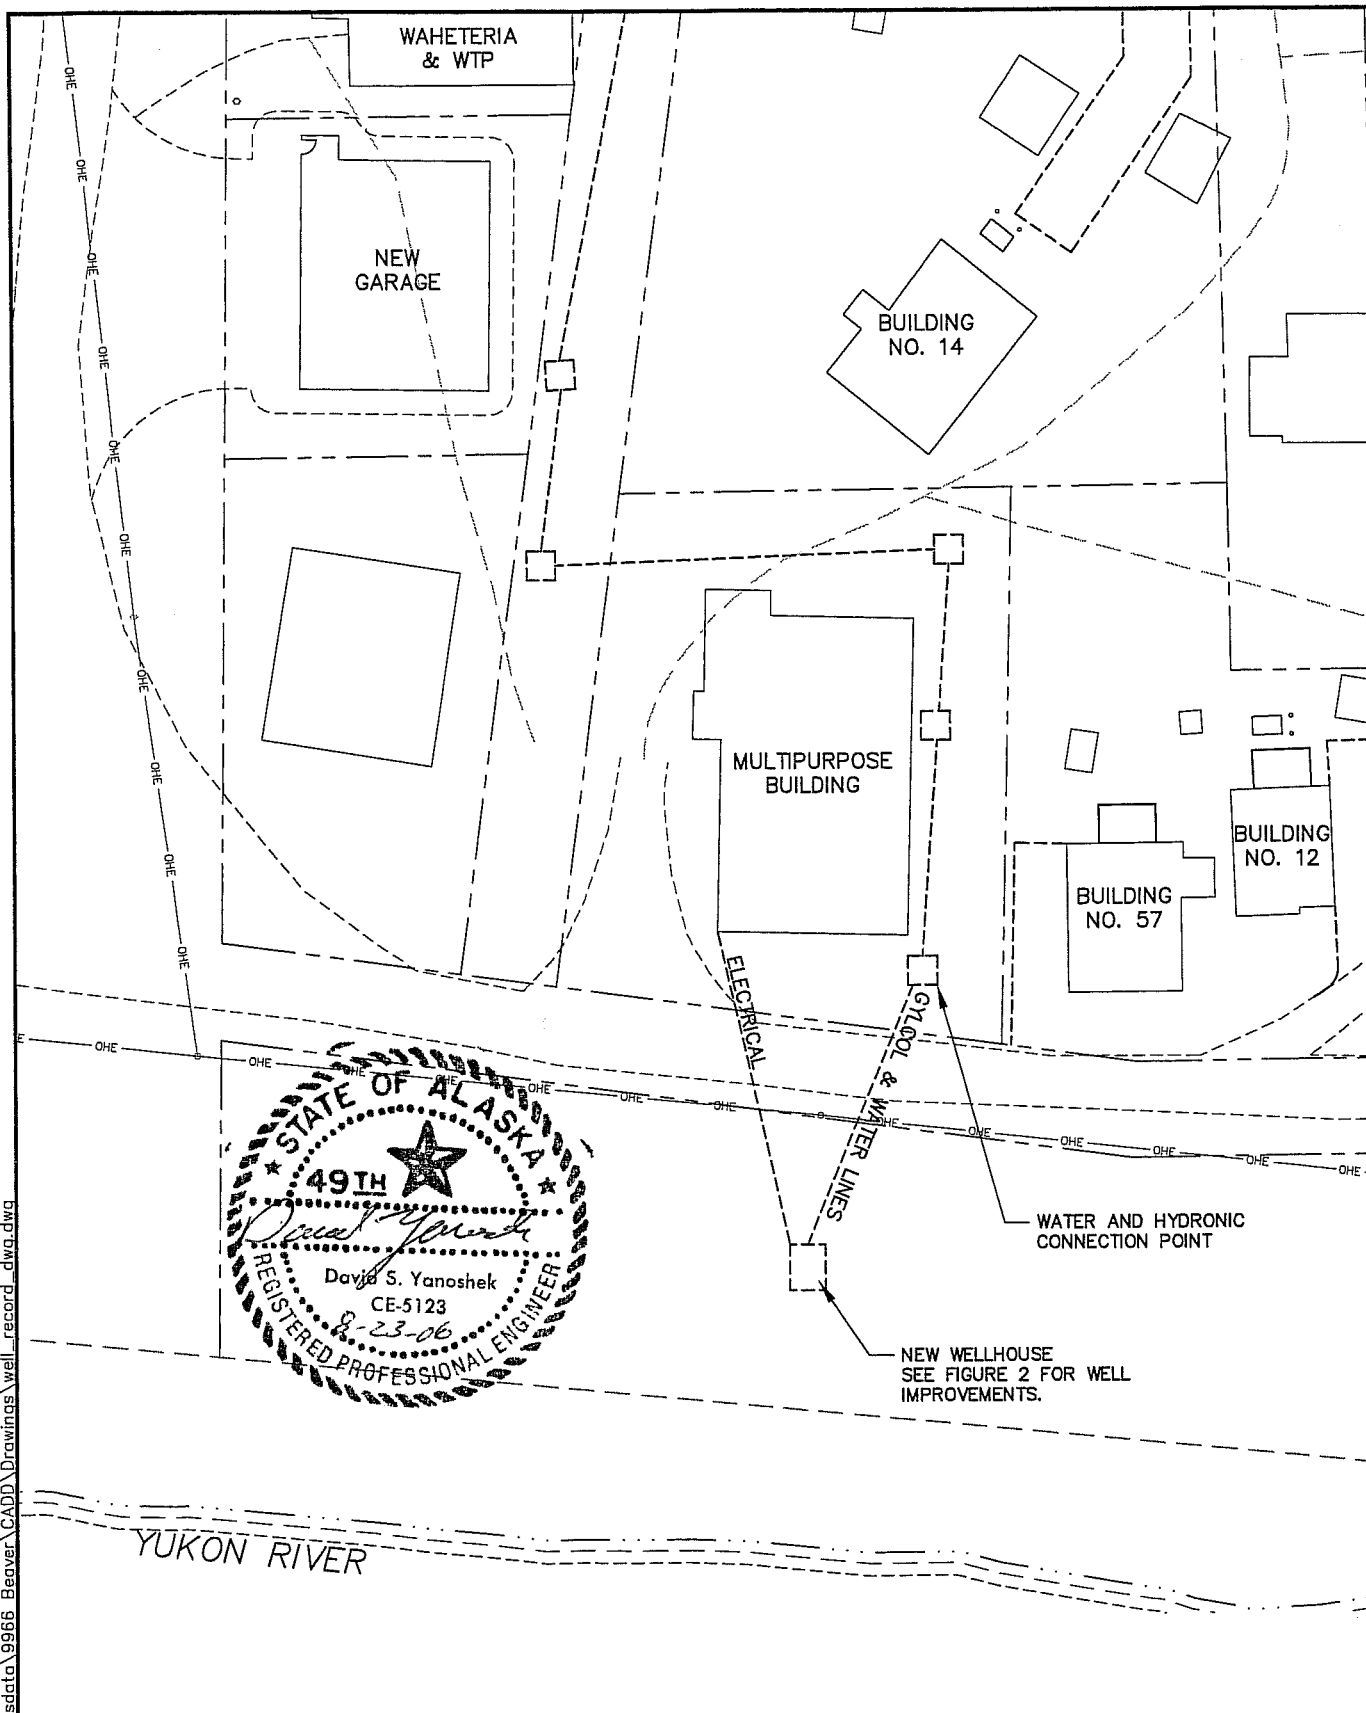
Project No:	9966
Drawn By:	TKM
Scale:	1"=40'
Date:	8/06
Figure:	1

NEW WELL HOUSE LOCATION

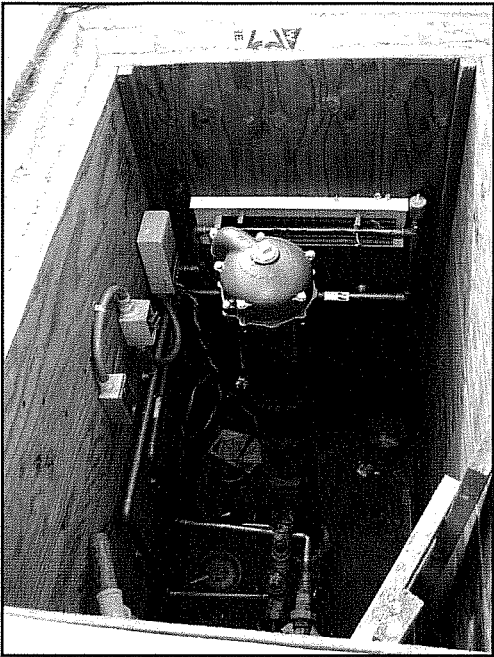
Well pit before modifications

Modifications were made to the existing well in Beaver to raise the well cap above existing grade and fill in the well pit in June and July, 2006. Modifications include removing existing valves and fittings for the water line and heat lines from the well pit. Existing pipes were replaced back at the next junction box (located near the multipurpose building). The water line was tied directly into the pitless adaptor. Heat lines were run up, above ground level to a new fin tube heater. The former well pit was filled with clean gravel and a protective structure was constructed over the well. Sanitary seal and cap were installed. See attached photos.

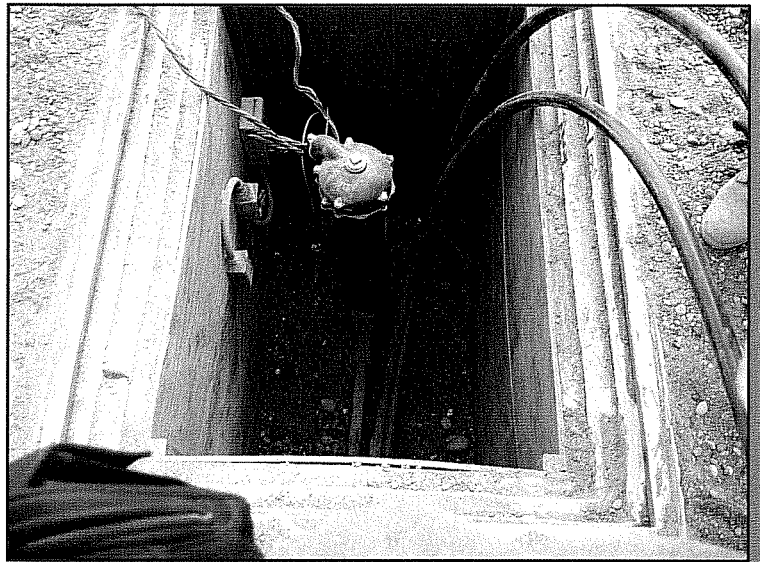
Well pit during modifications

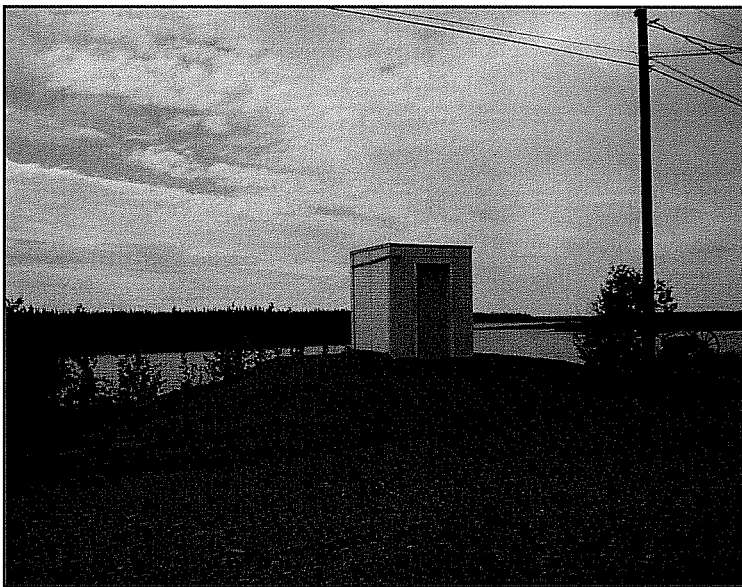
Well house after modifications

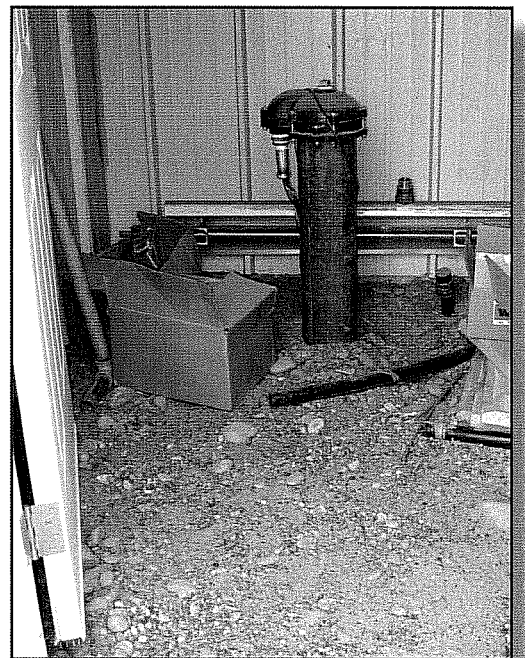
Inside of well house after modifications
