SUBJECT: Ekwok, Alaska Flood Survey Field Trip Report

1. On 16 October 2002 Mr. Jim Fuhrer and I traveled to Ekwok, Alaska to document the peak water surface elevation of the May 2002 ice jam flood at that community. The work was performed under Federal Emergency Management Agency Project Number SN00157N2002T of DR-1423-AK.

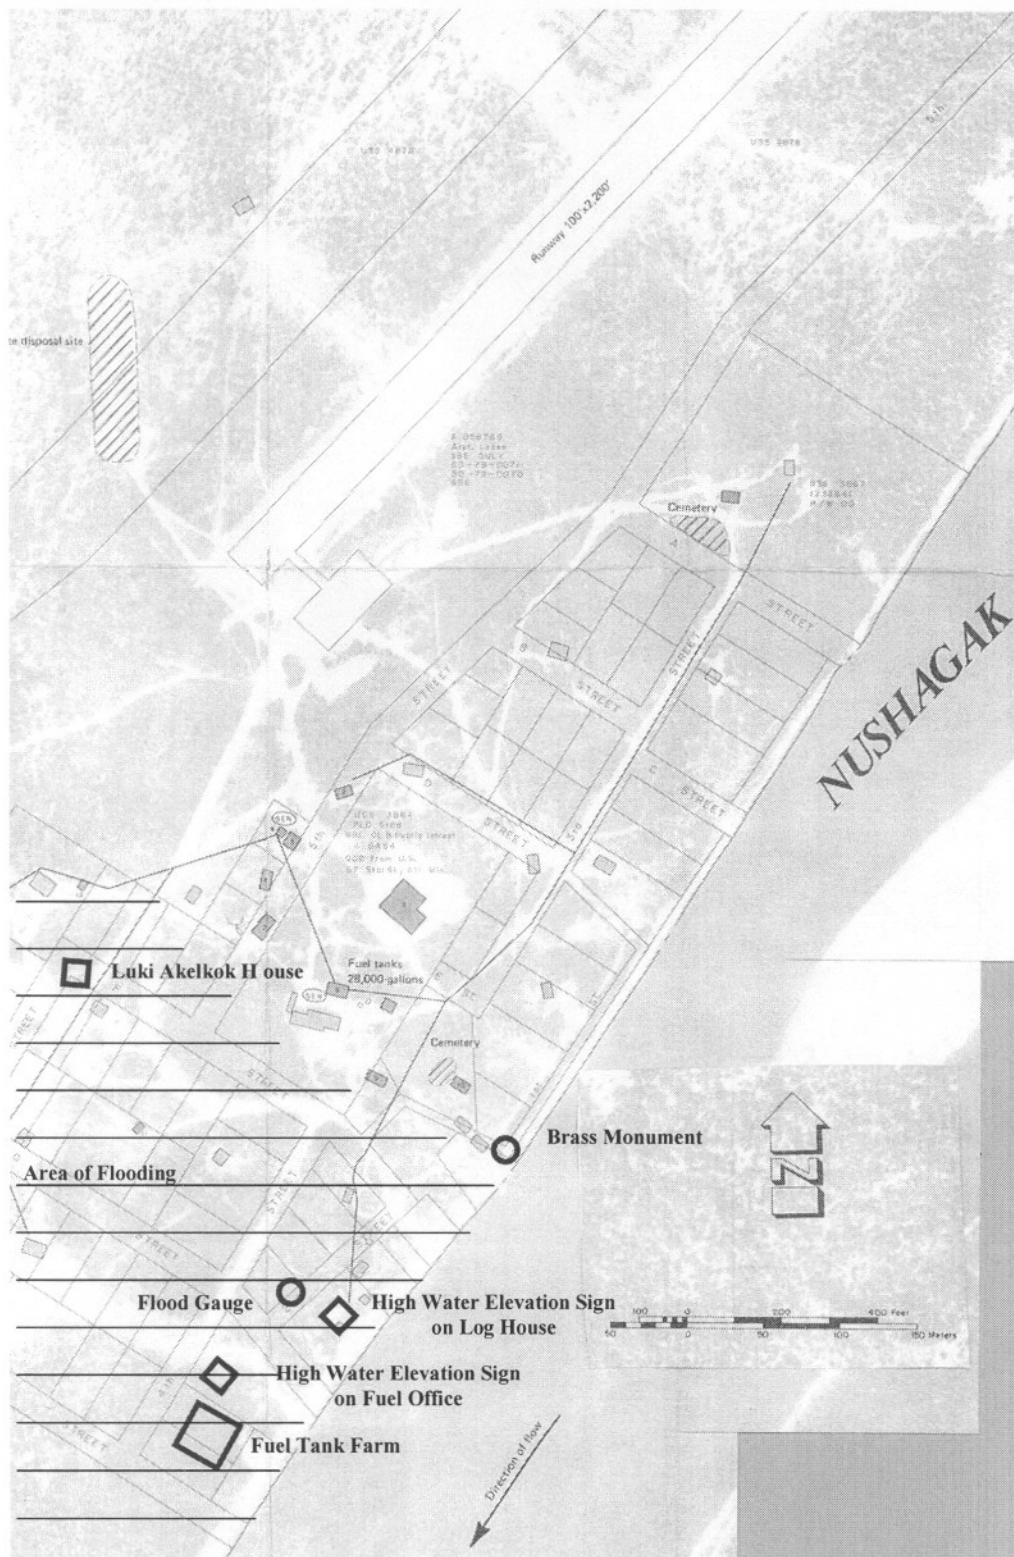
Figure 2. Map of Ekwok, Alaska showing the approximate area of the flood plain.

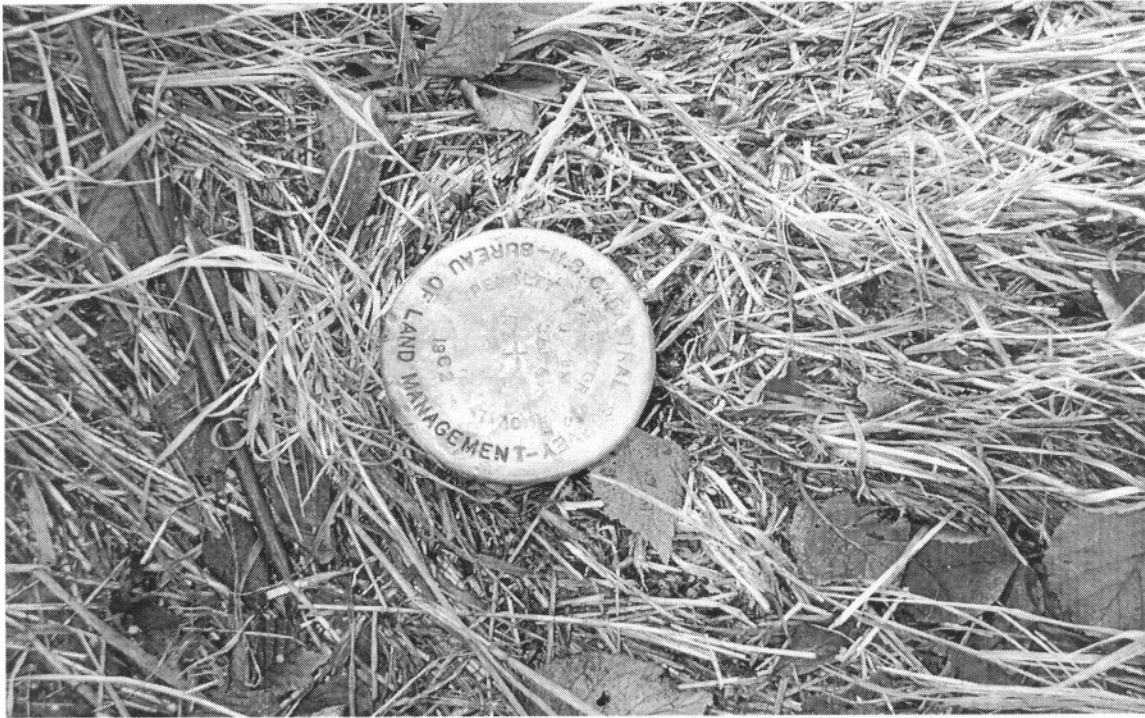
4. The top of a brass capped iron post monument was used as the datum for this survey. The monument is located 90 feet southeast of the north corner of lot 6, block 11, of U.S.S. No. 4878. The 3-inch brass cap was marked U.S. Cadastral Survey, Bureau of Land Management, U.S.L.M. No. 3864. It is located at the intersection of a high ridge running through the center of the village generally perpendicular to the Nushagak River and the top of the right bank of the river. The monument is on the top of the ridge about 25 feet above the river. The location is N59° 20.904 and W157° 28.529 by a hand-held Geographic Positioning System (GPS). Corwin & Associates Inc. arbitrarily set the elevation of the monument at 500.00 feet in 1985 for a sewage improvement project in the village. The monument is shown in figures 3 and 4.

Figure 3. A view of the monument used for the survey datum.

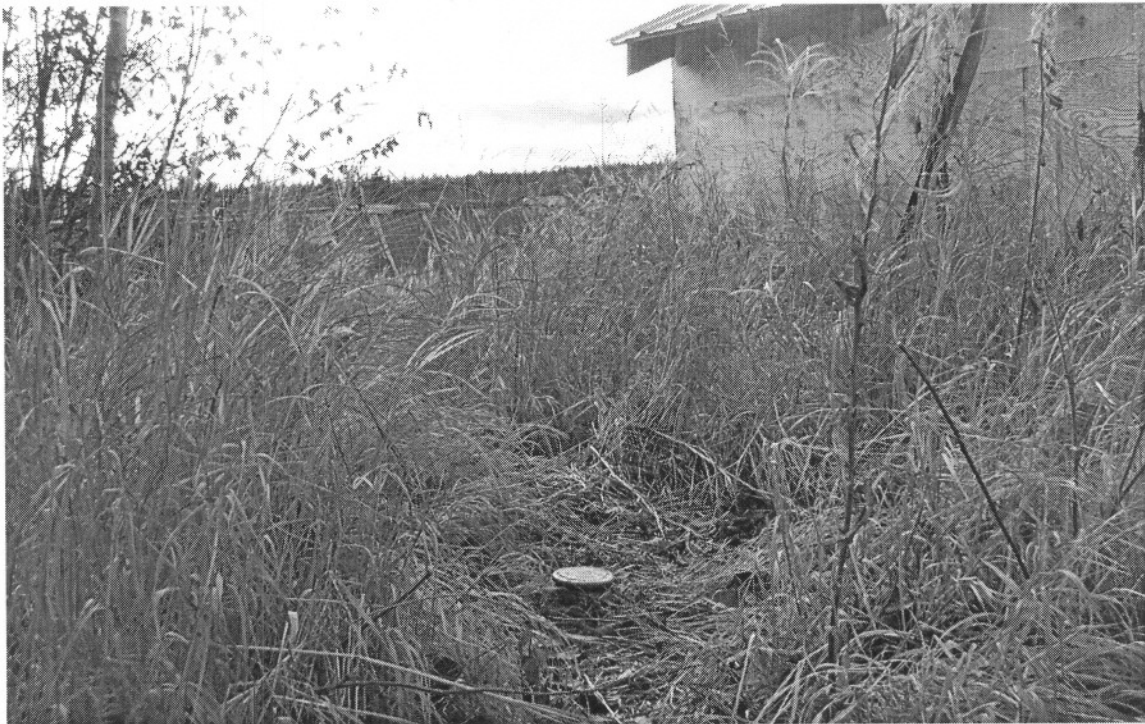
Figure 4. A view of the monument with the edge of the ridgeline in the background.

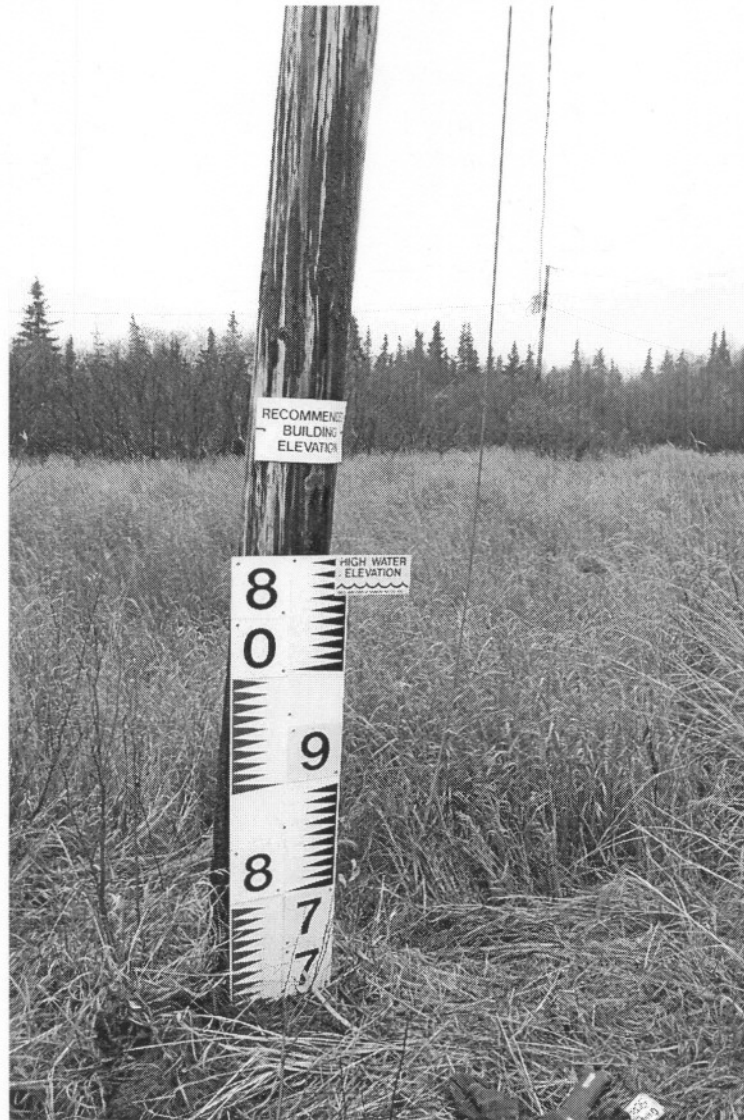
5. The elevation of the 2002 flood was recorded at 480.70 feet. A 1-foot by 4-foot flood gauge was placed on a power pole located at N59° 20.855 and W157° 28.664. Its location is also shown on the village map of figure 2. The general ground elevation at the pole was 476.56 feet. The bottom of the flood gauge is about a half a foot above the ground. The mounted gauge is shown in figure 5. The Recommended Building Elevation was set at 481.70 feet, one foot above the Flood of Record

Figure 5. A view of the mounted flood gauge.

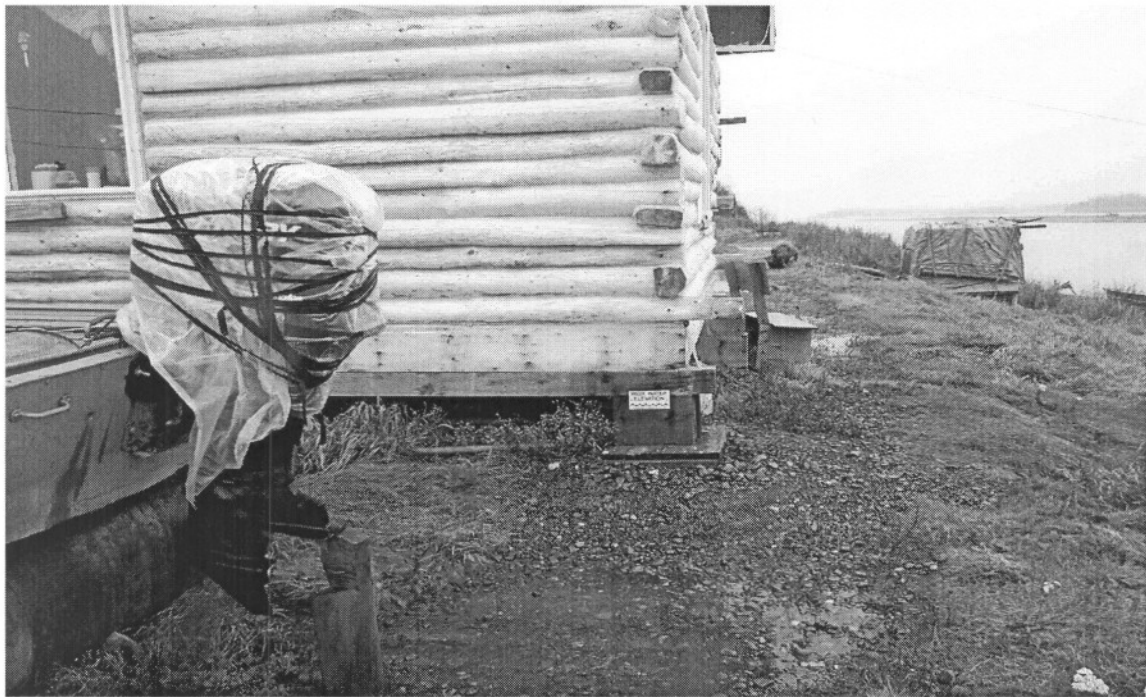
6. Three 4-inch by 8-inch High Water Elevation (HWE) signs were placed in the village. They are placed so that the height of the 2002 flood is at the water symbol on the lower edge of the HWE sign. One was mounted on the flood gauge as shown in figure 5. The second was mounted on the riverward, downstream footing of a log home located on the riverbank. The building and its HWE sign is shown in figure 6. The water symbol on the sign is one foot above the ground. Its location is N59° 20.847 and W157° 28.632, which is also shown on the village map. The third HWE sign was placed on the front downstream corner of the office at the Tesoro fuel tank farm. The first floor elevation of the office was 478.61 feet. The building and its HWE sign are shown in figure 6. Its location is N59° 20.798 and W157° 28.739. Its location is also shown on the village map.

Figure 6. A High Water Elevation sign mounted at the flood level on a house on the riverbank.

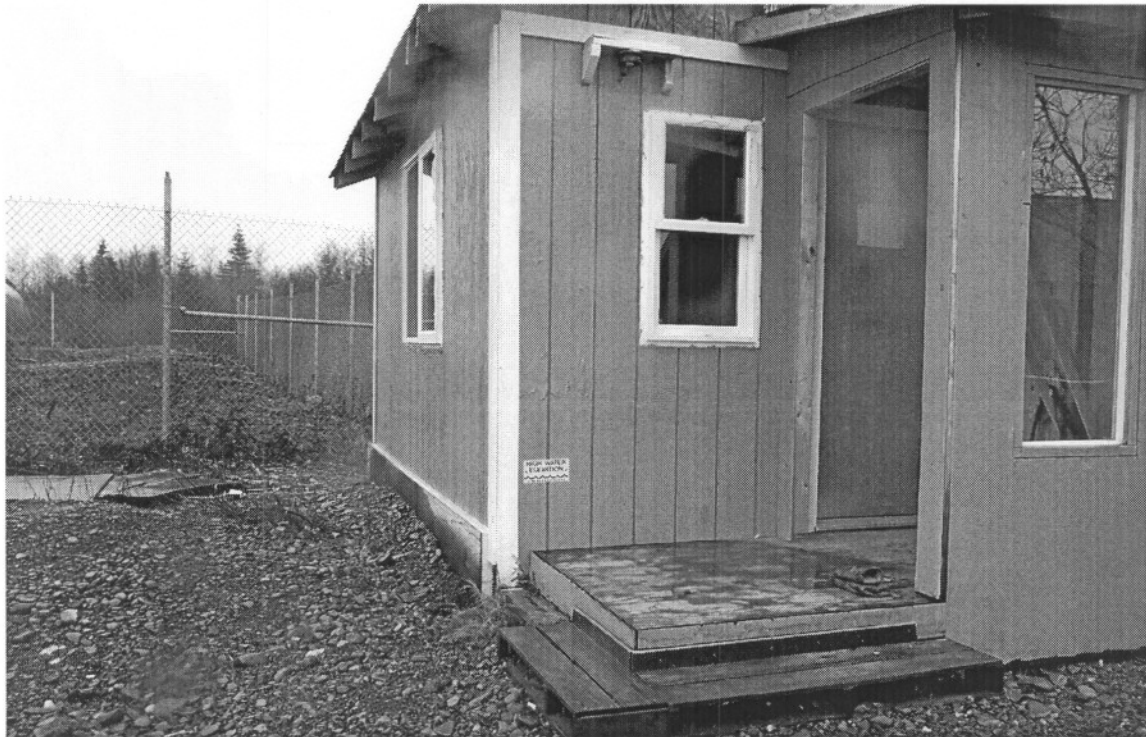
Figure 7. A High Water Elevation sign mounted at the flood level on the Tesoro fuel office.
