Prepared for: City of Ekwok P.O. Box 49 Ekwok, Alaska 99580

SECT	<u>PAGE</u>
1.0	INTRODUCTION
2.0	FIELD NARRATIVE
3.0	SEWER MAIN INSPECTION
4.0	WATER QUALITY TESTING9
5.0	SUNSHINE VIEW LEACHFIELDS
5.1	Karasti Property 15
5.2	Walcott Property 16
6.0	REFERENCES
	TABLES
Table 3	3.1 Sewer Main Inspection7
Table 4	4.1 Water Quality Testing (June 2009)9
Table 4	4.2 Water Quality Testing (September 2009)10
Table 4	1.3 Frank Nicholai – Additional Water Quality Testing (June 2009)11
Table 5	5.1 Leachfield Survey Results
Table 5	5.2 Percolation Test Results
Table 5	5.3 Sunshine View Groundwater Depths
	FIGURES
Figure	C1 Project Overview
Figure	C2 Sunshine View Subdivision On-Site Systems
Figure	C3 Sunshine View Subdivision On-Site Systems
Figure (C4 Existing and Proposed Sanitary Sewer System

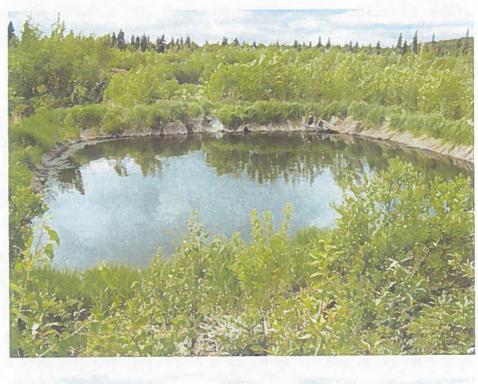
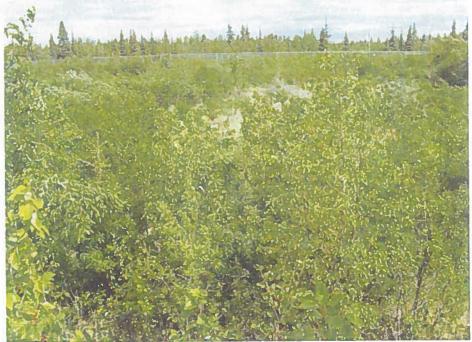
Figure 2. Ekwok sewage lagoon, Ekwok, Alaska, June 2009. Top Photo: view is to southwest. The areal extent of the waterbody in the foreground is ~150 m². Bottom Photo: The remainder of the ~8,600 m², two-cell sewage lagoon is not currently flooded and has become vegetated by willow, balsam poplar, and bluejoint. No wildlife use of the waterbody was observed during field surveys.

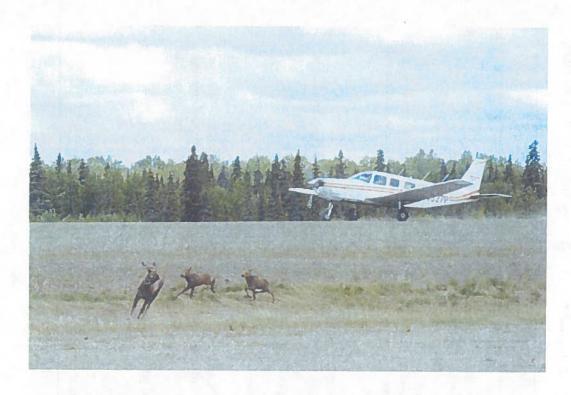
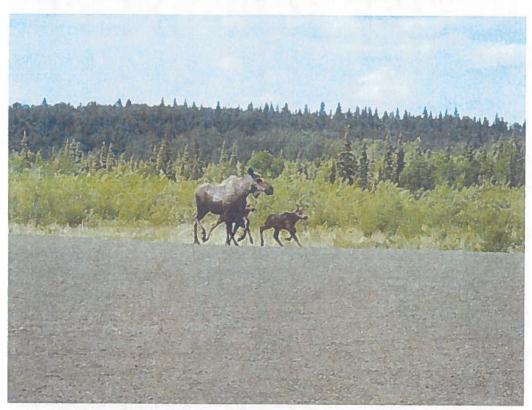
Figure 3. Cow moose and young calves within aircraft operations area during arrival of Pen Air PA-32, 19 June 2009, Ekwok, Alaska.

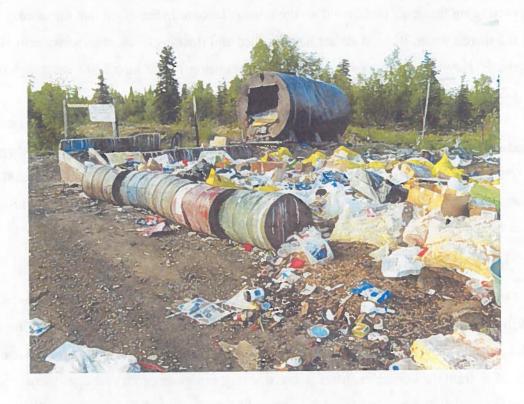
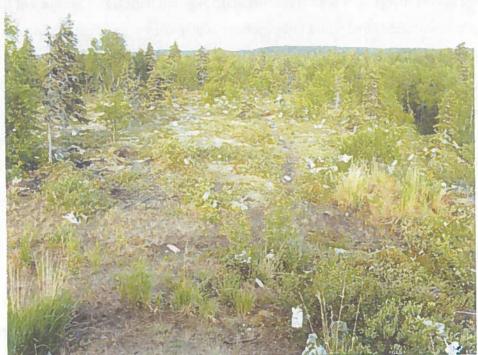
Figure 4. Ekwok landfill, Ekwok, Alaska, June 2009. View is to southeast. Note abundance of avian feces on barrels in foreground. Common Ravens and Black-billed Magpies were observed here during every survey conducted at the landfill.

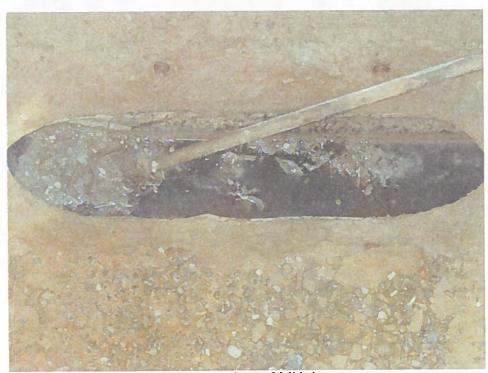
Closer view of MH-1

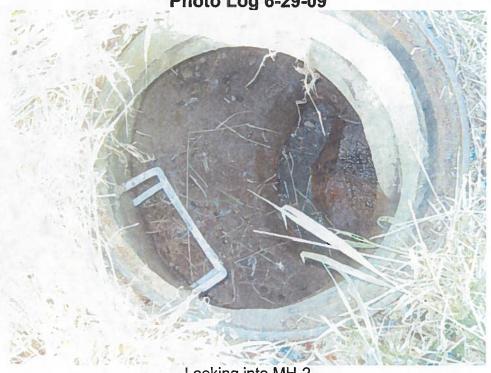
Looking into MH-2

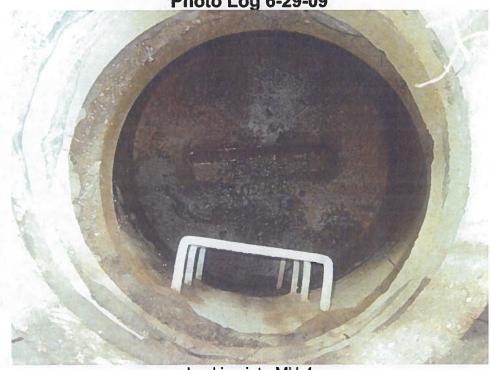
Looking into MH-4

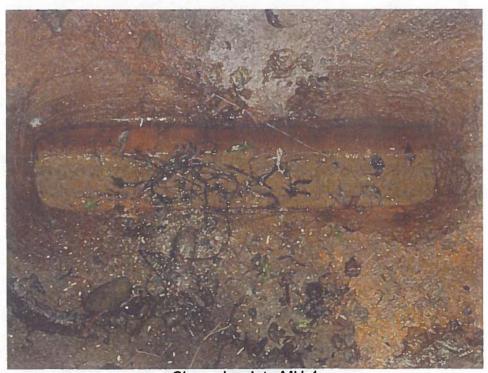
Close view into MH-4

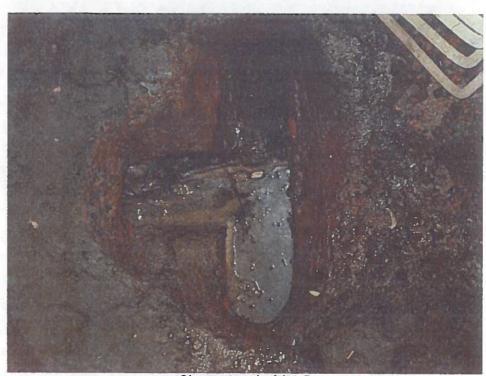
Close view in MH-5

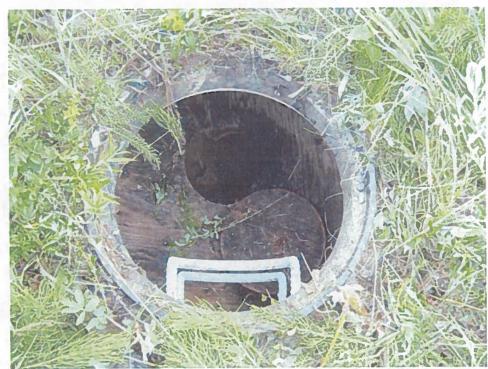
Looking into MH-6

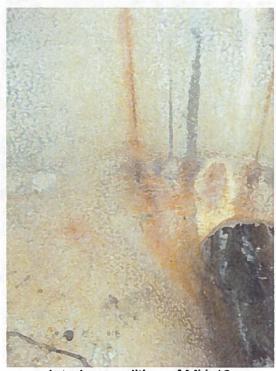
Interior condition of MH-13

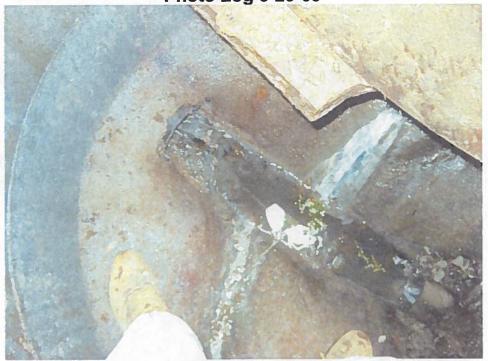
Interior condition of MH-13(2)

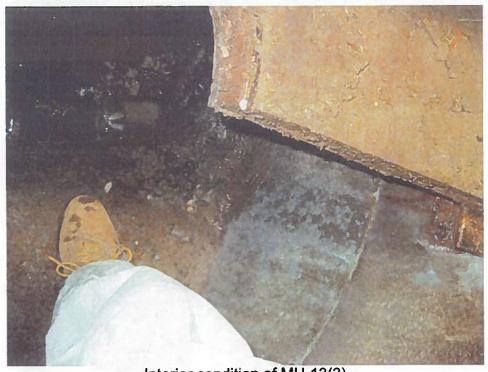
Interior condition of MH-13(3)

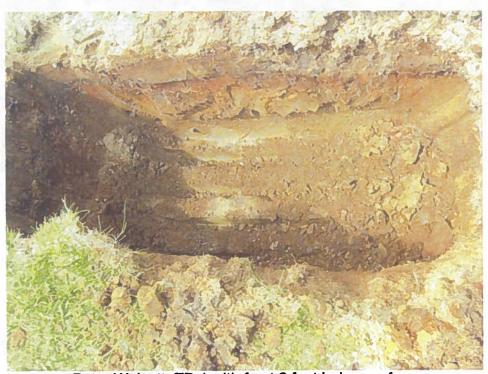
Peter Walcott, TP-1 with frost 2 feet below surface

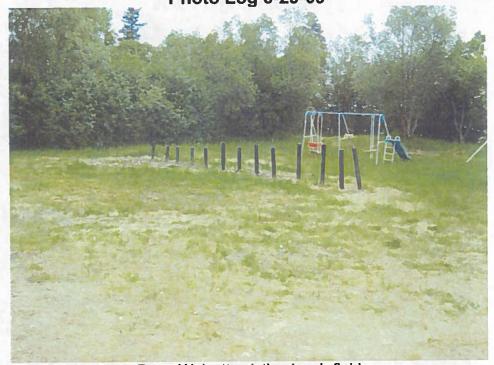
Peter Walcott existing leach field

Peter Walcott owns two lots adjacent to one another (Lot 3A and Lot 3B). It is not believed that a standard leachfield can be installed on Lot 3B due to separation distance requirements (lot lines, bluff, drinking well) and the presence of frozen soil on his property. The owner's leachfield is relatively close to Karasti's leachfield, and the installation of any system within 100 feet of the bluff is not recommended. It may be necessary to install a system on the owner's adjacent lot (3A), which would require the installation of a sand filter (or alternate system); possibly an integral lift station pumping chamber (STEP system); a new resized septic tank (for both the pumping chamber and the owner's actual usage - up to 10 people in the household); and insulation for the service piping.

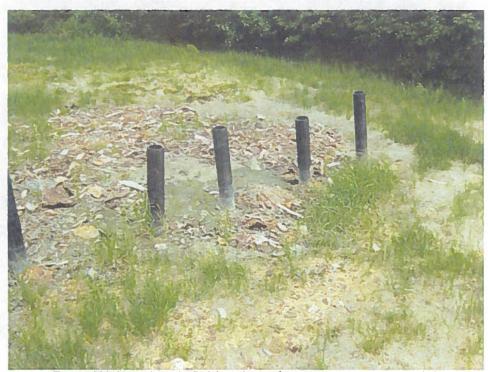
It is believed that the failures that have occurred for the Sunshine View on-site systems could be due to a failure of the "Infiltrator" absorption fields. This may be the result of clogging of the underlying soil matrix from passing fines, and clogging of the Infiltrators' manifold systems. Richard Stermer reported that during repairs completed on Sandra Stermer's system (in approximately 2005), that the system failure appeared to be solely a result of the infiltrators.

Peter Walcott leach field with surface sewage present(2)

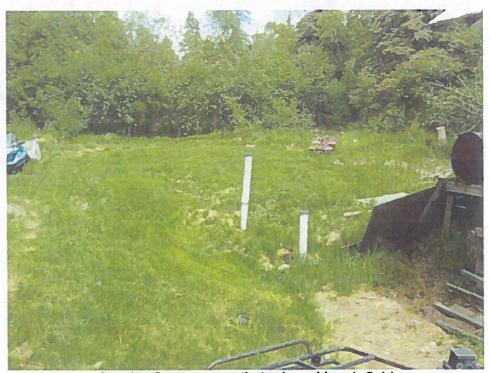
Sandra Stermer, septic tank and leach field
