**Report on Site Conditions and Recommended Plan of Action
For
Sanitation Improvements in Tununak, Alaska**

TUNUNAK TRIBAL COUNCIL

MWH

December 2010

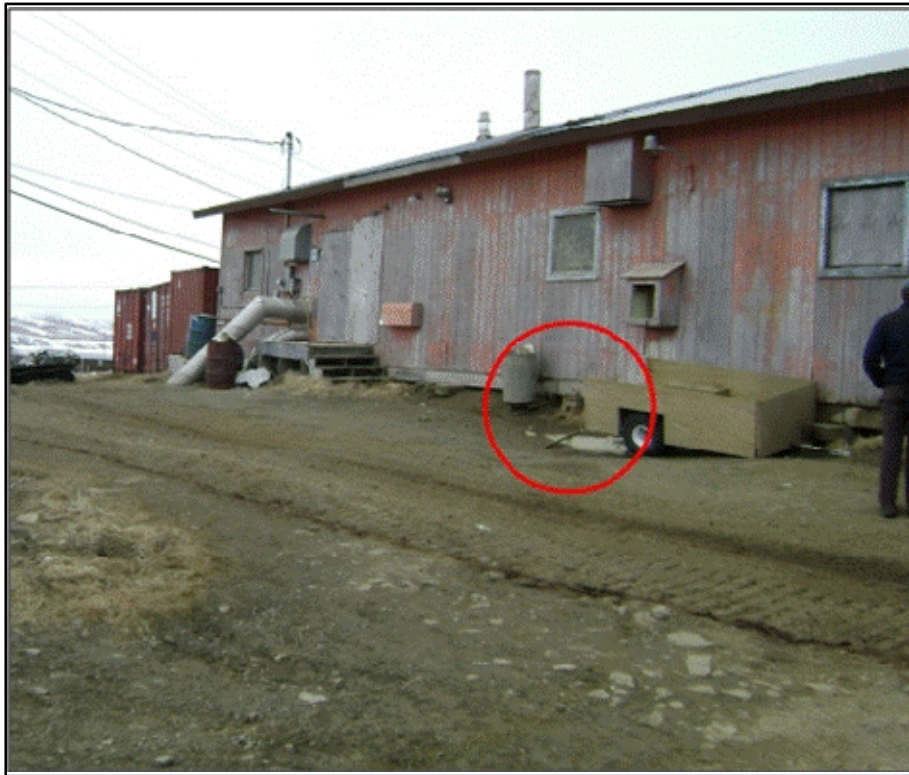
The building appears to lack adequate insulation and is not weather tight. Overall, the building shows obvious signs of serious exterior deterioration, with a foundation system that has not been adjusted to compensate for building movement due to frost heave and permafrost degradation. The watering point and backwash waste discharge have contributed to erosion of the building foundation, which has settled along the south side of the building.

Photo 1: South side of the Water Treatment Plant Washeteria Abandoned watering point drainage area (circled). Boarded-up door to boiler room. Arctic pipeline to clinic in background.

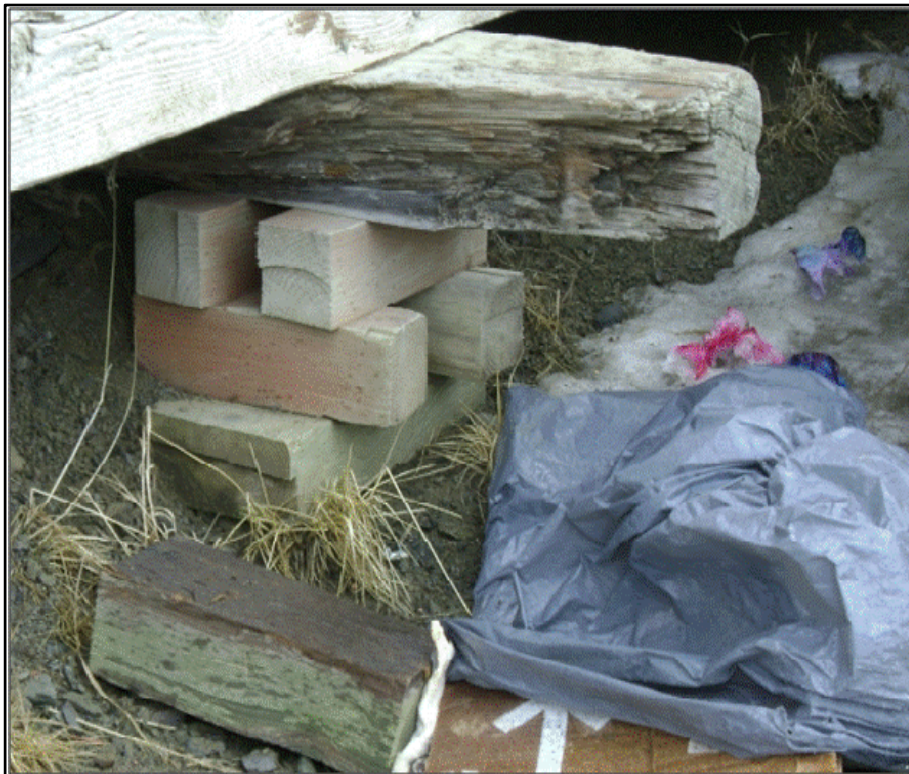
Photo 2: Detail of undermined building cribbing below abandoned watering point.

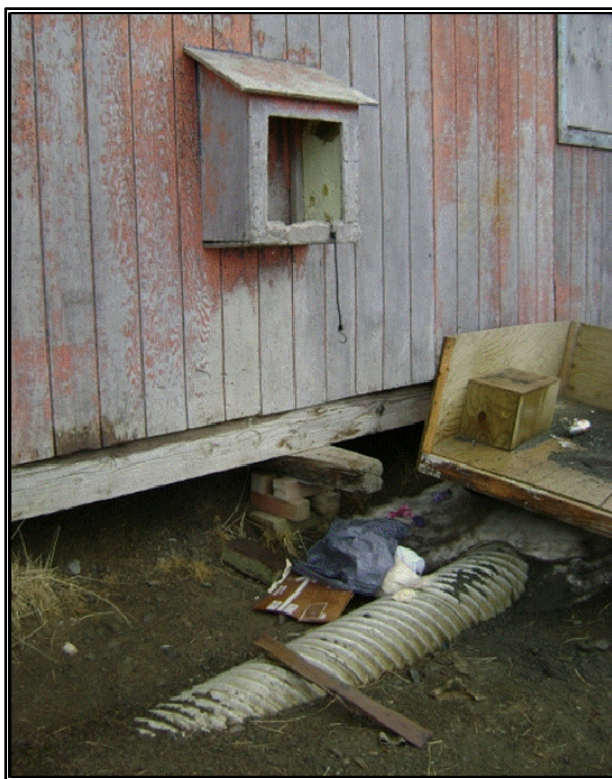
Photo 3: Abandoned watering point showing erosion of building footings. Arctic pipe from water source previously buried has been exposed.

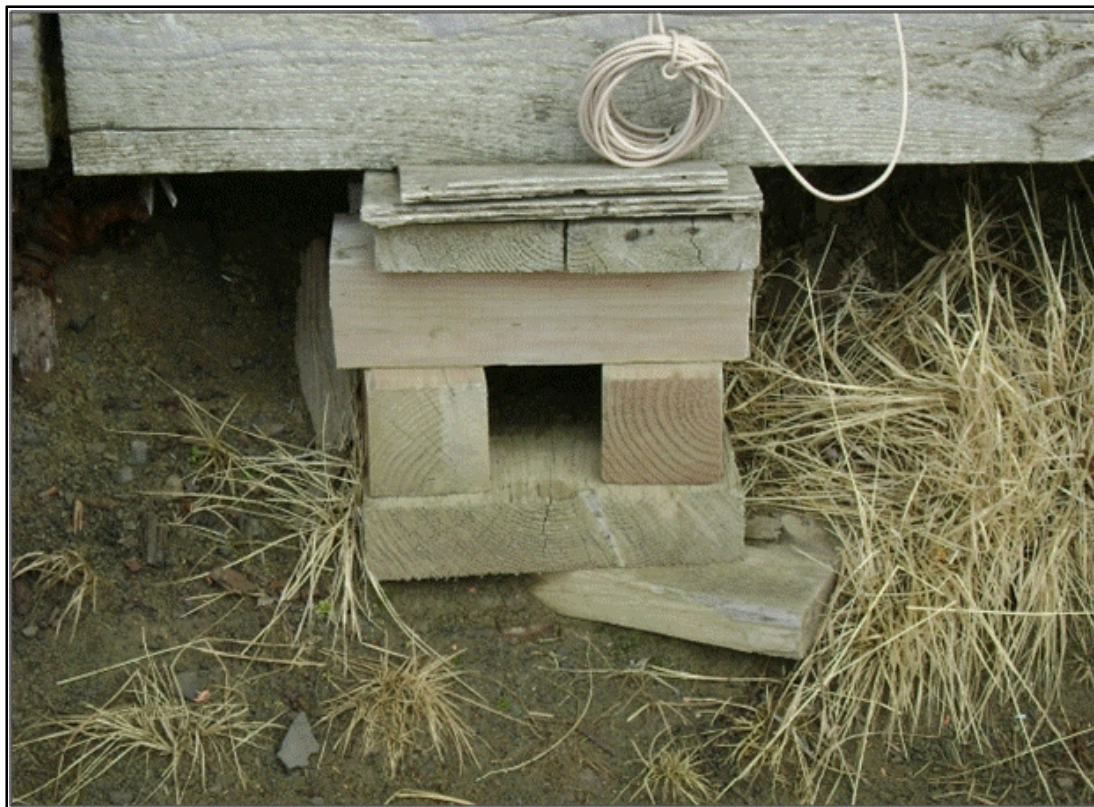
Photo 4: Another footing eroded along south wall of water treatment plant building.

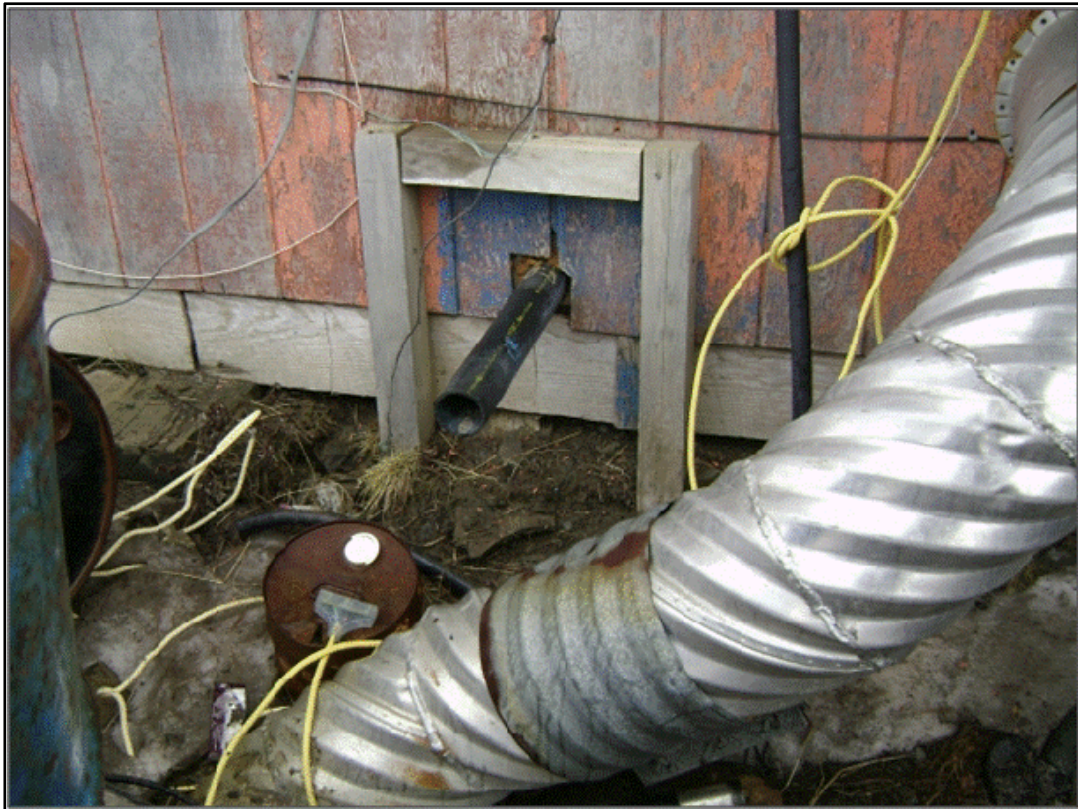
Photo 5: Discharge from filter backwash above Arctic pipes.

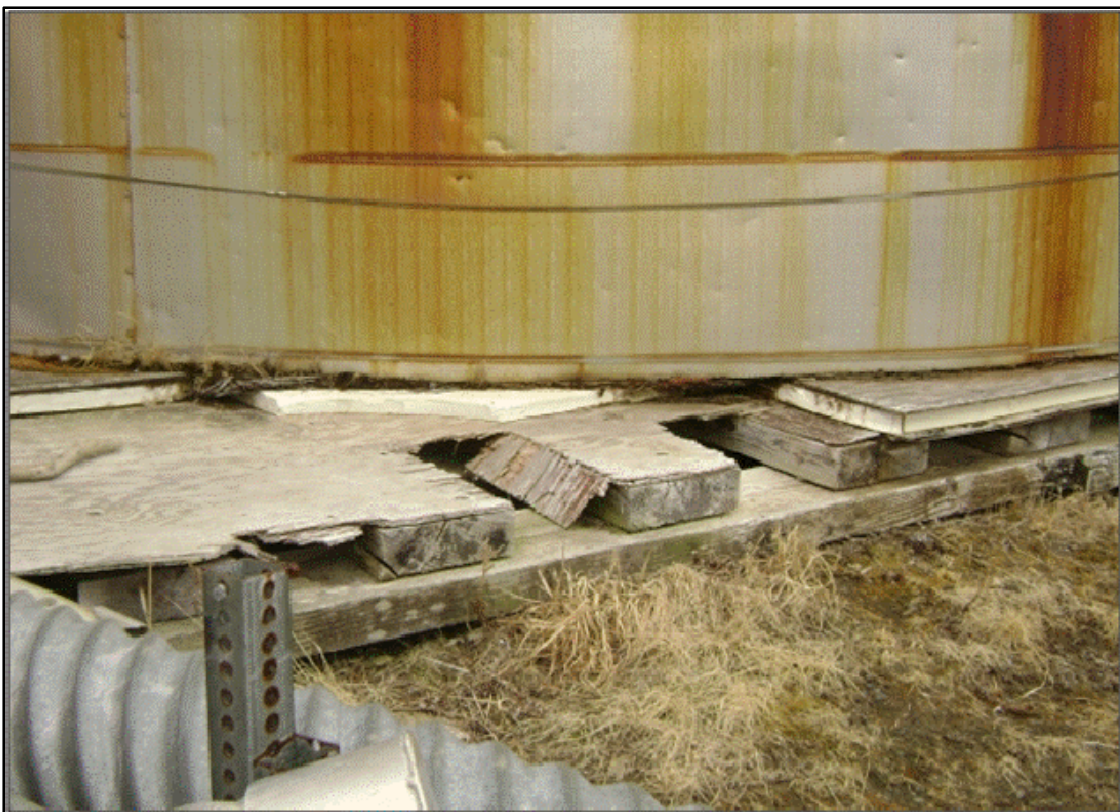
The foundation for the WST is in very poor condition as noted in the photos presented in Appendix B. The tank exterior has obvious signs of physical deterioration. The WST appears to be unsuitable for reconditioning or upgrade. The condition of the tank interior is unknown, but the current operator noted the tank's interior has not been inspected nor cleaned for many years.

Photo 6: Deteriorated tank foundation.

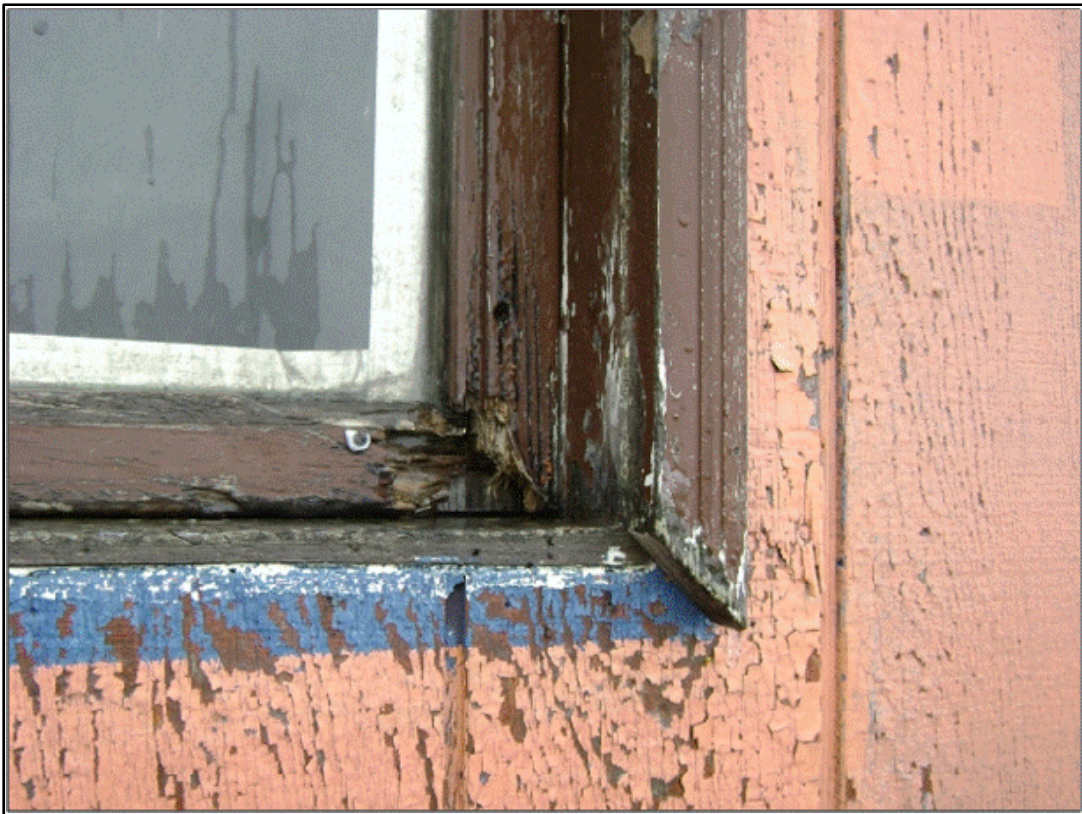
The building envelope is severely deteriorated, contributing to higher fuel consumption to offset high heat losses. Contributing to high heat losses are leaking window frames and broken windows replaced with single panes of Plexiglas or plywood, as well as roof leaks around the boiler stacks that have caused deterioration of insulation and finishes. The public watering point on the south side of the building has been abandoned, with the insulation value of the wall compromised.

Photo 7: Rotted window frames and replaced glass with single pane Plexiglas or plywood.

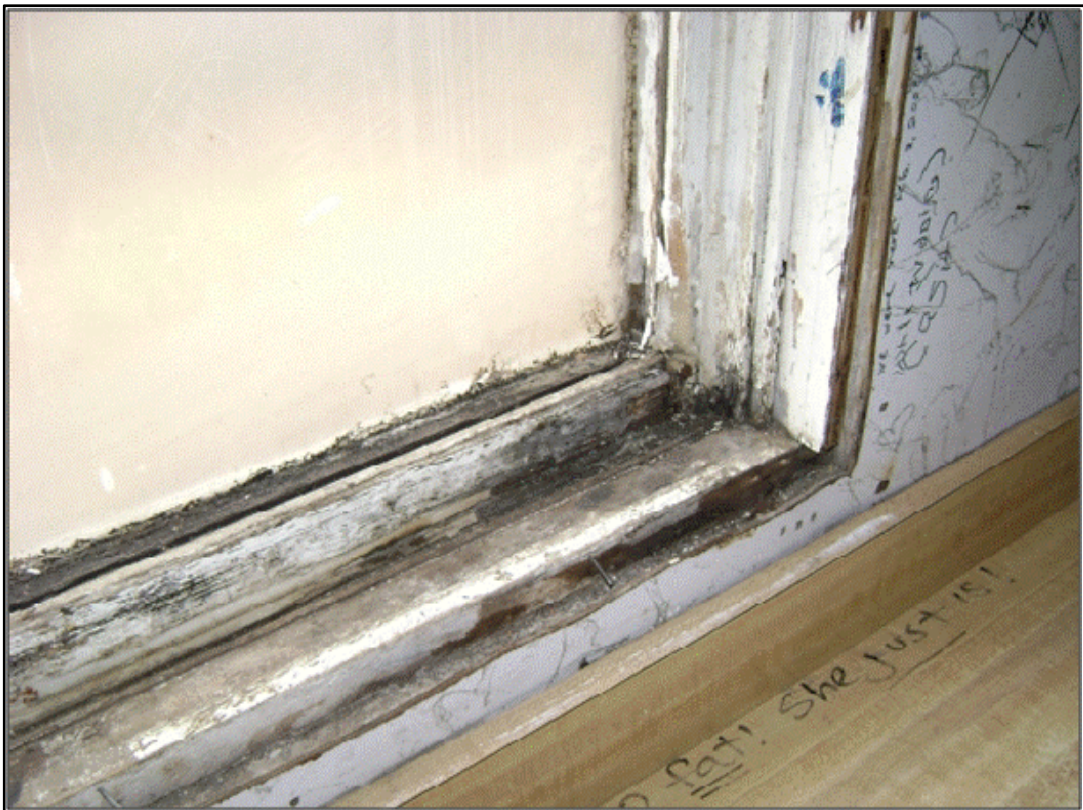
Photo 8: Rotted window frames and replaced glass with single pane Plexiglas or plywood.

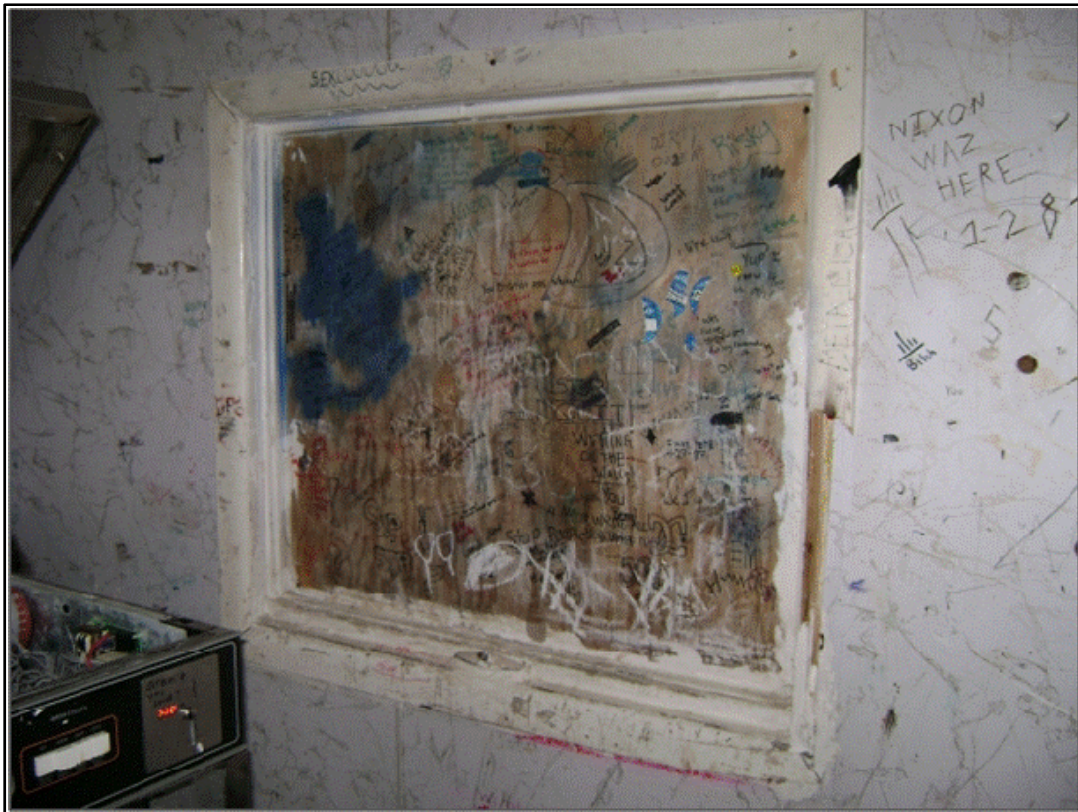
Photo 9: Rotted window frames and replaced glass with single pane Plexiglas or plywood.

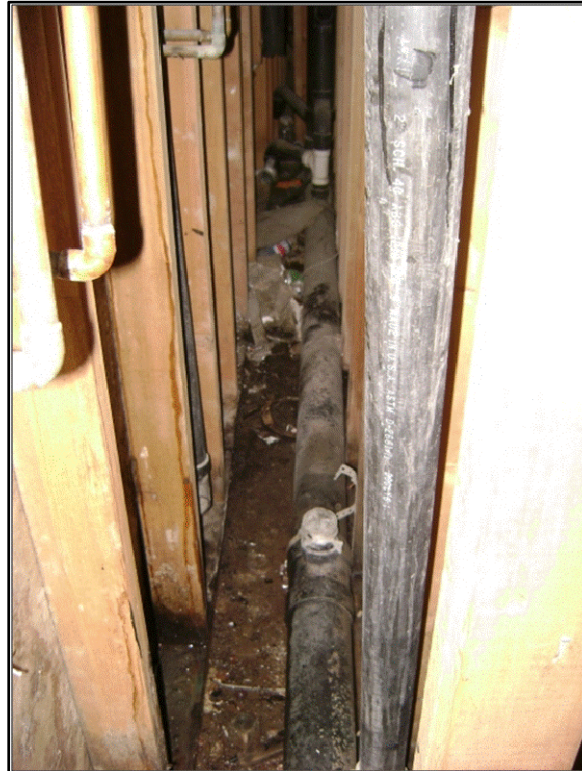
Photo 10: Showing disconnected drainage piping improperly sealed.

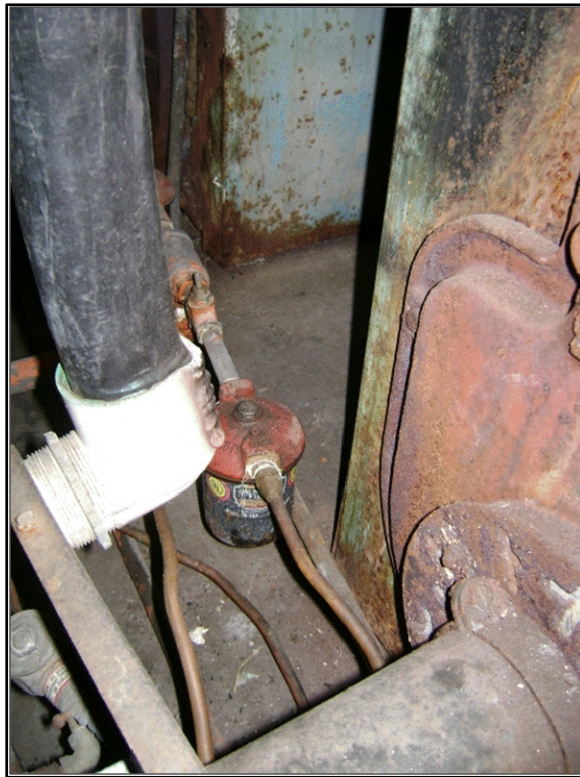
The heating boilers are both obsolete models (last produced 10 to 15 years ago) and are deteriorated beyond economical repair. Boiler 1 has jacket corrosion caused by acidic flue gasses leaking through firebox section gaskets. Boiler 2 is off-line with a disassembled burner, no expansion tank, and evidence of firebox leakage at the burner mounting plate. Direct combustion air piping to the boiler burners has been disconnected, and the plastic piping to the Boiler 2 burner housing has been melted. The boiler stack caps are missing and the stacks are dented above the roof line.

Photo 11: Boiler 2 burner showing firebox leakage and melting of combustion air inlet piping.

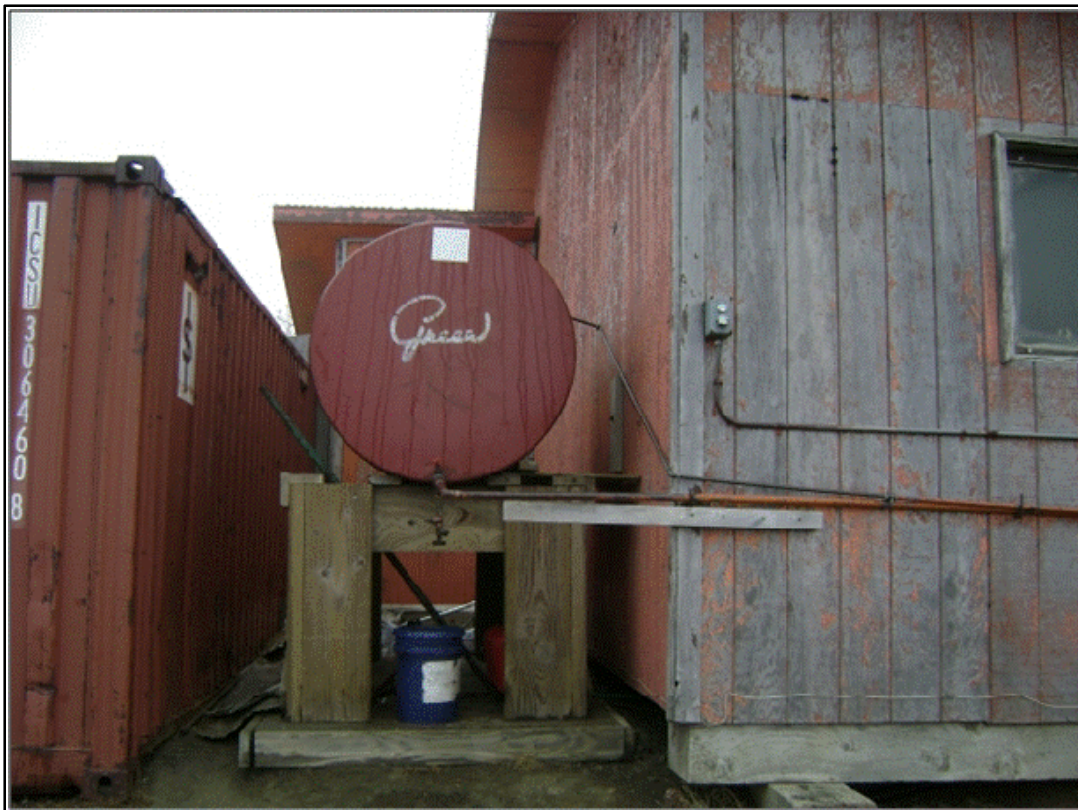
Numerous building code violations exist, including an exit door from the boiler room that has been sealed shut and a fuel tank located within 5 feet of the building. The standby heater installation is not proper, with the stack located too close to combustible materials. It is unknown whether the heater is operational. The heat exchanger for the WST is a single-wall design, which

Photo 12: Building fuel supply tank located too close to building. Piping is not properly connected. Fill access is at rear contributes to fuel spill potential.

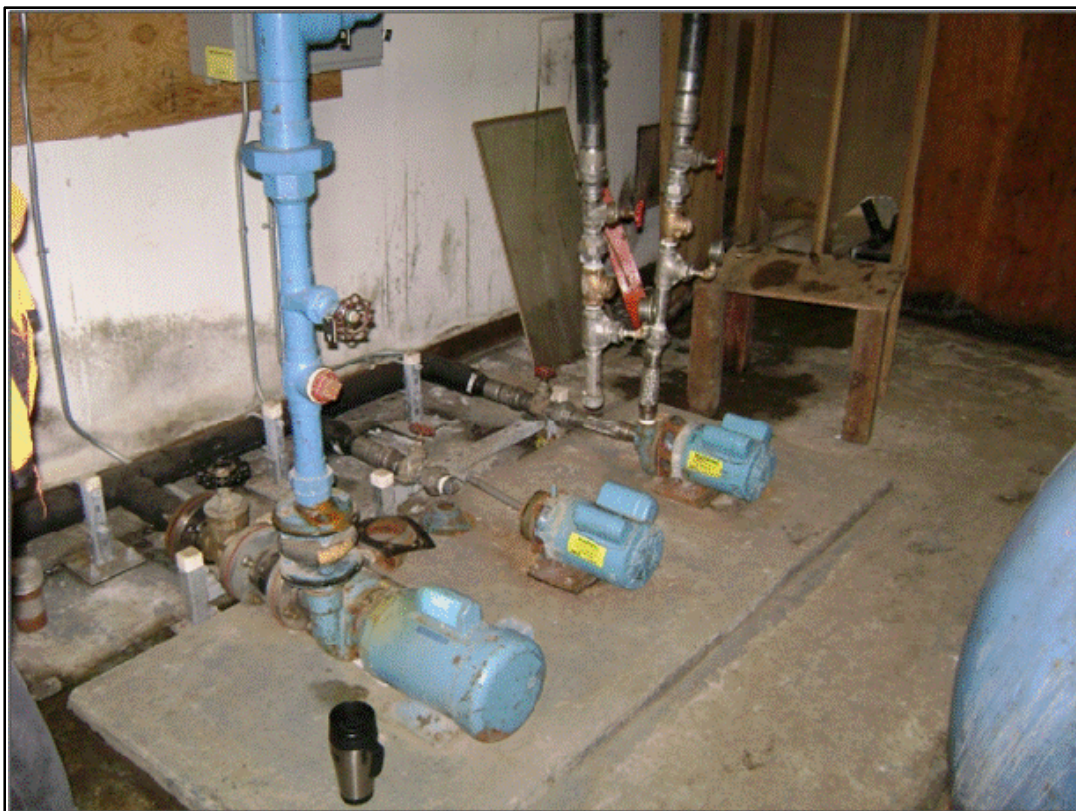
Photo 13: Backwash pump (foreground) and pressure pumps (only one serviceable).

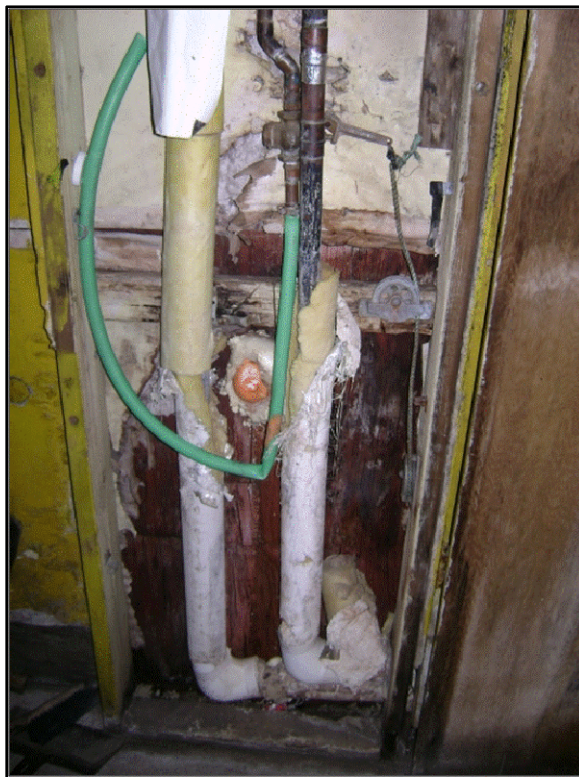
Photo 14: Abandoned watering point at south side of WTP showing deterioration of insulation and building envelope. Exterior siding is visible from building interior.

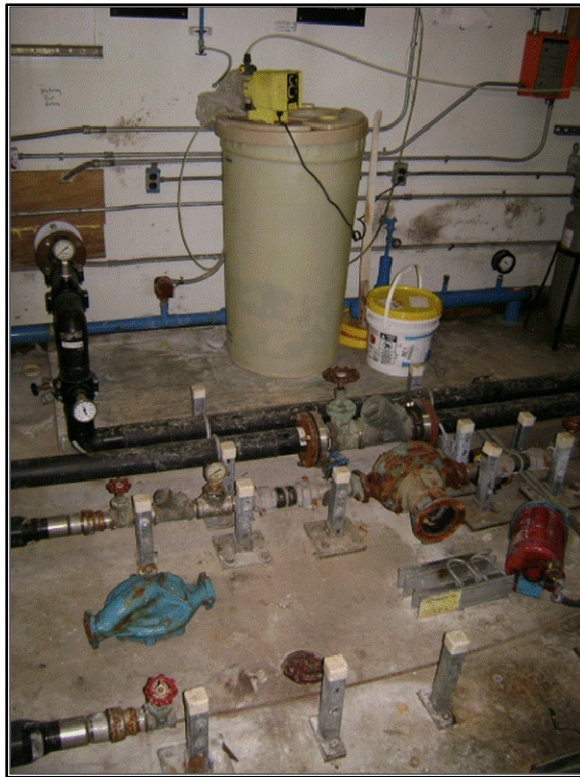
Photo 15: Watering point distribution piping circulation pumps (foreground) dismantled and inoperative.

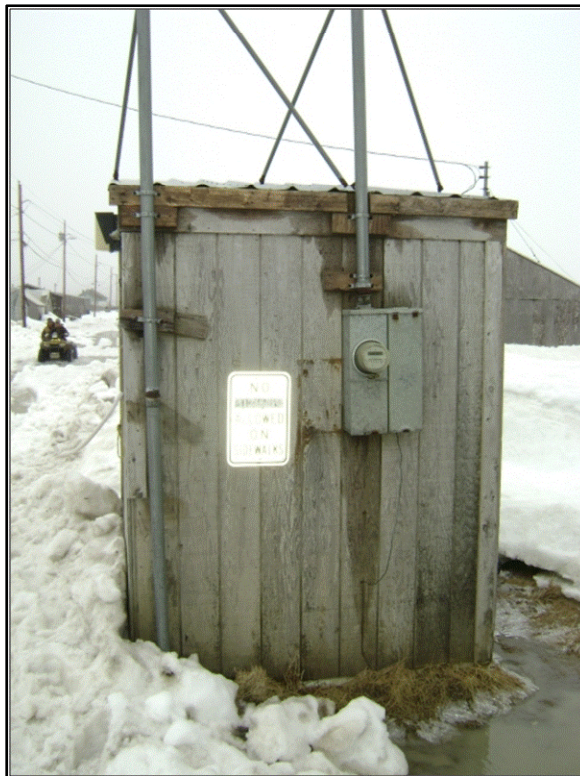
- Watering Point #1 nearest the Tribal Council Store #1 was boarded up due to vandalism.
- Watering Point #2 was accessible with non-operational heaters and heat trace controllers.
- Watering Point #3 had snow and ice inside the enclosure and valve pit, indicating possible freeze-up of the piping. The electrical panel face had been removed and heat trace controls had been disconnected. The enclosure heater had failed.
- Watering Point #4 could not be entered because of snow and ice built up inside.
- Watering Point #5 could not be entered because of snow and ice built up inside. The bottom of the door was severely corroded, which let blowing snow inside.
- Watering Point #6 had been boarded up and was not inspected.

**Photo 16: Exterior of Watering Point #2.
Typical of all watering points.**

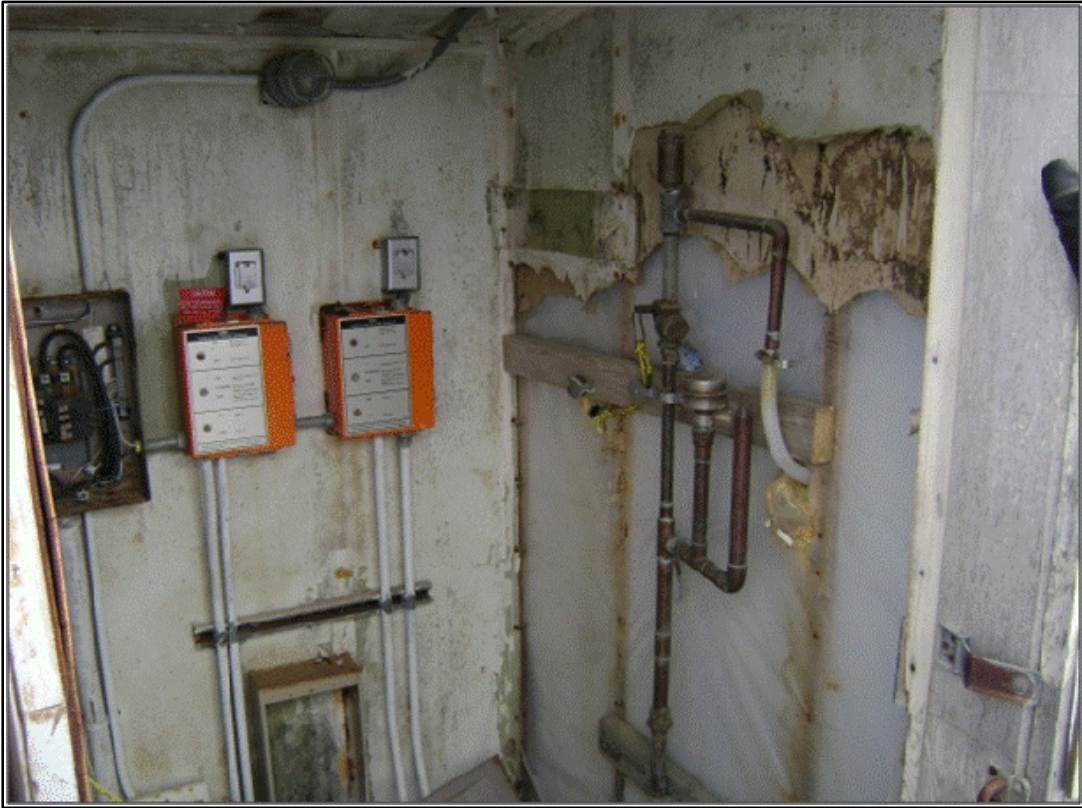
Photo 17: Interior of Watering Point # 2. Inoperative heater at bottom of photo.

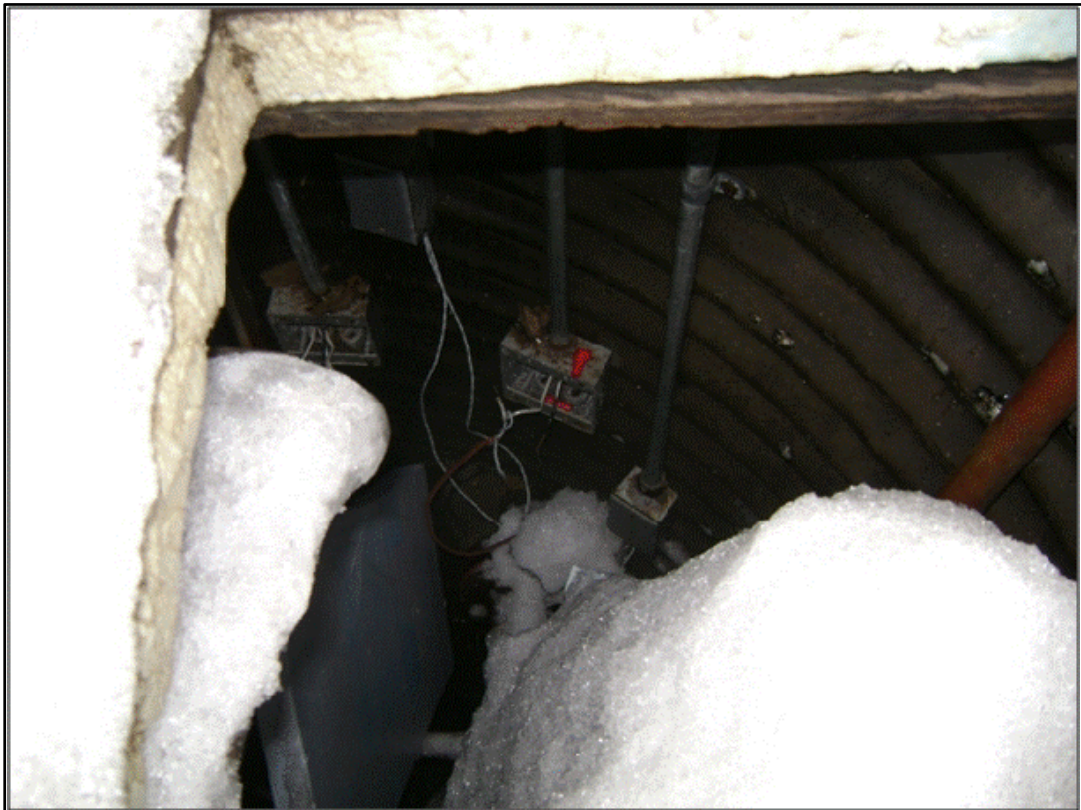
Photo 18: Valve pit of Watering Point #3. Snow packed with heat trace power and sensor wiring connections exposed.

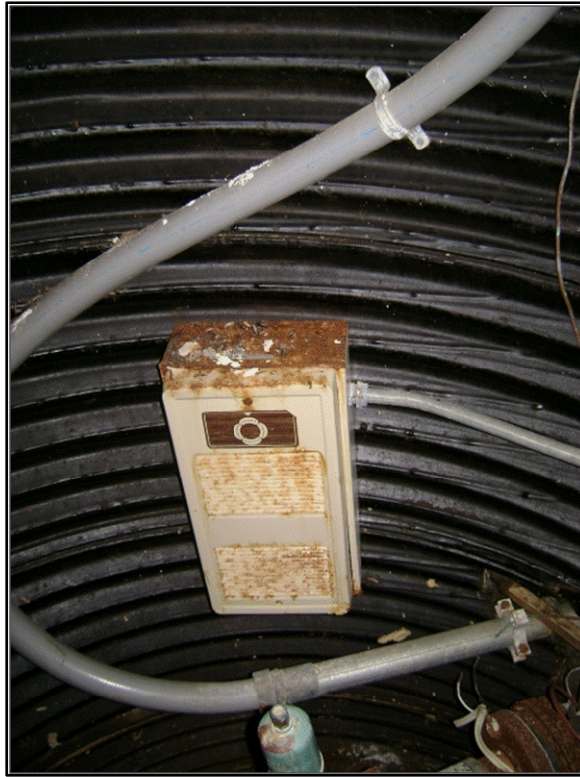
Photo 19: Valve Pit heater for Watering Point #2.

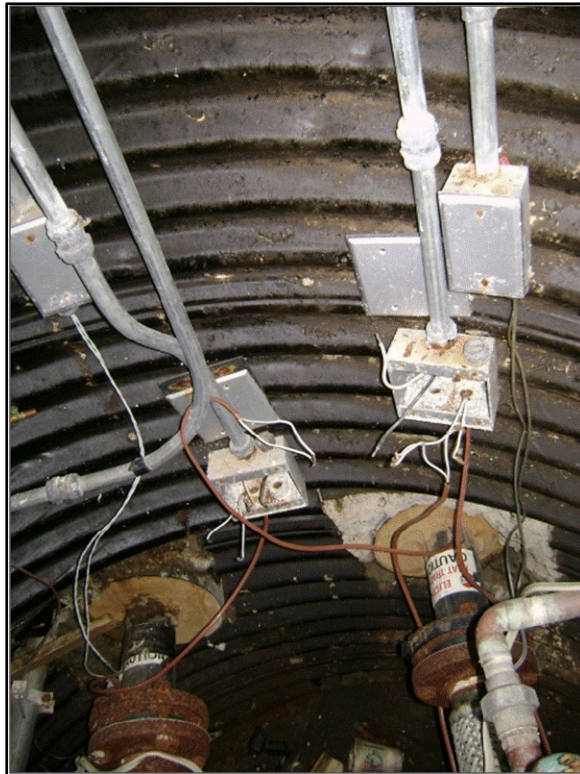
**Photo 20: Valve pit of Watering Point #2.
Heat trace power and sensor wiring.**

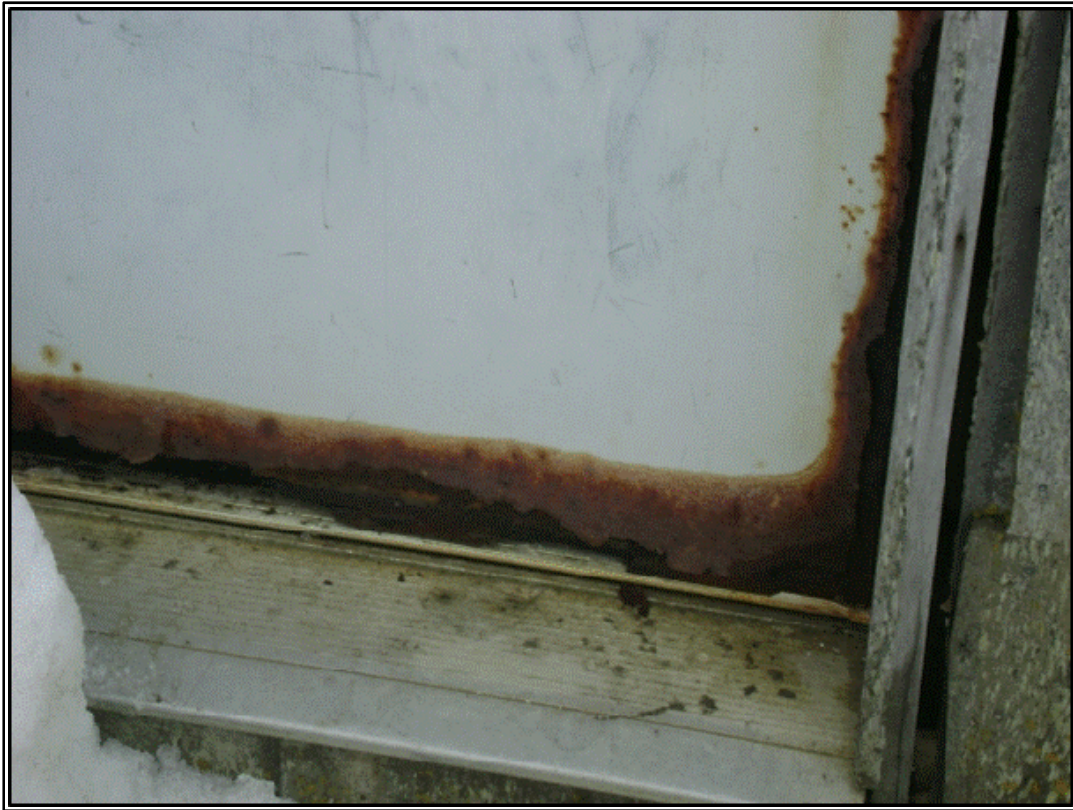
**Photo 21: Bottom of Watering Point #5 door.
Corrosion is typical of most watering points.**

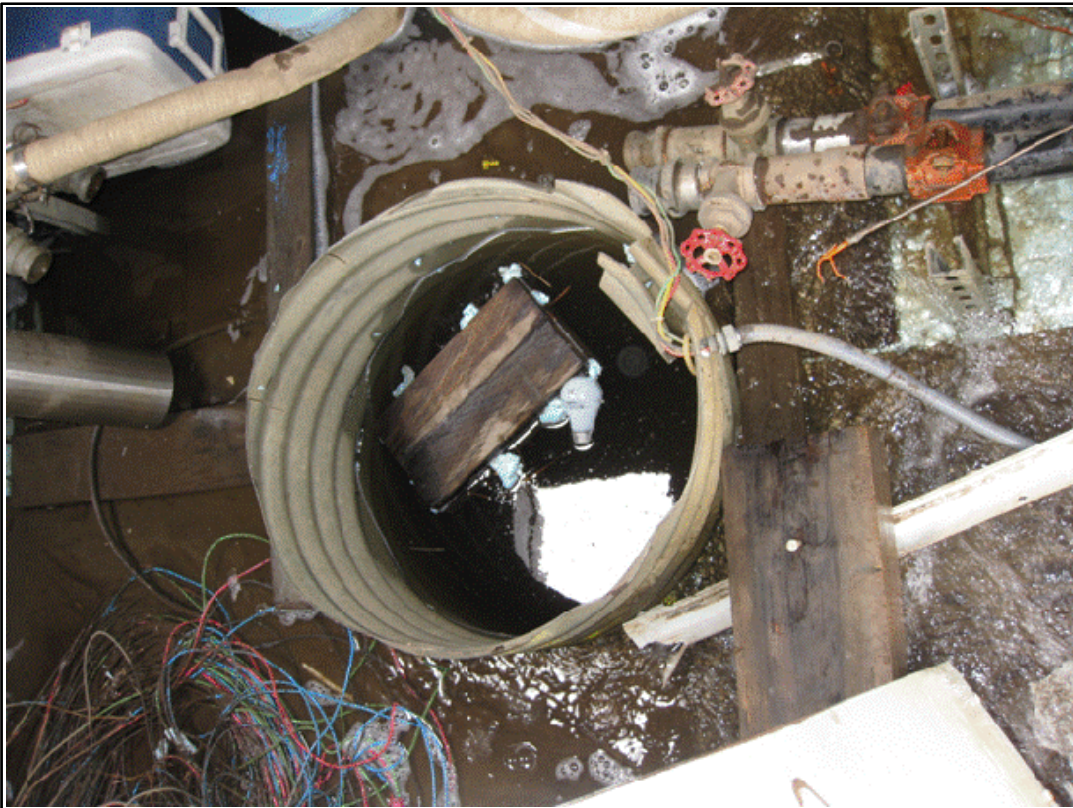
- The Unnamed Creek well and pump house were found to be in a flooded condition that prevented reasonable entry to hook up the well pump. The creek was overflowing the entire structure, which resulted in an unsanitary condition for a community drinking water source.

Photo 22: Interior condition of flooded well casing in Un-Named Creek well house.

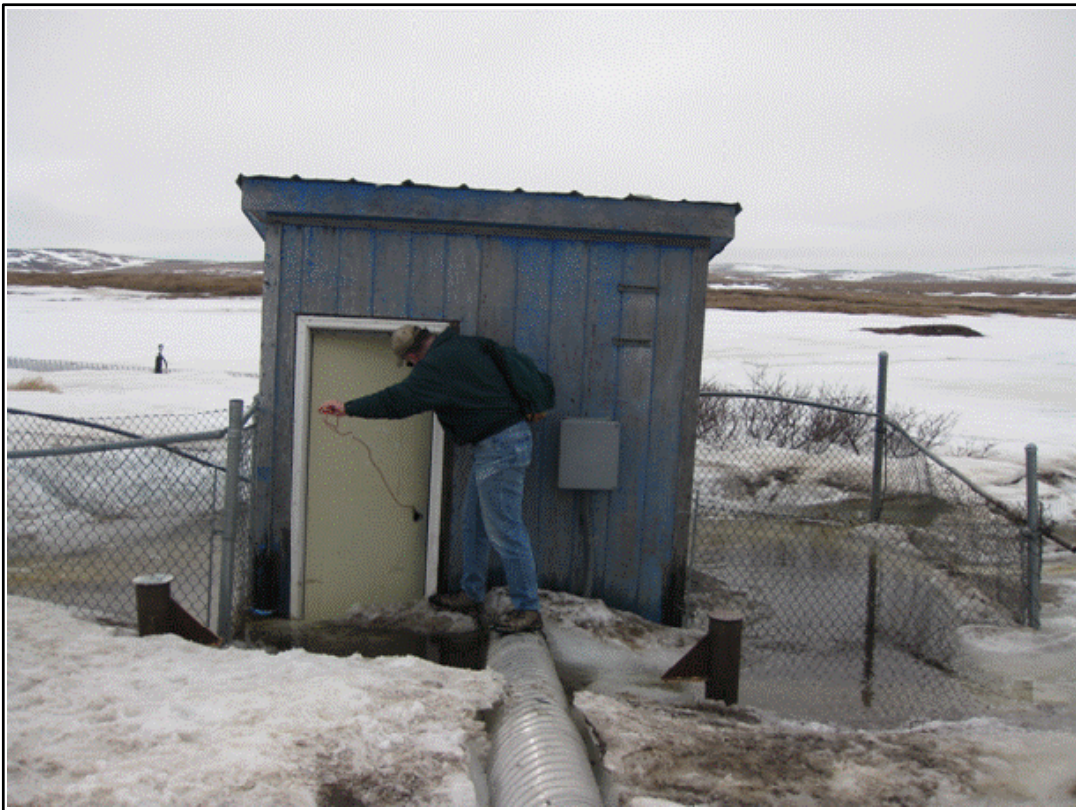
Photo 23: Flood conditions around Un-Named Creek well house.

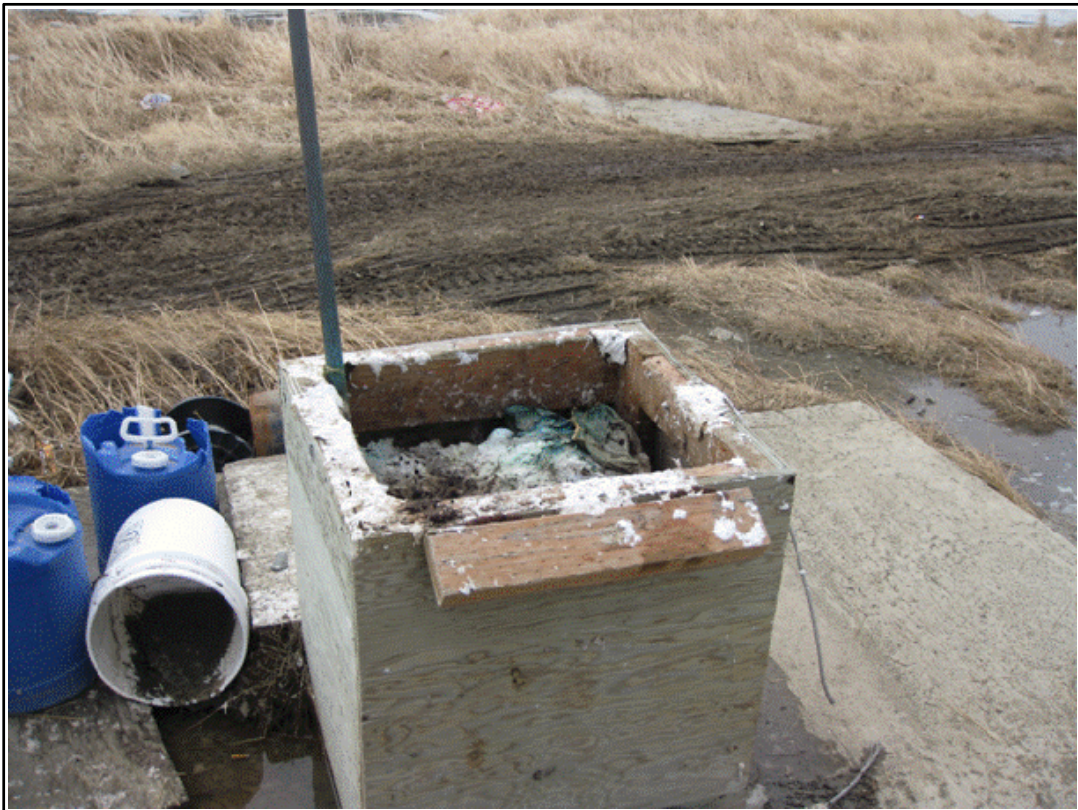
- The existing sewage bunkers located throughout the community all appeared to be in a state of failure and a serious health concern due to overflow of raw sewage from the dumping of honey-buckets.

Photo 26: Overflowing honey bucket bunker.

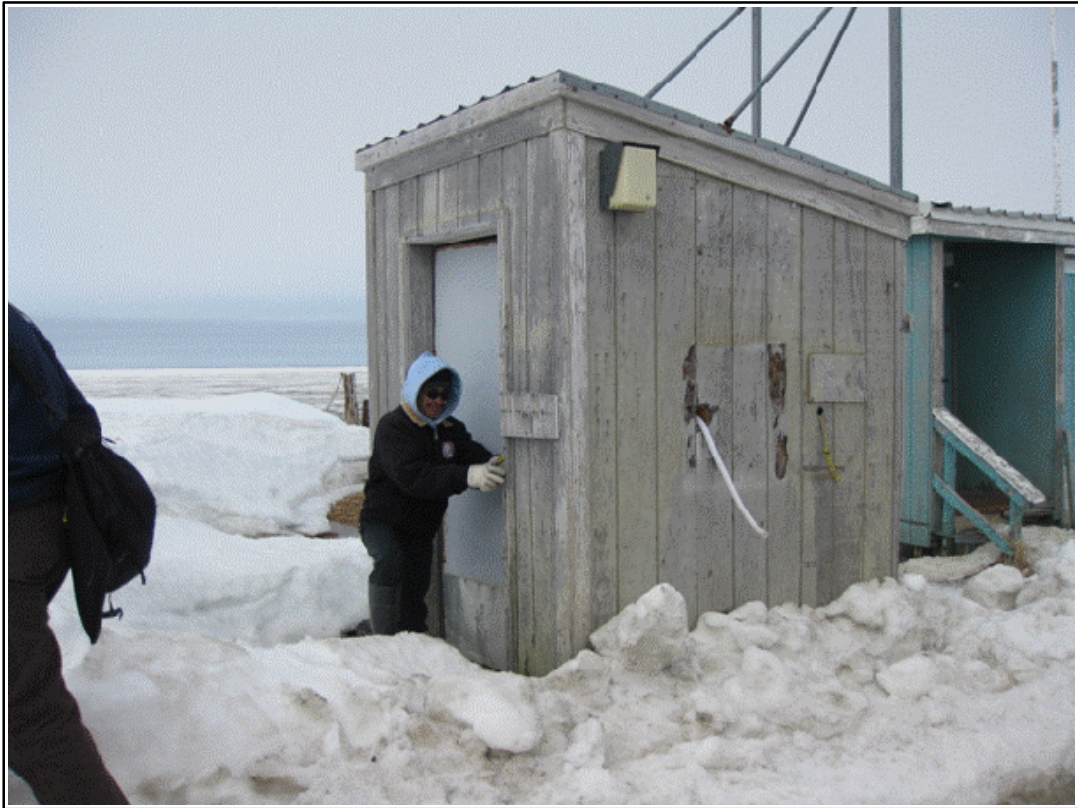
Photo 27: Snow drifts around community watering point.

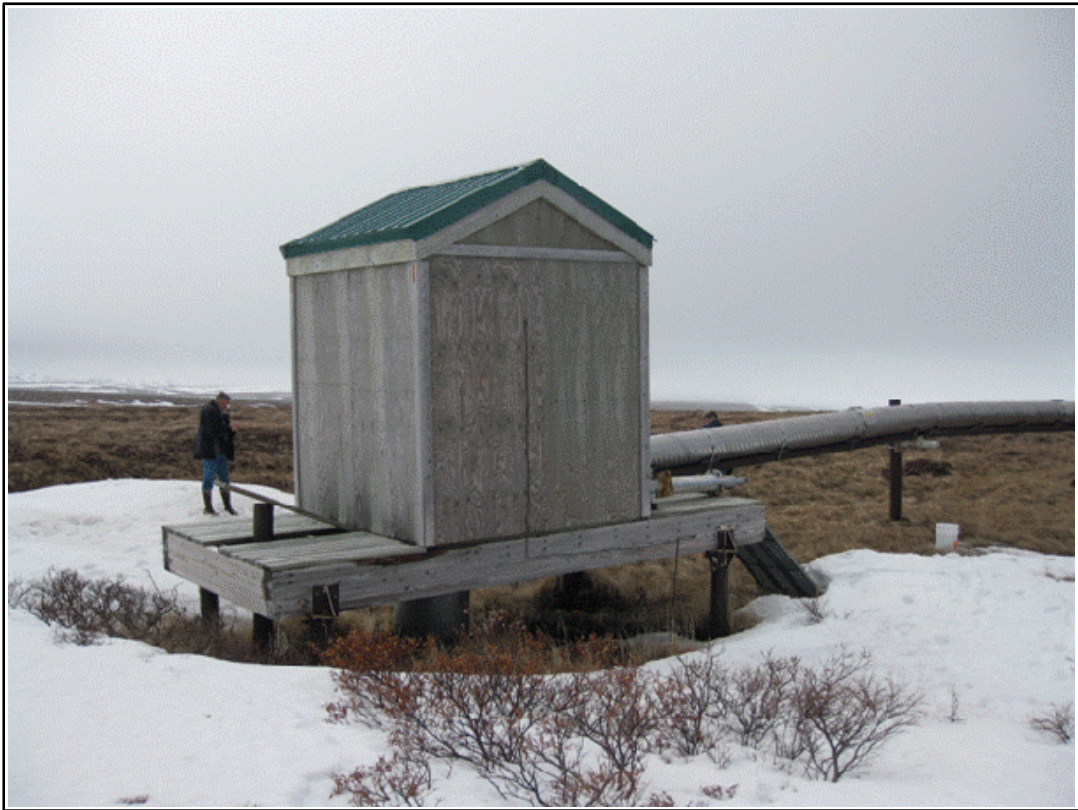
Photo 29: Frost heave damage to Musk Ox Well House.

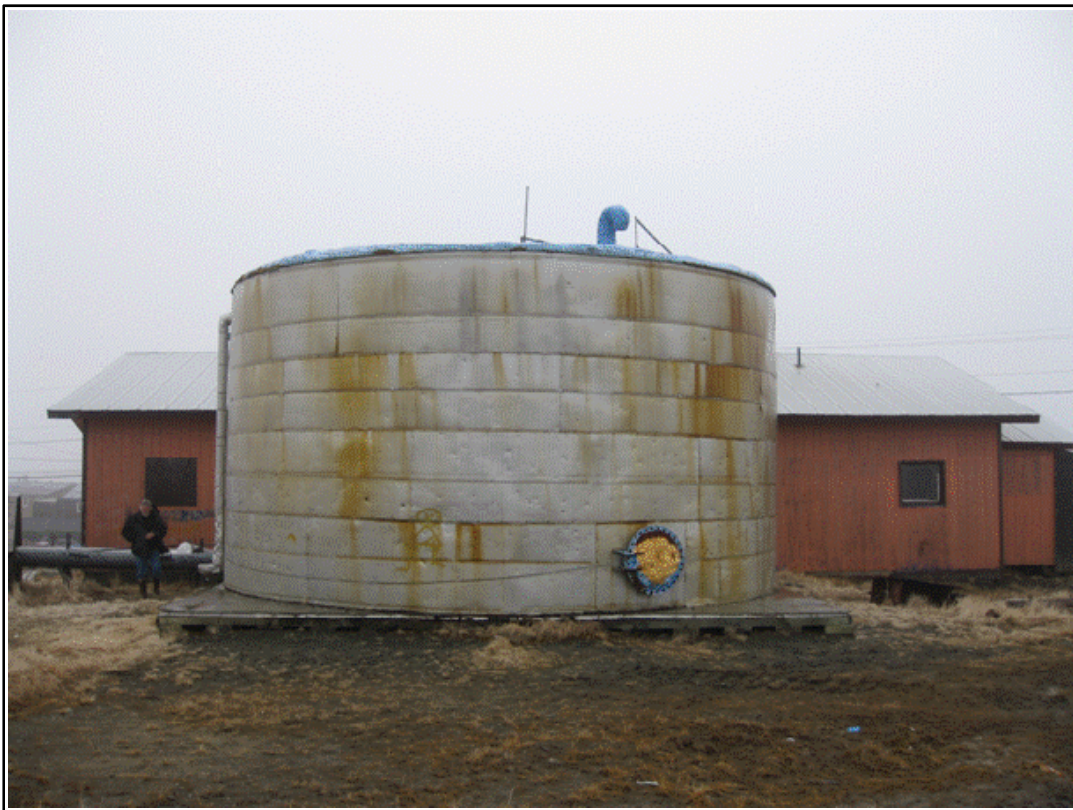
Photo 34: Deteriorated 50,000-gallon bolted steel water storage tank on timber foundation.

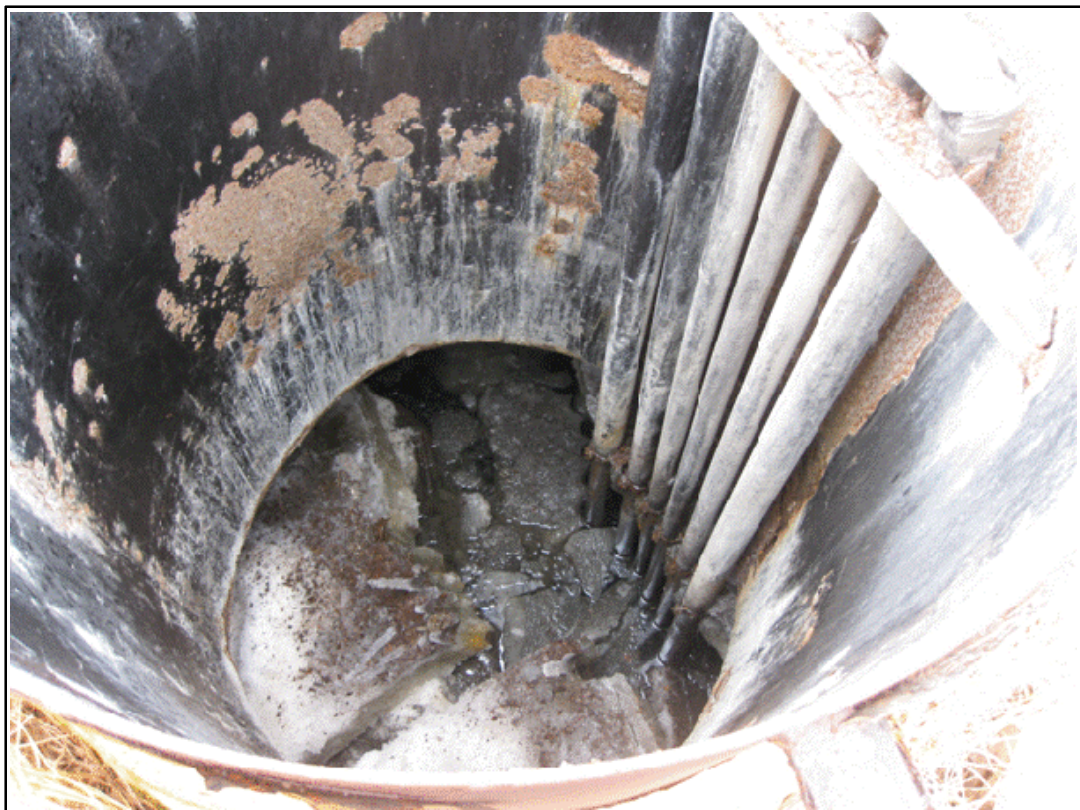
Photo 36: Frozen outlet in dosing tank on the In-Complete septic system.
