**Report on Site Conditions and Recommended Plan of Action
For
Sanitation Improvements in Tununak, Alaska**

TUNUNAK TRIBAL COUNCIL

MWH

December 2010

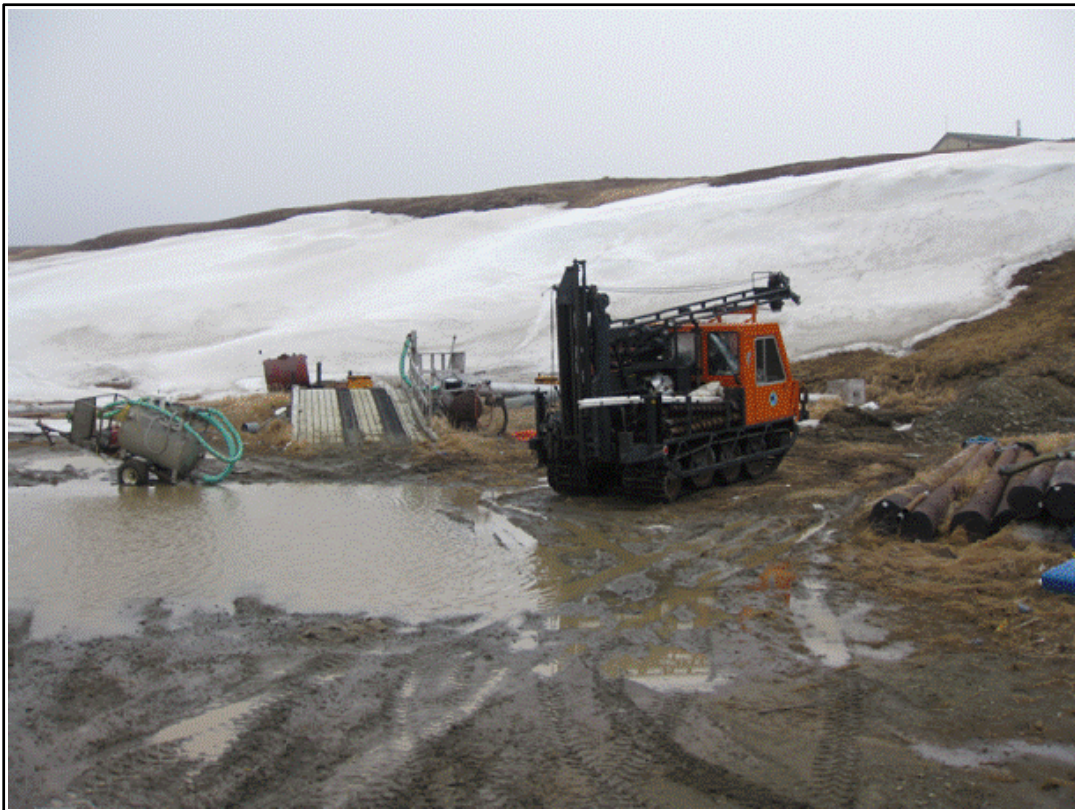
Photo 37: FTH trailer stuck in mud at off-loading ramp on In-Complete septic system.

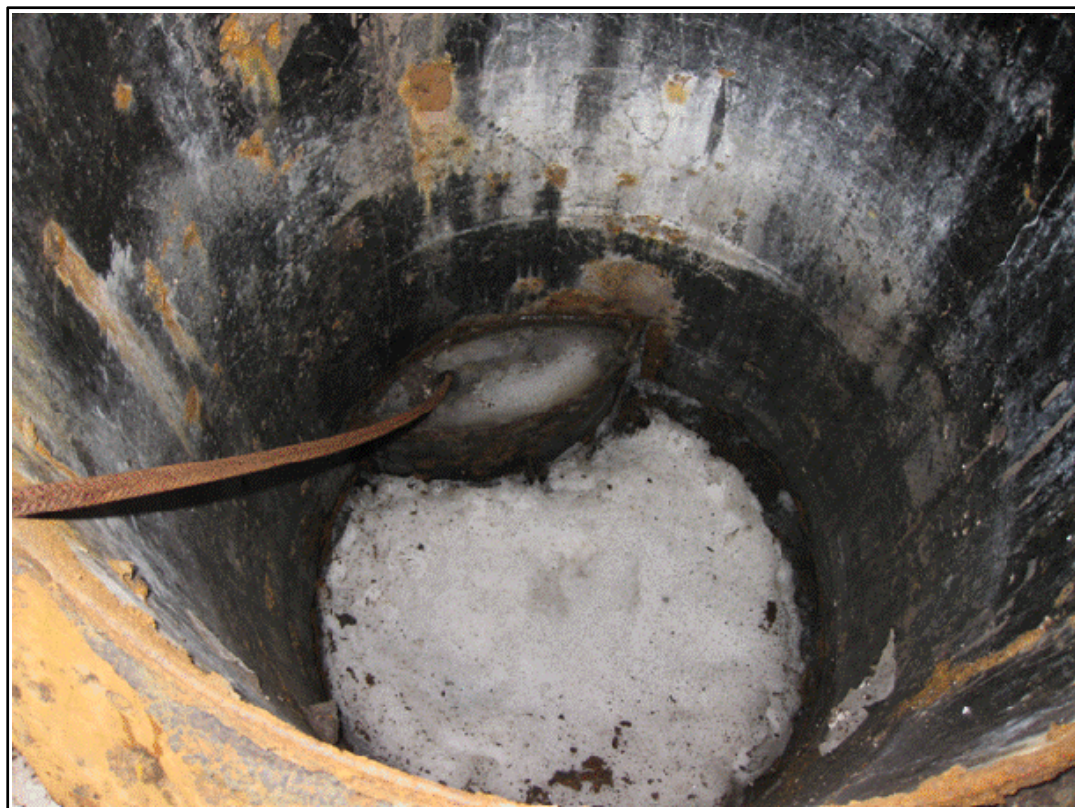
Photo 38: Ice blocked outlet baffle in septic tank #1 on the In-Complete septic system.

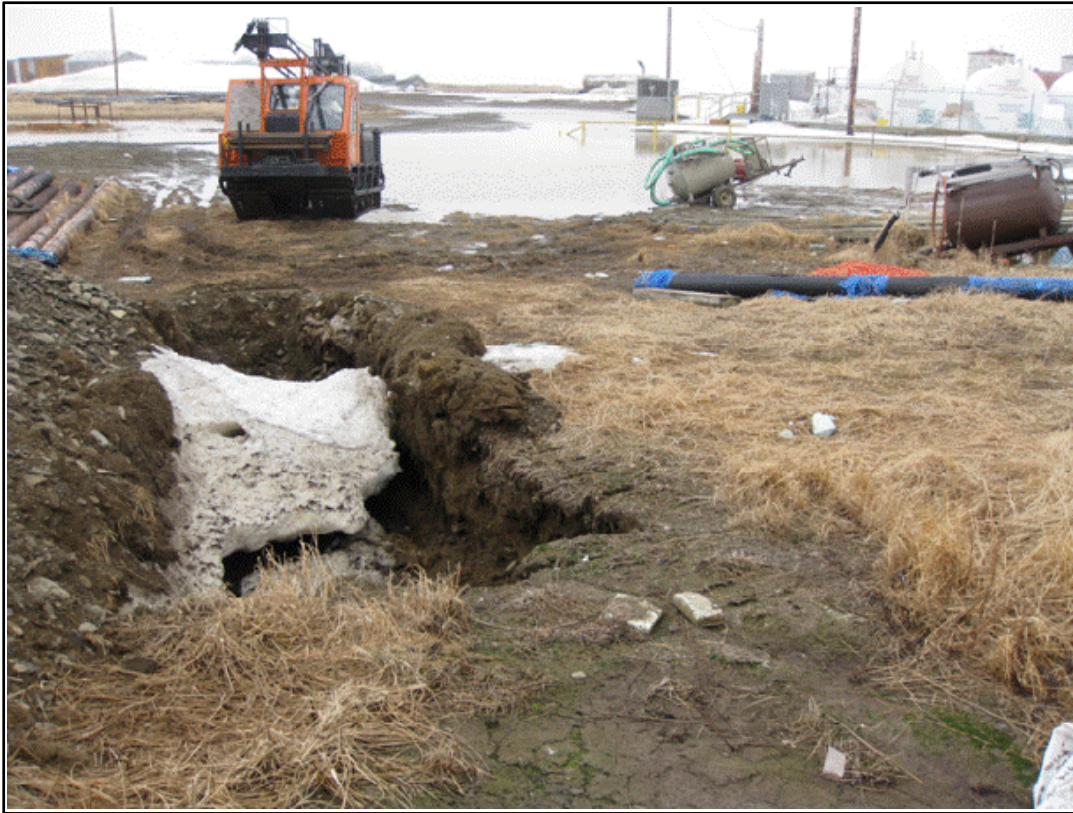
serving the flush tank and haul system are currently in a state of failure. Consequently, the operators dump their haul contents of raw sewage in an open trench located next to the septic tanks. The trench is accessible to the public and animals (especially loose dogs).

Photo 39: Open trench used for disposal of FTH hauled waste located near off-loading ramp on the In-Complete septic system.

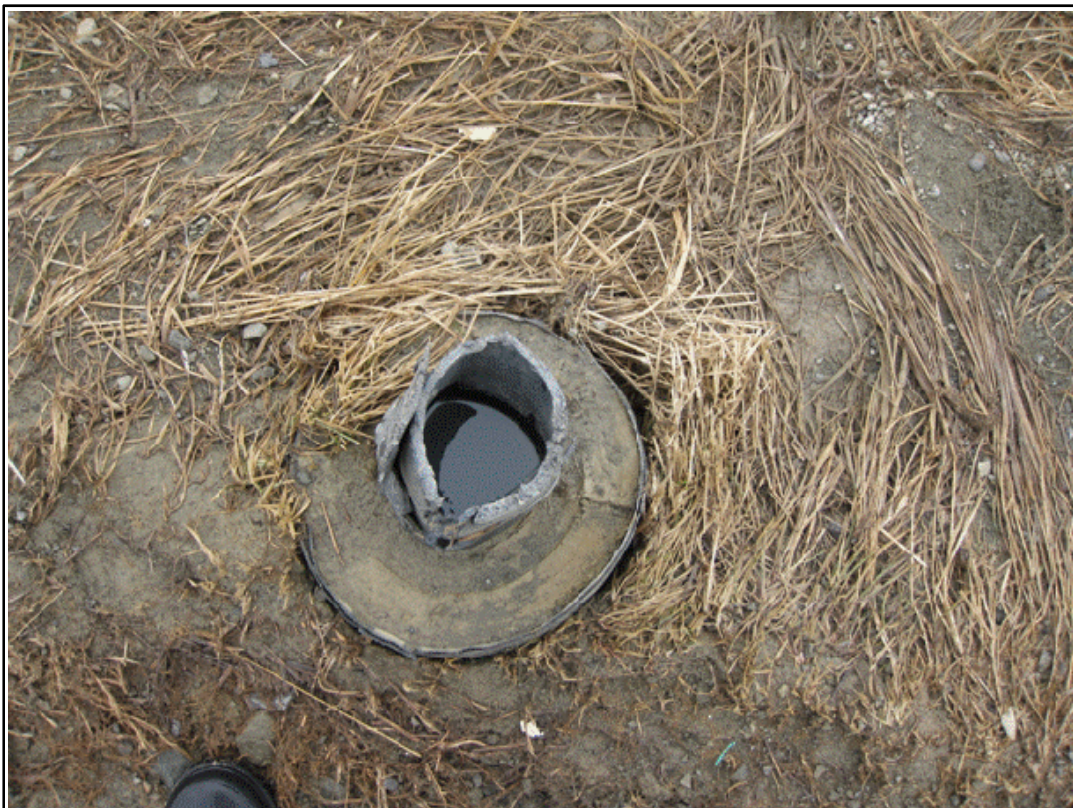
Photo 40: Overflowing sewage in observation pipe on the drainfield serving the Washeteria, teacher housing, and school.

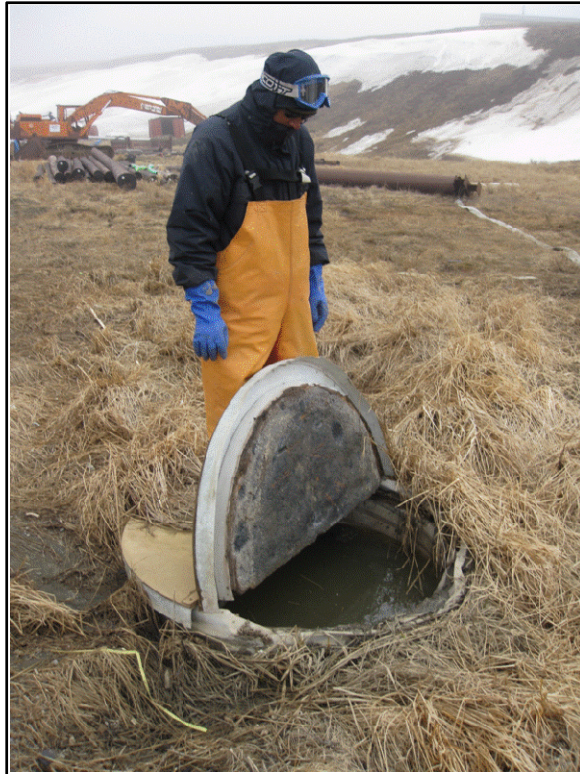
Photo 41: Overflowing sewage in manhole on septic tank serving the Washeteria, teacher housing, and school.

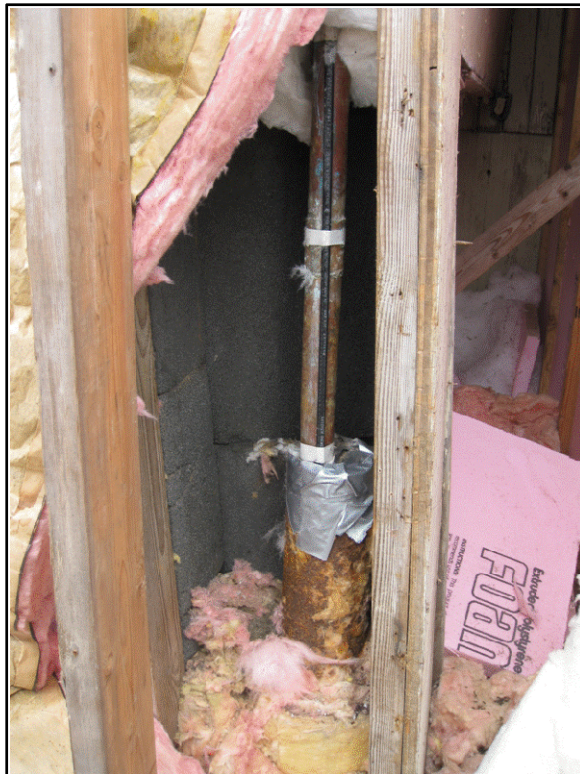
Photo 42: Exposed section of 4-inch steel well serving the former BIA school water system. Note the duct tape well cover.
