ACWA 09-12: Final Report

Sustainable Trail Design for Aquatic Habitat Protection: Deep Creek and Anchor
River Watershed

An Assessment of the Water Hole Trail Affected by the Caribou Hills
Fire

Plan for the Watermelon Trail/Beaver Creek Crossing

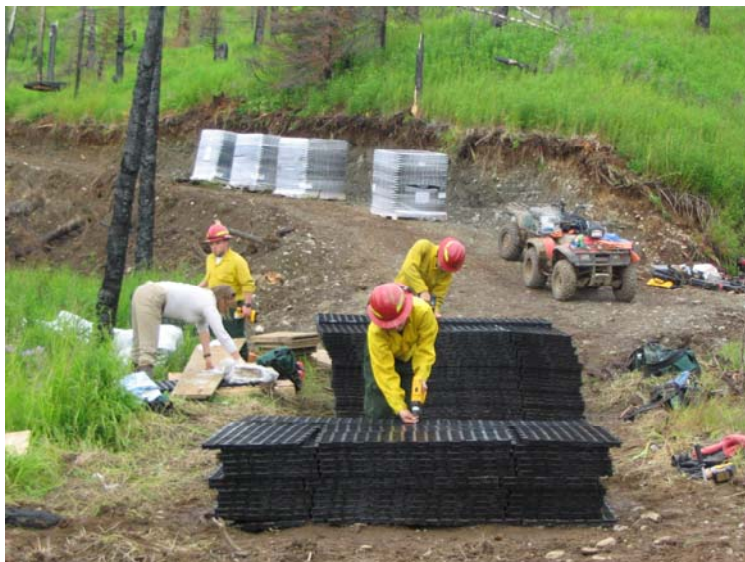
Figure 1: 7/22/2008; Div. of Forestry Interns help stage geoblock on newly graded trail reroute near Grandpa's Water Hole

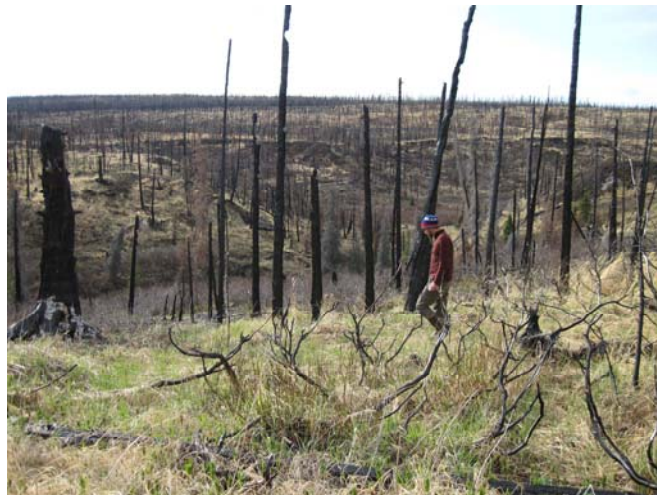
Figure 2: 5/22/2009; Blaine Spellman determines post-fire plant succession adjacent to the Water Hole Trail

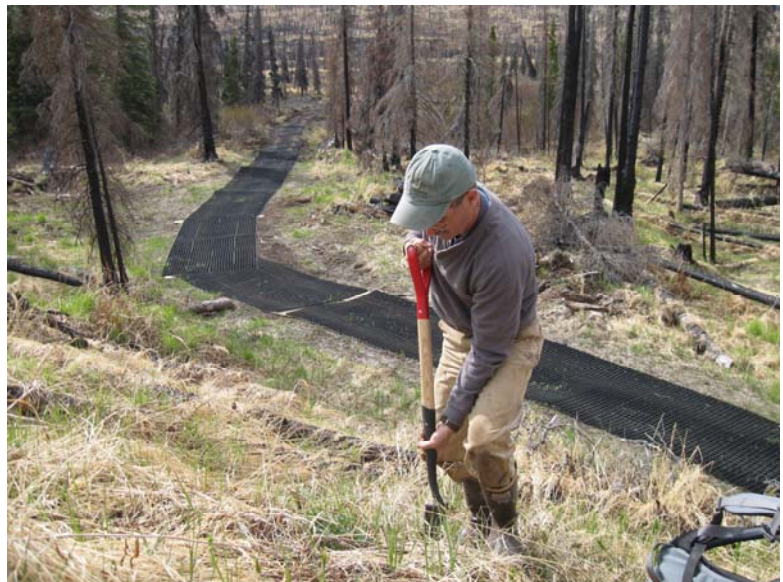
4) Slope: 52%; Aspect: S facing

Organic Matter: 4"

Soil: Mutnala Silt Loam, gravel starting at 15"

Vegetation: Prior to the fire, there was no spruce/birch growing on this steep hillside. There were trace amount of bushes found and they were burned by regenerating. Dominant overstory was *Calamagrostis canadensis*. There was 65% of the ground

Figure 3: 5/22/09; Mike Mungoven digs soil pit #4, adjacent to the GeoBlocked reroute as part of the post-fire assessment

covered by grass litter. Other species found: *Salix barclayi*, *Chamerion angustifolium*, *Sanguisorba canadensis*, *Geranium erianthum*, *Luzula parviflora*.

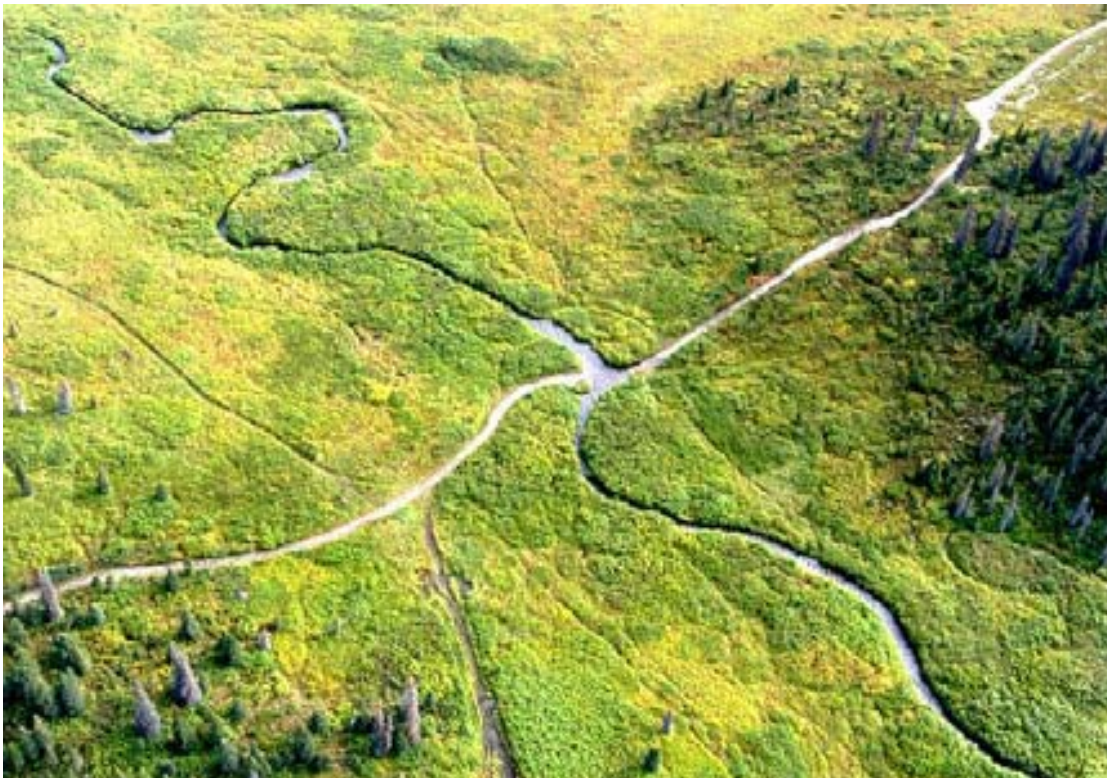
Figure 4: 2004; Beaver Creek Crossing aerial photo taken by Cliff Larson (DNR) as part of the Deep Creek and Anchor River Off-Road Vehicle Trails Assessment

The purpose and general work plan for this project is in two parts: **1)** staging a bridge structure upstream of the current in-water crossing, and **2)** rerouting the trail's approach upstream to the bridge while blocking off and rehabilitating the old crossing, scheduled for late summer 2009/early spring 2010.

- 1) Stage and install bridge structure (heavy-duty flatbed trailer) approximately 60 feet upstream of the current in-water crossing on Beaver Creek
- 2) Relocate the trail approaches to the newly installed bridge; build ramps to ends of bridge using gabion baskets and fill material from near the site, install railings, and post official weight limit signage.
- 3) Perform a streambank restoration of the old in-water crossing and thoroughly block off the old trail after all other work at the site is complete. Simple lifts and willow brush layers will be used according to techniques in "Streambank Revegetation and Protection: A Guide for Alaska" (revised 2005). Signage will be installed to keep trail users off the restored streambanks.
