January 2013 Reports

Tuluksak Water Treatment Plant Structural Condition Survey, Reid Middletoon, Jan 2013

Tuluksak Water Treatment Plant Mechanical Condition Survey, EDC Engineers, Jan 2013

Tuluksak Water Treatment Plant Structural Condition Survey Report

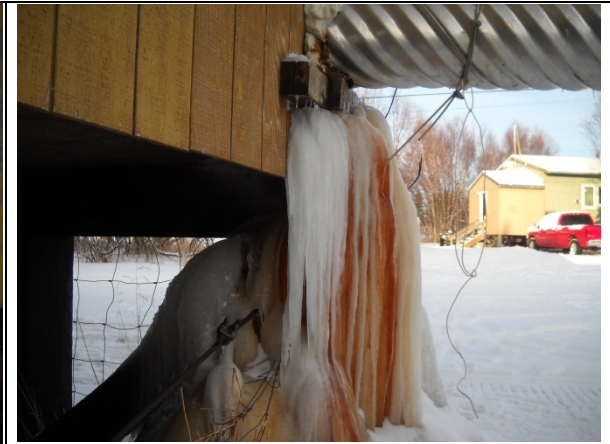
While Bev and Jon completed the council meeting, I walked to the WTP to take photos and document conditions (see trip photos). The gravity wastewater line from the building show signs of leaking at the pipe/bldg. interface. The red water is presumably backwash water from the treatment system (the raw water is very high in iron). The gravity line shows signs of bellies between pipe supports. According to Bob White, the gravity line freezes often. The WTP/Washeteria facility shows its age (30 plus years), there appear to be many sections of rotten flooring. Most of the water treatment piping appears to have been either modified, repaired or added to over the last 30 years and the resulting plant is a mishmash of pipes, valves and pumps (some clearly not operable). While we were there, Bob worked with Carl troubleshooting a problem with their well pump. Neither had information about the size and type of well pump being used. Ken pointed out the holes in the flooring where water apparently ponded and rotted the floor. These holes were apparent in the mechanical and treatment rooms.

Leaky (glaciated) wastewater line from WTP/Washeteria (notice iron content in filter backwash water).

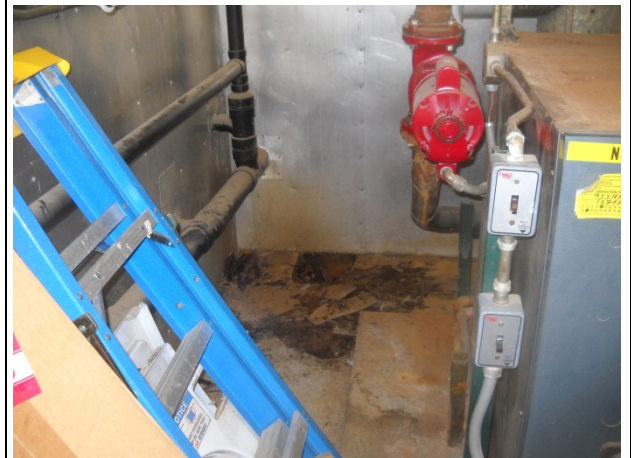
Rotten floor in mechanical room

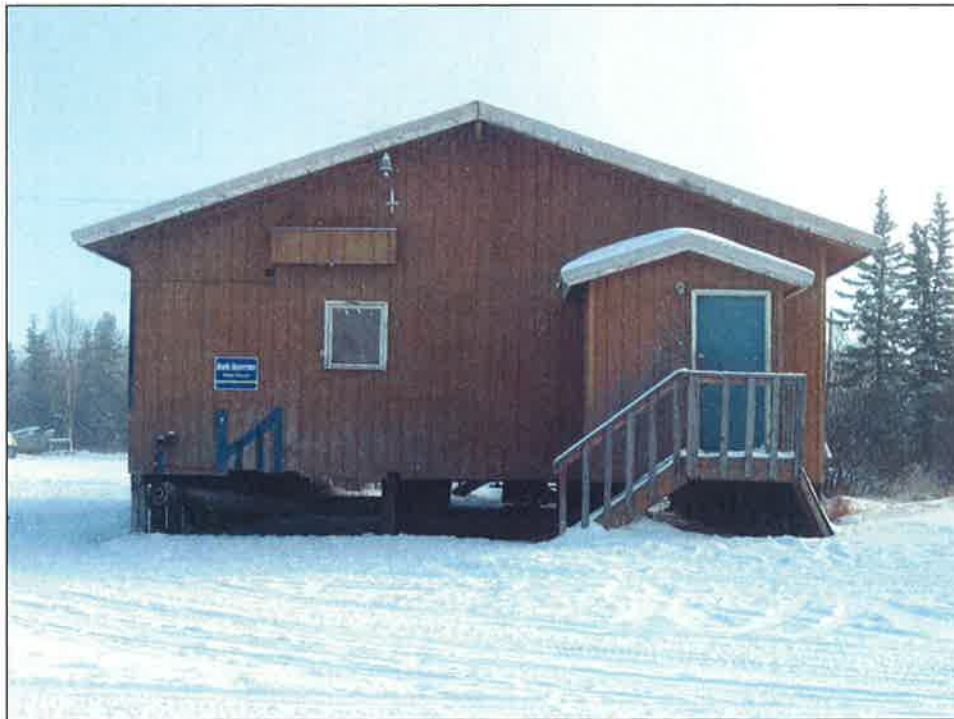
1. The exterior T1-11 siding could use new paint.
2. A 3-foot section of corner trim is missing from the northwest corner of the building (Photo No. 4).
3. West Stairs: The railing system is not code compliant - too large of opening between vertical members (Photo No. 3).
4. East Stairs:

Photo No. 3: West Elevation
Note: Non-compliant railing at stairs

1. Repair/Upgrade the railing systems at the east and west Stairs.
2. Replace the stair treads at the east stairs.
3. Replace the missing corner trim at the northwest corner of the building.
4. Tighten existing cable bracing or replace the bracing with new rod bracing and turnbuckles.
5. Replace broken window on the south wall of the building.

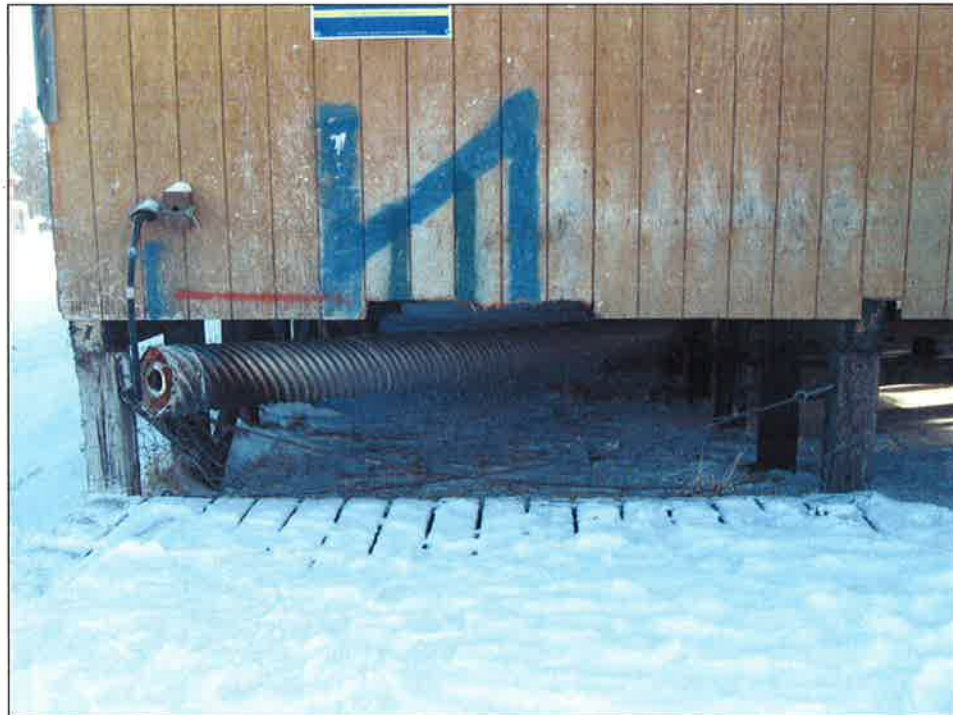
1. West Elevation: The design drawings showed three sets of cross bracing, one in each of the three bays of the building in the transverse direction. Cross bracing is missing from the middle bay. The braces in the end bays are loose.
2. Mid-building braces: The original drawings showed two more rows of braces at the third points of the building. These braces were not installed.
3. East Elevation: The design drawings showed three sets of cross bracing, one in each of the three bays of the building in the transverse direction. Cross bracing is missing from the middle bay. The braces in the end bays are loose.

Photo No. 4: West Wall
Note: 1. Missing trim from corner of building
2. Cable bracing not tight

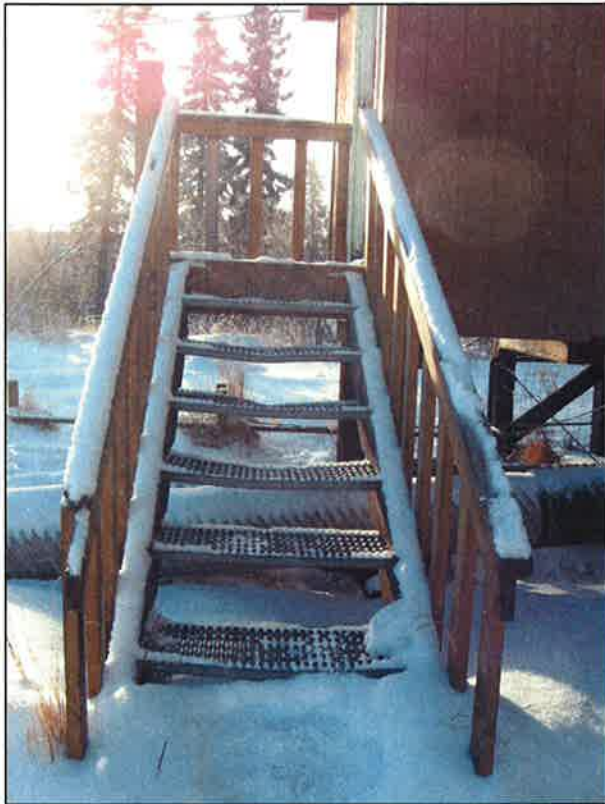
- a. The railing system is not code compliant – too large of opening between vertical members (Photo No. 5).
- b. The top rail is rotten in places and should be replaced (Photo No. 6).
- c. The stair treads are damaged and should be replaced (Photo No. 5).
5. The ramp and landing on the south side of the building, although not used, does not have a code compliant railing system and the sheathing/decking at the landing has been removed. The ramp and landing poses a potential hazard and should be repaired, removed, or chained off so that people cannot access the ramp.
6. Window on the south wall is broken.

Photo No. 5: East Entry Stairs
Note: 1. Non-compliant railing
2. Damaged stair treads

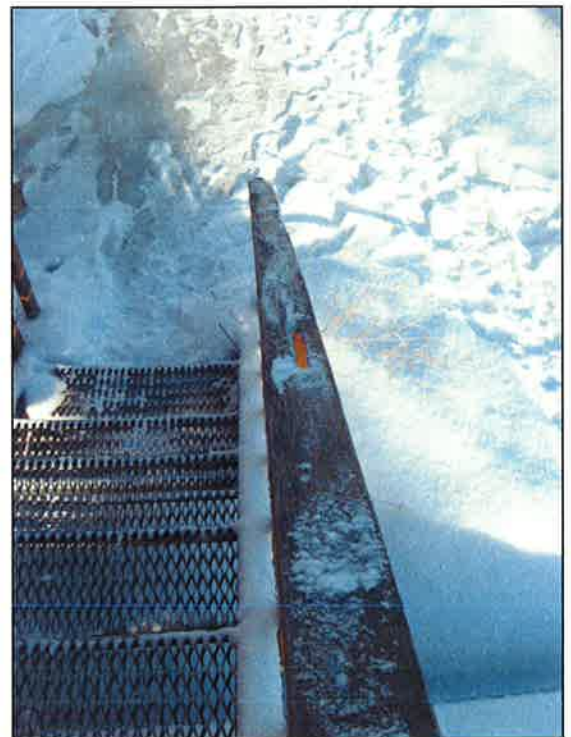
Photo No. 6: West Entry Stairs
Note: Rotten stairrail

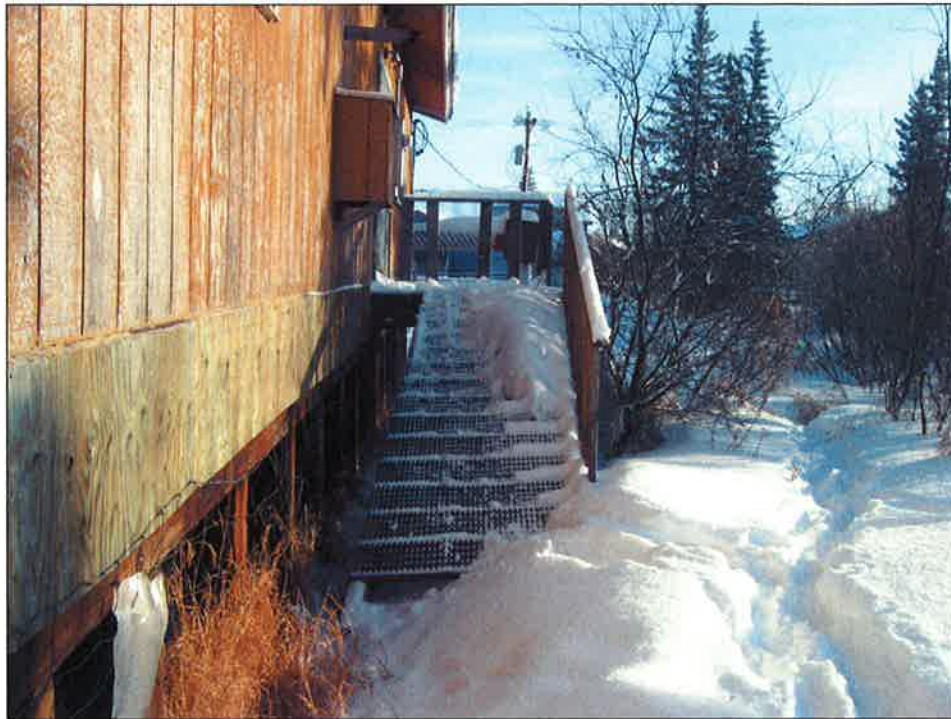
Photo No. 7: Ramp on South Wall
Note: Non-compliant Railing

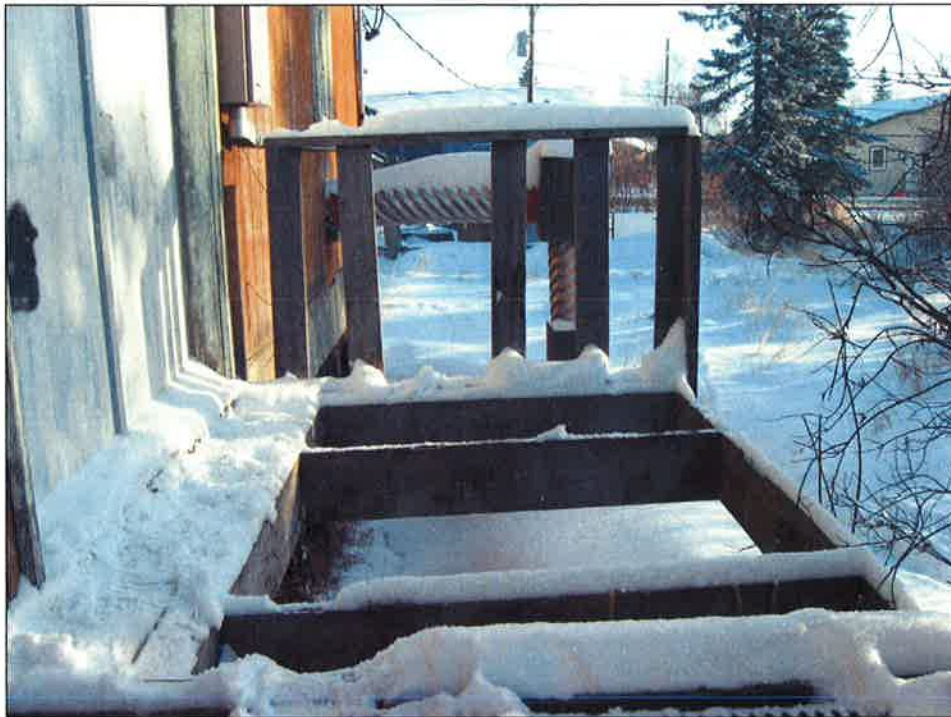
Photo No. 8: Landing on South Wall
Note: No decking creates potential safety hazard

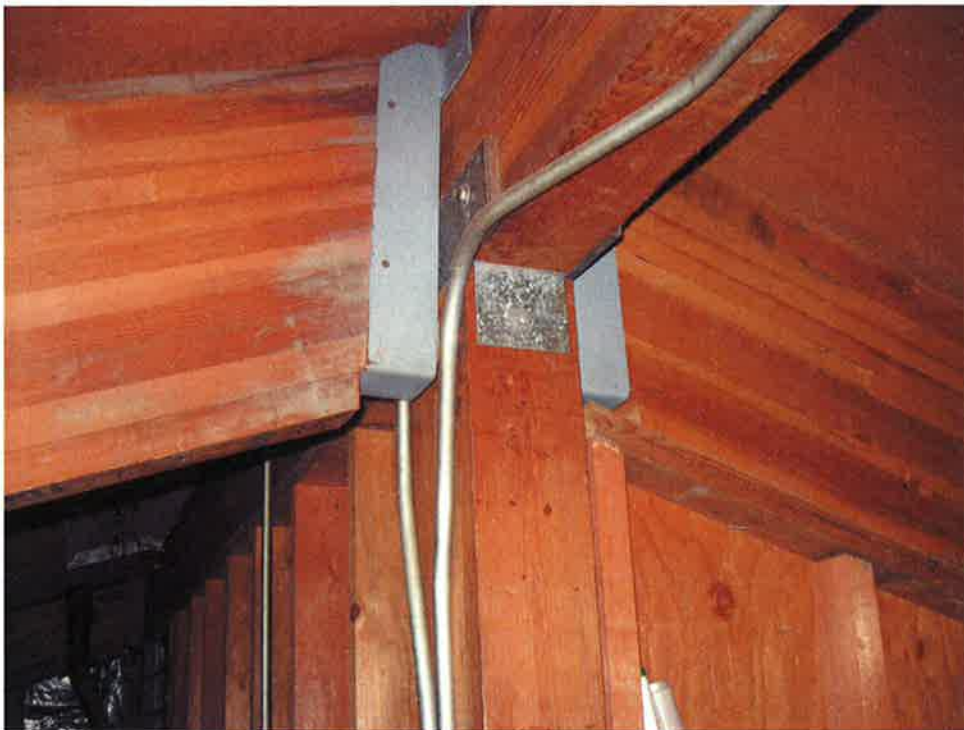
We observed no structural issues with the roof framing. Water stains were noticed on several of the roof beams (Photos 10 and 12), but no rot was observed in the roof framing members. Where glued-laminated beams framed into columns, it appears that the steel hanger connections were too short and the beams were notched to allow for installation (Photo No. 11). This is not a recommended detail as it can lead to splitting of the bottom of the beam at the notch. However, the beams are performing adequately with no splitting. No action is required.

Photo No. 11: Roof Framing
Note: Dapped GLB at connection

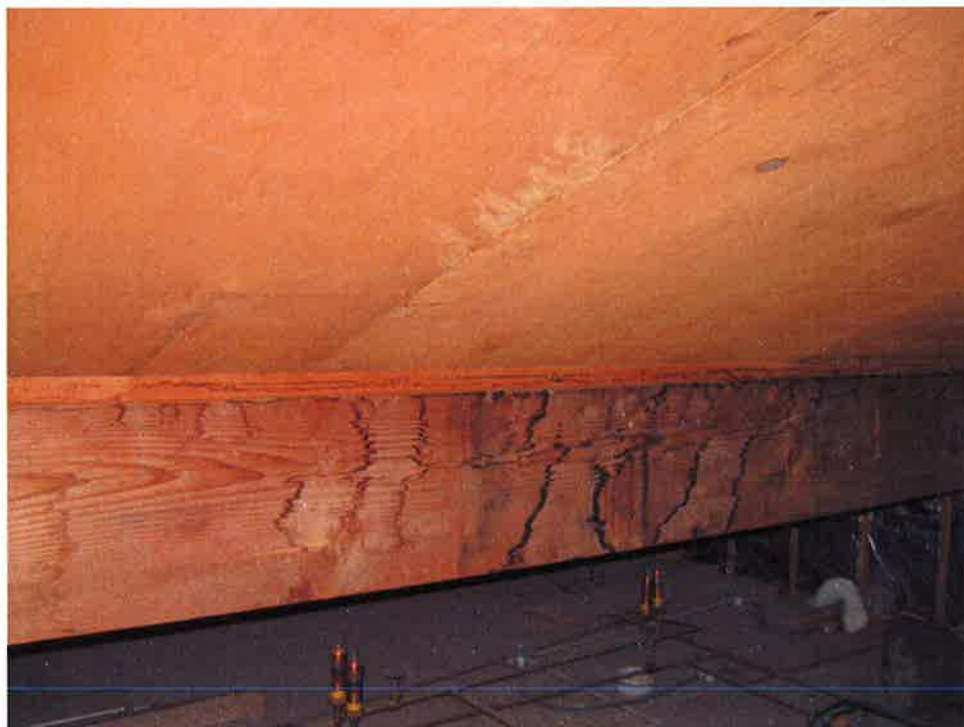
Photo No. 12: Roof Beam
Note: Water stains on beam

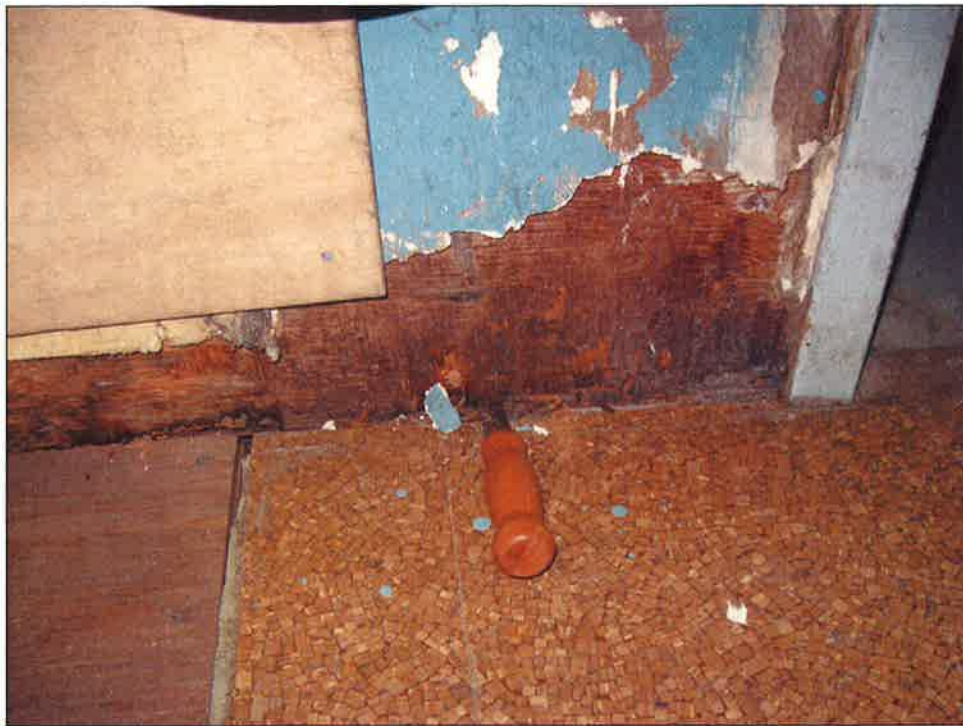
Photo No. 13: Washeteria – Rot at base of wall separating Washeteria and Boiler Room

1. Prevent water accumulation on the floor. This would include ensuring that washers are not leaking and are properly draining, boiler leaks are fixed promptly, and water is not allowed to pond on the floor. Water from washeteria and treatment plant operations are the cause of rot in the floor framing of the platform.

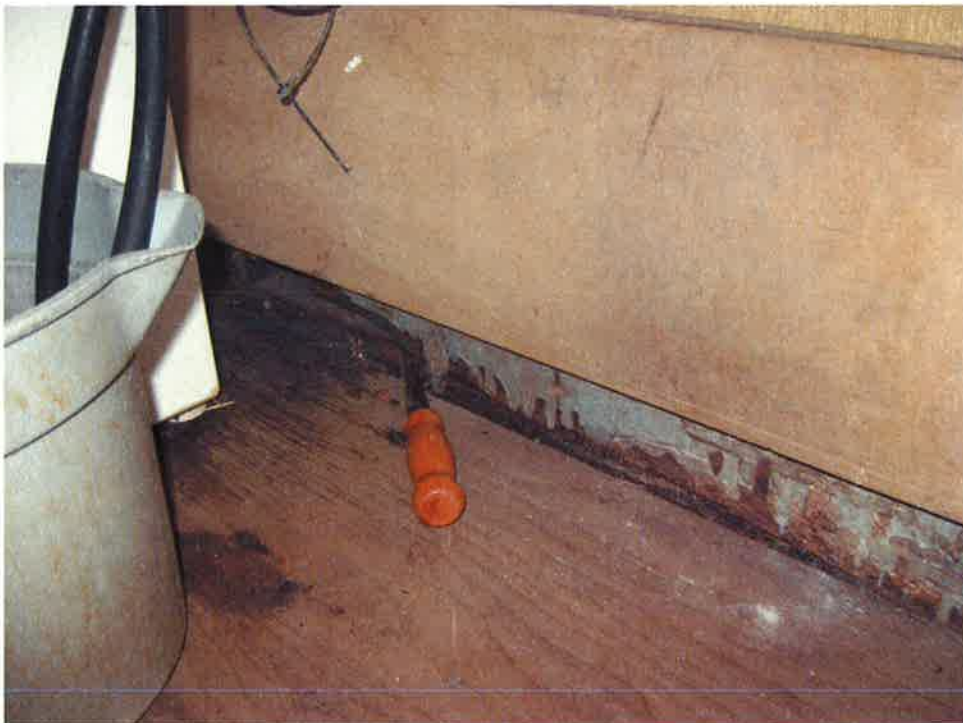
Photo No. 14: Washeteria - Rot at base of wall separating Washeteria and Boiler Room

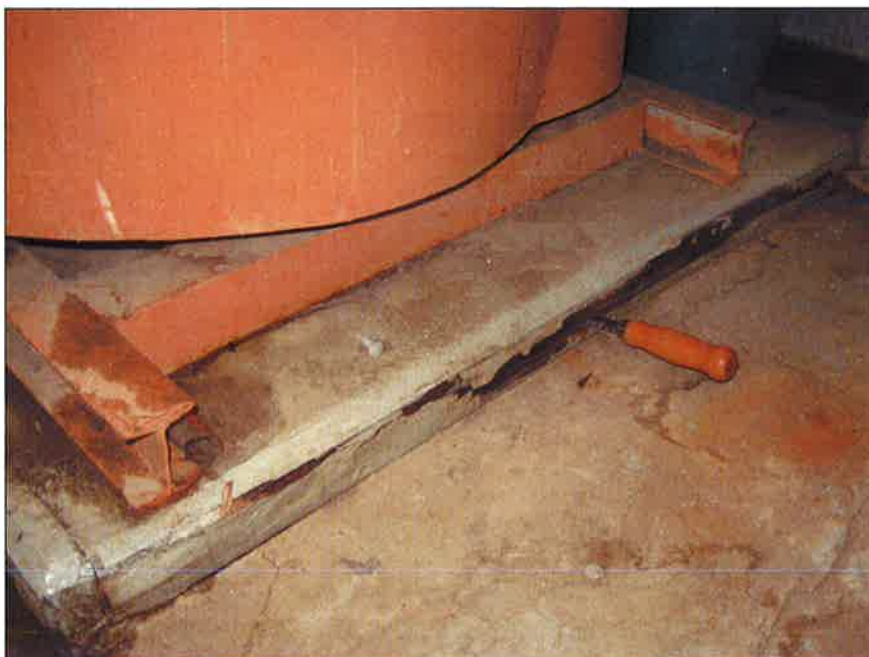
The plywood sheathing and joists in the boiler room, at least in the area adjacent to boiler no. 2, should be replaced. As the equipment pad under the water heater is also severely rotten, there is a chance that the floor under the water heater is rotten or damaged as well. Replacing the flooring and joists would not be an easy task. The best approach would be to remove existing equipment, remove all damaged flooring, and replace with new framing and sheathing, including the wall separating the washeteria from the boiler room. This approach would work well if the existing boilers and water heaters were scheduled for replacement. The flooring could be removed from below, but even this approach would probably require the temporary removal and replacement of equipment. For budgeting purposes, I would recommend that the entire boiler room floor be considered for replacement.

Photo No. 16: Boiler Room – Wood platform supporting hot water tank

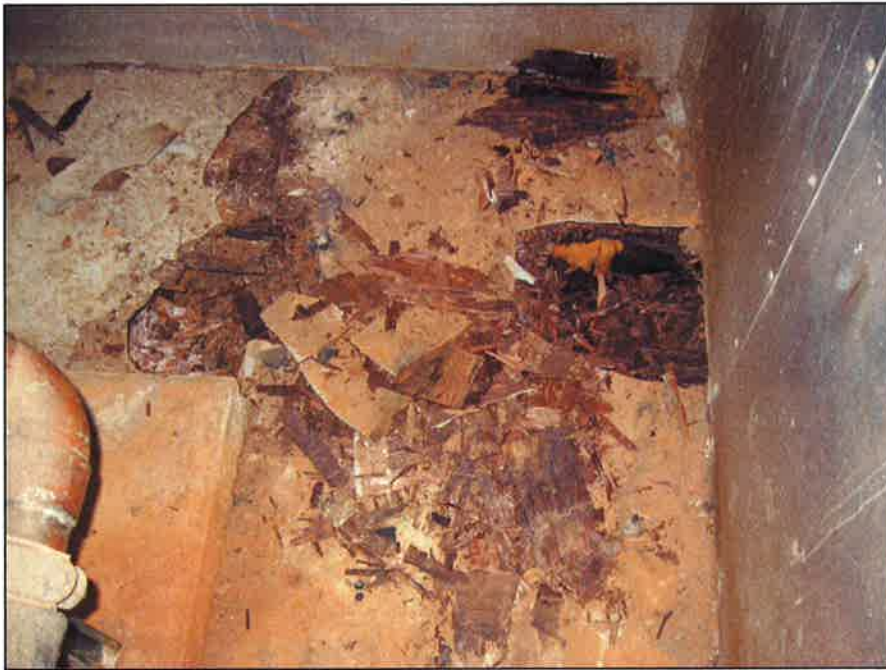
In general, the water treatment plant is in reasonably good condition. The most significant issue is the presence of significant rot in the floor sheathing and joists in the northwest corner of the boiler room. The rot is caused by water penetration from the washing machines in the washeteria or by leaks from the boilers.

2. Northwest corner of the boiler room, behind boiler no. 2 (Photo 17). The floor in this area has a soft spot that “gave” under the weight of a foot. The plywood could be easily removed by hand. The top of the 3x12 joists in this area could also easily be removed by hand – indicating extensive rot. The insulation between joists was wet, not just damp.

***Photo No. 17: Boiler Room – Rotten plywood and joists
behind Boiler No. 2***

1. Replace the flooring in the boiler room.

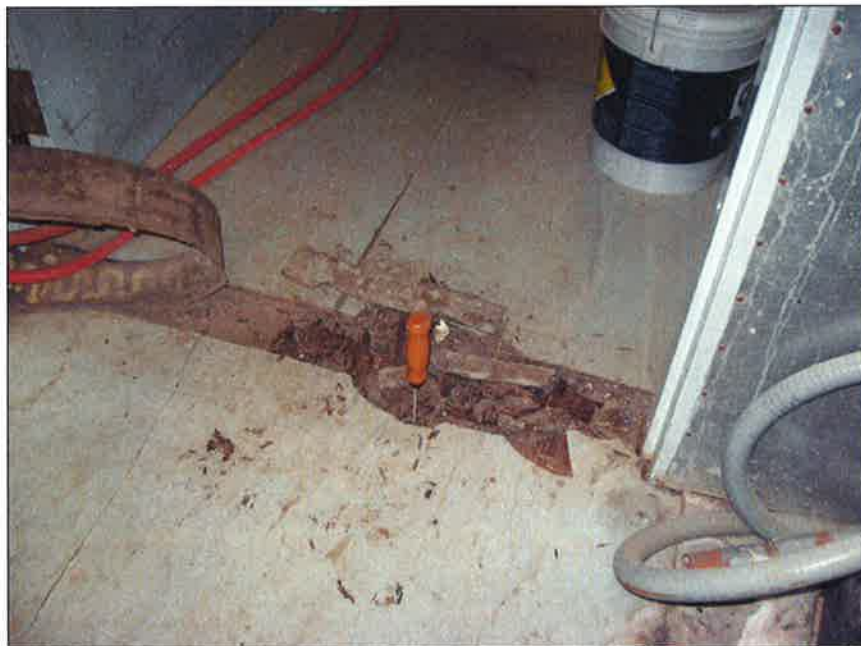
4. Doorway between the boiler room and treatment room: The wood framing under the door is rotten (Photo 18).
5. Floor in front of the water treatment tank (Photo 19): An area of the floor in front of the water tank is soft. The plywood is soft and can be scraped easily with a knife. The extent of rot is not as severe as in the boiler room.

***Photo No. 18: Boiler Room – Rotten sill at door between
Boiler Room and Treatment Room***

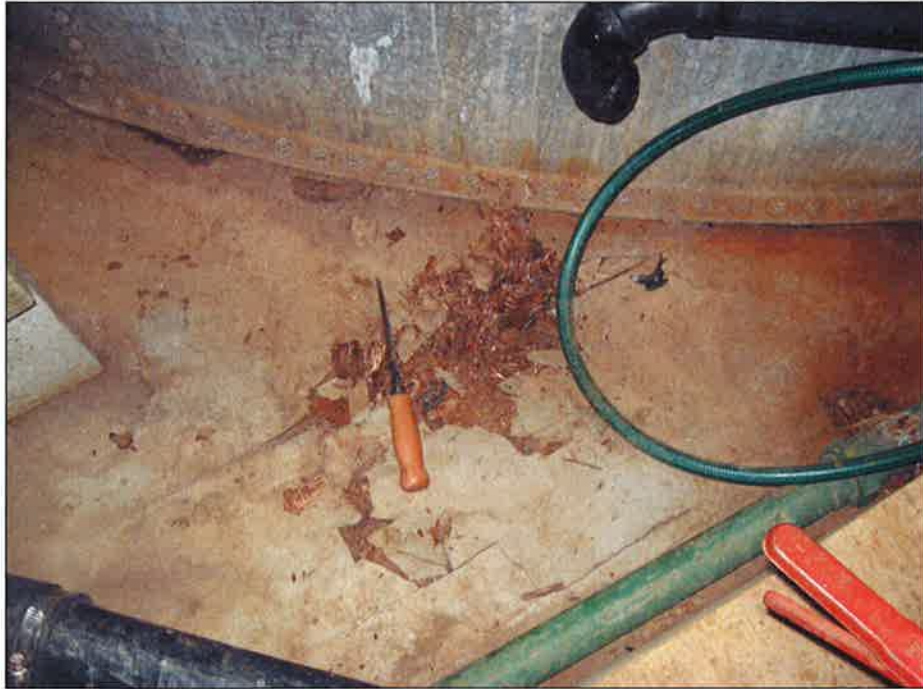
Photo No. 19: Water treatment tank – rotten plywood adjacent to tank

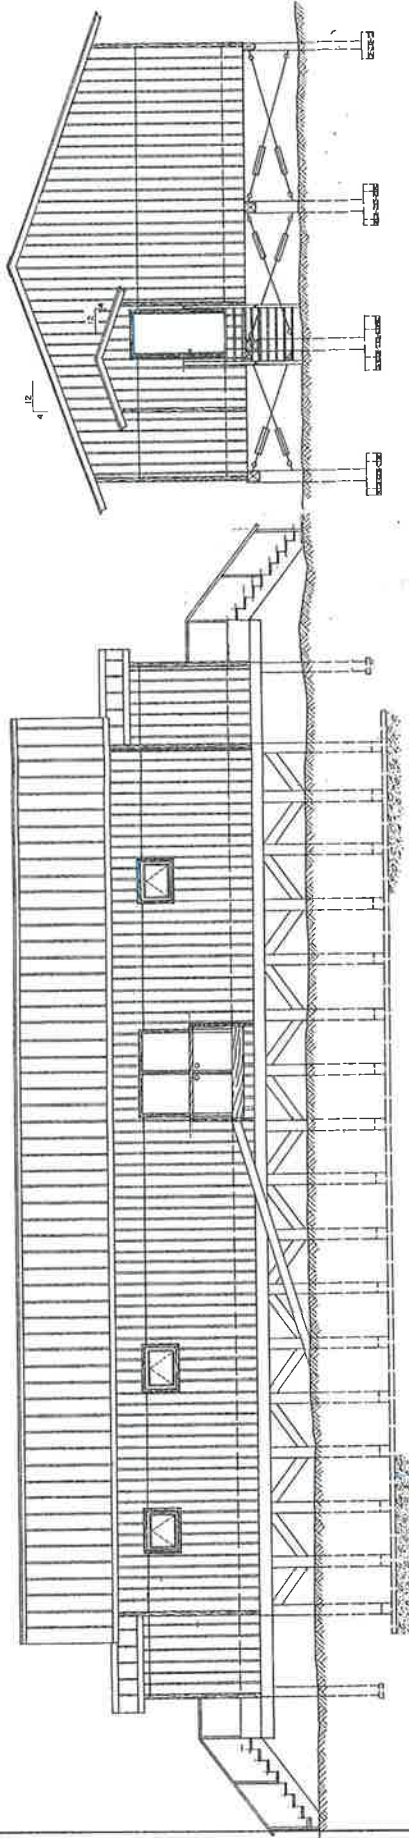
ROT @ DOOR THRESHOLD
PHOTO 18

SOFT SPOT IN FLOOR
AND ROT
PHOTO 19

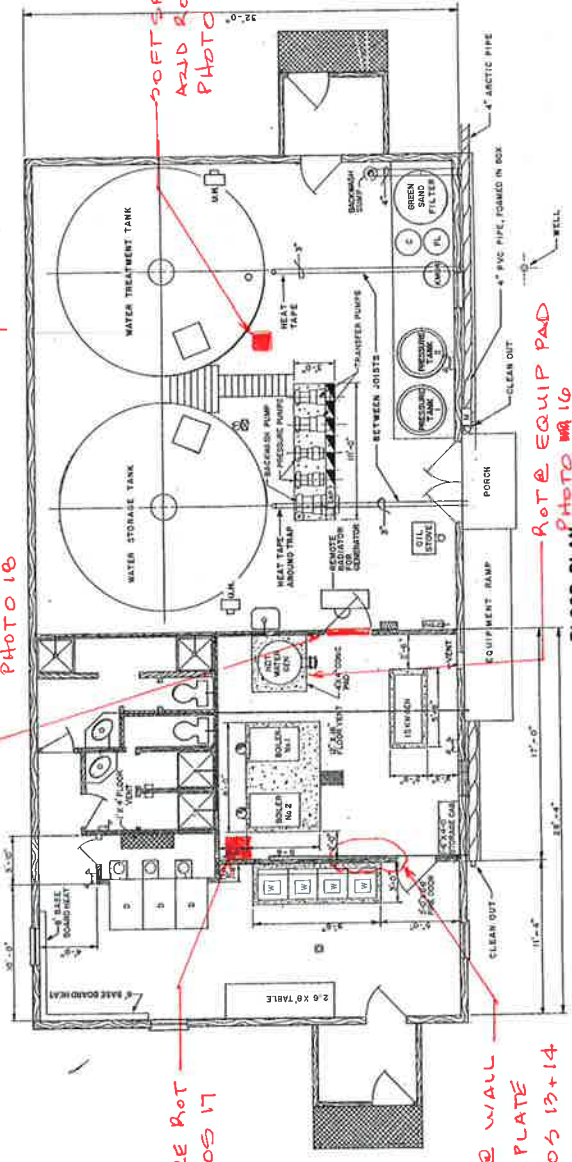
SEVERE ROT
PHOTOS 17

ROT @ WALL
SILL PLATE
PHOTOS 13+14

ROT @ EQUIP PAD
PHOTO 16

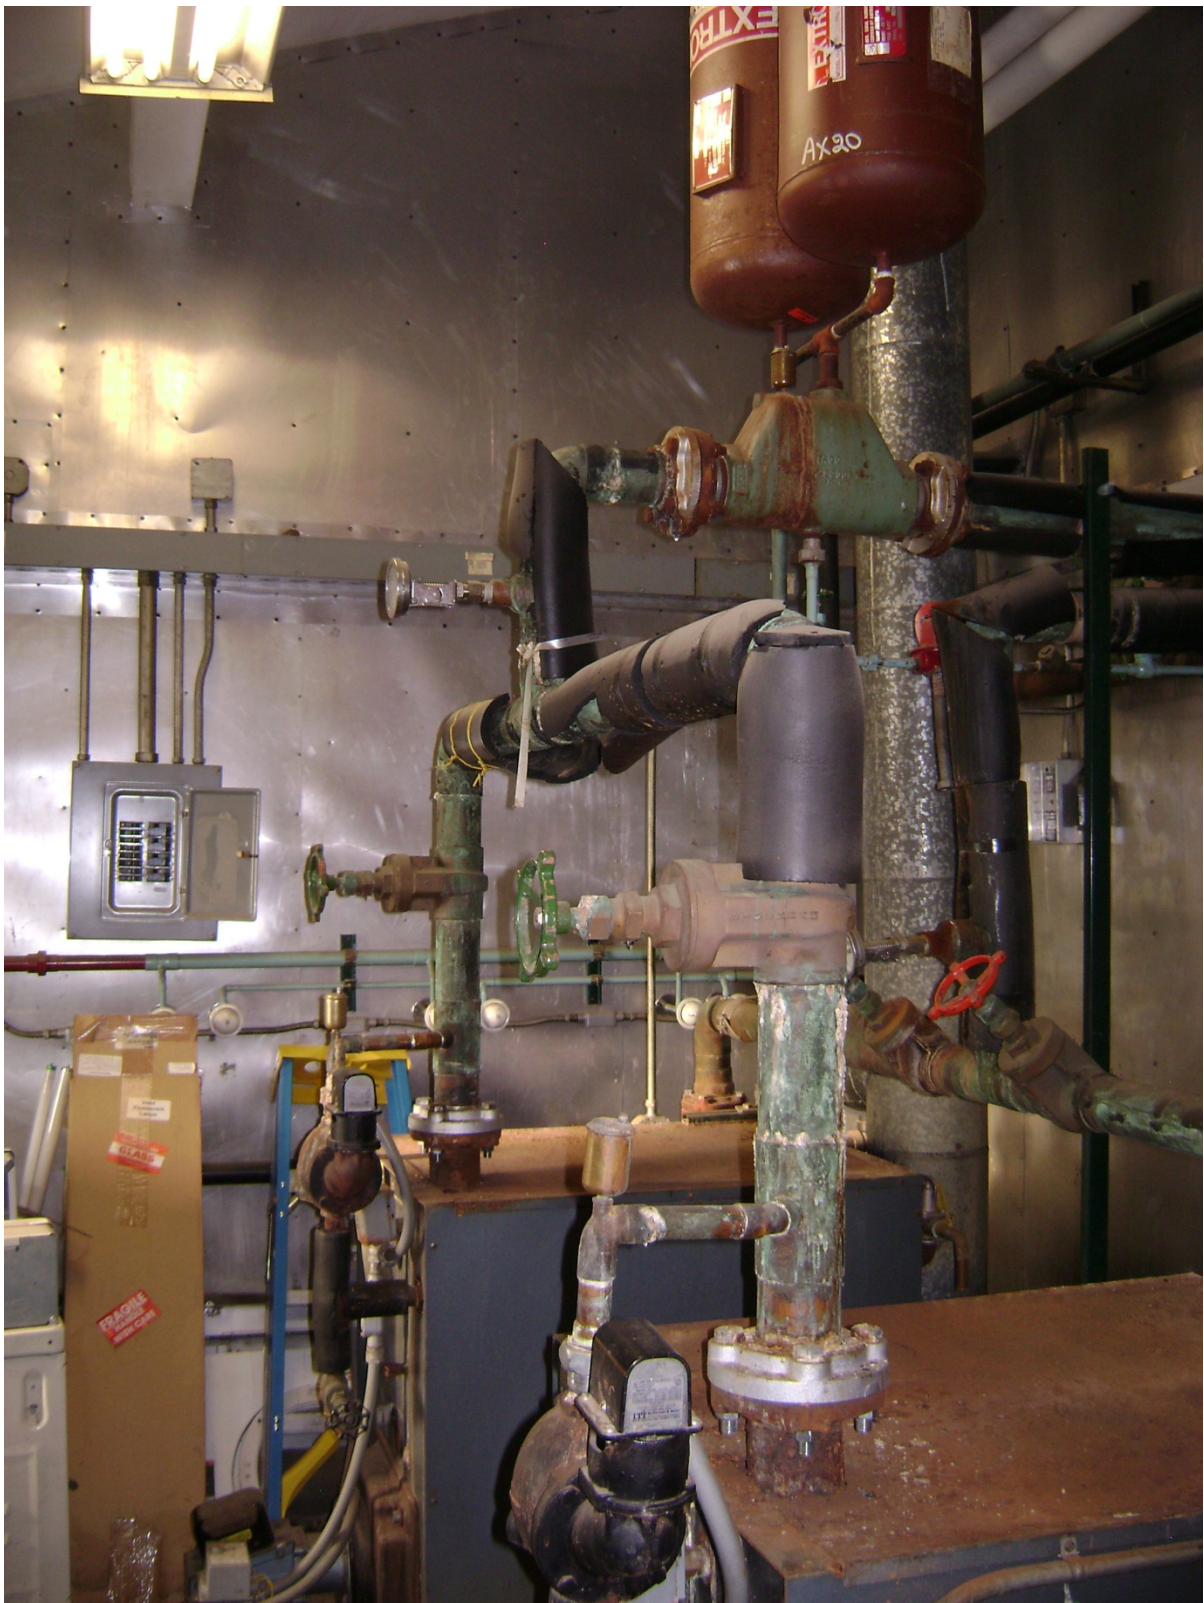
Piping near the boilers is deteriorating badly, with multiple joints starting to leak. The supply flange connections at both boilers have been replaced due to leakage, but copper sweat joints will either need to be re-soldered after disassembling and cleaning or the piping replaced. The hydronic system fill is water, and has no corrosion inhibitors as a glycol system would. The fill valve is maintaining steady pressure in the system, but the relief valve at the fill valve started leaking and was plugged by Carl to stop the leak. The relief valve is a redundant one, as the relief valves on the boilers are in place and so not appear to be leaking. However, relief valves should be tested or replaced on a regular basis (10 years maximum interval), and the service record of these is unknown.

View of Boilers with leaking piping and deteriorated piping insulation

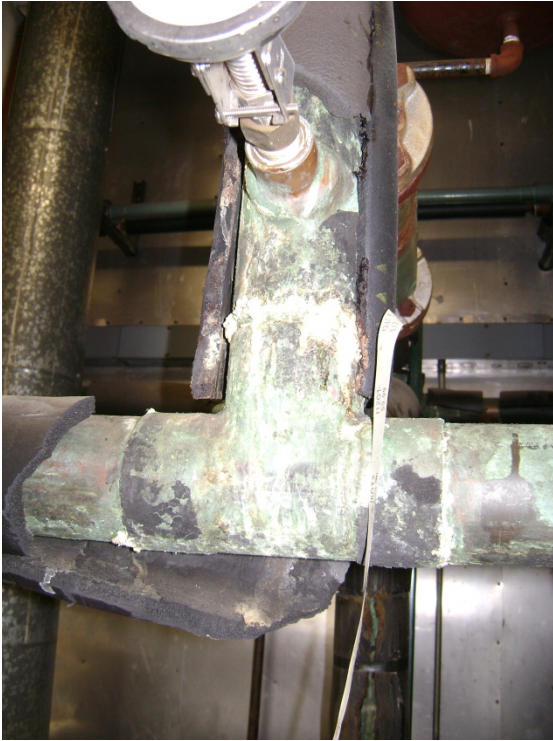
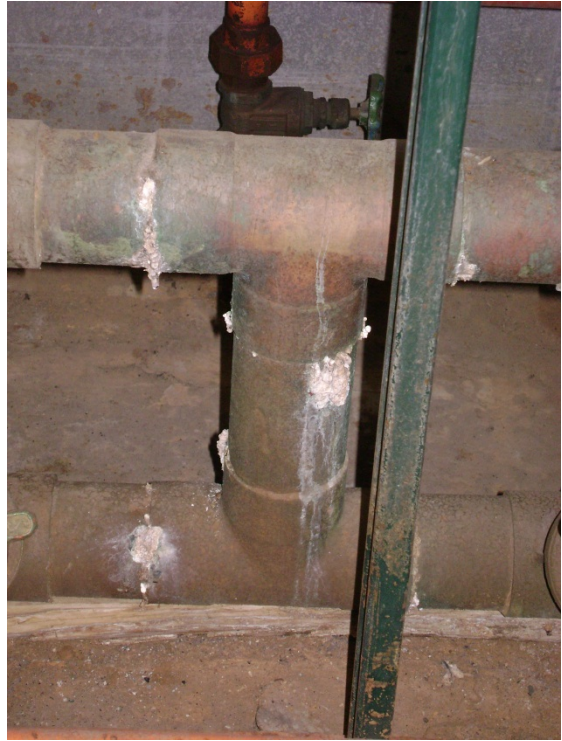
Close-ups of copper boiler piping with corroding, leaking joints

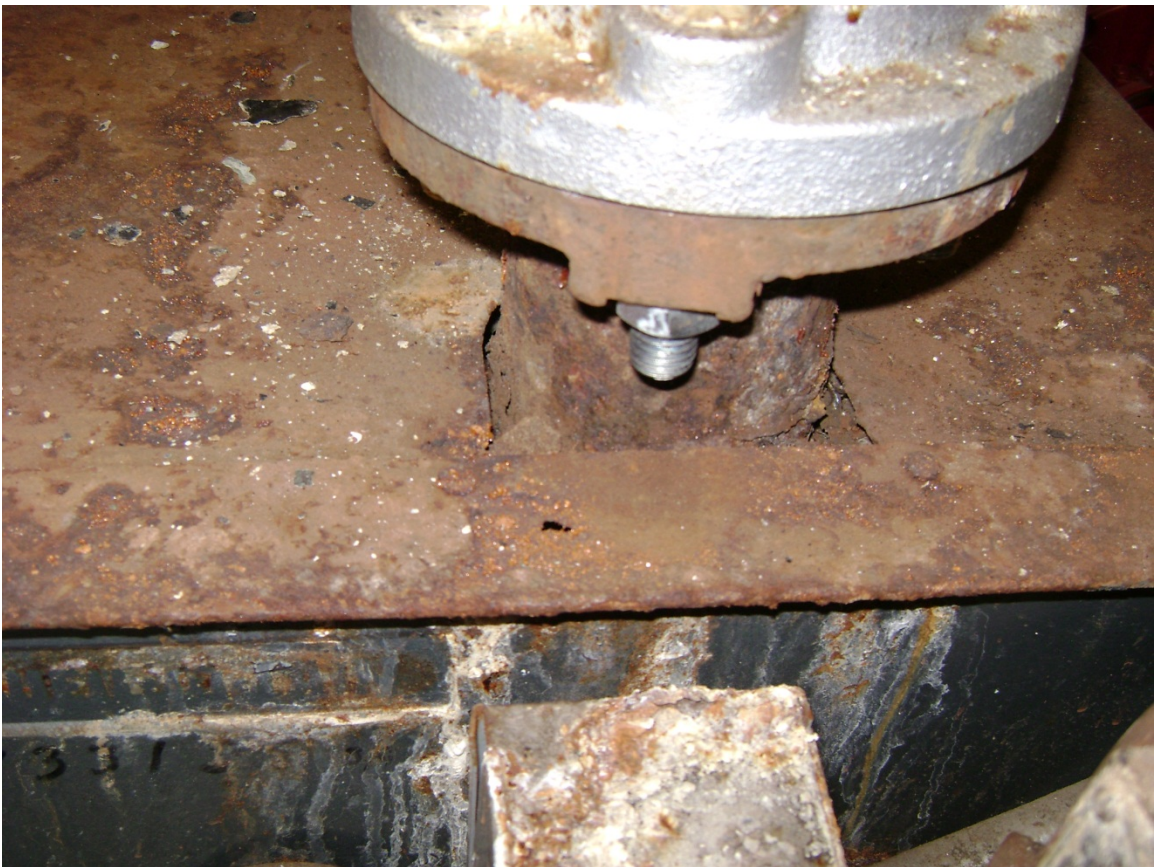
Close up of corroded boiler supply nipple.

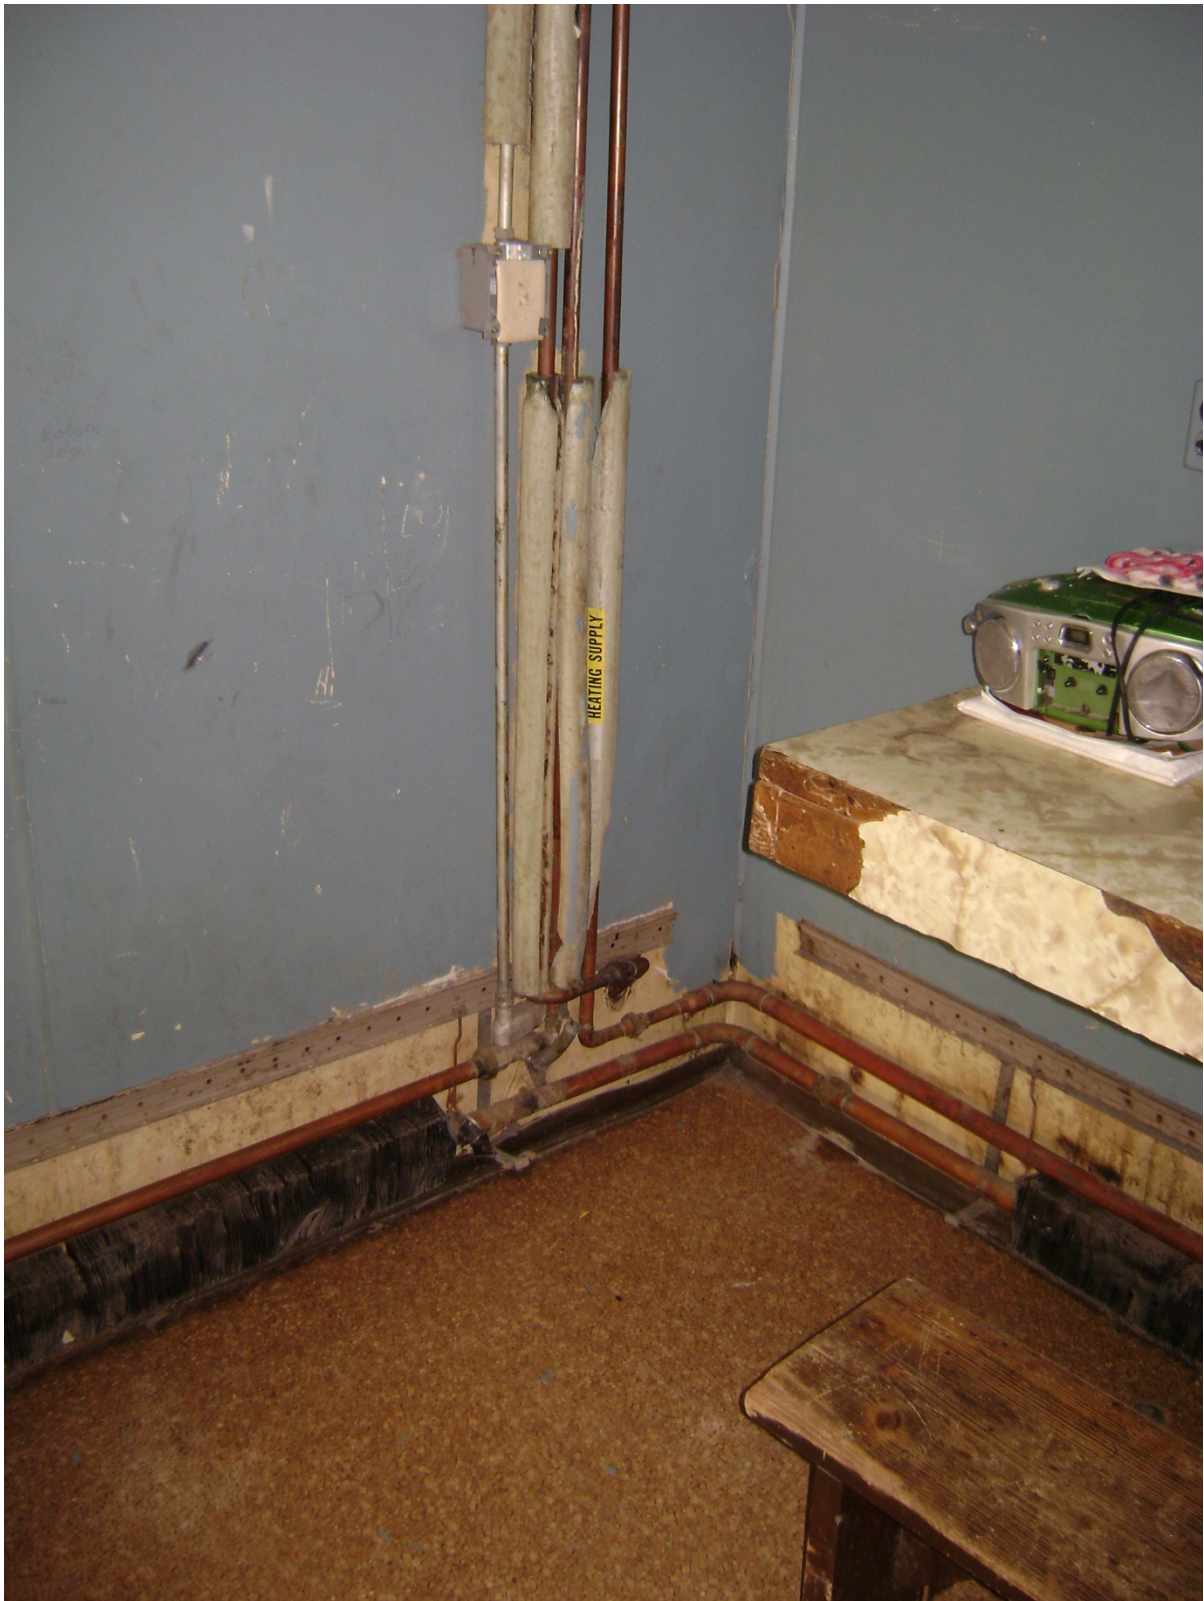
Baseboard heaters in the public area of the building have missing covers and the fins are badly damaged. The bent fins and lack of covers significantly reduces the capacity of the heaters. The unit heaters in the treatment area appear to be in reasonably good shape and are operating. They may need to be cleaned to remove dust and obstructions from the coils, but are otherwise serviceable.

Baseboard Heaters: Operating at less than designed output due to damaged fins. Should be replaced.

Baseboard heaters with missing covers and damaged fins.

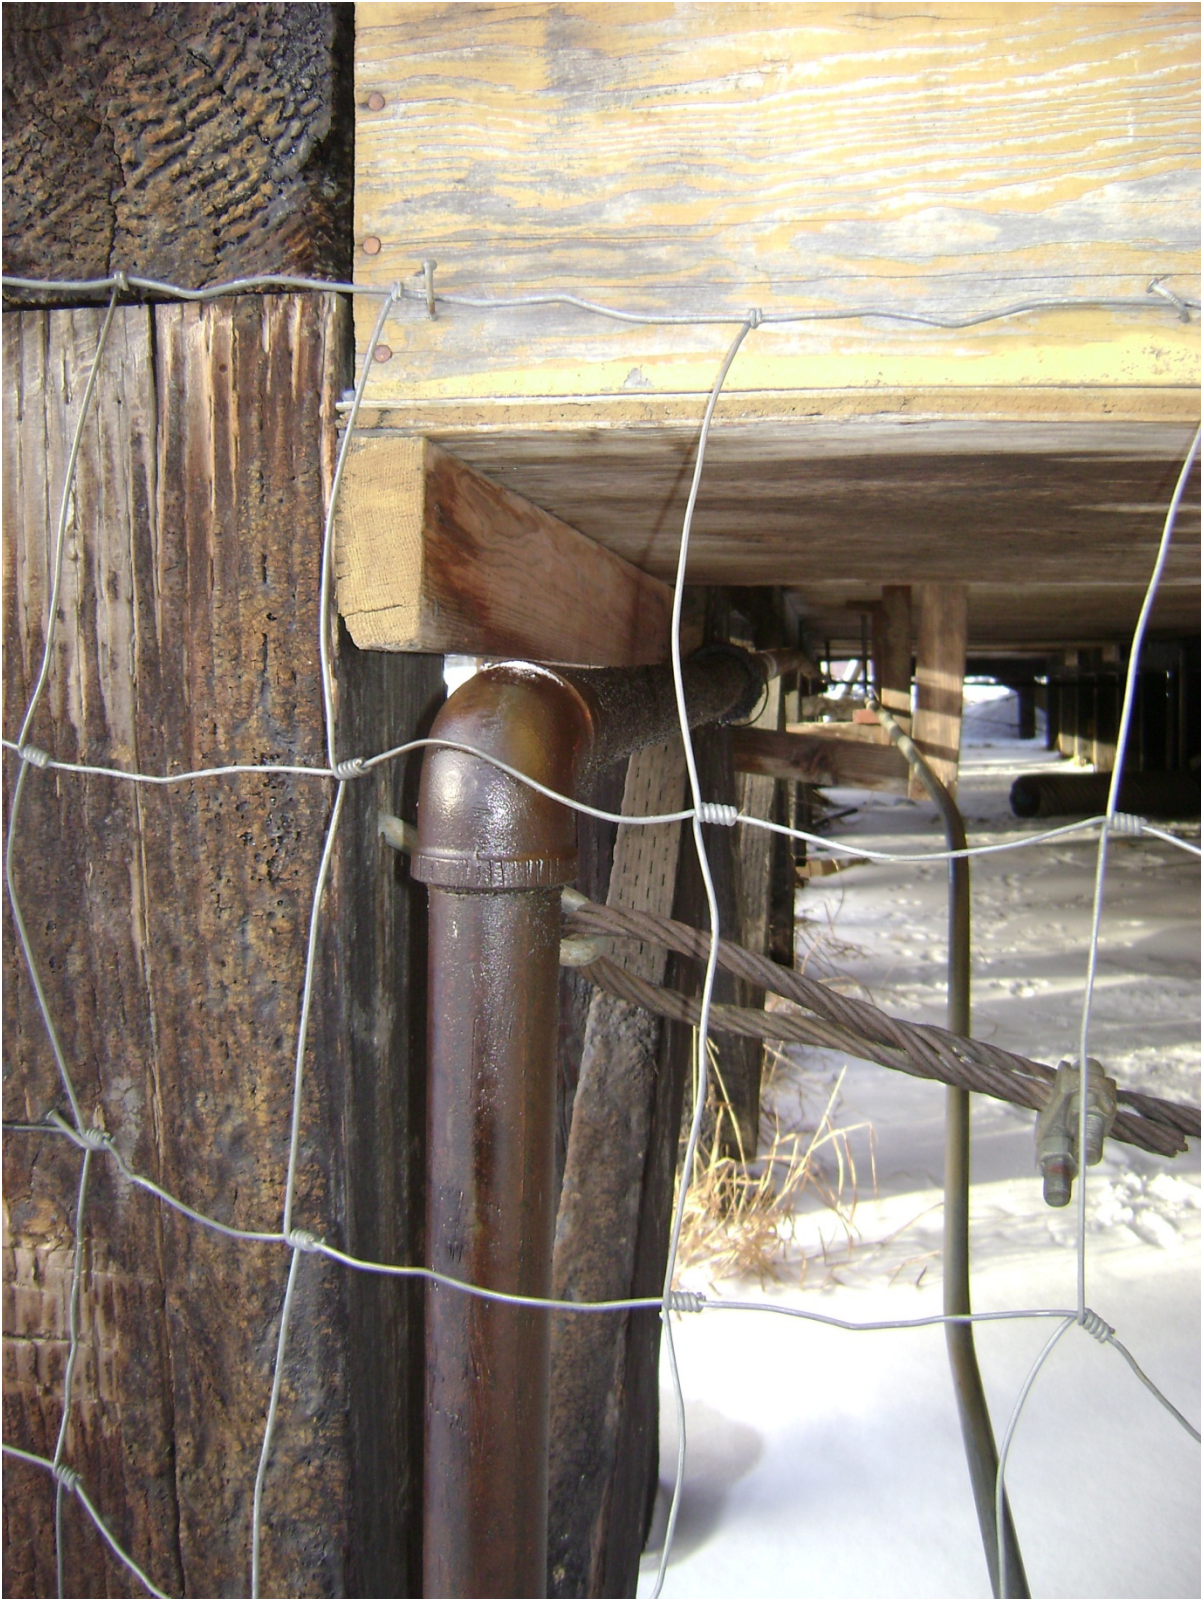
The fuel supply pipeline has a leak where the piping first crossed under the building which should be fixed to reduce fire hazard and contamination of the nearby well.

Photo of leaking fuel supply piping – Well pump is in the background to the left. Leak is at union about 4 ft from elbow.

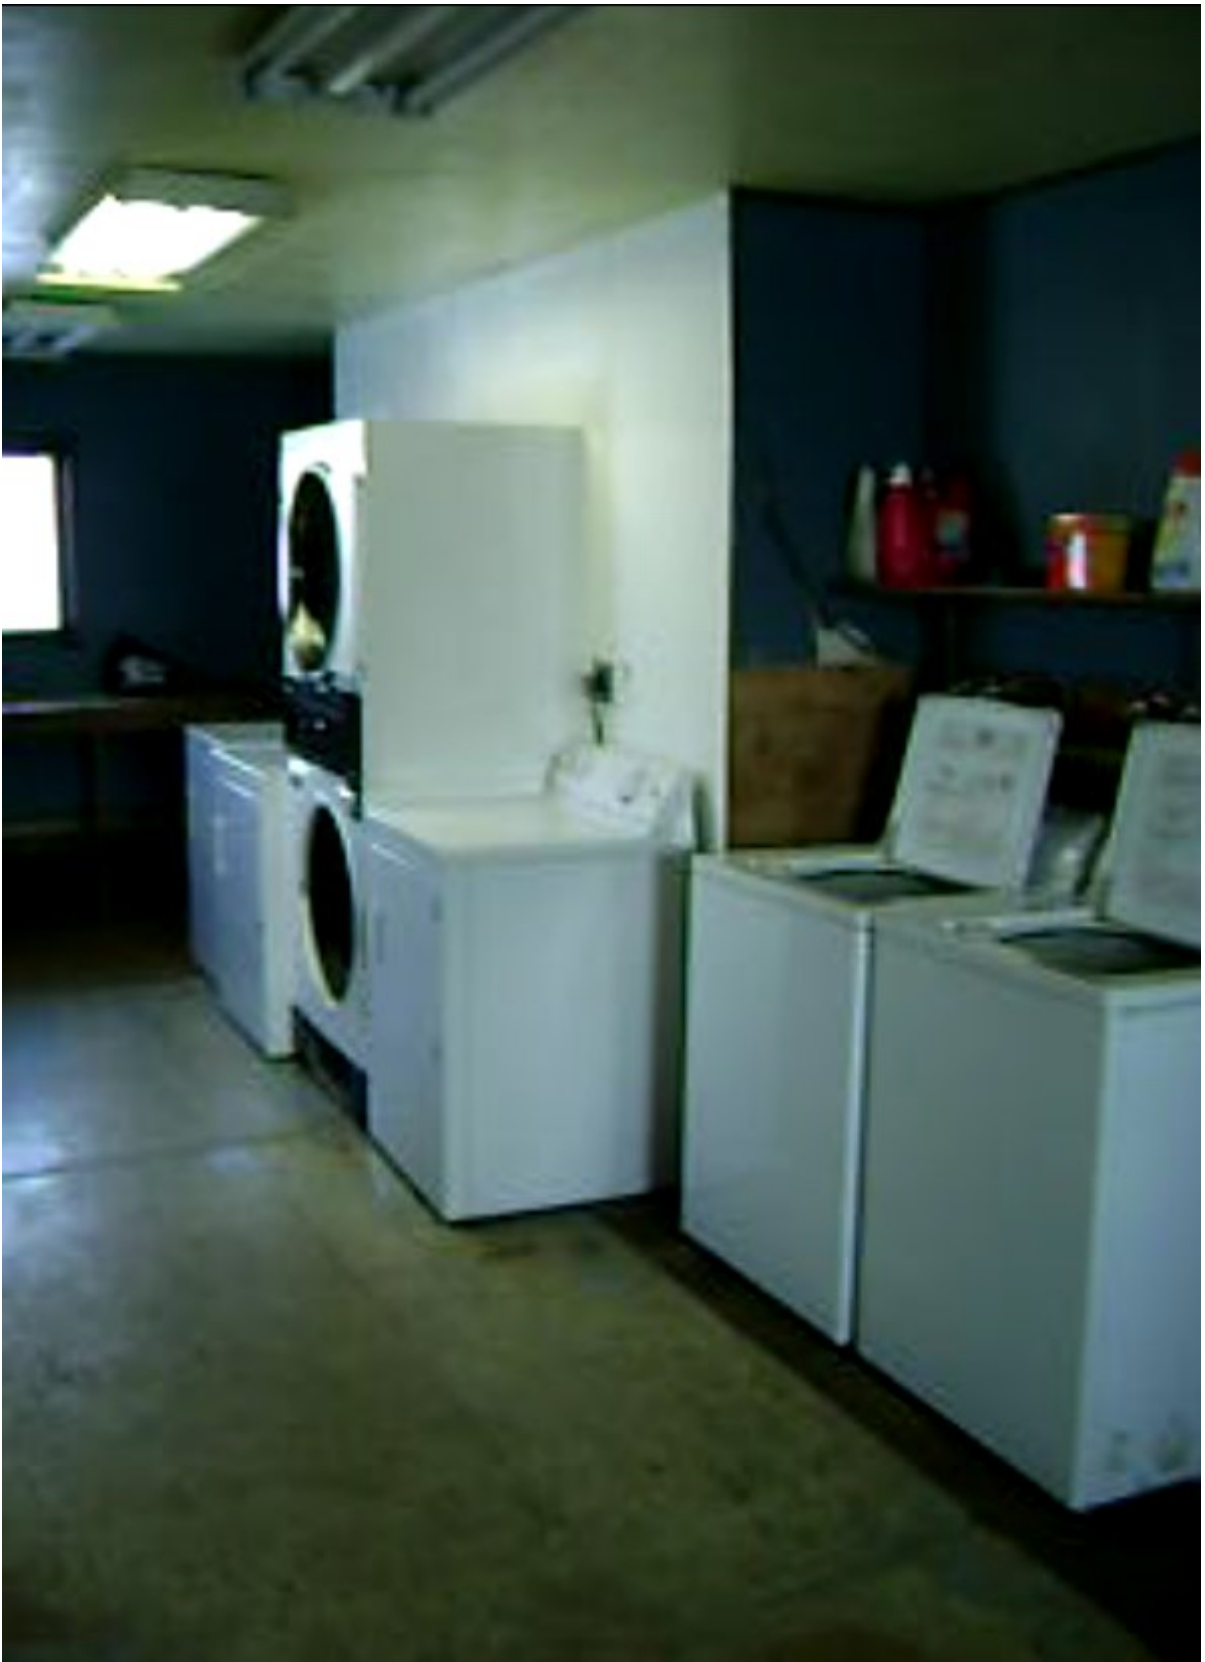
Washeteria area. Two unoccupied washer connections at right. Two stacked dryers are inoperable
