January 2013 Reports

Tuluksak Water Treatment Plant Structural Condition Survey, Reid Middletoon, Jan 2013

Tuluksak Water Treatment Plant Mechanical Condition Survey, EDC Engineers, Jan 2013

Tuluksak Water Treatment Plant Structural Condition Survey Report

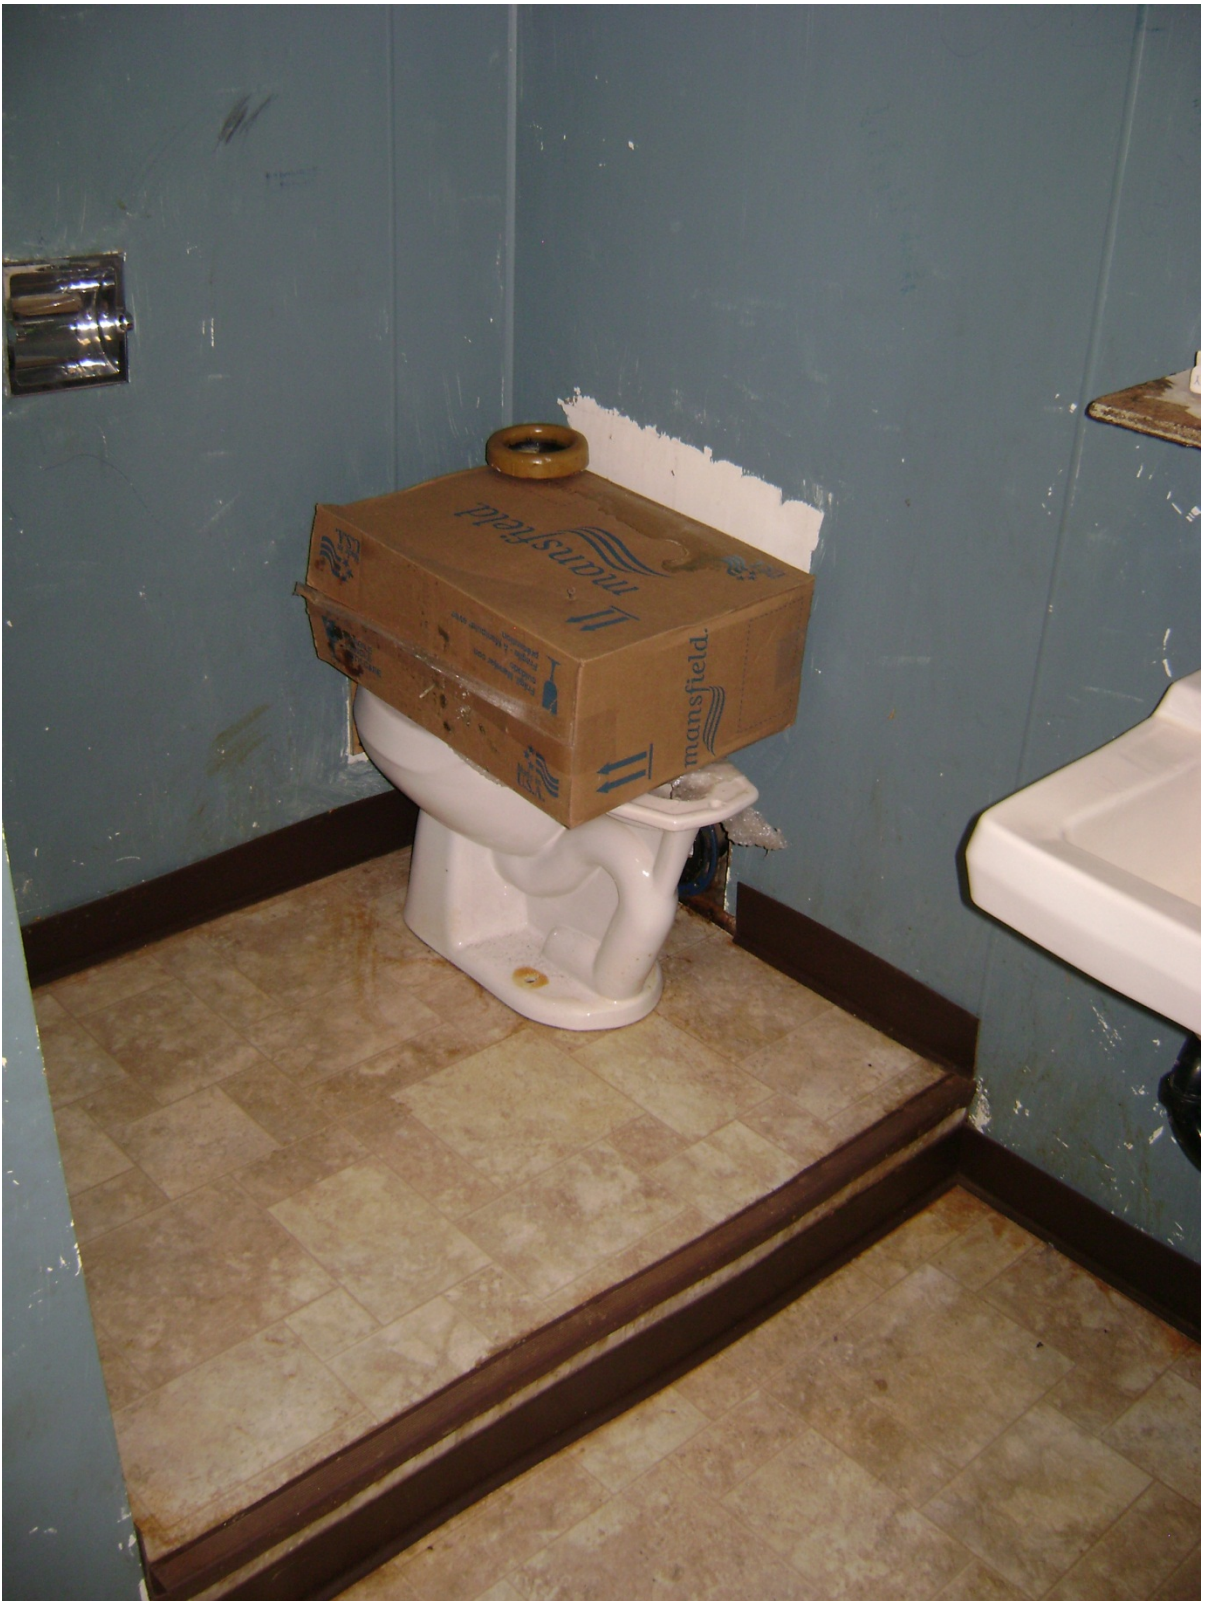
Typical Toilet/Shower room. Toilets not connected.

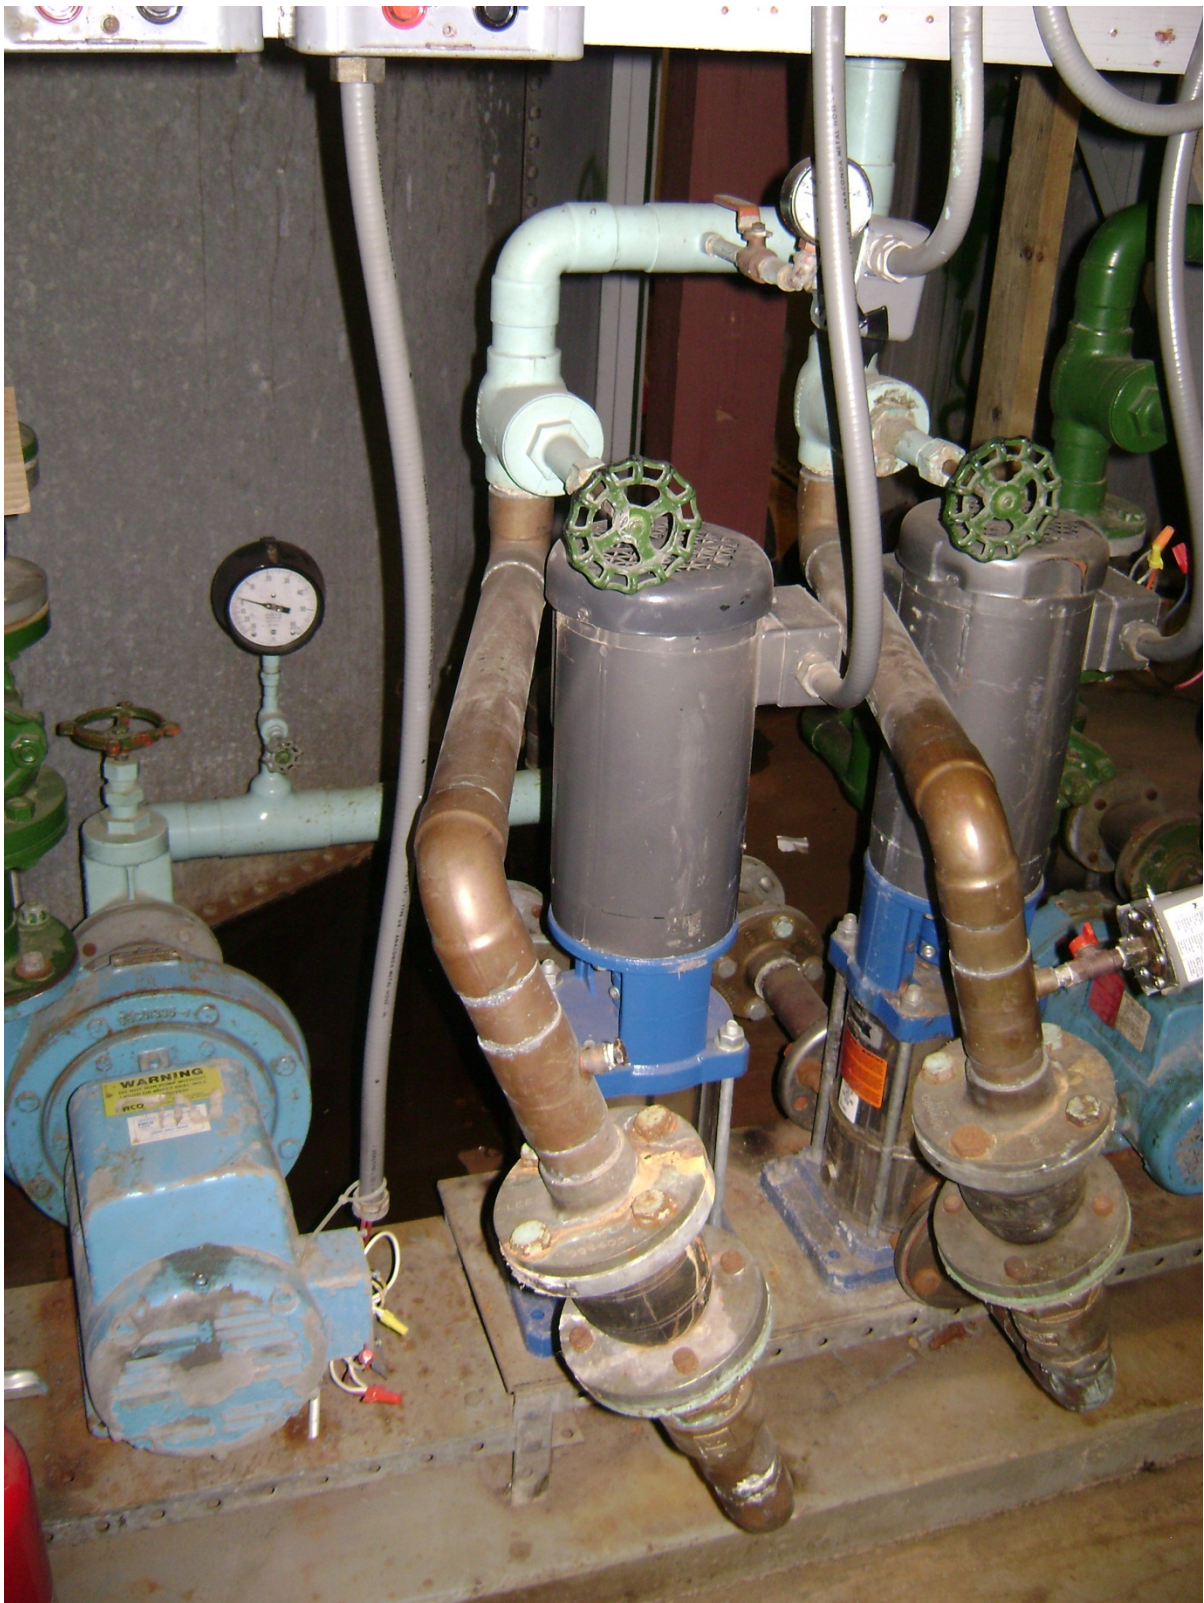
Pressure pumps (right two). One is not working. Note piping obstructing pump maintenance.

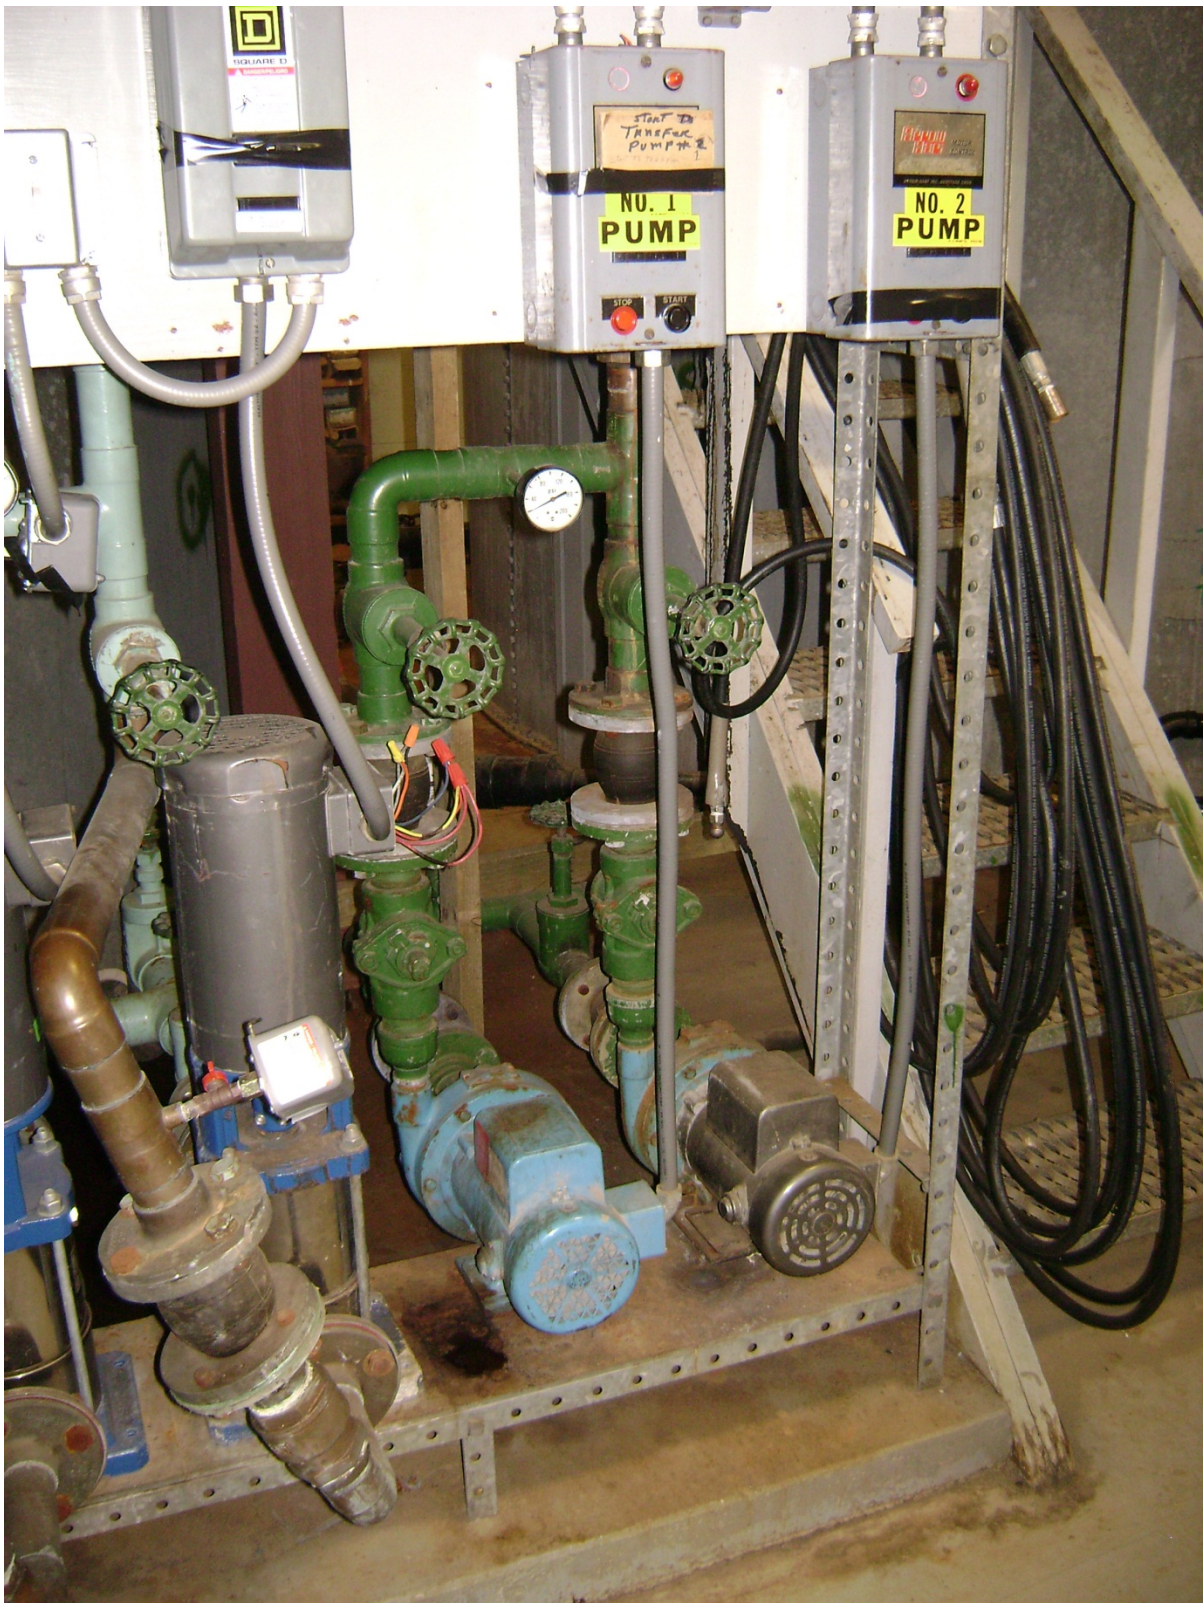
Treatment Transfer Pumps (right two). One is not working

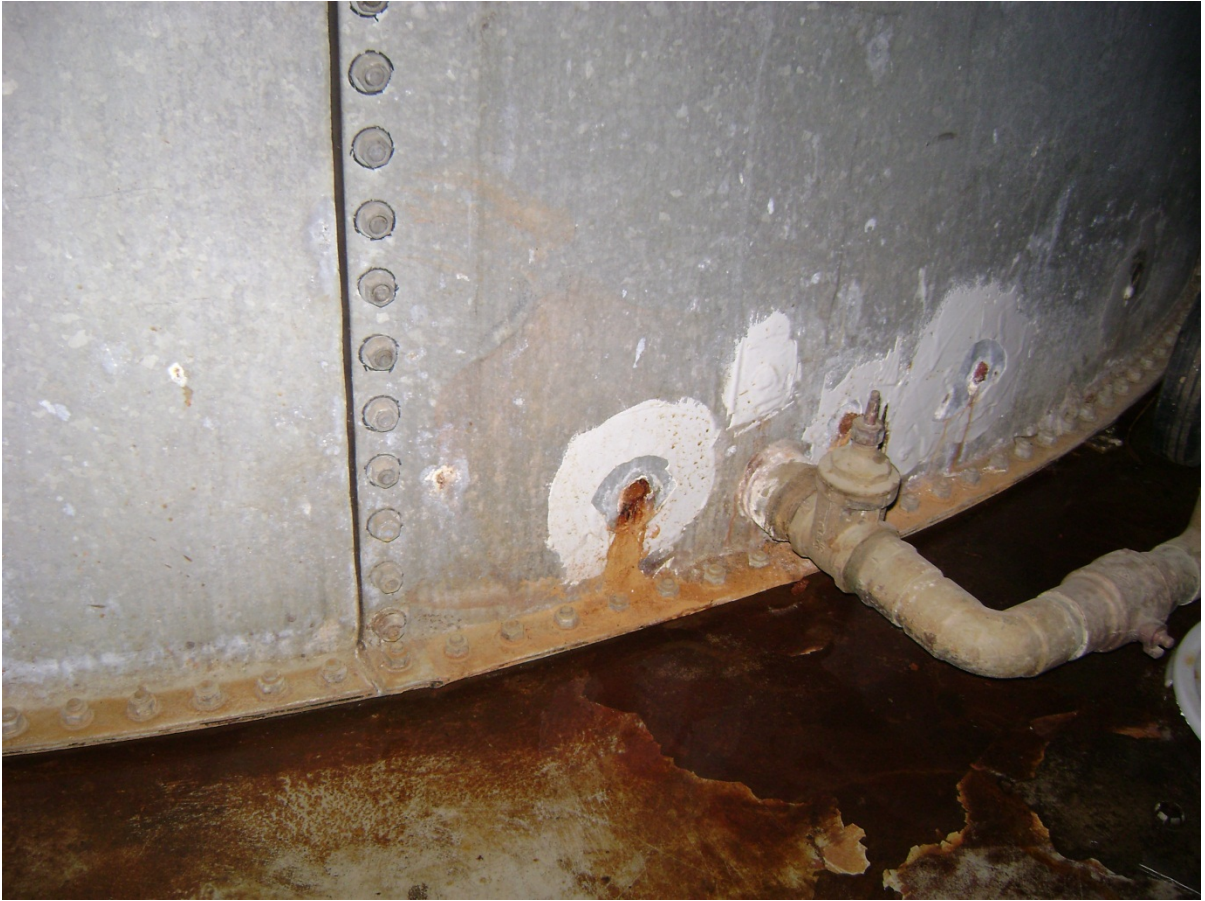
Treated water tank corrosion. Tank has been lined, but water still appears on floor underneath

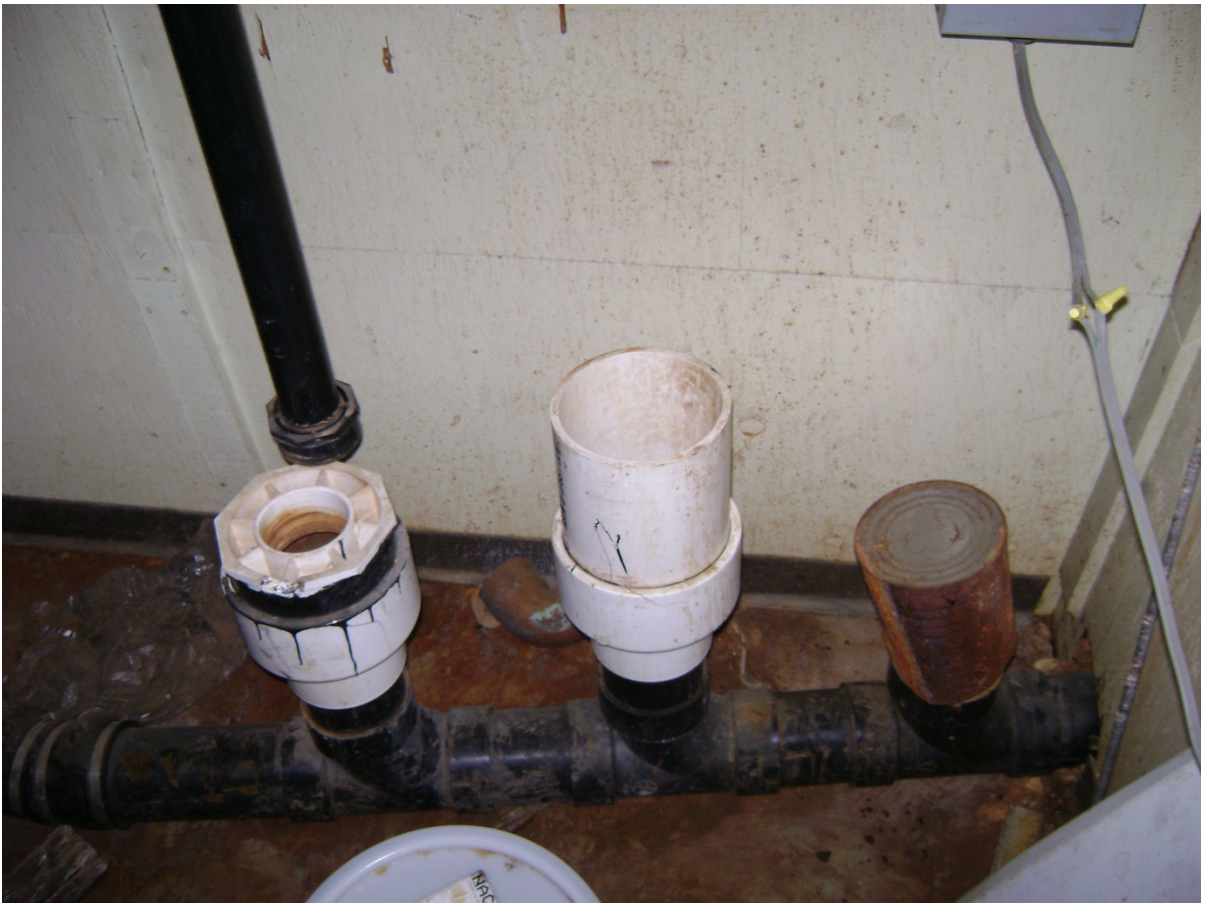
Open connections at Backwash drain line. Line is broken at exterior of building wall

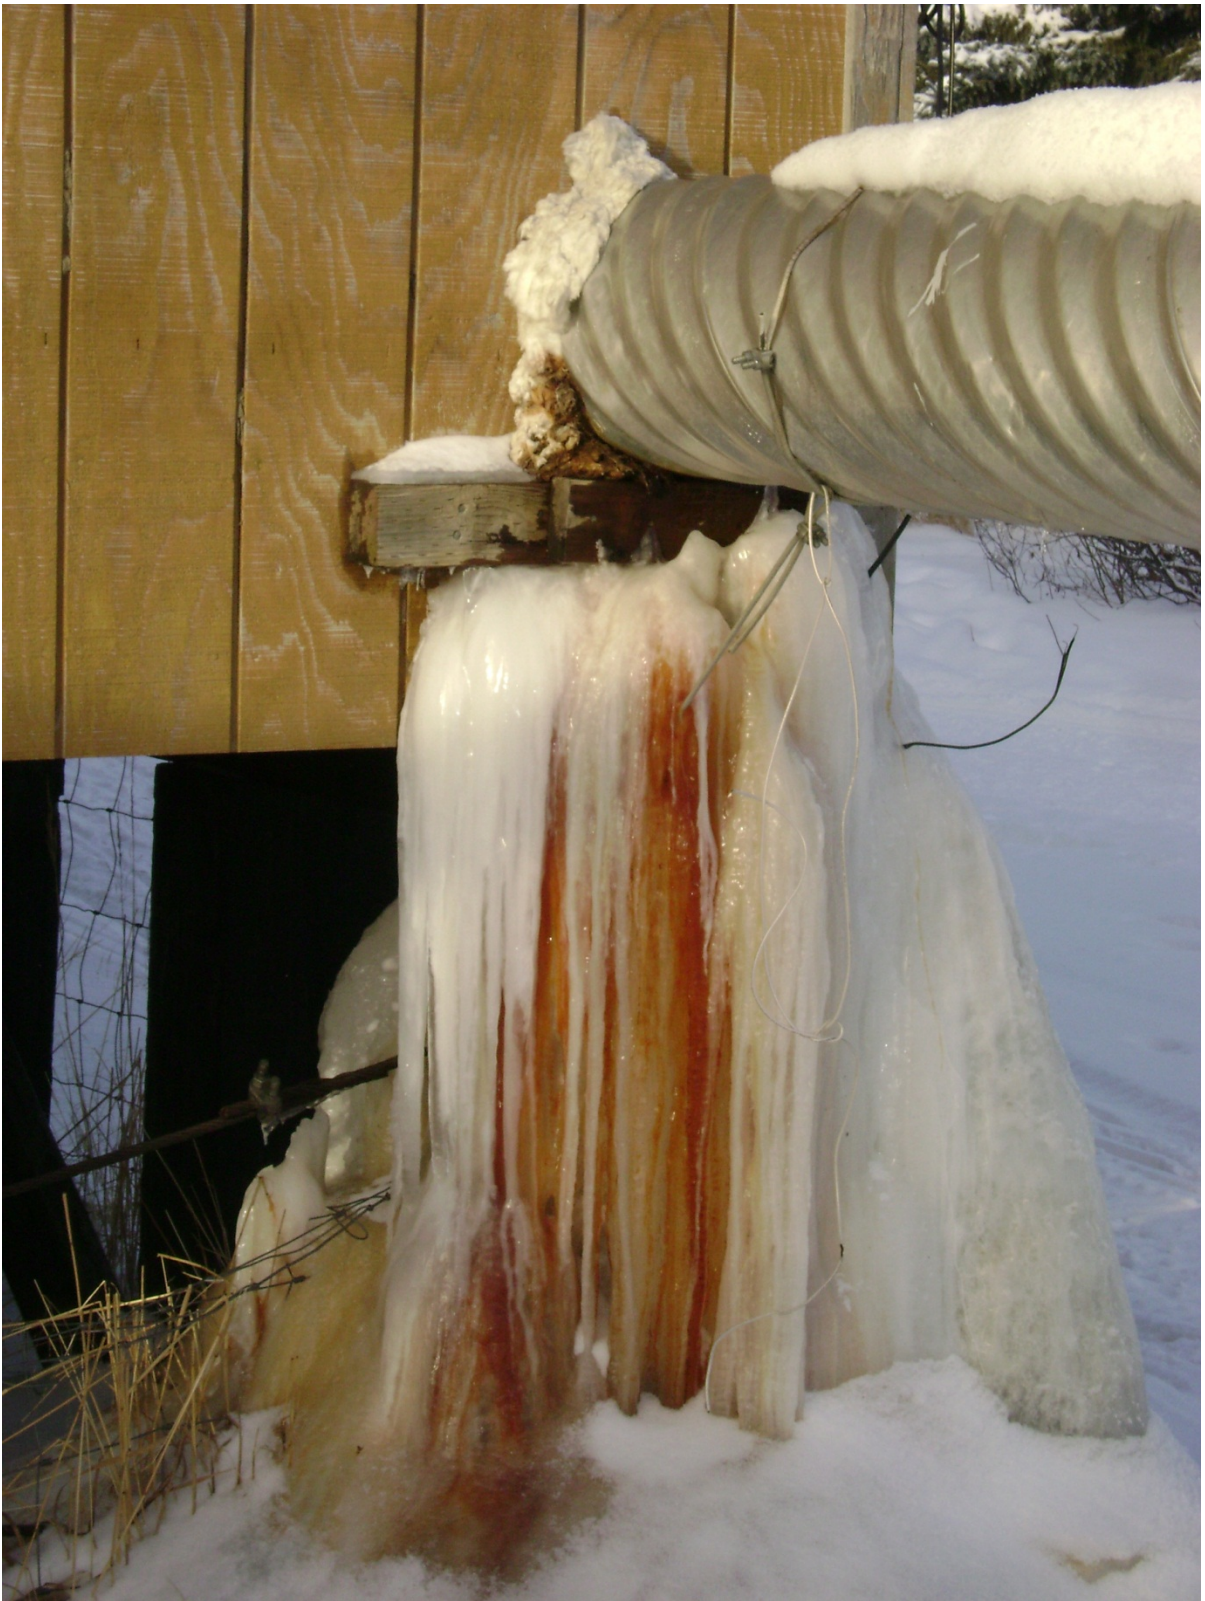
Leak at backwash drain piping from outside.

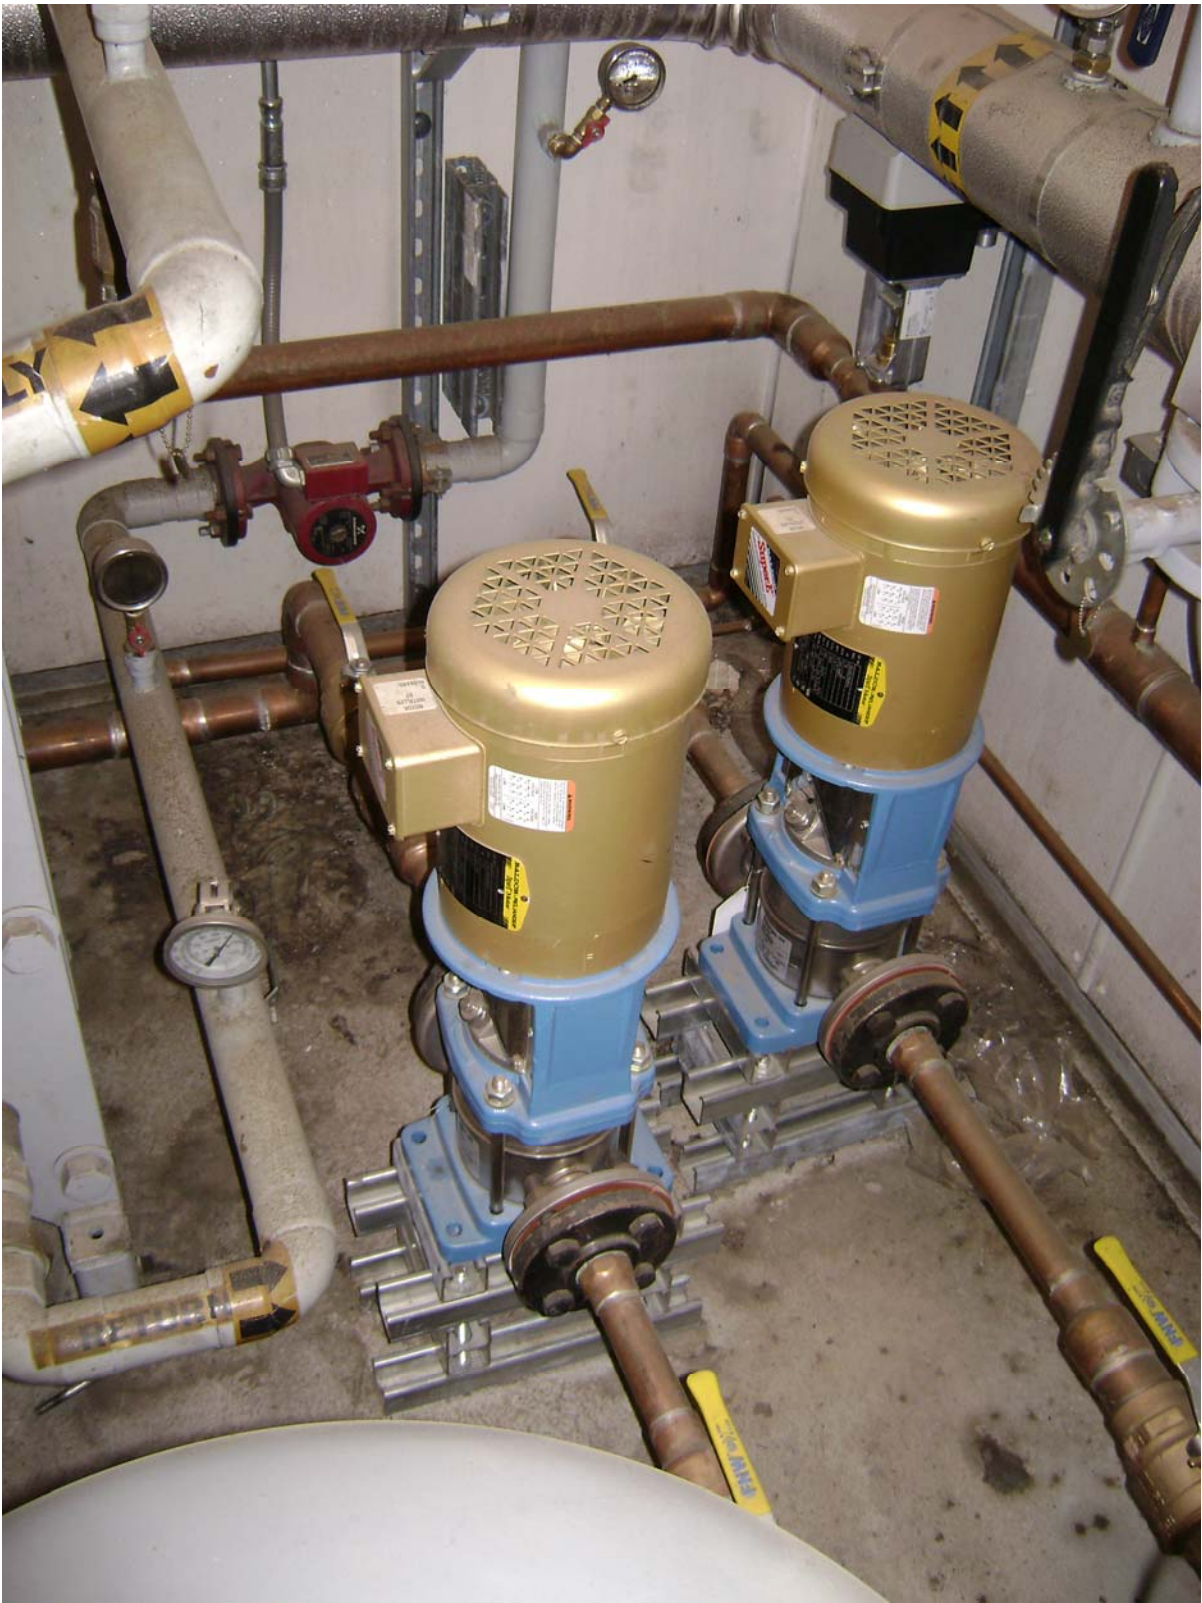
We discovered that Waste Heat equipment had been partially installed. The system consisted of an Ameridex plate-and-frame type heat exchanger using a pumped branch from the engine cooling lines on the hot side, and two branches with pumps on the cold (output) side of the heat exchanger. The hot side supply to the heat exchanger uses a Grundfos UP 50-75F pump, with a nominal capacity of 20-25 GPM. One output side branch (3/4-inch size) serves the power plant itself with a Grundfos Model 15-42SF pump delivering glycol to unit heaters in the plant and is in operation. The other branch is 2-inch size with duplex Goulds 2SVB, 2-stage, 3/4 HP, 480/240V 3-phase pumps. The pumps have a capacity somewhere between 10 and 40 GPM. The branch piping is valved off and stubbed out to the building exterior. The Goulds pumps are not connected, nor are controls for the 2-inch branch. Duplex PEX piping is routed under the road adjacent to the power plant, but not connected at either end. Assuming a 20 degree temperature drop on the hot side of the heat exchanger, approximately 180,000-200,000 BTUH of waste heat could be utilized.

Circulation pumps for Waste Heat supply. Note pumps and control valve at upper right not connected to power. Pump in background is hot side circulator for heat exchanger.
