Site Inspection Trip Report

Native Village of Kongiganak, Water Treatment Plant and Washeteria

REPORT DATE:	Monday Aug 26, 2019
INSPECTION DATE:	Tuesday July 22 – Wednesday July 23, 2019
PROJECT:	Kongiganak WTP / Washeteria, Bristol # 32190078
LOCATION:	Kongiganak, AK
VSW PROJECT LEAD:	Susan Randlett, PE, VSW
PERFORMED BY:	Vanessa Wike, PE; David Beiswenger; PE, John Pepe, PE; Craig Fredeen, PE
OTHERS PRESENT	Joseph Mute, Paul Paul
WEATHER:	Overcast, 55 °

To: Vanessa Wike, P.E., Bristol Engineering Services Company
From: John Pepe, P.E. and Craig Fredeen, P.E.
Subject: Kongiganak Site Inspection Trip Report: July 22-23, 2109
Project: Kongiganak Washeteria and WTP Improvements
Date: August 26, 2019

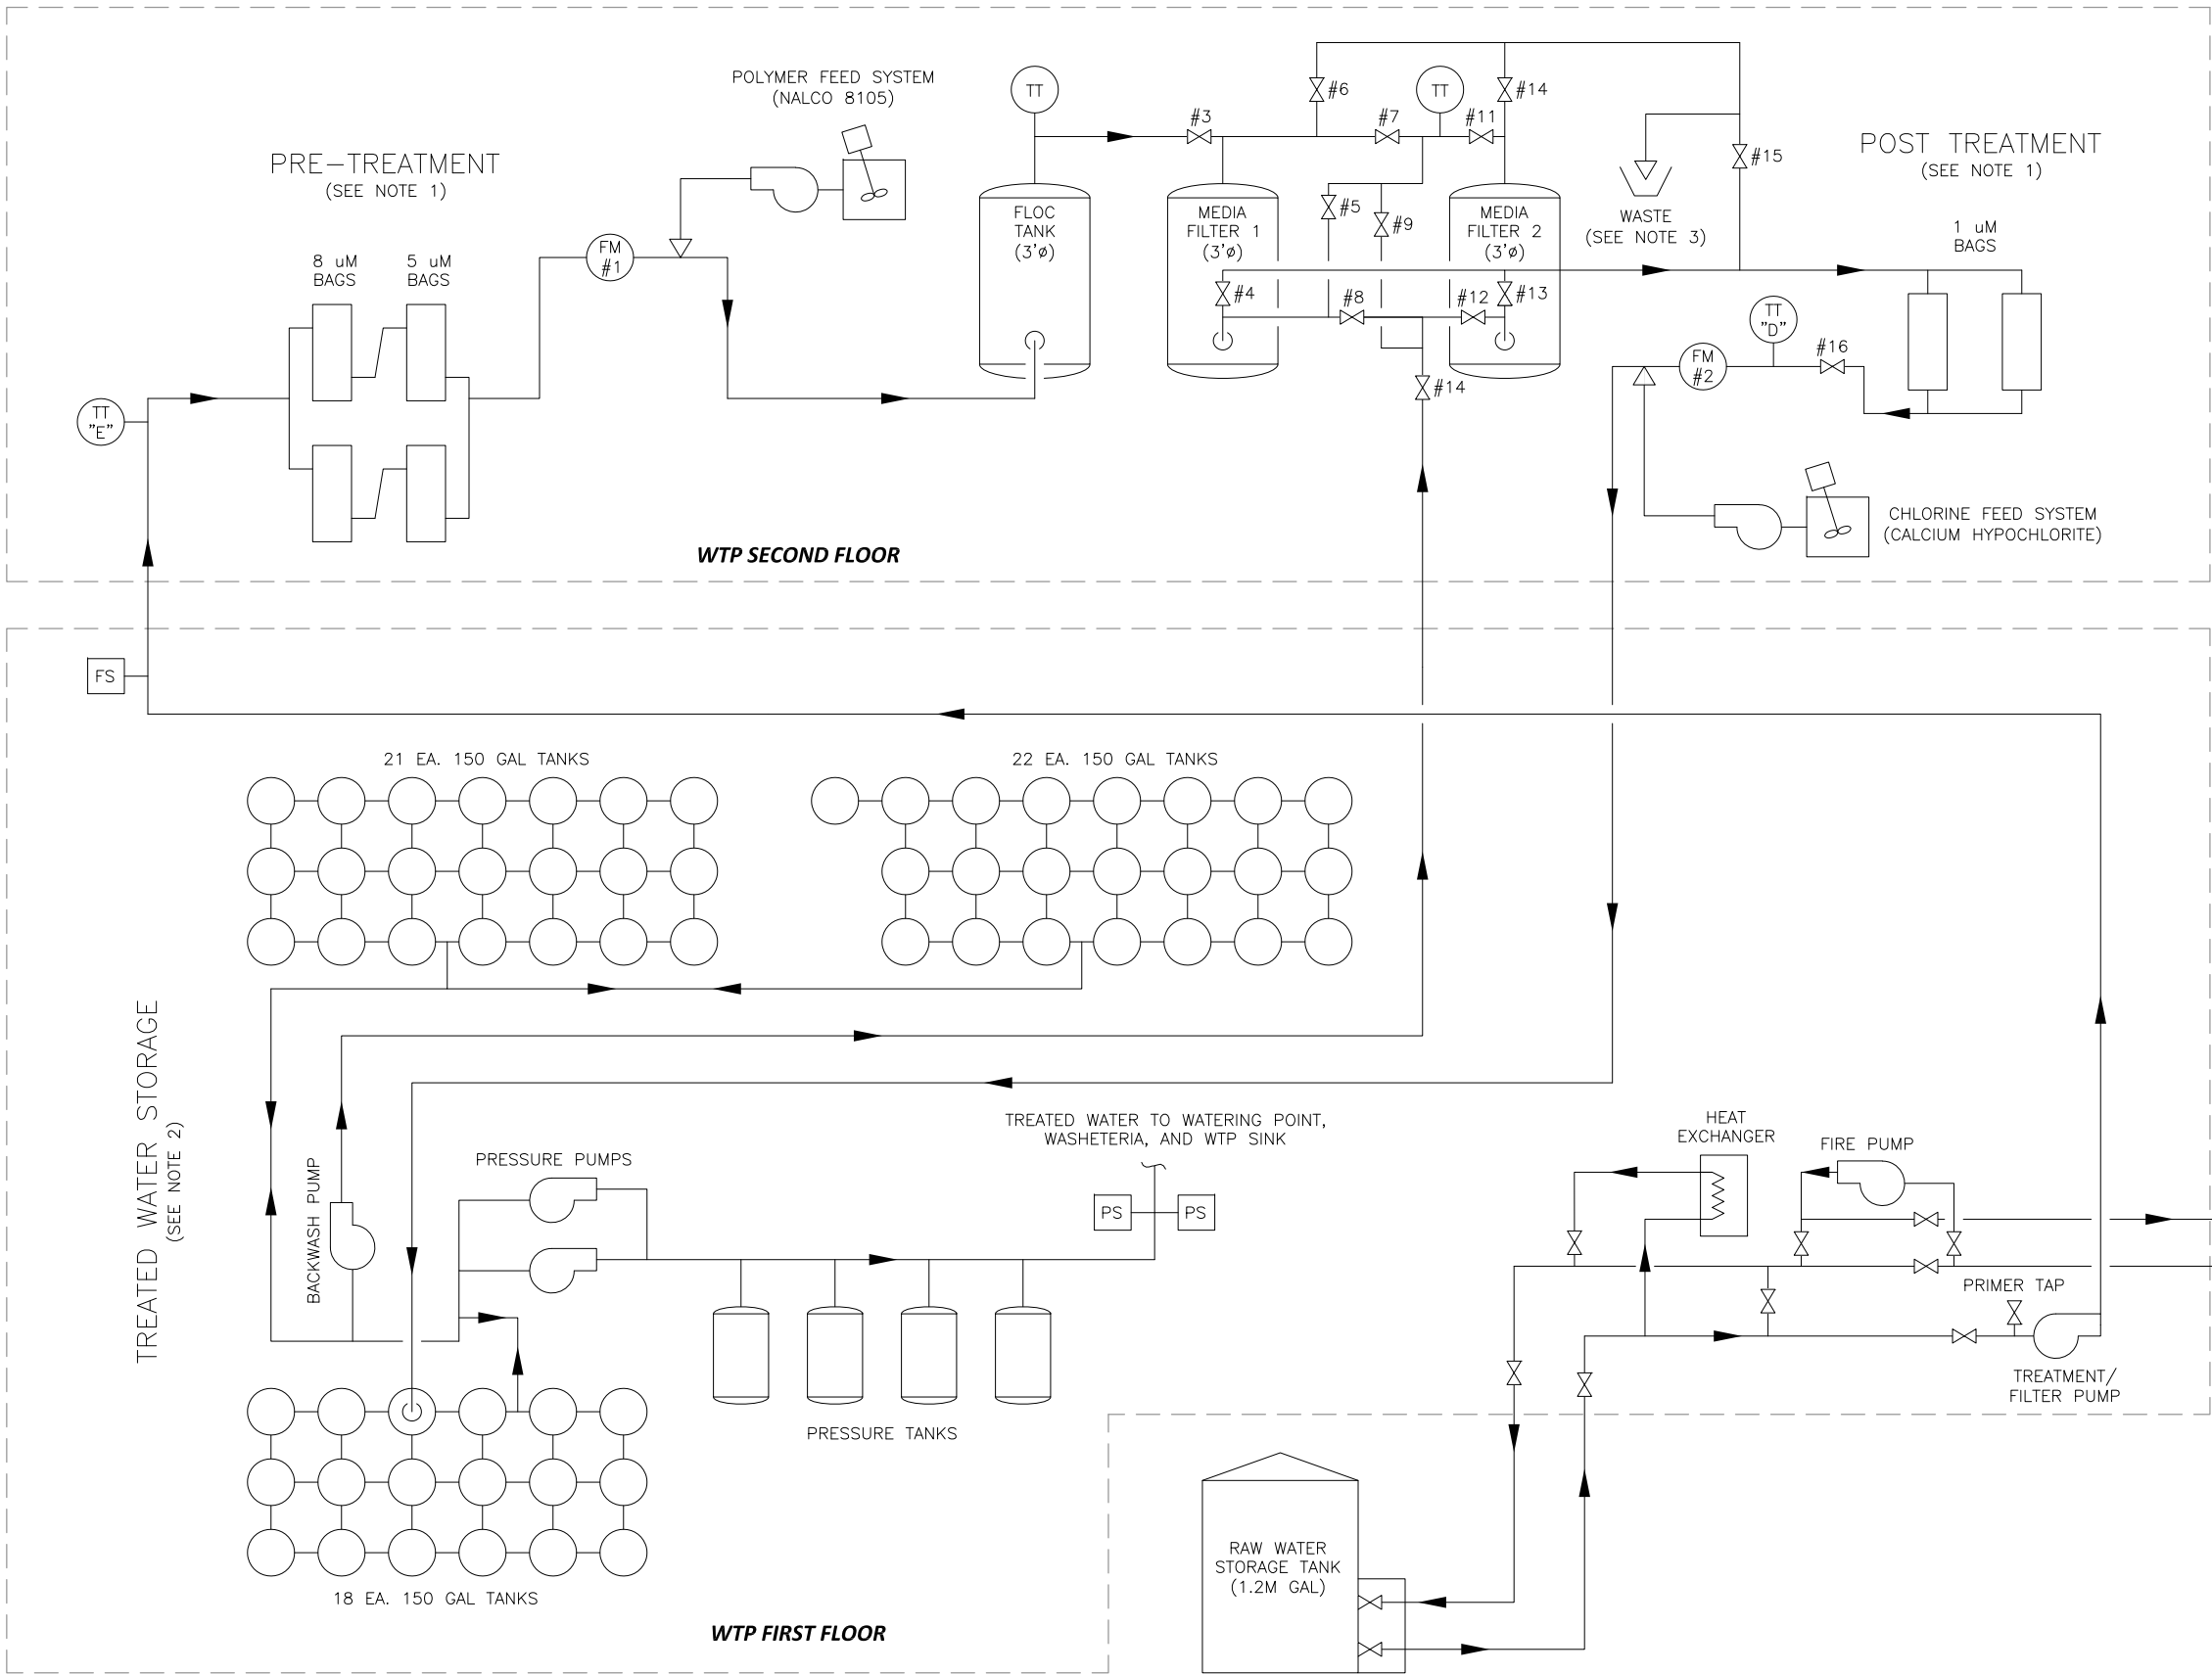
FIG 1

At the time of the site visit the system had completed filling the 1.2 million gallon raw water storage tank from Contractor's Lake within the last week. The filling process took approximately 2 weeks (running 24/7). The system was actively treating water (coagulation, flocculation tank, media filtration, and chlorination. Treated water is stored in 61, 150-gallon, plastic tanks, cumulatively providing approximately 7,500 gallons of storage. The water treatment process is summarized in the attached schematic.

INOPERABLE ON 7/22/2019.
2.

TOTAL TREATED WATER STORAGE IS APPROXIMATELY 7,500 GALLONS IN 61 EA 165-GAL TANKS.
3.
