# Washeteria Replacement

## Preliminary Engineering Report

### Beaver, Alaska

**FINAL REPORT**  
**May 21, 2019**

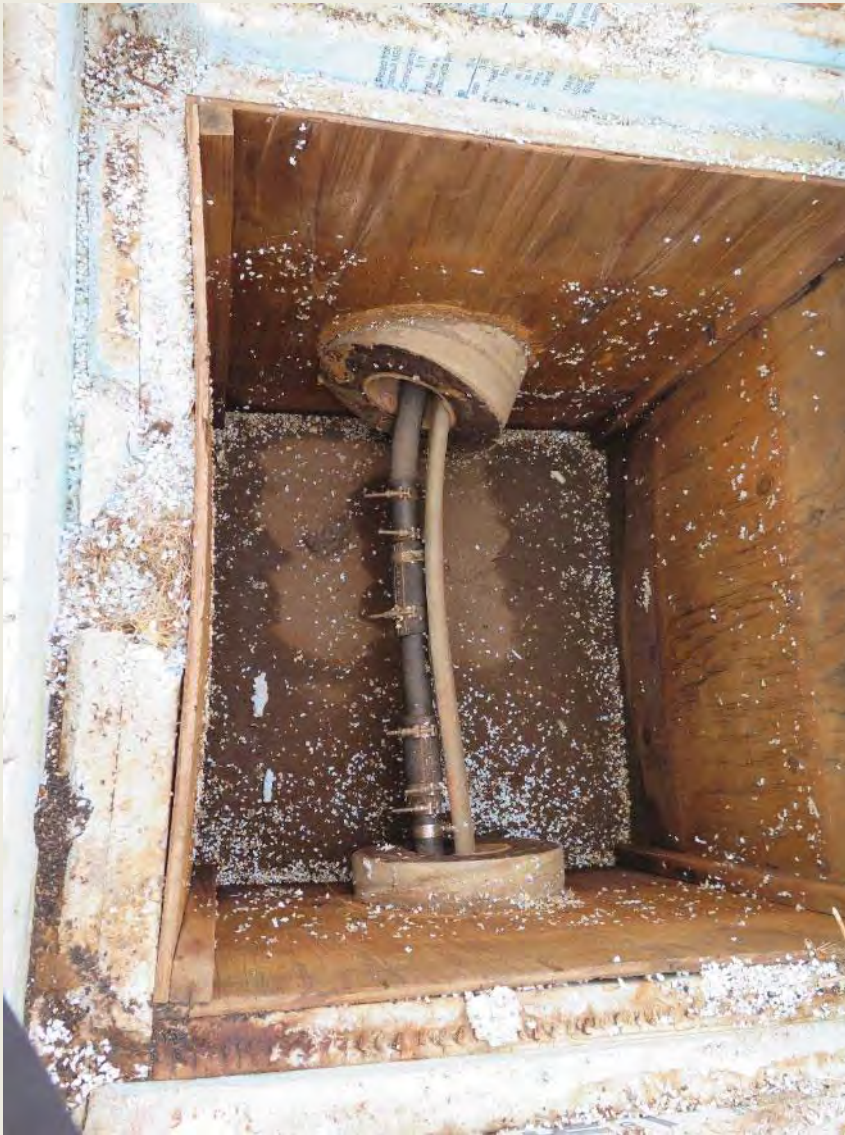
Photo 8: Raw water transmission piping (black) and glycol heat trace inside first manhole from well. Note repair couplings from previous leaks.

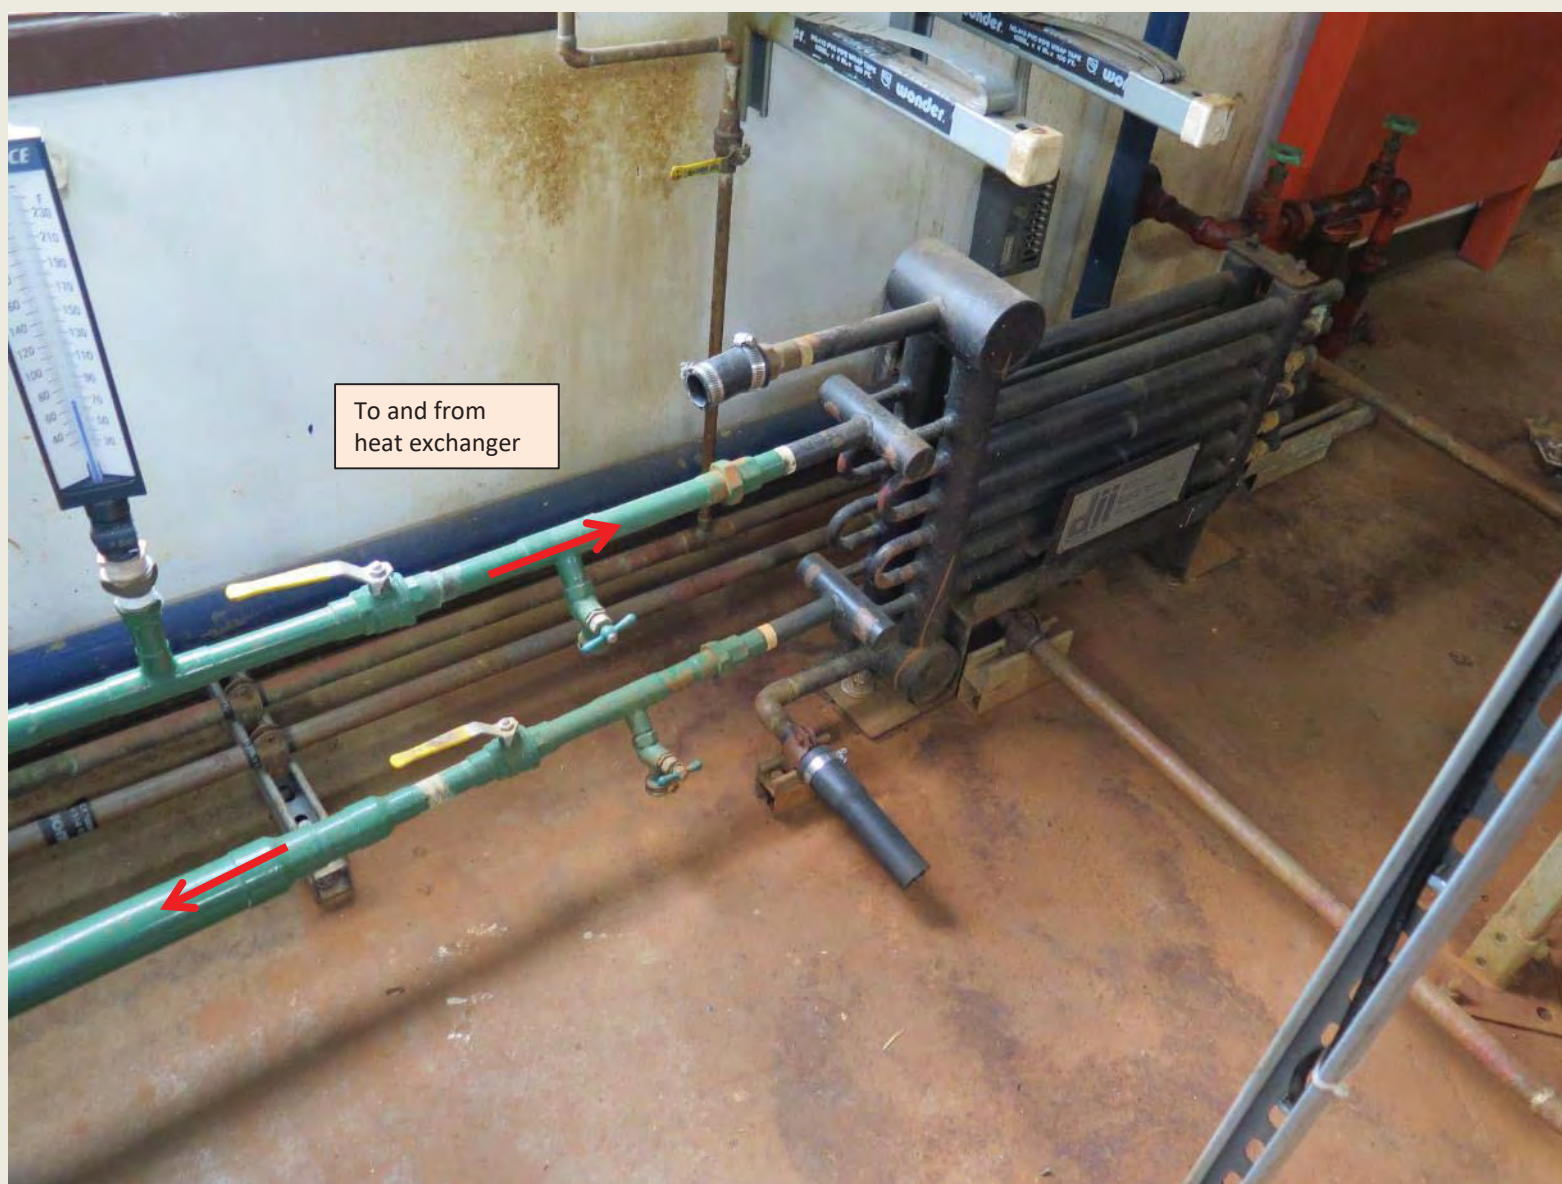
Photo 11: Raw water line heat exchanger (meant to raise temperature to improve oxidizer performance). No longer functional – disconnected from glycol supply.

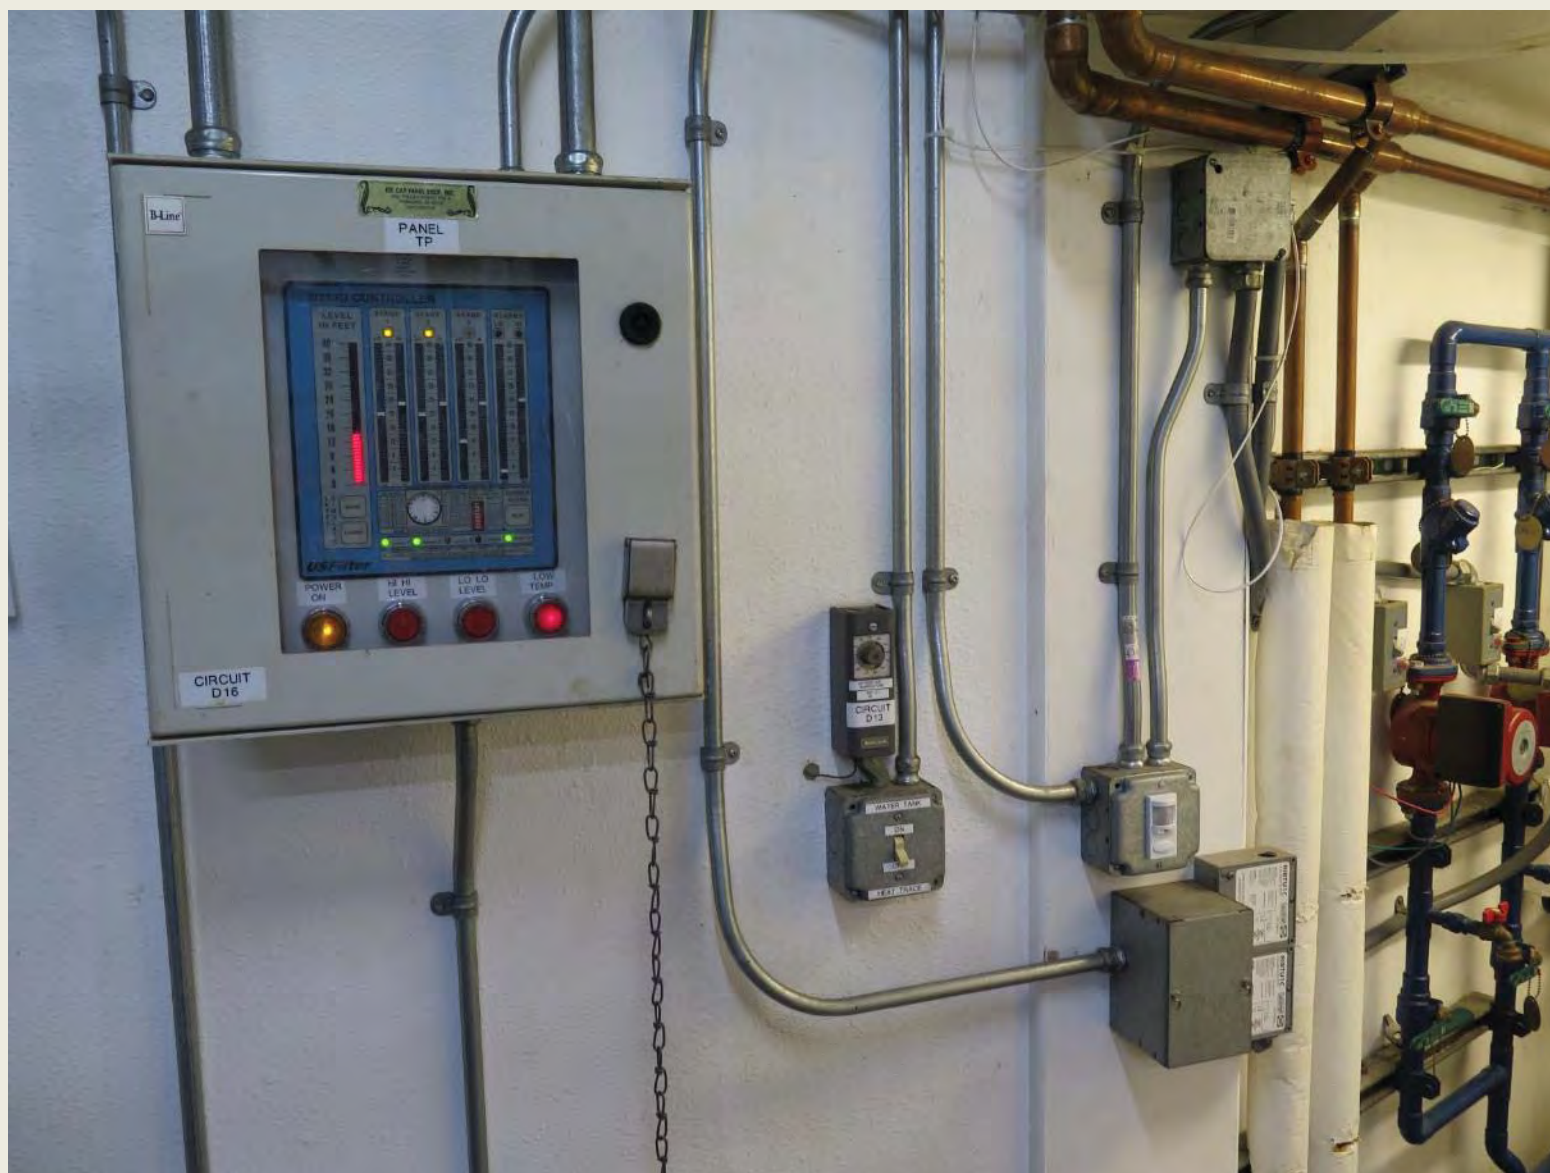
Photo 23: Digital tank level display – not functional because the suspended electrodes used for the high and low level conditions are not working and have been removed. This failure has caused the well/filtration system to only operate in hand mode. In addition, it appears the pressure transducer is not working properly, as the depth display is inaccurate.

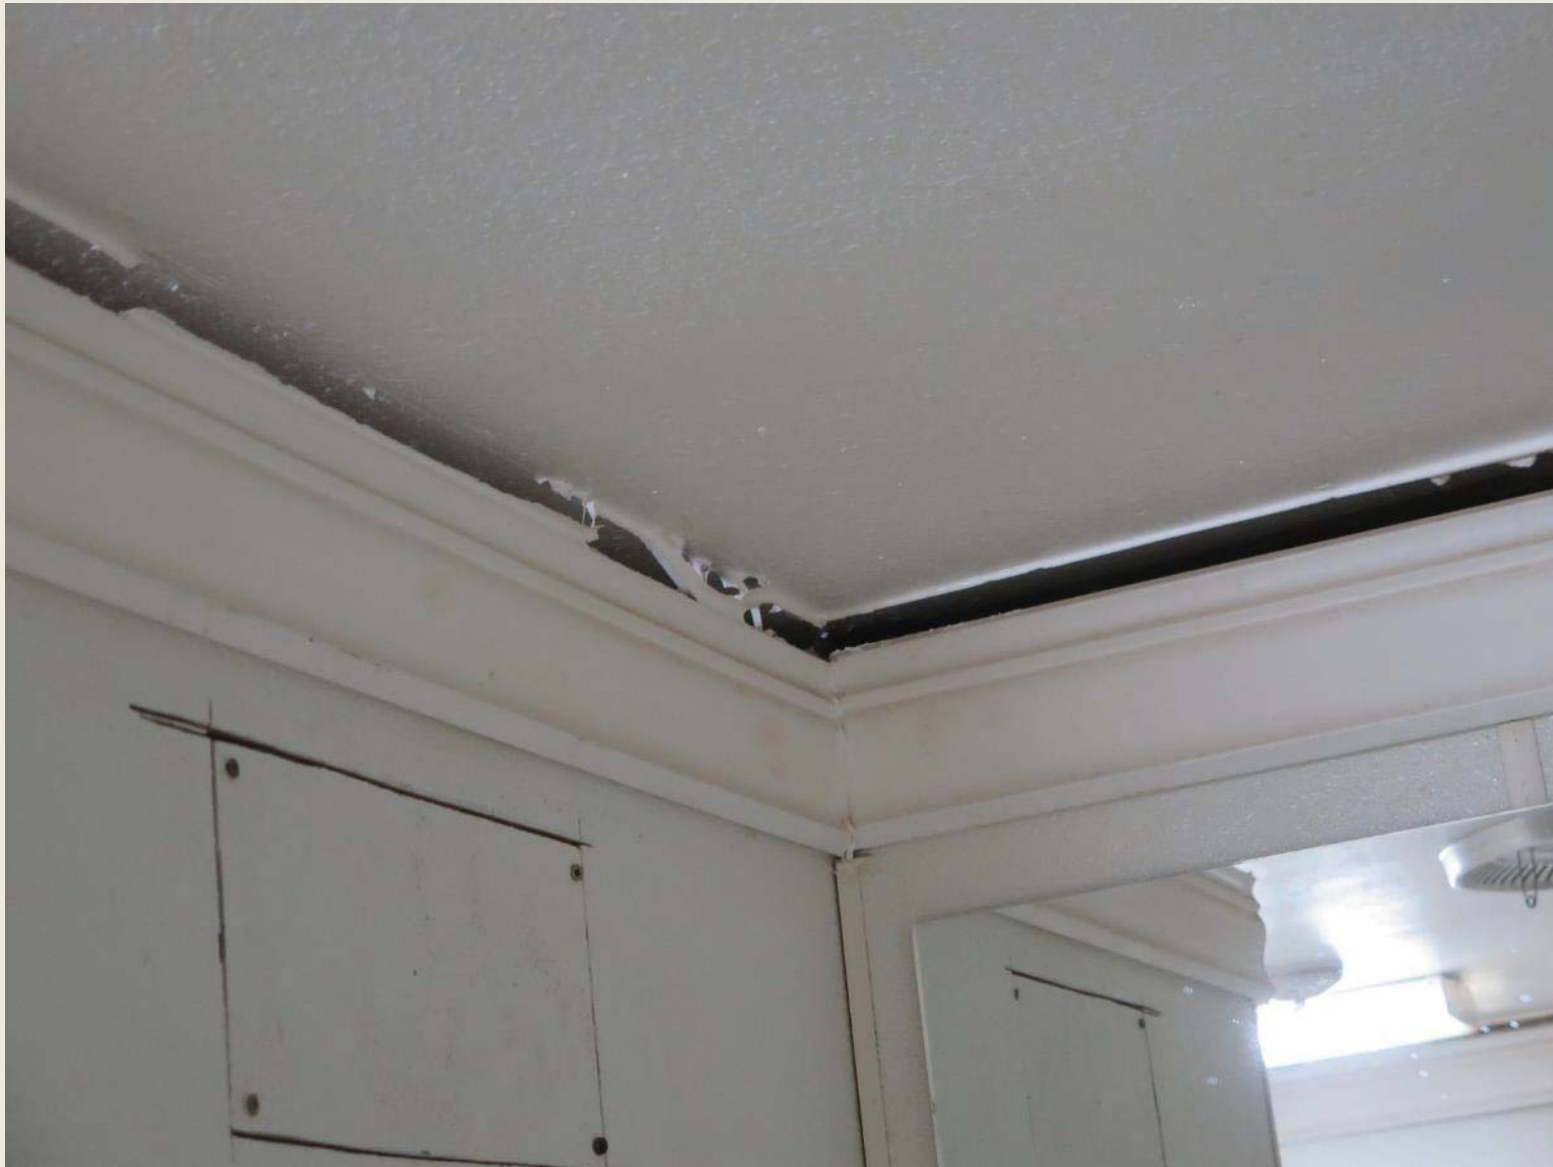
The building now has severe settlement damage. The building has settled approximately four to five inches on one side. There are one- to two-inch gaps along the internal walls where the ceiling has pulled away from the walls. Winter 2017/2018, daylight was visible inside the building due to the gaps. Summer 2018, the building settlement was so great the sewer service broke. Maintenance staff had to cut off several inches of the pipe to reconnect it because the building had settled so much. The community was without access to the washeteria for approximately two days. Interior plumbing also had to be adjusted.

Photo 57: Evidence of the building suffering differential settlement: the ceiling in the washeteria area has separated from the walls by more than one inch. This extends into the office/chemical storage room, but was not observed in the water plant area.

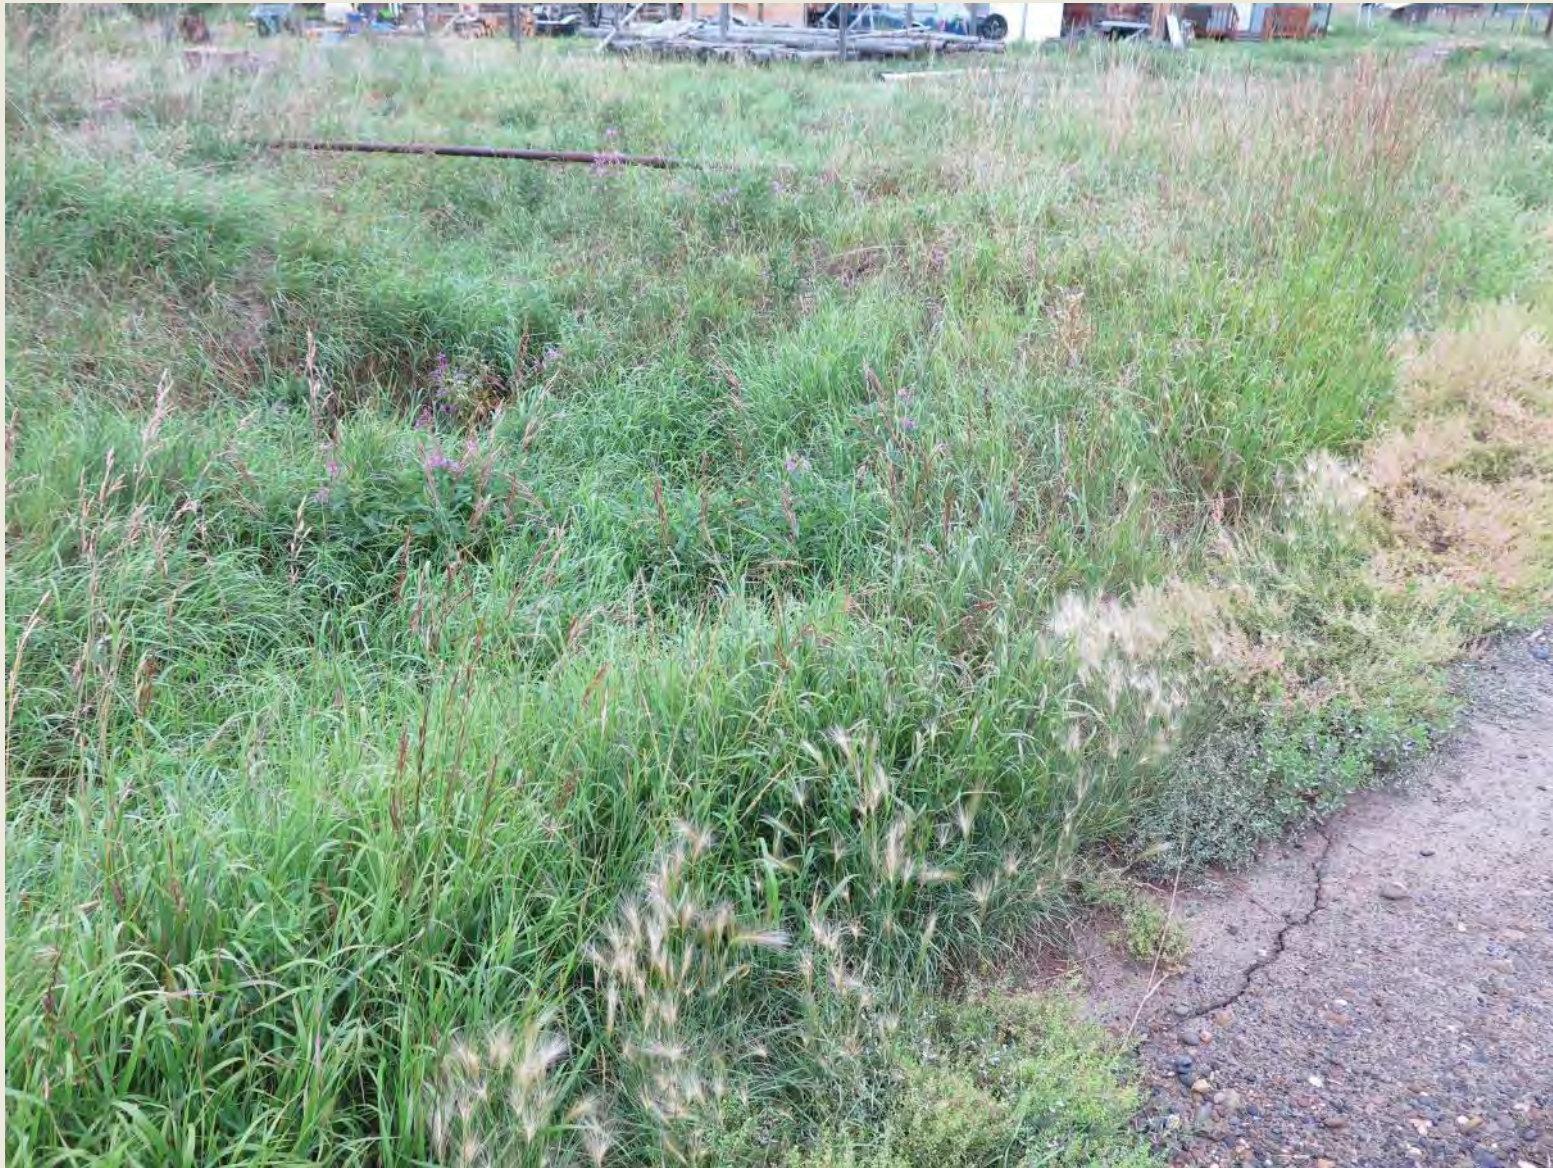
Photo 58: Large sinkhole(s) located less than 100 feet from water plant/washeteria building.

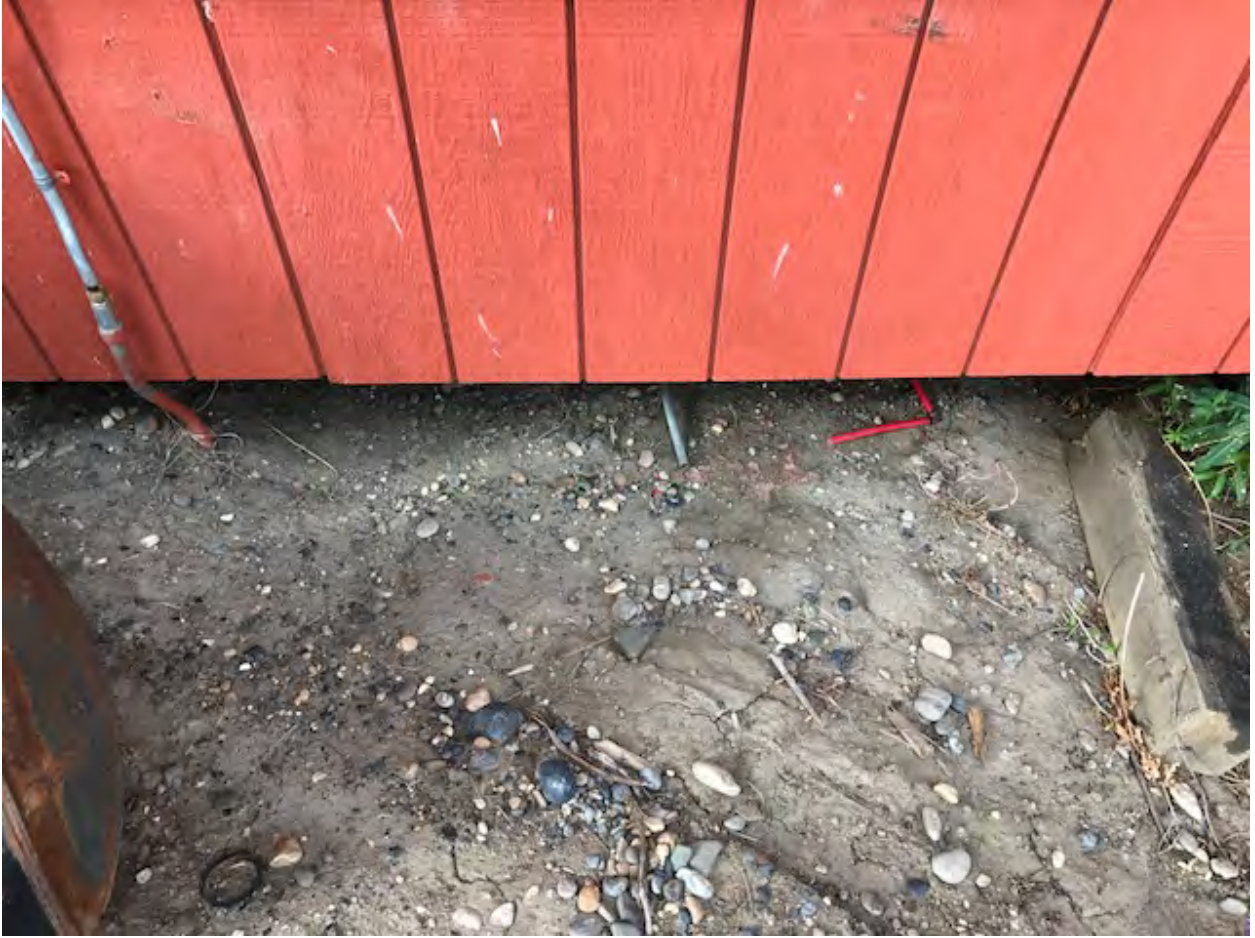
Notice the “fractures/fissures/cracks forming on the surface of the ground.

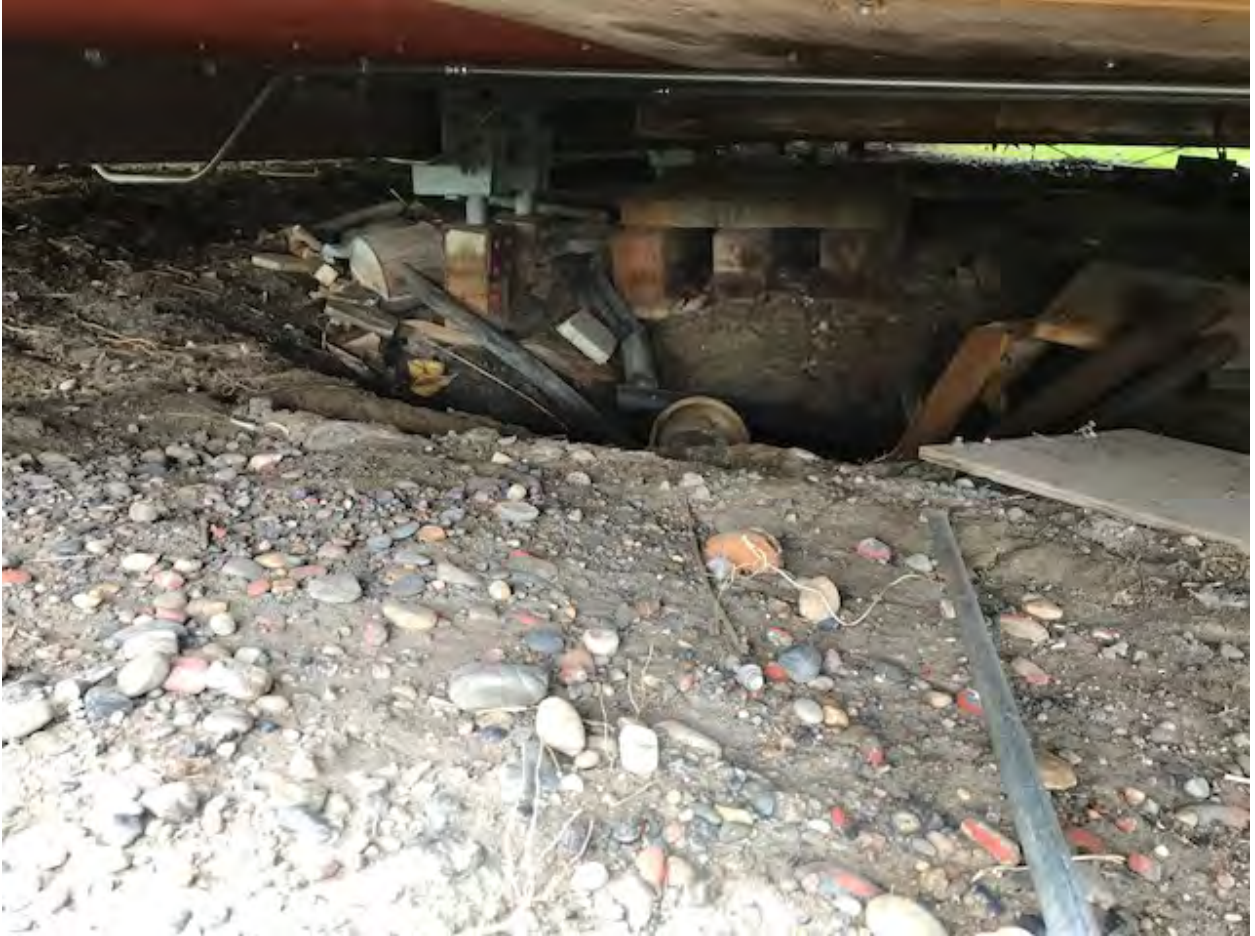
Notice how rocks/dirt that received spray from prior spray painting of the outside of the building are migrating towards the sink hole!

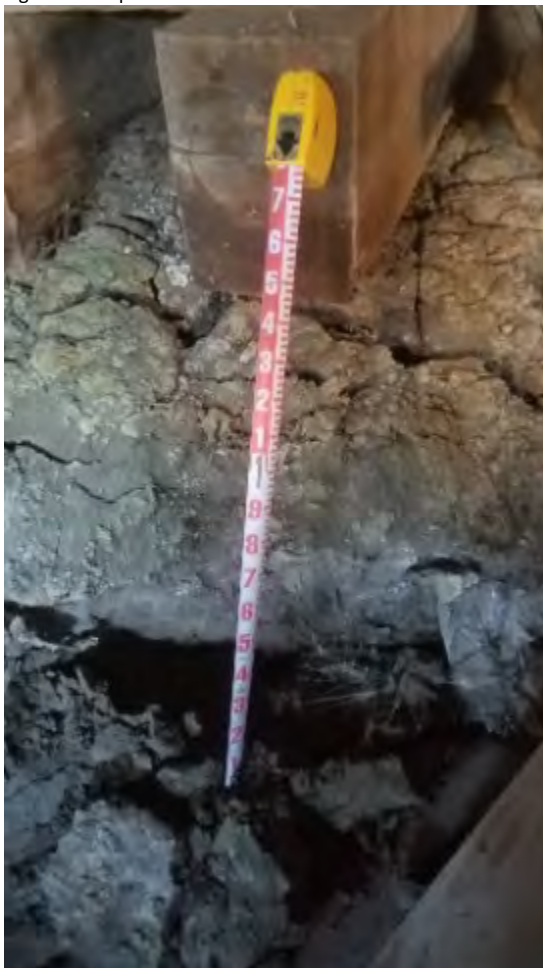
Figure 20: Soil Subsidence Under Cutting Foundation

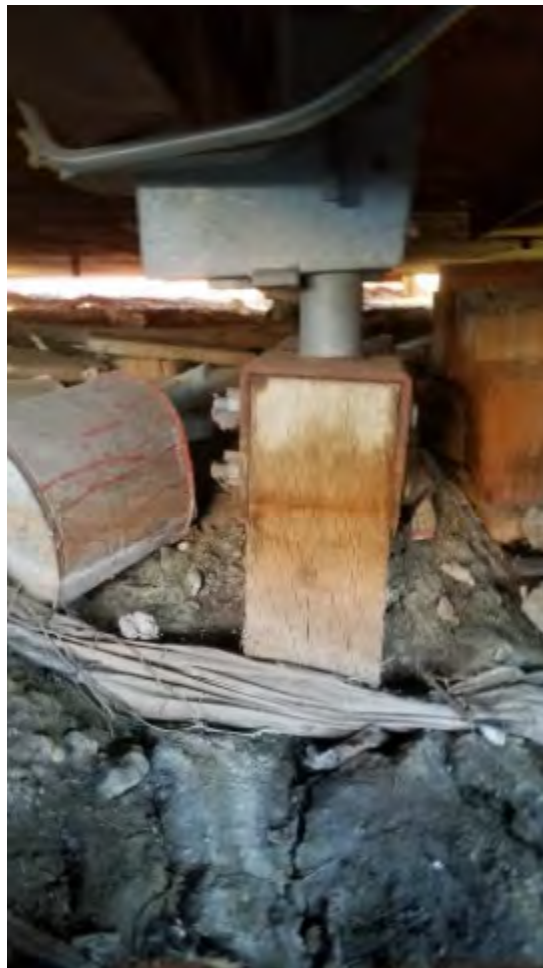
The washeteria has several severe problems. First, its foundation is settling. In a 2014 structural report, the settlement was documented but the damage was merely cosmetic. The next year, a hole appeared under the raised building. Since that time, the hole has rapidly increased. It is currently approximately ten feet in diameter and a minimum of two feet deep. There is evidence of water ponding in the hole. There are shear failure cracks around the hole indicating it is expanding. Several footings along the center line have been undercut and are failing.

Figure 21: Washeteria Foundation Pile Failing

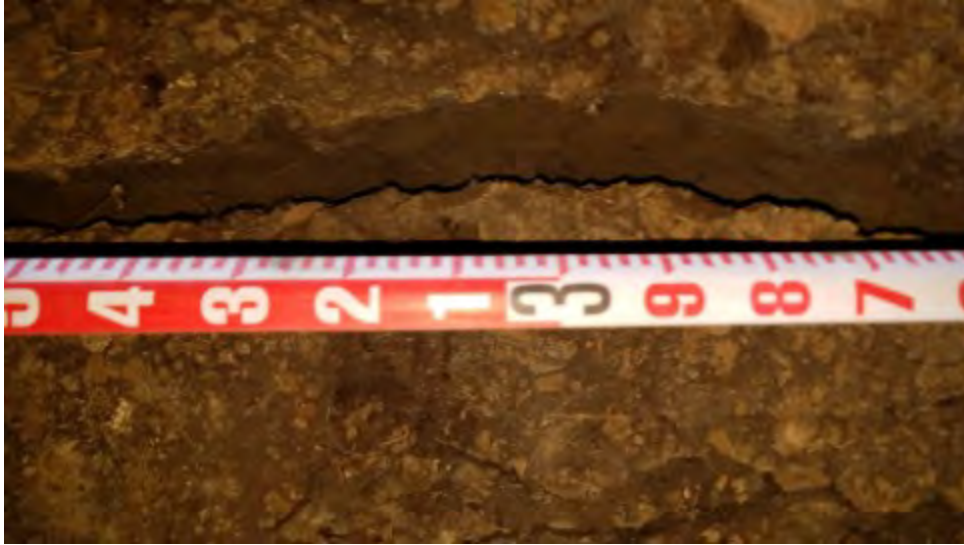
Figure 22: Shear Failure Around Depression

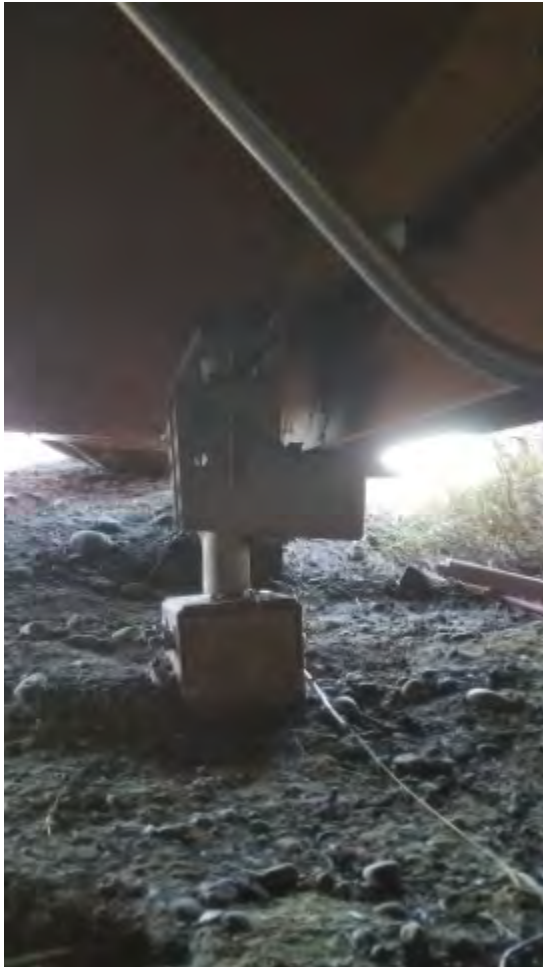
Figure 23: Typical Perimeter Pile, Beginning to Fail, Leans Towards Depression Figure 24: Water Storage Tank-Exterior Valve Box

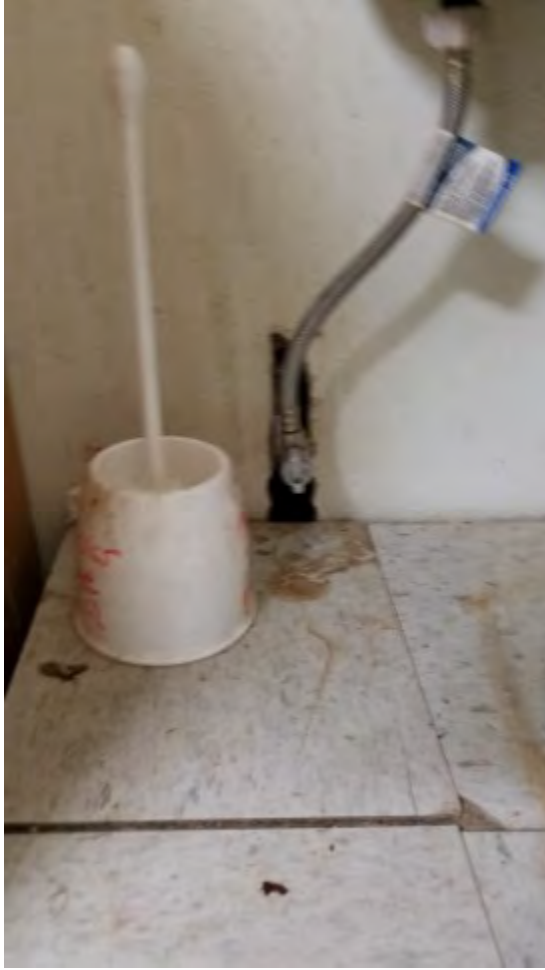
Figure 36: Bathroom-Toilet Repair Due to Settling

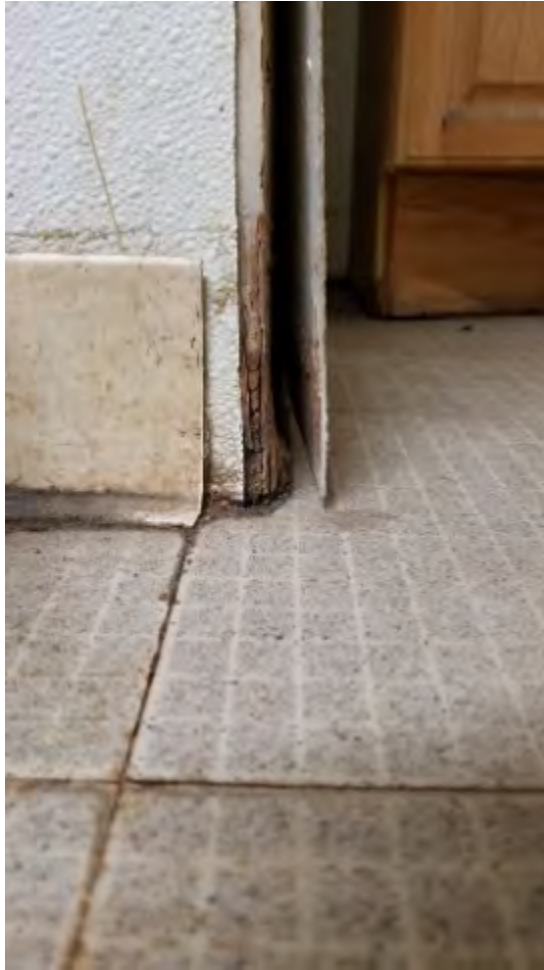
Figure 37: Bathroom-Wall Separation, Plywood Delamination
