95% Draft Preliminary Engineering Report Water Treatment Plant and Washeteria Tununak, Alaska

March 13, 2020

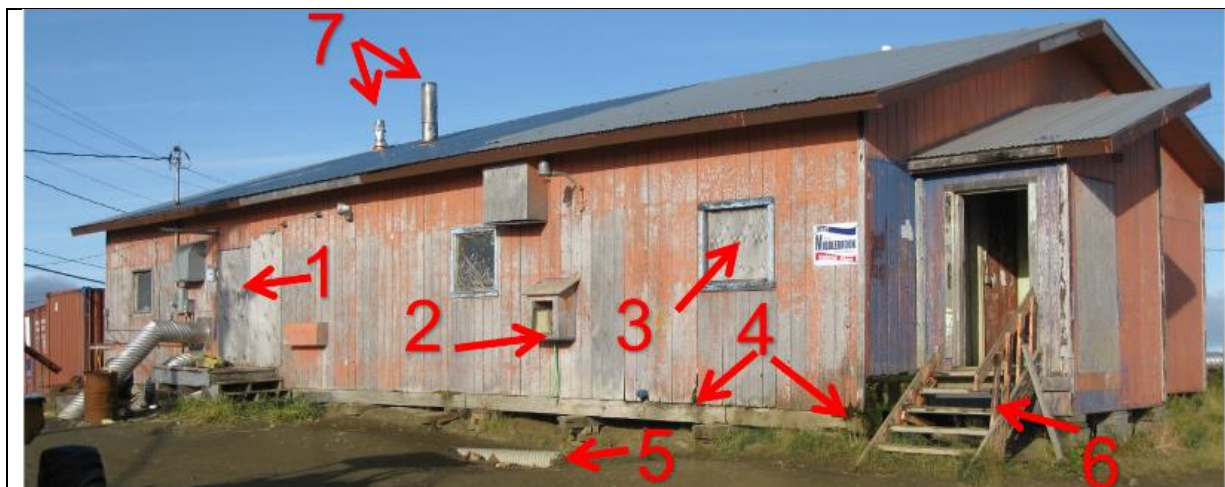
Photo 1 Exterior Condition of North East Side of Washeteria Building from 2009

The Washeteria side of the building needs extensive repairs. Floors have hole caused by wood rotting through, concrete slabs within the building are noticeably sloped, there are plumbing issues, exposed wiring in common areas, and egress exits are permanently blocked. Some of the building's exterior issues were documented with a photo in 2009 then compared with ANTHC and Stantec condition assessment completed in 2018. Photo 1 has red arrows with numbers for seven issues on the seen from the northeast side of the building and they are:

1. Sealed/boarded over egress door on Water Treatment half of building.
2. Abandoned Watering Point
3. Board up window
4. Decaying, damaged, and missing siding. Siding needs to be sealed/painted. Foundation lower at corner than center of building.
5. Soil under foundation washing out under foundation cribbing.
6. Handrail unstable and requiring repair/replacement.
7. Missing Chimney Caps.

Visual inspection of building finds a minimum of 7 items that need to be addressed. (File photo 9/24/2009)

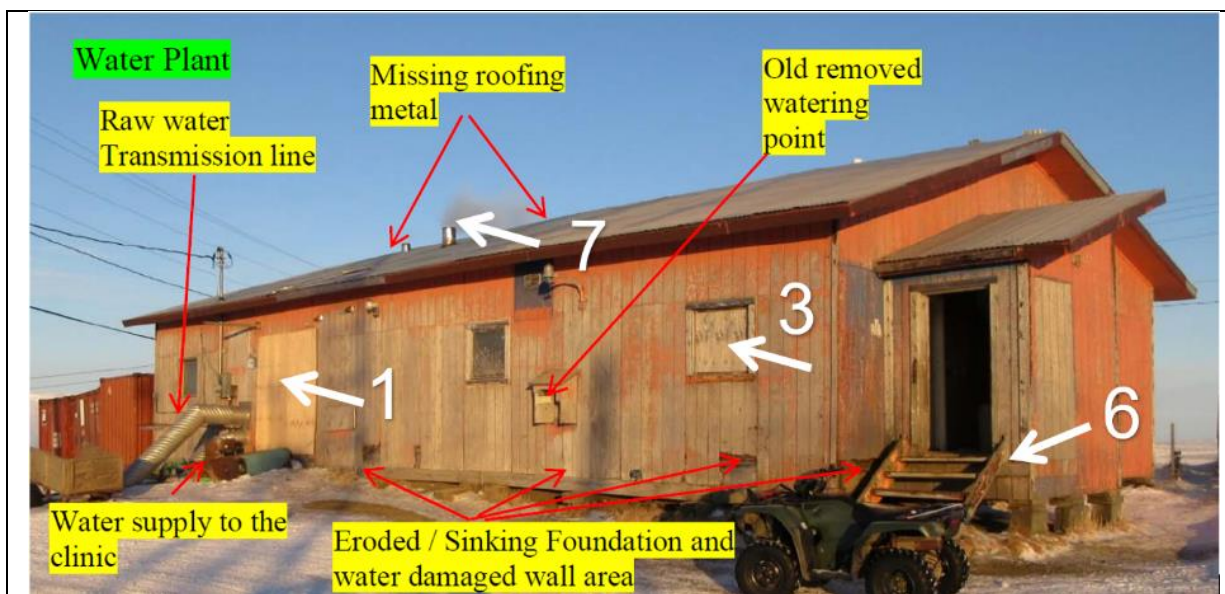
Photo 2 Exterior Condition of North East Side of Washeteria Building from 2017

Photo 2 is the same view of the Washeteria taken almost 8 years later as part of the Rural Alaska Village Grant (RAVG) assessment in March of 2017. All of the deficiencies present in 2009 are present in the 2017 photo. White arrows and numbers matching the callouts of the items identified in photo 1 that were not identified by the RAVG assessment. One chimney stack is shorter, the handrail at entrance of the washeteria is gone, more siding is missing and there are no longer stairs leading up to the boarded up mechanical room entrance on the east side of the building.

Visual inspection of building finds a that the 7 items identified in the 2009 Photo were not addressed and the building condition continued to deteriorate further. (RAVG 3/21/2017)

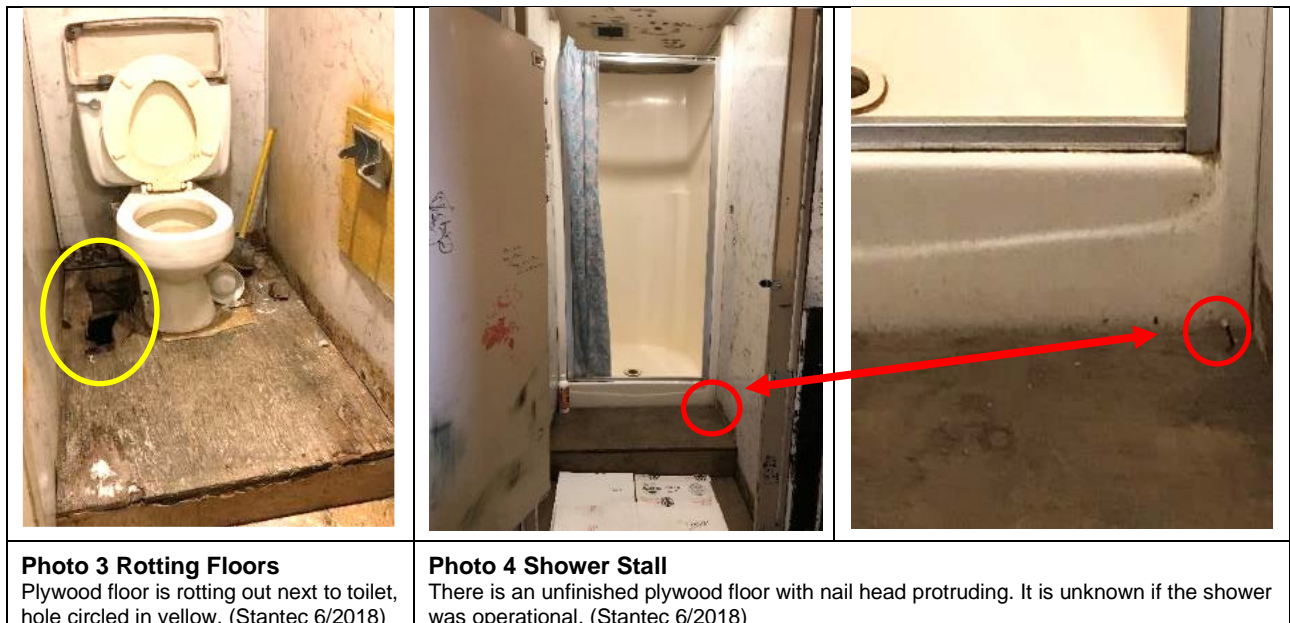
Stantec completed an initial assessment in 2017 and a utility condition assessment in 2018, finding that every system almost inoperable due missing components, dangerous wiring, mold and decay involving the structure, and that all of the system would require extensive upgrades or complete replacement to bring the Washeteria back into a safe operational status. The current facility is not meeting the needs of the community and the limited laundry facilities are failing. The overall condition of the facilities is dangerous for both the patrons and the facility staff. Images 3-7 show conditions that are hazardous both inside and outside of the Washeteria as documented by Bob Gilfilian in June of 2018.

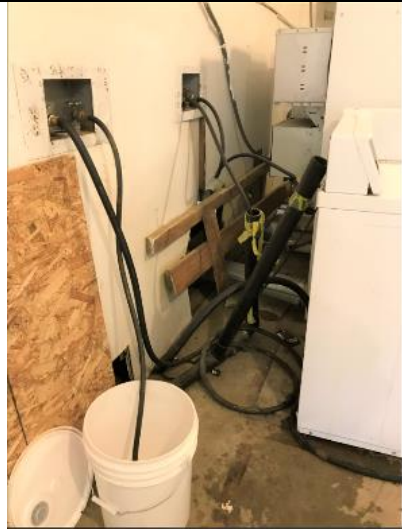
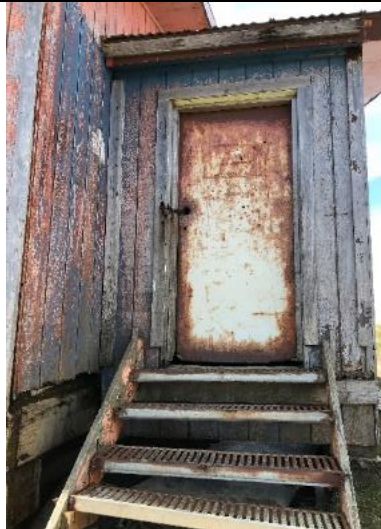
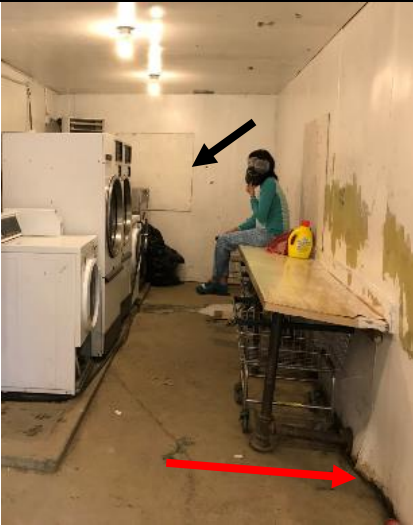
Images 3 through 7 show the conditions in 2018 of interior and exterior issues with the Washeteria.

<p>Photo 5 Incorrect Plumbing of Washers Incorrect venting of washer septic drain line inside of building. Water supply line hooked up incorrectly. Large holes (Stantec 6/2018)</p>	<p>Photo 6 Entrance to Washeteria is Unsafe Railing is missing, stairs have need to be replaced, siding is heavily weather damaged. (Stantec 6/2018)</p>	<p>Photo 7 Foundation Issue Red Arrow, concrete floor is sloped. Wall has water damage. Black Arrow shows window that has been boarded over.</p>

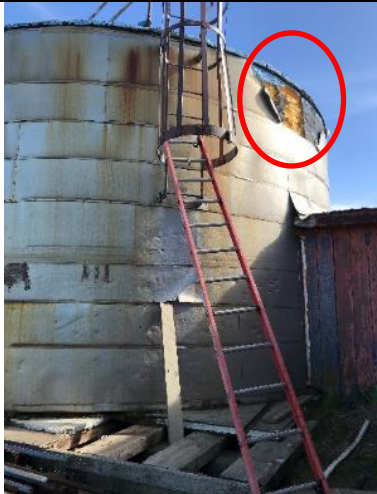
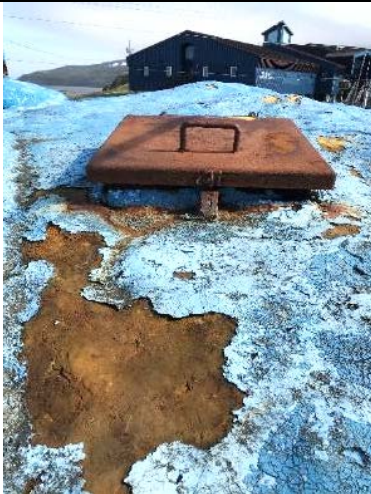
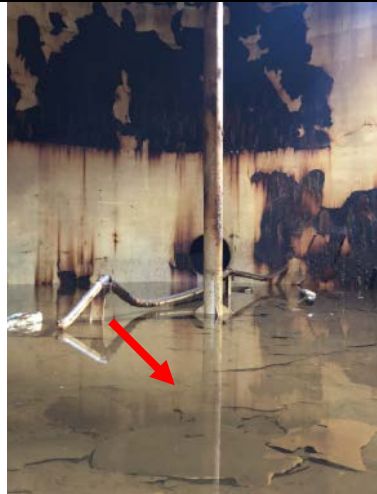
- The exterior of the WST appeared to be in reasonable condition for a tank installed in 1978. On the northwest exterior side of the tank there are rust stains on the aluminum siding. The access

ladder to the tank is missing as well as a section of siding located just below the top of the tank. There was one small section of siding on the exterior of the tank that was missing siding, but the remainder of the exterior appeared to be intact and completely covered the underlying foam insulation. The overflow drain needs to be screened to prevent anything from nesting or crawling into it.

- The exterior of WST's cover was checked for deficiencies and was found to be in fair condition, with small sections of foam insulation missing. There was a missing section of insulation over the roof hatch. The condition of the ladder cage at the tank top appeared to be intact and functional.

- The interior of the WST was visually checked via access through the roof hatch. The water surface in the tank was observed to have a considerable amount of floating debris that included an empty soda pop can, fragments of foam insulation, and rust particles. The tank's north side interior wall appeared to be in good condition above the water surface; however, the remaining exposed interior wall had obvious signs of surficial deterioration. The underside of the WST cover appeared to be in fair to good condition.

<p>Photo 8 Damaged Siding on Water Tank Missing access ladder and siding with exposed insulation circled in red. (Stantec 6/2018)</p>	<p>Photo 9 Damaged Insulation Roof insulation showing sun damage where missing protective paint has left it exposed. Insulation missing from hatch. (Stantec 6/2018)</p>	<p>Photo 10 Missing Tank Lining Interior condition prior tank cleaning. Tank lining is floating in water, outflow assemble is bent. (RMW 10/2018)</p>

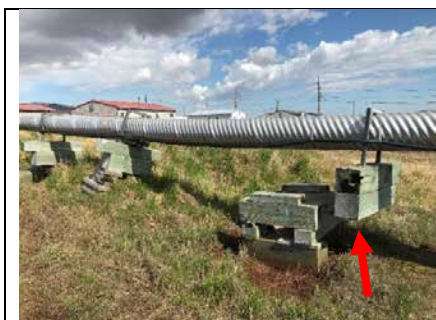
Photo 11 Failed Waterline Supports
Support has failed and is pulling waterline down. (Stantec 6/2018)

- As shown in Photos 11-12, the failing condition of the timber foundation system supporting many sections of the WTL has caused water line to developed significant sags in the water line profile. The sags in the water line causes air entrapment and is difficulty for the operators to clear from the lines. Normally, the lines can only be the flushed when ambient temperatures are above freezing. The WTP operator has stated that the effort required for flushing with compressed air requires additional labor and can take more than a day to complete.

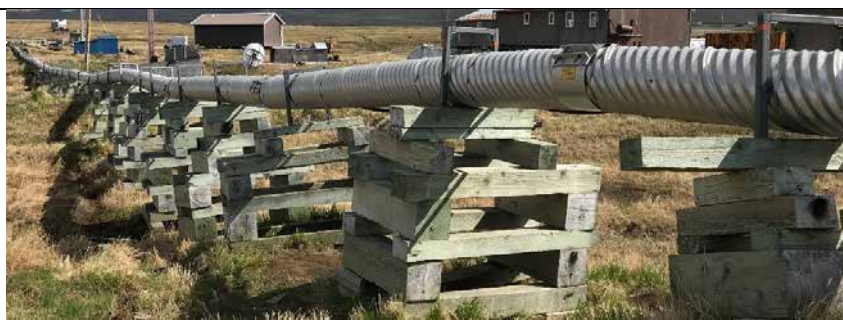
Photo 12 Waterline Sagging on Failing Supports
Supports are unstable and falling over, line has visible sagging. (Stantec 6/2018)

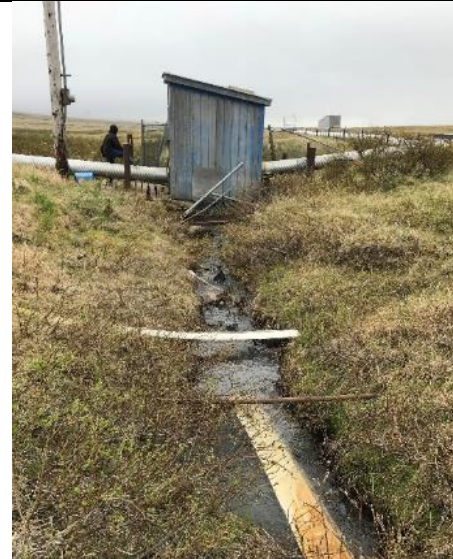
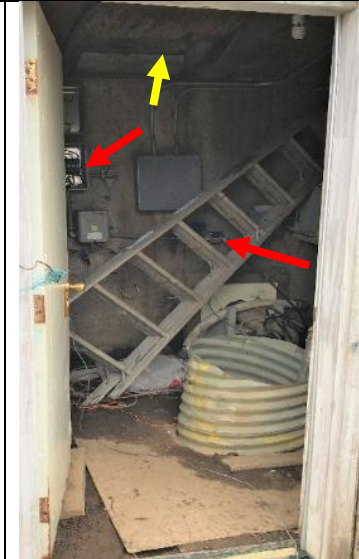
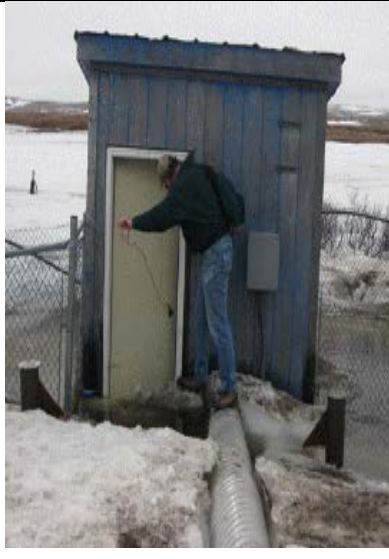
- The WTP operator is exposed to dangerous electrical wiring in multiple areas of the pump house and within the gallery. Previously, a submersible pump had been installed to pump raw water from the gallery but was found to be too dangerous to utilize due to the exposed electrical wiring and the deteriorated pump control located inside the pump house infiltration gallery.

<p>Photo 13 Unnamed Creek Pumphouse Looking north. The fencing around the gallery is falling into the stream. (Stantec 6/2018)</p>	<p>Photo 14 Inside Pumphouse Red arrows point to open electrical connections. Roof access panel is used to get into building in winter (yellow arrow). (Stantec 6/2018)</p>	<p>Photo 15 Pumphouse Flood Levels In the winter and spring, it is common for winter ice to cause flooding. (MWH 2010)</p>
