DRAFT
SITE CHARACTERIZATION REPORT
UNIVERSAL RECYCLING, INC.
FAIRBANKS, ALASKA

ADEC SPAR Term Contract: 18700026

JULY 2004

**ADEC Division of Spill Response and Prevention
Contaminated Sites Program
ADEC SPAR Term Contract: 18700026**

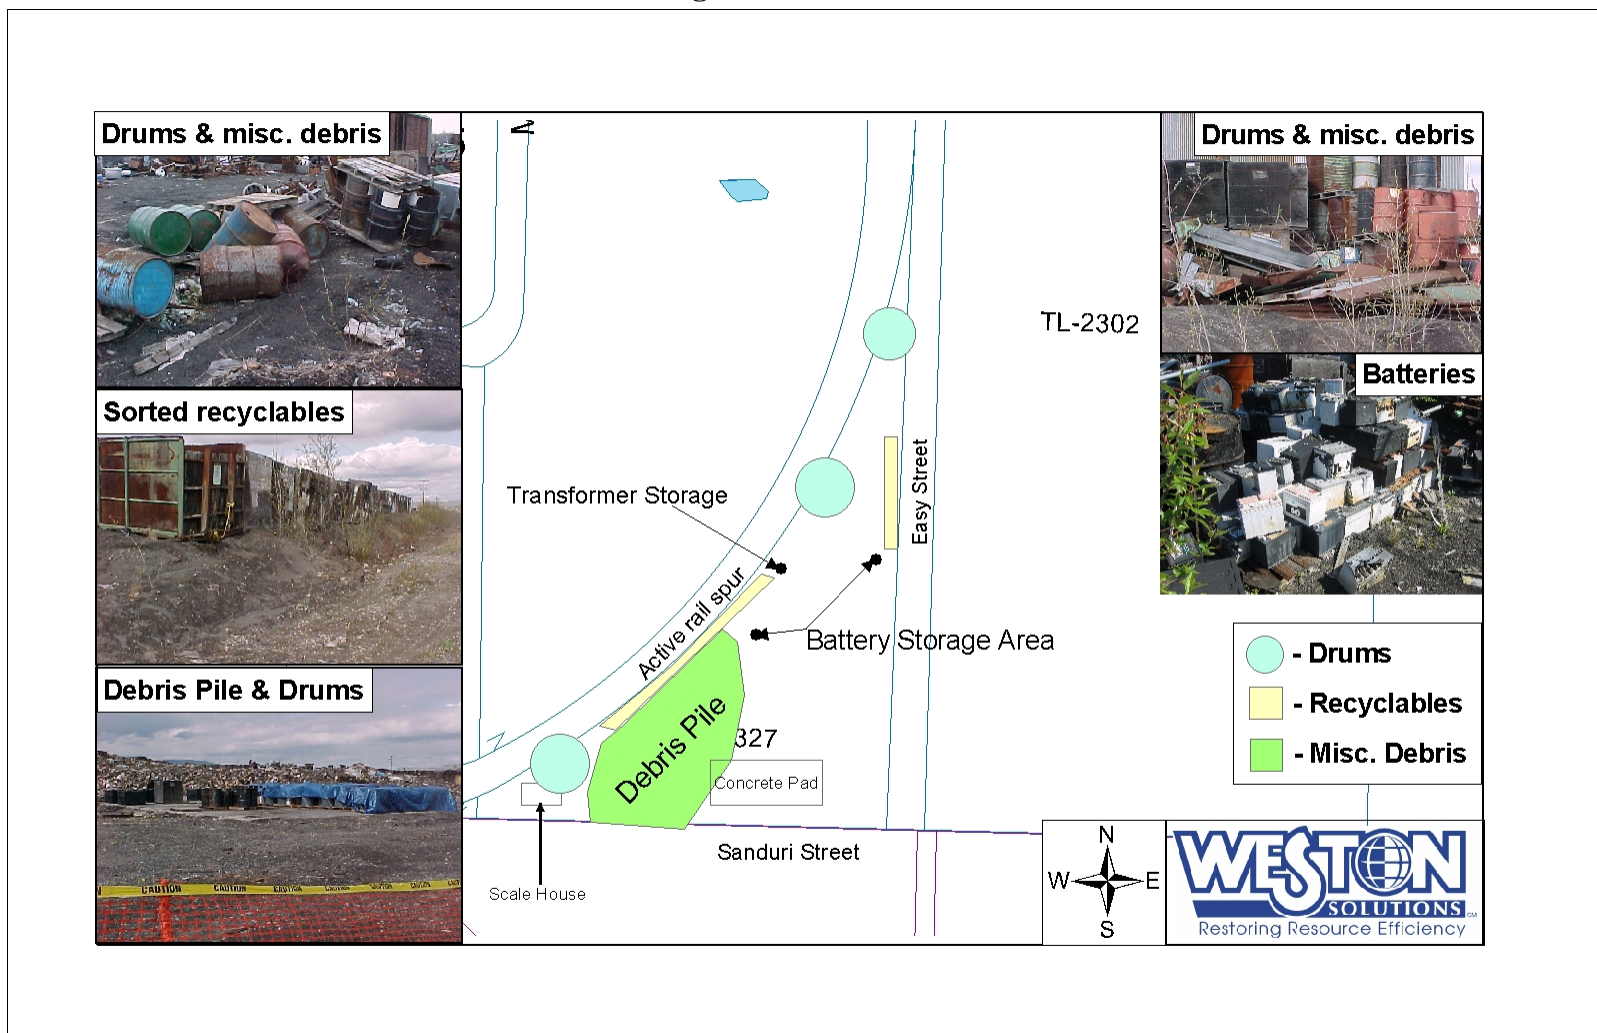
Figure 2-2 Site Schematic

The site consists of a concrete pad in the southeast, a scale house in the southwest, and extensive debris spread across the site. FNSB Assessors records indicate that the approximately 10,000 square feet concrete pad is the remains of the main building which housed a shop, bailer/sorting area, and an incinerator. This building was destroyed in a 1996 fire. ADEC Solid Waste files indicate the bailer/sorting area housed waste-to-energy treatment operations from 1988 through 1991 and sorting of recyclables from 1988 through 1997. The shop was used for general mechanical maintenance. An incinerator was used to burn cable and wire in the main building. The concrete pad is currently used to stage drums recovered from the site after a second fire that occurred in 2003. The scale house is approximately 1,000 square feet with a wooden scale comprising half of the floor plan and a break room/office on the other half (FNSB, 2003b).

A large pile of paper and debris fills the area between the concrete pad and the scale house and runs north about halfway along the rail spur. Automotive parts, bailed and sorted recyclables, drums, propane tanks, wire, and various other debris are staged and littered across the site with limited ground surface accessible near the center and north end of the lot. A schematic of the site is presented in Figure 2-2.

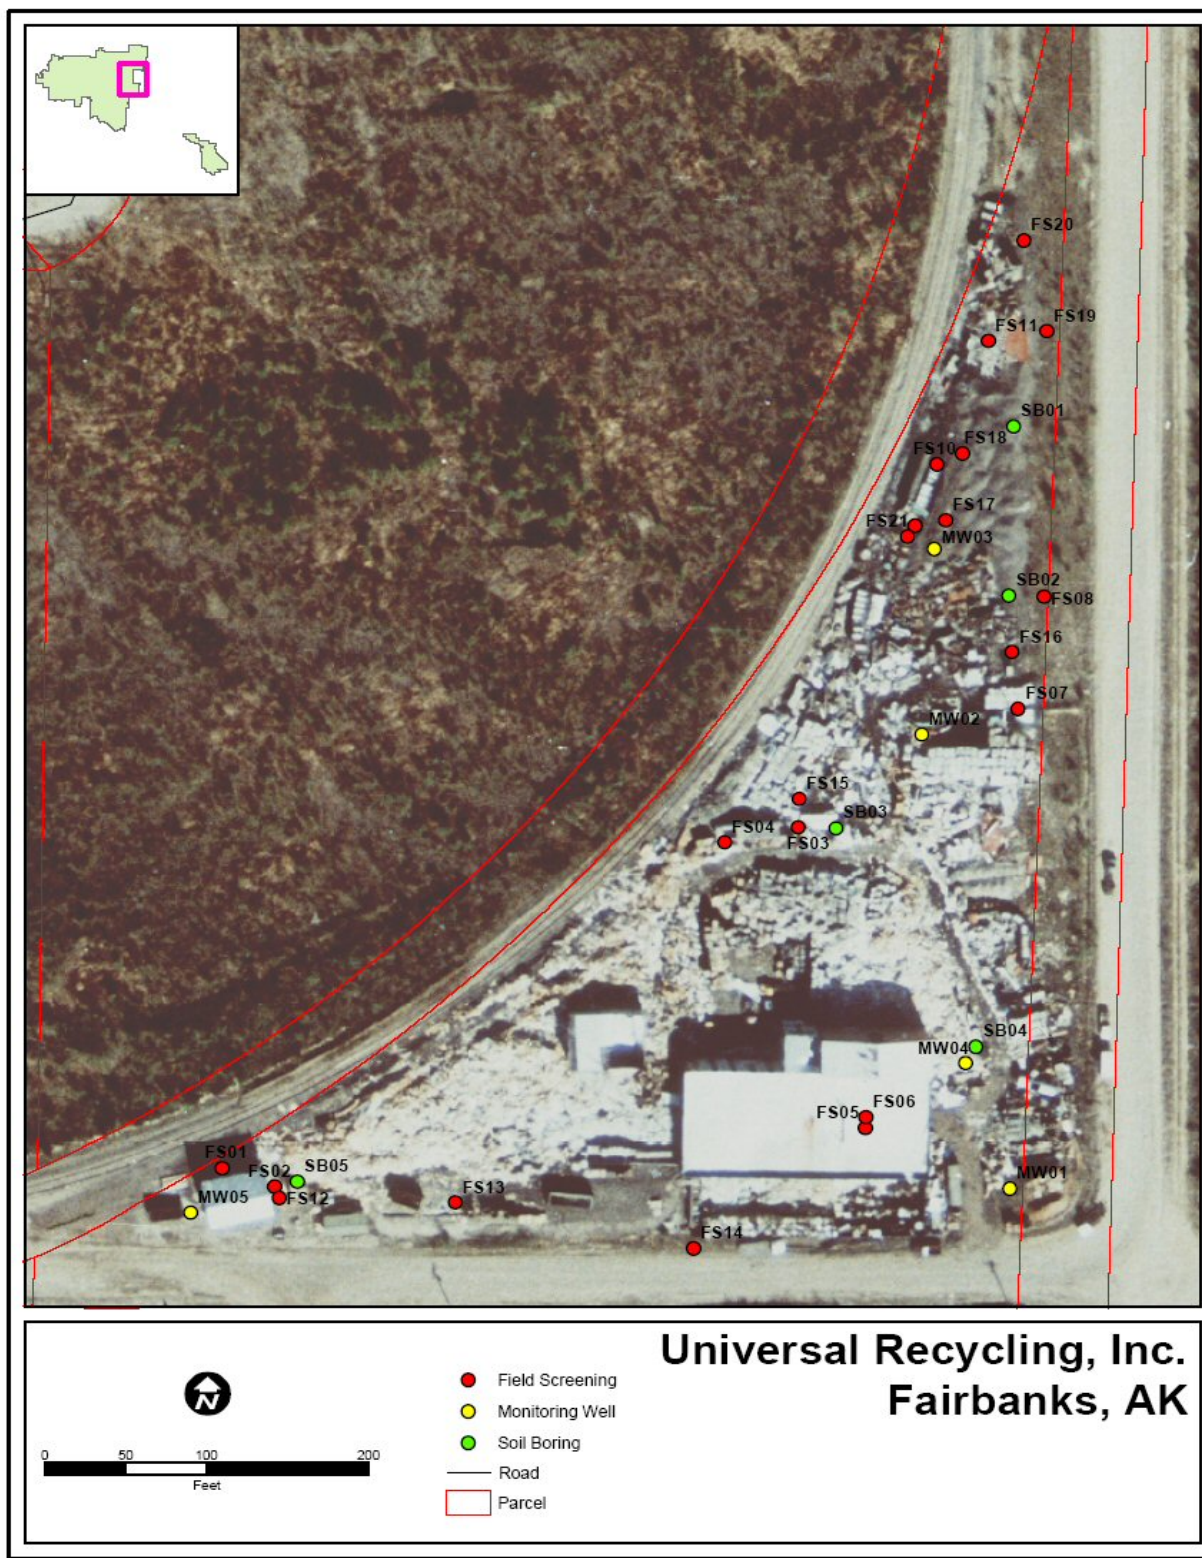
Figure 4-1 **Locations of Field Screening, Soil Borings, and Monitoring Wells**

Sample Number	Location GPS NAD 27	Description	Results	
			Petroflag	Chlor-n-Soil
FS01	235416.031 3952655.000	W. end of drums along north side of scale house. Visible staining.	2098 ppm	ND
FS02	235448.453 3952643.250	Stained area at east entrance to scale house.	EEEE	ND
FS03	235772.844 3952876.000	Base of the S. side of middle roll-off dumpster.	84 ppm	ND
FS04	235727.359 3952866.250	N. side of the roll-offs near transformer and computer tape reels. Drums nearby.	193 ppm	50 ppm
FS05	235814.406 3952681.000	Hole Near E. end of concrete pad	1472 ppm	ND
FS06	235814.609 3952688.250	Crack in concrete just north of FS05 on pad.	555 ppm	ND
FS07	235909.016 3952952.750	E. border of site near burned telephone pole. Highly stained soil.	122 ppm	ND
FS08	235925.000 3953025.750	N. of FS07 on E. border of site near drums labeled "Pipe-Lax."	EEEE	ND
FS09	235845.141 3953071.750	Near aircraft fuselage, drums, and misc. debris in N.W. portion of site.	626 ppm	ND

FS10	235858.688 3953111.500	N. side of drum pile. Over 28 drums with various labels.	128 ppm	ND
FS11	235890.453 3953191.250	W. side of suspected ash pile at extreme N. end of site.	54 ppm	ND
FS12	235451.375 3952635.750	Stained area on E. side of scale building.	EEEE	ND
FS13	235560.469 3952633.000	W. side of debris pile approximately 100' from scale house.	43 ppm	ND
FS14	235707.844 3952603.250	S. side of debris pile between pile and Sanduri Street below drum pile.	0	ND
FS15	235773.328 3952894.250	E. side of center (green) roll-off.	60 ppm	> 50 ppm
FS16	235905.328 3952989.500	Heavily stained area N. of burned telephone pole.	11 ppm	ND
FS17	235863.938 3953074.750	Adjacent to electrical equipment piled on N.W. corner of site in discolored area.	21 ppm	ND
FS18	235874.469 3953118.500	Center of drum pile near N. end of site.	89 ppm	ND
FS19	235926.484 3953197.500	E. of stacked drums on extreme N. side of site.	66 ppm	ND

FS20	235912.469 3953256.500	W. side of stacked drums in discolored area.	431 ppm	ND
FS21	235840.266 3953064.500	Approximately 20' N. of aircraft fuselage and drum pile in discolored area.	103 ppm	ND
