PHASE I ENVIRONMENTAL SITE ASSESSMENT

3901 MOUNTAIN VIEW DRIVE

ANCHORAGE, ALASKA

JUNE 2005

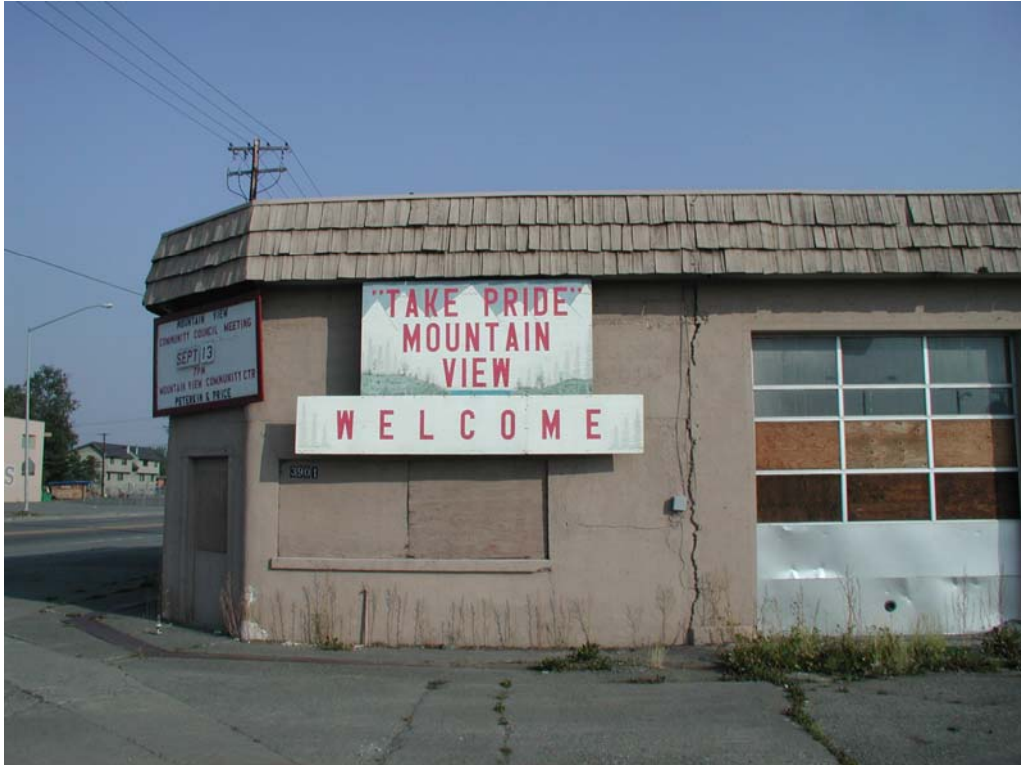
**Photo 1. South side of the building facing north.
Bragaw Street is on the left.**

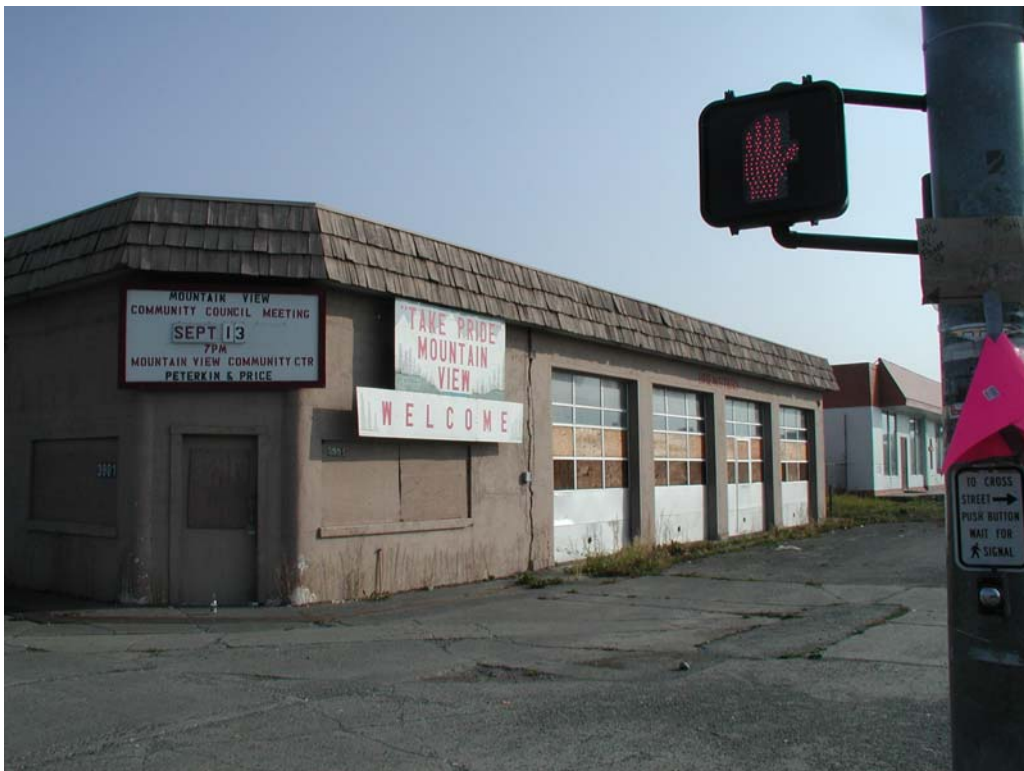
Photo 2. 3901 Mountain View Drive, facing northeast. Mountain View Drive is on right.

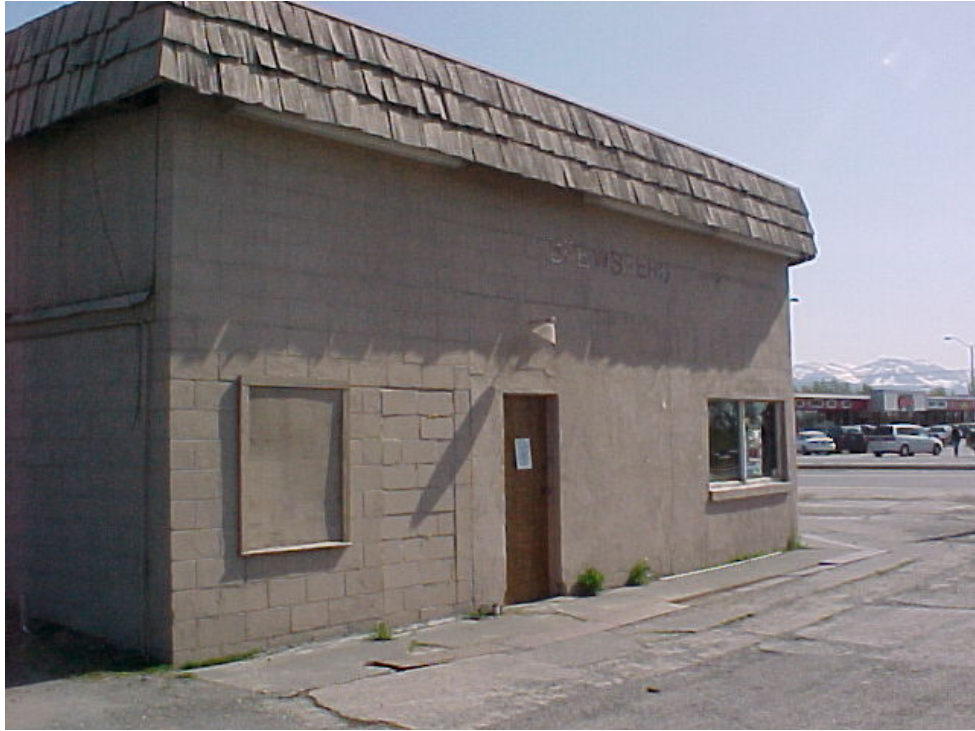
Photo 3. West side of building, facing southeast. Mountain View Drive in background.

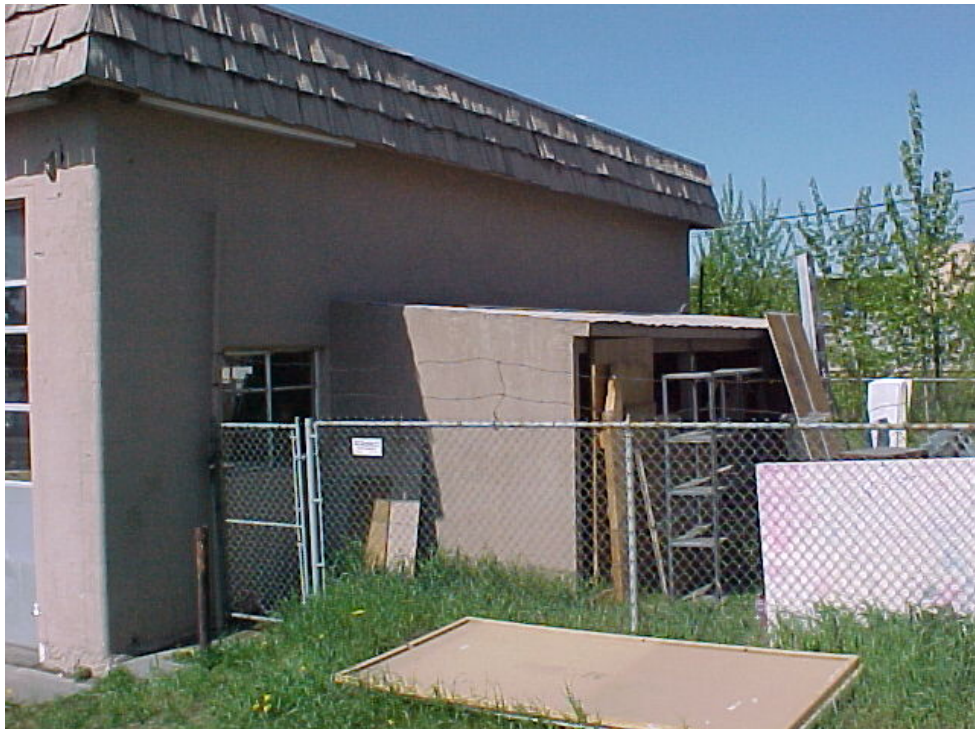
Photo 4. East side of building, storage area, facing northwest.

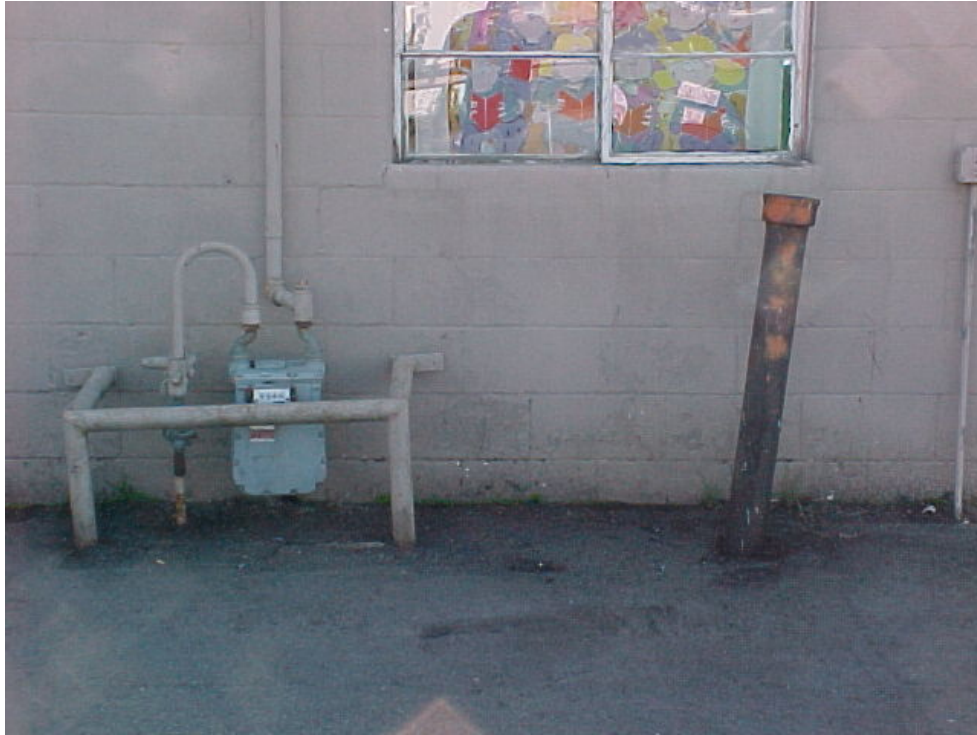
Photo 5. Gas meter and well stickup located on north side of building.

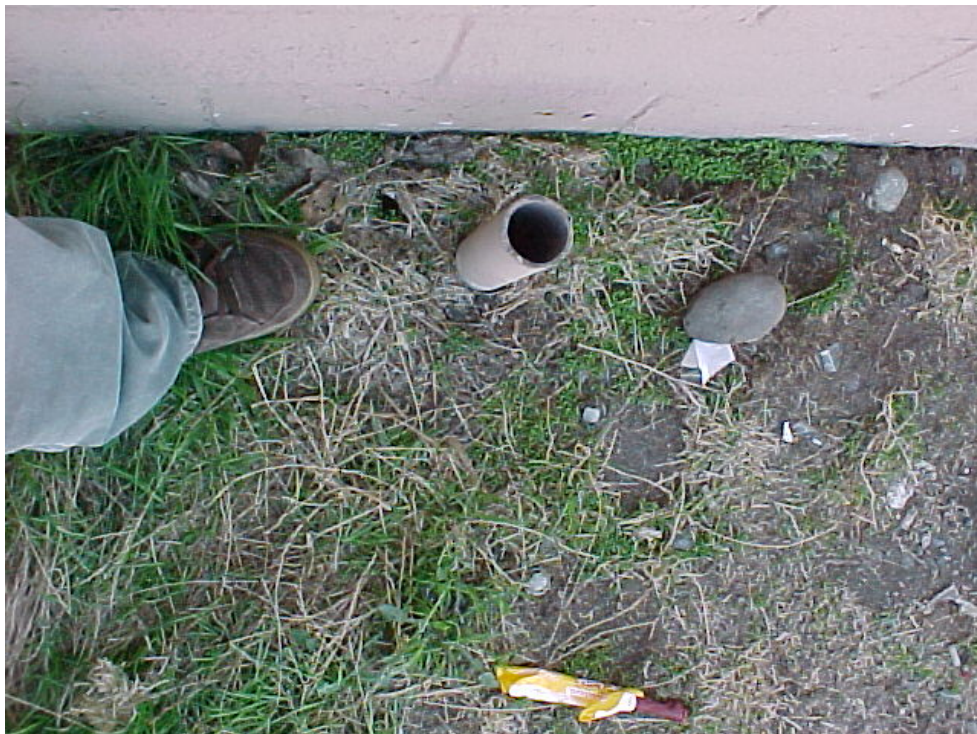
Photo 6. Unknown two inch diameter pipe located on north side of building.

- Because there is no definitive information regarding the status of historic USTs associated with the gas station operations, an exploratory effort consisting of ground penetrating radar and/or exploratory soil borings may be required to ensure any USTs have been properly removed. Soil and/or groundwater should be screened for petroleum contamination associated with USTs during any exploratory drilling. Further investigation may be required based on the results of exploratory drilling.
- The hydraulic lifts associated with the vehicle maintenance operations should be removed and the pits permanently filled.

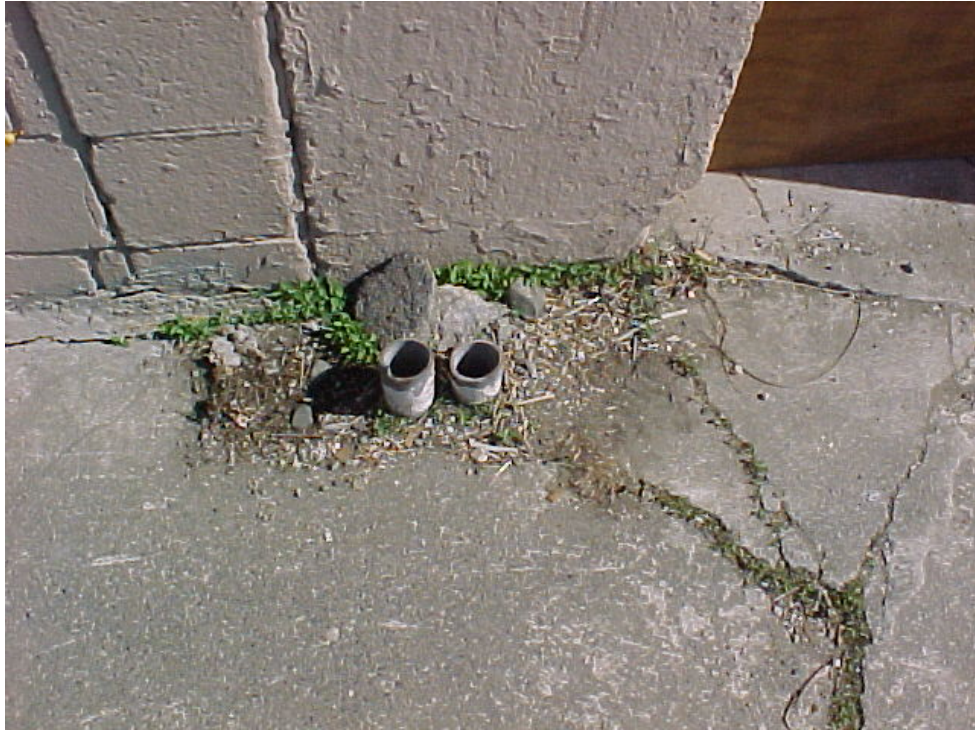
Photo 7. Two unknown two inch diameter pipes located on west side of building.

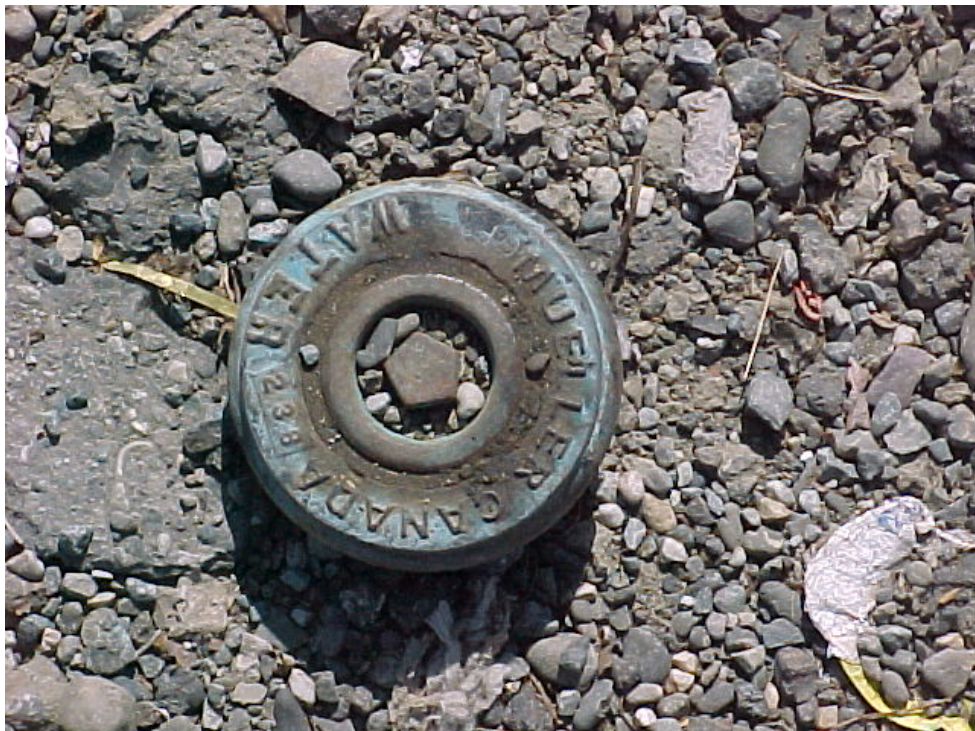
Photo 8. Water well cap located in the northwest corner of property.
