**Brownfield Assessment and Cleanup  
Old BIA School  
Chevak, Alaska  
ADEC File No. 2409.57.001**

January 2018

Submitted To:  
**Alaska Department of Environmental Conservation**  
555 Cordova Street  
Anchorage, Alaska 99501

By:  
**Shannon & Wilson, Inc.**  
5430 Fairbanks Street, Suite 3  
Anchorage, Alaska 99518  
Phone: 907-561-2120  
Fax: 907-561-4483

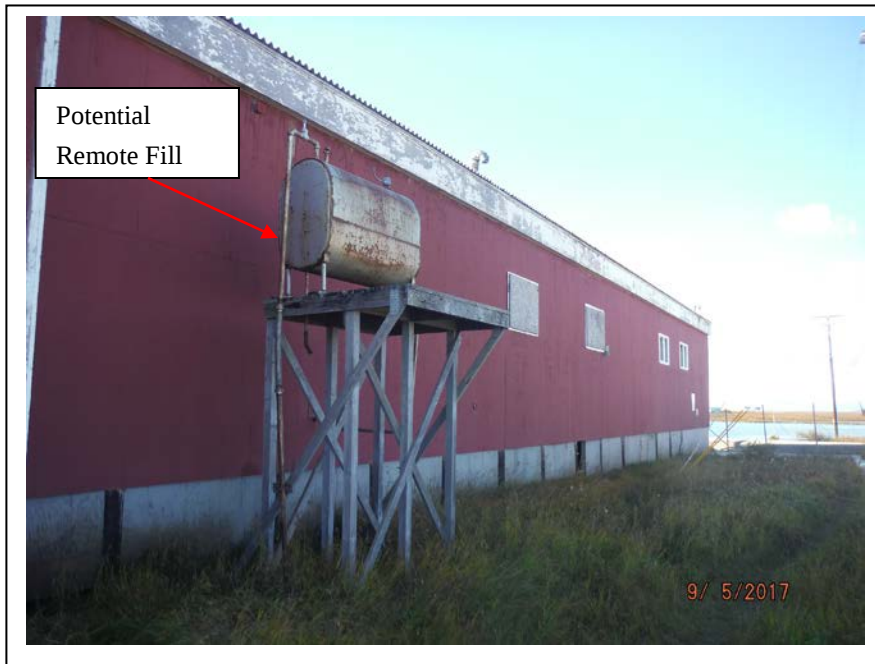
Photograph 1: Looking northwest at the AST located along the northeast wall of Building S1. (September 5, 2017)

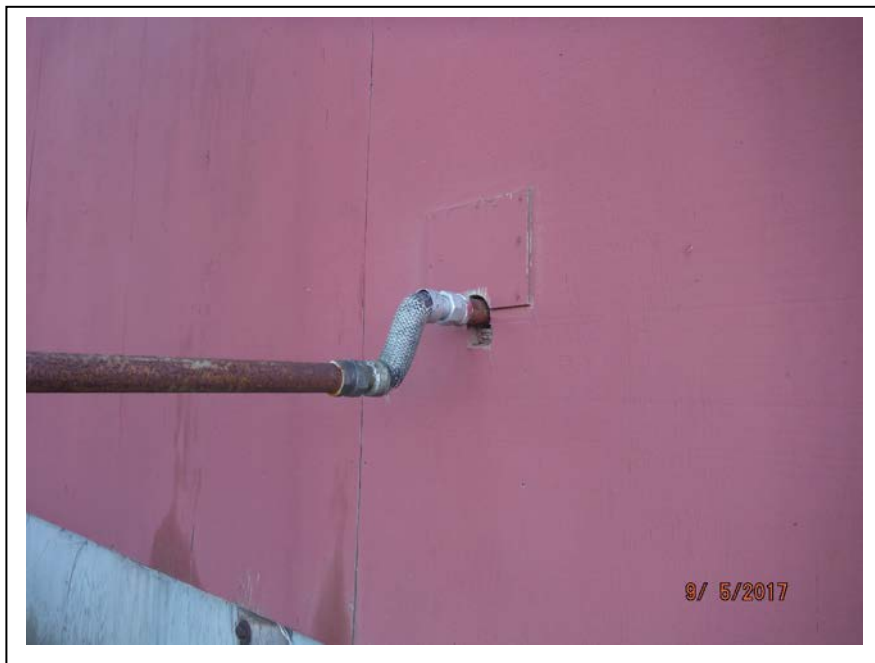
Photograph 2: Product feed piping. (September 5, 2017)

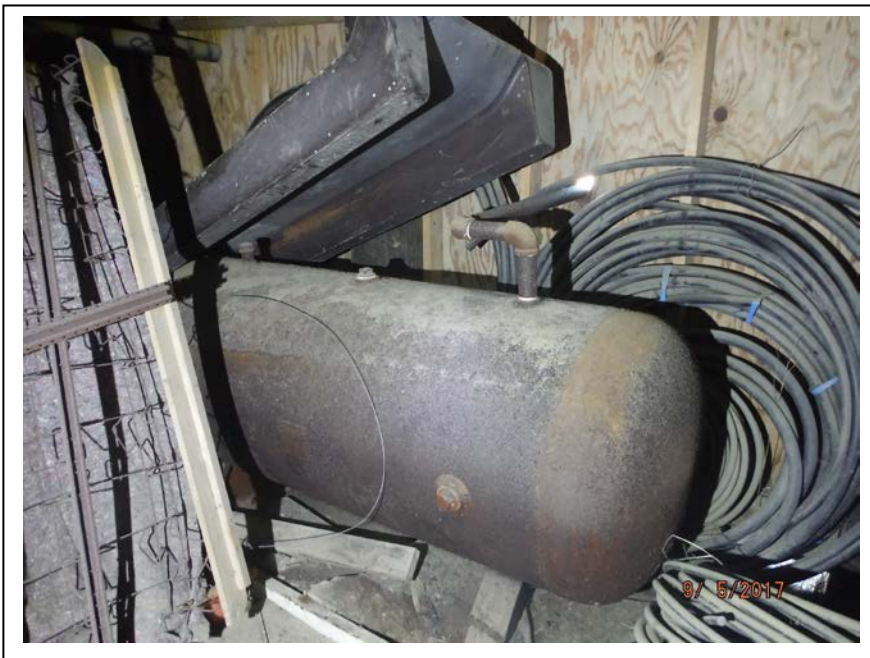
Photograph 3: Approximately 250-gallon located beneath the western portion of Building S1. (September 5, 2017)

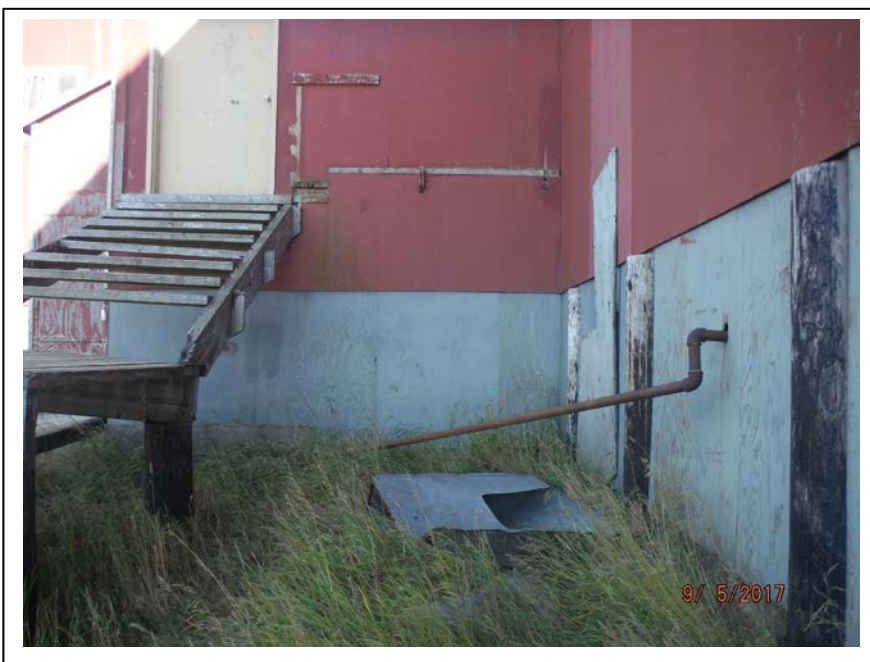
Photograph 4: Piping connected to AST located beneath Building S1. (September 5, 2017)

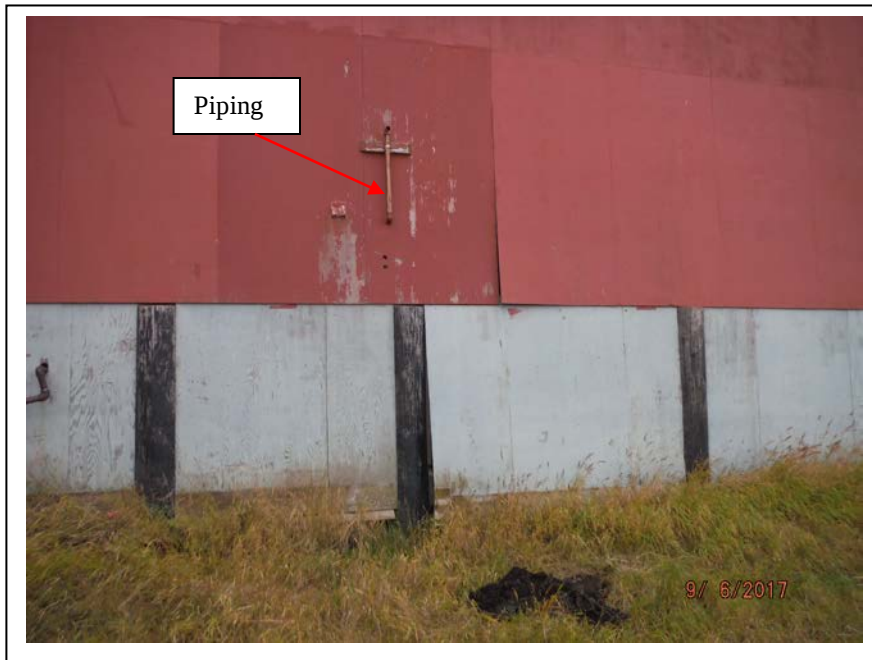
Reportedly, a second tank was located in this area on an elevated wooden platform. A pipe associated with this potential tank remains on the exterior wall of the structure (Photo 5). Ponded water and creosote piles were observed lying on the ground surface north of the building (Photo 6). Area of Concern 2 is shown on Figure 4.

Photograph 5: Piping associated with a potential former AST located on the northern wall of the western portion of Building S1. (September 5, 2017)

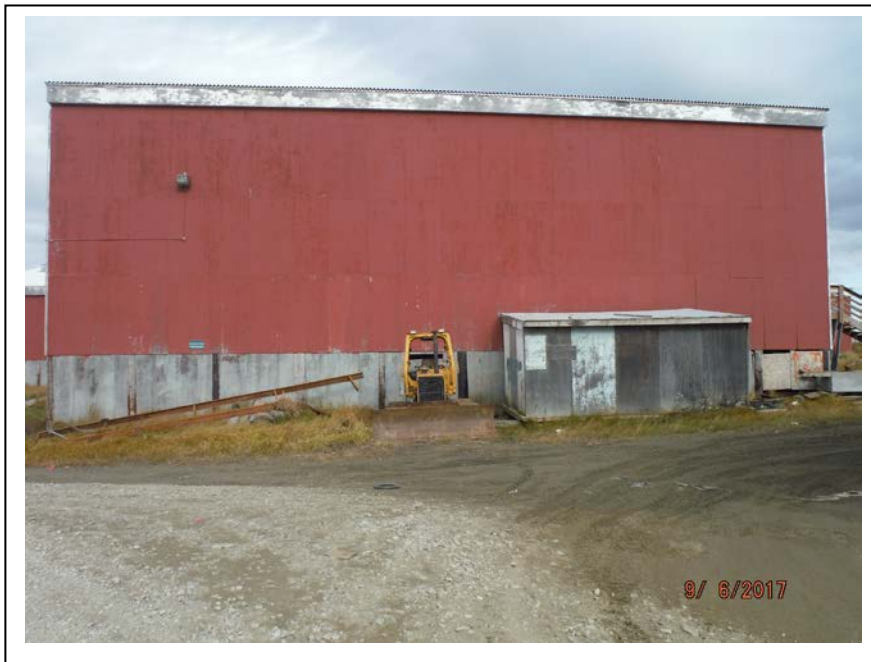
- Area of Concern 3 - The 2014 Phase I ESA documented an oily sheen on ponded water northwest of Building S6. In addition, crushed batteries were reportedly observed adjacent to Building S6. During our site visit, ponded water, oil staining, or crushed batteries were not documented in this area. Metal and wood debris, and a bull dozer are currently stored in this area (Photo 7). The 2014 Phase I ESA documented 55-gallon drums, batteries, and solid waste within Building S6. During our site visit, Building S6 contained a wooden table, lumber, plywood, and insulation (Photo 8). Area of Concern 3 is shown on Figure 5.

Photograph 7: Looking northeast at Area of Concern 3. Building S6 is in the right side of the photo. (September 6, 2017)

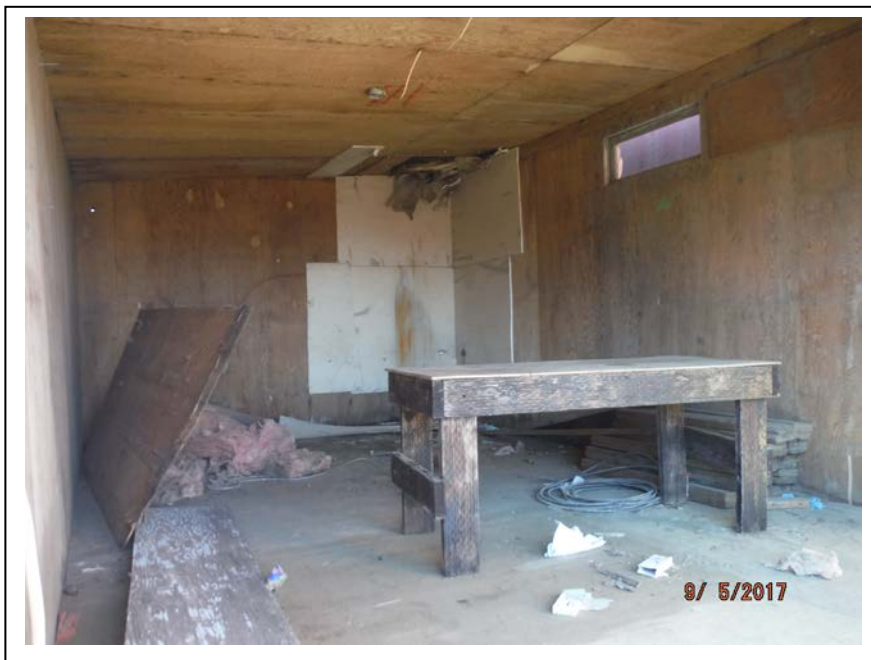
Photograph 8: Looking at the interior of Building S6. (September 5, 2017)

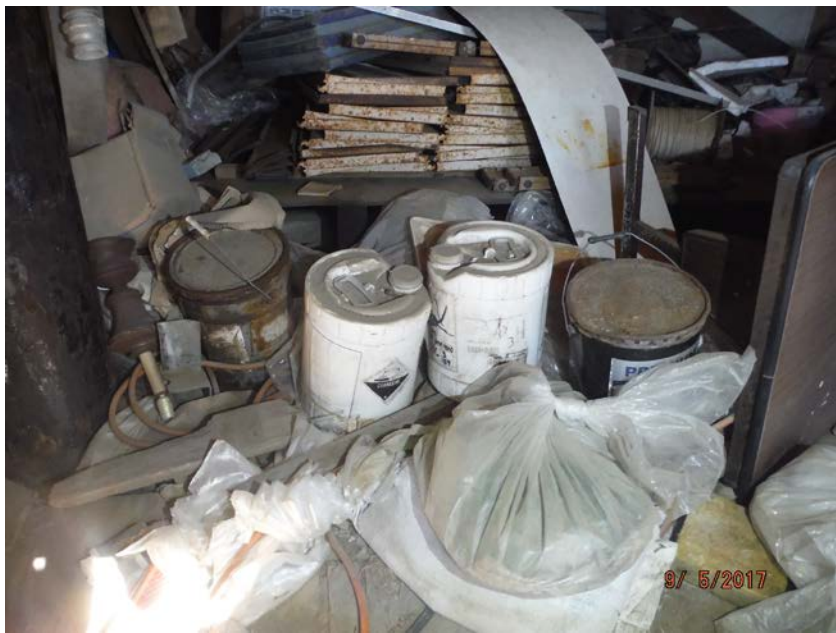
- Area of Concern 4 – Building supplies, miscellaneous equipment, 55-gallon drums, miscellaneous containers, and debris are located beneath the western portion of Building S1. Five-gallon containers labeled “corrosive” (Photo 9) and a 5-gallon container of used anti-freeze (Photo 10) were observed. A 55-gallon, which appears to contain used oil, was also observed (Photo 11).

Photograph 9: Containers labeled “corrosive” located beneath the western portion of Building S1. (September 5, 2017)

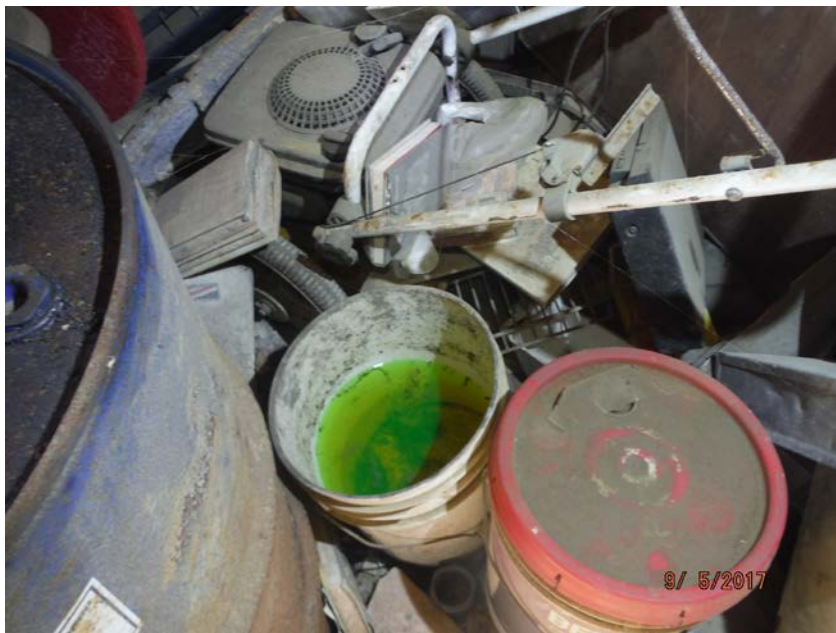
Photograph 10: 5-gallon bucket with used anti-freeze located beneath the western portion of Building S1. (September 5, 2017)

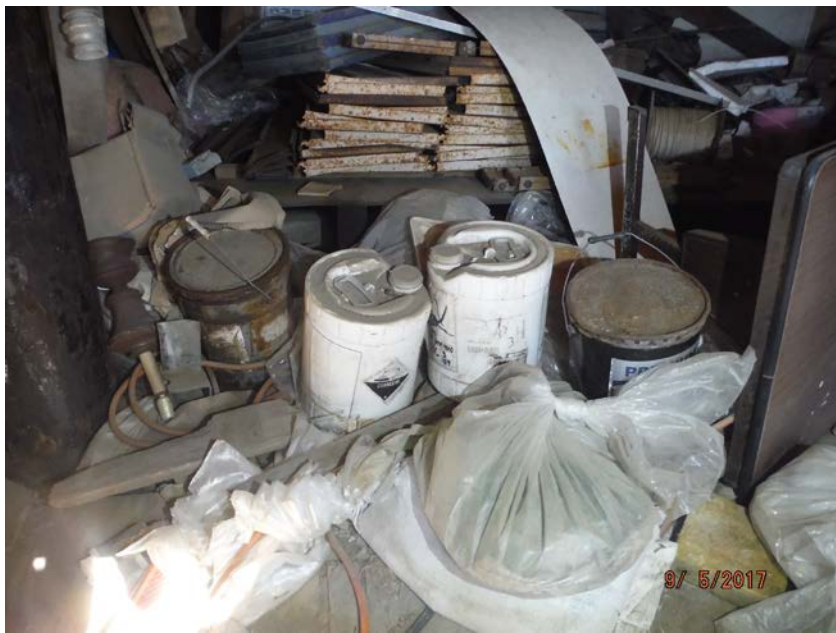
Photograph 11: Containers labeled “corrosive” located beneath the western portion of Building S1. (September 5, 2017)

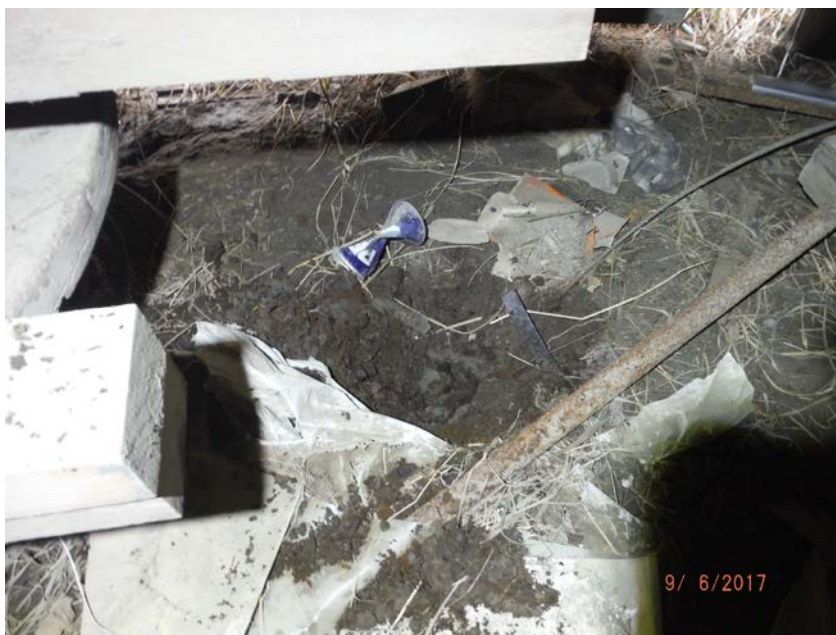
Photograph 12: Looking at the location of Surface Sample SS13 which was collected beneath the western portion of Building S1. (September 6, 2017)

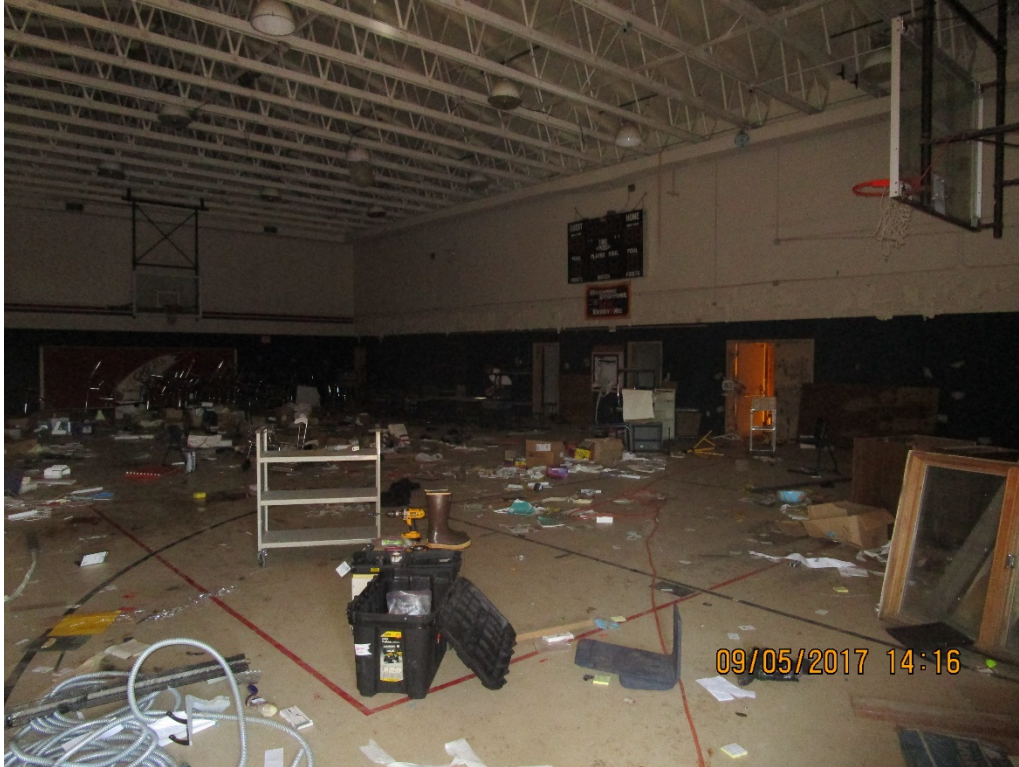
Photo 1: View of Gym showing typical conditions and stored materials in the interior of the building.

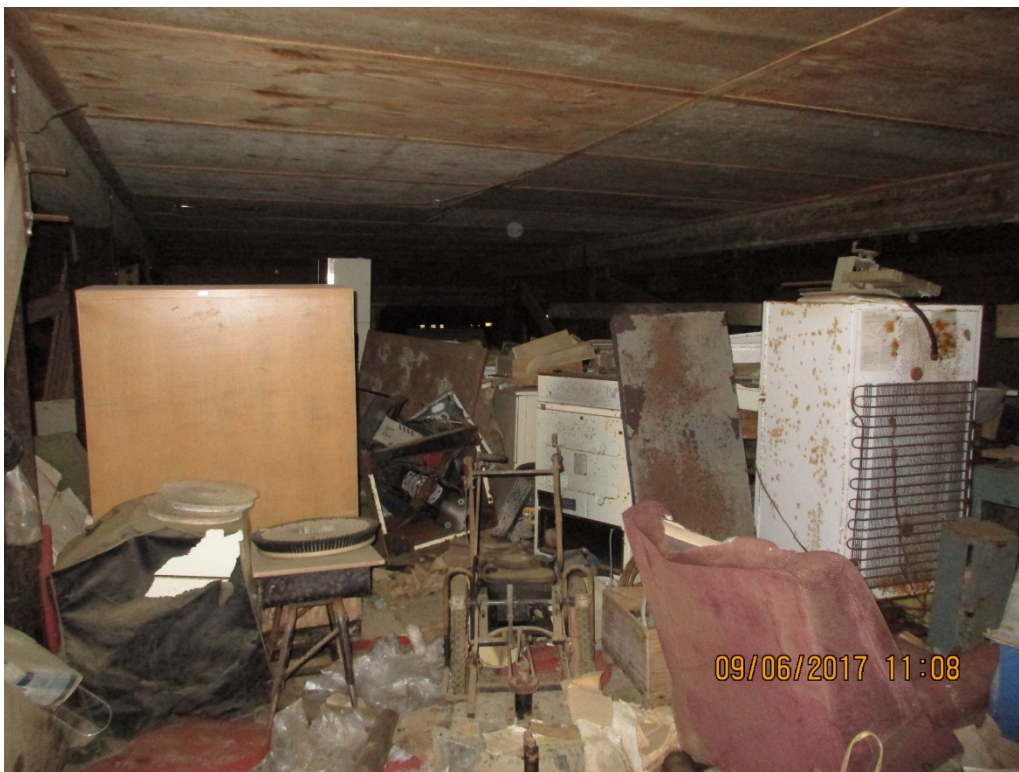
Photo 2: View under Gym showing typical condition of the underside of the building.

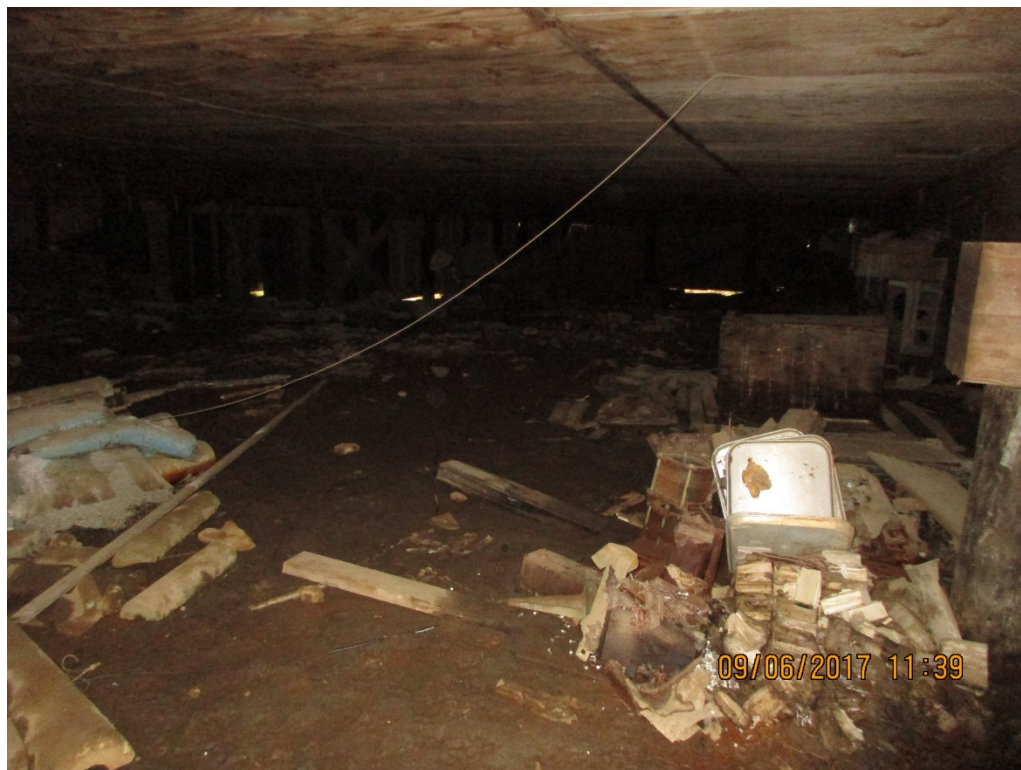
Photo 3: View under "Classroom Wing" showing typical condition of the underside of the building.

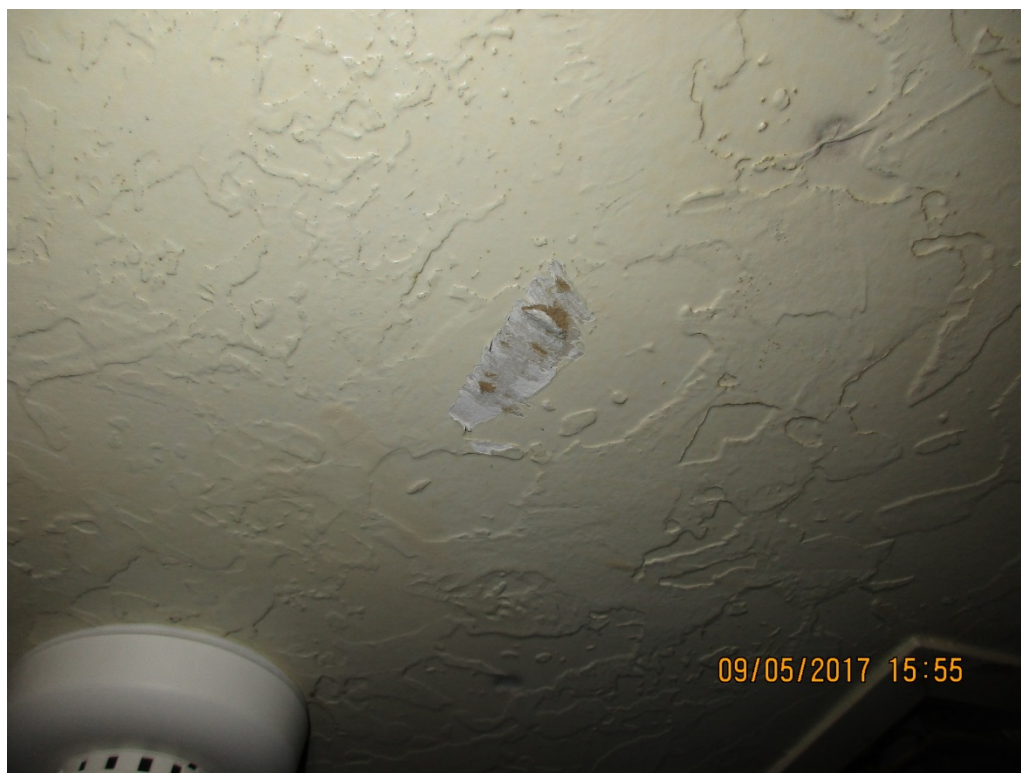
Photo 4: Asbestos-containing troweled-on ceiling texture.

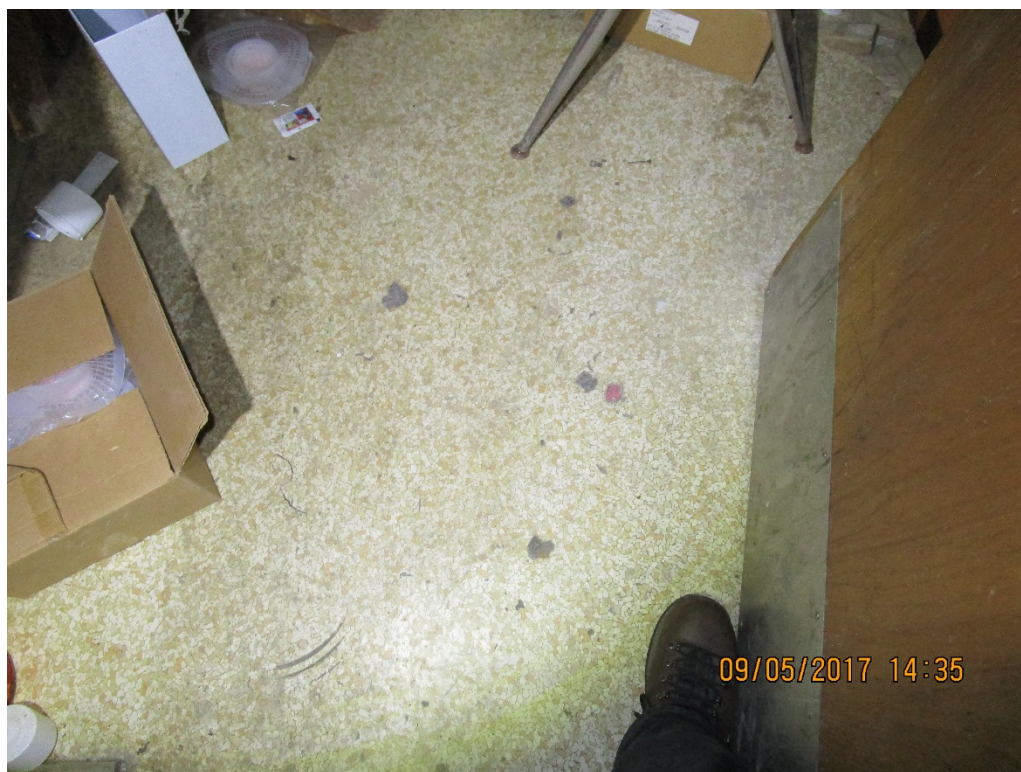
Photo 5: One pattern of asbestos-containing sheet vinyl.

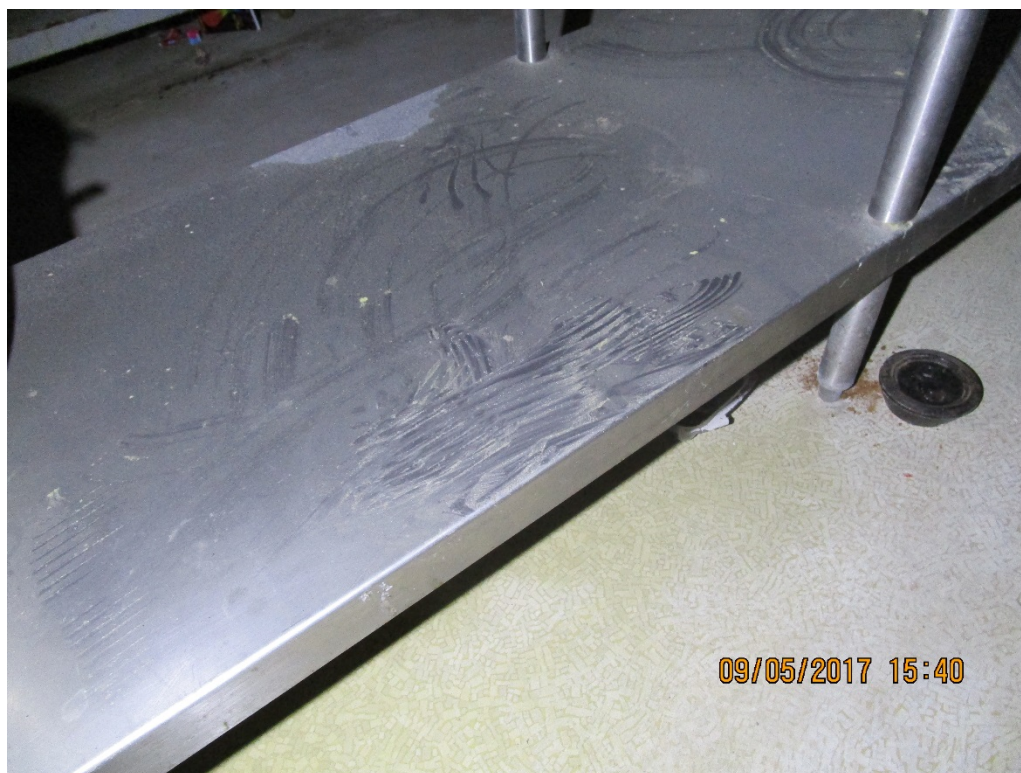
Photo 6: Another pattern of asbestos-containing sheet vinyl.

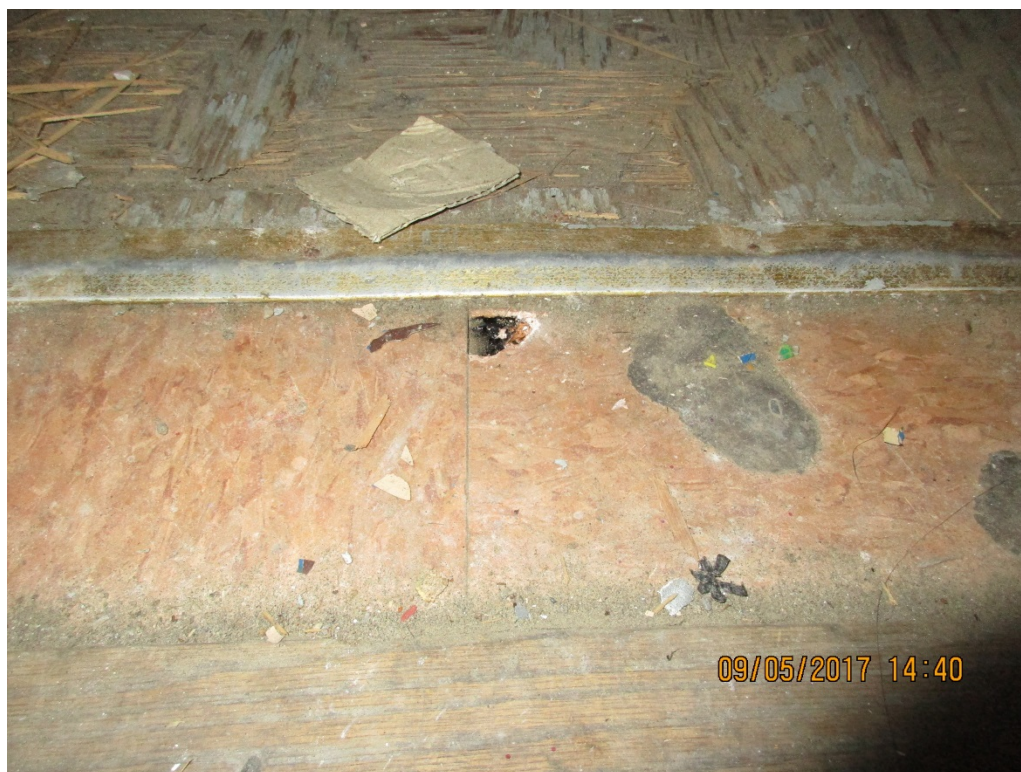
Photo 7: Asbestos-containing black floor tile mastic under vinyl floor tiles under rubber floor in Gym.

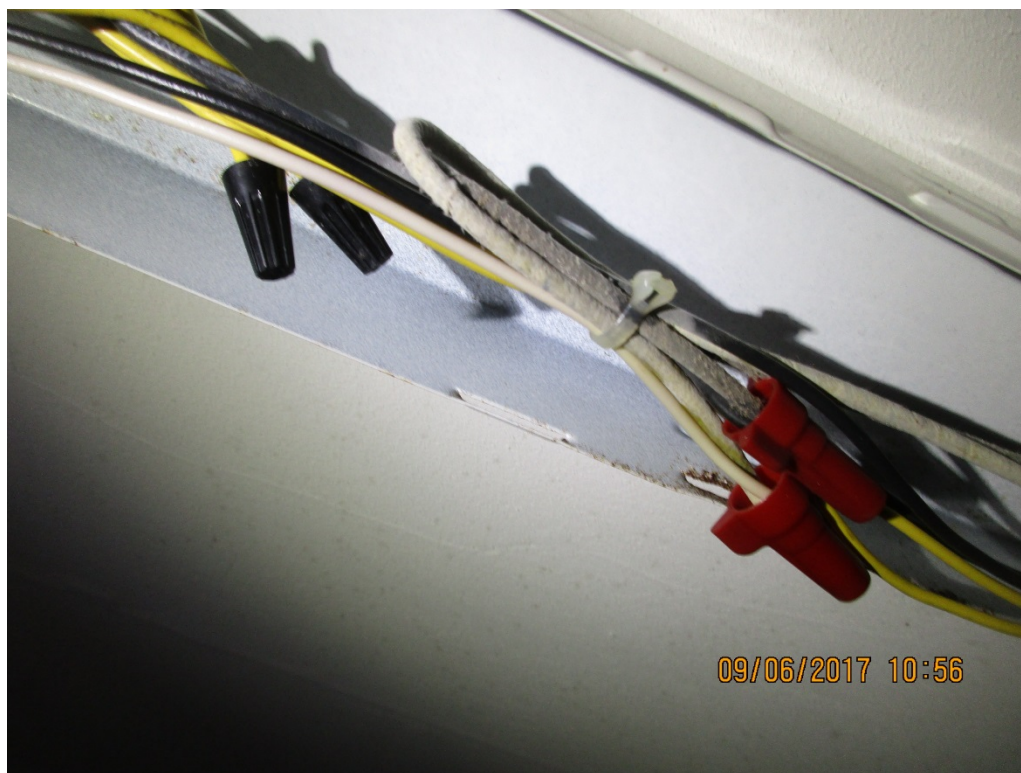
Photo 8: Asbestos-containing high temperature wiring insulation in light fixture.

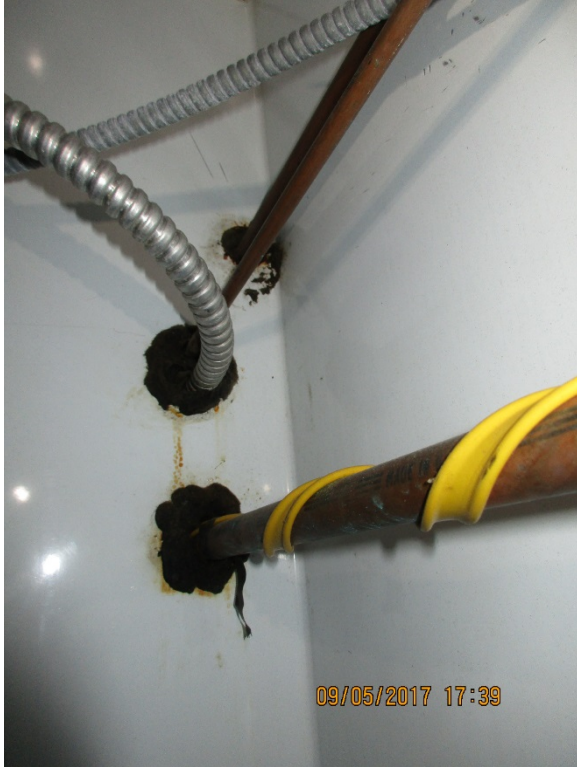
Photo 9: Asbestos-containing penetration putties on refrigerant lines in walk-in freezer in Kitchen.

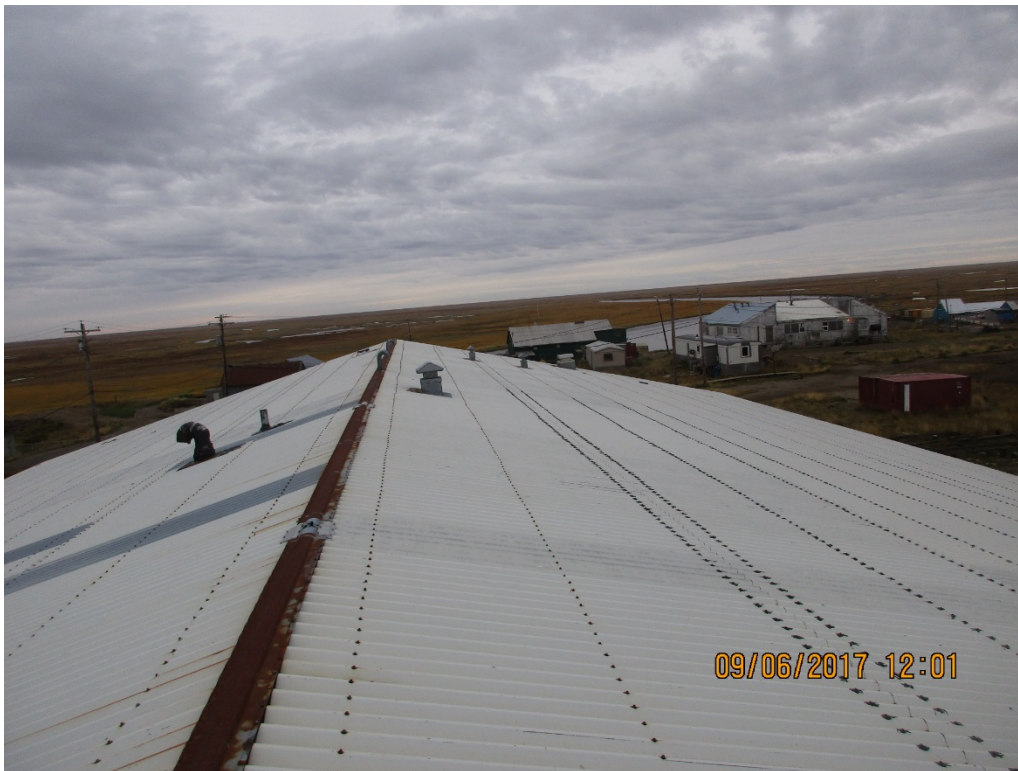
Photo 10: Asbestos-containing patch tars on ridge vent, equipment, and screw heads.

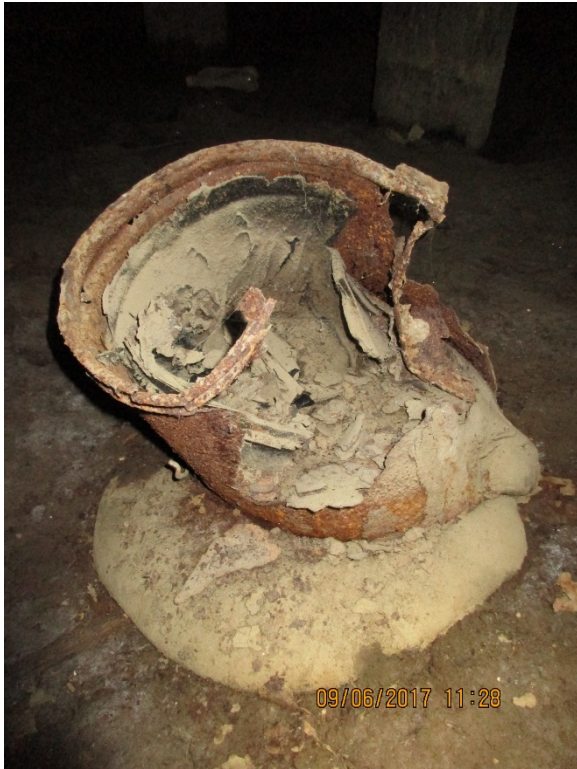
Photo 11: Loose 5-gallon bucket of asbestos-containing roof patching tar under building.

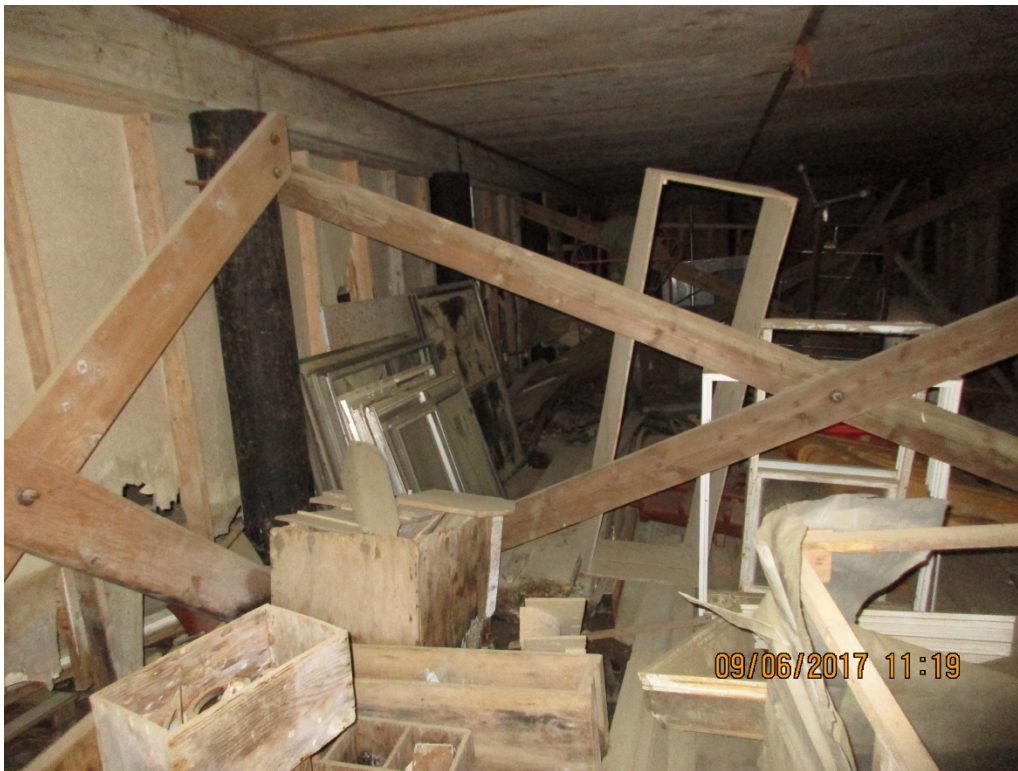
Photo 12: Loose pile of old windows with asbestos-containing window putties under building.

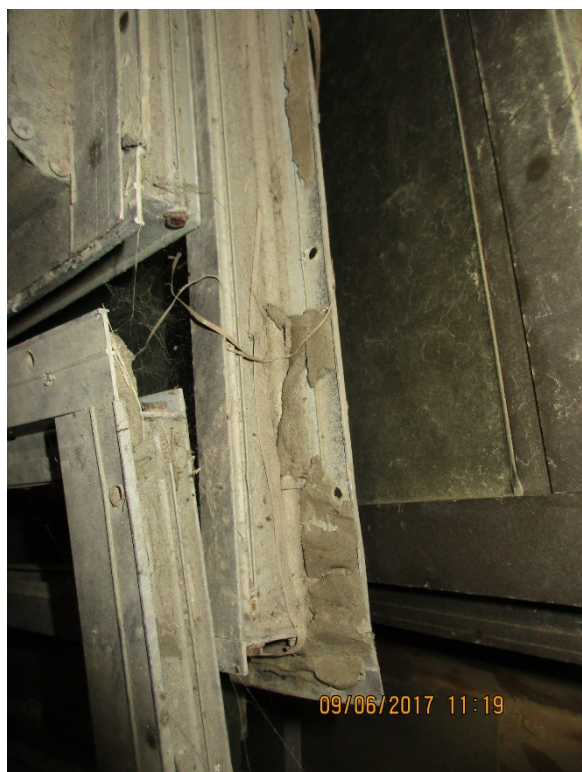
Photo 13: Close-up view of asbestos-containing window putties and sealants

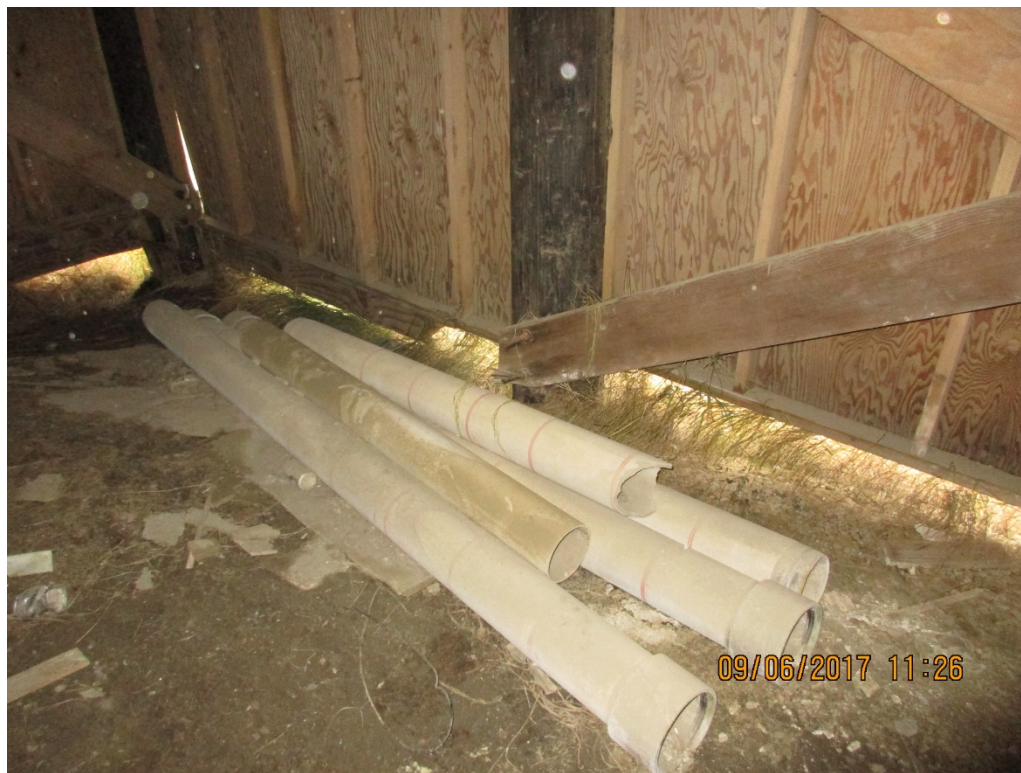
Photo 14: Loose pile of asbestos-containing "Transite" piping under building.

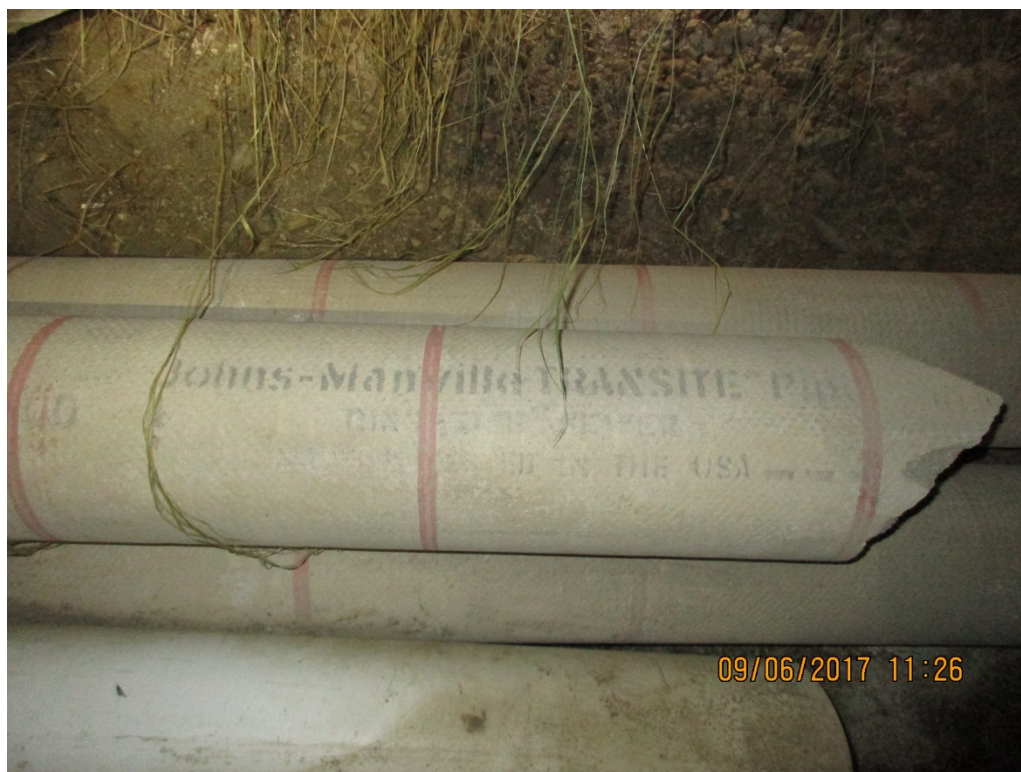
Photo 15: Close-up of loose pile of asbestos-containing "Transite" piping under building.

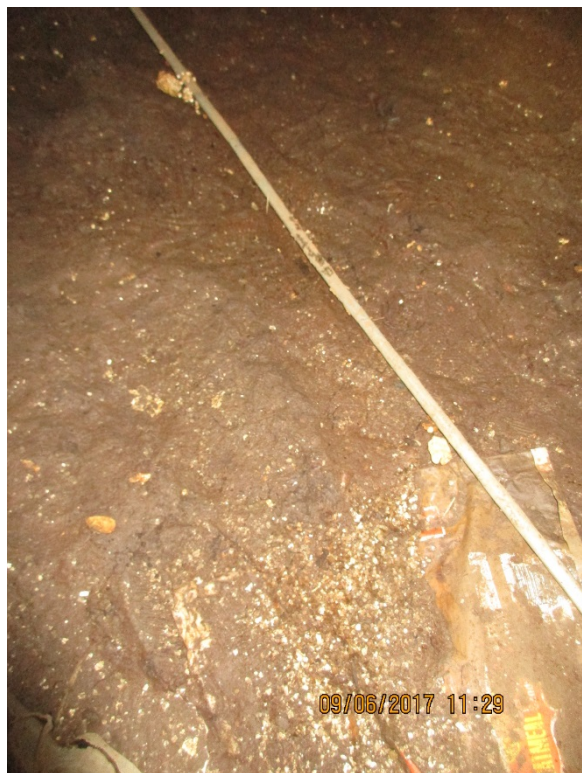
Photo 16: Loose-fill asbestos-containing Vermiculite insulation in soils under building.

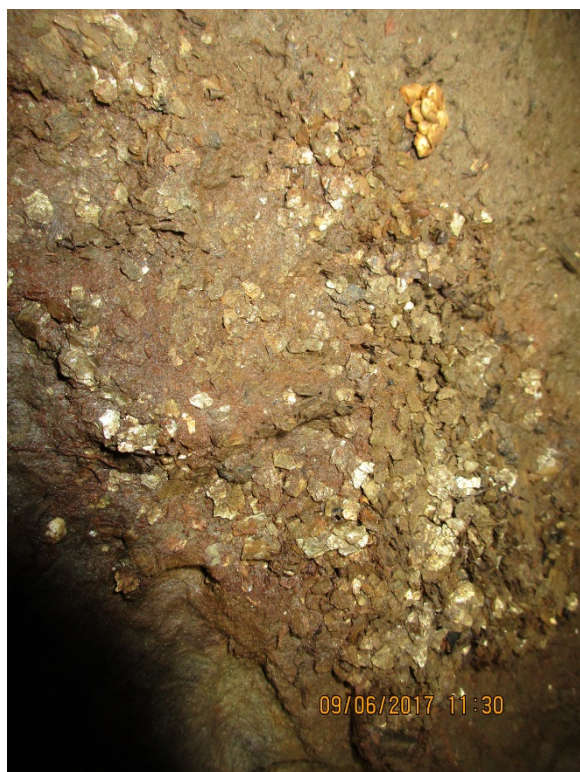
Photo 17: Close-up of asbestos-containing loose-fill Vermiculite insulation in soils under building.

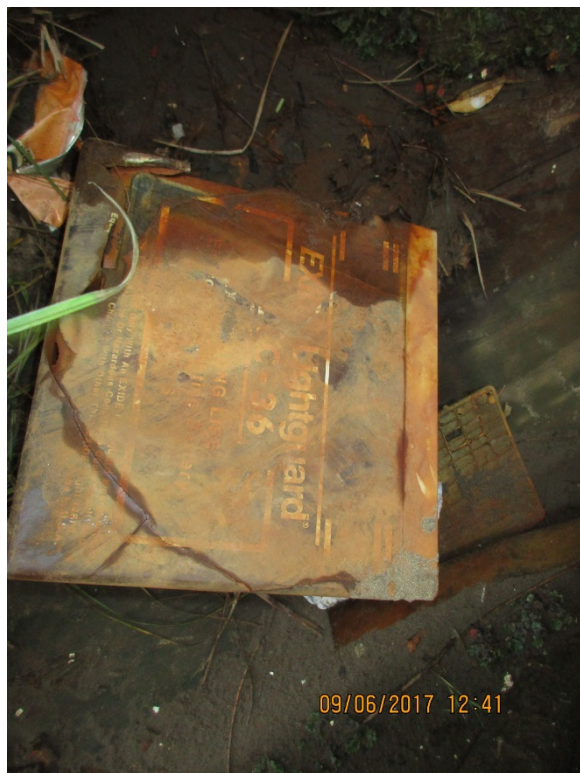
Photo 18: Loose lead-acid battery laying on ground next to building.

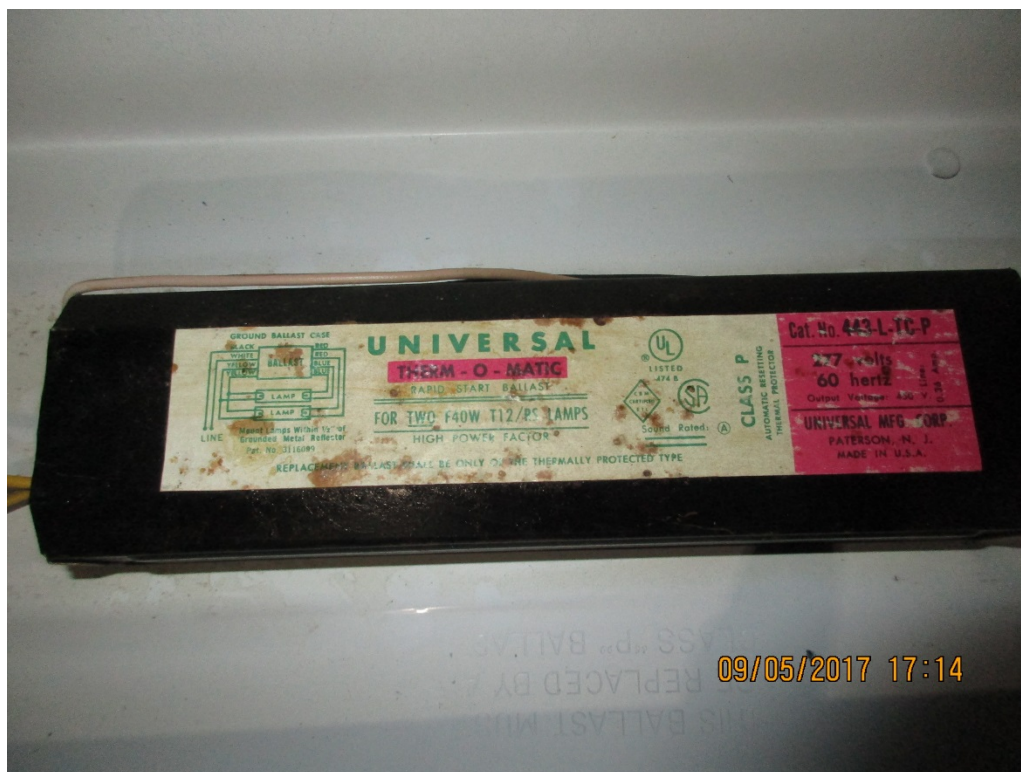
Photo 19: PCB-containing light ballast.

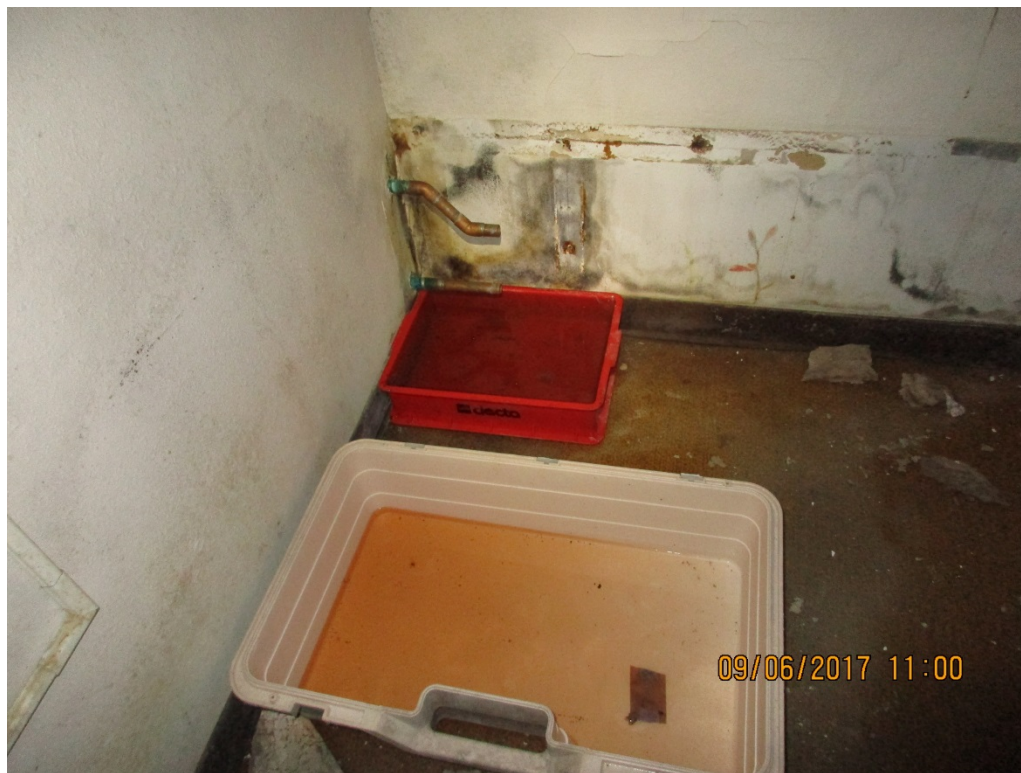
Photo 20: Loose containers of heating system glycol inside the building.

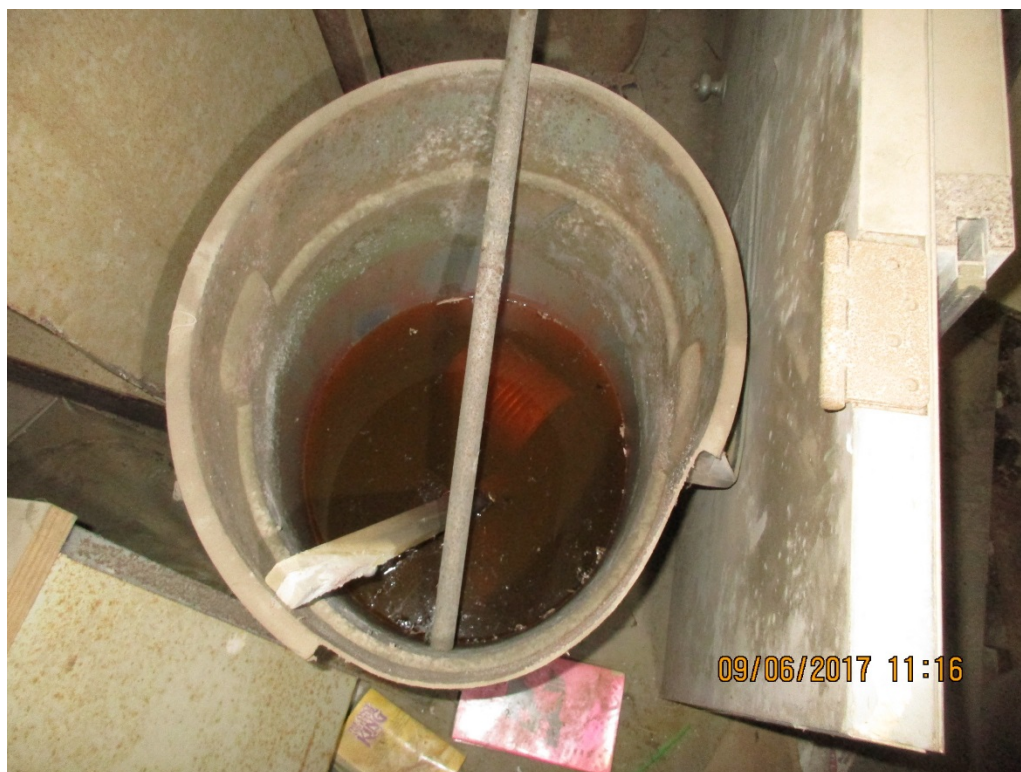
Photo 21: Loose container of heating system glycol under building.

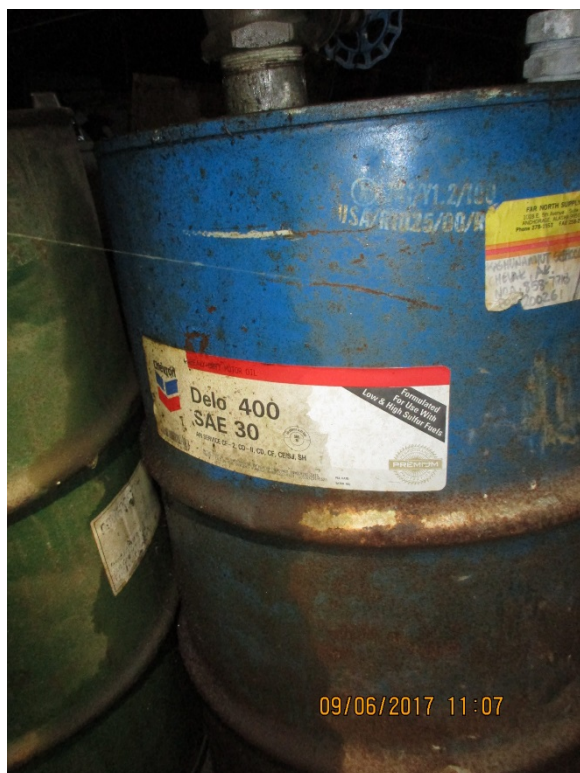
Photo 22: 55-gallon drum of oil under building.

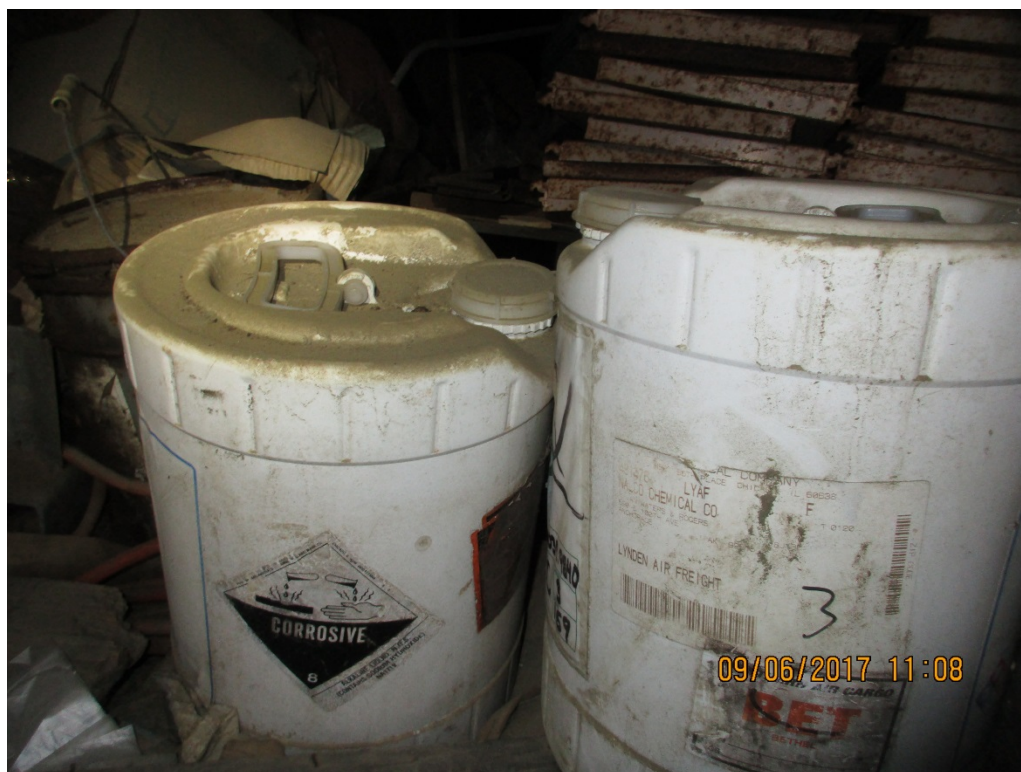
Photo 23: Loose containers of corrosive chemicals under building.
