**Brownfield Assessment and Cleanup  
Old BIA School  
Chevak, Alaska  
ADEC File No. 2409.57.001**

January 2018

Submitted To:  
**Alaska Department of Environmental Conservation**  
555 Cordova Street  
Anchorage, Alaska 99501

By:  
**Shannon & Wilson, Inc.**  
5430 Fairbanks Street, Suite 3  
Anchorage, Alaska 99518  
Phone: 907-561-2120  
Fax: 907-561-4483

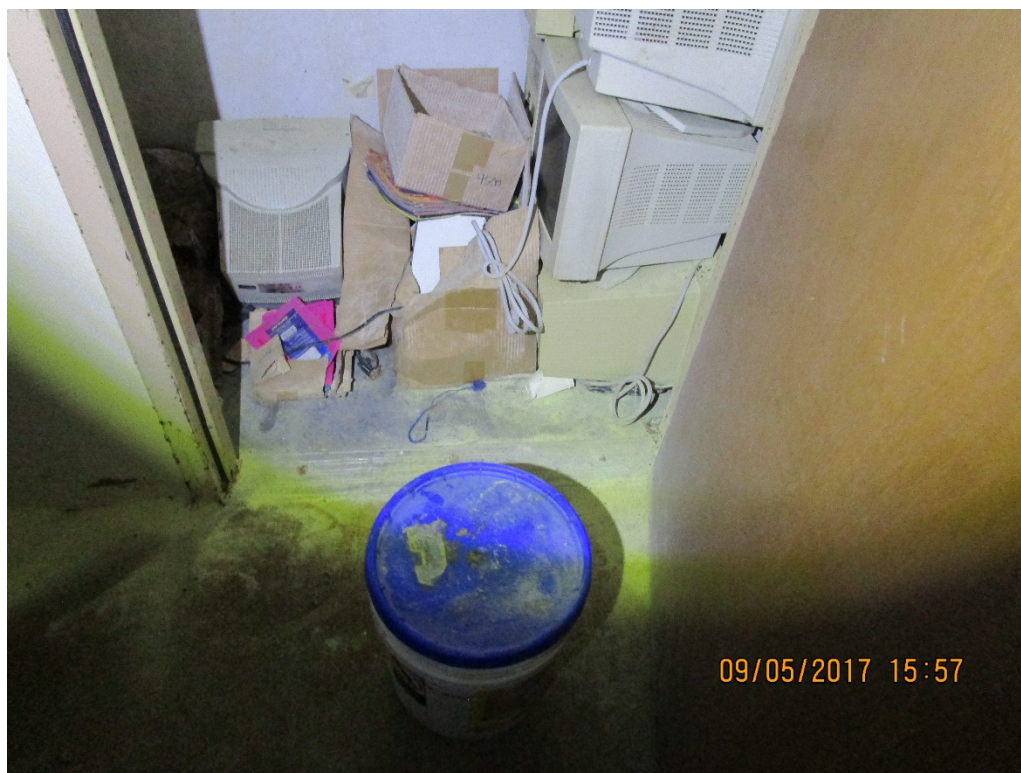
Photo 24: Loose cathode-ray computer monitors and miscellaneous chemicals.
