**ALL APPROPRIATE INQUIRY SITE CHARACTERIZATION  
FOR  
JOHN'S MOTEL AND RV PARK  
3543 MOUNTAIN VIEW DRIVE  
ANCHORAGE, ALASKA**

Prepared for  
**ALASKA DEPARTMENT OF ENVIRONMENTAL CONSERVATION**

**FINAL  
DECEMBER 2005**

**Hoefler Consulting Group**  
3401 Minnesota Drive, Suite 300  
Anchorage, Alaska 99503  
Point of Contact: Peggy Yang  
(907) 563-2132  
ADEC SPAR Term Contract 18-9028-05

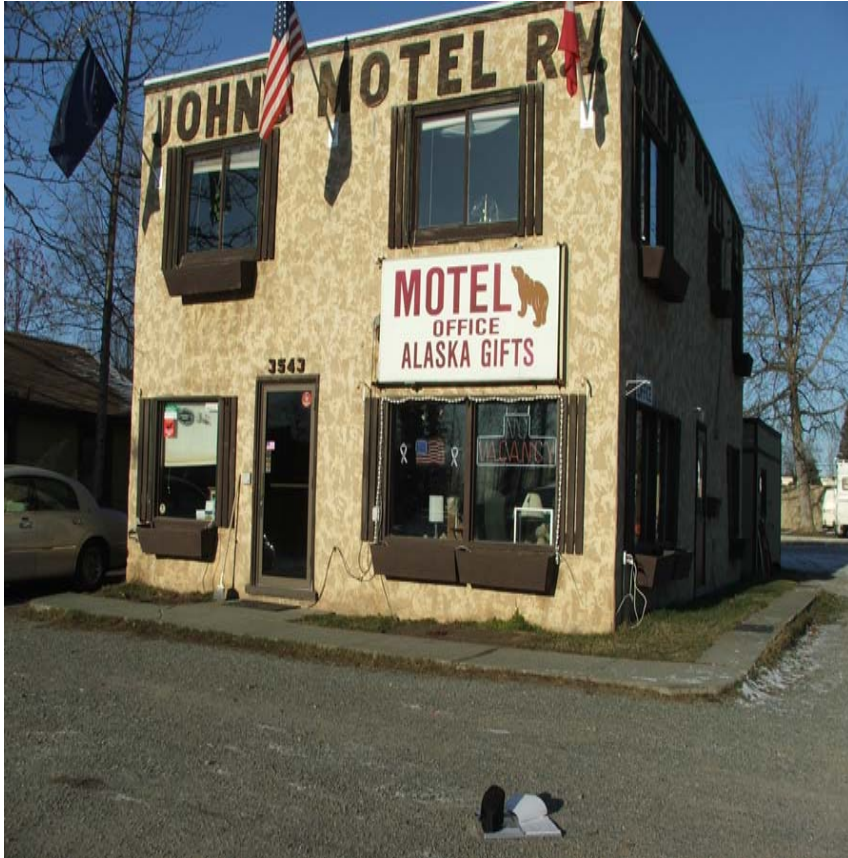
Main Office/Owner residence,  
facing North

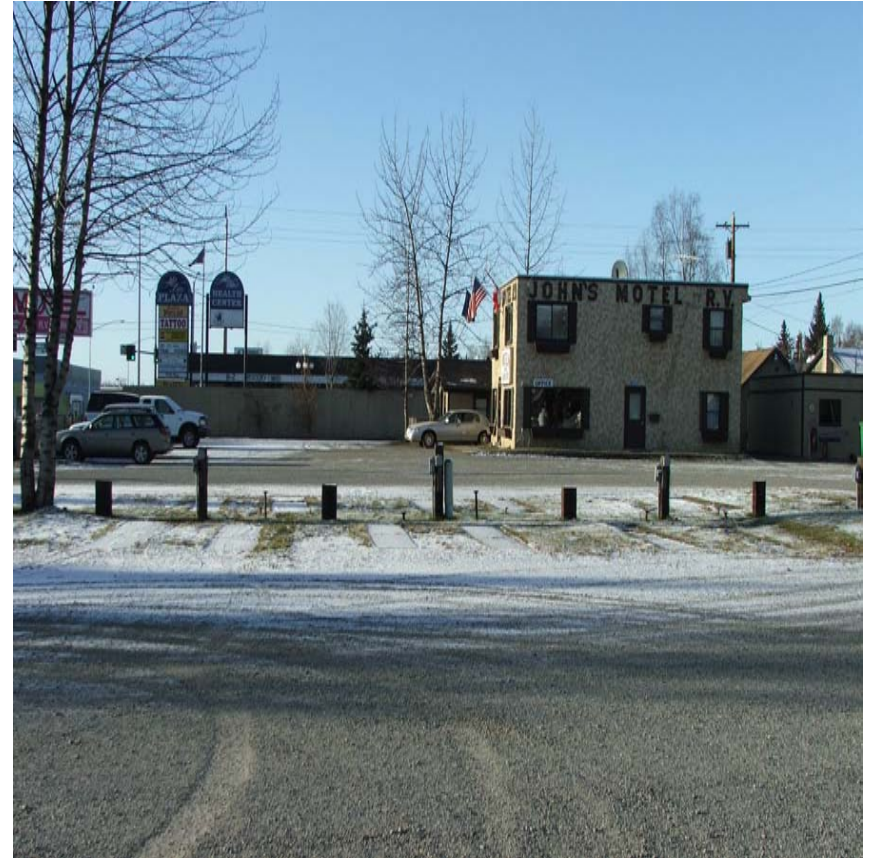
RV parking area, facing west

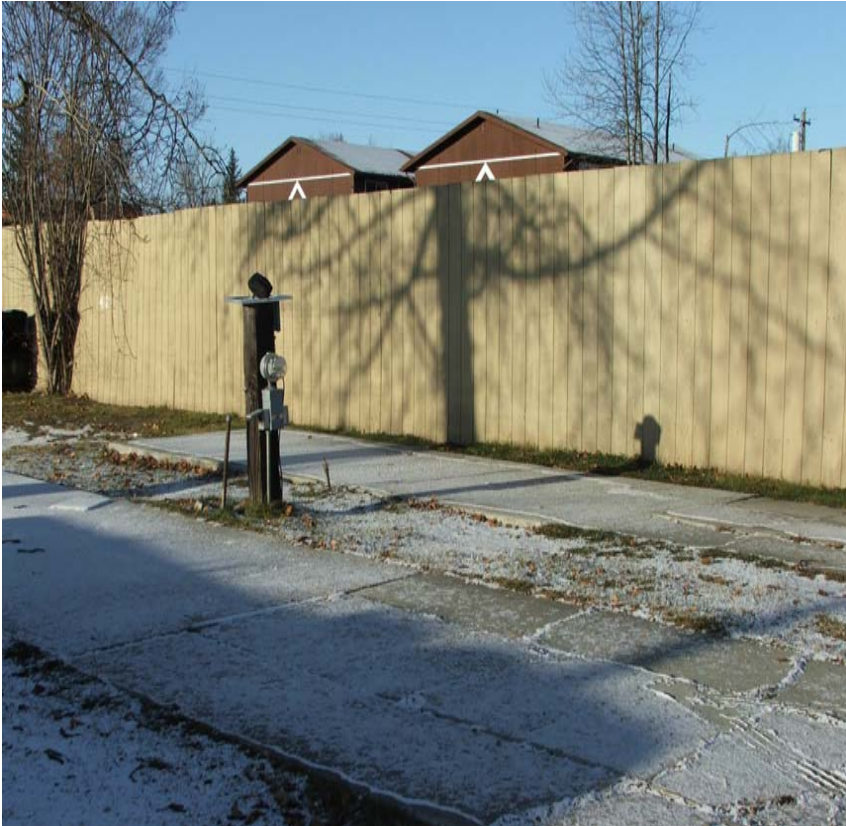
RV parking area, and electrical  
hook-up, facing north

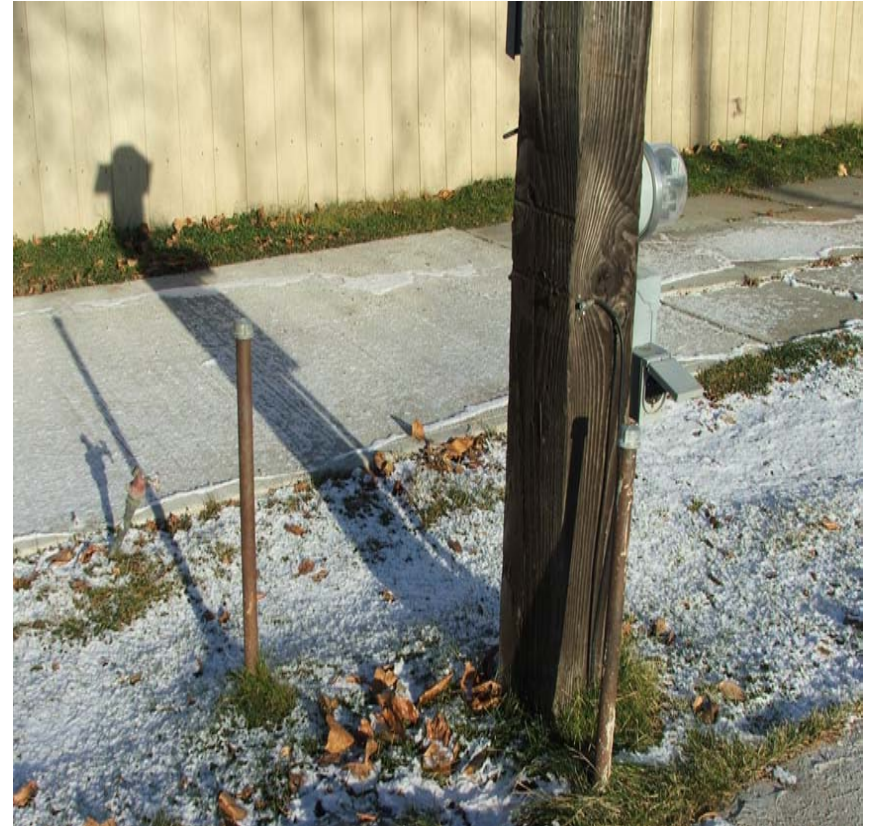
Close-up of concrete pads in RV  
parking area

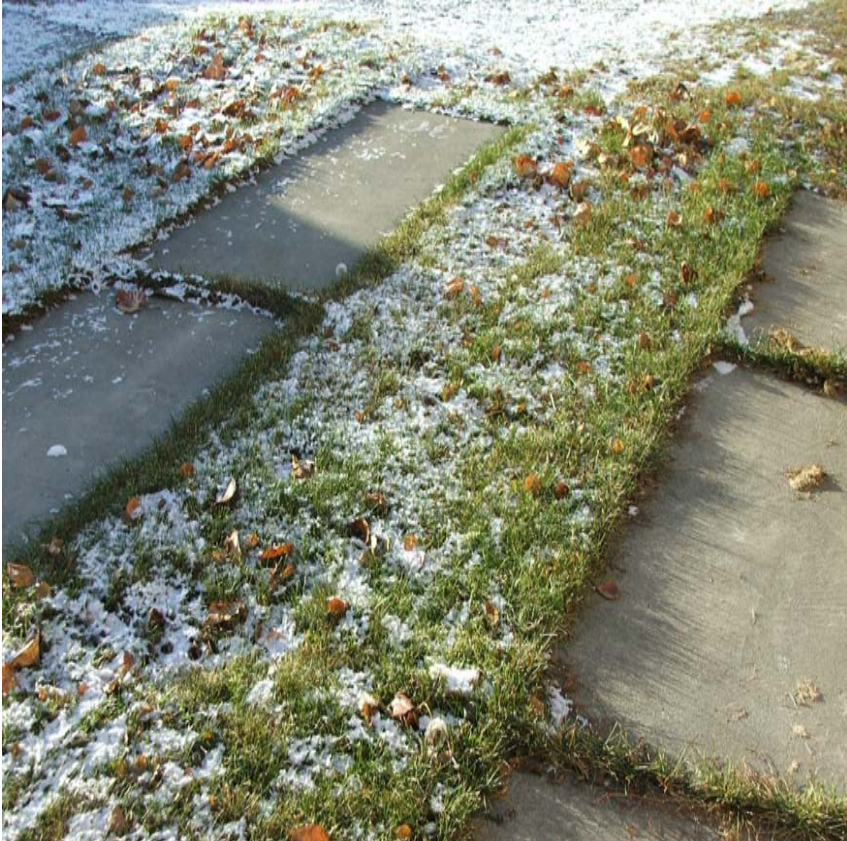
Concrete and grass RV parking  
areas

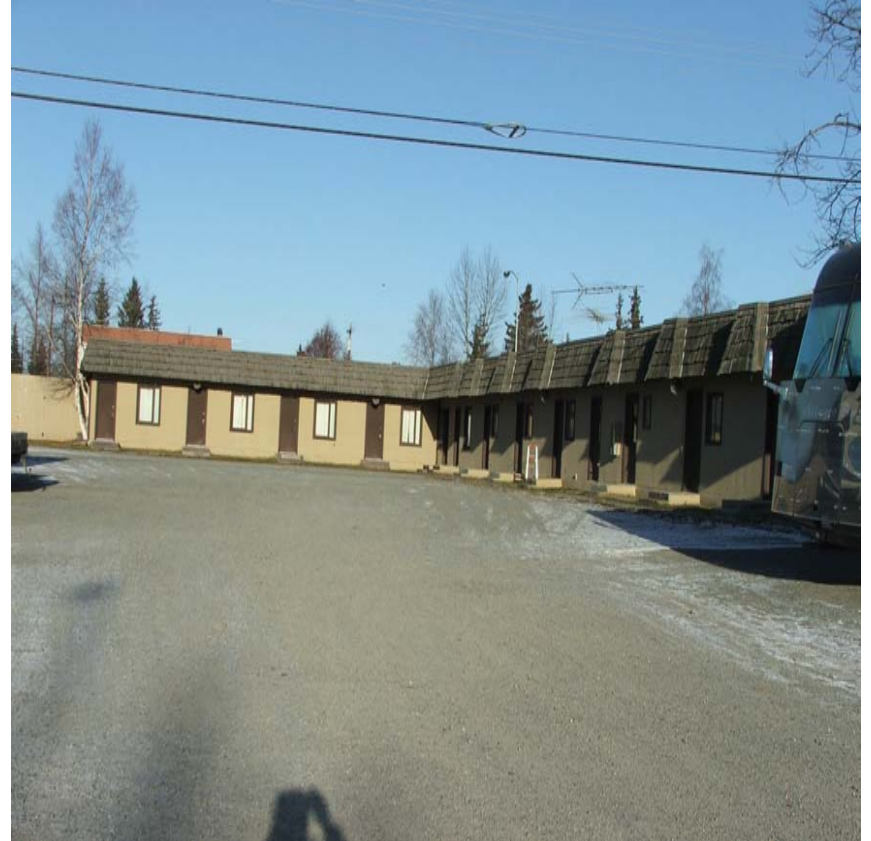
Motel building, facing north

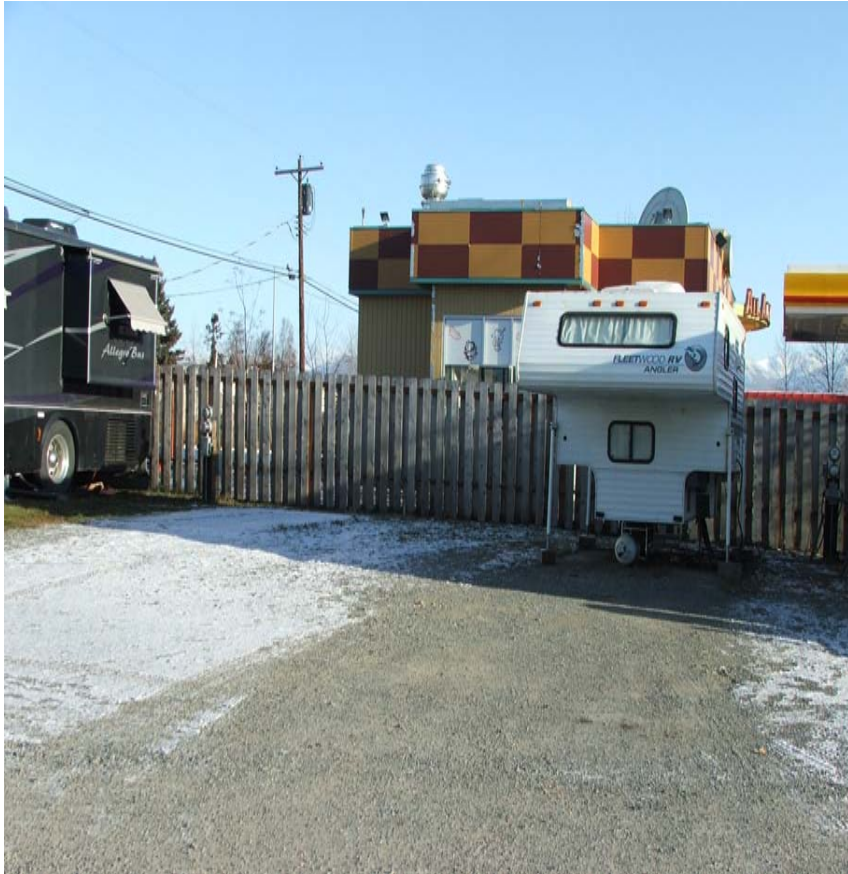
RV parking areas, facing east

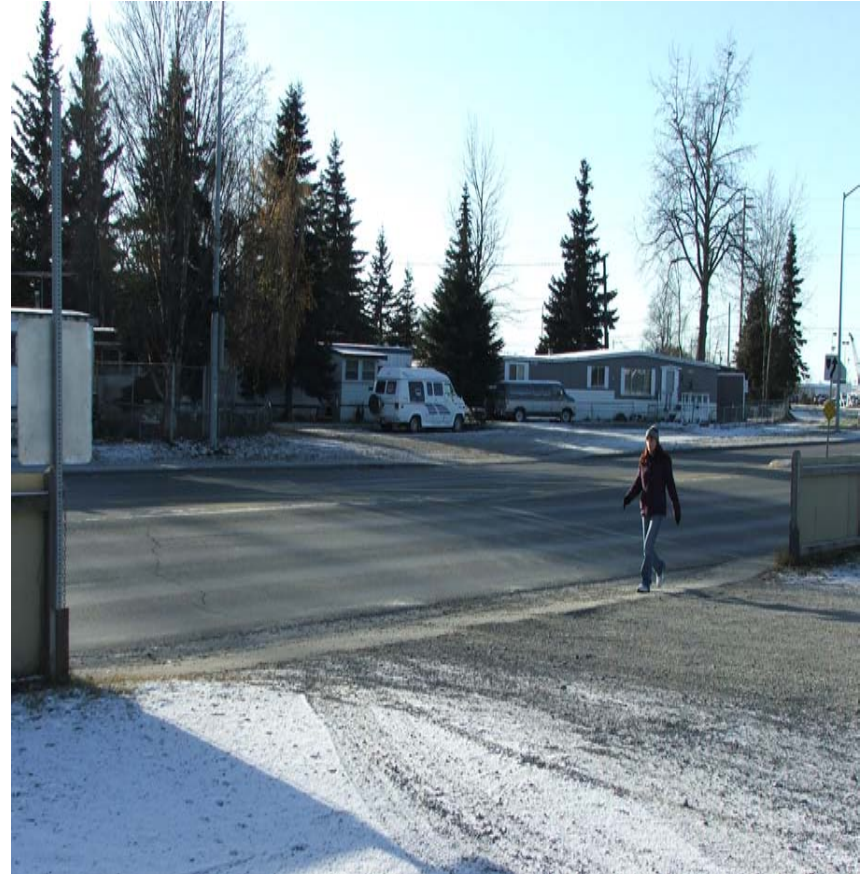
Entrance to property, facing  
Mountain View Drive

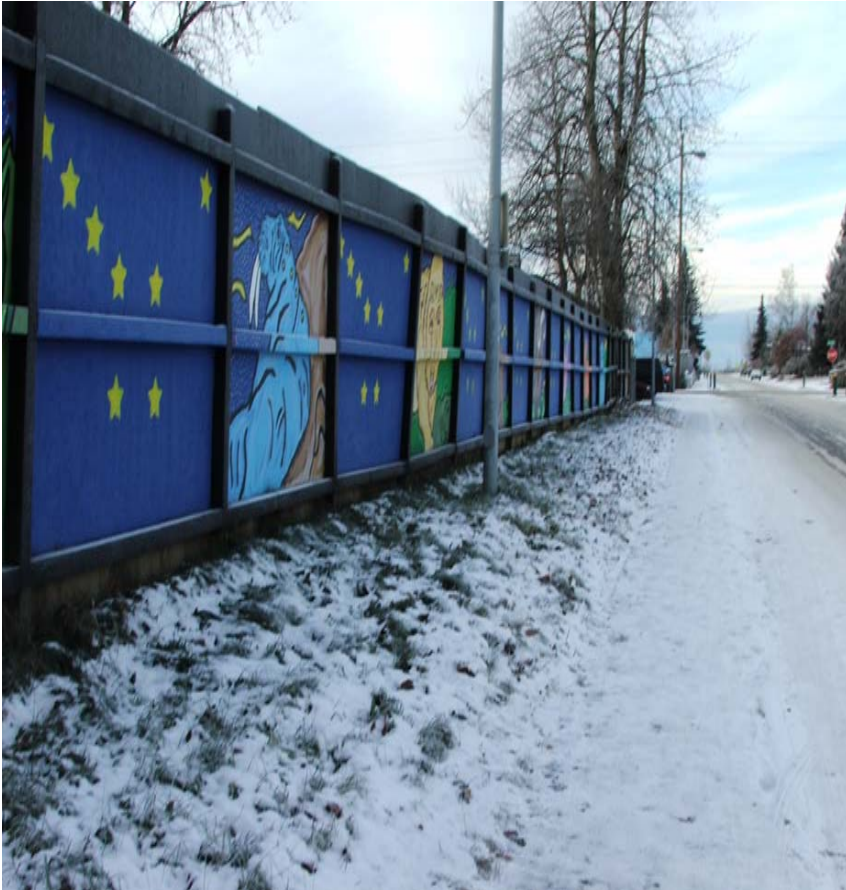
Opposite side of property fence, facing  
Richmond Avenue (north)

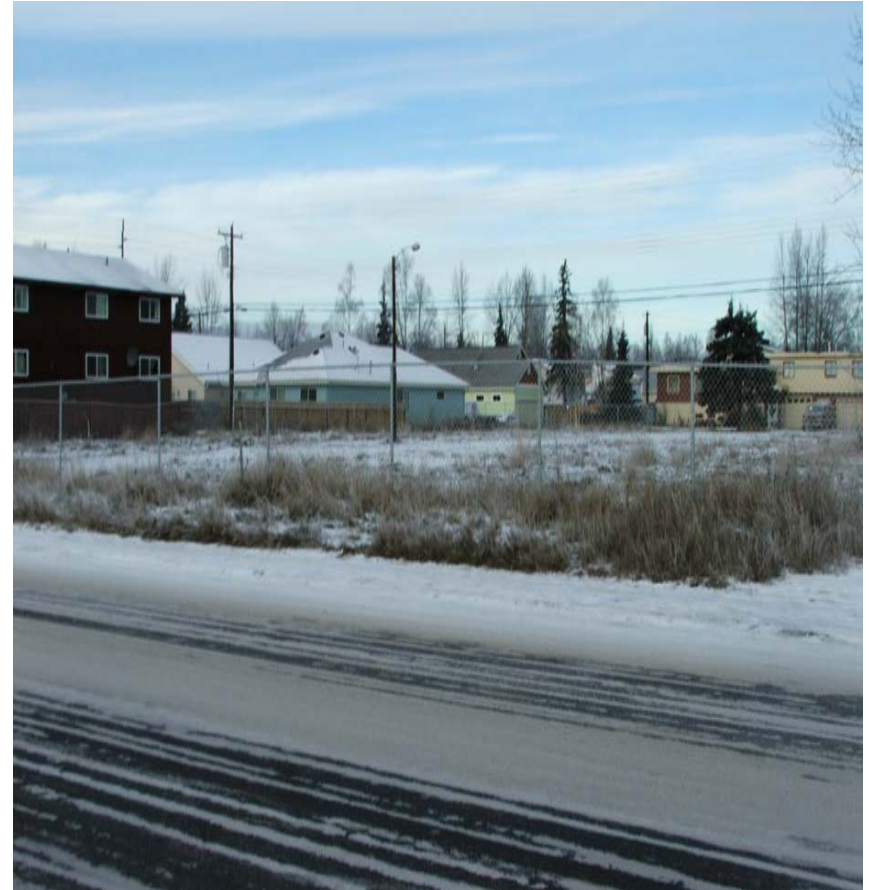
Neighboring property to the north,  
facing Richmond Avenue

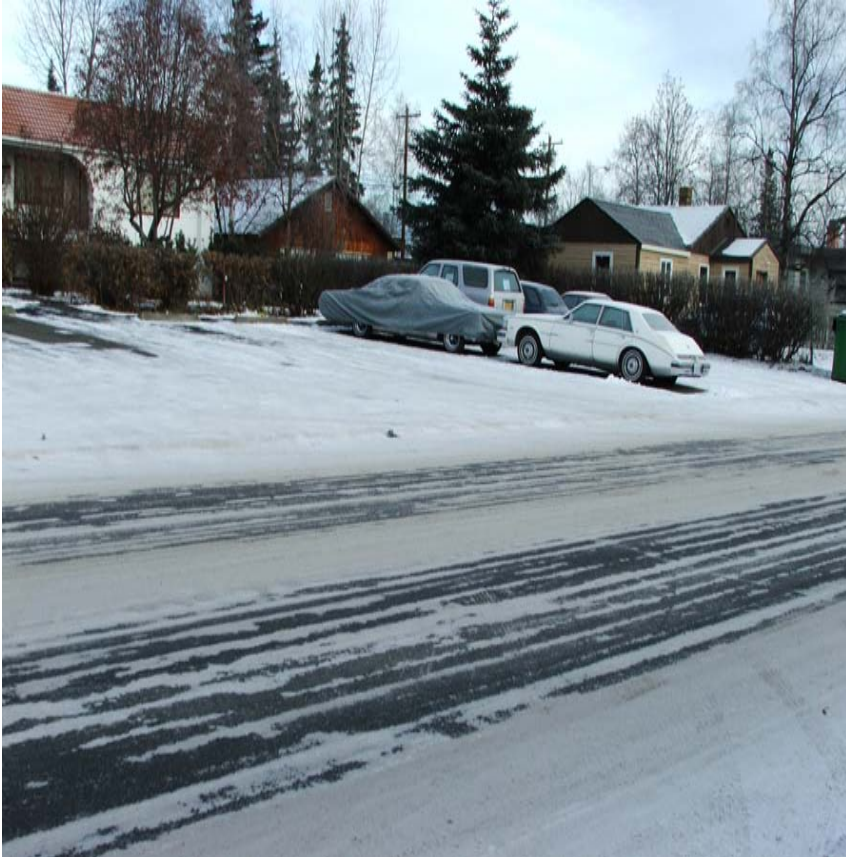
Residential properties north of  
John's Motel and RV Park, facing  
Richmond Avenue

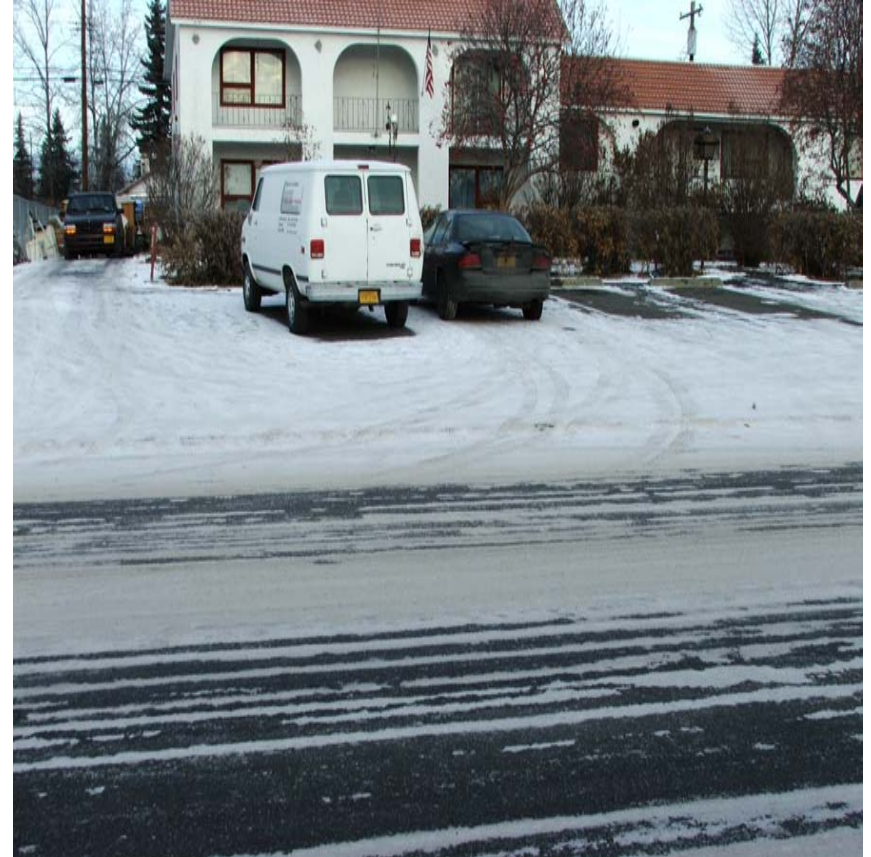
Residential property north of John's  
Motel and RV Park, facing  
Richmond Avenue
