**PHASE I ENVIRONMENTAL SITE ASSESSMENT
FOR
WILHOUR-WARNER TRUST
3300 AND 3340 MOUNTAIN VIEW DRIVE
ANCHORAGE, ALASKA**

Prepared for
ALASKA DEPARTMENT OF ENVIRONMENTAL CONSERVATION

**FINAL
FEBRUARY 2006**

Hoefler Consulting Group
3401 Minnesota Drive, Suite 300
Anchorage, Alaska 99503
Point of Contact: Peggy Yang
(907) 563-2132
ADEC SPAR Term Contract 18-9028-12

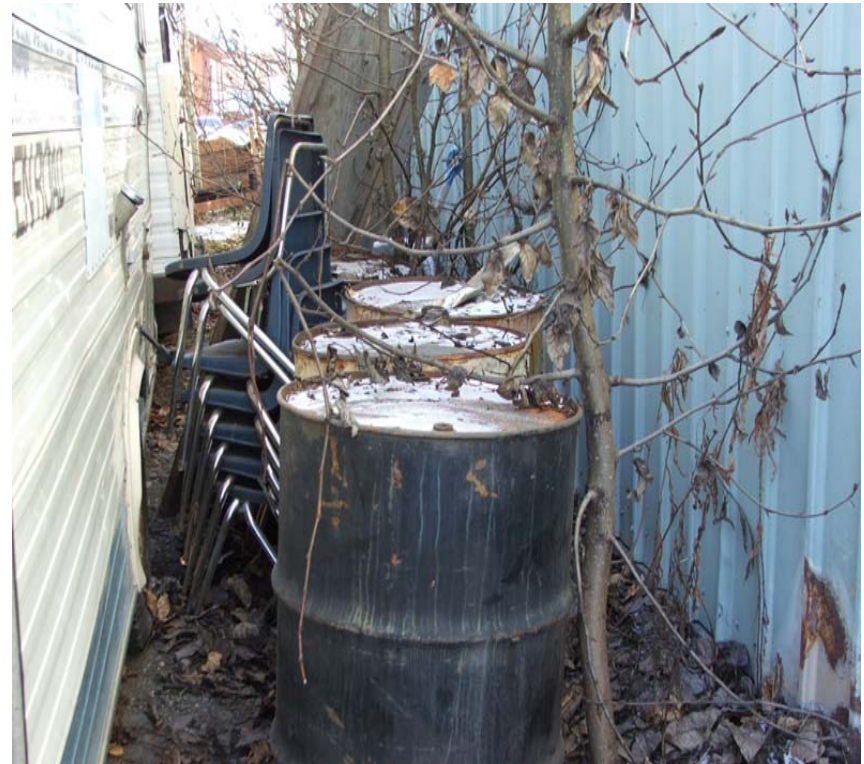
Open drums with liquids observed on south side of Coker's Machine Shop/D&M Auto.

Several
rusty 55-gal
DMS - one open
w/ liquid
no fuel
odors

Based on the findings of this ESA, further assessment is recommended at Wilhour-Warner at two localized areas: the open drums and the battery/waste pile prior to or in conjunction with property redevelopment efforts. Sampling of the contents of the drums for waste characterization purposes and disposal/recycling of the batteries and discarded antifreeze/liquids is recommended. Following removal of the discarded batteries/wastes and drums it is also recommended that surface and subsurface soil samples be collected to confirm that the contents did not leak into the surrounding soil. Contaminants of potential concern could include fuels/petroleum products, solvents and lead. Analytes selected for the confirmation soil samples collected beneath the drums should be determined based on the results of the waste characterization samples.

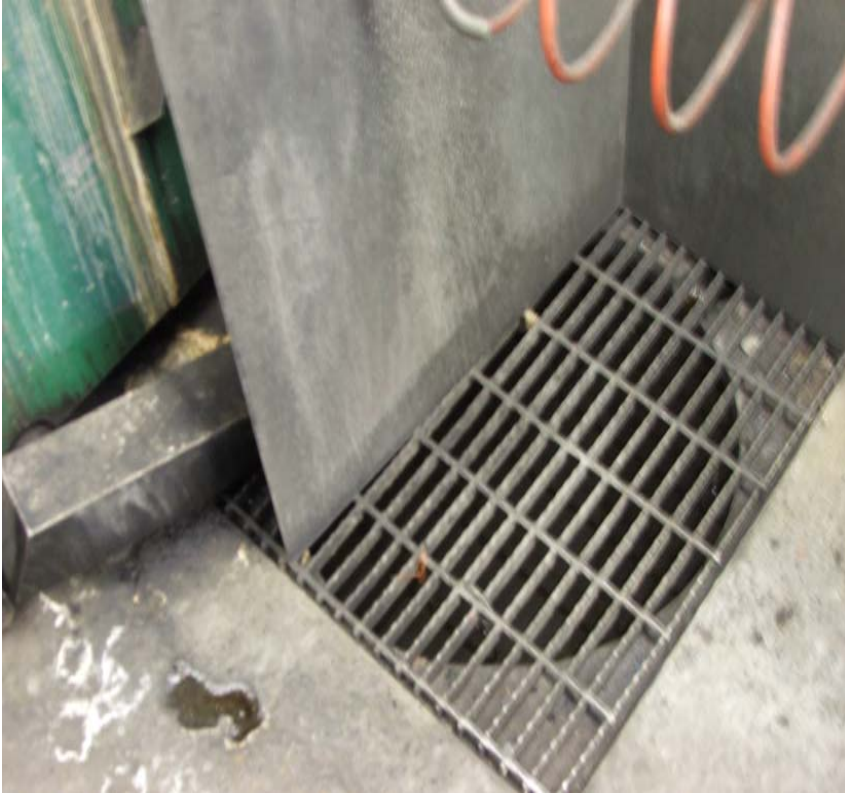
Coker's Machine Shop floor
drain to oil/water separator tank.

One floor drain observed near the parts washer tank - this is for fresh/gray water only and is connected to the oil/water separator tank.

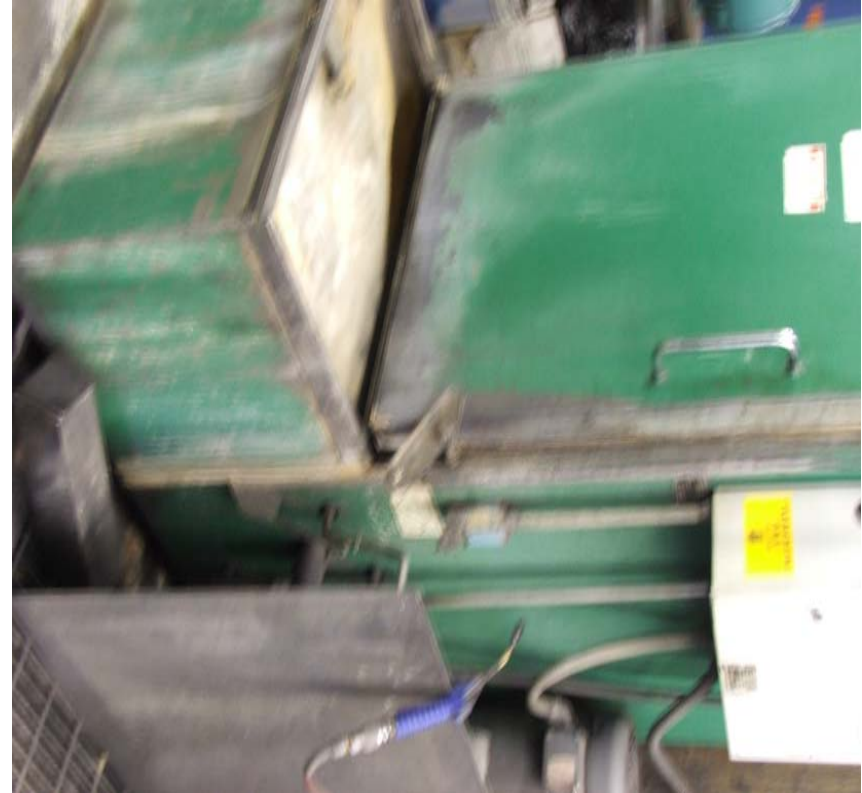
Enclosed parts washer
containing biodegradable (non-
chlorinated) detergent.

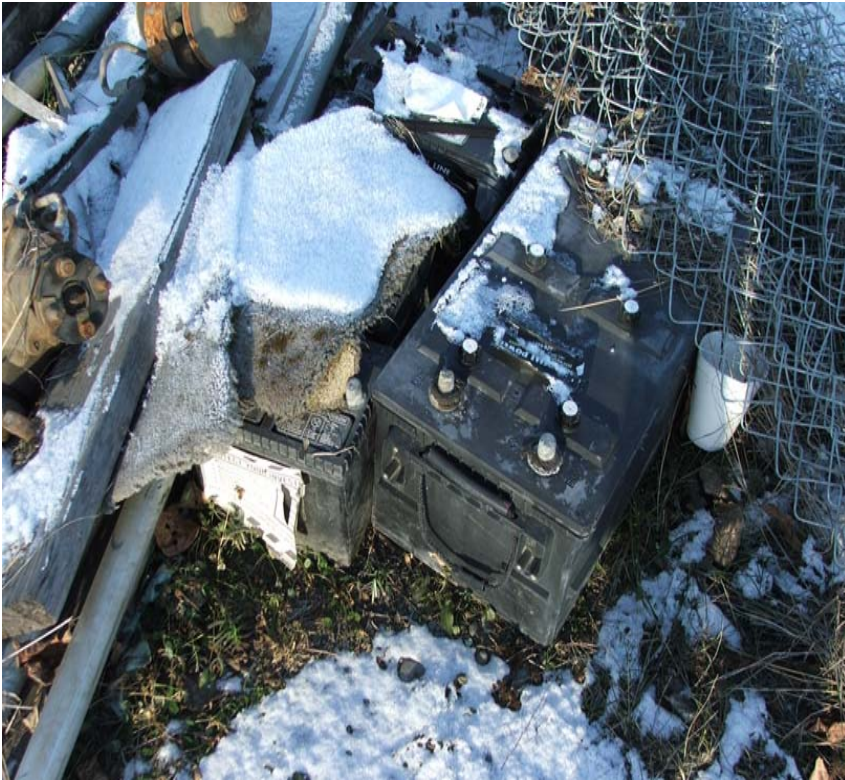
Discarded car batteries observed
south of the fenced empty lot.

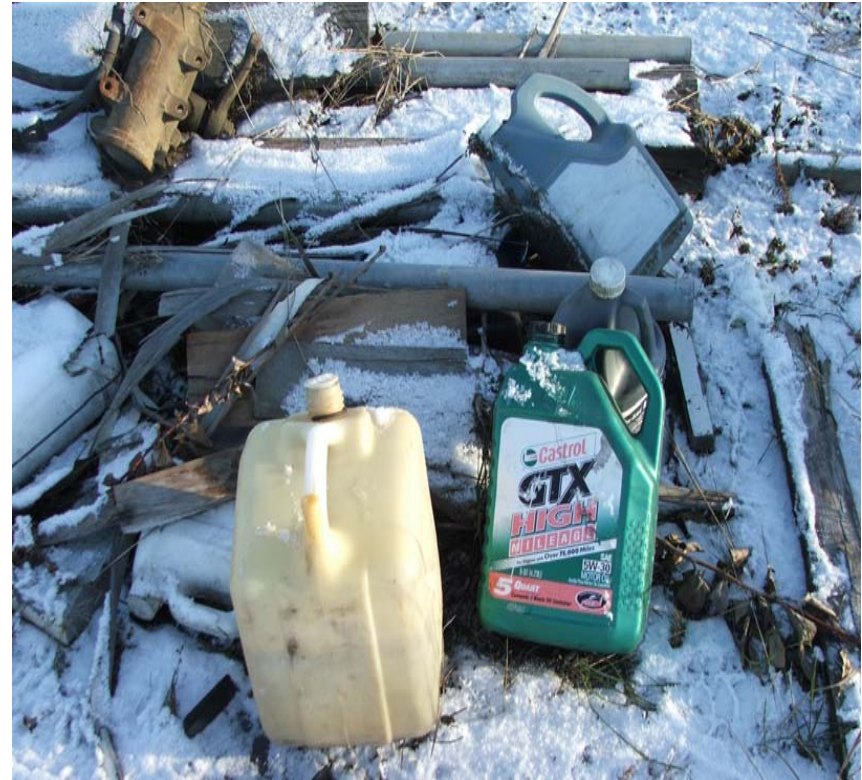
Discarded antifreeze and containers
with unknown liquids south of the
fenced empty lot.

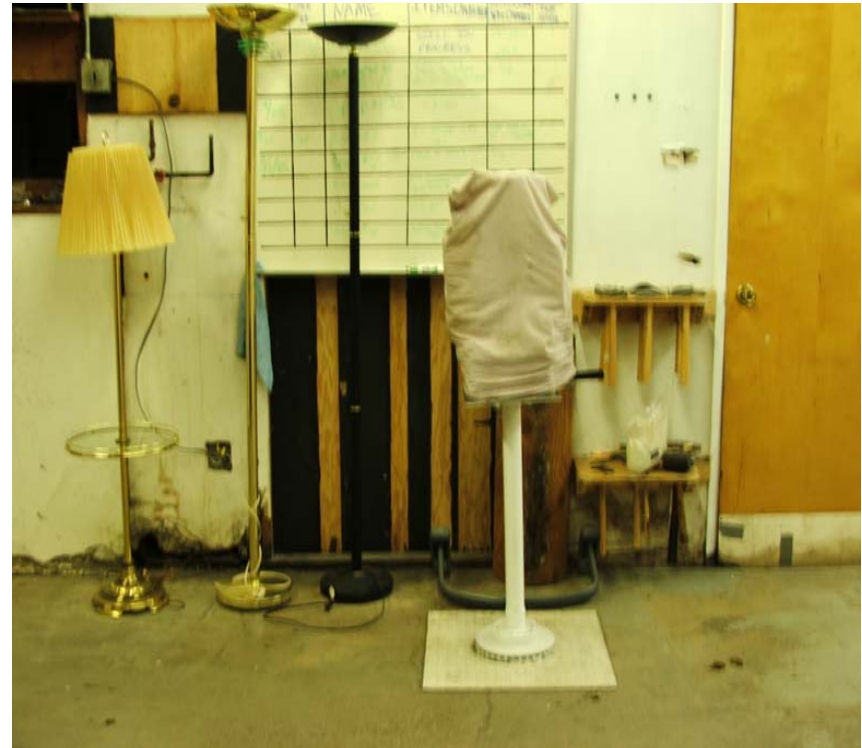
Interior wall of LFJ Manufacturing, note black staining at base of wall.

Several of the walls have visible damage
(sheetrock)
OR CORROSION likely from historical film chemical
spills ~~not~~ noted
faint odors in the
former
dark
rooms

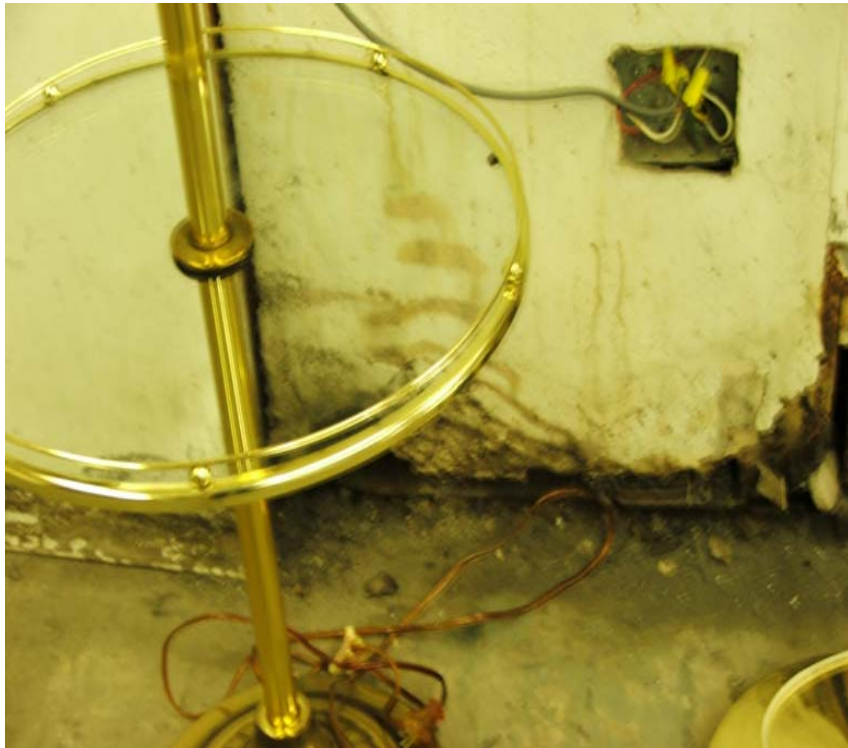
Interior wall of LFJ Manufacturing,
note staining and dry wall damage.

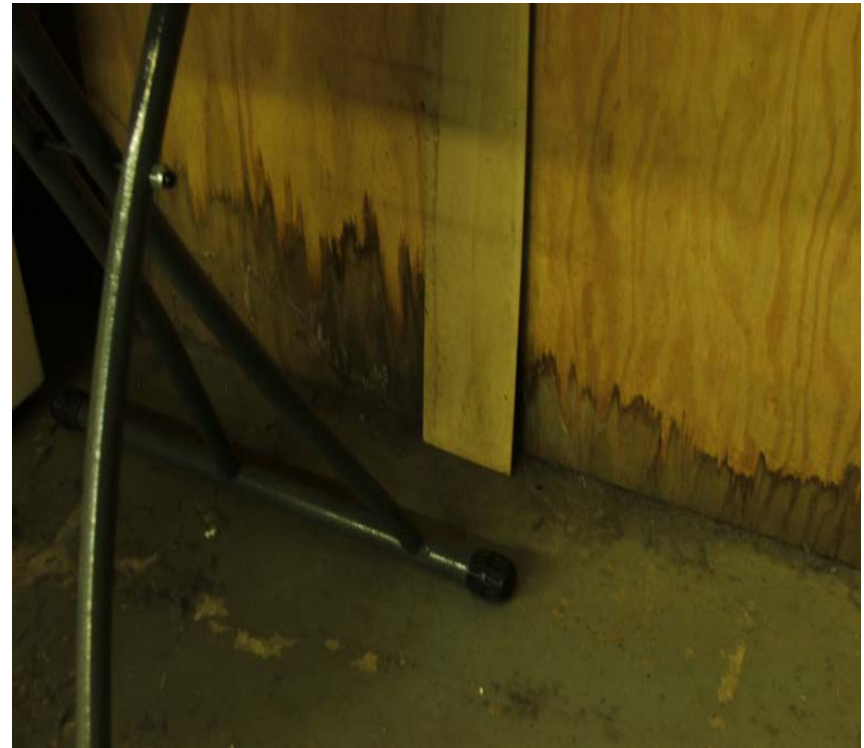
Interior wall (east side) of LFJ
Manufacturing, note staining at
base of wall.
