Site Assessment Pitkas Point School Site Pitkas Point, Alaska ADEC File ID: 2444.57.001

January 2016

Alaska Department of Environmental Conservation
Spill Prevention and Response
555 Cordova Street
Anchorage, Alaska 99501

By: Shannon & Wilson, Inc. 5430 Fairbanks Street, Suite 3 Anchorage, Alaska 99518

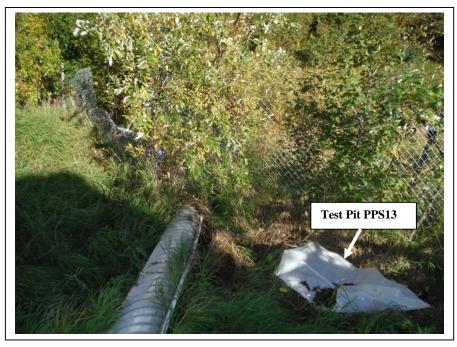
Photo 5: Looking east at the location of the PPS13 sample area west of Infiltration Gallery. (September 16, 2015)

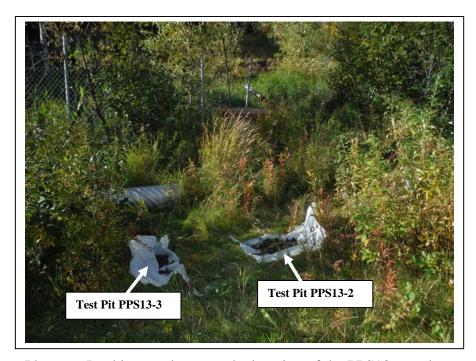
Photo 6: Looking northwest at the location of the PPS13 sample area east of Infiltration Gallery. (September 16, 2015)

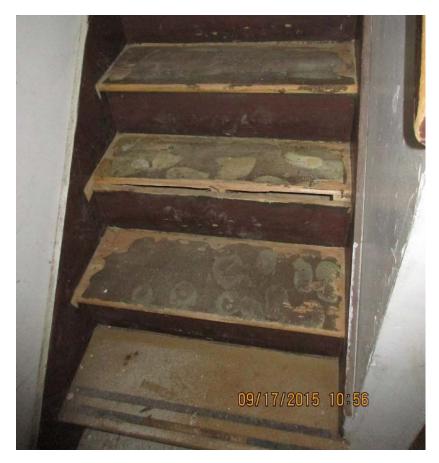
Example of damaged asbestos-containing stair treads at stairway that leads from the Kitchen to the Mechanical Room in the Main School Building.

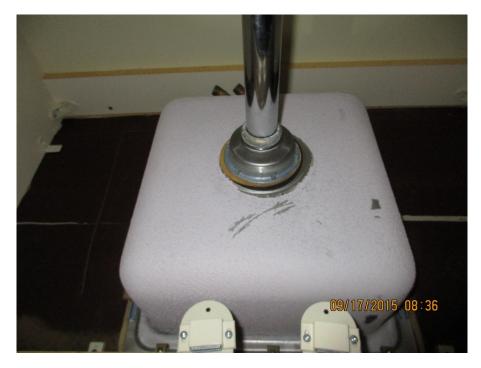
Typical stainless steel sink with asbestos-containing undercoating in the Main School Building.

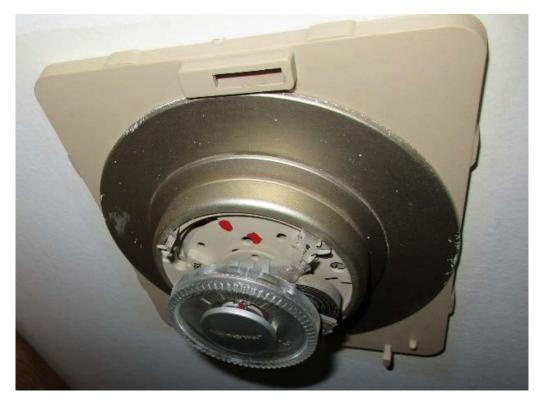
Typical example of a thermostat with a mercury filled ampule in the Main School Building.

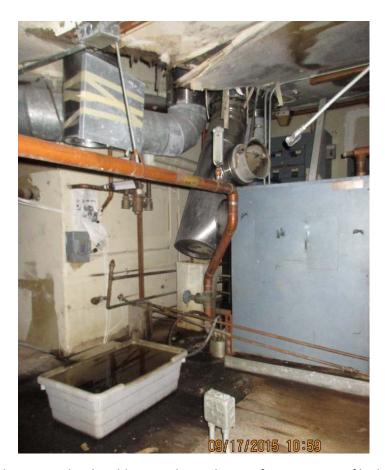
Damaged ceiling in the Main School Building Mechanical Room from active roof leaks above. Note bucket full of water that has overflowed causing more water damage.

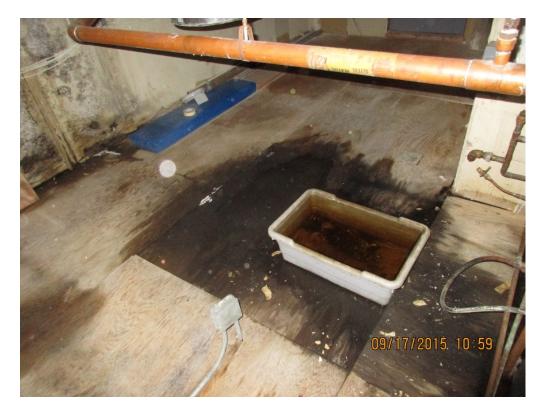
Bucket full of water in Mechanical Room. Water has overflowed causing damage to the floor and adjacent walls. The wall to the left in the photo leads to the large classroom at the southeast corner of the Main School Building which has water damage from these leaks. The Kitchen is directly below where more water damage has occurred from these leaks.

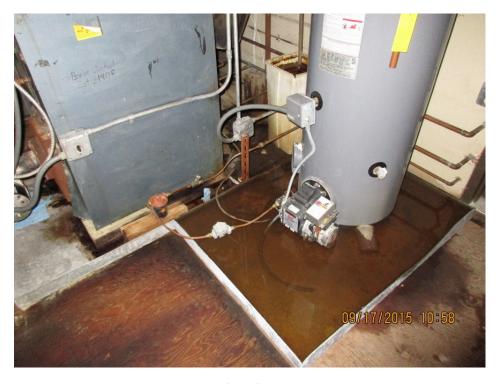
Drip pan and white trash can in the background full of water in Mechanical Room in the Main School Building. These have overflowed and caused water damage to surrounding walls and floor. The source of the water appears to be from the roof leak above.

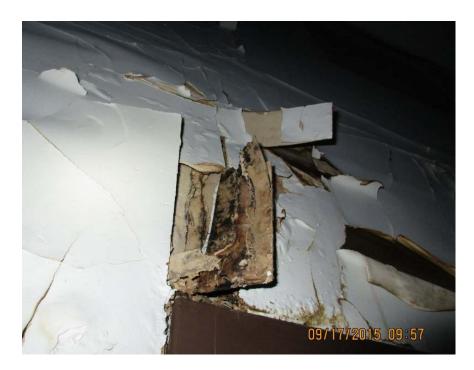
Close up of damaged wall above door leading to Kitchen in large classroom at southeast corner of Main School Building. Note the black mold and deteriorated gypsum board. The source of the water appears to be from the roof leak in the Mechanical Room above.

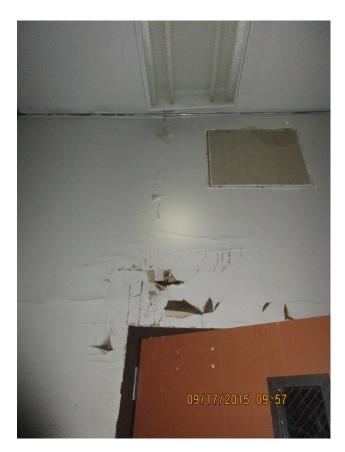
Damaged wall above door leading to Kitchen in large classroom at southeast corner of Main School Building. Note water staining and damaged gypsum board. The source of the water appears to be from the roof leak in the Mechanical Room above.

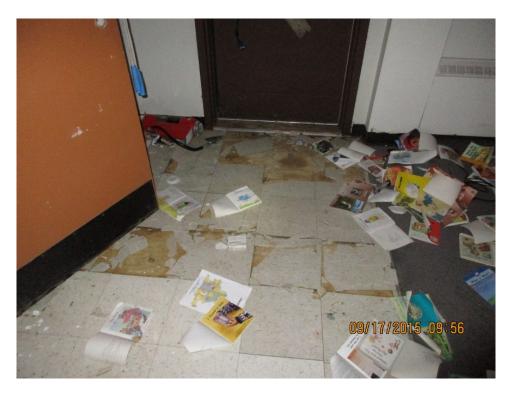
Example of damaged asbestos-containing floor tiles in the large classroom at the southeast corner of the Main School Building. Damage is caused by a combination of water damage, foot traffic, and abrasion from the doors being opened and closed.

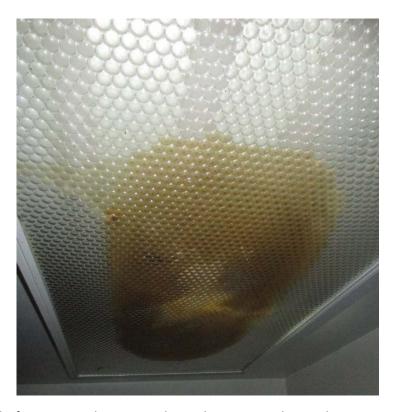
Water damaged light fixture in Kitchen area in large classroom at the southeast corner of the Main School Building. The source of water appears to be from the leaking roof and overflowing catch buckets in the Mechanical Room above.

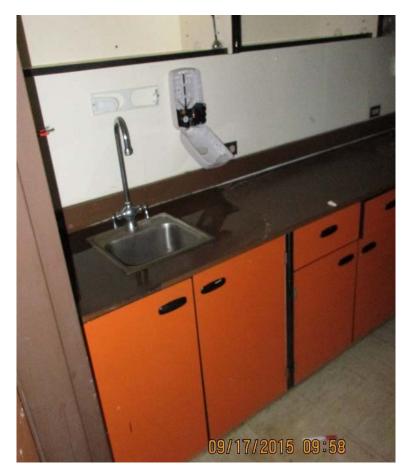
Standing water on countertop in Kitchen in the Main School Building. The source of the water appears to be from the roof leak in the Mechanical Room above.

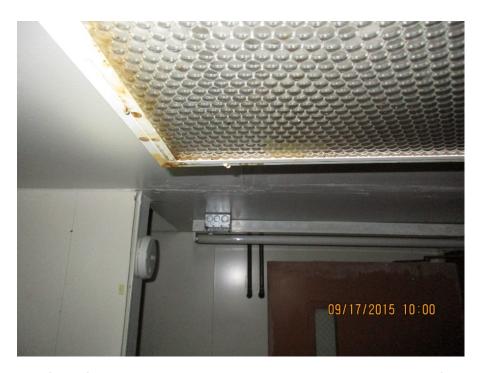
Water leaking out of light fixture in Kitchen in the Main School Building. The source of the water appears to be from the roof leak in the Mechanical Room above.

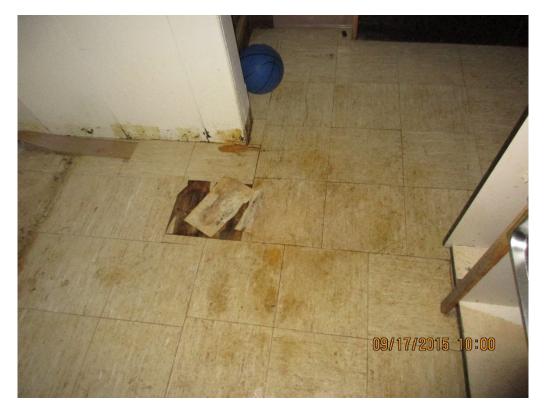
Non-asbestos floor tile damaged by water leaks from above in Kitchen. The source of the water appears to be from the roof leak in the Mechanical Room above.

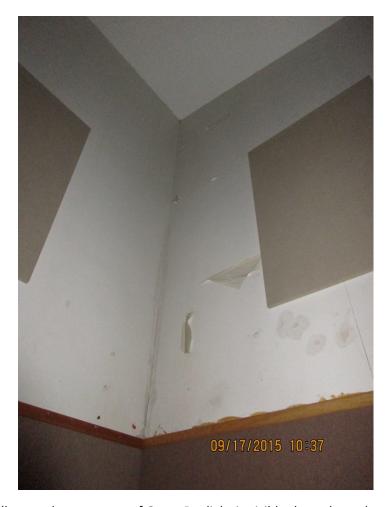
Water damaged wall at northeast corner of Gym. Daylight is visible through cracks at the wall/ceiling connection.

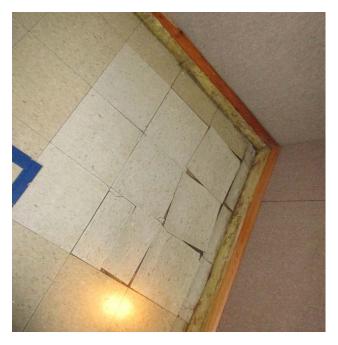
Example of damaged asbestos-containing floor tiles at the northeast corner of the Gym in the Main School Building. Damage is caused by water leak from above.

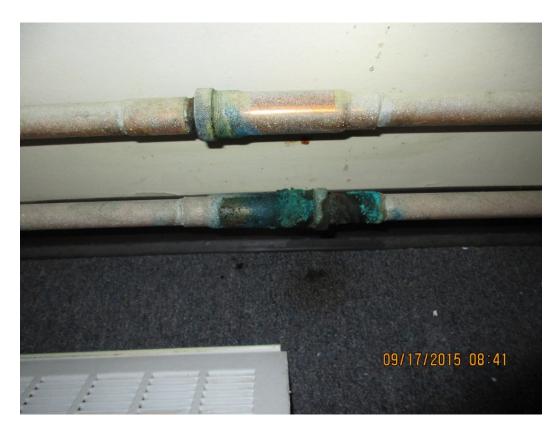
Evidence of past leaking heat piping in classroom on north side of Main School Building. Note water droplets on pipe.

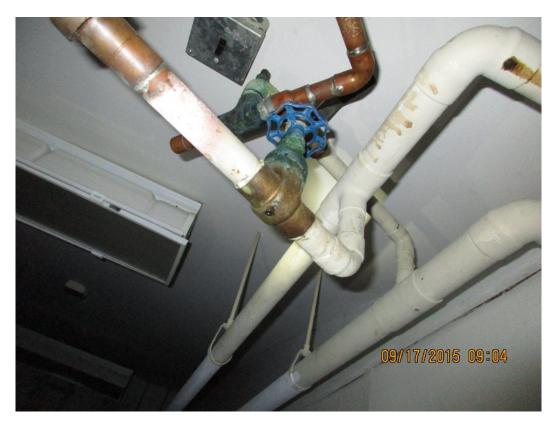
Further evidence of past leaking pipes in classroom on south side of Main School Building.

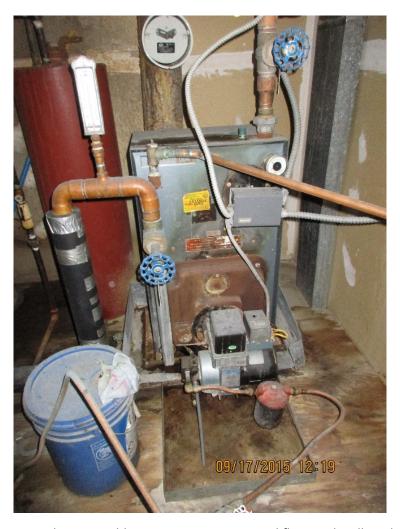
Small Mechanical Room in the 1984 addition. Note water stained floor and wall, and mineral build up on boiler flue. There did not appear to be an active leak at the time of inspection.

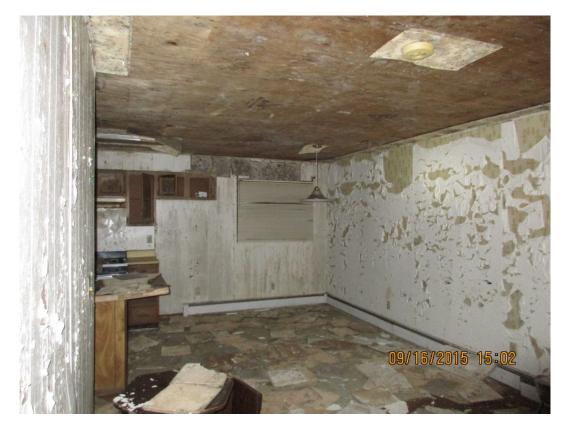
View of Living Room area in Teacher Housing Unit 1. Note extensive water damage and mold on virtually all surfaces.

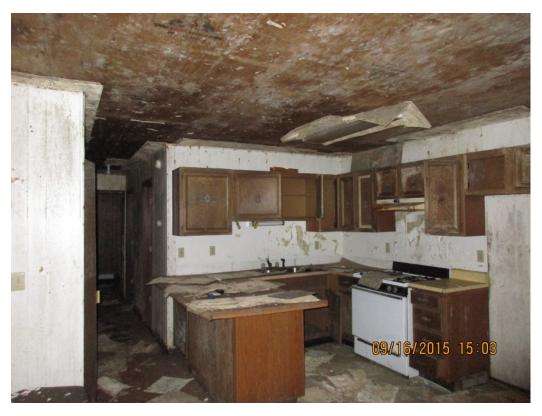
View of Kitchen in Teacher Housing Unit 1. Note extensive water damage and mold on virtually all surfaces.

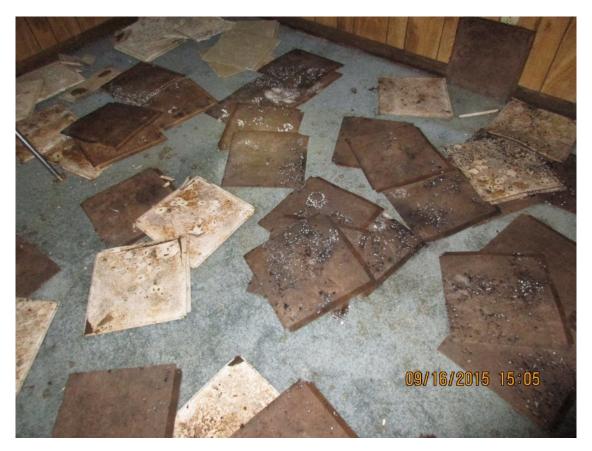
Typical bedroom in Teacher Housing Unit 1 with water damaged and moldy ceiling tiles and other surfaces.

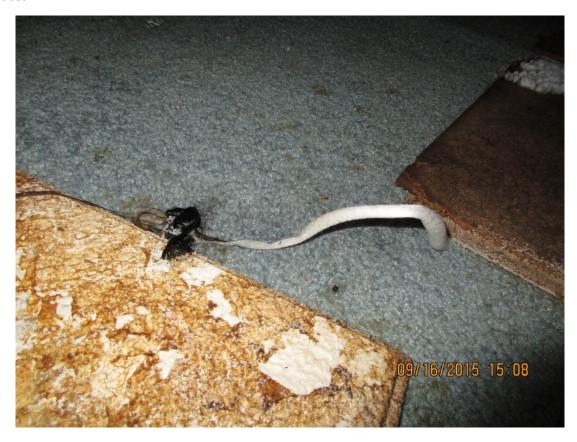
Mushroom growing out of floor with mold on ceiling tile in a bedroom in Teacher Housing Unit 1.

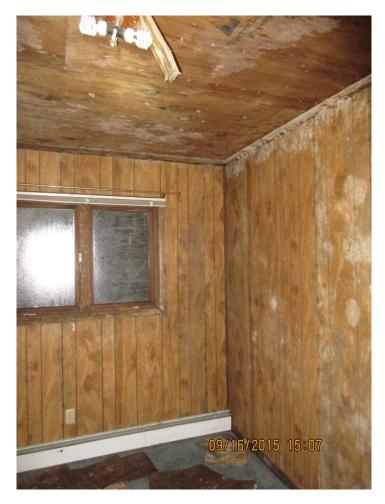
Water damaged floors, walls, and ceiling with mold in a bedroom in Teacher Housing Unit 1. Note moisture on the inside face of the window glass.

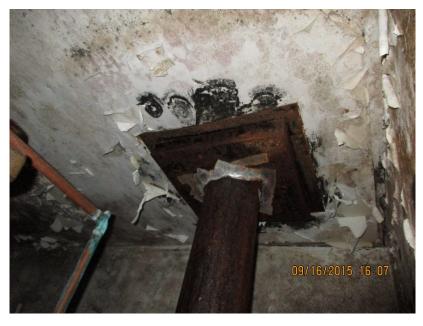
Water damaged ceiling and walls with mold at boiler flue in Teacher Housing Unit 1.

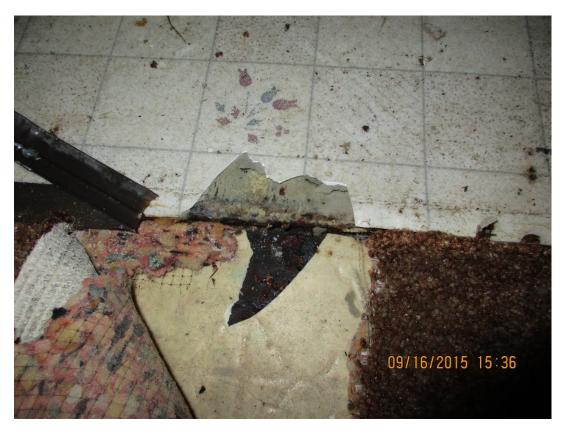
Looking under sheet vinyl in Teacher Housing Unit 1. Note plywood subfloor saturated with water.

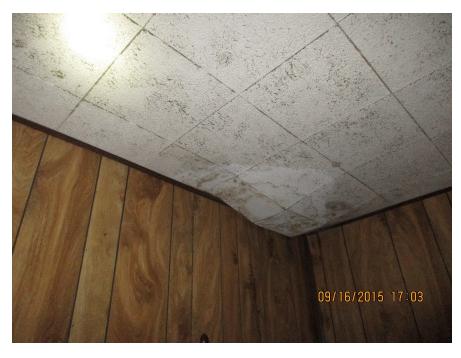
Water damaged ceiling in a bedroom in Teacher Housing Unit 2. Note mold growth on ceiling tiles and walls.

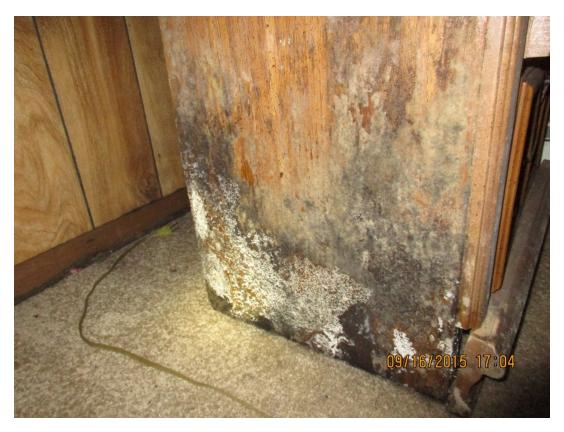
Water damage and fungal growth on loose furniture in Teacher Housing Unit 2.

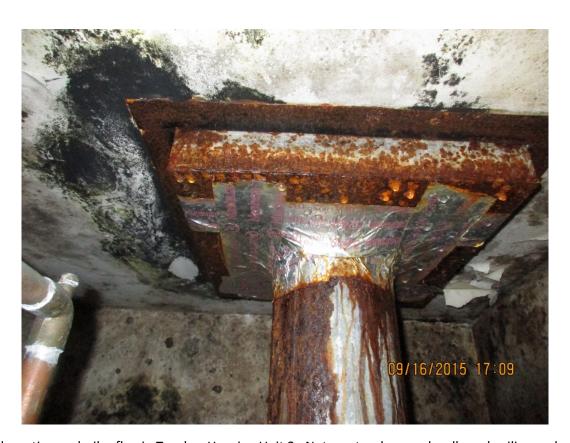
Condensation on boiler flue in Teacher Housing Unit 2. Note water damaged walls and ceiling and mold.

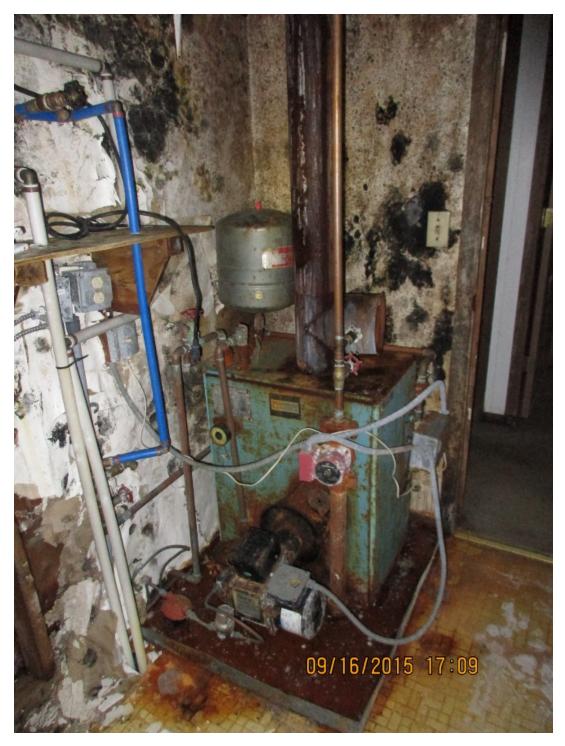
Boiler in Teacher Housing Unit 2. Note boiler drip pan is full of water, water damage to floors, walls, and ceiling, and the extensive mold growth.

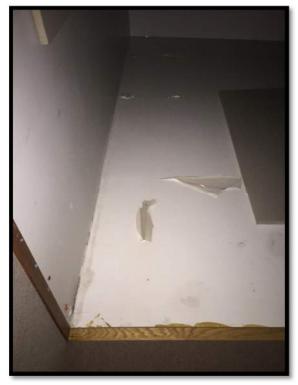
17. Water Damage at Wall of NE Corner of Gymnasium

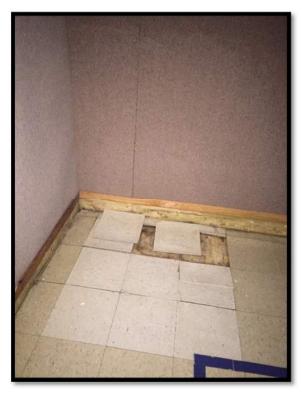
18. Water Damage at Floor of NE Corner of Gymnasium

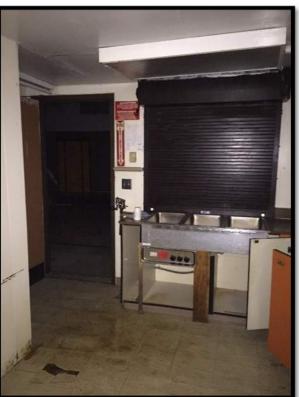
20. Active Leak at Ceiling of Kitchen

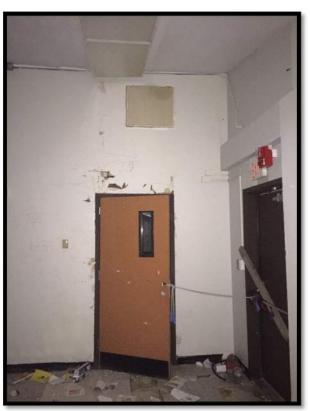
22. Water Damage at NE Corner of Academic Room

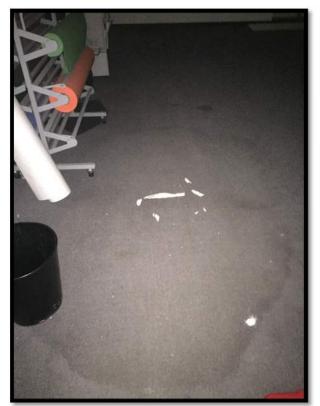
27. Water Stain at Corridor 103

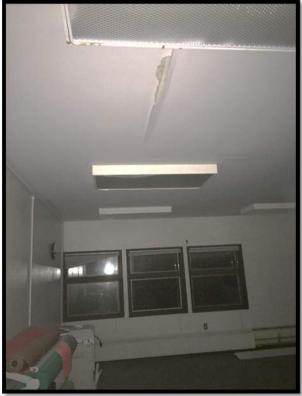
28. Ceiling Water Damage at Corridor 106

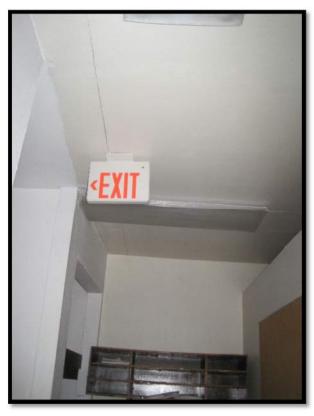
29. Ceiling Sheetrock Damage at Library Entry

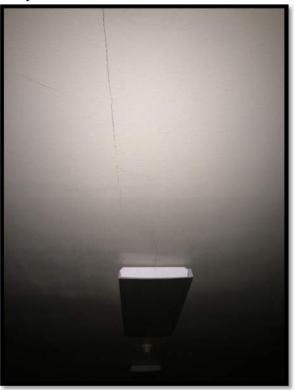
31. Ceiling Sheetrock Damage at North Half of Library
