Property Assessment and Cleanup Plan
Mile 13-14 Copper River Highway

Cordova, Alaska

Submitted to: Department of Environmental Conservation Reuse and Redevelopment Program

> By: Shannon & Wilson, Inc. 5430 Fairbanks Street, Suite 3 Anchorage, Alaska 99518

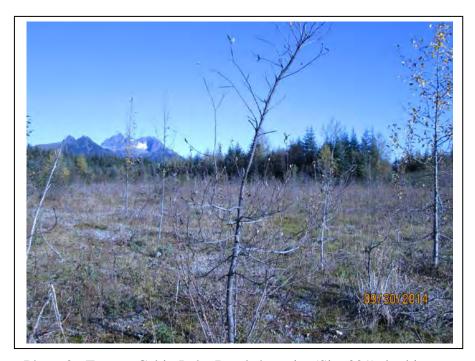
PHOTOS 1 AND 2

Photo 2: Former Cabin Lake Road shop site (Site 021), looking northeast. (September 30, 2014)

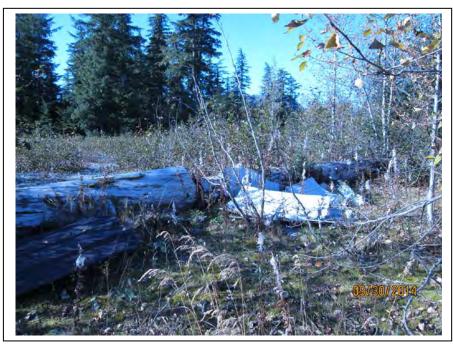
PHOTOS 3 AND 4

Photo 3: Creosote-treated logs blocking off the former Cabin Lake Road shop site (Site 021), looking southwest. (September 30, 2014)

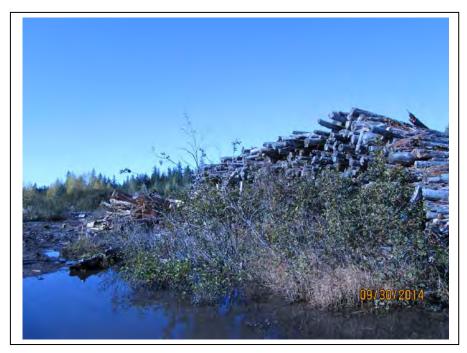
Northeast of the former Cabin Lake Road shop site is the "log pile" (Photo 3, Site 019). According to Ms. Patton, this is popular location for illegal dumping of animal carcasses. Several moose carcasses were observed during the site visit (Photo 5). Remnants of metal culverts, a refrigerator, and a stove were also observed in the Cabin Lake Road Area and are identified as Sites 020 and 025 (Photos 6 and 7). No evidence of leaks and/or spills associated with the Cabin Lake Road sites was observed.

Photo 4: The "log pile" near Cabin Lake Road (Site 019), looking north. (September 30, 2014)

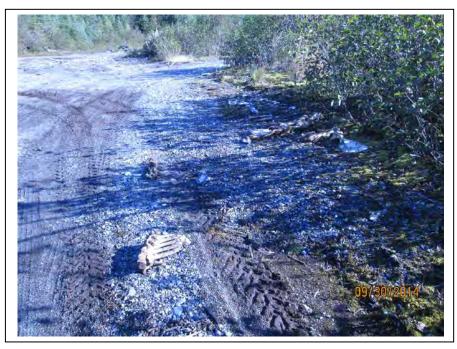
PHOTOS 5 AND 6

Photo 5: Moose carcasses near the "log pile" (Site 019), looking east. (September 30, 2014)

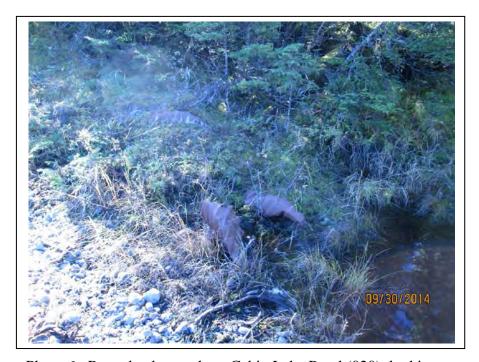
Photo 6: Rusted culverts along Cabin Lake Road (020), looking northwest. (September 30, 2014)

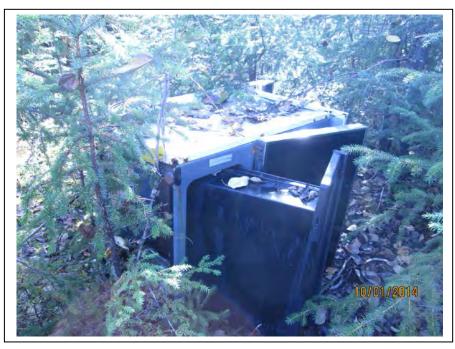
PHOTOS 7 AND 8

Photo 7: Refrigerator and stove near Cabin Lake Road (Site 025), looking east. (October 1, 2014)

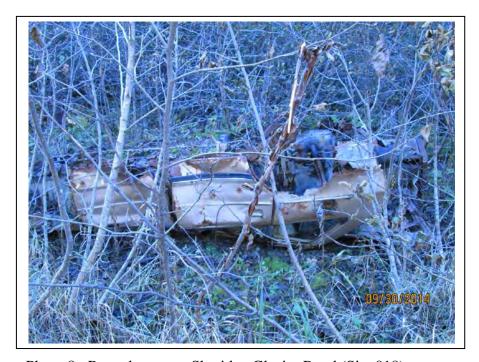
Photo 8: Rusted car near Sheridan Glacier Road (Site 018), looking southwest. (September 30, 2014)

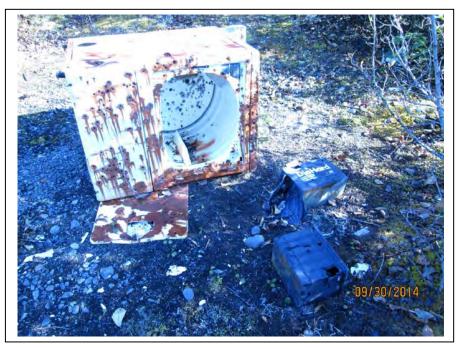
PHOTOS 9 AND 10

Photo 9: Washing machine and batteries near Sheridan Glacier Road (Site 017), looking northwest. (September 30, 2014)

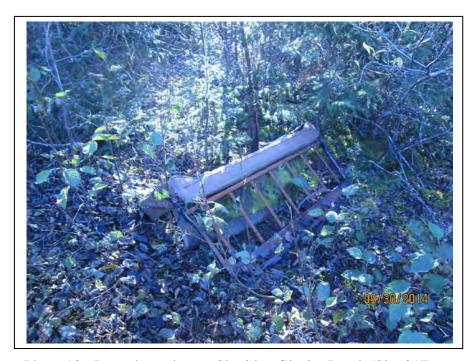
Photo 10: Rusted couch near Sheridan Glacier Road, (Site 017), looking southwest. (September 30, 2014)

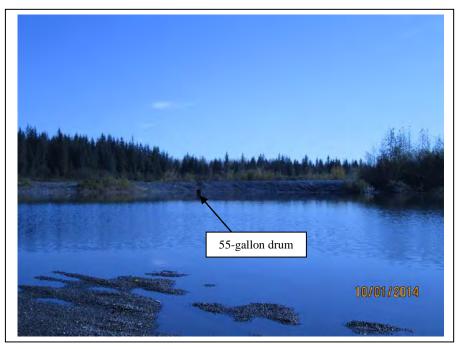
PHOTOS 11 AND 12

Photo 11: A 55-gallon drum in flooded gravel pit near Sheridan Glacier Road (Site 028), looking southeast. (October 1, 2014)

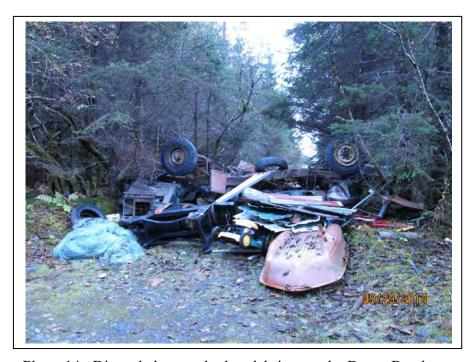
PHOTOS 13 AND 14

Photo 14: Discarded car and other debris near the Dump Road (Site 006), looking northeast. (September 29, 2014)

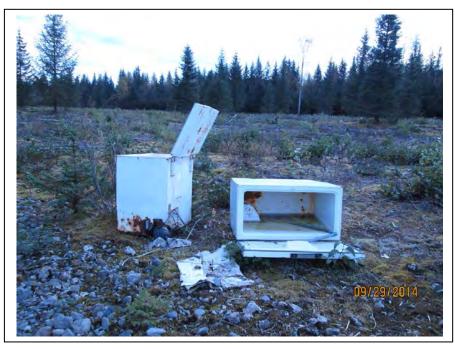
PHOTOS 15 AND 16

Photo 15: Discarded freezers in moose habitat area near the Dump Road (Site 007), looking south. (September 29, 2014)

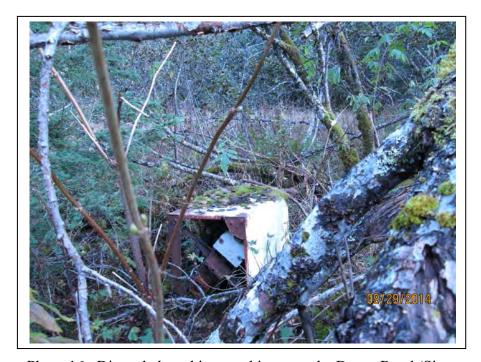
Photo 16: Discarded washing machine near the Dump Road (Site 008). (September 29, 2014)

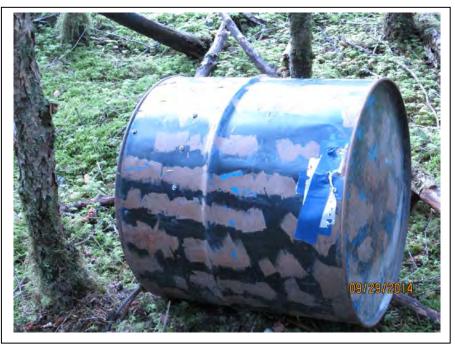
PHOTOS 17 AND 18

Photo 17: Drum observed near the Dump Road (Site 009). (September 29, 2014)

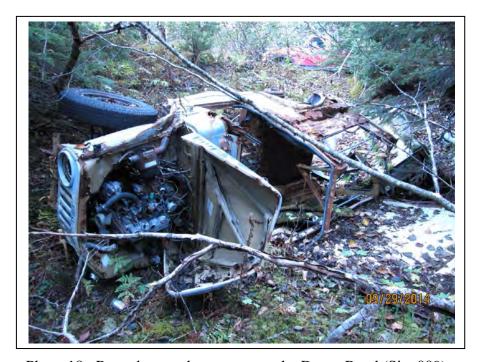
Photo 18: Rusted car and camper near the Dump Road (Site 009), looking west. (September 29, 2014)

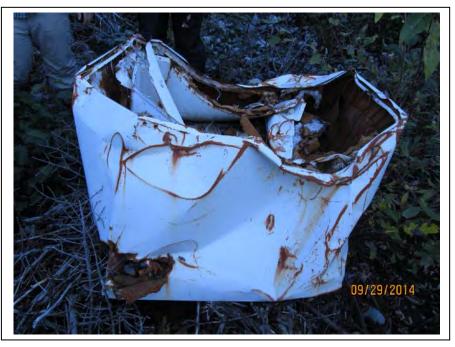
PHOTOS 19 AND 20

Photo 19: Discarded freezer near the Dump Road (Site 012). (September 29, 2014)

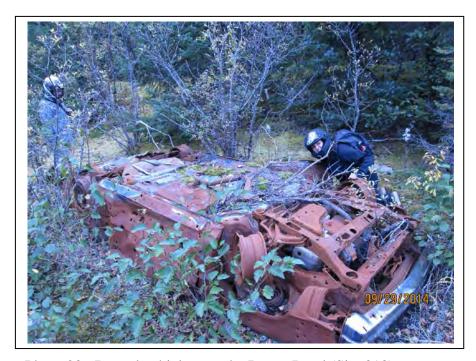
Photo 20: Rusted vehicle near the Dump Road (Site 013). (September 29, 2014)

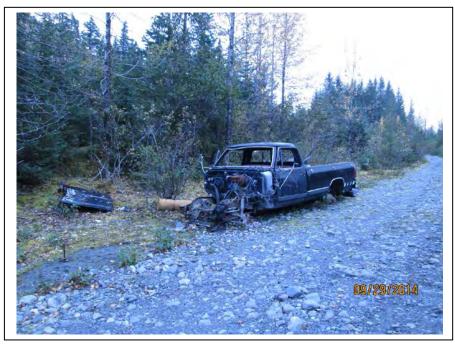
PHOTOS 21 AND 22

Photo 21: Discarded truck near the Dump Road (Site 014), looking northeast. (September 29, 2014)

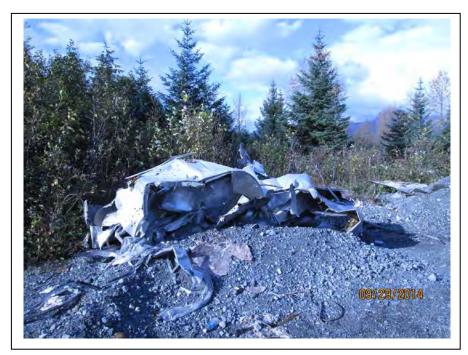
Photo 22: Scrap metal near Boulder Alley (Site 010), looking north. (September 29, 2014)

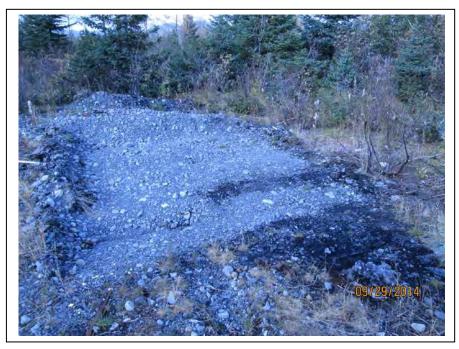
PHOTOS 23 AND 24

- Analytical soil and water samples were not collected as part of this assessment.
 Therefore, there is no definitive evidence regarding the presence or absence of contamination on the Property.
- Notable staining was observed at Site 010. The extent of contamination associated with the release is unknown.
- Several empty drums were observed during the site visit. It is unknown if these drums were originally full and, if so, the contents of each drum.
- Former military use has been reported; however no evidence of bunkers or military uses were observed during our 2014 site visit.

Photo 23: Stained soil near Boulder Alley (Site 010), looking north. (September 29, 2014)

Data gaps identified at the Property are described in Section 5.2. While some of the data gaps are a result of areas requested by NVE to not be included as part of the Property evaluation, the effect of those sources if contamination extends onto other areas of the Property remains unknown. In addition, debris remains on the Property and no analytical samples have been collected. Staining was observed at one site and there may be further indication of a release upon removal of the debris. Additional information may necessary to confirm the presence and/or magnitude of the contamination associated with these data gaps, including sampling the staining at Site 010 and sampling the potential staining revealed during debris removal.

The presumed remedy for this site is removal and disposal of the debris. "Junk" vehicles may be disposed of at the landfill provided fluids have been drained and hazardous materials including the batteries, radiator, and air conditioner have been removed. These materials are collected by the landfill, but are transported to an Outside disposal facility. The need and scope of the remedial action would be defined based on the results of additional site characterization, including characterization of the staining at Site 010.

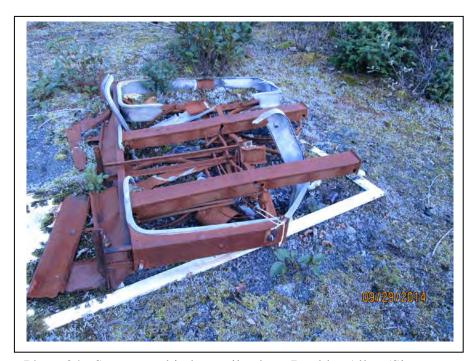
Photo 24: Scrap metal in burn pile along Boulder Alley (Site 011). (September 29, 2014)

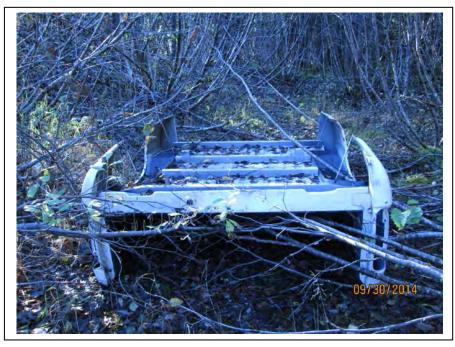
PHOTOS 25 AND 26

The Dump Road extends northeast from the Copper River Highway to the Cordova Mile 17 Landfill (See Figures 2 and 5). The Dump Road area is largely forested with clear cut areas to create additional moose habitat (Photo 12). ATV trails run throughout the area, starting from the Copper River Highway and the Dump Road (Photo 13). Eleven illegal dump sites were identified in the vicinity of the Dump Road (Sites 006 though 016). These sites contained abandoned vehicles, freezers, empty drums, household trash, scrap metal, and burn piles (Photos 14 through 26). Debris was used for target practice at two of these sites (Sites 010 and 013). Household trash was observed throughout the area. Burn piles and scrap metal were observed along Boulder Alley at Sites 010 and 011 (Photos 22 and 24). Stained soil was observed at Site 010 (Photo 23). A part of a rusted car and a burn pile were found along John Gorsch Road at Sites 015 and 016 (Photos 25 and 26).

Photo 25: Part of a discarded vehicle along John Gorsch Road (Site 015), looking south. (September 30, 2014)

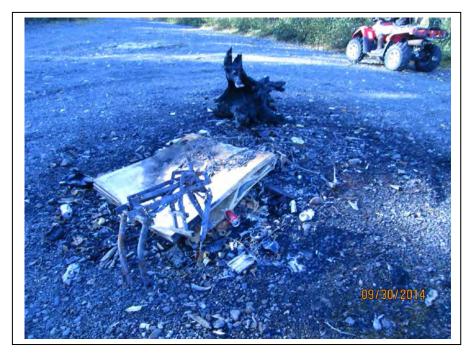
Photo 26: Scrap metal in burn pile along John Gorsch Road (Site 016), looking south. (September 30, 2014)
