PROPERTY ASSESSMENT AND CLEANUP PLAN

COPPER VALLEY SCHOOL TAZLINA, ALASKA

Submitted to: Department of Environmental Conservation Reuse and Redevelopment Program

> By: Oasis Environmental, Inc. May 19, 2010

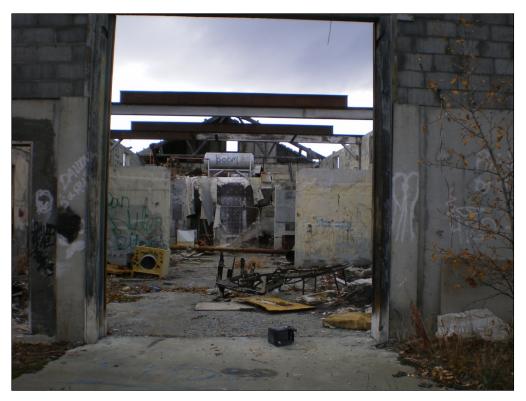
A 1989 asbestos assessment documented the presence of asbestos insulation in the boiler room (Environmental Management Inc. 1989). During the site visit, OASIS observed potential asbestos-containing insulation in the boiler room, likely the same

insulation noted in the 1989 asbestos assessment, which is open and exposed to the elements. The bulk of the insulation potentially containing asbestos remains on the boilers, although there are small scraps of insulation spread throughout the room. The boiler room is open and exposed to the elements, but the insulation appeared to be largely contained within the boiler room and not scattered outside the building area (see Photographs 1 and 2, Appendix E).

PHOTOGRAPH 1: BOILER ROOM BUILDING, VIEW SOUTHWEST

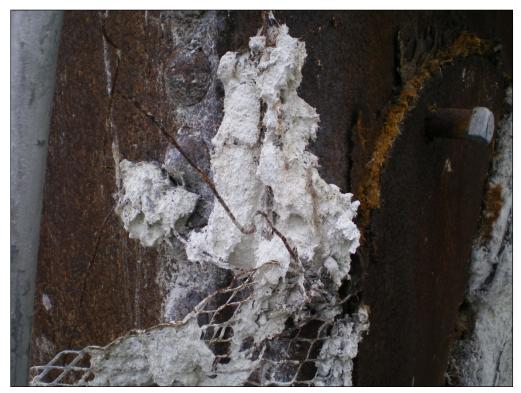
PHOTOGRAPH 2: ASBESTOS-CONTAINING INSULATION IN THE BOILER ROOM

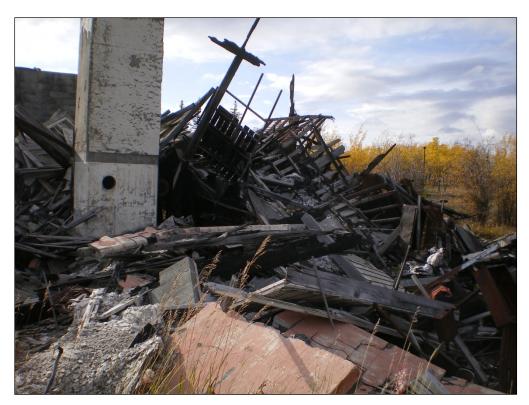
contained asbestos. The amount of debris in the kitchen wing made it difficult and unsafe to fully inspect the kitchen area (see Photographs 3 and 4, Appendix E).

PHOTOGRAPH 3: KITCHEN AREA, VIEW WEST

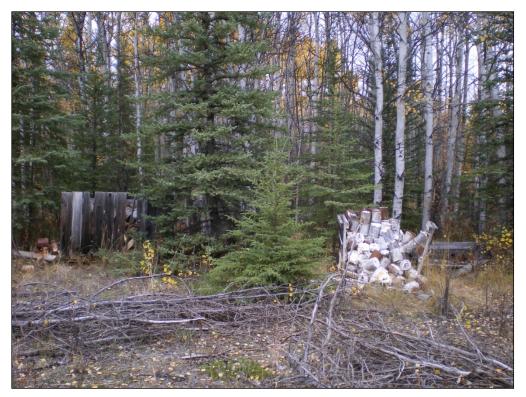
Approximately 600 feet northeast of the main school building, three pallets were observed with containers of unknown contents. The containers most likely contain paint based on professional judgment. The cans have been exposed to the elements for some

time, as most are rusted and split open with the contents exposed. None of the cans had markings to indicate what the contents may have been. The westernmost pallet had approximately 150–200 cans

PHOTOGRAPH 5: PAINT PALLETS, VIEW NORTH

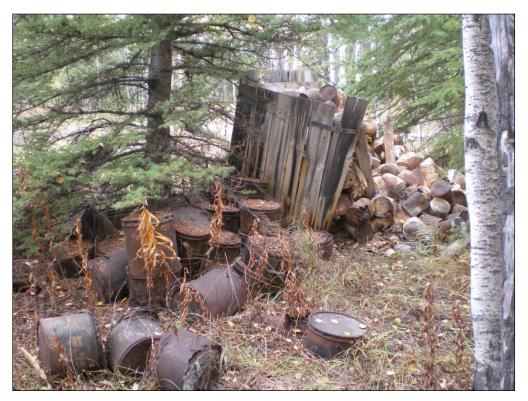
Between the western and center pallets, approximately 30 buckets were scattered on the ground. Several were rusted and/or split open with exposed contents, but the

majority was intact. Hardened gray or black material was observed in the buckets that were open. The buckets may be surplus materials from the Army, since some containers had markings that read "Ladd Field," and former students recalled that the school routinely received military surplus supplies and materials. Photographs 5–9 in Appendix E show the cans and buckets in this area.

PHOTOGRAPH 6: PAINT PALLET AND BUCKETS ON GROUND, VIEW SOUTHWEST

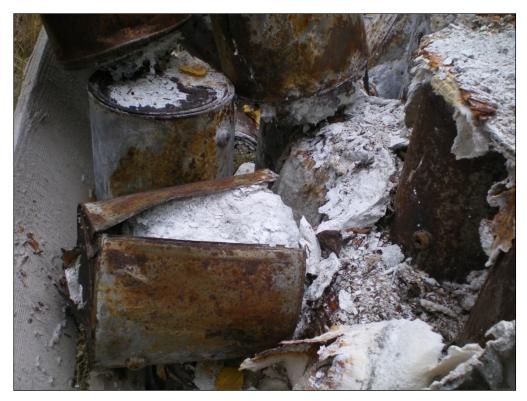
PHOTOGRAPH 7: CONTENTS OF A PAINT CAN

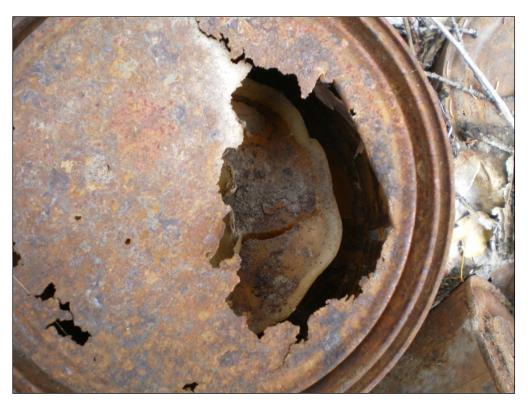
PHOTOGRAPH 9: CONTENTS OF A PAINT CAN

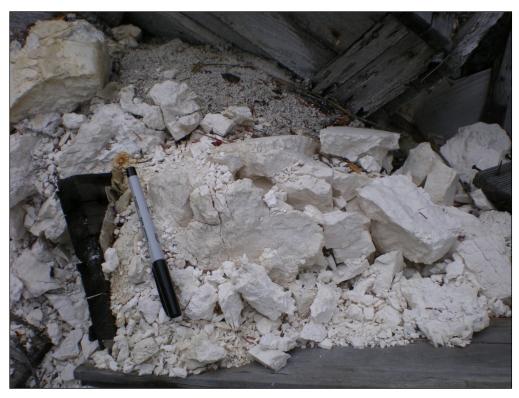
Approximately 1,000 feet north of the main school building area is a pile of stacked crates measuring approximately 20 feet long by 8 feet wide by 8 feet high. There are approximately 300–400 crates present. Some crates near the outer edges of the pile have fallen and broken open. The open crates contain a hardened white

PHOTOGRAPH 11: CLOSE UP OF WHITE POWDER IN THE CRATES

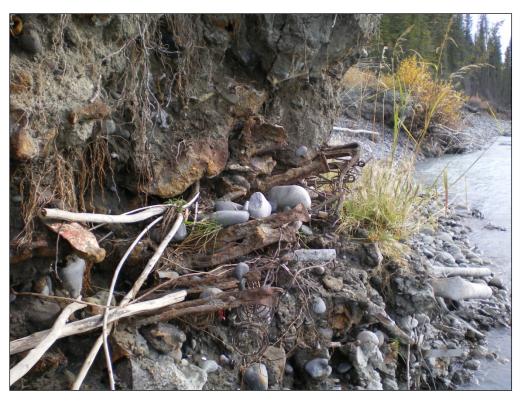
material consisted mostly of metal debris, such as pipes, metal cans, bedsprings, and other assorted debris. Christopher Wright of the Native Village of Tazlina mentioned that batteries have been previously observed at this dumpsite eroding into the river, although no batteries were visible during the site visit. Community members indicated that the river level was high at the time of the inspection, which may have hindered additional

PHOTOGRAPH 13: DUMPSITE ERODING INTO TAZLINA RIVER, VIEW EAST

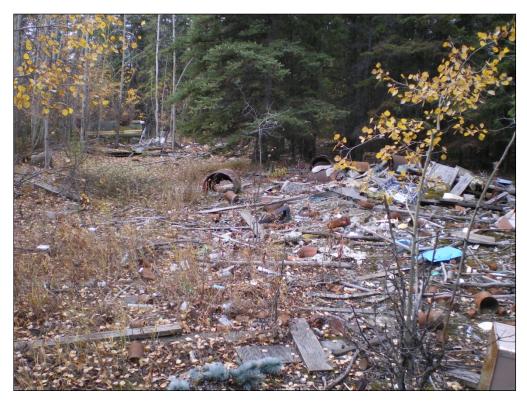
Several aboveground dumpsite areas of considerable size were observed throughout

the property. One area is approximately 1,000 feet southeast of the school near the river ("Dumpsite 1"); one is approximately 650 feet east-southeast of the school in the woods ("Dumpsite 2"); and one is east-northeast of the school near the shop ("Dumpsite 3"). A smaller dumpsite was observed approximately 700 feet in the woods south-southeast of the school. Debris in the dumpsites appeared to be both historical waste from when the

PHOTOGRAPH 14: DEBRIS IN AN ABOVEGROUND DUMPSITE, VIEW SOUTHWEST

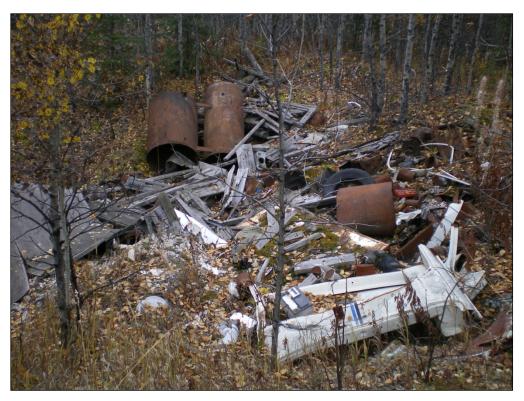
PHOTOGRAPH 15: DEBRIS IN AN ABOVEGROUND DUMPSITE, VIEW EAST

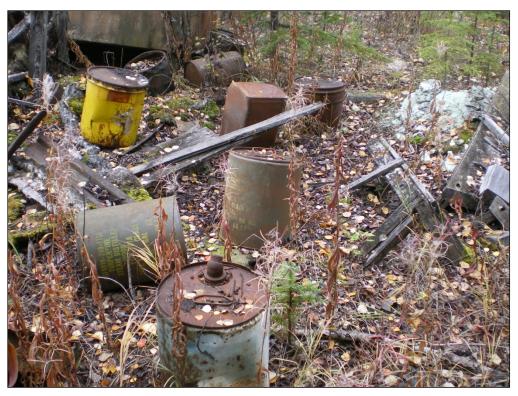
buckets were observed, some containing small amounts of liquid (see Photograph 17, Appendix E). Three of the drums were labeled as having contained turpentine. One drum was marked as previously containing a floor emulsion product. Another drum read "RPM Delo," which probably refers to a diesel engine lubricating oil product. The rest of the drums either had no labels, or the former contents were not able to be discerned based on the

markings present. A faint chemical odor was detected near the 5-gallon drums and buckets. Table 2 provides a general summary of drums observed in the various dumpsites around the propertery.

PHOTOGRAPH 17: 5-GALLON DRUMS CONTAINING SMALL AMOUNTS OF LIQUID IN DUMPSITE, VIEW NORTHEAST

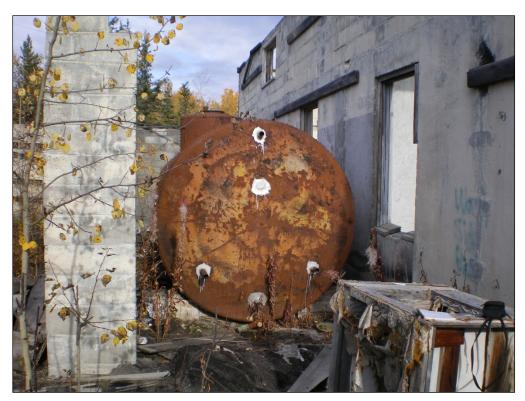
approximately 6.5 feet was noted in the boiler room (Photograph 19, Appendix E). It is unknown for certain what the tank may have contained, but a community member who worked in the boiler room when the school was in operation thought the tank contained water. The tank appeared empty at the time of the inspection, and no evidence of leaks was observed.

PHOTOGRAPH 19: TANK IN BOILER ROOM, VIEW NORTHEAST

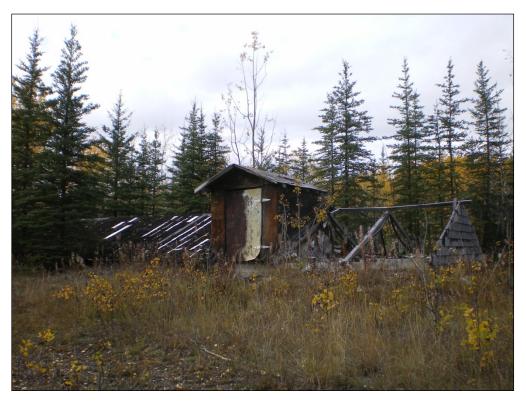
PHOTOGRAPH 20: WELL HOUSE, VIEW NORTHWEST

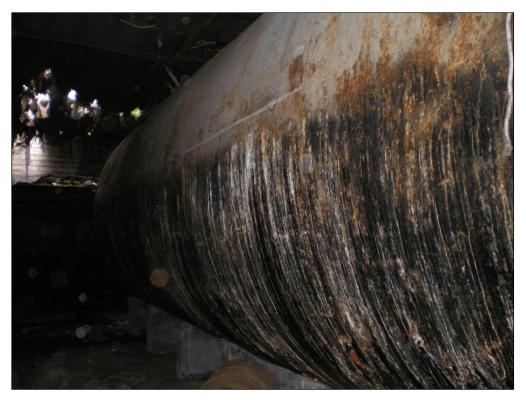
PHOTOGRAPH 21: TANK IN WELL HOUSE CELLAR, VIEW SOUTHEAST

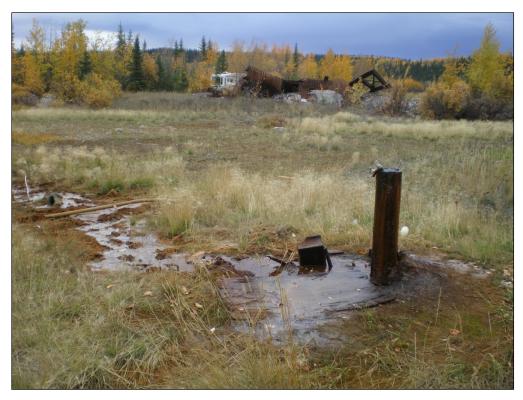
An artesian well is located near the school, south of the boiler room. The well is continually flowing, with a flow rate of approximately 1.25-1.50 gallons per minute. The well casing has a diameter of approximately 6-8 inches. Standing water and iron staining were observed in the vicinity of the artesian well, extending approximately 100 feet southeast of the well. (See Photographs 23 and 24 in Appendix E).

PHOTOGRAPH 23: ARTESIAN WELL, VIEW SOUTH

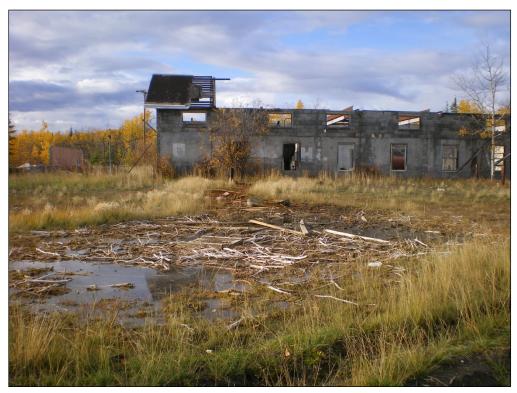
PHOTOGRAPH 24: STANDING WATER AND STAINING FROM ARTESIAN WELL, VIEW NORTHWEST

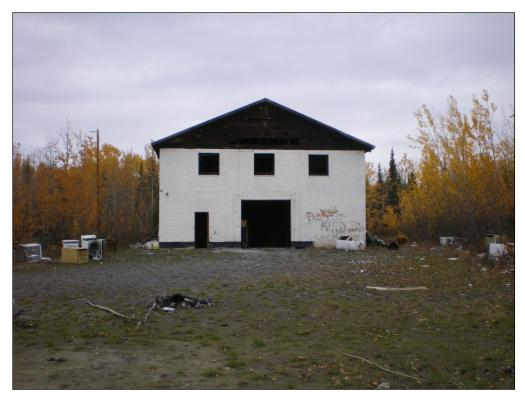
PHOTOGRAPH 25: SHOP BUILDING, VIEW NORTH-NORTHEAST

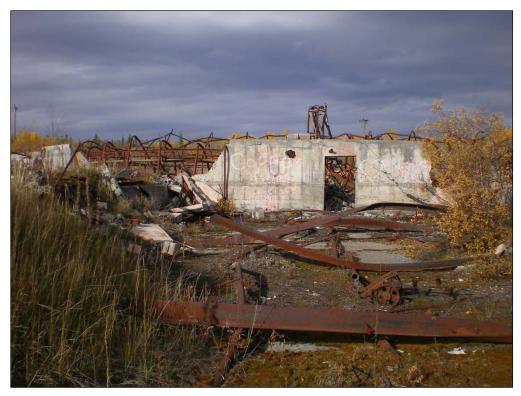
PHOTOGRAPH 27: SCHOOL BUILDING DEBRIS, VIEW NORTHWEST

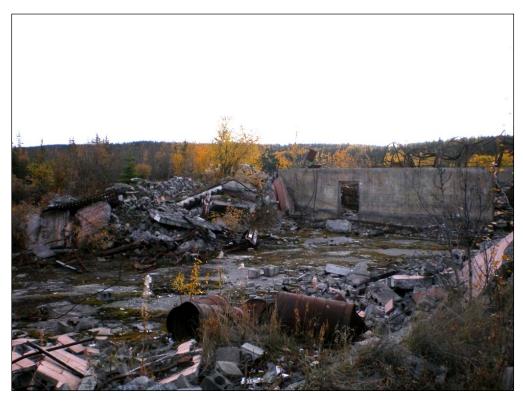
PHOTOGRAPH 28: SCHOOL BUILDING DEBRIS, VIEW SOUTHEAST

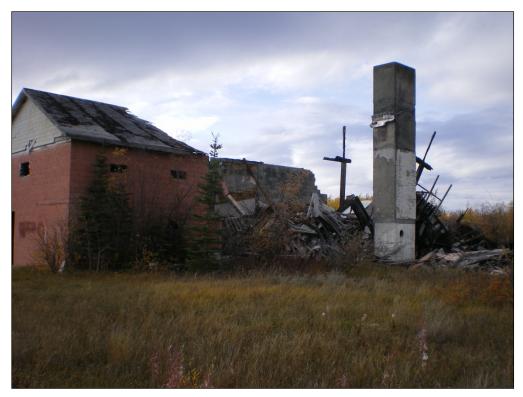
PHOTOGRAPH 29: SCHOOL BUILDING DEBRIS, VIEW SOUTHWEST
