ENVIRONMENTAL MANAGEMENT PLAN

Tanana Airport Facility and Community

Tanana, Alaska

By:
SLR International Corp
June 2009

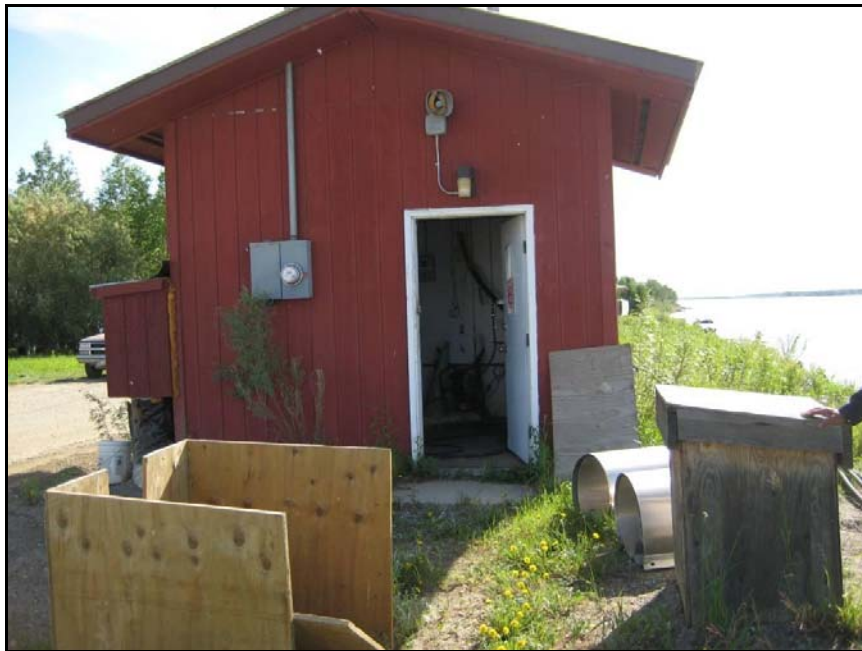
Photograph 1: The red well house in the picture is the location of the Tanana City Drinking Water Well site. The new Toogha well (Well #3), the current drinking water source, is located in the box in the lower right hand corner of the photograph.

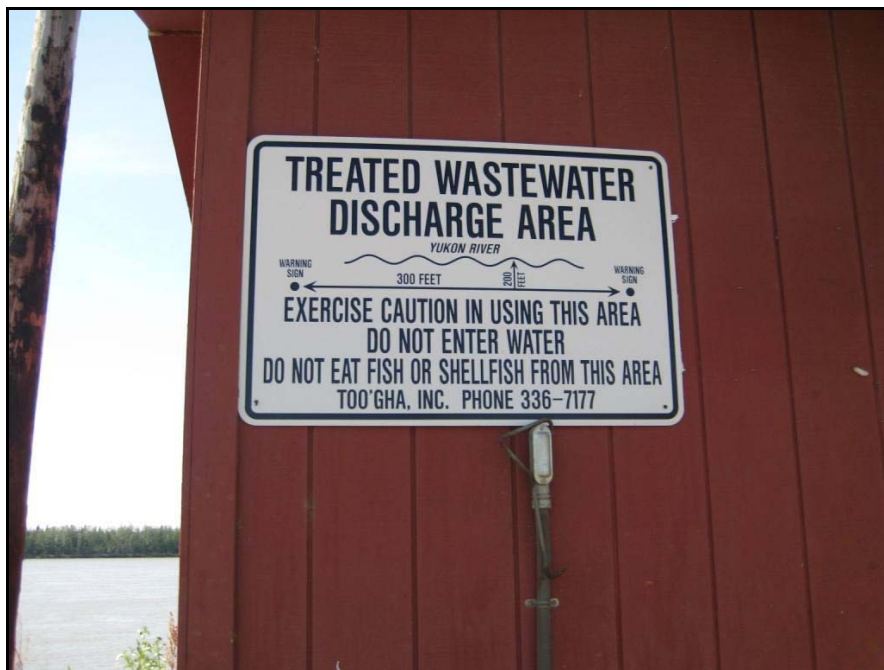
Photograph 2: The old well house is also the location where sewage from the sewage lagoon is pumped into the Yukon River during fall months of the year.

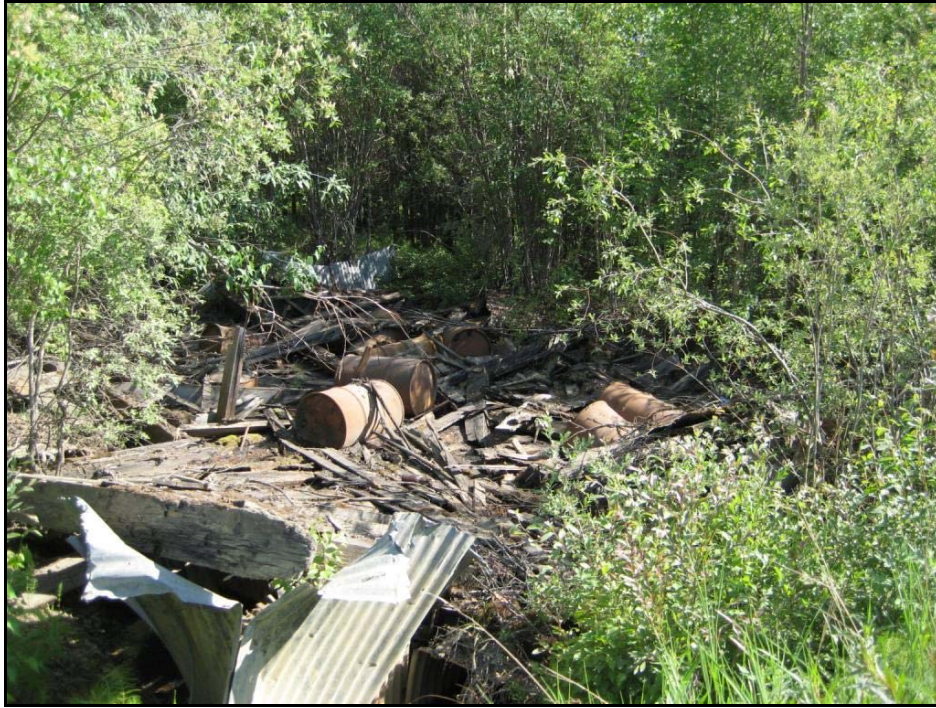
Cynthia identified a large swale containing wooden and metallic debris and 55-gallon drums located near the city water well as a potential contamination source for the drinking water well (also known as the Joe Burns property) (Photograph 5 in Appendix B). Additional sources in the area identified include the current Don's Video property. While Don's Video is no longer operational, fuel was formerly stored and dispensed at the site. Cynthia also

A large drum dump was observed during the site visit. Ten to 15 drums were present in this location. All of the drums observed during the June 2009 site visit were in poor condition, and the drums were corroded such that a release may be imminent. The site area is shown in photograph 5 in Appendix B.

Photograph 5: Drums and Debris in Swale site of environmental concern. This site is adjacent to the former Fort Gibbon Tank Farm and former Front Street Drum Storage Area.

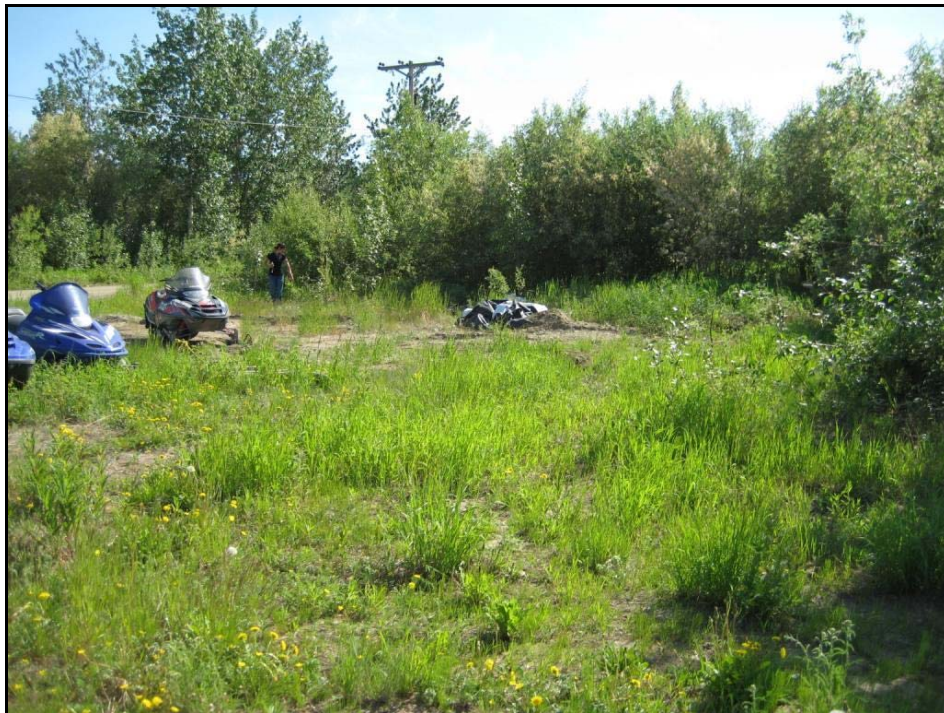
Photograph 6: Tanana Power Company known contaminated site.

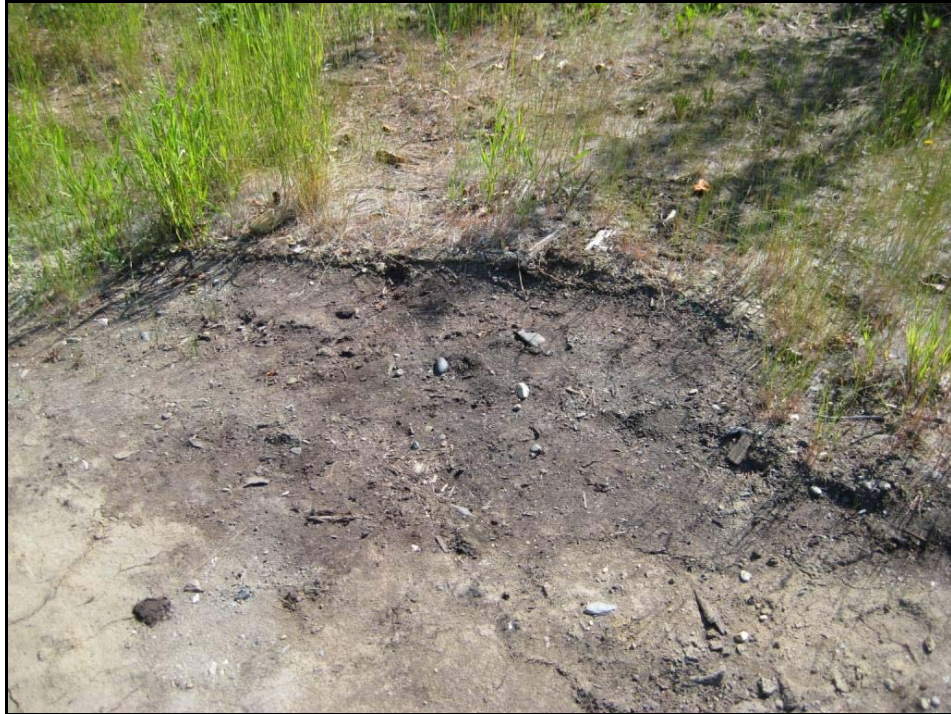
Photograph 7: Soil staining with odor at the *Tanana Power Company* known contaminated site.

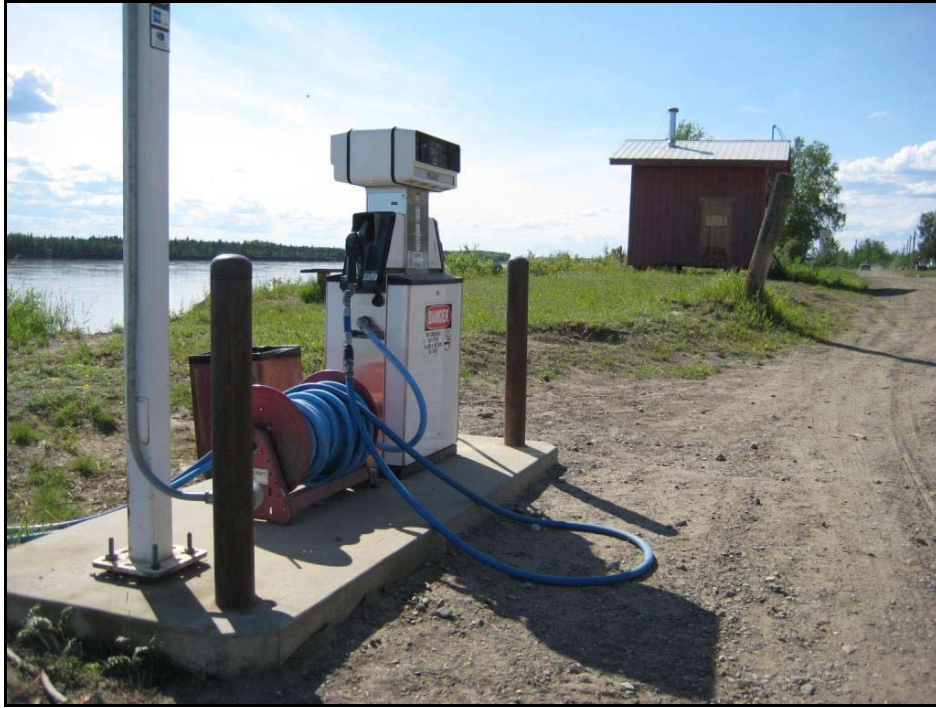
Photograph 9: The dispenser at Tanana Gas Company Fuel Station site of environmental concern.

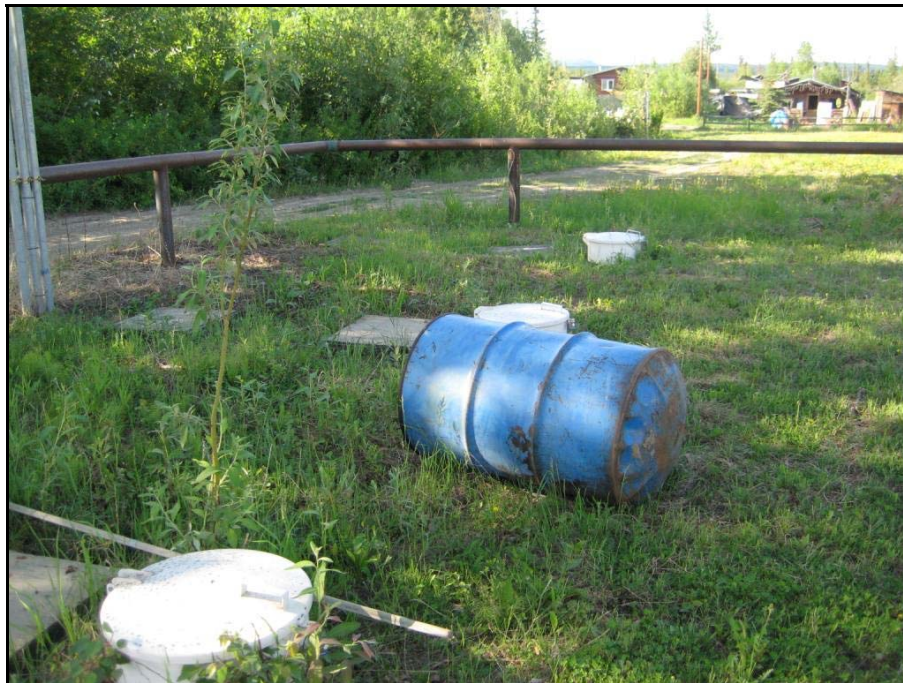
The Tanana Gas Company is identified as a closed LUST site in the DEC LUST database, therefore, the former underground storage tank is not included as a potential source of contamination. A bulging drum containing unknown liquids was observed on the property during the site visit. This drum has the potential for leaks and could be a possible contamination source. The Tanana Gas Company Fuel Station is shown in photographs 9 and 10 in Appendix B.

Photograph 10: Expanded drum above UST's at the Tanana Gas Company Fuel Station site of environmental concern.

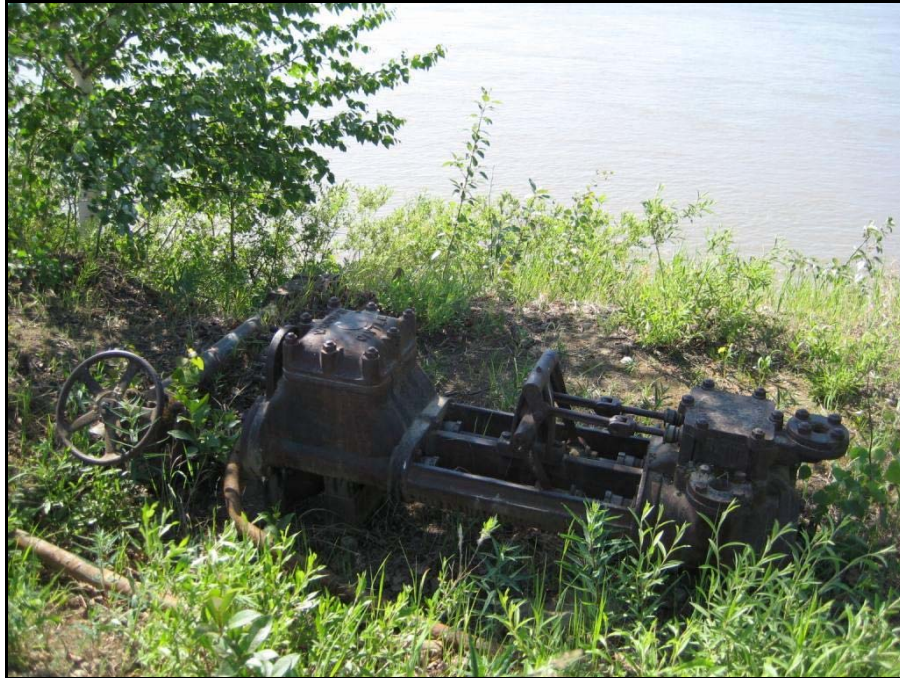
Wooden containers and wood stave tanks were reportedly used to store fuel for the Fort Gibbon facility. Wood alone is not sufficient containment for fuel, and it is likely that historical contamination is present in the areas of any former wooden fuel storage containers. Additionally, an old pump reportedly associated with the wood stave tank farm was observed during the site visit. The pump was in poor condition and any oil used to operate this pump likely has been released. It is not known when this system was decommissioned. Photograph 11 in Appendix B shows the pump at the site.

Photograph 11: Old pump which fueled the Former Fort Gibbon Wood Stave Tank Farm site of environmental concern.

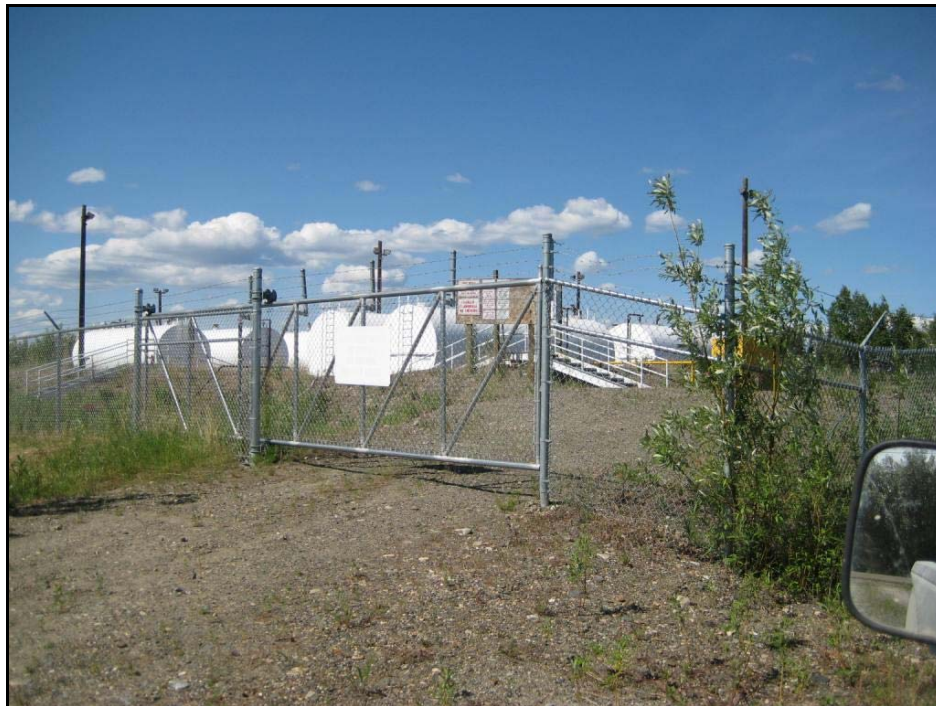
Tanks stored at the Tanana Power Company include eight 25,000-gallon capacity diesel storage tanks, two 25,000-gallon capacity compartment diesel tanks, one 4,000-gallon capacity city fuel dispenser tank, and one empty 25,000-gallon capacity contingency tank. While this is a bulk petroleum storage facility and could be a potential contaminated site, no staining, stressed vegetation, or other evidence of spills were observed during the site visit. The Tanana Power Company is shown in photograph 12 in Appendix B.

Photograph 12: Tank farm at the Tanana Power Company site of environmental concern.

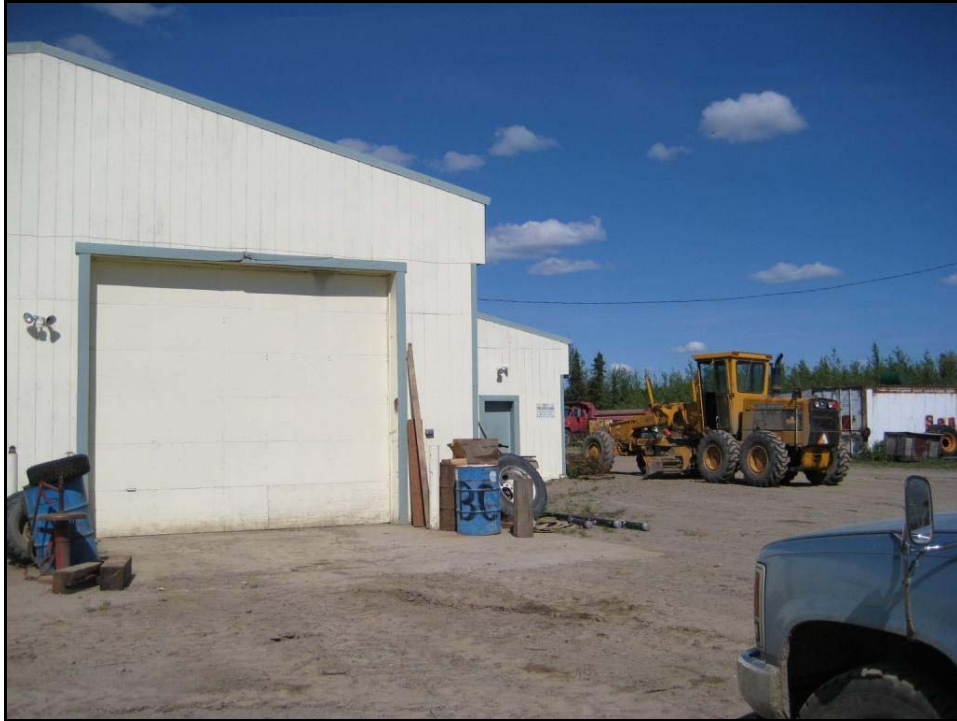
Photograph 13: City Shop/Garage site of environmental concern.

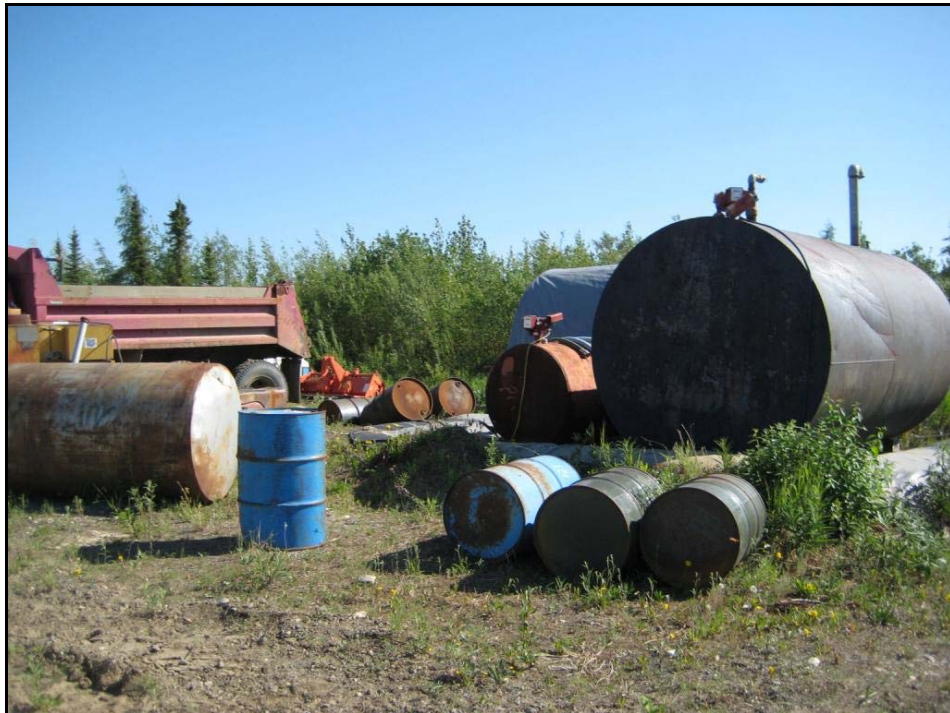
Multiple miscellaneous bulk fuel storage tanks under 1,000 gallons, as well as heavy machinery identified in Section 6.3, are stored at the city shop. There was some minor staining observed during the site visit indicating a possible release at this site. The City Shop / Garage are shown in photographs 13 and 14 in Appendix B.

Photograph 14: Tanks and drums at the City Shop/Garage site of environmental concern..

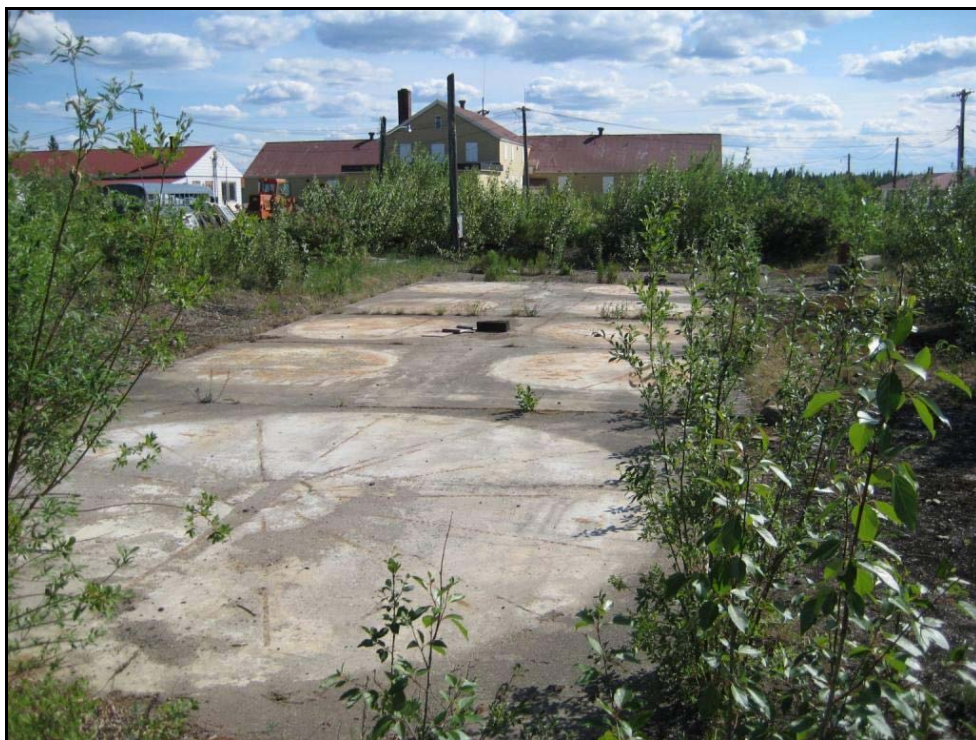
Photograph 15: IHS Tanana Health Center contaminated site former tank farm.

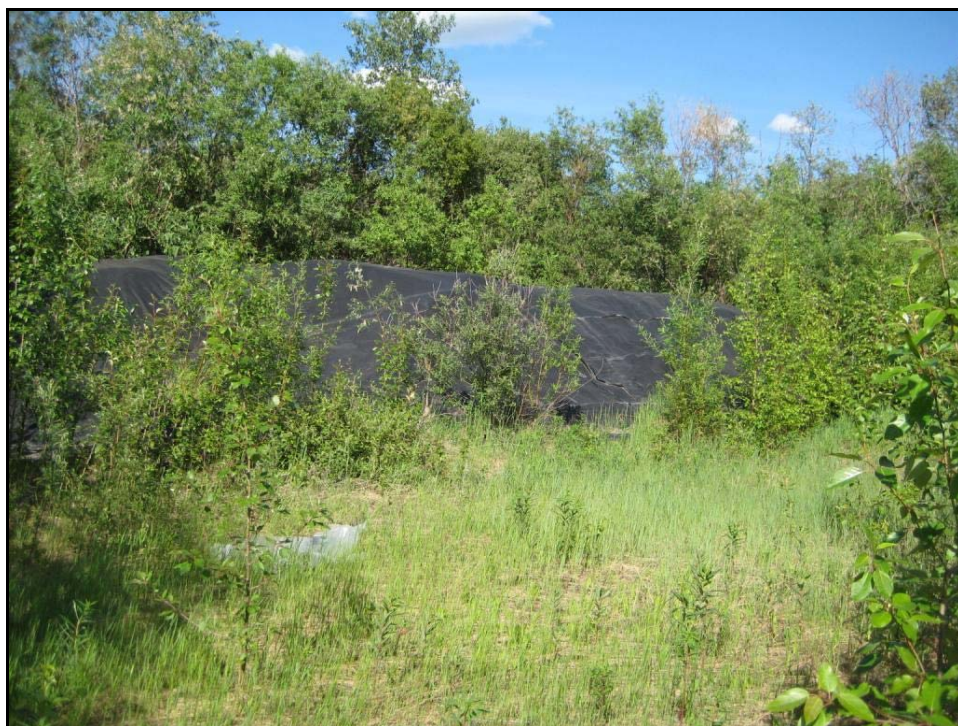
Photograph 16: Large stockpile located north of the former tank farm at the IHS Tanana Health Center.

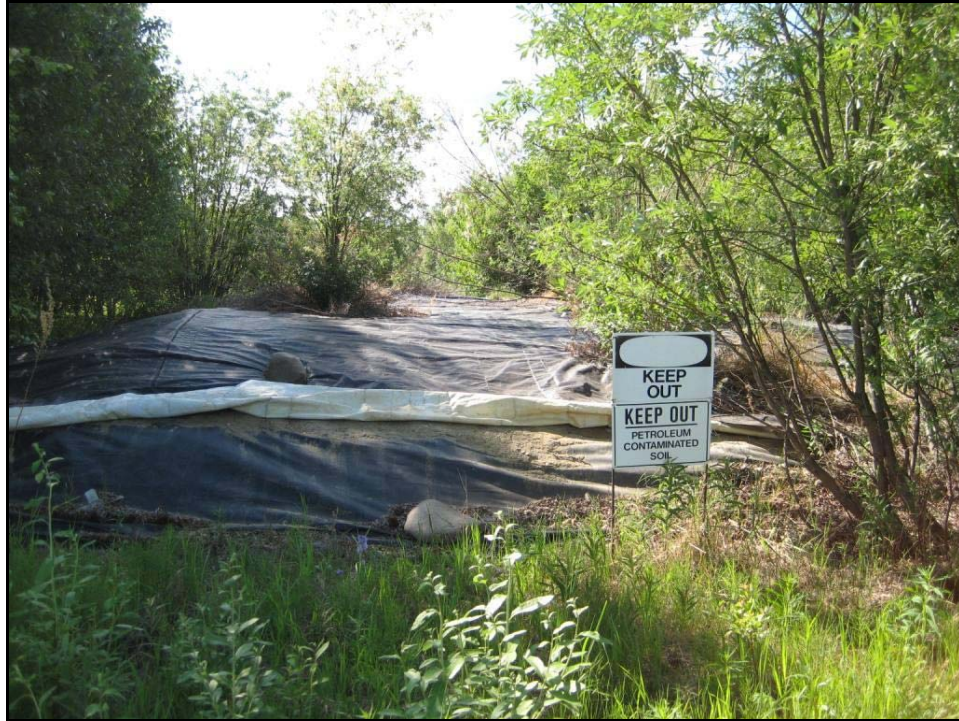
Photograph 17: Large stockpile located west of the former tank farm at the IHS Tanana Health Center.

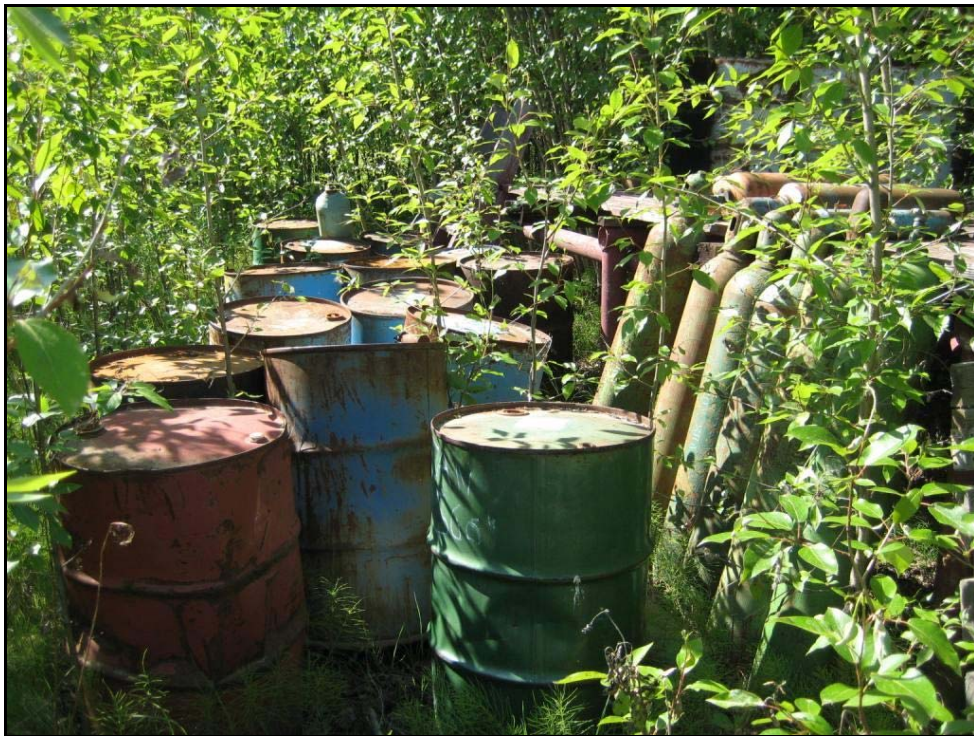
Photograph 18: Drum/cylinder storage at the IHS Tanana Health Center.

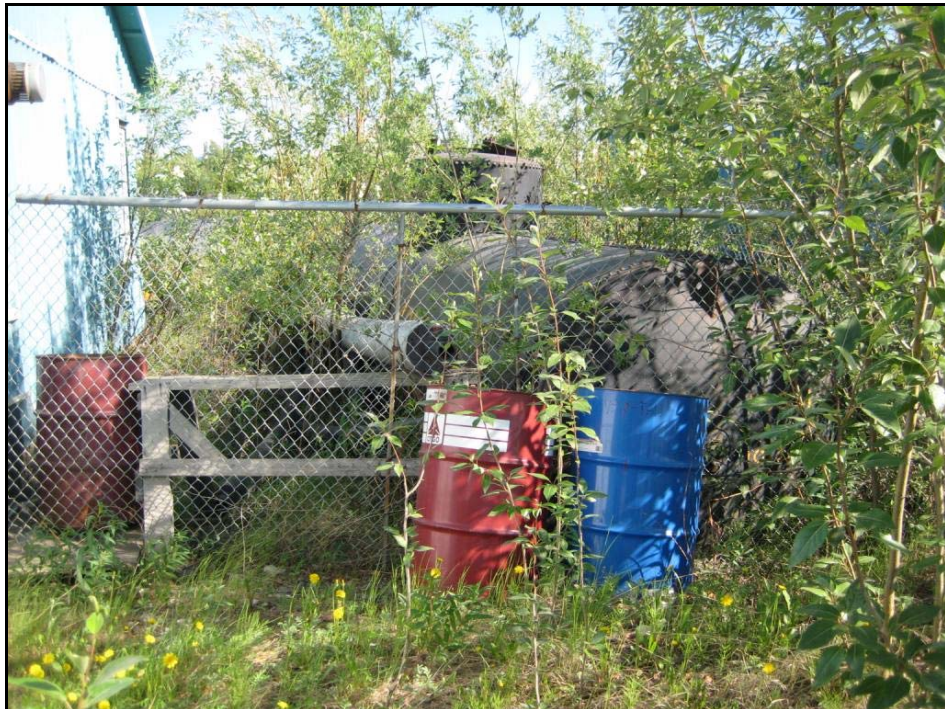
Two 55-gallon capacity drums and a 10,330-gallon train fuel tank were observed at the site of the former washeteria during SLR's site visit. No soil staining was observed at this facility; however, a fuel odor was noted indicating contamination is present in this area. The site is shown in photograph 20 in Appendix B.

Photograph 20: 10,000 gallon train-car fuel tank used for heating the Former Washeteria site of environmental concern.

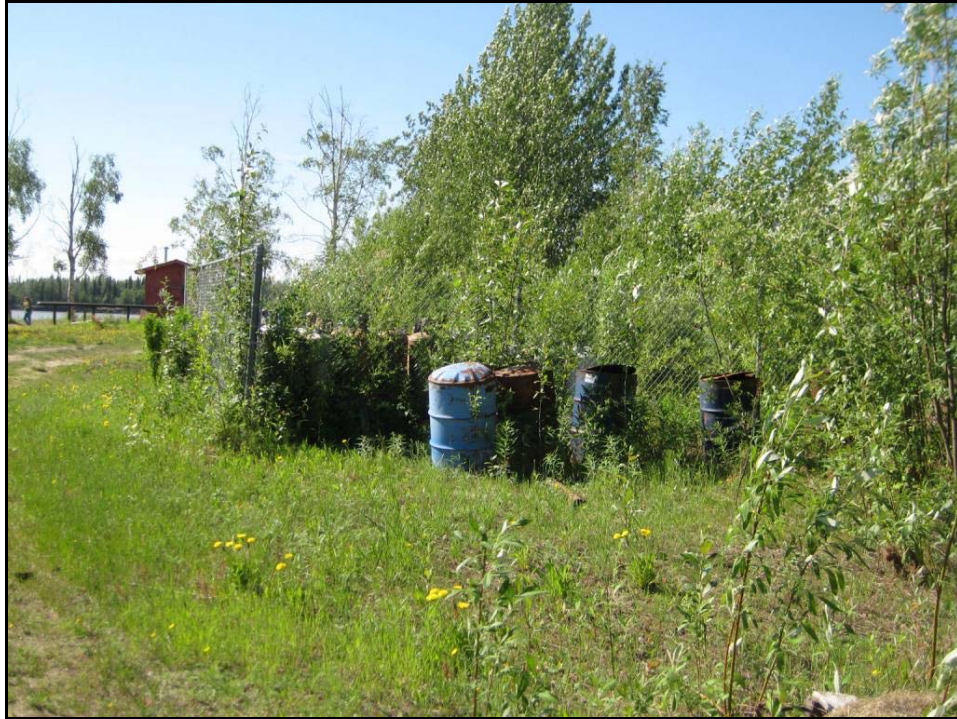
This drum storage area was observed during the site visit. Approximately eight drums and 30 gas cylinders were present at the time of observation. All of the drums appeared to be in poor condition and one of the drums was bulging. It is possible the weathered drums at this location have previously caused a release and potential contamination. The site area is shown in photograph 21 in Appendix B.

Photograph 21: Second Avenue Drum Storage Area site of environmental concern.

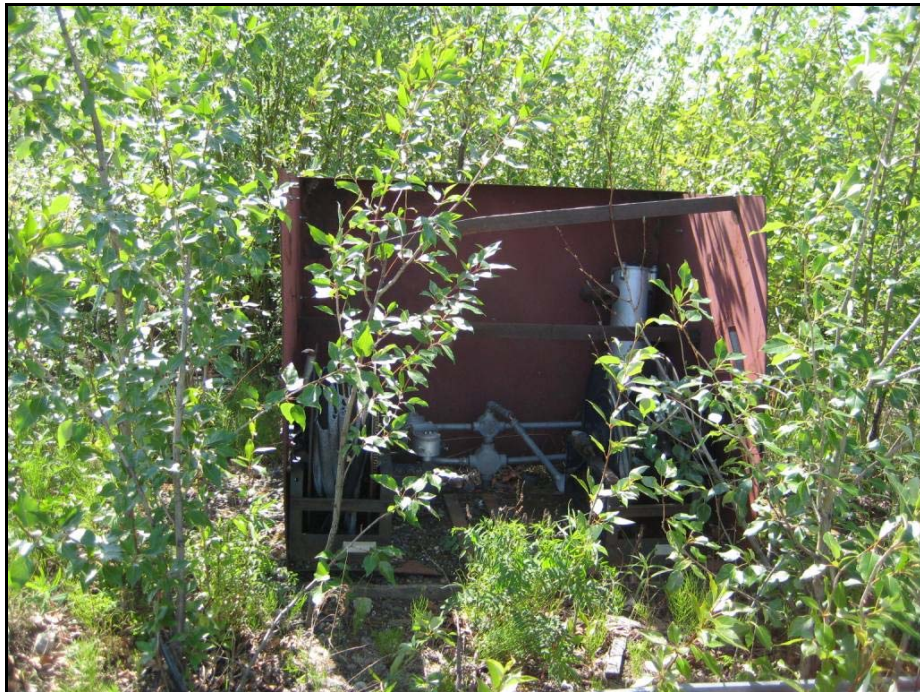
Three rail tank cars, each reportedly 15,000-gallons in size, are buried near the runway at the airport. The tanks have manholes visibly protruding upwards through the ground surface. A former fuel dispenser is located near the tanks. No evidence of fuel spills at this area was observed; however, as a bulk fuel storage location, this area is a potential contamination source. The tanks are reportedly abandoned and information on the owner and operational history of this fuel storage and dispensing system was not available. The site is shown in photographs 22 and 23 in Appendix B.

Photograph 22: This dispensing unit formerly drew fuel from the Buried Rail Cars site of environmental concern.

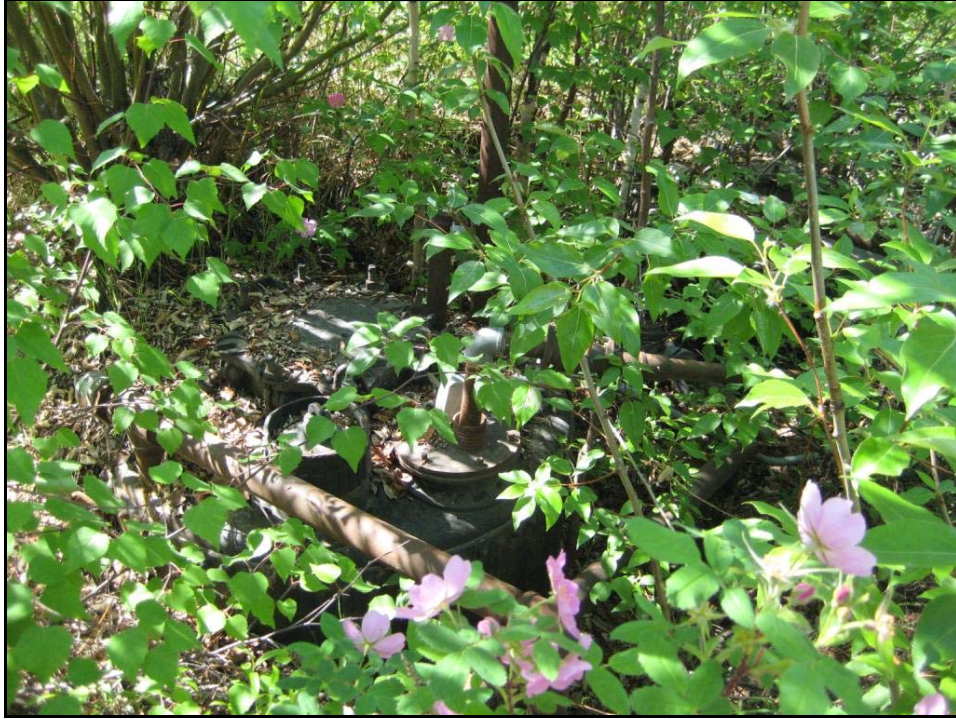
Photograph 23: Manhole to one of the Buried Rail Cars site of environmental concern.

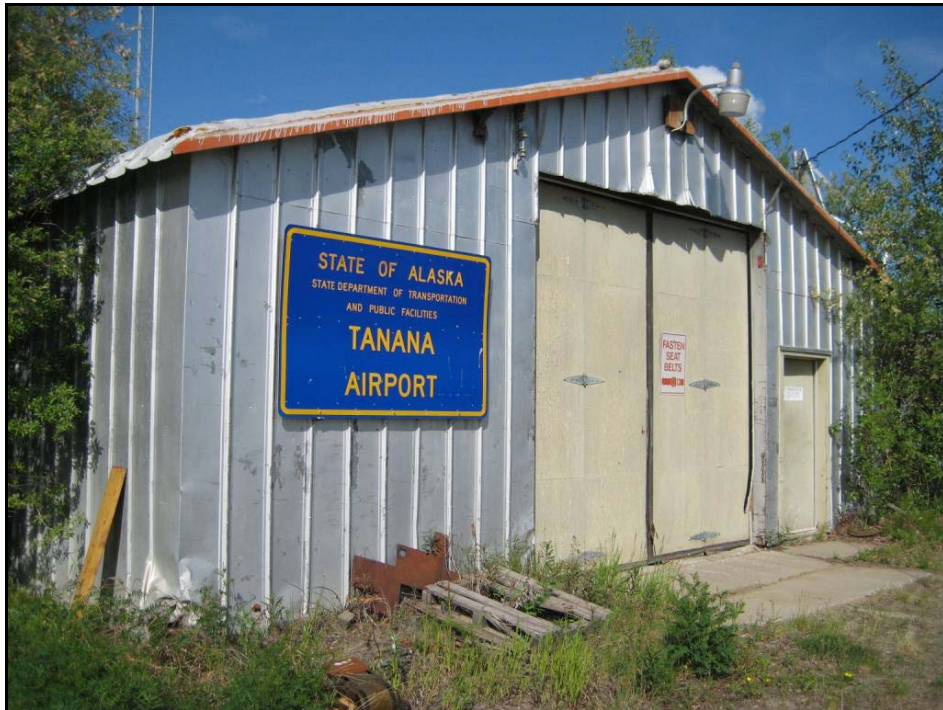
DEC File Number	Site Owner	Site Name	History	Recommendations	Reference
			location of contamination in this area. Results from both the 2007 and 2008 investigations at the former AST location indicate DRO, benzene, and ethylbenzene above ADEC cleanup levels are present in soils around the former AST. The site is shown in photograph 24 of Appendix B.

Photograph 24: ADOT&PF Tanana Maintenance Shop
