Old Alatna Village Site

Environmental Audit

Alatna, Alaska

By:
OASIS Environmental, Inc
April 17, 2008

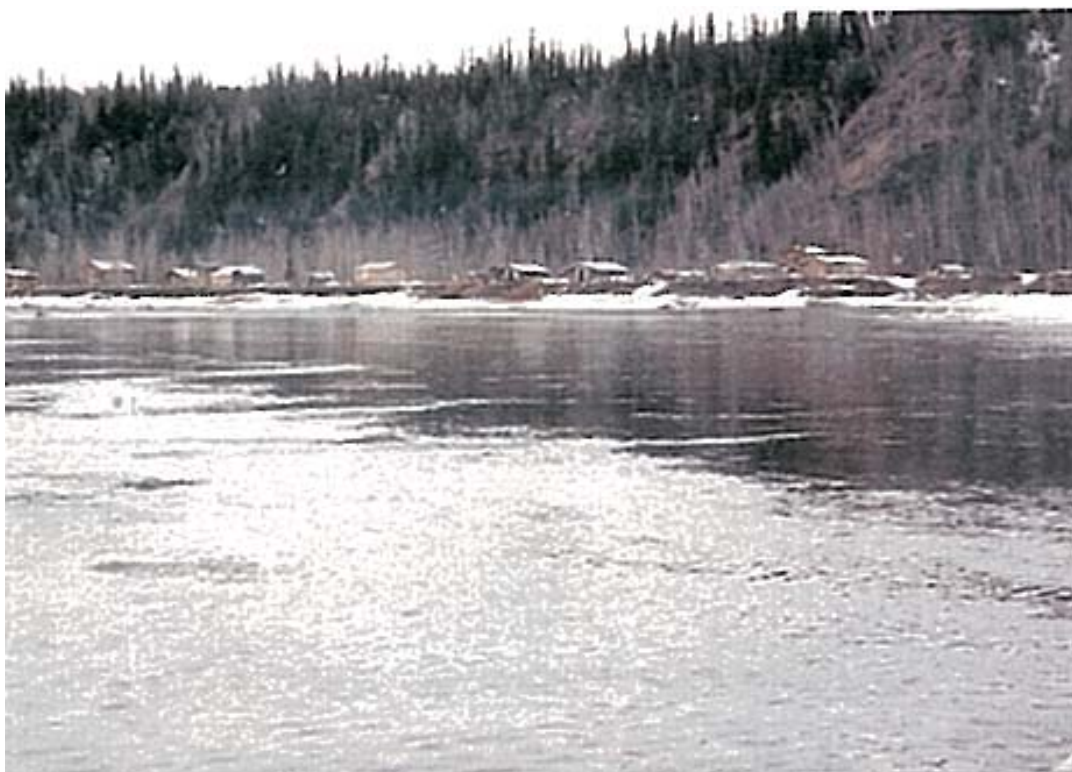
No information was found on the soil and groundwater conditions at the Old Alutna site. The surface soils are likely typical of a shoreline environment (fine sand and silt). Bedrock is probably shallow, judging by the proximity of the steep bedrock hillside (Figure A1 in Appendix A).

Figure A1. Looking southwest from Koyukuk River at Old Alatna site, prior to 1994 flood. Photo courtesy of Larry Edwards.

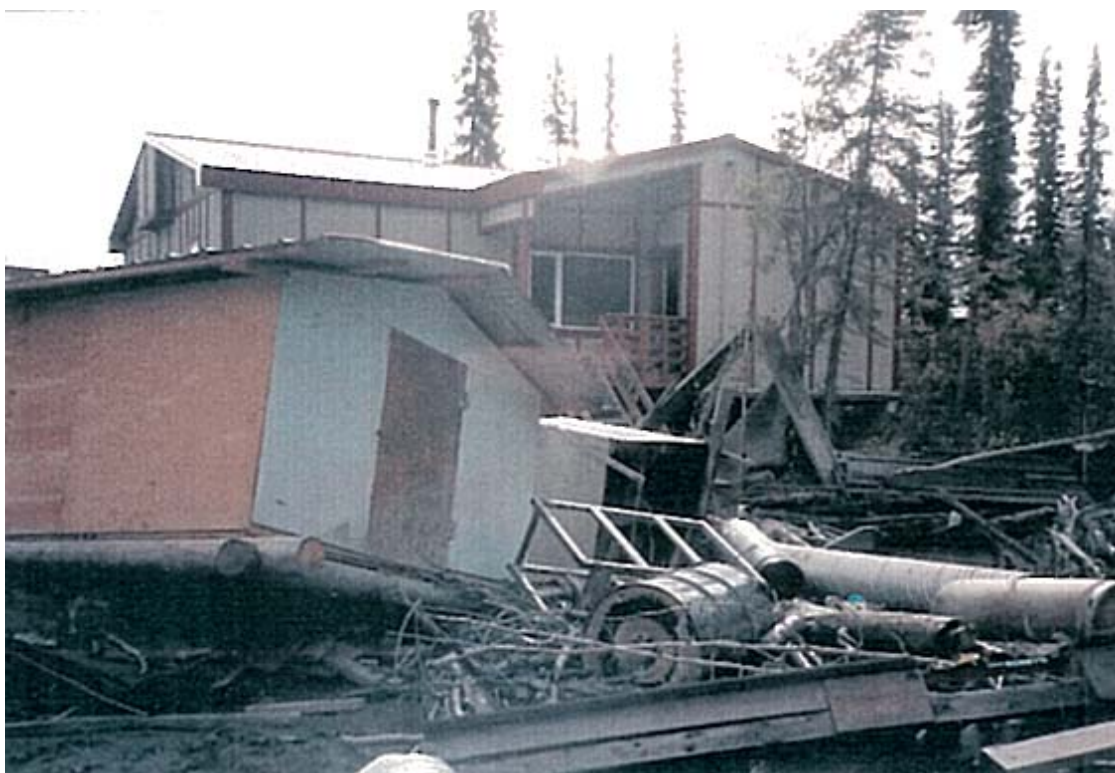
1995 village cleanup and relocation effort. After the flood, residents collected what was left of the personal belongings they wanted. They staged a burn-pile for unwanted items and also flew some items out. Larry Edwards provided a few historical photos from soon before and after the flood. The Old Alatna site before the flood is shown in Figure A1 of Appendix A. Two frame cabins that were damaged by the flood are shown in Figure A2. Both cabins were later demolished (Edwards, 2007).

Figure A2. Two frame cabins that were taken down after 1994 flood. Photo courtesy of Larry Edwards.

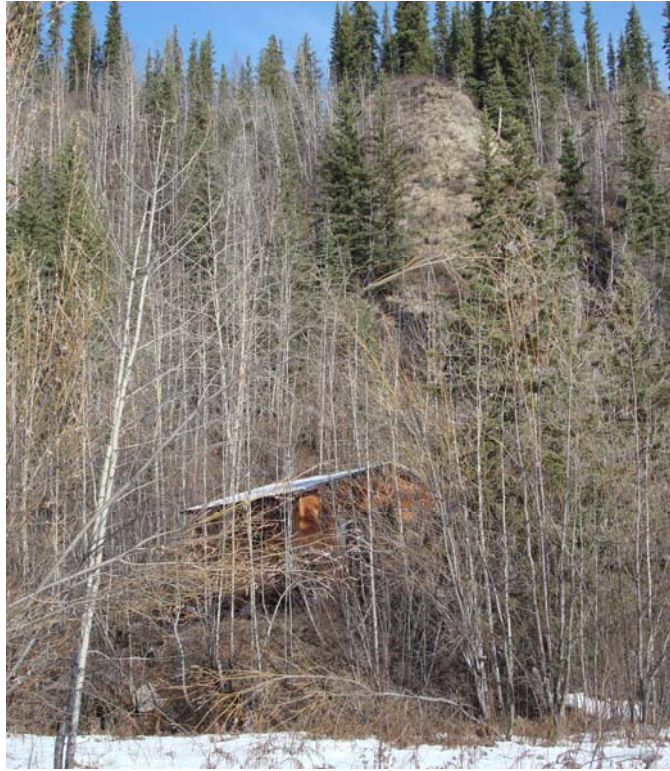
Figure A5. Raised cabin at former village site. This is the only cabin that has not been moved by flood waters. (Photo courtesy of Janelle Dayton, 4/2007)

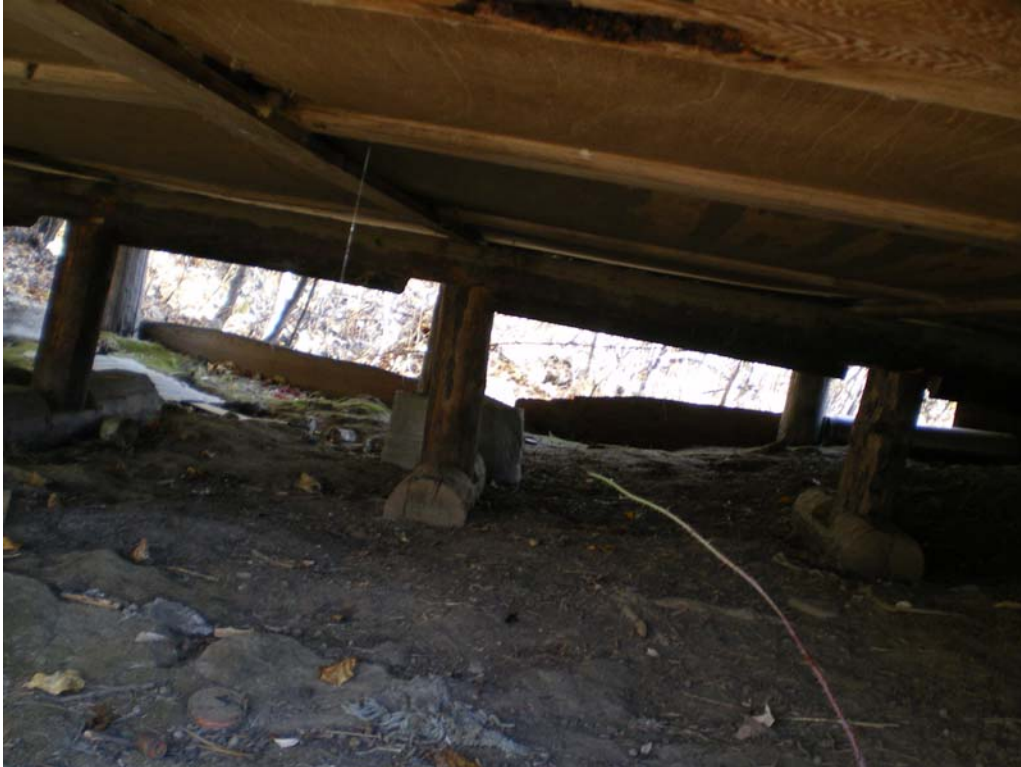
Figure A6. Beneath cabin on hill; this is the only cabin that was not moved by flooding.

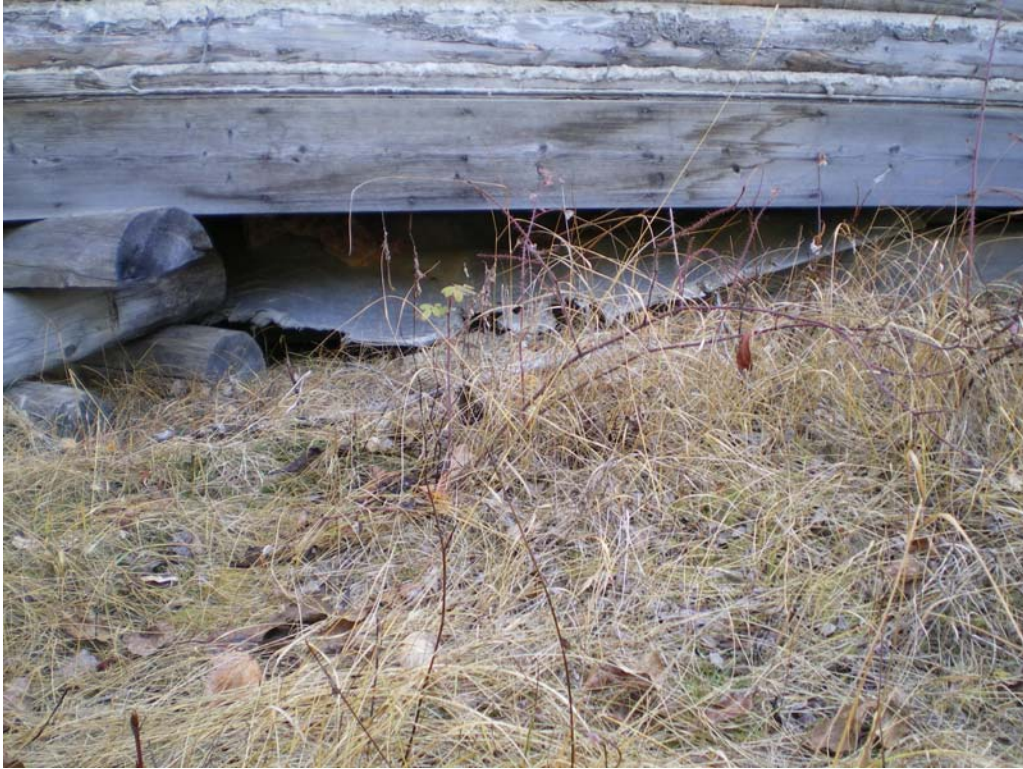
Figure A7. Beneath cabin that has been moved (for comparison with previous figure).

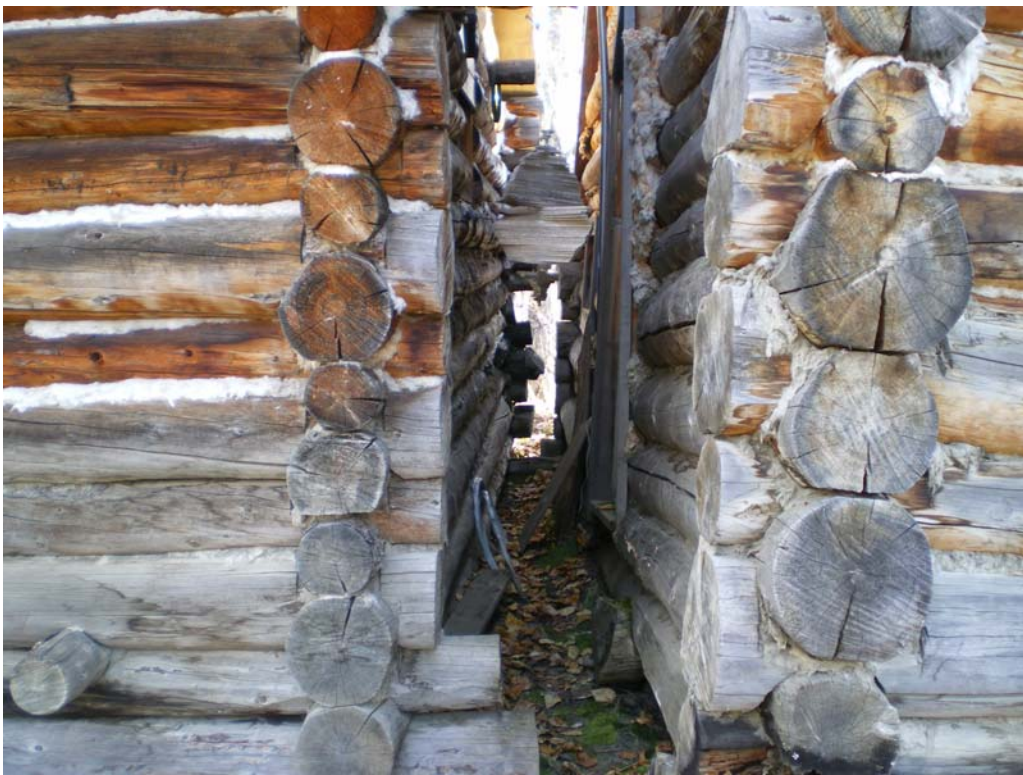
Figure A8. Example of cabin movement cause by flood.

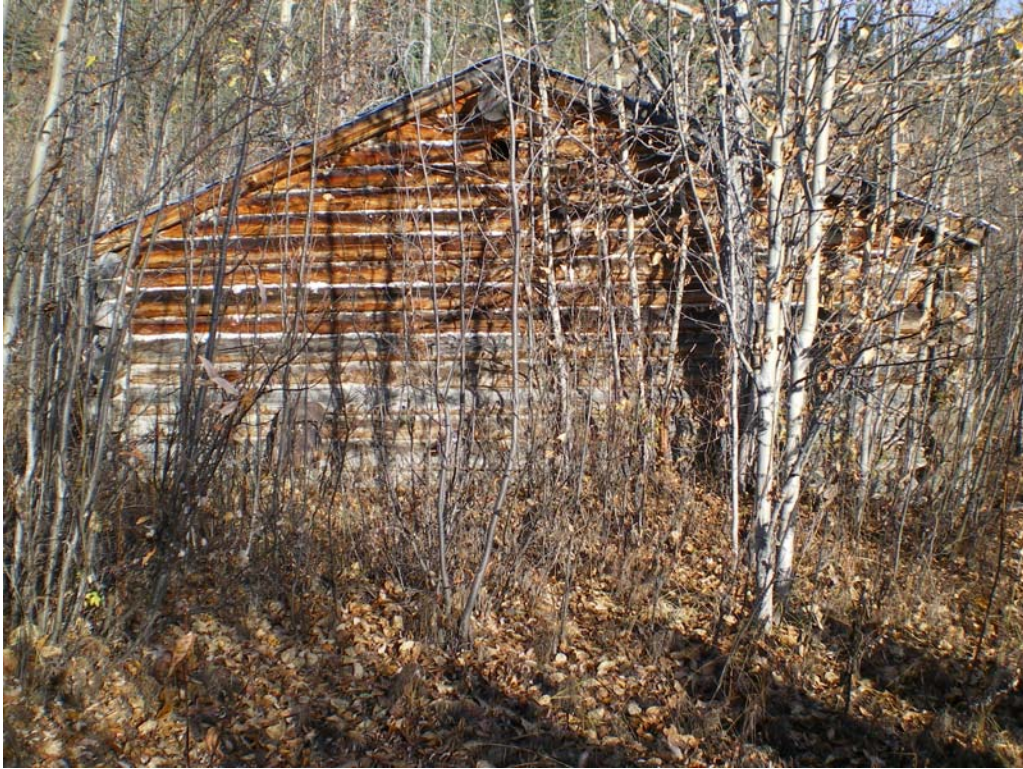
Figure A9. Flood-level marked by faded coloration on cabin at former village site.

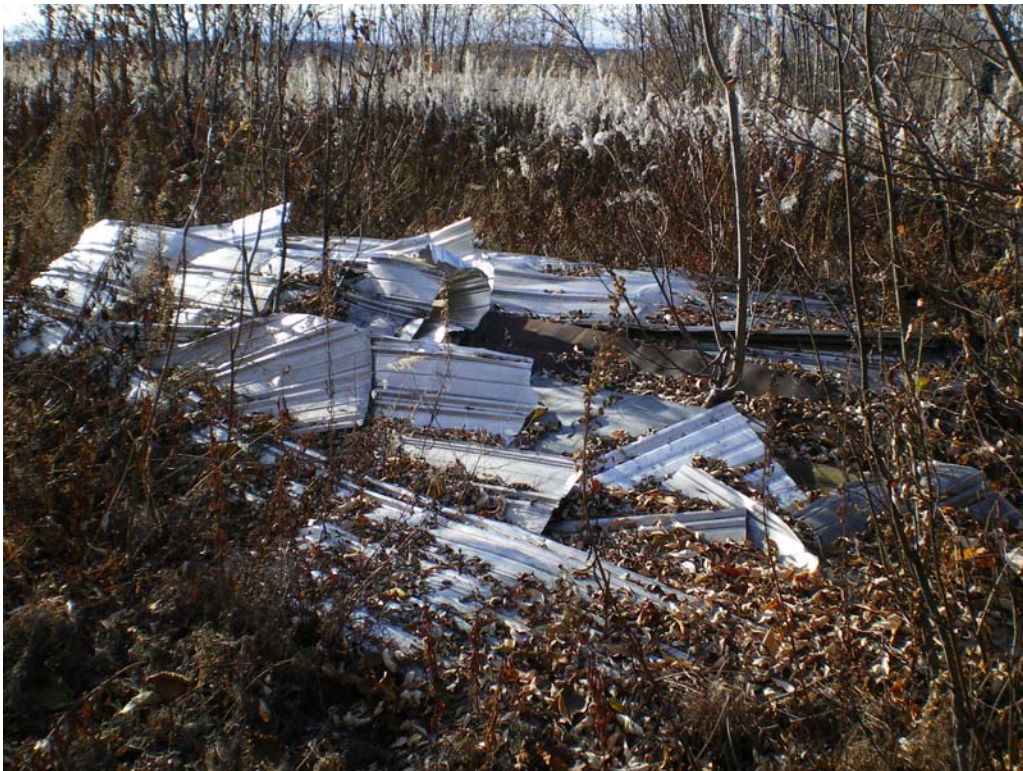
A significant amount of debris remains at the site. Large articles include building material such as sheet metal (Figure A10) and lumber; 55-gallon drums that were either empty or contained non-hazardous waste (Figures A11 and A12); partially-buried electrical cable (Figure A13); large spools of electrical cable (Figure A14); and interior items such as tables, shelving, bed frames, wood stoves, kitchen stoves, and fiberglass insulation (Figures A15 and A16). For heating, all of the cabins contained only wood stoves except for one. A monitor was found in one of the nine cabins (Figures A17 and A18); however, there was no heating oil tank anywhere near the cabin.

Figure A10. Sheet metal. One of several piles at site.

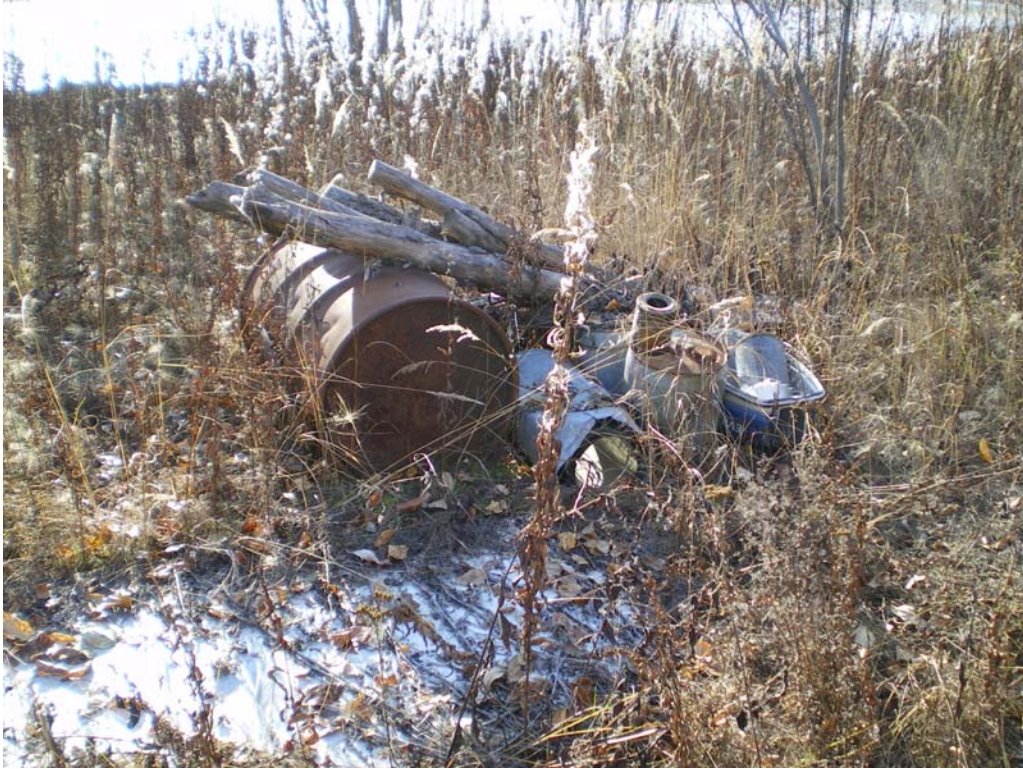
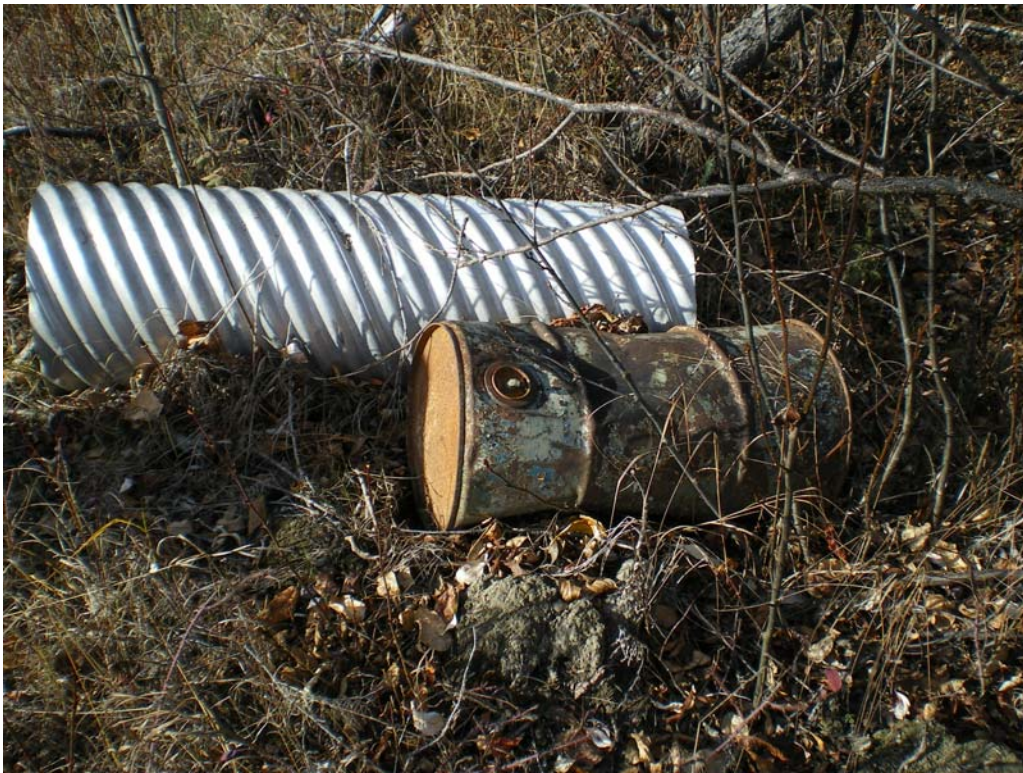
Figure A11. Various sized drums and other debris.

Figure A12. Another 55-gallon drum.

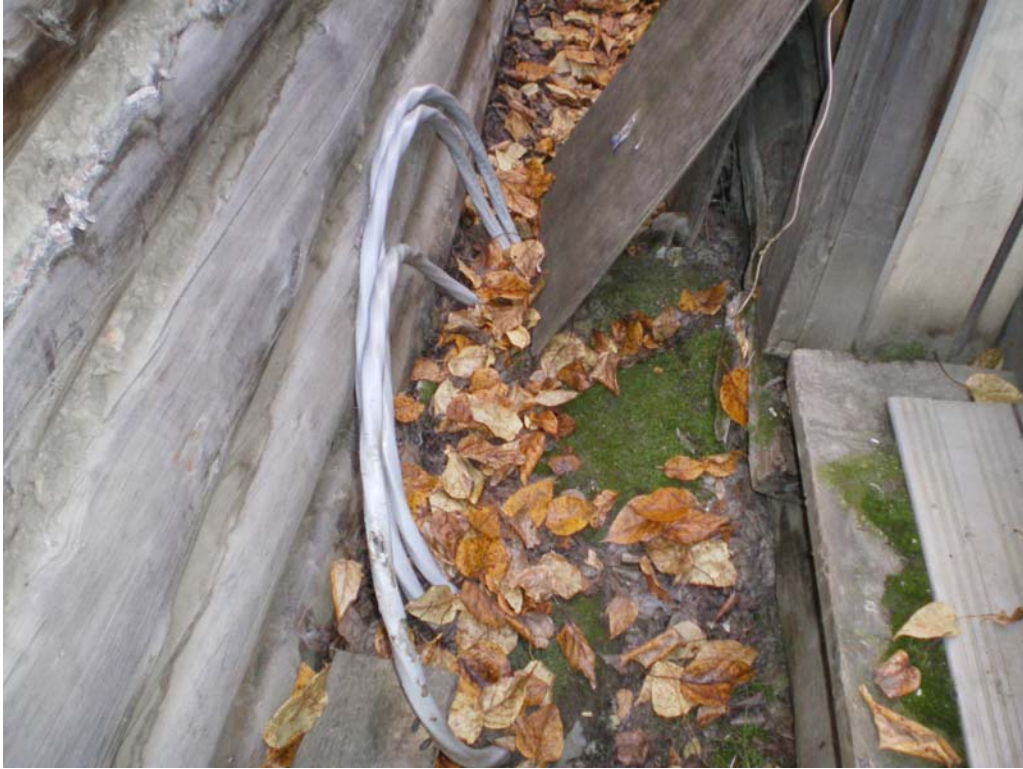
Figure A13. Partially-buried electric cable.

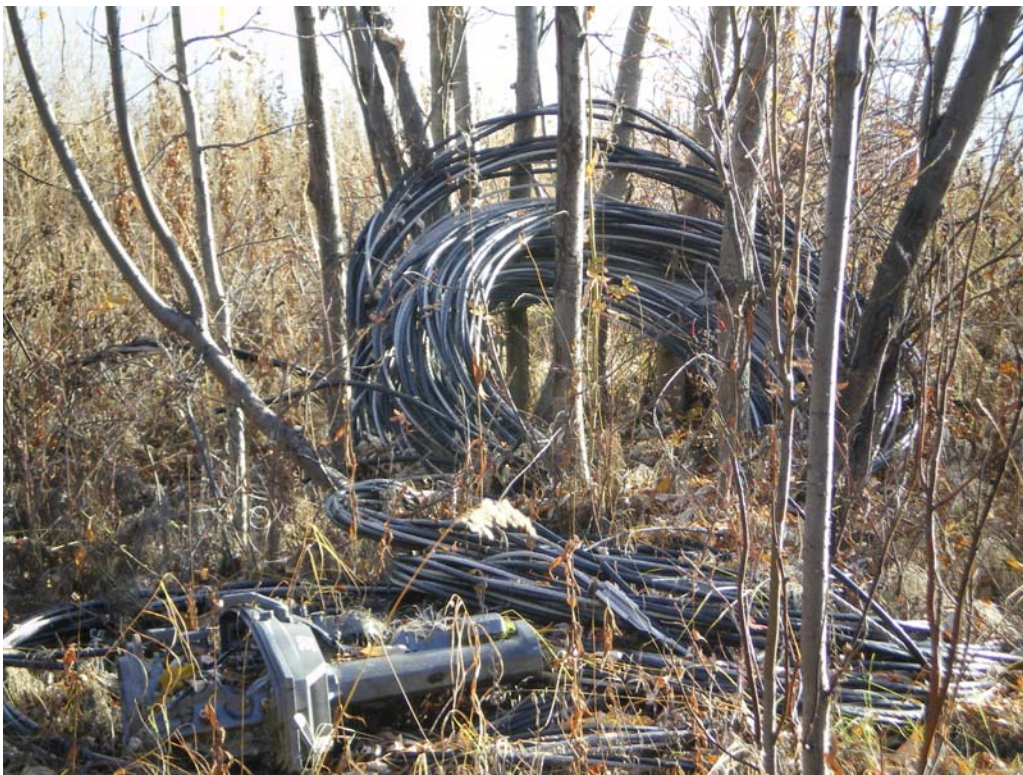
Figure A14. Electrical cables.

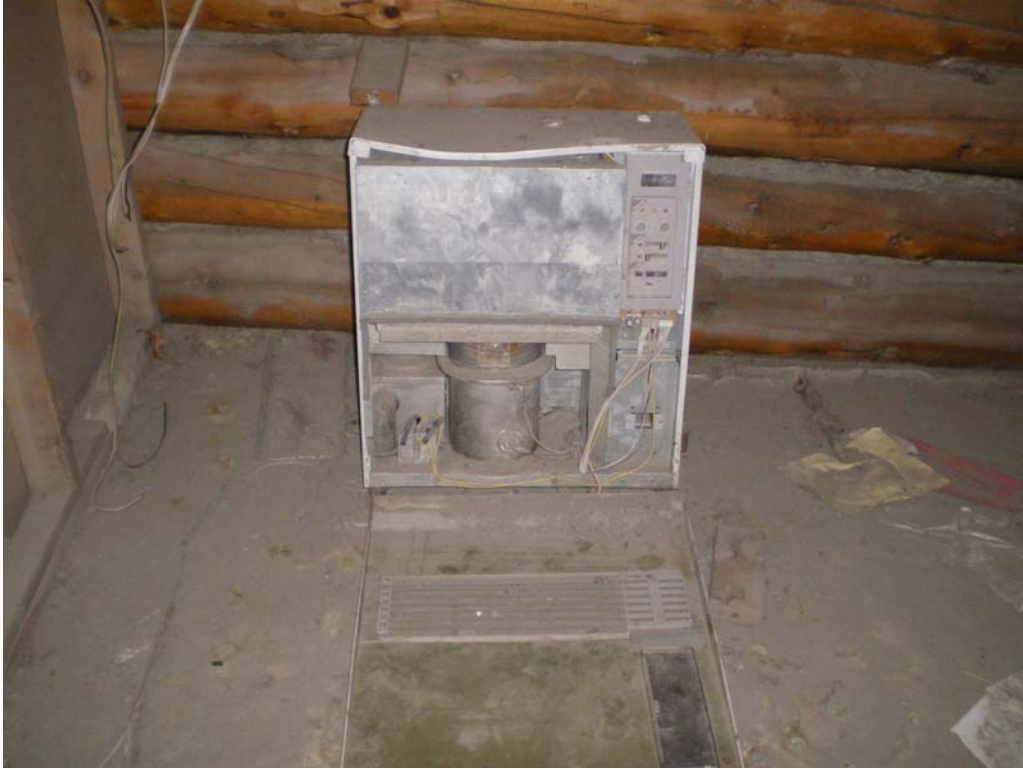
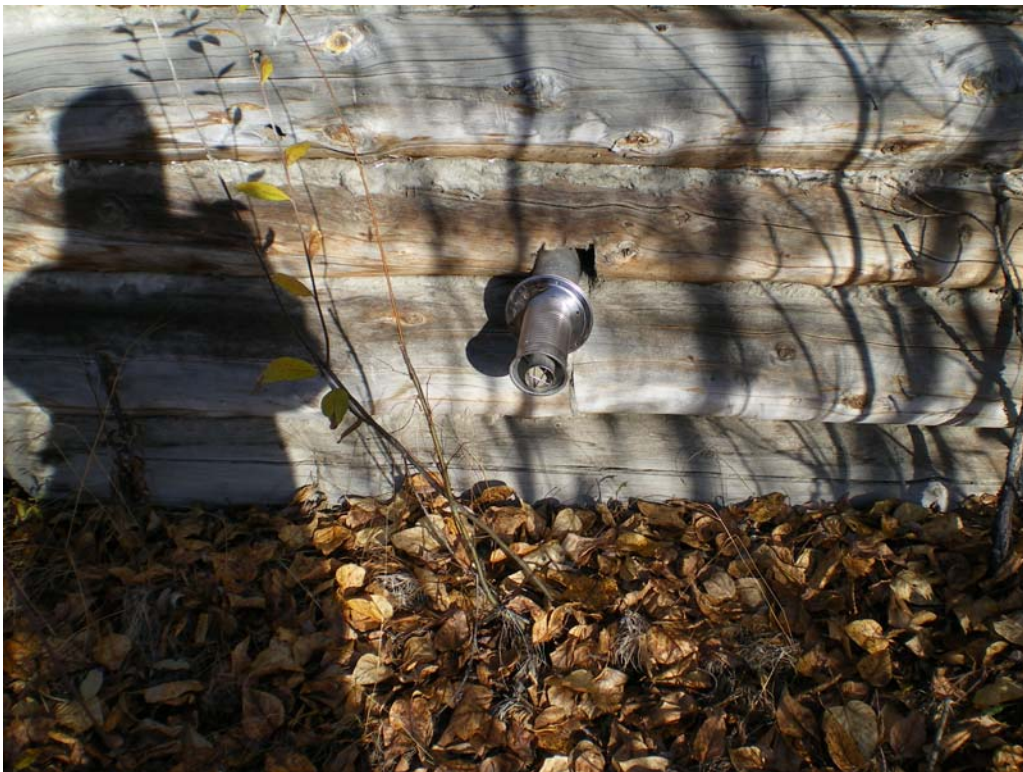
Figure 17. Monitor in cabin at former village site. This was the only cabin at the site with an oil-fueled heating system.

Figure 18. Monitor exhaust outlet from cabin at former village site.

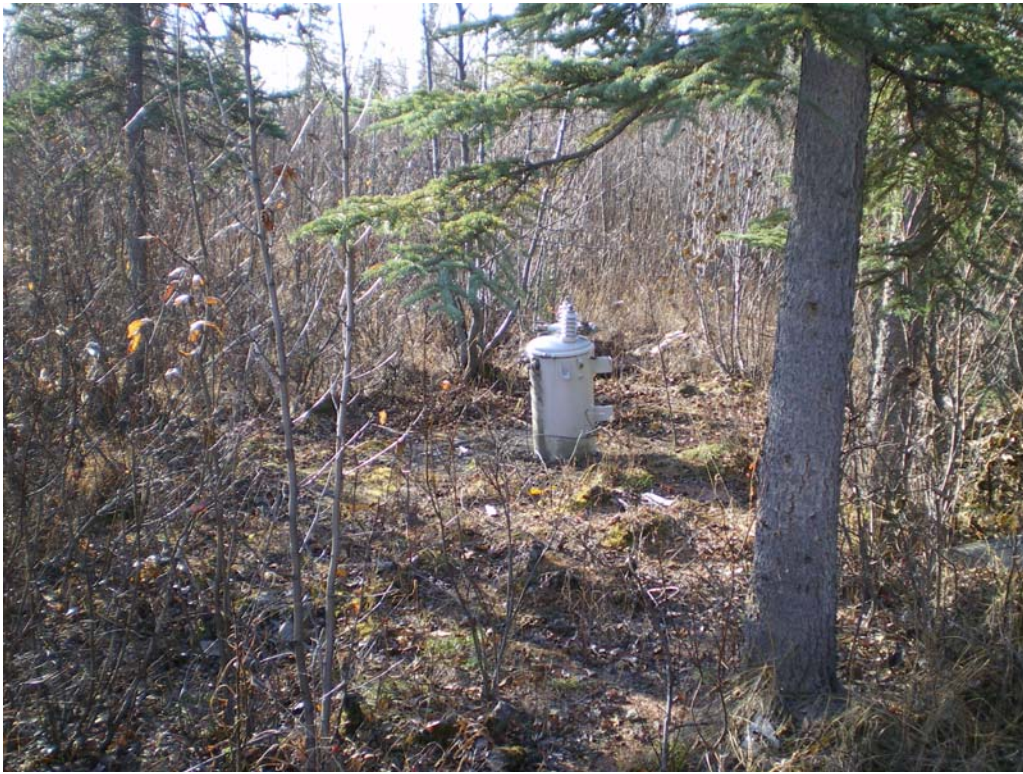
1. Transformers – two white transformers were located on-site. The first transformer that OASIS observed was located near the southern border of the site (Figure A19). It stood upright and alone and did not appear to be damaged. The second transformer was in the middle to northern region of the site near two cabins (Figures A20 and A21); two pieces were broken off and lying next to it (Figure A22). Like the

first, it stood upright. It was not possible to determine if the transformers had leaked in the past.

Based on our findings, OASIS concludes that the possible presence of PCBs within or around the on-site transformers is a potential environmental hindrance to site reuse. While other hazardous materials are potentially present on-site, they appear to be contained and pose little risk to human or ecological health if properly disposed.

Figure 19 Transformer near southern edge of former village site.

Therefore, as the first step in achieving site reuse, OASIS recommends determining whether the transformers contain PCBs by looking for manufacturer's labels, which may give the date of manufacture and the trade name of the fluid. Some trade names that may refer to PCBs include Aroclor, Askarel, Eucarel, Pyranol, Dykanol, Clorphen, Clorinol, Chlorextol, Diacolor, Hyvol, Asbestol, Inerteen, Elemex, Saf-T-Kuhl, No-Flanol, Nepolin, EEC-18, and others. Equipment manufactured after 1979 usually does not contain PCBs. Most pre-1979 capacitors do contain PCBs, while many pre-1979 transformers do not. Transformers within buildings or vaults are more likely to contain PCBs. New equipment should be labeled "No PCBs."

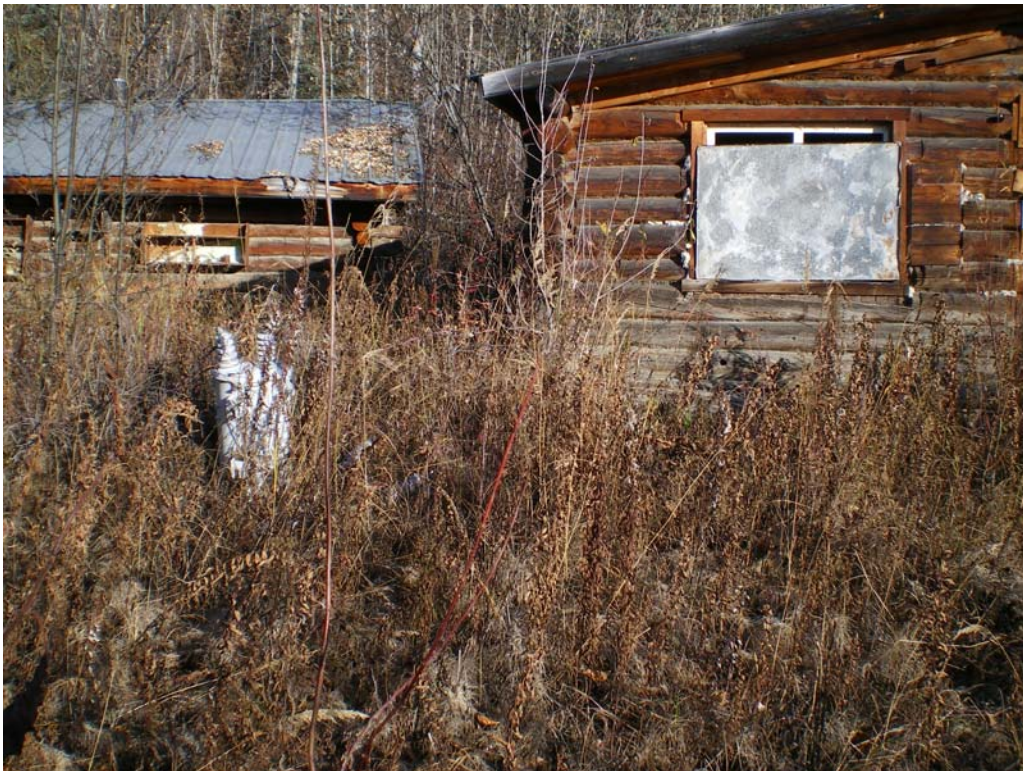
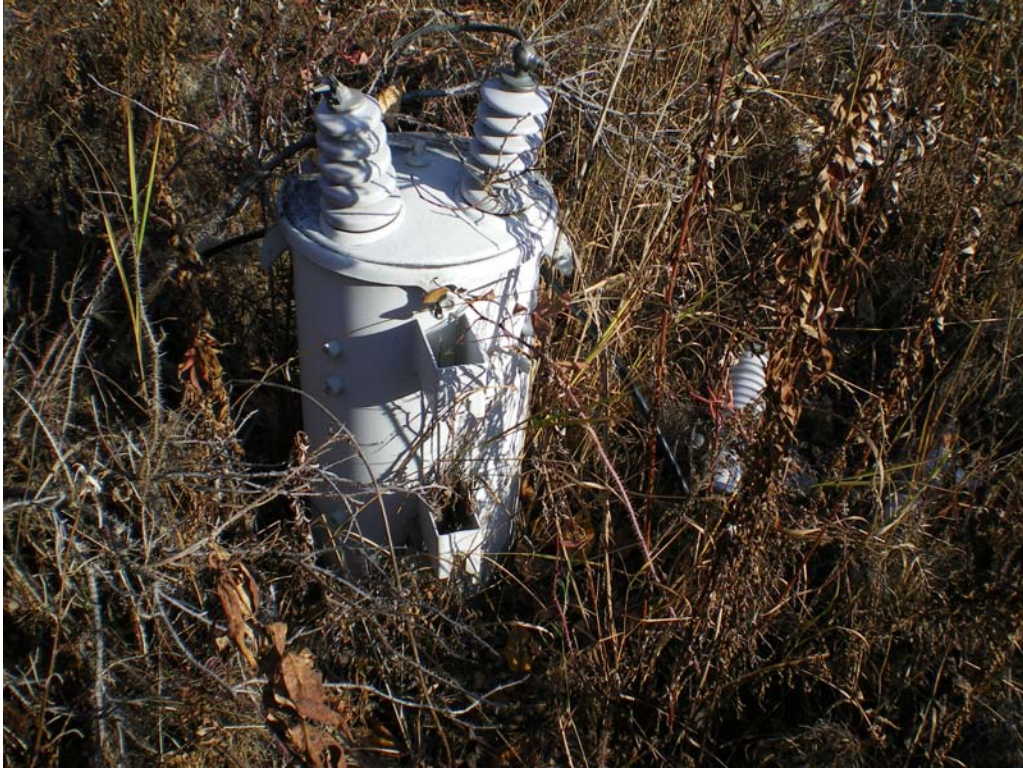
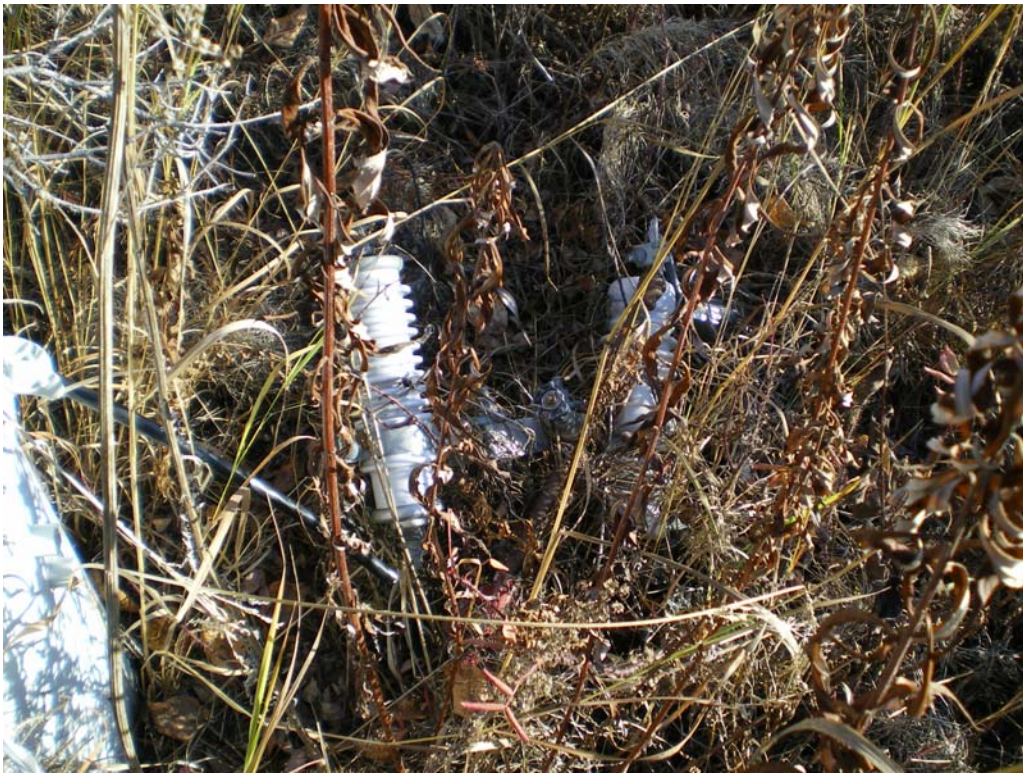
Figure A20. Second transformer, located in central area of former village site.

Figure A21. Close-up of second transformer.

Figure 22. Pieces broken off of tranformer.

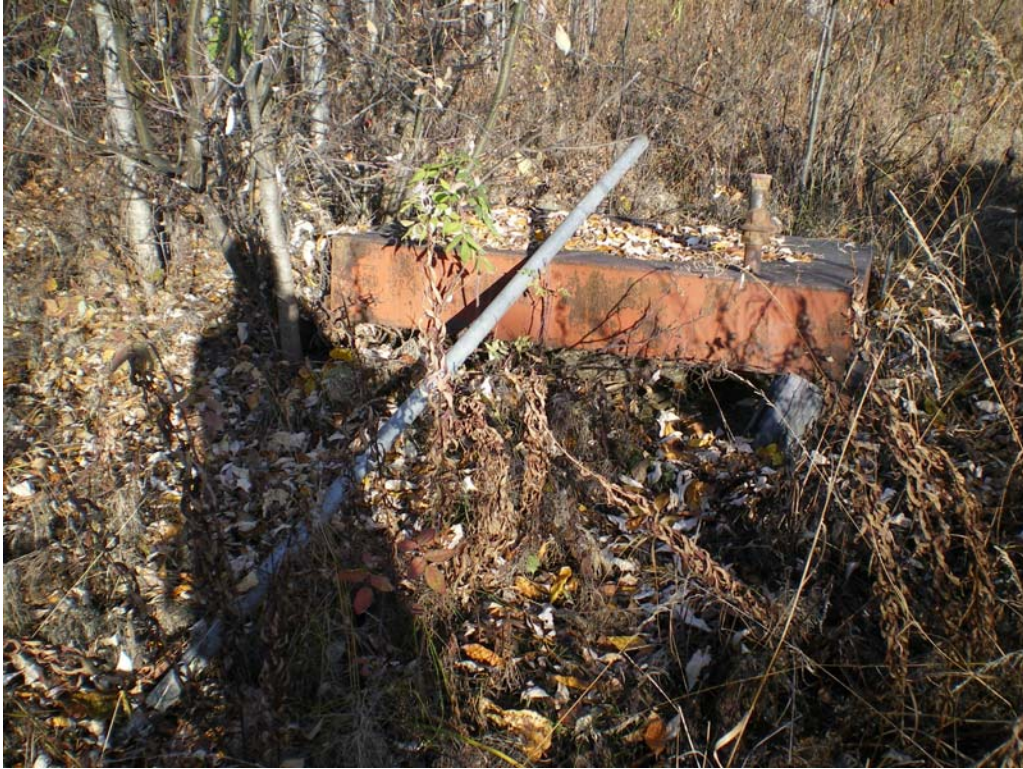
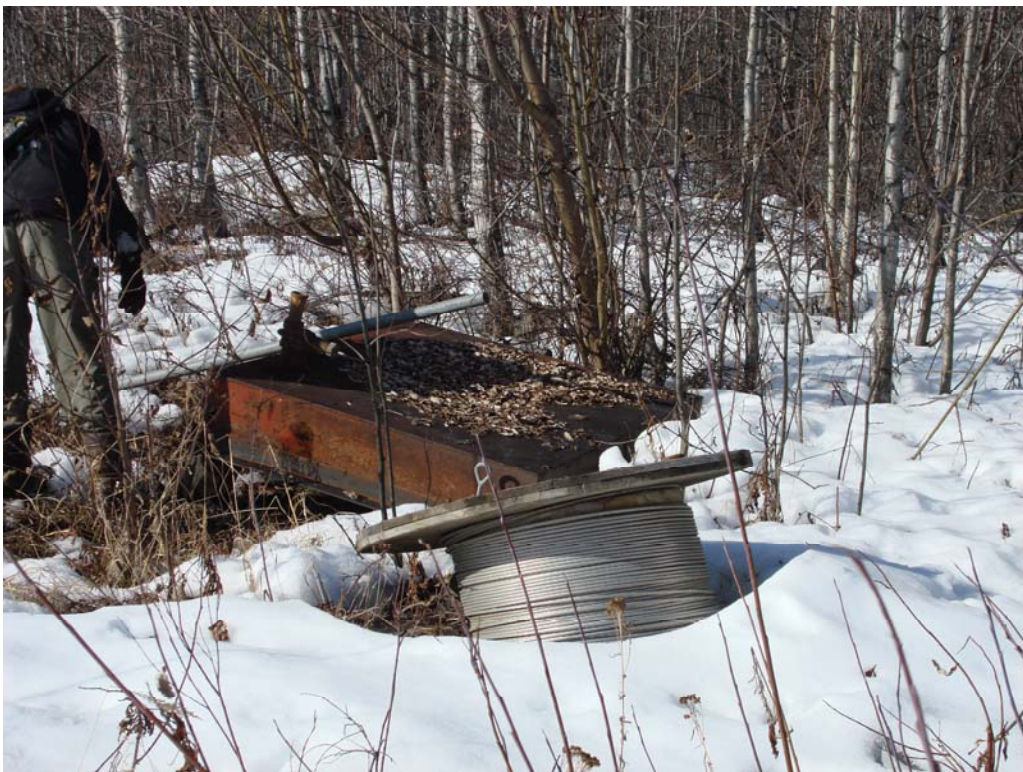
2. Fuel tank – a red, rectangular tank was observed, with dimensions of approximately 3 feet by 3 feet by 1 foot (Figures A23 and A24). Amelia Edwards identified it as a diesel fuel tank that was part of the former generator. The generator was constructed in the 1970s (Sam, 2007). The tank was improvised for it (Edwards, 2007). No hydrocarbon odors or stained soil were observed around the tank.
3. Refrigerator – one refrigerator was found in a shed that was shoved into a cabin (Figure A25). No other refrigerators or freezers were observed. Community members removed the majority of freezers and refrigerators as part of a cleanup event last spring.

- Items potentially containing hazardous materials include two transformers, one fuel tank, and one refrigerator. None of these items appeared to be leaking or punctured. There were no hydrocarbon odors around the fuel tank that would indicate a recent release.

Figure 23. Rectangular tank identified as a fuel tank and possibly containing diesel.

Figure 24. Fuel tank potentially containing diesel (Photo courtesy of Janelle Dayton, 4/2007)

Following the removal of the transformers, OASIS recommends removal and proper disposal of the items potentially containing hazardous materials, namely the fuel tank and the refrigerator.

The fuel tank must be decommissioned by an UST-certified contractor by pumping out any remaining fuel, cleaning, and dismantling the tank. If the tank is in good condition, it may be used again; if not, it may be backhauled. If there is a used oil heater in the village, the drained fuel may be burned. If not, it must be contained in Department of Transportation (DOT) certified drums and shipped to Anchorage for recycling.

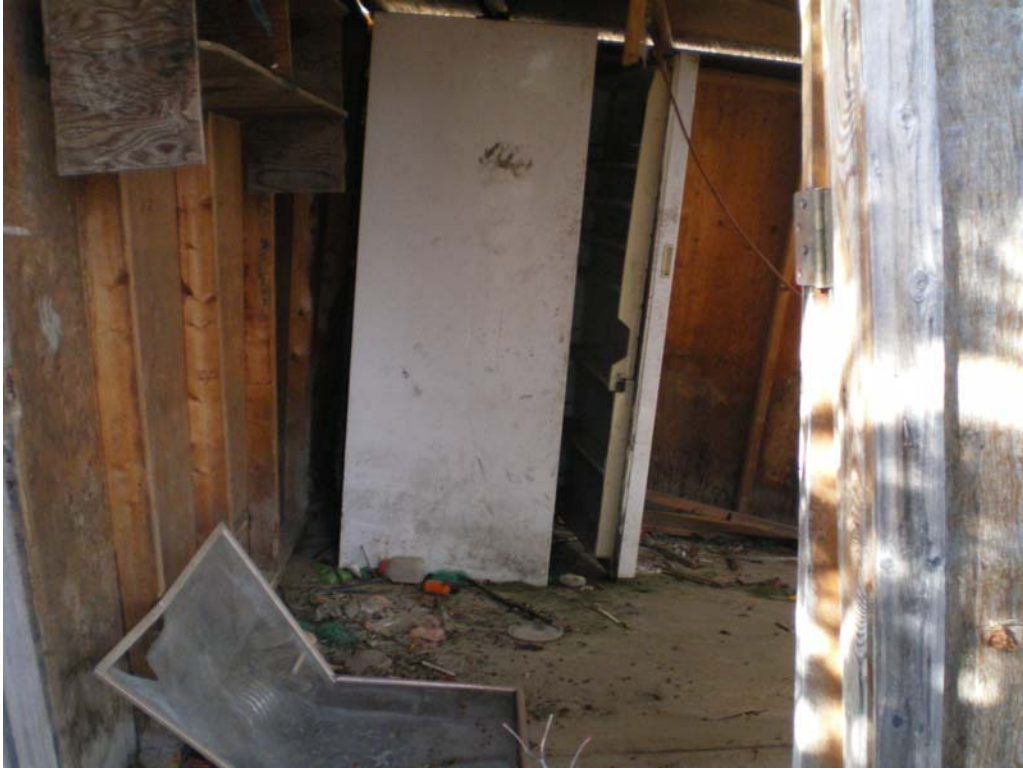
Figure 25. Refrigerator found inside shed.

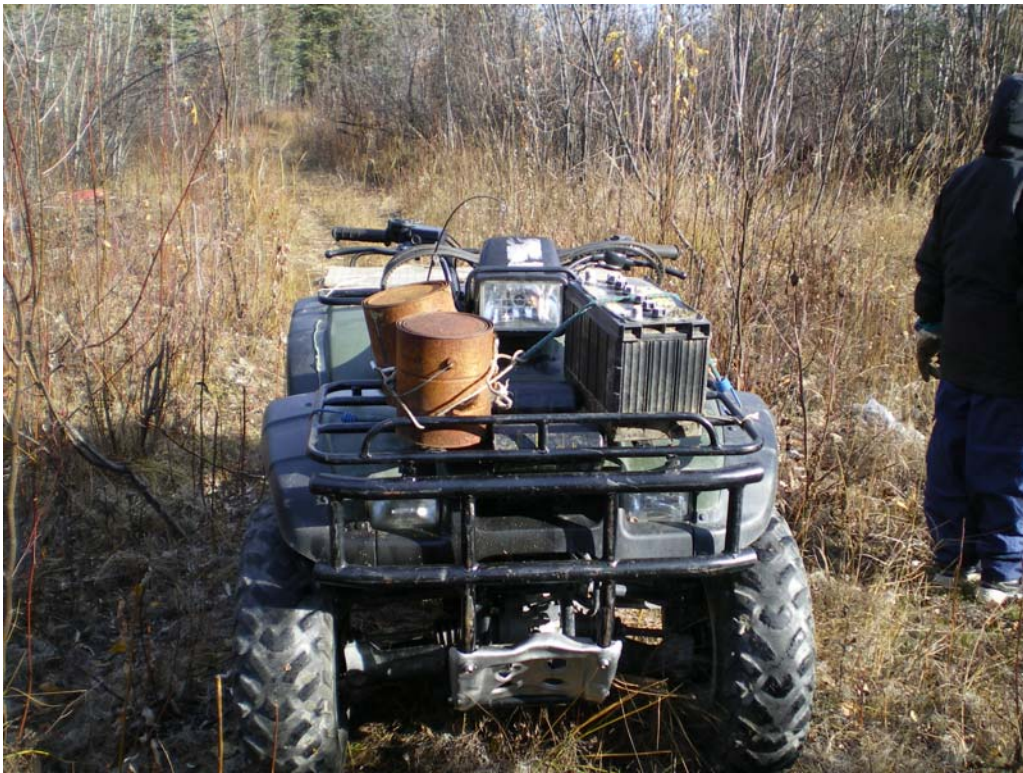
At the end of the site visit, Leonard Vent loaded a few items onto his ATV and transported them back to the current village site. The items included two small rusted buckets (contents unknown) and a large battery (Figure A26).

Figure 26. Two buckets and battery being hauled offsite.

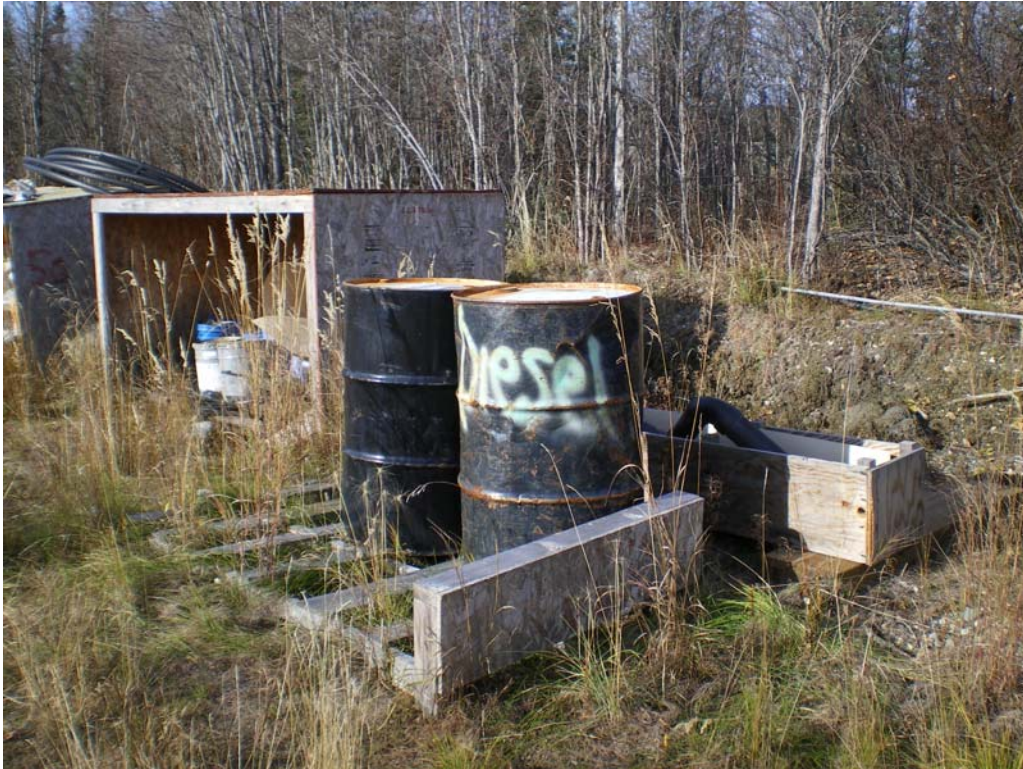
Figure C5. Two drums labeled as 'diesel.'

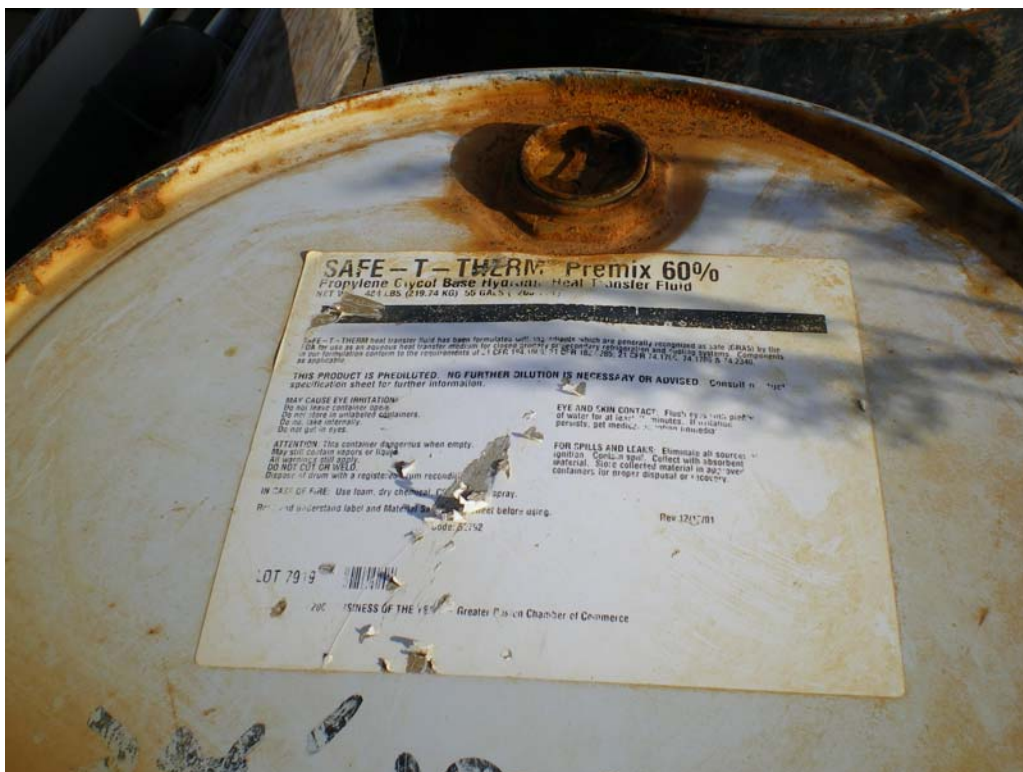
Figure C6. 55-gal drum labeled as propylene glycol.

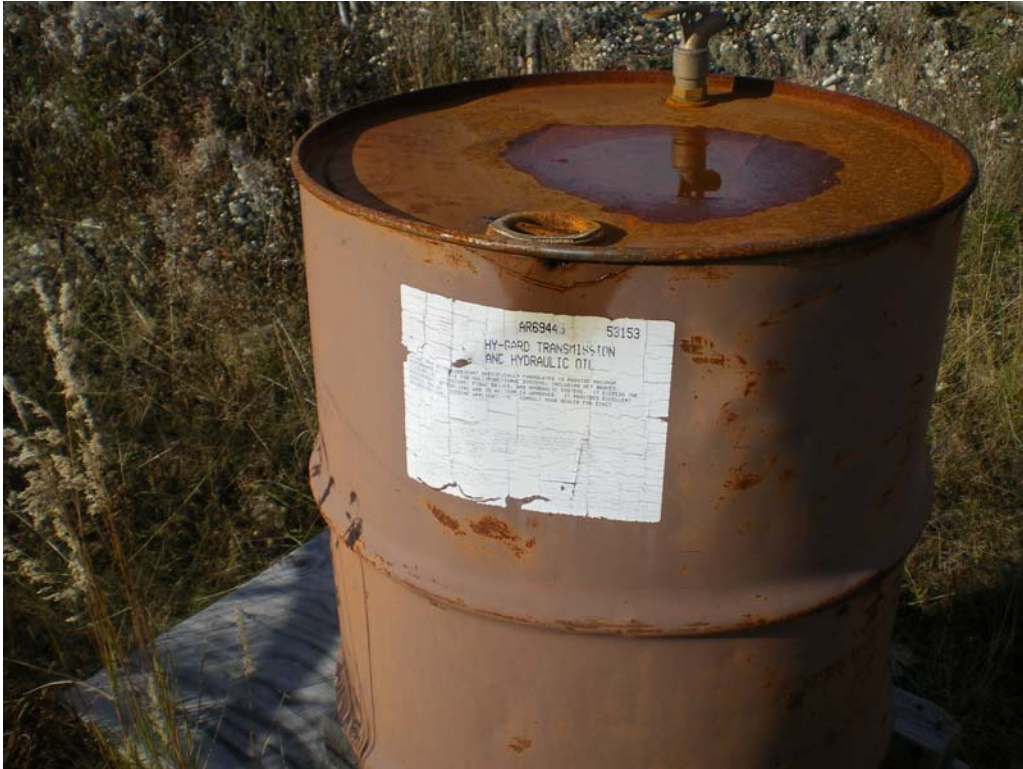
Figure C7. 55-gal drum labeled as hydraulic fluid.

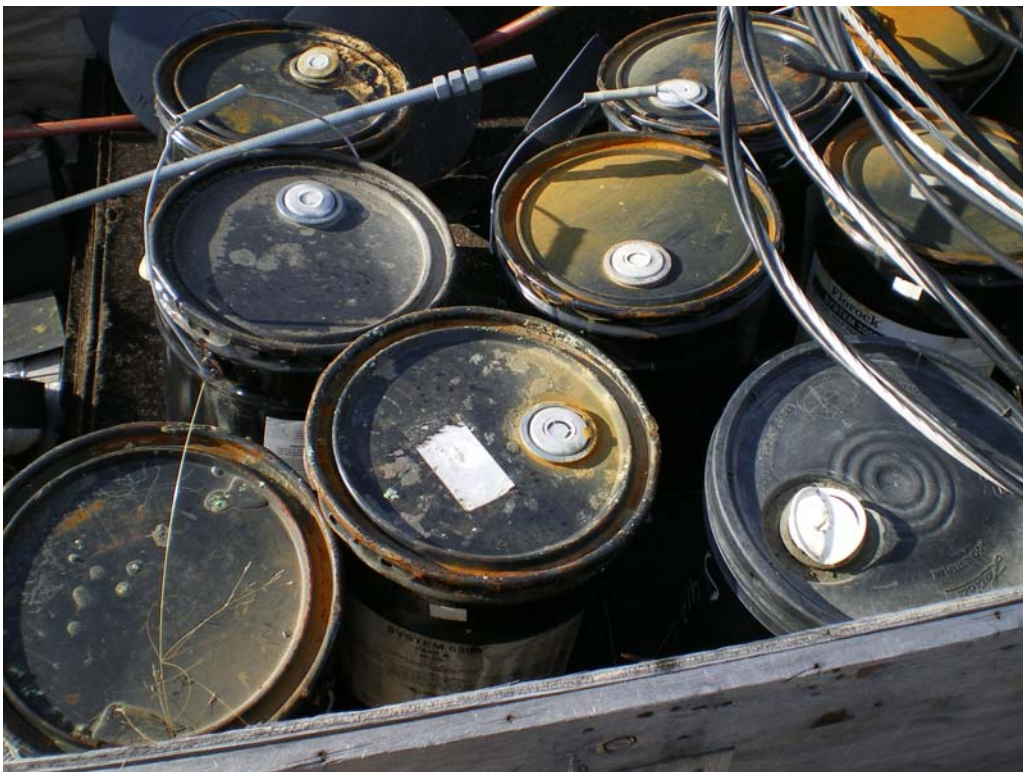
Figure C8. Buckets labeled as epoxy.

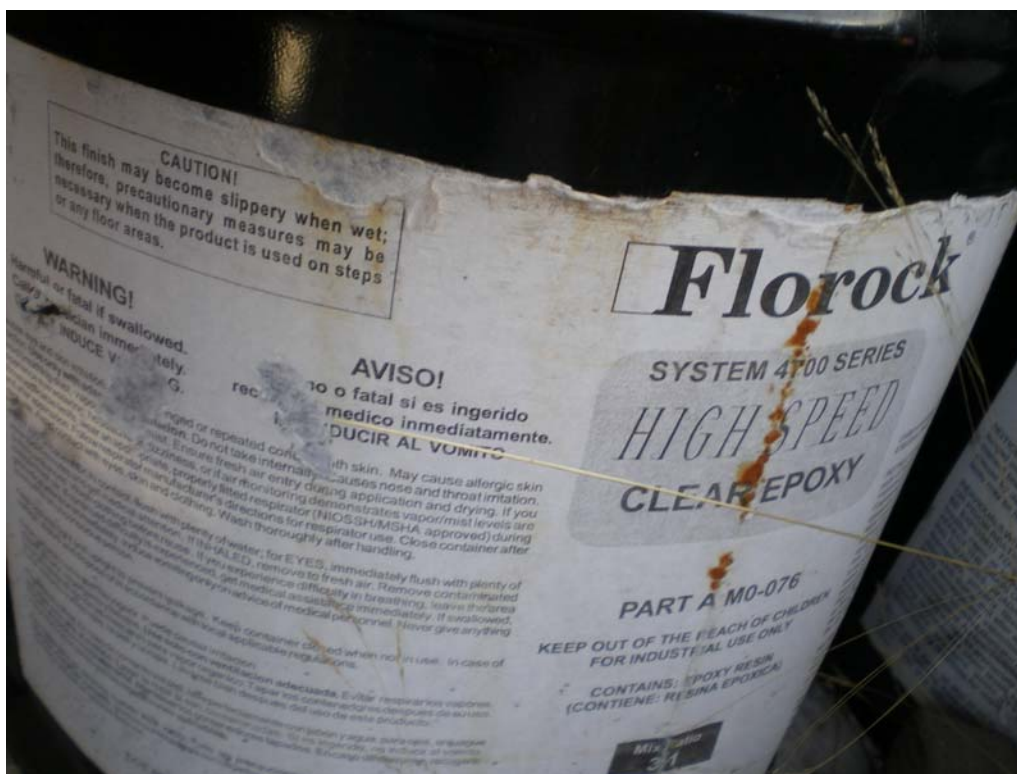
Figure C9. Bucket labeled as epoxy.
