Old Alatna Village Site

Environmental Audit

Alatna, Alaska

By:
OASIS Environmental, Inc
April 17, 2008

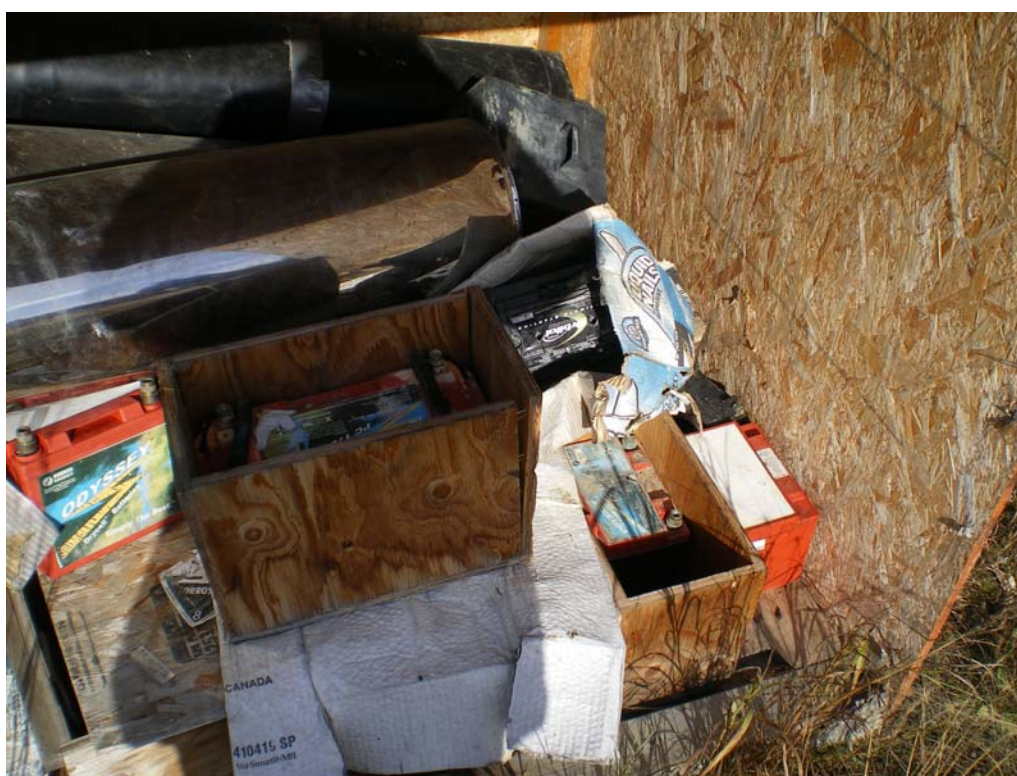
Figure C10. 12-volt batteries.
