Property Assessment and Cleanup Plan

Buckner Building

Whittier, Alaska

April 2015

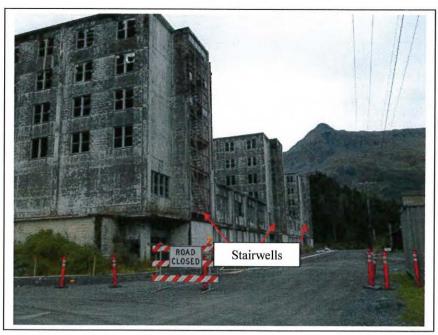
Photo H-1: Exterior of Buckner Building with exterior stairwells highlighted by arrows; looking southwest. (September 8, 2014)

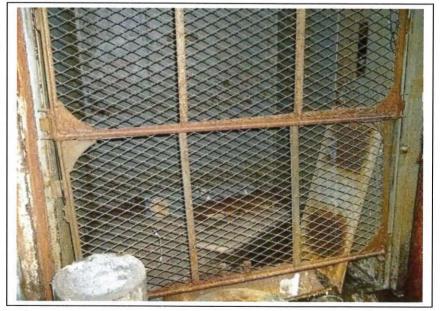
Photo H-2: Representative elevator. Note not all elevators had protective doors blocking the elevator shaft. (September 8, 2014)

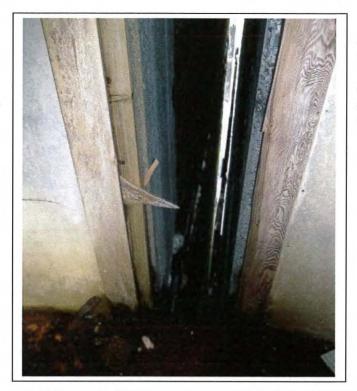
Photo H-3: Representative 8inch "crumple" joint that separates the Buckner Building's seven structural sections. (September 8, 2014)

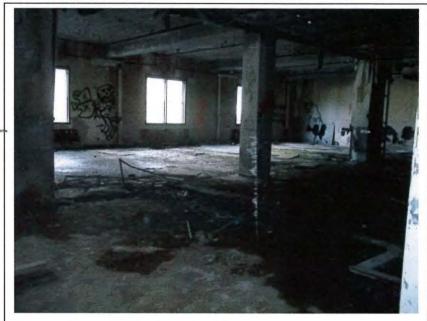
Photo H-4: Former owners and/or vandals have removed most valuables from the structure. In the photo above, the floor and ceiling tiles have been removed. (September 8, 2014)

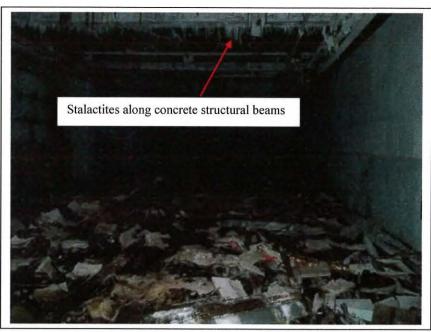
Photo H-5: Former bowling alley located in the basement of the Buckner Building. Presumed ACM-containing ceiling and wall tiles litter the floor of the former bowling alley. (September 8, 2014)

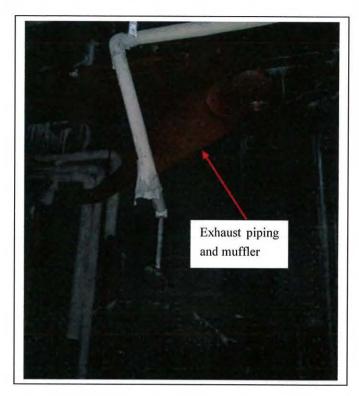
Photo H-7: Presumed muffler and exhaust piping for the former generator. The white piping insulation is suspected of containing asbestos.
(September 8, 2014)

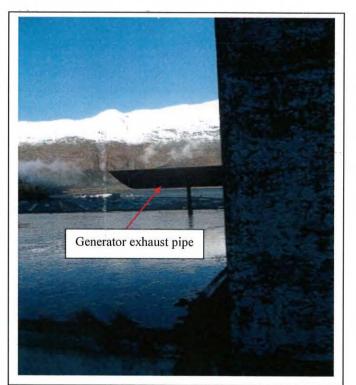
Photo H-8: The exhaust from the basement-level generator was conveyed to the rooftop via a pipe in the stairwell; looking west. (October 22, 2014)

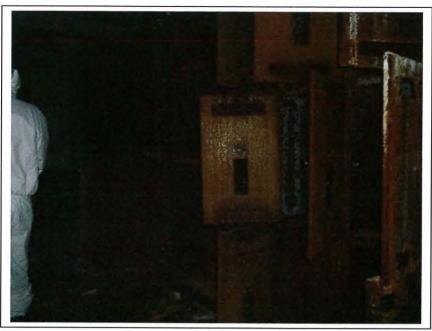
Photo H-9: Distribution panels in the Section A electrical distribution room. (September 8, 2014)

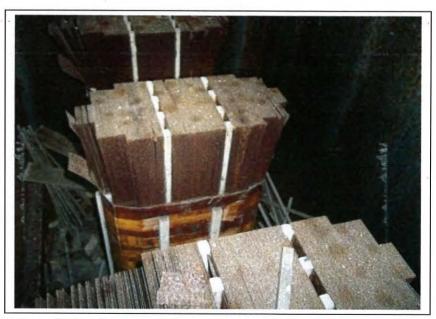
Photo H-10: Representative transformer plates in the Section A electrical distribution room. The transformer plates are suspected of containing asbestos. (October 22, 2014)

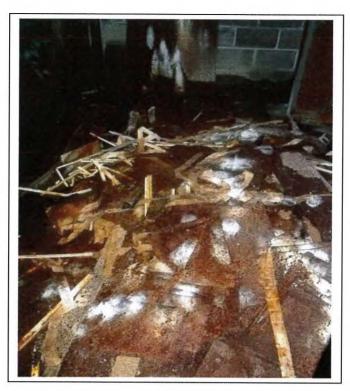
Photo H-11: Most transformer plates have been disassembled and discarded on the floor. Note the white spots on the transformer plates are minerals deposits that have dripped from overhead stalactites. (October 22, 2014)

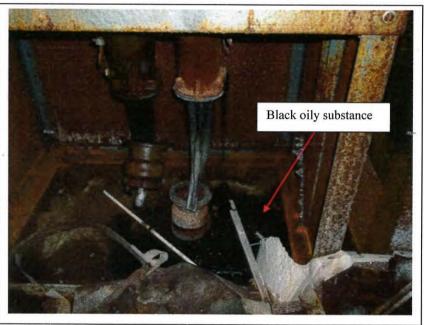
A black, oily substance was observed beneath the oil-filled switches in the basement electrical distribution rooms. Based on our current understanding of the switches, the oil may contain polychlorinated biphenyls (PCBs). In addition, light ballasts likely containing PCBs were observed dangling from the ceiling throughout the structure. There is a potential that PCBs from the switches and light ballasts have impacted the building's floor and have the potential to enter floor drains. PCBs are regulated under the Toxic Substances Control Act (TSCA) and DEC contaminated site regulations.

Photo H-12: A black, viscous, oily substance was observed beneath the former oil-filled switches in the Section A electrical distribution room (shown on Figure 4). The oil is suspected of containing PCBs. (October 22, 2014)

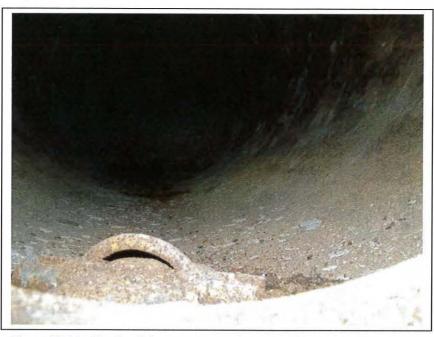
Photo H-13: Each of the two approximately 5,000-gallon tanks in the basement mechanical room are empty. It is presumed that the tanks were formerly used as hot water tanks. (October 22, 2014)

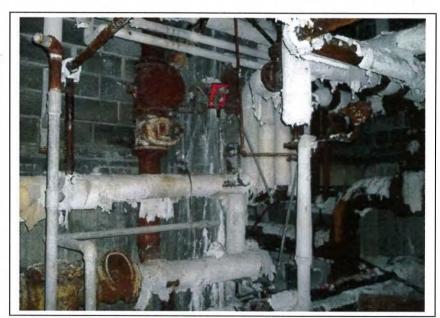
Photo H-14: Pressure reducing system and condensate return lines in the basement mechanical room. Note the white piping insulation is suspected of containing asbestos. (October 22, 2014)

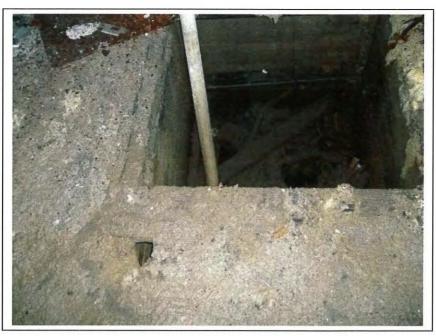
Photo H-15: The mechanical room sump contained standing water during each of our 2014 site visits. Note the floor is covered by a presumed asbestos slurry. (September 8, 2014)

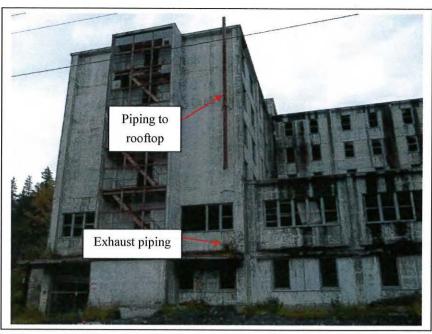
Photo H-17: Presumed bakery and kitchen exhaust piping; looking southeast. (September 8, 2014)

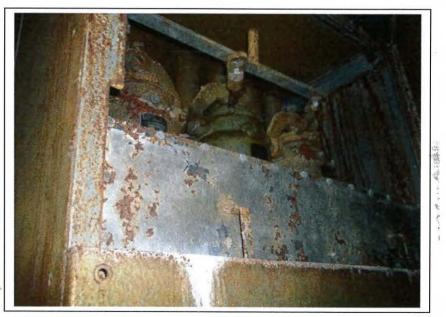
Photo H-18: It is presumed that the oil-filled switches remain intact behind the gray panel; electrical distribution room in Section E of the basement. (October 22, 2014)

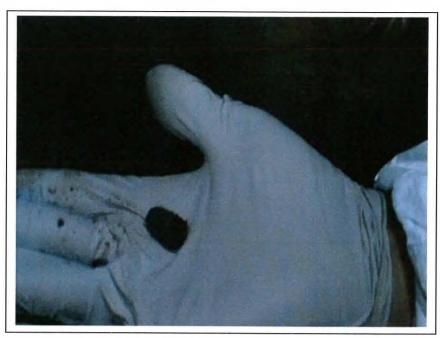
Ammunition fragments are present at the target line of the former rifle ranges in the basement of the Buckner Building. Because these fragments likely contain lead, it is our experience that both the target line sand and spent ammunition fragments are solid wastes subject to hazardous waste regulation under the Resource Conservation and Recovery Act (RCRA).

Photo H-19: Lead fragments from spent bullets were observed in the target line sand of the basement rifle ranges. (October 22, 2014)

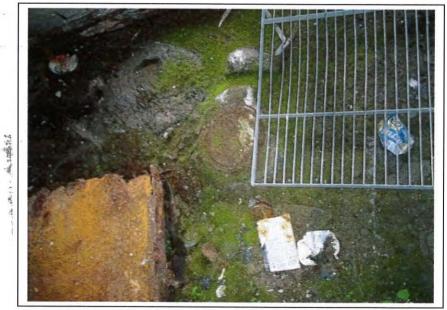
Photo H-20: Representative floor of a ground floor room covered with moss and other litter/debris. (September 8, 2014)

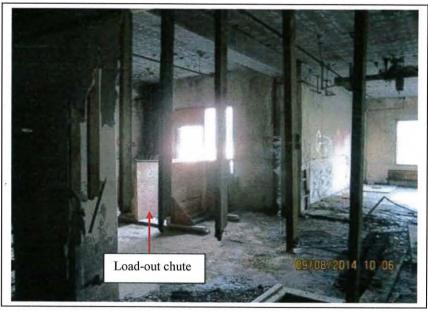
Photo H-22: What appears to be a load-out chute was observed on the ground floor level near the juncture of Sections A and C. (September 8, 2014)

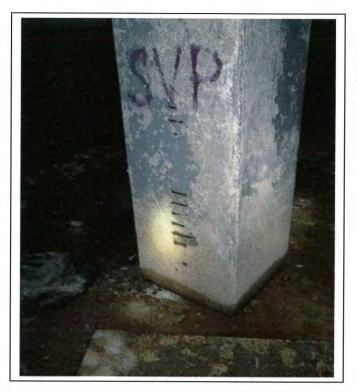
Photo H-23: Representative ground-floor structural column. Note that the concrete has spalled exposing the rebar. (October 22, 2014)

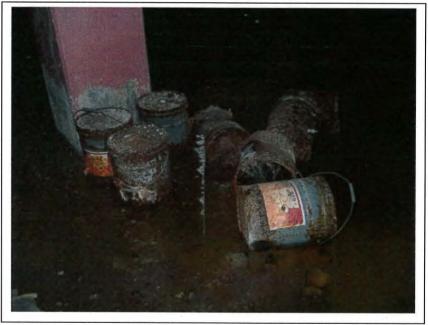
Photo H-24: Five-gallon buckets of the adhesive "DAP." Note the buckets were full of a solid black material. (September 8, 2014)

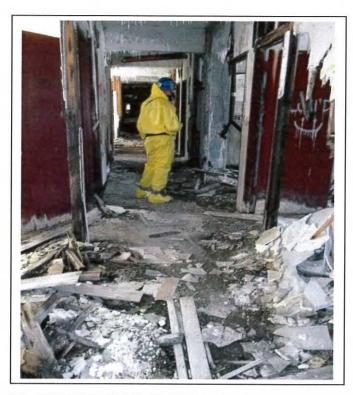
Photo H-25: Representative third floor hallway. Wallboard and ceiling tiles are suspected of containing asbestos. (September 8, 2014)

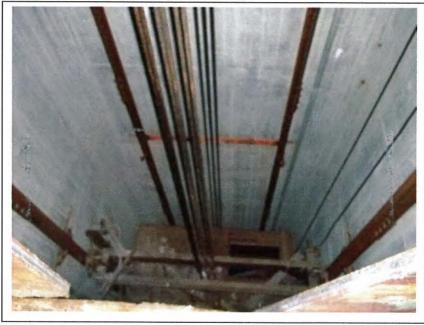
Photo H-26: Third floor elevator shaft without safety barricade or gate. (September 8, 2014)

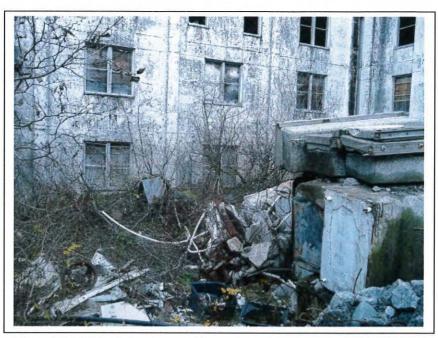
Photo H-29: Debris observed between Sections B and C; looking north. (October 22, 2014)

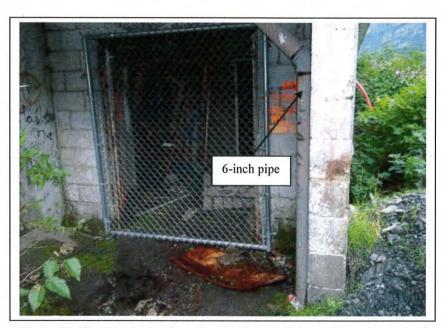
Photo H-30: Six-inch pipe observed near the northeast corner of the structure; looking northwest. (October 22, 2014)

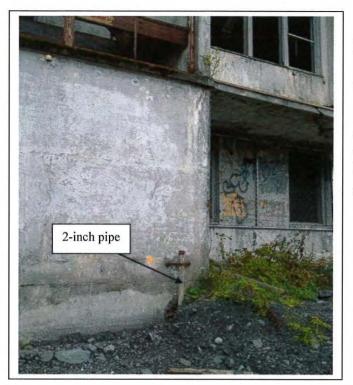
Photo H-31: Two-inch pipe observed near the northwest corner of Section C; looking southeast. Note that based on the size, location, and construction of the pipe, the pipe may be a vent pipe associated with an undocumented UST. (September 8, 2014)

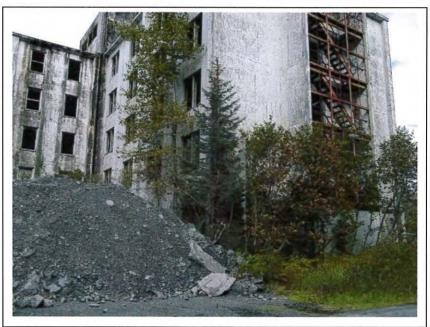
Photo H-32: Soil, asphalt, and concrete rubble stockpile observed between Sections E and G; looking north. (September 8, 2014)

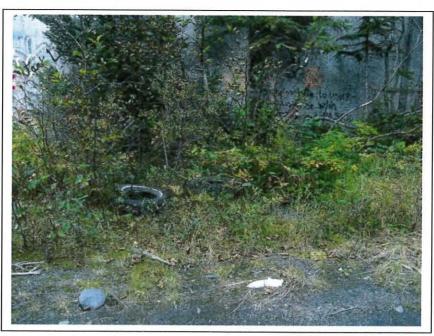
Photo H-33: Tire and litter observed along the north side of Eshamey Loop, adjacent to north side of the Buckner Building; looking northwest. (September 8, 2014)

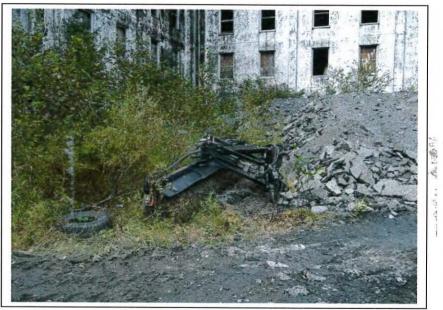
Photo H-34: Discarded materials observed between Sections E and G; looking west. (September 8, 2014)

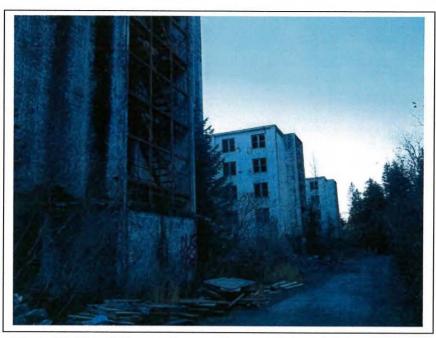
Photo H-35: Pallets and general construction debris observed between the Buckner Building and Eshamey Loop; looking northeast. (October 22, 2014)

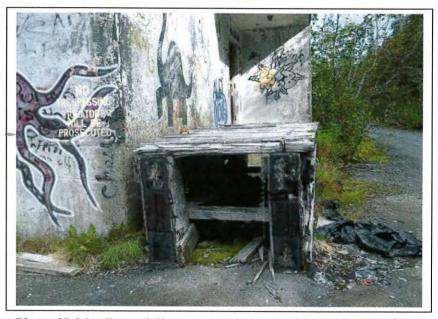
Photo H-36: Potentially creosote-treated railroad ties and litter observed near the southeast corner of the Buckner Building; looking northeast. (September 8, 2014)

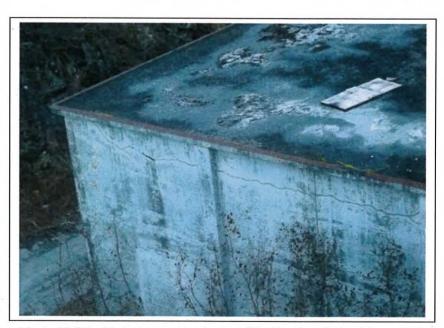
Photo H-38: Exterior crack observed in Section B; looking south from fourth floor Section A. (October 22, 2014)

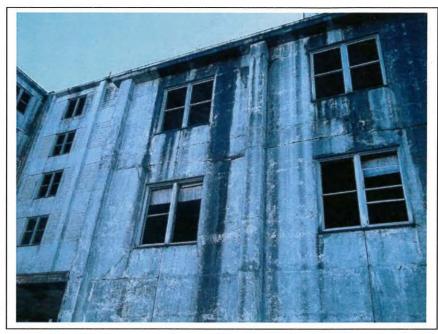
Photo H-39: Many exterior cracks appeared to form at individual floor levels; looking southeast. (October 22, 2014)
