¹ Southeast Alaska Watershed Coalition, project #ACWA-23-05 funded by Alaska DEC from an EPA pass through grant

Summary

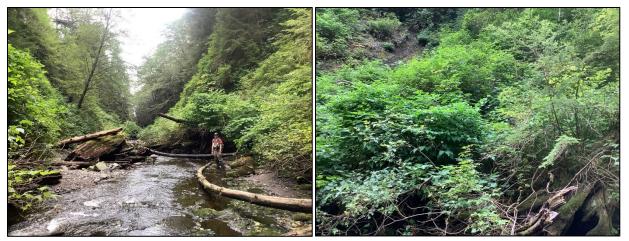
Figure 7. Left: Large knotweed infestation (behind person), view from downstream. Right: Knotweed spreading on river left (lower left of image).

- Invasive plant survey and management; especially knotweed, including along the stream and in the neighborhood area on the east side of Carlanna creek.
- Restore damaged riparian vegetation in the downstream developed areas and on steep slopes to prevent erosion (Figure 9).
- > Education and outreach about not dumping yard waste into the riparian area.
- Establish a setback from the terrace edge for any future development.
- > Potential stormwater BMP project (requires additional vetting for feasibility and efficacy):
 - Explore stormwater BMP opportunities for parking lot runoff on the property NW of Tongass Ave., including enhancing the riparian area and/or the drainage ditch (Figure 9).

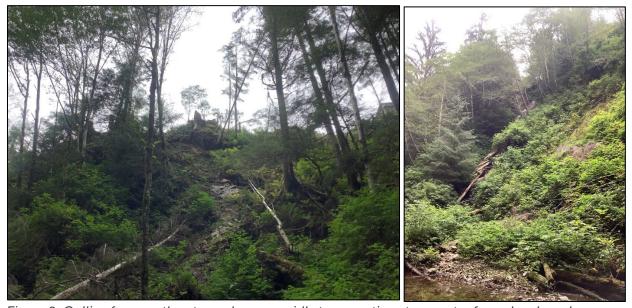
The steep stream banks are prone to erosion, particularly if native vegetation is removed or replaced with certain invasive species like knotweed (Matte et al., 2021). Damaged riparian vegetation was documented downslope of the residential development on the west side (river right) (Figure 8), and there were areas of erosion around stormwater outfalls on the east side (river left)

Figure 8. Gullies form on the steep slopes, rapidly transporting stormwater from developed areas on the terrace to the stream. The gully shown in the right photo is below a stormwater outfall.

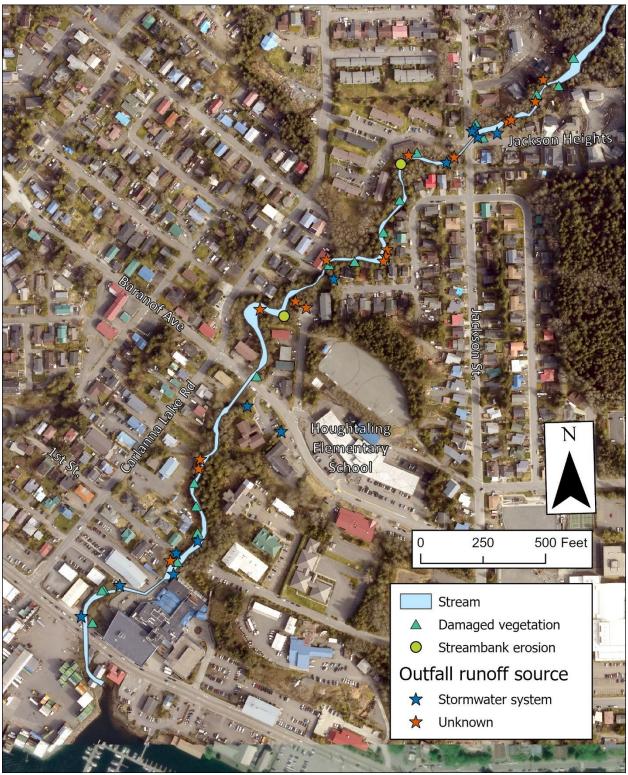
In addition to the impervious and semi-pervious development in the buffer, many locations where natural vegetation had been damaged by cutting, disposal of yard debris, and/or erosion associated with development were noted (Figure 13, Figure 14). These areas provide less functional habitat for wildlife and fish and make the banks more susceptible to erosion and should be a target for restoration. Additionally, many outfalls of local drains separate from the city stormwater system (e.g. French drains from private property) were documented along Hoadley Creek. Some outfalls empty onto bare soil, potentially contributing to erosion or increasing the risk of mass wasting events by saturating the soil, while other drains extended nearly to the creek, bypassing potential stormwater treatment in the riparian buffer (Figure 15). Outreach to landowners adjacent to the creek could improve storm drain outlet BMPs.

Figure 13. Locations where native riparian vegetation has been damaged and increased erosion risk, and other locations where the bank is being actively eroded and/or undercut. Additionally, locations of stormwater inputs with runoff source indicated ("Stormwater system" is indicated where outfall locations correspond to mapped outfalls on city stormwater maps).

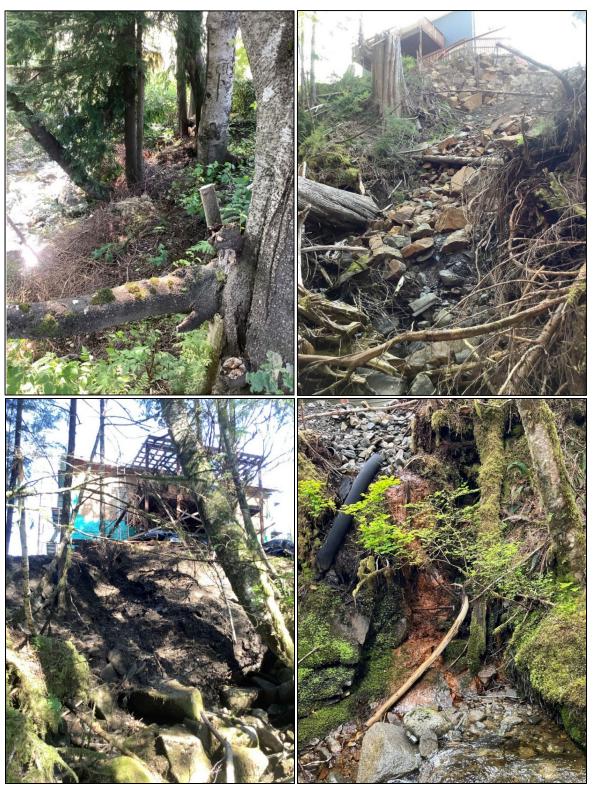
Figure 14. Damaged vegetation and erosion along Hoadley Creek. Top left: yard debris choking native vegetation. Top right: large rock and debris pushed over the terrace edge. Bottom left, Damaged vegetation and erosion below new construction. Bottom right: a displaced sediment filter sock and sediment-laden runoff below new construction.

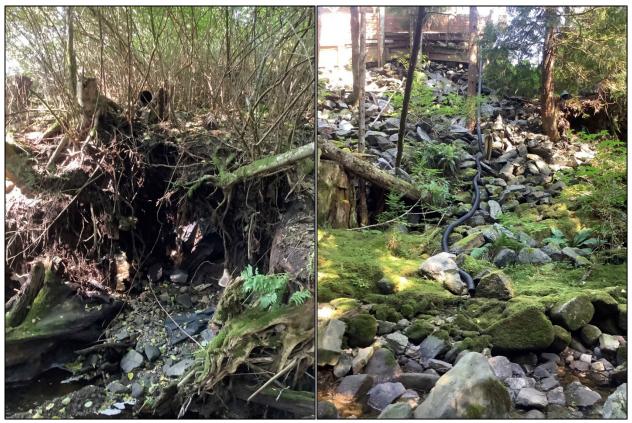
Figure 15. Local drains empty onto bare soil (left) or right next to the creek (right).

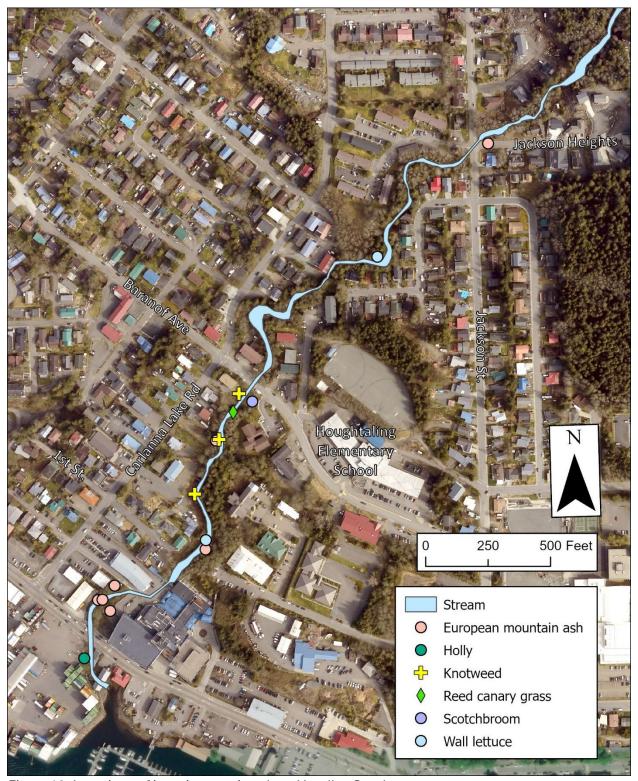
Figure 16. Locations of invasive species along Hoadley Creek.

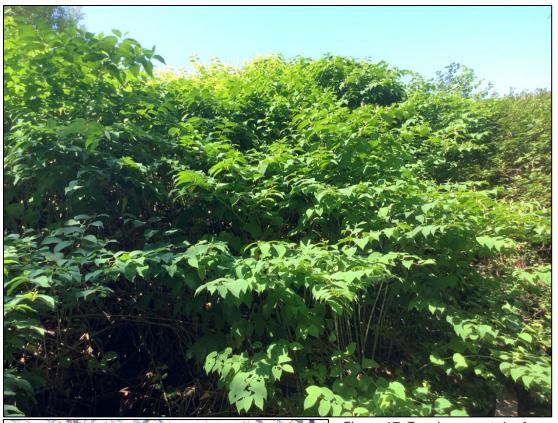
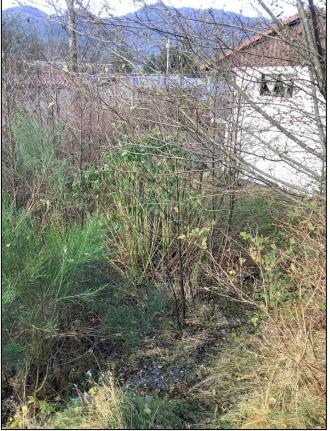
Figure 17. Top: Large patch of knotweed between Baranof Ave. and 1st St. that extends from the creek up and over the bank.
Bottom:: a patch of knotweed (center midground) just downstream of Baranof Ave only visible after the surrounding alder lost their leaves, with non-native invasive Scotchbroom in the foreground.

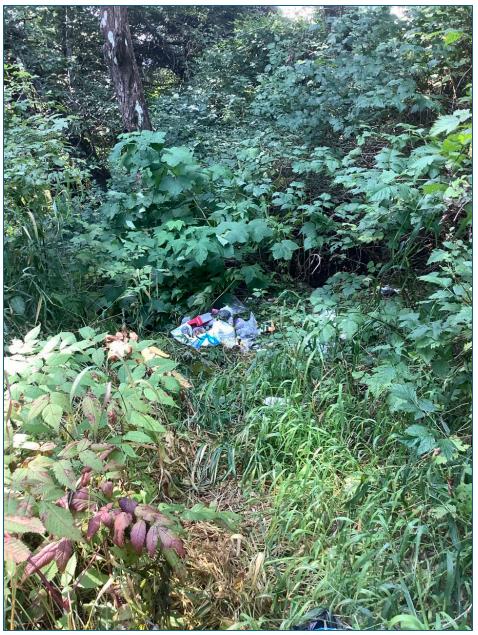
Figure 18. Litter spread through the vegetation just downstream of Baranof Ave.

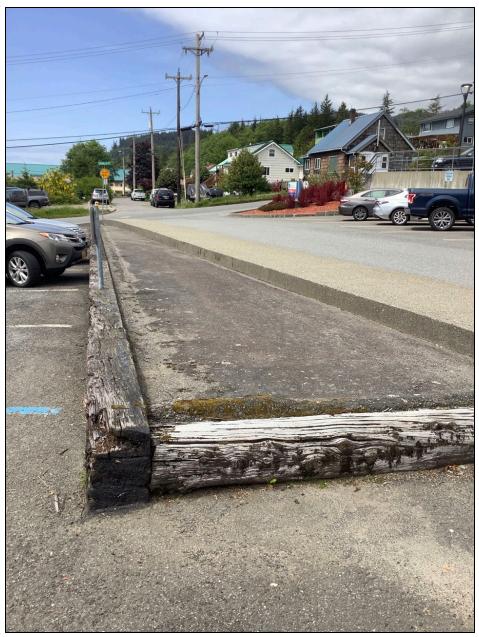
Figure 19. An unused paved area at 130 Carlanna Lake Rd. that could be converted to an infiltration basin or bioswale and capture and treat stormwater runoff from the upper parking lot and/or part of the lower lot.

- o Tongass Ave. bridge area
- Potential stormwater BMP opportunities (all require additional vetting for feasibility and efficacy) (Figure 23):
 - Create an infiltration basin in the parking lot of professional building at 130 Carlanna Lake Rd. (area that is already non-functional for parking) (Figure 19)

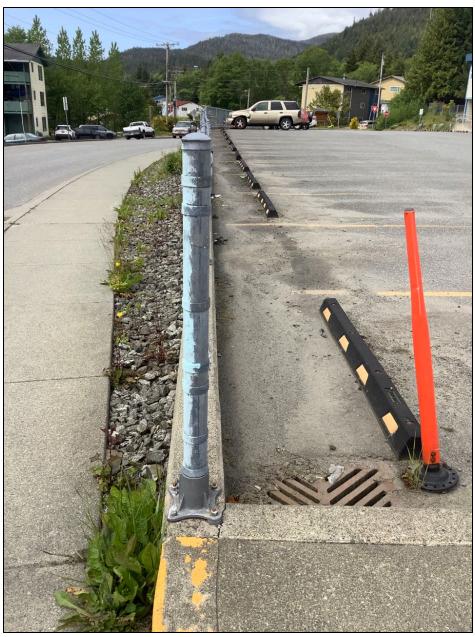
Figure 20. Existing gravel strip in front of Houghtaling Elementary Parking lot. The area could be modified to direct parking lot runoff to the gravel strip for infiltration and treatment before reaching the stormwater system.

- Explore ways to re-route stormwater into gravel area between sidewalk and parking lot of Houghton Elementary along Baranof Ave. to create a retention basin/bioswale (Figure 20).

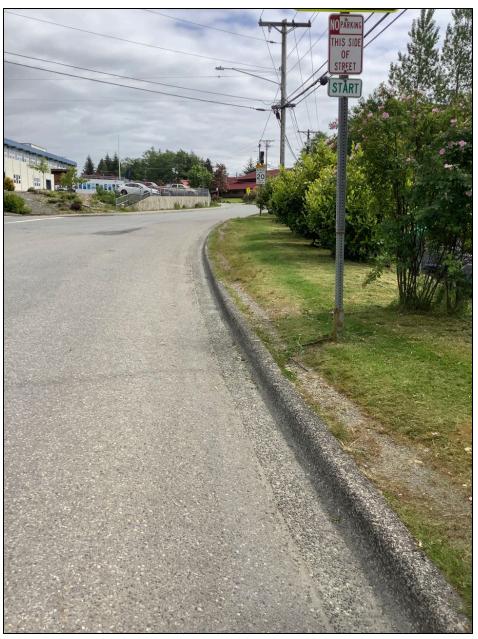
Figure 21. An undeveloped strip of land along Baranof Ave. near Hoadley Creek Crossing that could be modified to accept street runoff before it reaches storm drains. For example, curb cuts and an infiltration basin could be installed.

- Create curb cuts and an infiltration basin along the downstream side of Baranof Ave to the east of Hoadley Creek (Figure 21).
 - Explore BMP options and potential efficacy at the NE corner of Jackson Heights and Jackson St. (Figure 22).

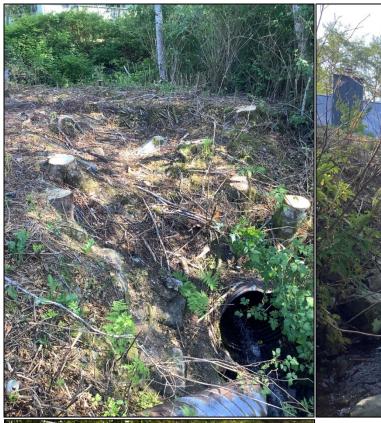
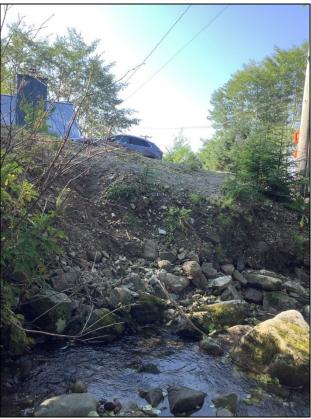
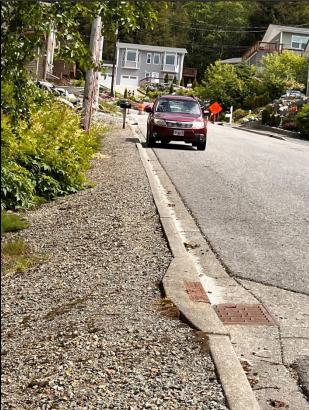
Figure 22. Ketchikan Gateway Borough-owned land at the upstream corner of Jackson Heights and Jackson St. where riparian restoration would be beneficial, and stormwater BMP opportunities could be assessed.

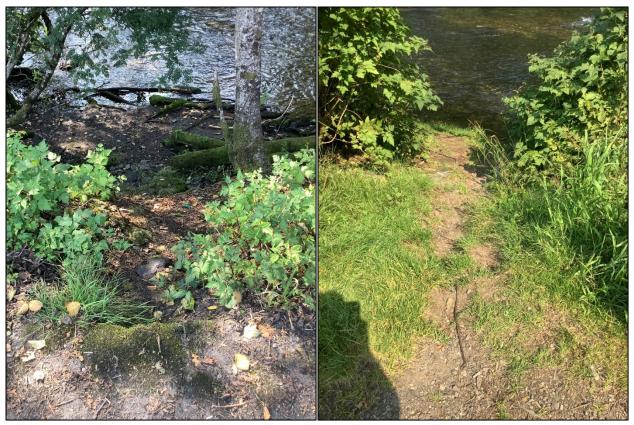
Except for a few areas, most of the vegetated riparian buffer is easily accessible to the many tourists and locals who enjoy Ketchikan Creek. Consequently, there are many social trails and areas with damaged vegetation, which has contributed to the formation of gullies and erosion (Figure 27). This is especially prevalent along Freeman St., Totem Dr. and the gravel trail upstream, Salmon Rd. and the gravel trail upstream, and by the skate park. Vegetation along these areas has also been damaged by mowing, cutting, and yard debris (Figure 28). Developing sanctioned trails with proper drainage that access popular spots and restoring the existing vegetated areas to reduce gully formation could help reduce erosion and increase the treatment of runoff that currently reaches the riparian buffer.

Figure 27. Examples of social trails along Herring Way (left) and Freeman St. (right) that damage vegetation, increase the risk of bank erosion and promote the formation of gullies that concentrate runoff and reduce infiltration and treatment potential.

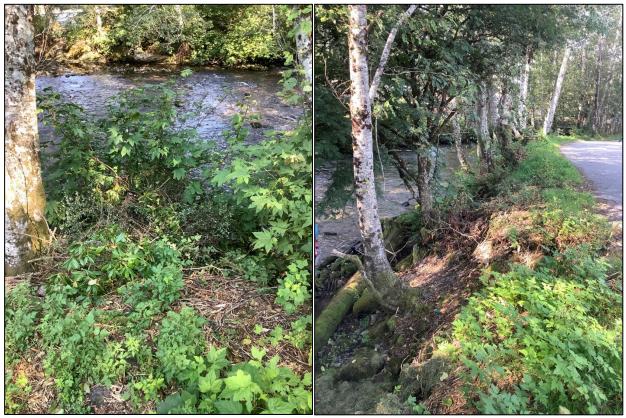
Figure 28. Yard clippings dumped in a narrow riparian buffer strip (left), and a long, narrow buffer strip with mowed/damaged understory (right) along Herring Way.

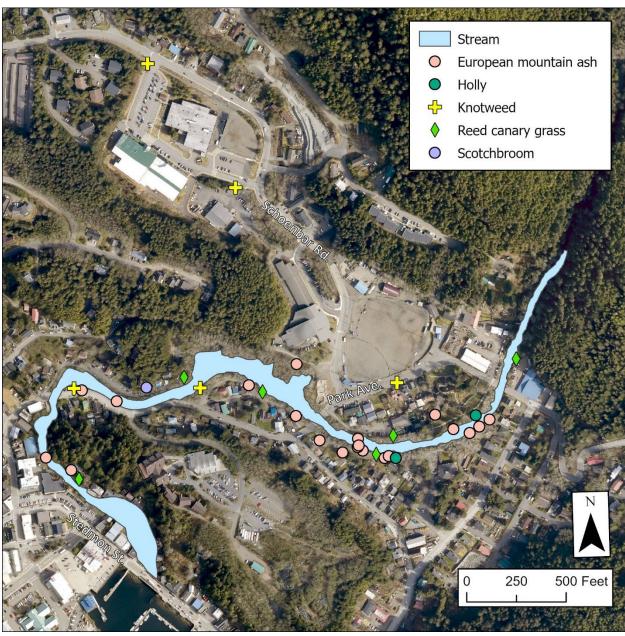
Within vegetated areas, many invasive species, including knotweed, reed canary grass, European mountain ash, and holly were identified (Figure 29). Several knotweed infestations observed along the creek, including just upstream of the Park Ave. bridge and at Freeman St., are noticeably growing over time and need to be controlled (Figure 30). There are additional infestations along Schoenbar Creek downstream of Valley Forge and at the entrance of the Borough Parks and Recreation facility that should also be addressed to prevent downstream spread. European mountain ash was prevalent along and upstream of Totem Way, where holly was also interspersed (Figure 31).

Figure 29. Invasive species documented along Ketchikan Creek

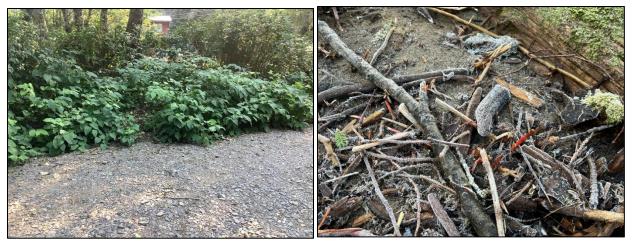
Figure 30. Knotweed on Ketchikan Creek by Freeman St (left). The patch was cut back but is regrowing (left). All cuttings must be bagged and disposed of to prevent the spread of vegetative propagules.

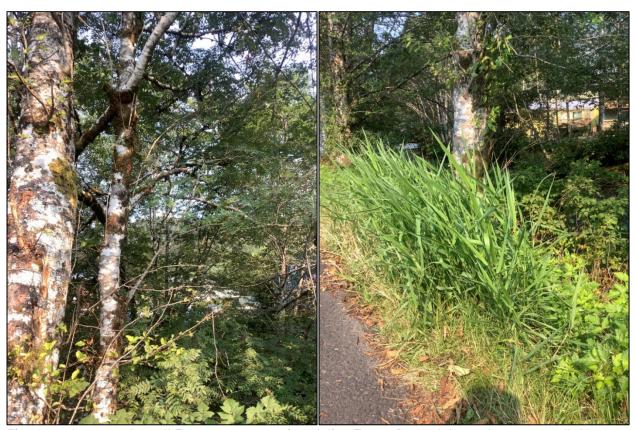
Figure 31. Large and small European mountain ash line Totem Dr. and the path upstream (left). Reed canary grass in a disturbed strip of vegetation along Totem Way.

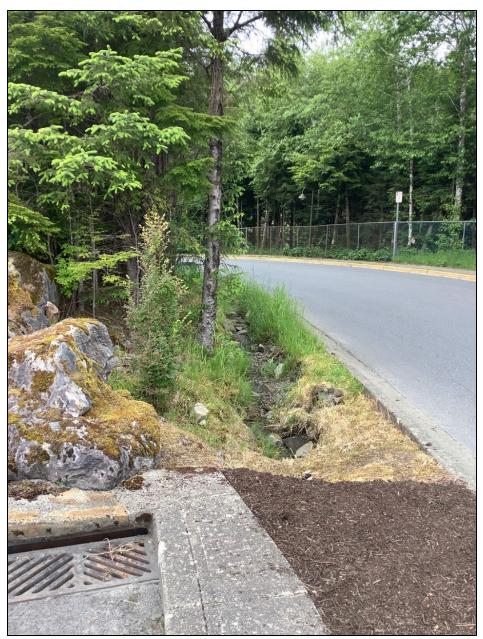
Figure 32. Storm drain at a low point of the Cape Fox Lodge parking lot and the top of a drainage ditch that extends downhill to Park Ave that could be enhanced as a biofiltration swale with check dams and vegetation to promote infiltration and water treatment. Curb cuts could be added to direct more street runoff to the ditch.

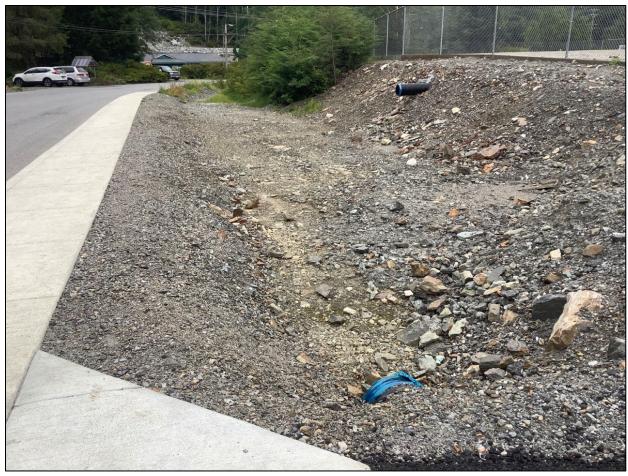
Figure 33. Unvegetated gravel ditch along the south side of Schoenbar road that could be upgraded with check dams, vegetation, and curb cuts to intercept, infiltrate and treat stormwater runoff (biofiltration swale).

o Install check dams and vegetate the gravel ditch area along Schoenbar Rd. in front of the charter school and ball field.

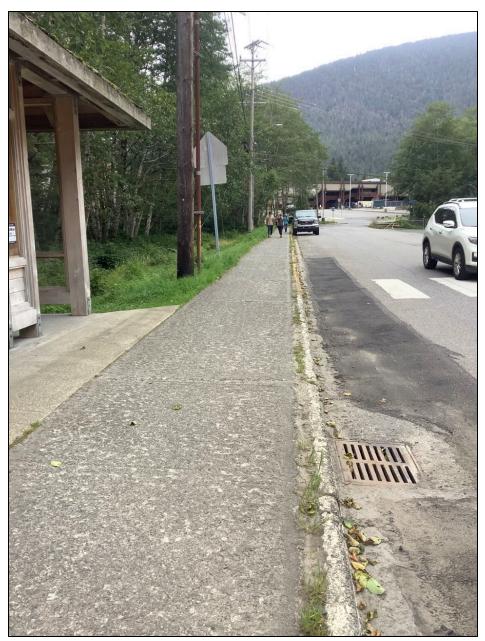
Figure 34. Vegetated buffer on the south side of Schoenbar Rd. that could accept and treat street runoff via curb cuts before it reaches the storm water system. Stormwater treatment capacity of the area could be upgraded with a bioswale or filtration trench.

- Create a bioswale or other GSI feature and install curb cuts along Schoenbar road between the charter school and middle school to allow street runoff to enter the vegetated riparian area instead of the storm drain system.'
- Reclaim/revegetate or create a green stormwater feature on the uphill entrance to the middle school.

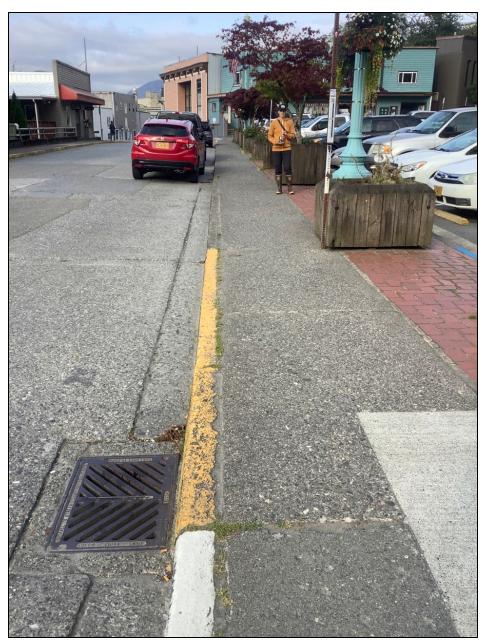
Figure 35. Raised planters on Dock St. that could be converted to bioretention planters that receive and treat runoff from the parking lot and/or street.

- Convert raised planters along Dock St. to bioretention planters that accept runoff from the parking lot and/or street.
 - Re-grade the parking area and roundabout to direct more runoff to the existing vegetated area by the Totem Heritage Center. The vegetated area may better infiltrate and treat stormwater with more porous substrate and/or different grading.

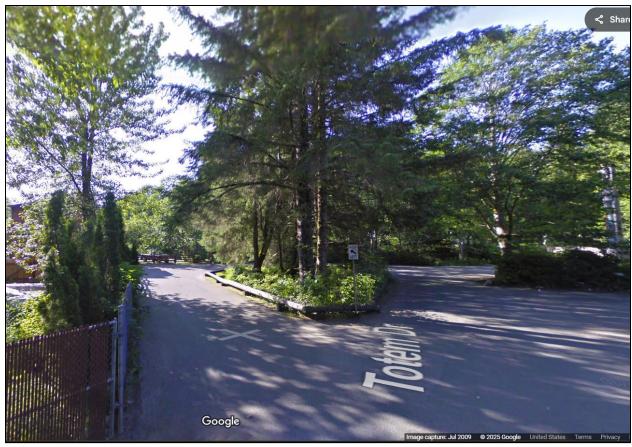
Figure 36. Existing vegetated area in front of the Totem Heritage Center. The existing drainage system passes through the area, and the road and parking lot could be regraded to direct more water into the area. The vegetated area could be upgraded to a biofiltration swale with more porous substrate and/or alternative grading to promote infiltration and treatment before water leaves through a drain and enters the stream a few meters away.
