City of Seldovia

FINAL Stormwater Management Plan

P.O. Box B
Seldovia, AK 99663
February 20, 2025

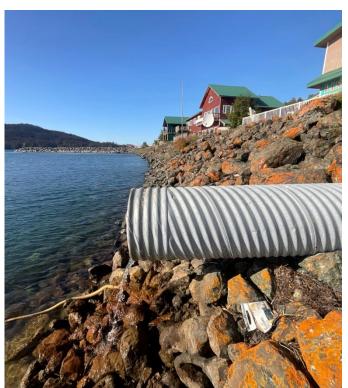
Photo: Outfall of SEL System (SEL-S-006)

The SEL system crosses Main Street and collects flow along Main Street from the City of Seldovia Central Park to Harborview Drive via SEL-S-005 (curb inlet). The system then outfalls onto the harbor's breakwater via SEL-S-005. This outfall is in good condition.

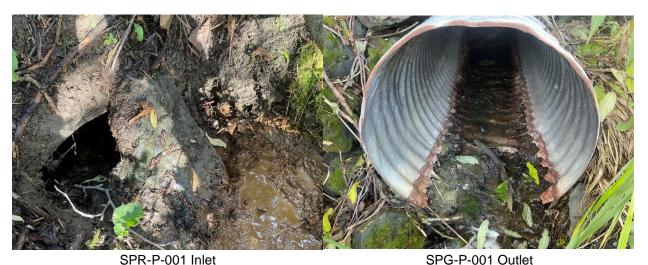
Figure 2. Select Photos – SPR and SPU

Spring and Spruce streets are located in the northwest corner of City limits and provide drainage for Vista Avenue, the City boat yards, and some residences along Spruce Street. The terminus of these systems consists of two culverts (SPG-P-001 and SPU-P-001) that outfall onto Inside Beach. City Public Works noted that the southern detention basin at the intersection of Spruce and Spring Streets often ponds and that the ditch along Spring Street is in bedrock. The inlet of SPU-P-001 was dug out during field inspections.

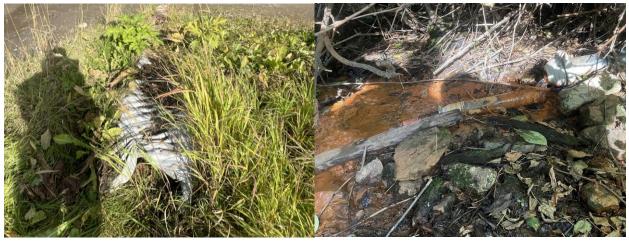
VIS-P-003 Inlet
Figure 3. Select Photos – VIS

The water exiting VIS-P-001 contains a large amount of orange flocculant, which could indicate ironrich ground water. The HDR team spoke with several local residents about drainage along Vista Avenue. Additionally, the City mentioned that they are actively replacing corroded water lines in this area, which is an issue not experienced in other areas of the town.

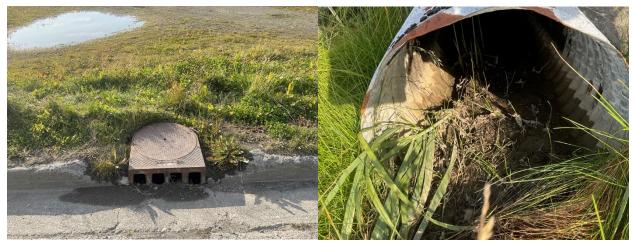
BYD-S-002 BYD-S-003 Outlet Figure 4. Select Photos – BYD

The City boat yards are located at the northern end of Main Street and drain to the northeast (VIS) and to the southwest (BYD). The southern part of the boat yard is assumed to accumulate flow from the hillside and VIS-P-001. Main Street and the gravel boat yards are relatively flat throughout the area. Main Street also transitions from gravel to pavement in front of Eternal Buzz Espresso (346 Illiamna Street). BYD-S-001 and BYD-S-002 have sediment buildup around the curb inlets and in the pipe network. Sediment accumulations are common across the whole drainage system. The outlet (BYD-S-003) is in fair shape with some sediment buildup. No major water quality concerns from the City boat yards were identified from field investigations and community discussions.

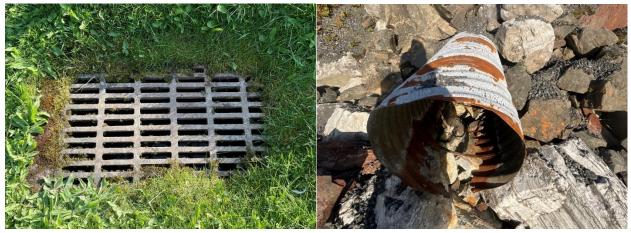
ENG-S-002 Field Inlet

The ENG system spans English Drive and Kenai Street. Some parts of this system were not located during the field inspection, so record drawings were used to supplement. A 1993 *Drainage Improvement* plan set by William J. Nelson & Associates details an 8-inch-diameter drain pipe and associated stormwater infrastructure (ENG-P-002* through ENG-P-003*) between residences at 270 and 284 English Drive (City 1993). This area was checked during field inspections, but the infrastructure was not located. A 2010 *Water and Sewer Improvements* record drawing, developed by CRW Engineering Group, LLC, with the ADEC Village Safe Water Program, shows ENG-S-002 through ENG-S-005*. The outlet (ENG-S-006) was located during field investigations, and based on its general direction, seems to indicate that it connects to stormwater infrastructure along Kenai Street. The HDR team discussed this system with City Public Works. This system was mapped using available resources and information gathered during the field inspection, but it should be field located if improvement projects are planned.

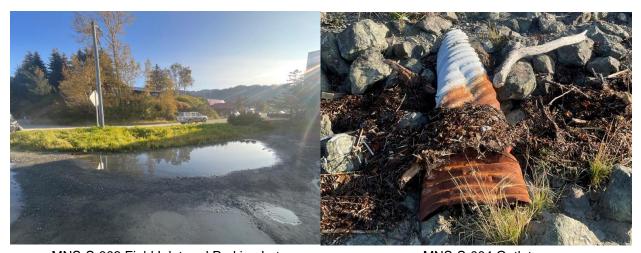
MNS-S-003 Field Inlet and Parking Lot

Along Main Street, from Barnes Street to the City of Seldovia Central Park, stormwater is collected by the MNS system. Several individuals and entities informed HDR that water frequently ponds near MNS-S-001. MNS-S-001 is not located in the low point of the road, which contributes to this problem. On the southwest side of Main Street, the system contains another curb inlet (MNS-S-002) and a field inlet (MNS-S-003) within a small, vegetated area, both outfalling via (MNS-S-004) onto the breakwater rock. Both curb lines show sediment accumulation. The parking lot that MNS-P-003 crosses through is poorly drained and does not appear to grade well towards MNS-S-003. MNS-S-004 shows signs of corrosion and is horizontally smashed. During discussions with City Public Works, storage of snow along this stretch of Harbor coastal rock was mentioned and may factor into the condition of the outfall (MNS-S-004).

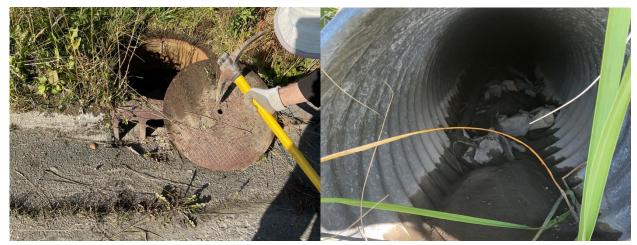
HBR-S-002 Curb Inlet HBR-S-003 Outlet Figure 8. Select Photos – HBR

HBR consists of two curb inlets (HBR-S-001 and HBR-S-002) that drain Harborview Drive at its southwest end. Harborview Drive and southeastward roads generally consist of residential properties except along Main Street, where there is a concentration of commercial properties. There was some fine sediment accumulation in the curb lines, in front of the curb inlets, and in the outfall pipe (HBR-S-003). Otherwise, the system is in fair condition, outfalling onto the breakwater.

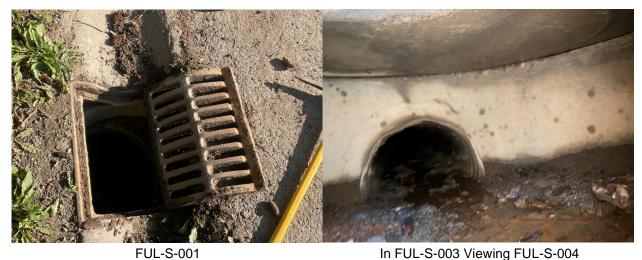
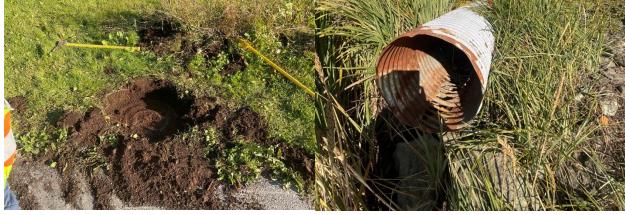
FUL-S-004 FUL-S-008 Outlet Figure 9. Select Photos – FUL

FUL consists of two sets of three curb inlets located at the Alder and Main streets intersections. The first set of curb inlets, at Alder Street, appears to be in fair condition with a moderate amount of sediment and water accumulation. FUL-S-001 has a different style inlet grate than what was commonly found during the inspection. The City mentioned that a drainage pipe (FUL-P-003) at 240 Fulmor Avenue was hit. The HDR team briefly spoke with the contractor to verify that the drainage pipe had been repaired to provide connectivity for the upstream network. A low spot in the pavement at 240 Fulmor Avenue ponds water. After some investigation, the downstream manhole (FUL-S-004) was located and exposed by the HDR team in the front yard of 232 Fulmor Avenue.

The second set of curb inlets, at Main Street, appear to be in fair condition with water accumulation in their sumps. FUL-S-005 does not appear to be located in the low spot, as indications of ponding near it are present. FUL-S-007 has a partially broken inlet grate, has some fine sediment accumulation in its curb line, and collects flow from the west side of Main Street. Additional dirt/gravel parking lots along Main Street show rutting and drainage issues. The outfall (FUL-S-008) to the breakwater is in poor condition with a corroded bottom.

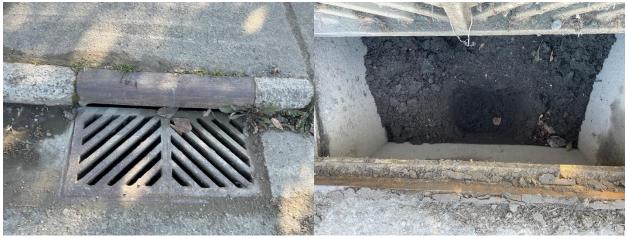
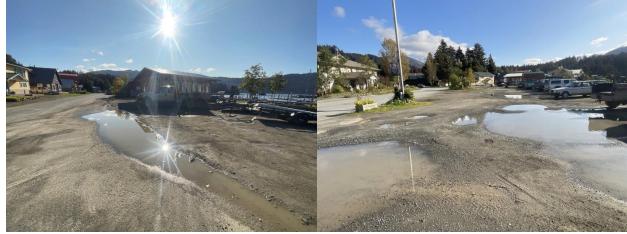
PEN-S-001 Inlet Grate

The PEN drainage system consists of two, large catch basins, PEN-S-001 and PEN-S-002. Both have curb and gutter inlet grates and concrete rectangular catch basin boxes, unlike most of the other curb inlet configurations, which consist of a curb inlet grate over a round concrete manhole. Both have heavy sediment accumulation; the HDR team dug out the inlet pipe in PEN-S-001. PEN-S-001 is not located in the low spot, and significant ponding occurs just down-gradient of the curb inlet. The inlet to PEN-P-002 was seen exiting PEN-S-002 but the outlet (PEN-S-003*) is not located in the breakwater. Community input and field observations also noted significant ponding in front of 194 Main Street and the Gateway Pavilion.

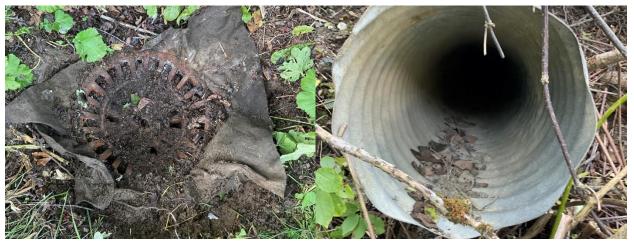
KAK-S-001 Field Inlet

Willow Street appears to flow to both the northwest and southeast, with shallow ditches along its southern side. At the intersection of Kachemak and Willow streets, a field inlet (KAK-S-001) collects flow from the shallow, southwestern ditch and conveys it across Kachemak Street to outfall north of 246 Kachemak Street (via KAK-S-003). During field inspections, KAK-S-001 was dug out and consisted of an upside-down beehive-shaped inlet grate lined with weed barrier fabric, which is assumed to prevent dirt and debris from entering the piped system. The 2010 *Water and Sewer Improvements* record drawing (City 2023) shows a turn in the pipe that is assumed to require a manhole structure (KAK-S-002*); however, the structure was not located during the field inspection. The outfall, KAK-S-003*, was located and appears to be in good condition, outfalling into rock riprap before flowing into the Slough.

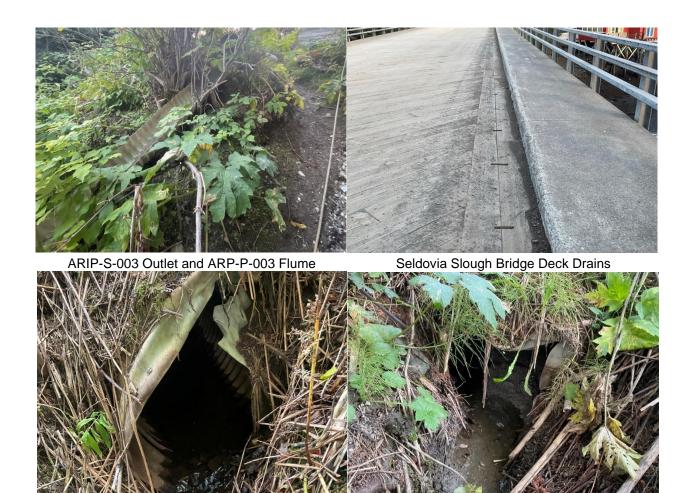
Figure 12. Select Photos – ARP

The ARP system describes four separate drainage systems along Airport Avenue, from Kachemak Street to where Airport Avenue transitions from pavement to gravel, towards the Seldovia Airport. Two of these drainage systems (ARP-S-001 through ARP-S-006) are at the ends of the Seldovia Slough Bridge. The west end system consists of a curb inlet catch basin (ARP-S-001), a junction structure that directs flow at a 90-degree angle (ARP-S-002), and a flume (ARP-P-003) that provides erosion protection down the embankment. The east end system consists of a curb inlet catch basin (ARP-S-004) and an outlet pipe (ARP-S-005) that directs flow down the dirt embankment. In addition to the curb inlets, the Slough Bridge has deck drains sawed through the wood decking along its southern shoulder; many of these are plugged with sediment. One of the public comments mentioned noticeable turbidity in the street drainage by the Slough Bridge. The area that this comment referred to was not definitively determined, but road runoff from Kachemak Street's gravel road and Airport Avenue from the northeast were noted as a potential sources of stormwater turbidity. Additional investigation of this area should be conducted to determine if stormwater turbidity could be improved.

The other two systems are located near the Airport Avenue pavement-to-gravel transition and consist of a cross culvert and a curb inlet drainage system. The cross culvert (ARP-P-005) drains the area along the southern side of the road. Curb inlets (ARP-S-006 and ARP-S-007) drain flow from the road curbs. Both systems outfall on the northern side of the road into Seldovia Slough. DOT&PF mentioned that ARP-P-006 and ARP-P-007 are collapsed and are to be replaced in the next Airport improvements project (currently in design phase).

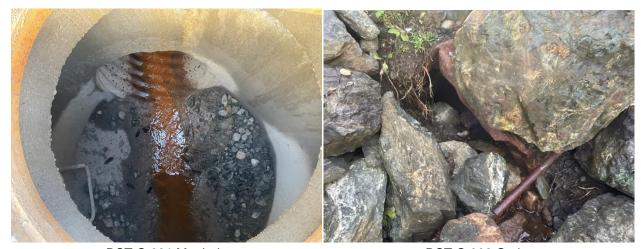
DST-S-001 Manhole DST-S-002 Outlet Figure 13. Select Photos – DST

AUG-P-002 cross culvert provides driveway drainage across 150 Augustine North Avenue. A shallow ditch directs flow to DST-P-001 inlet. Flows are directed down D Street, through a manhole (DST-S-001), and outfall beside a residence at 165 Augustine North Avenue. DST-S-001 appears to be in good condition with some cobbles accumulated within it. DST-S-002 appears corroded and crushed within a pile of riprap rock. Seldovia Slough tide elevations may contribute to corrosion of this outlet. There appears to be some roadway ponding on the southwest corner of D Street and Augustine North Avenue.

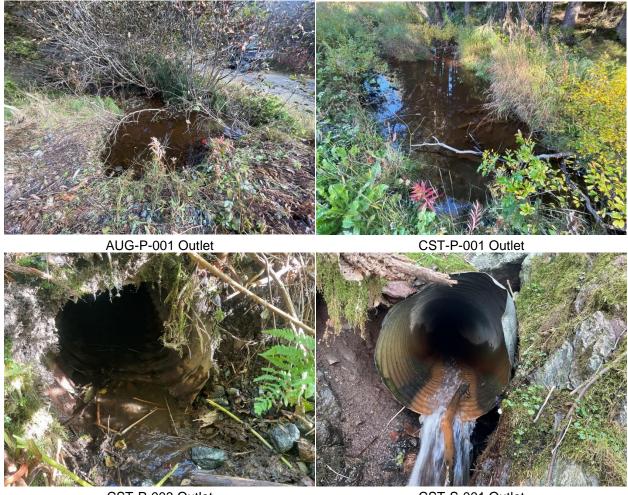
CST-P-003 Outlet CST-S-001 Outlet Figure 14. Select Photos – CST

Two cross culverts (AST-P-001* and AST-P-002) were found at the southern end of Augustine North Avenue, along the drivable portion of A Street. The inlet of AST-P-001* was not located. These pipes direct flow into a deep ditch along the eastern side of Augustine North Avenue. Flow crosses Augustine North Avenue through AUG-P-001, which is submerged at both ends. Flow meanders in a ditch along C Street and crosses C Street via CST-P-001. Sediment was dug out of the inlet of CST-P-001, and its outlet was found to be submerged. Surface flow from Eider Lane also contributes to this system. Some road rutting was noted at the southeast intersection of Eider Lane and C Street. Flow is otherwise contained in ditches that meander through properties north of C Street, along the southern roadway of C Street, and along the eastern roadway of Willards Way. The northern side of C Street contains two additional cross culverts (CST-P-002 and CST-P-004). WIL-P-001 resides on private property at the southern end of Willards Way that joins with C Street drainage at CST-P-003 and crosses via CST-P-004. CST-P-004 appears to have a corroded bottom at its inlet end. Upstream of CST-P-005, plastic blocks in the ditch that may limit or backwater flow were observed. CST-S-001 outfalls into Seldovia Slough and appears to be in good condition, with a moderate amount of flow.

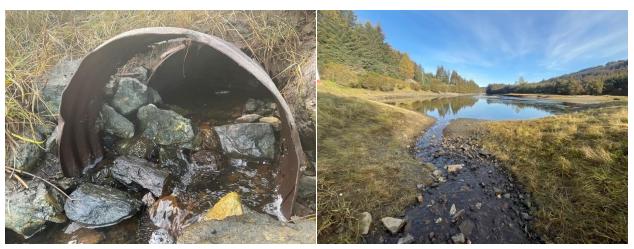
SHL-P-002 Outlet SHL-P-002 Outlet Downstream Figure 15. Select Photos – SHL

Shoreline Drive generally drains towards a marsh at its north end or surface-flows into the Seldovia Slough along its eastern side. SHL-P-002 drains a marsh area into the Seldovia Slough. The pipe is in poor condition and highly corroded, likely due to the tide elevations. Road rutting near and over SHL-P-002 was also noted.

Half of Malcom Street flows towards the marsh, and the other half flows towards Shoreline Drive, where it surface flows off the road and into the Slough. SHL-P-001 is located in a shallow ditch near 313 Shoreline Drive. The inlet of the pipe has a short metal bridge above it, and the outlet of the pipe can be seen below the guard rail, outfalling down the steep dirt embankment. Road rutting and ponding were noted near 271, 313, and 337 Shoreline Drive.

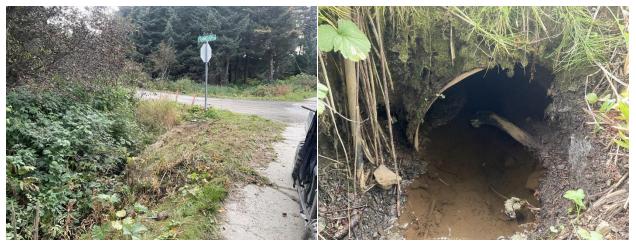
FKR-P-003 Outlet

At Airport Avenue, flow from Frank Raby Road and Airport Avenue are conveyed north by two cross culverts (FKR-P-003 and FKR-P-004). Both pipes have 30- to 50-percent sediment accumulation and have corroded bottoms at their outlet ends. On the north side of Airport Avenue, flows are ditched to the Seldovia Slough.

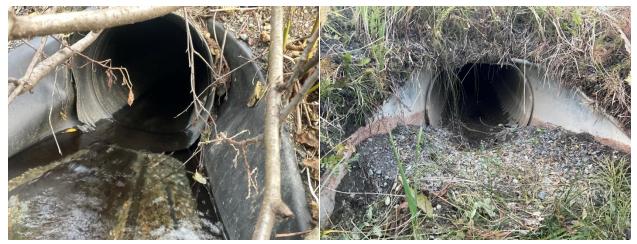
AIR-S-002 Outlet

Fish Creek crosses Airport Avenue south of the Seldovia Airport and is on the Alaska Department of Fish and Game's (ADF&G) Anadromous Waters Catalog (ADF&G 2023). A 108-inch, round, structural aluminum pipe with no embedment was observed. This crossing has an ADF&G Fish Passage Inventory Database site number of 20303061 (ADF&G 2023). This pipe is tidally influenced and floods during a significant portion of the tide cycle. Spawning and dying fish were seen at this creek during the field inspection. It does not appear to pose an impediment to fish passage.
