# DMTS Fugitive Dust Risk Assessment

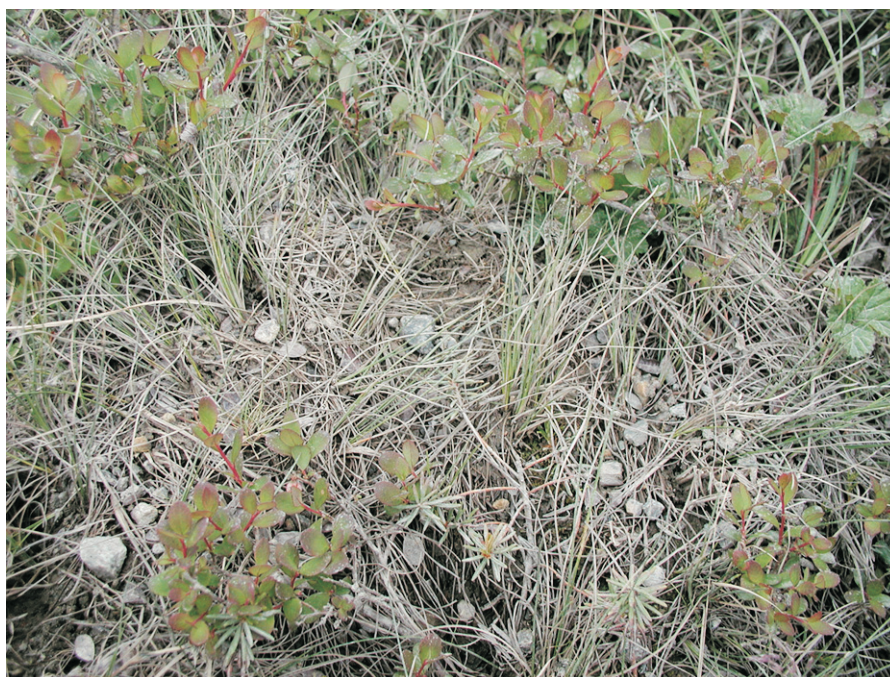
**Photograph 24.**  
Dust deposition and road gravel at station TT5-0010

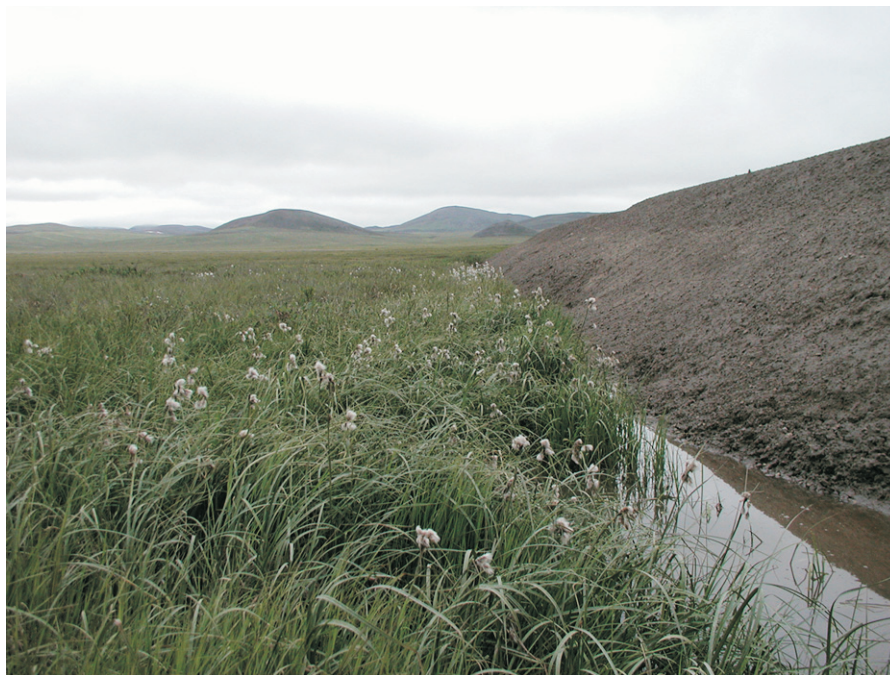
**Photograph 25.**

Impounded water along the DMTS road shoulder at station TT2-0010

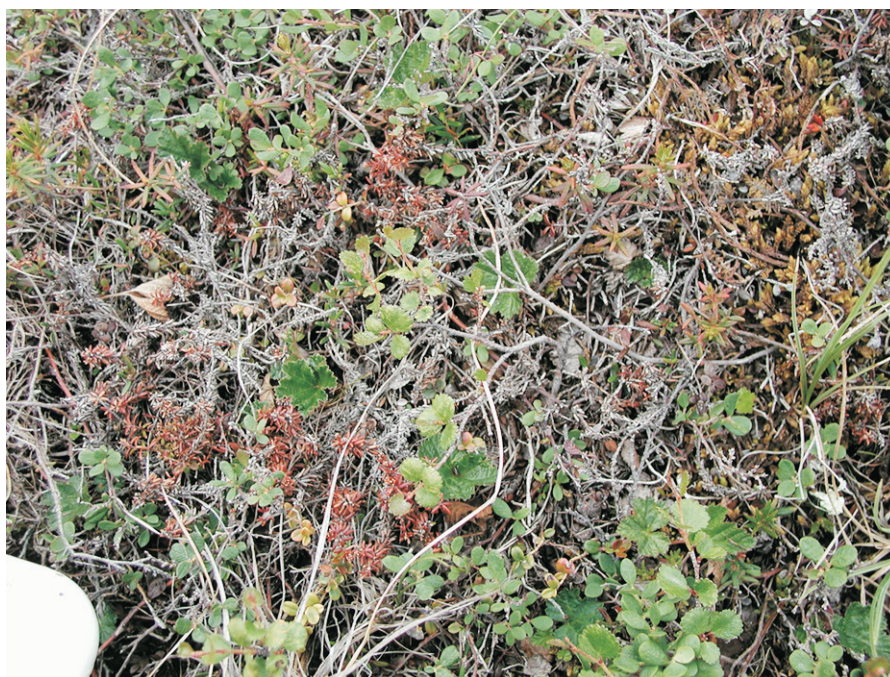
**Photograph 26.**

Stressed blueberry (*Vaccinium uliginosum*), Labrador tea (*Ledum palustre*), and crowberry (*Empetrum nigrum*) at station TT3-0100

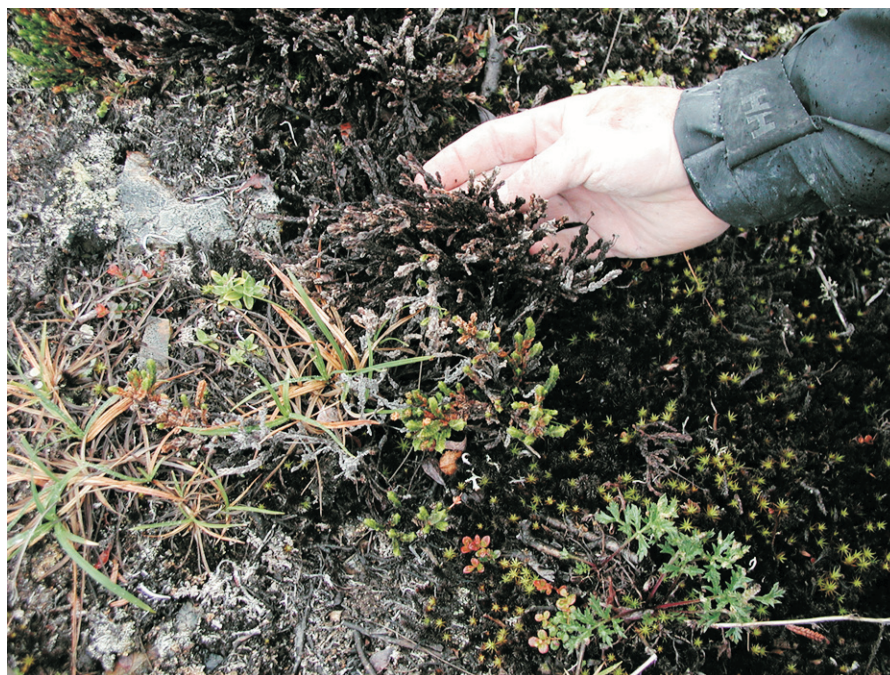
**Photograph 27.**

Blackened heather (*Cassiope tetragona*) in a snow accumulation area at station TT7-0010

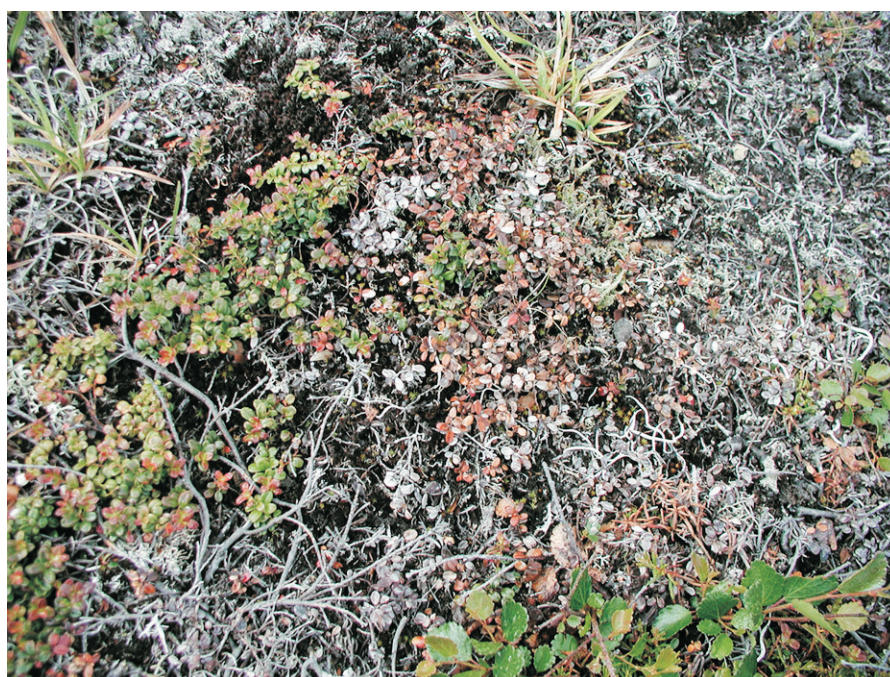
**Photograph 28.**

Bleached lingonberry (*Vaccinium vitis-idaea*) in a snow accumulation area at station TT7-0010

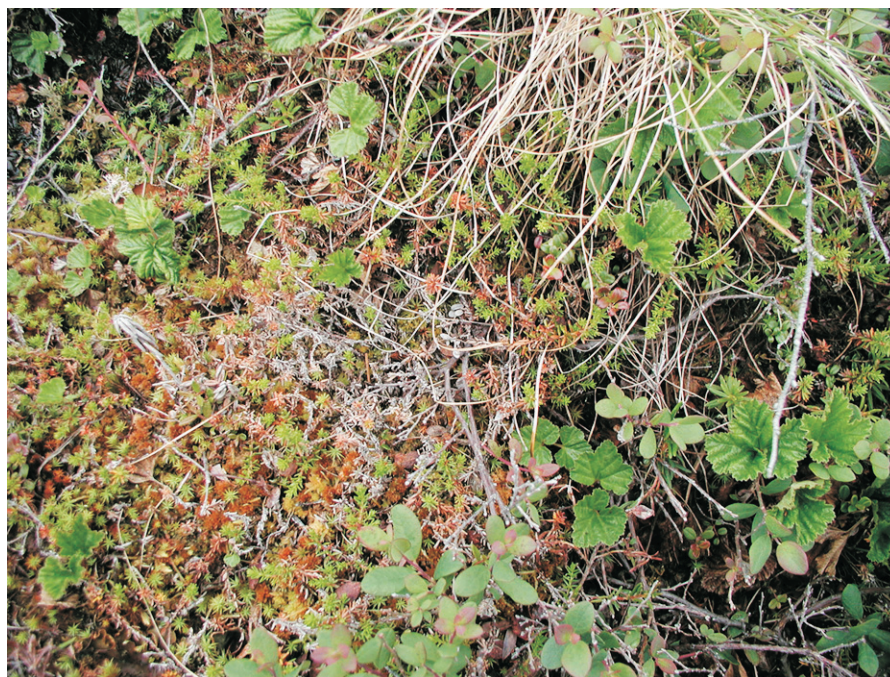
**Photograph 29.**  
Brown crowberry and bleached lingonberry at reference station  
TS-REF-5

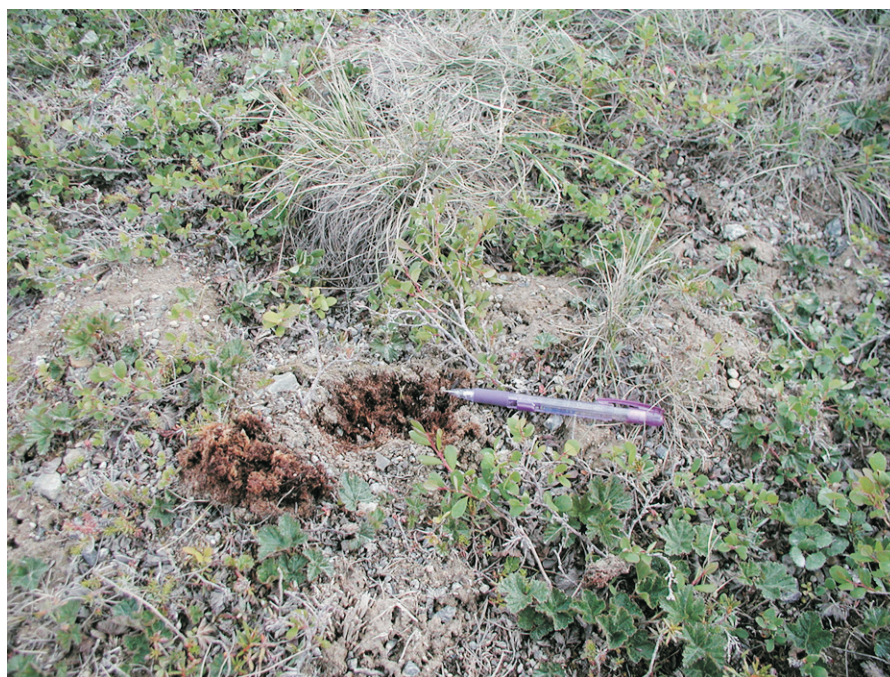
**Photograph 30.**  
Bare ground showing dead mosses under dust at station  
TT3-0010

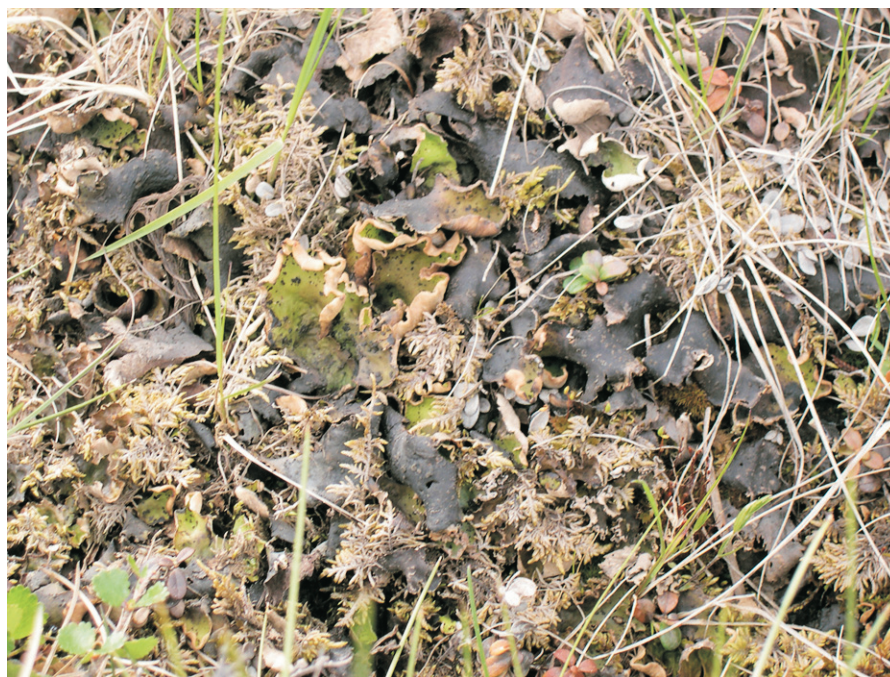
**Photograph 31.**  
Blackened *Peltigera* lichen at station TT2-0010

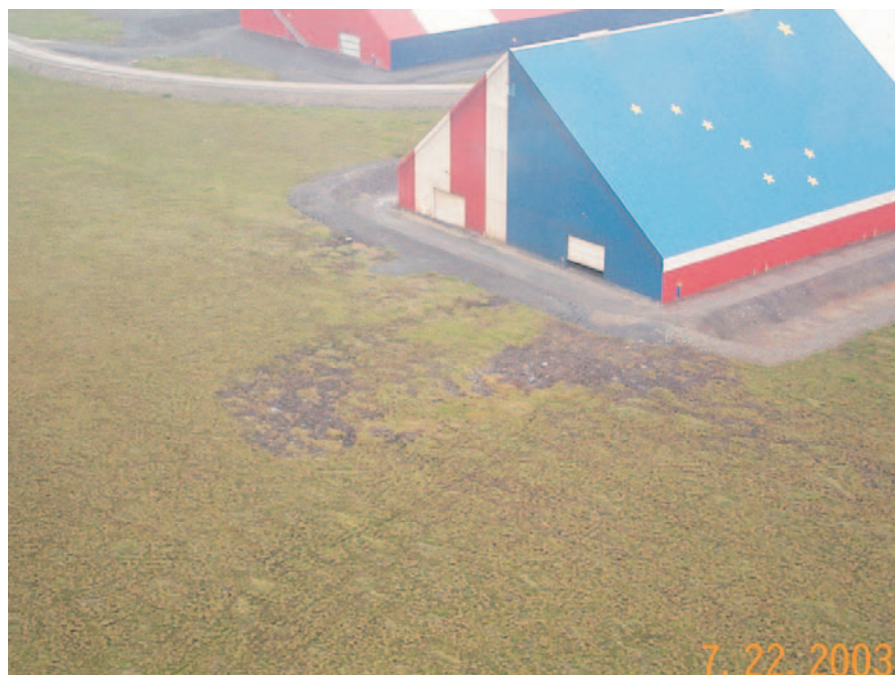
**Photograph 49.**  
Aerial view of stressed vegetation to the northwest of CSB1.

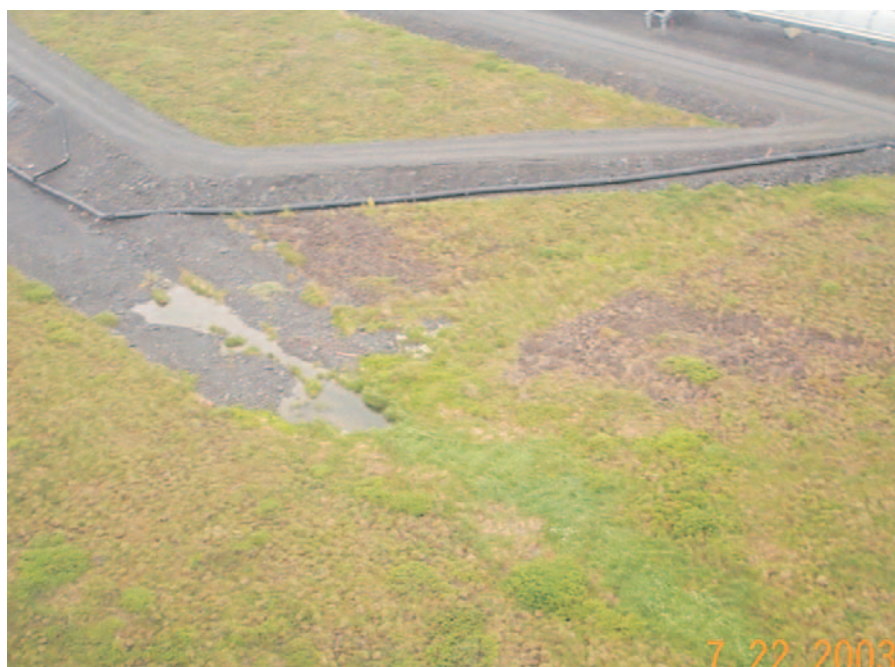
**Photograph 50.**  
Aerial view of stressed vegetation near the ion exchange  
treatment overflow ditch

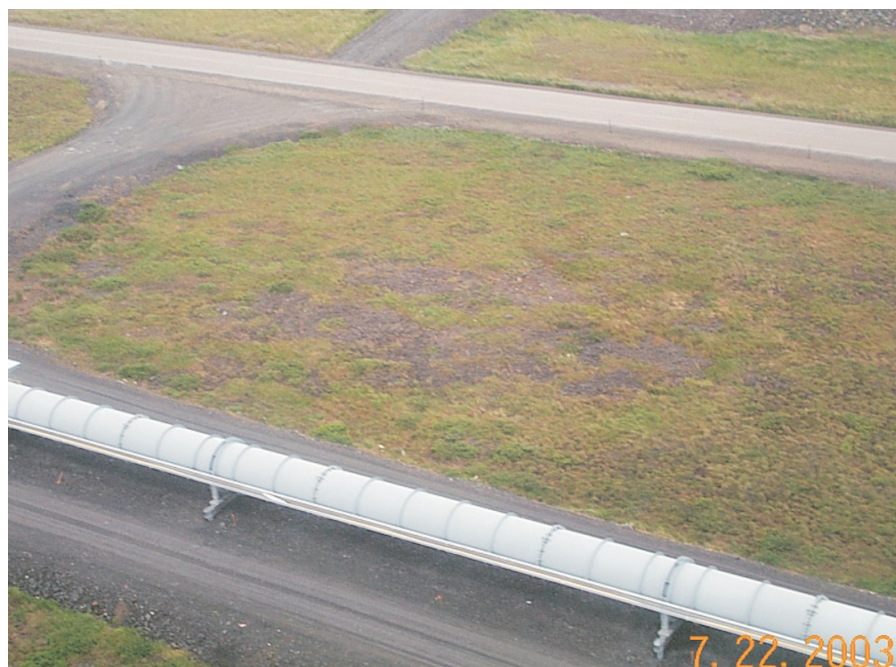
**Photograph 51.**

Aerial view of stressed vegetation between the southwest corner of CSB1 and the DMTS road

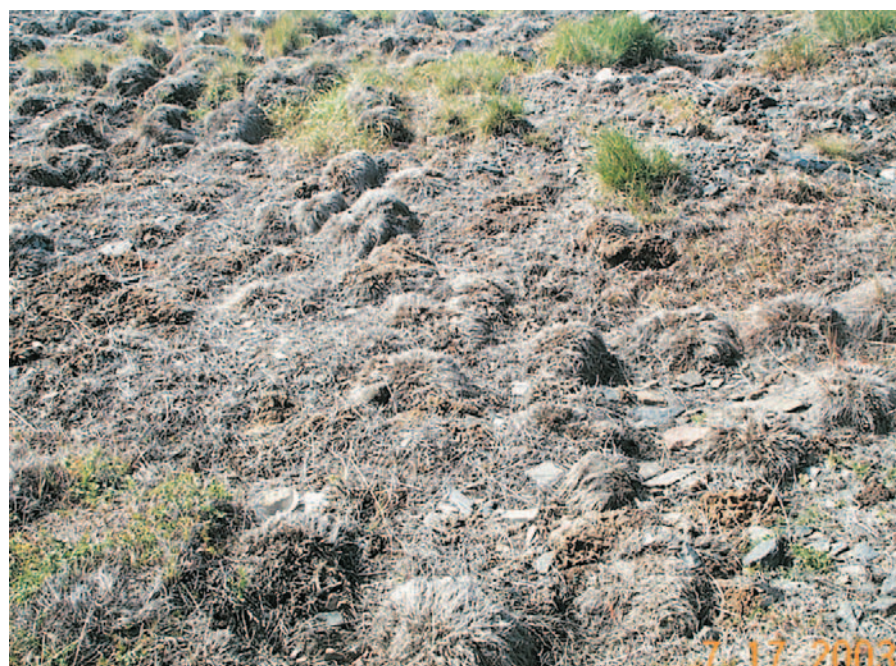
**Photograph 52.**

Stressed vegetation area northwest of CSB1

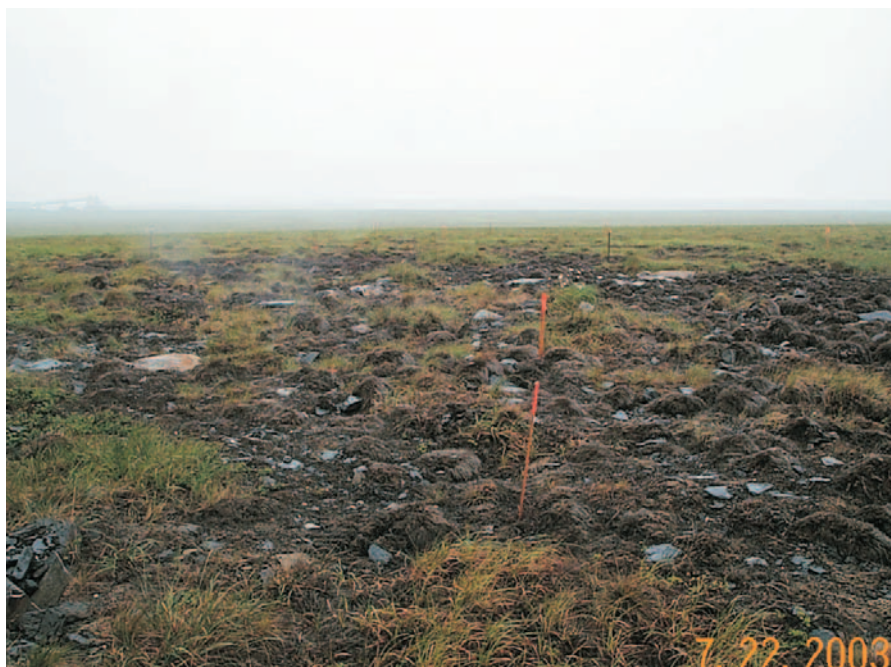
**Photograph 53.**  
Stressed vegetation area northwest of CSB1

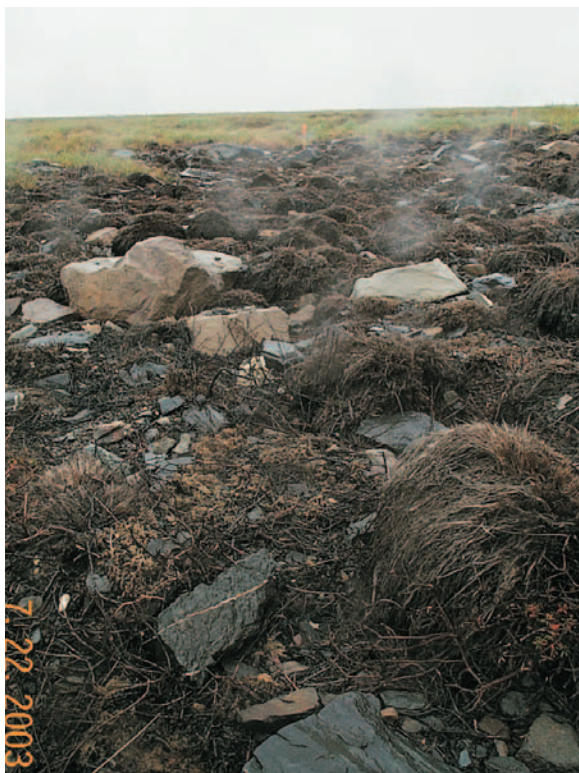
**Photograph 54.**  
Exposed rocks and  
dead vegetation  
northwest of CSB1

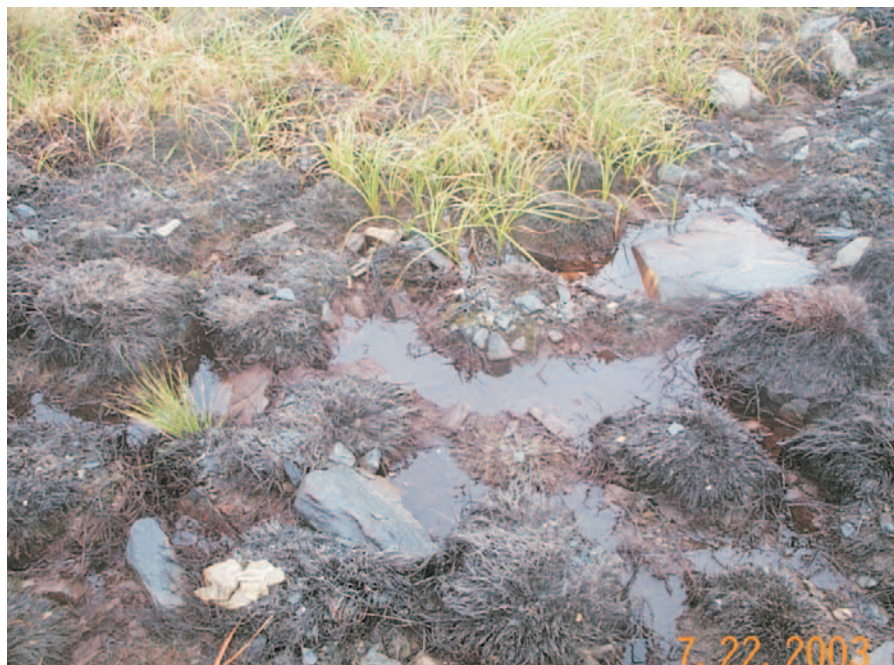
**Photograph 55.**

Standing water and sedges at the edge of the stressed vegetation area northwest of CSB1

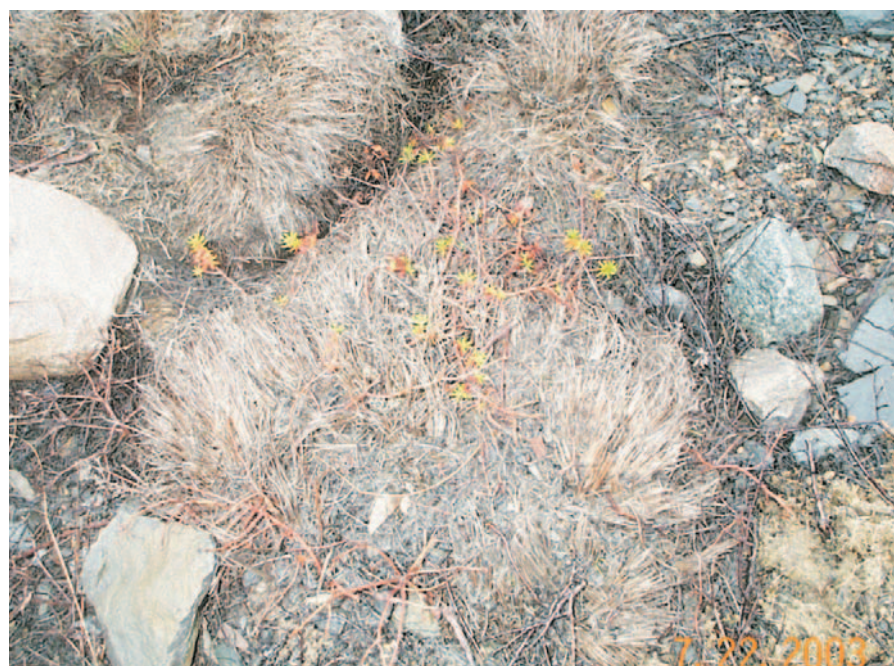
**Photograph 56.**

Close-up of sedge tussock in stressed vegetation area northwest of CSB1

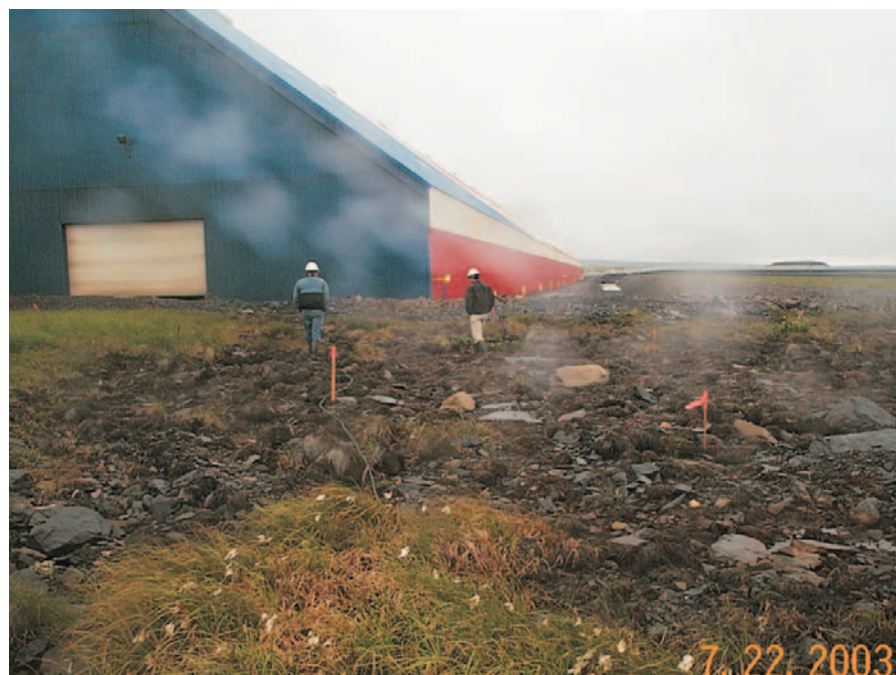
**Photograph 57.**

Exposed soil and rock, dead tundra vegetation, and live cottongrass northwest of CSB1

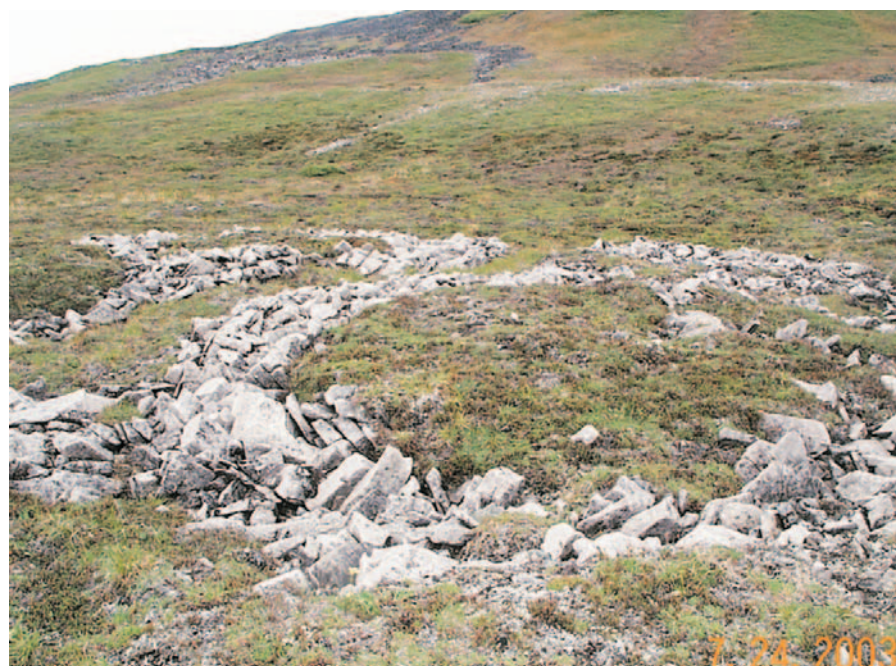
**Photograph 58.**

Frost-heave formation observed in the hills around the mine
