**Analysis of Brownfield Cleanup Alternatives
Jumping Salmon Lodge
Chenega Village, Alaska
May 2025**

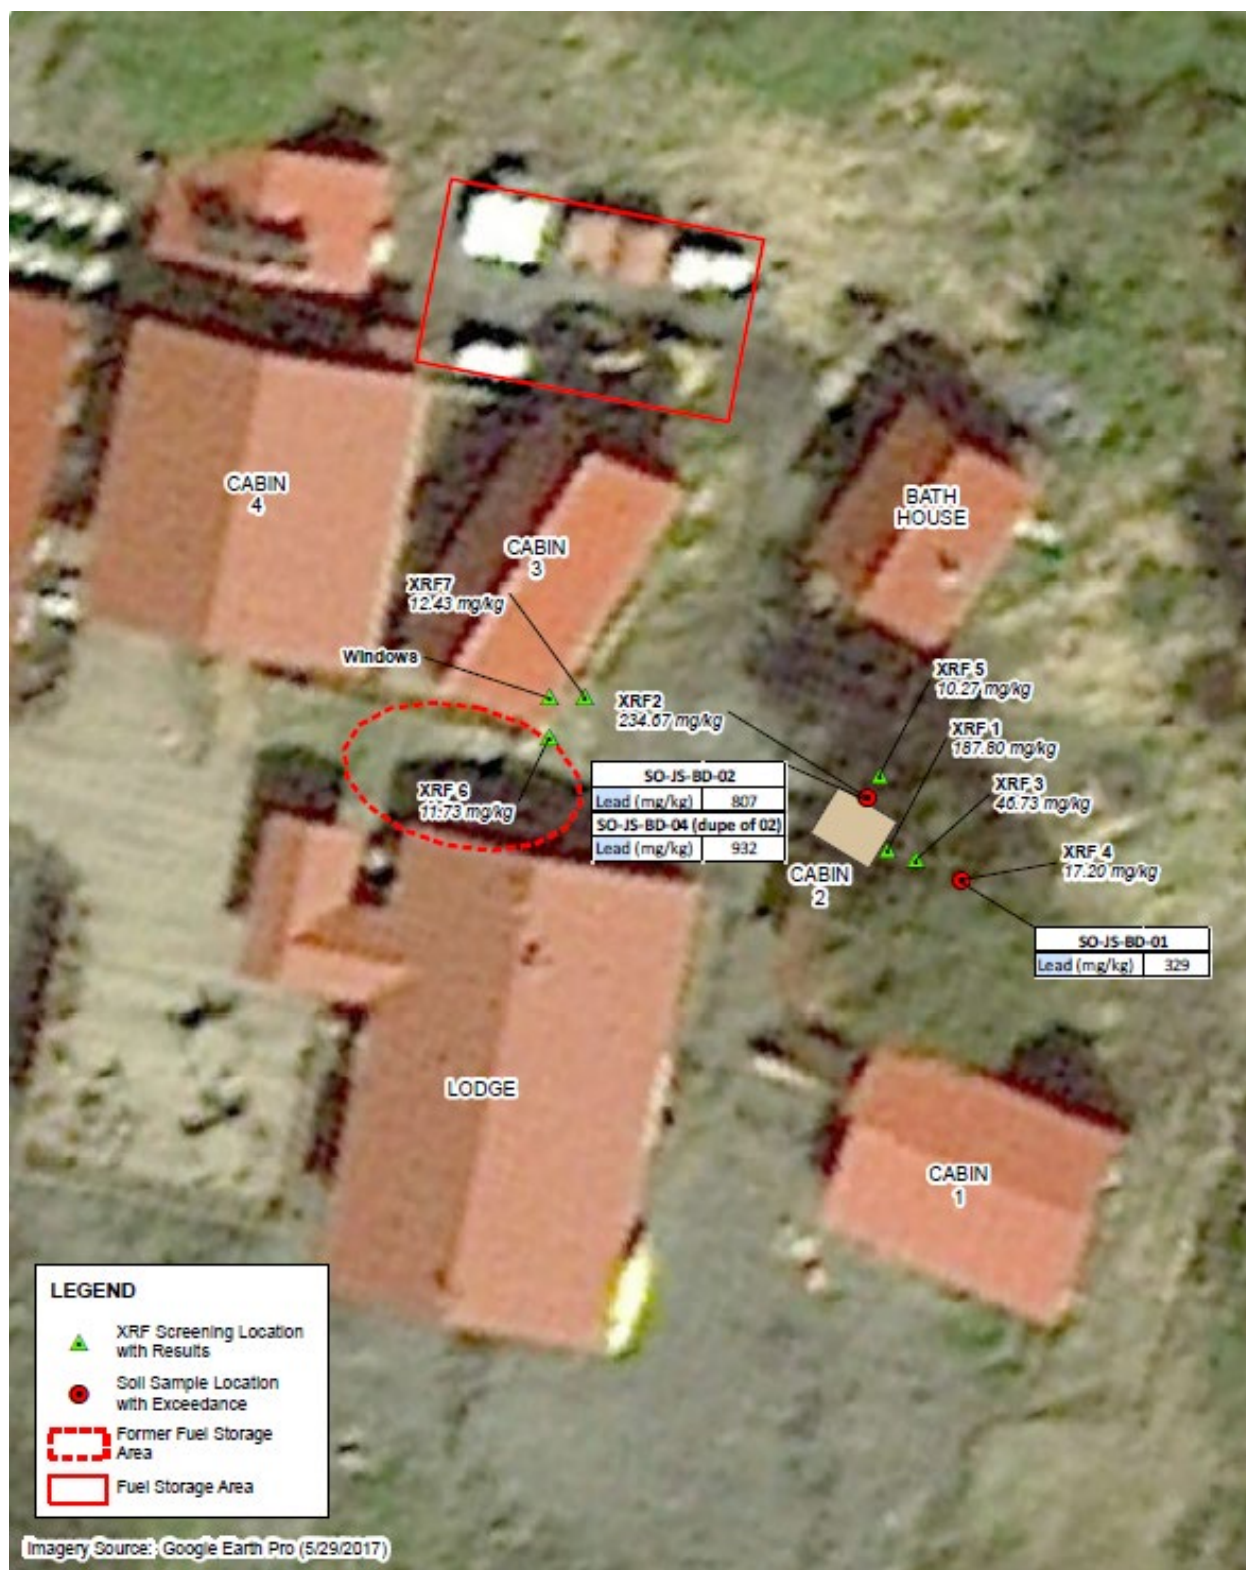
Figure 2: 2020 XRF Field Screening and Lead Analytical Results

Lead was reported in exceedance of DEC cleanup levels in both soil samples collected in 2020 (329 and 807 mg/kg), within 10 ft of Cabin 2, on the east and north sides of the cabin. Lead contamination appears to be limited to a confined area on the northern and eastern sides of Cabin 2. Analytical results from sampling conducted in 2022 around Cabin 2 found no additional exceedances of lead concentrations.

Removal and disposal of construction materials containing lead-based paint, and lead-contaminated soil. This alternative assumes five (5) cubic yards of lead-contaminated soil will be removed, considered hazardous waste and subject to RCRA requirements, and will be transported to a subtitle C landfill in Arlington, Oregon. Any nonhazardous materials and soil will be transported to a subtitle D landfill.

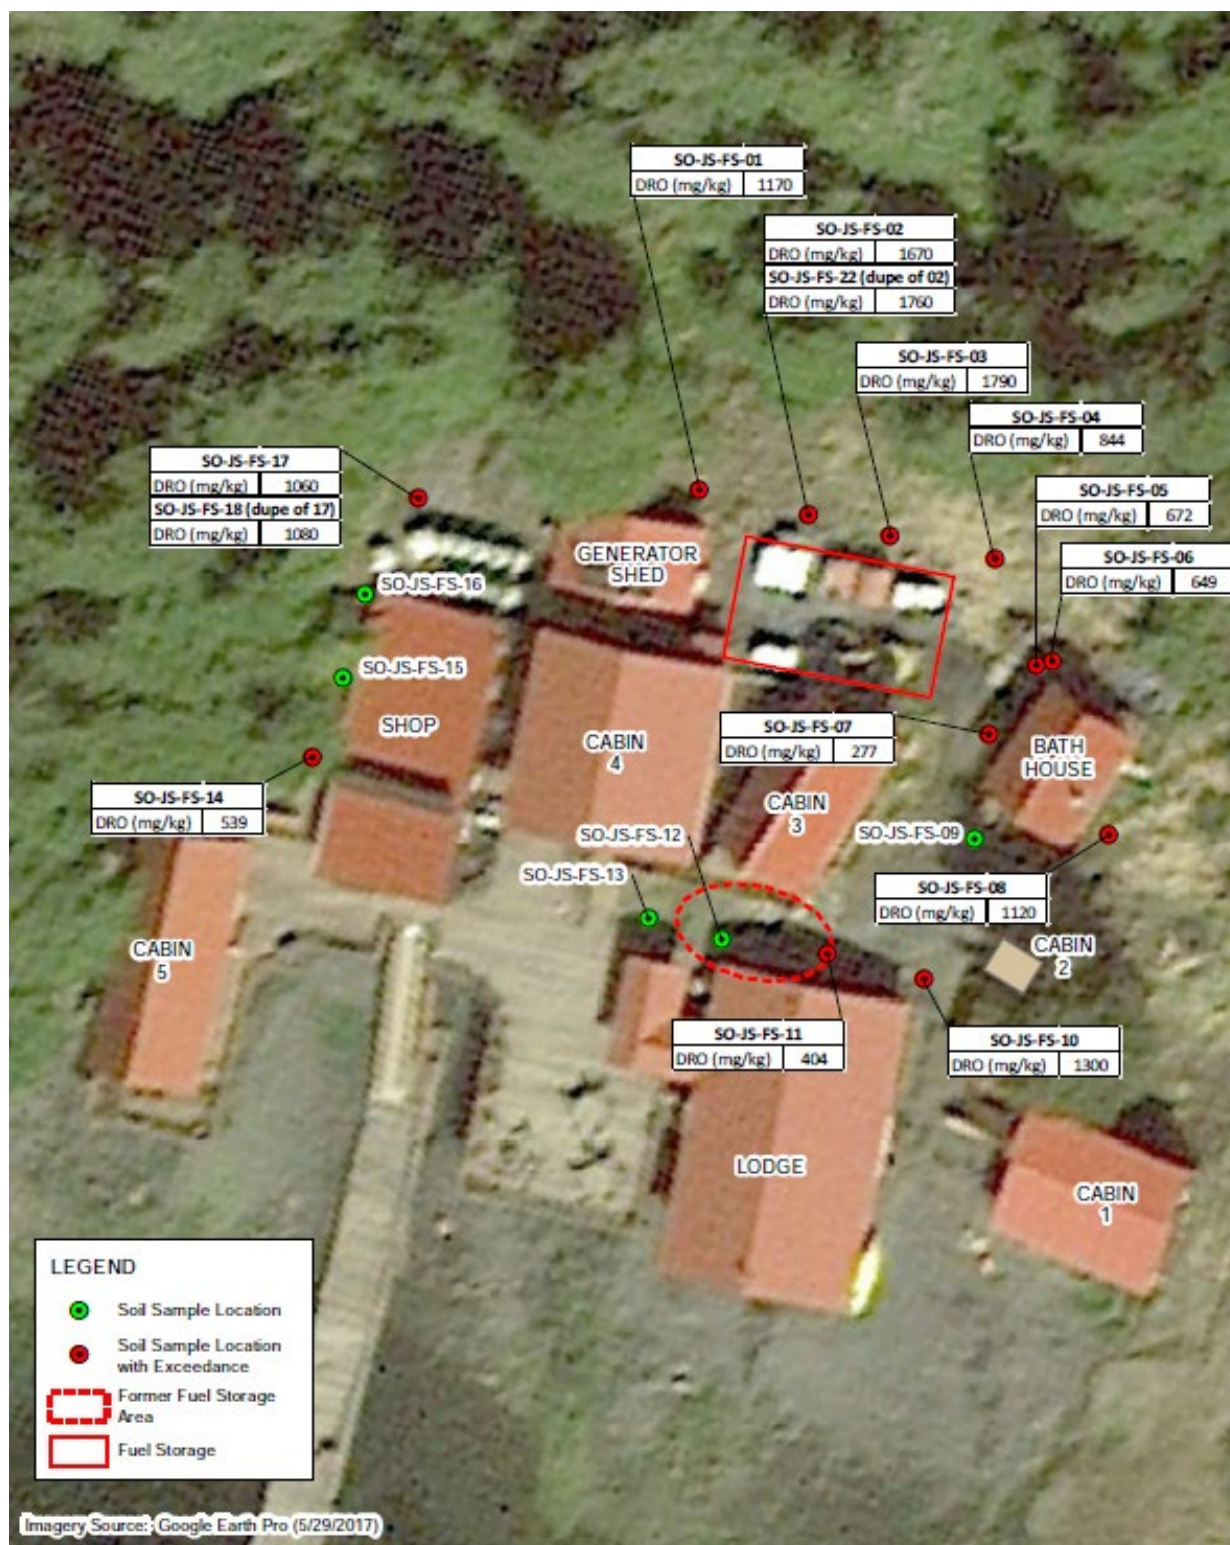
Figure 3: 2020 Petroleum Soil Samples and Analytical Results

Weston conducted site characterization activities in September 2020, which included a hazardous building materials survey; a drum, tank, and container inventory and hazard classification; and soil sample collection. Soil samples were analyzed for diesel-range organics (DRO), residual-range organics (RRO), volatile organic compounds (VOCs), polycyclic aromatic hydrocarbons (PAHs), and lead. Analysis identified that DRO, RRO and lead were present in the soil at concentrations exceeding ADEC Method Two Table B1/B2 migration to groundwater (MTG) cleanup levels for soil but were below human health cleanup levels.

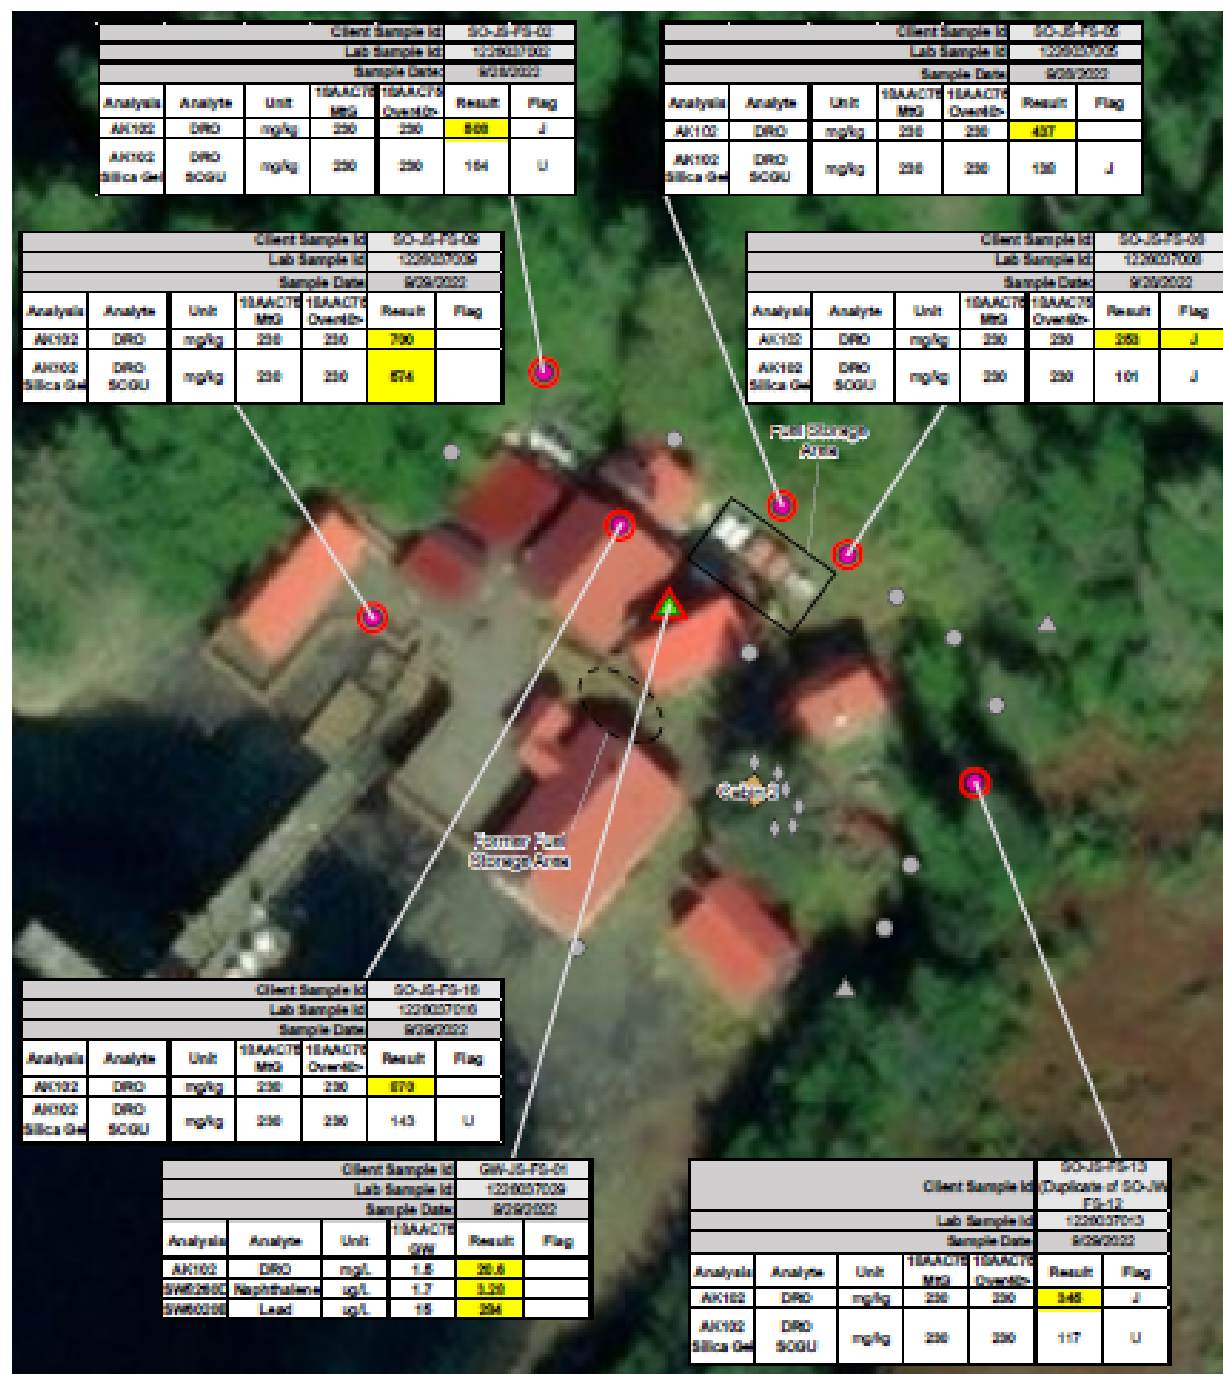
Figure 4: 2022 Soil and Groundwater Exceedance Locations

Additional site characterization was conducted in September 2022 by Weston Solutions. Characterization activities included an investigation of soil, surface water, and groundwater at the site to evaluate concentrations and extent of lead and petroleum hydrocarbons. Analytical results showed DRO concentrations over MTG cleanup levels in six samples, though when processed

with silica gel cleanup (SGCU) methods, all but one sample were reported at concentrations below MTG cleanup levels and all were below human health cleanup levels. One sample collected from the intertidal zone was reported at a concentration of 574 milligrams per kilogram (mg/kg). Analytical results indicate most DRO exceedances are attributable to biogenic interference.

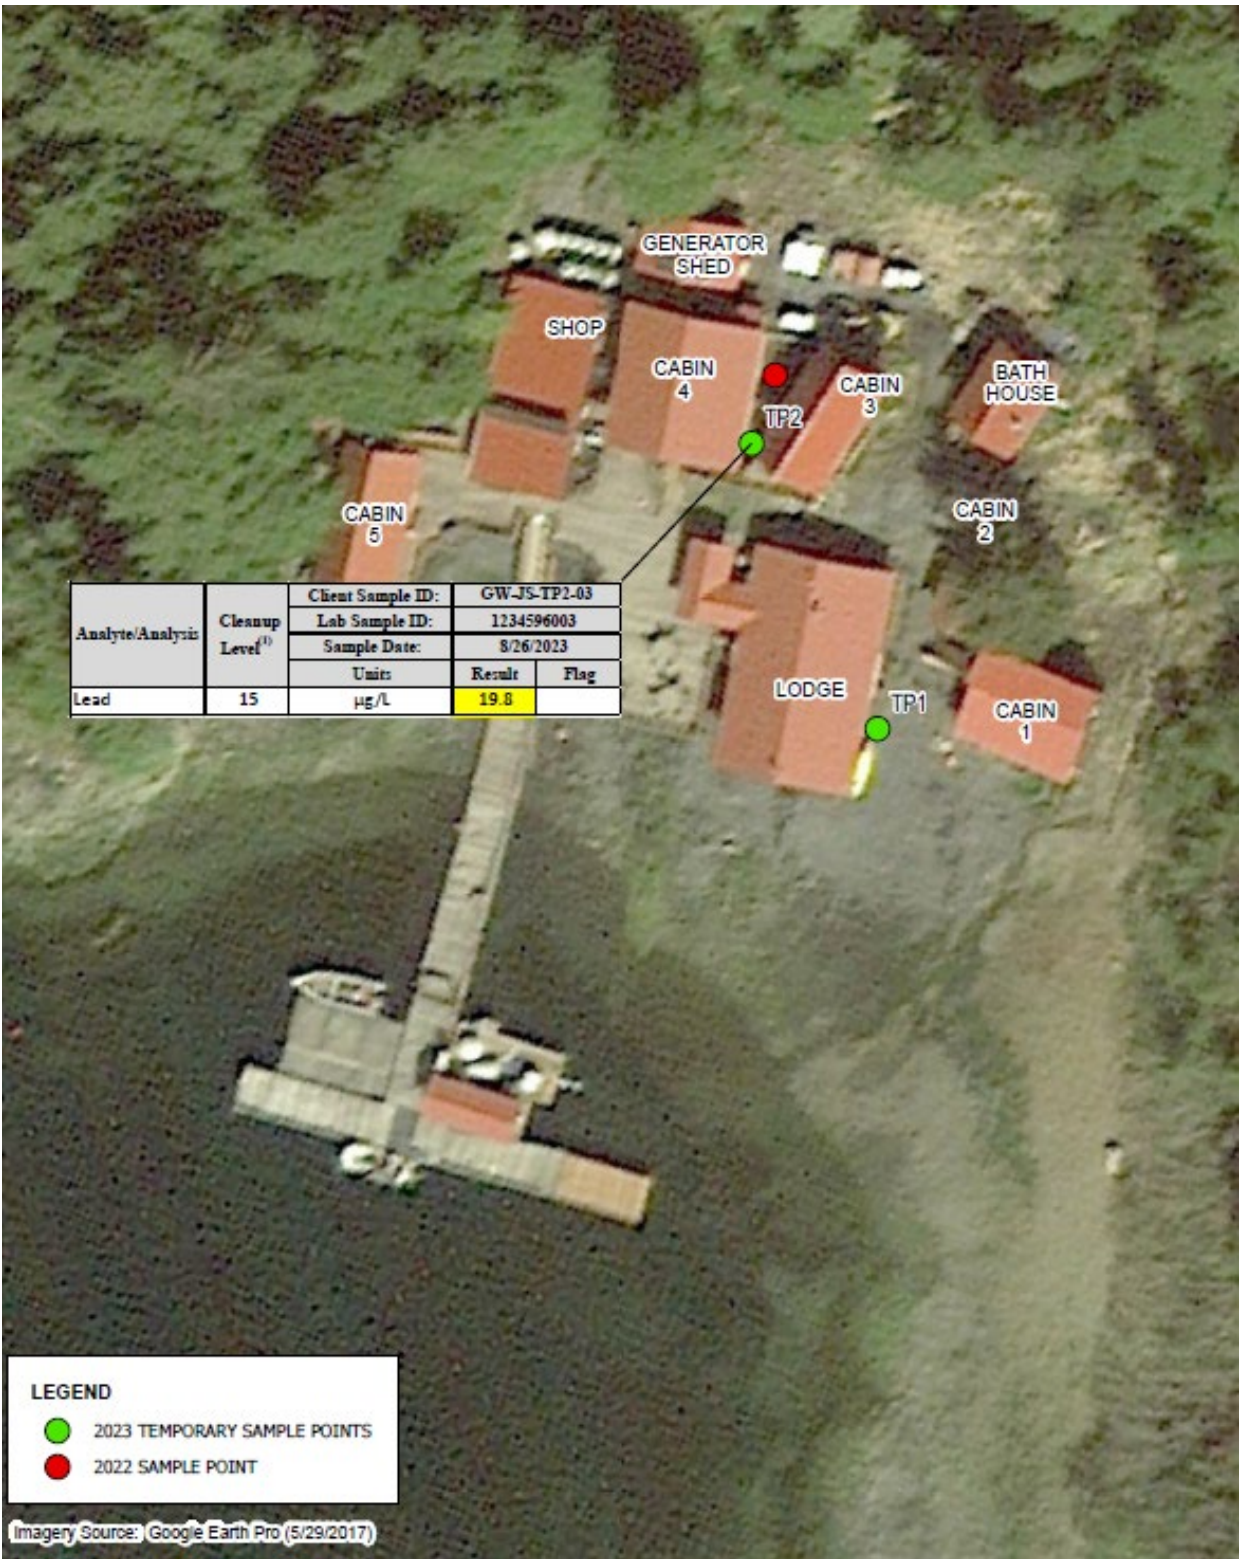
Figure 5: Temporary Well Point Locations and Groundwater Exceedances

In 2023, Weston Solutions returned to the site to conduct additional investigation of groundwater at the site and to determine concentrations and extent of lead and petroleum compounds in groundwater at the property. Groundwater samples were collected from two temporary sampling points. Analytical results of groundwater samples from one of the temporary well points reported concentrations of lead above DEC's Table C Groundwater Cleanup Levels (19.8 µg/L as compared to 15 µg/L). This sample was collected downgradient of the fuel storage area at the site. However, water was not present in either temporary point boring at the time of installation. After a rainfall event occurred at the site, field personnel collected groundwater samples. These samples were noted to be extremely turbid and were considered to be porewater and not true groundwater.

The absence of water in any of the seven borings which were advanced to bedrock depth at points across the property indicates groundwater at the site is not persistent and a contaminant exposure pathway is likely incomplete. Based on depth to bedrock at the site and the lack of drinking water wells onsite, DEC has determined the migration to groundwater pathway to be incomplete at this site. Additionally, collection of qualitative and quantitative groundwater samples has been unsuccessful at the site, indicating groundwater is porewater over bedrock. Consequently, the remedial alternatives considered in this ABCA focus on addressing soil contamination.
