Strategies

Geographic

Chickaloon River, NCI-17

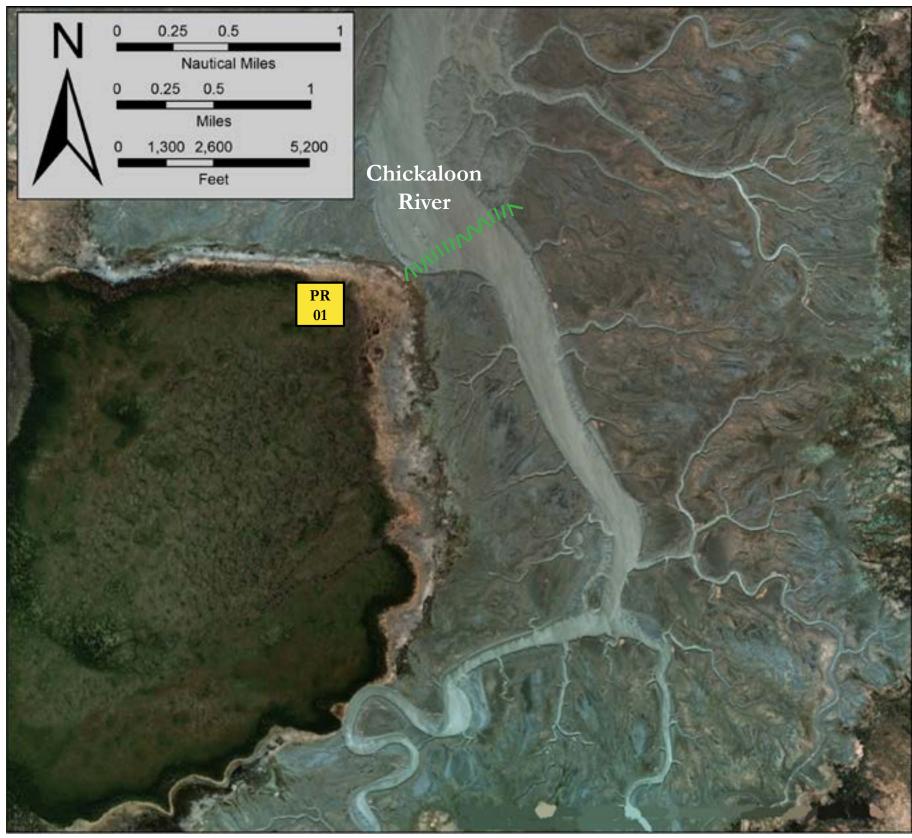
Beaufort Chukchi Sea Sea Anchorage Inlet Peninsula Chickaloon Bering Sea Kodiak Gulf Island of Alaska Aleutian Islands Location of NCI-17 _& Map Photo Chickaloon River mouth, View Northwest **Passive Recovery** and Collection **Passive Collection** (Snare Line)

Lat. 60° 53' 4.7" N Lon. 150° 0' 54.1" W

T					1	D D . 1	
ID	Location and Description	Response Strategy	Implementation	Response Resources	Staging Area	Site Access	Resources Protected (months)	Special Considerations
NCI-17-01	Chickaloon River	Passive Recovery	Transport equipment by	Deployment Equipment	Anchorage	Helicopter	Fish- salmon	Steep and soft mud banks
			helicopter from Anchorage.	4000 ft. snare line or sorbent				present significant hazards to
	Lat. 60° 54.15′ N	Use snare line or sorbent		boom		Chart	Marine Mammals-	responders.
PR	Lon. 150° 01.33' W	boom to recover oil prior to	Use inflatable raft to deploy	4 ea. anchor systems (~20 lbs.)		16660-1	Beluga Whales	
		impacting the marsh and	boom across Chickaloon River.	4 ea. anchor stakes				REPORT any cultural
		stream at the Chickaloon					Habitat- exposed tidal	resources found during
		River.	Replace as necessary to	Vessels			flats, marsh	operations to the FOSC
			maximize recovery.	1 ea. helicopter				Historic Properties Specialist.
