RE: 2011 Sanitary Survey Follow-up for Beaver Water System PWS ID: 360230; Class: Community; Source Type: Groundwater

Re: 2011 Enhanced Sanitary Survey for Beaver Water System, PWSID # 2360230

# Sanitary Survey - Deficiency Report

Sanitary Survey Photo Log

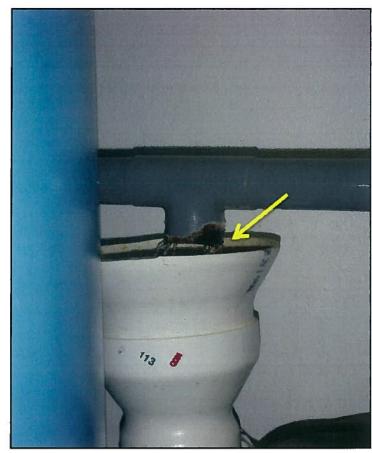
Figure 9: Filter Backwash Discharge Into Sump - Air Gap (<2D)

1. The air gap for the filter backwash discharge line to the sump needs to be adjusted so that the air gap is 2.5 times the diameter of the discharge line. This must be done within 120 days of receipt of this letter.

Filter Backwash Discharge Into Sump - See Figure 9

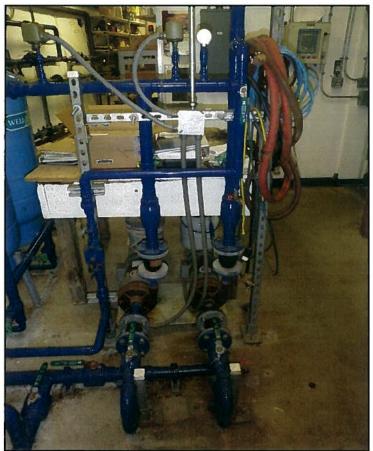
Figure 18: Distribution Pressure Pumps

If yes, is it adequate?	☐ Yes☐ No ✓ NA☐ Unknown
CR WATER SYSTEM - (Active) / Pumps	
How many pumps are there?	3
Notes: See Figures 18 & 19	
What type of pump(s) are they?	Centrifugal
What are the pump(s) used for?	Pressure & Truck Fill
	If backflow preventers are installed, is there a scheduled testing of the devices?  Notes: Staff was unaware of any scheduled testing. "Quarterly Inspection & Maintenance Checklist" calls for Inspection of Backflow Preventers. Unable to find any additional documentation regarding scheduled testing of backflow prevention devices.  If backflow preventers are installed, do they have isolation valves to facilitate removal and maintenance?  Are any backflow prevention devices installed in a pit?  Are backflow prevention device drains provided with a suitable air gap if applicable?  Has the system operator been trained in identifying and controlling cross-connections?  Is there a cross-connection control program in writing?  If yes, is it adequate?  CR WATER SYSTEM - (Active) / Pumps  How many pumps are there?  Notes: See Figures 18 & 19  What type of pump(s) are they?

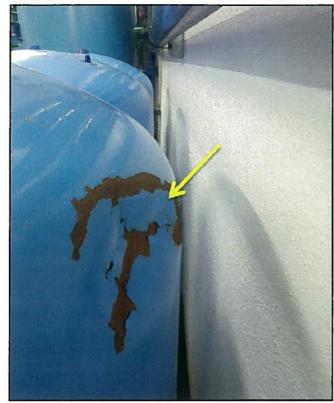
Figure 21: Damaged (Dented) Hydropneumatic Tank

- 3. It was noted that one of the pressure tanks has been damaged (dented). Damaged tanks may not operate properly and should be replaced as they could pose a safety risk.

Damage (Dented) Upper Portion of Tank #3 (See Figure 21)

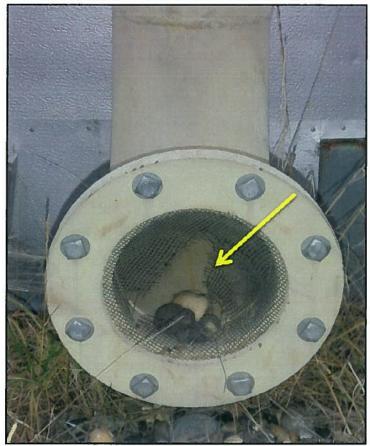
Figure 23: Torn WST Overflow Screen

- 1. As noted in a previous survey, the screen on the overflow vent on the water storage tank is torn. This must be fixed within 30 days of receipt of this letter.

Overflow Screen is Torn (See Figure 23)
