Subject: Foundation Recommendations  
Bulk Fuel Upgrades  
Ekwok, Alaska  
DMA Job No. 4084.054

This letter presents the results of our geotechnical review for the proposed bulk fuel upgrades in Ekwok, Alaska. The object of our review was to evaluate the soil and groundwater conditions at the proposed bulk fuel upgrade sites for the City of Ekwok and for the school, in order to develop conclusions and recommendations regarding fuel tank foundations. Our review and recommendations are based on existing file information and test pit logs and samples provided by CRW Engineering Group, LLC (CRW); DMA did not conduct a field investigation.

There are two potential sites for the City bulk fuel facility and one proposed site for the school bulk fuel facility. The bulk fuel facilities will each consist of a tank farm with three to four 30,000 gallon, double-walled, aboveground storage tanks (ASTs). The ASTs will be mounted on skids and placed on gravel pads at the selected site(s). A vicinity and site map is presented on Plate 1.

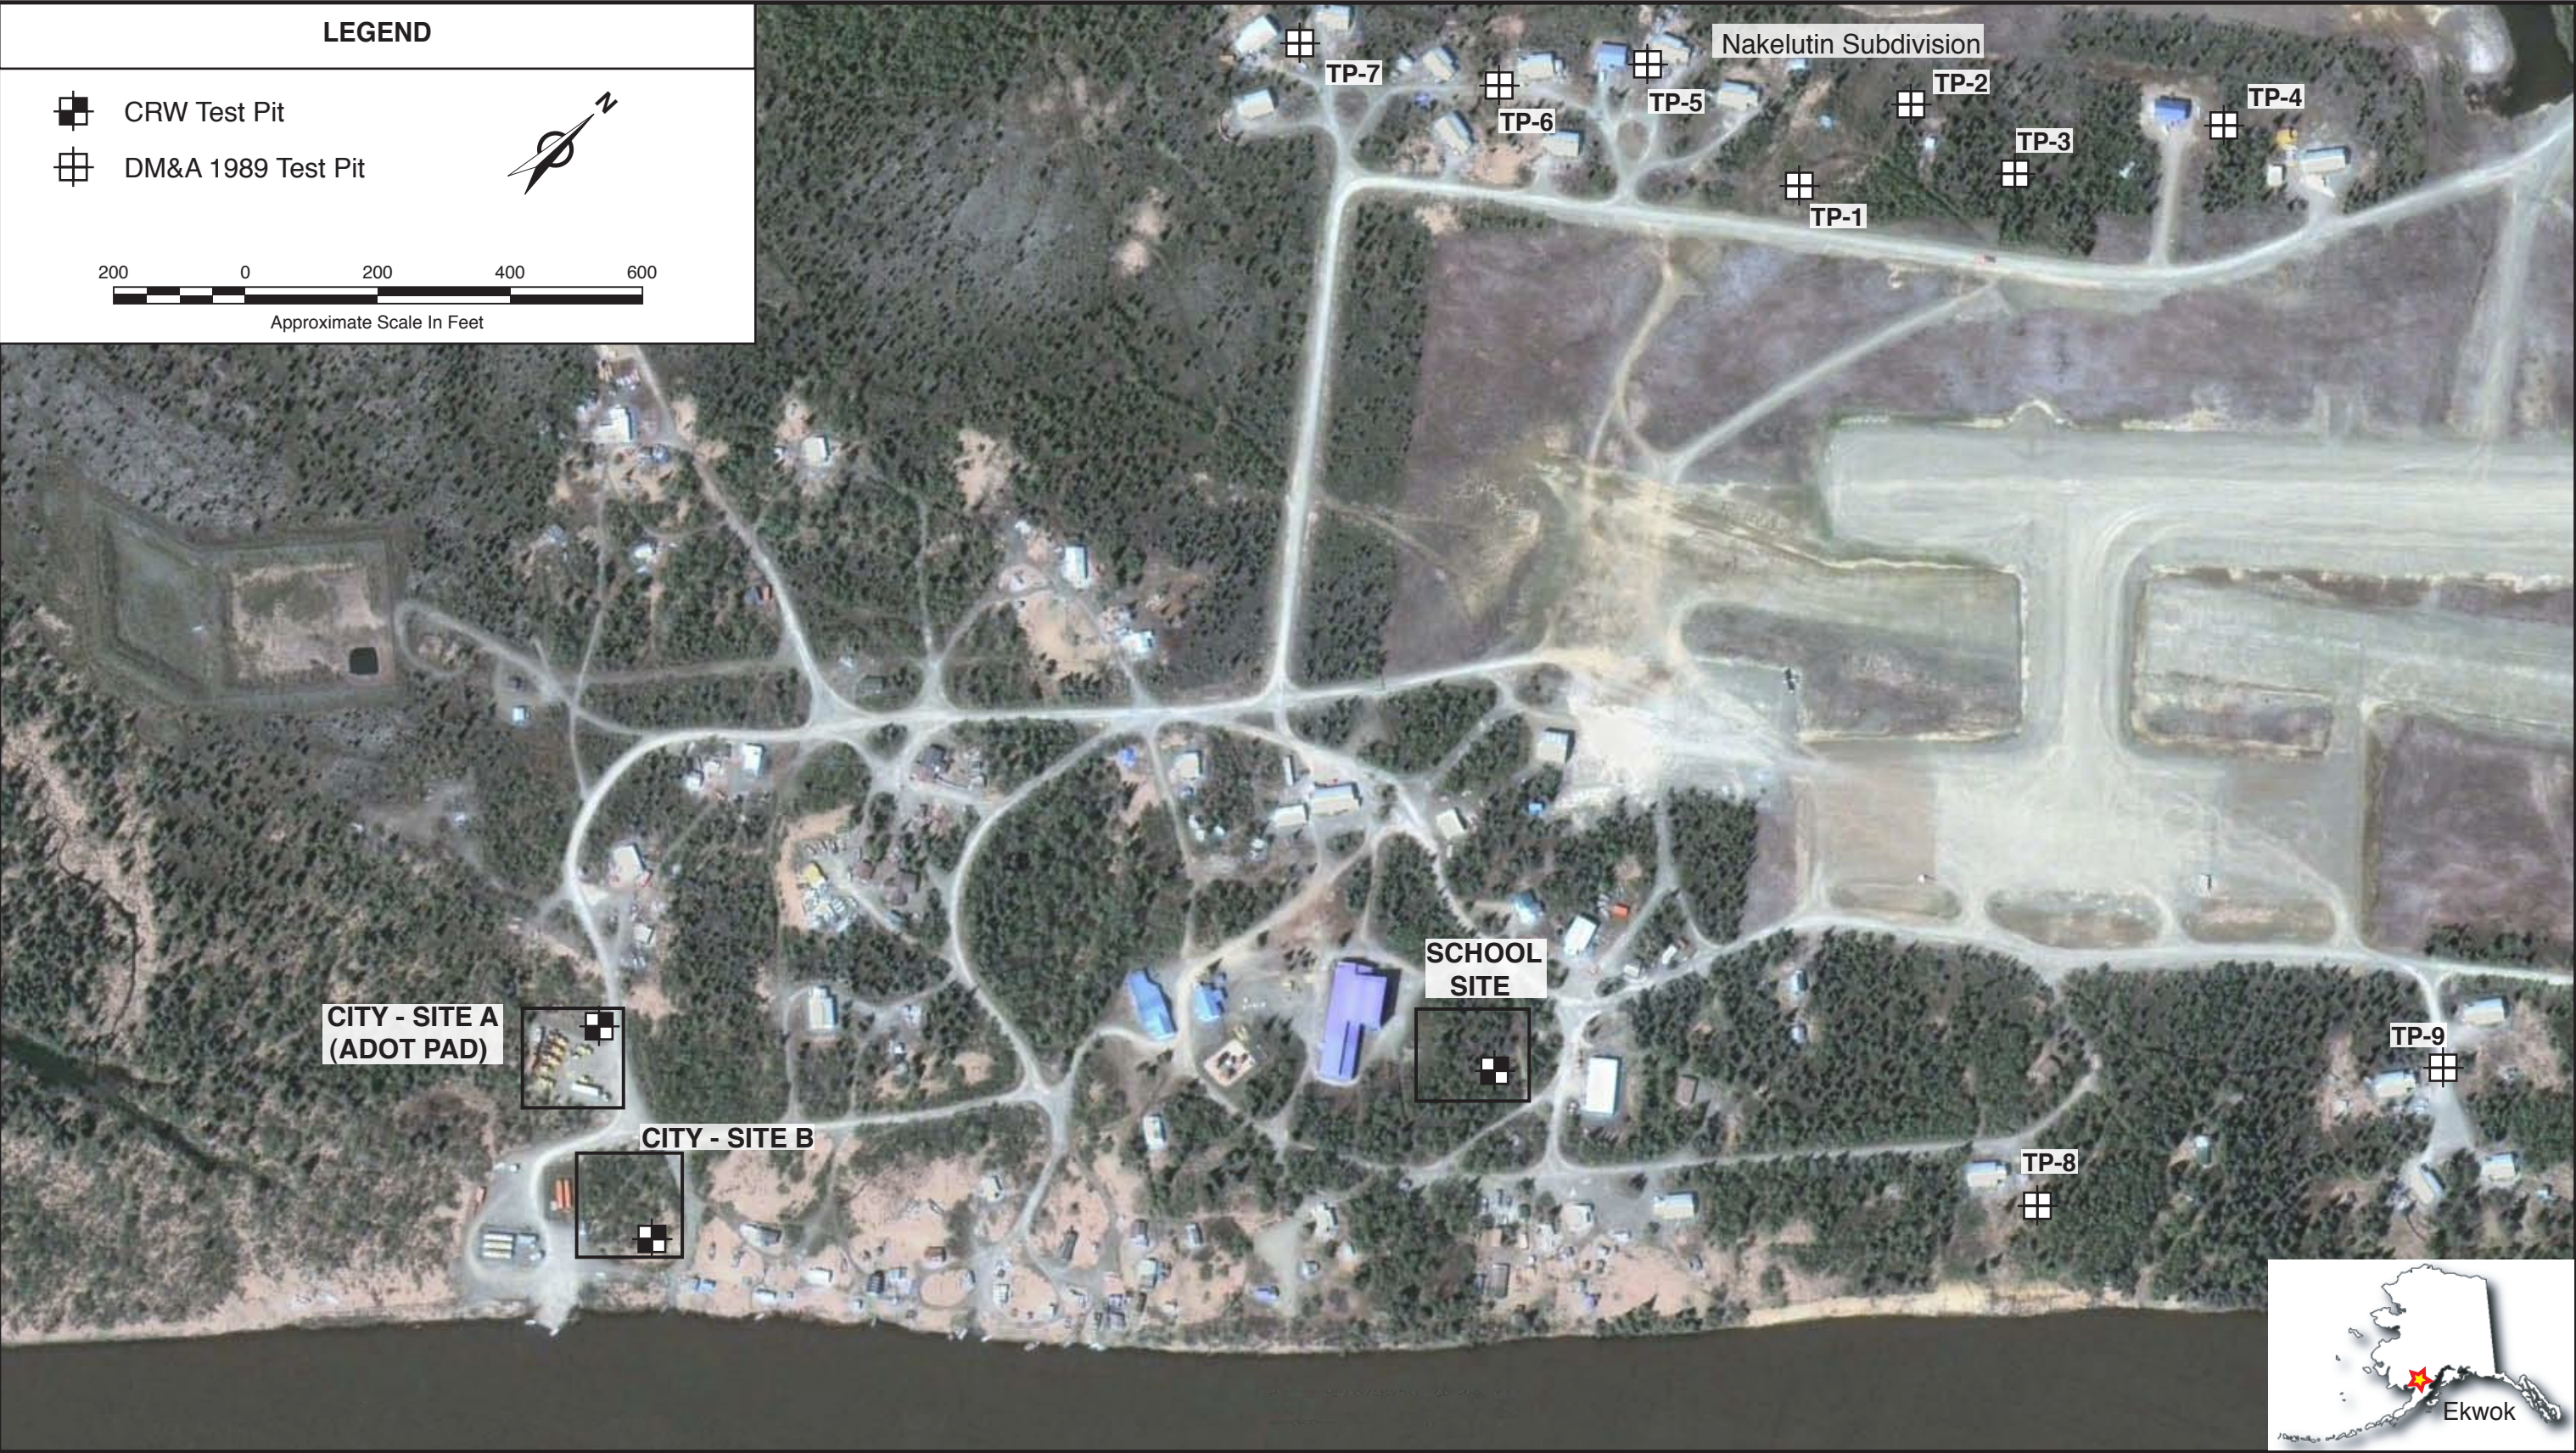
Base © 2006 Digital Globe, Imagery Dated May 28, 2006

The proposed site for the school's tank farm is on undeveloped land northeast of the school building. The site is relatively flat, on high ground above the Nushagak River bluffs in the northern part of the village. The site is vegetated with spruce-poplar forest with small clearings of dwarf shrubs and grasses. The locations of the three potential sites, are presented on Plate 1, Site & Vicinity Map.

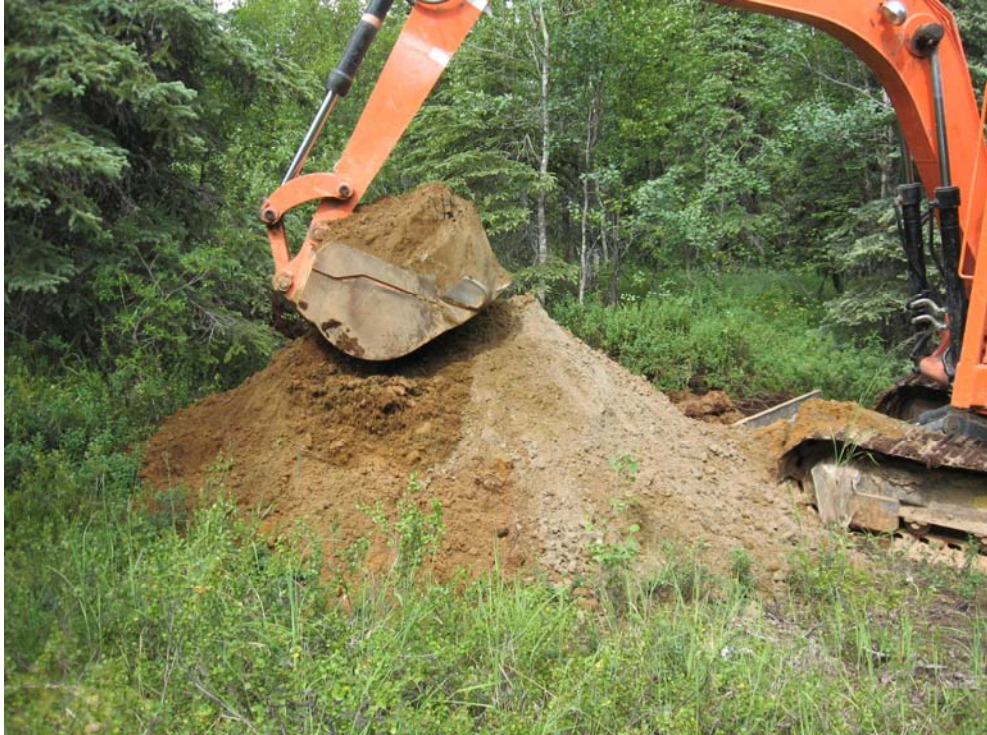
Photo 1 – Excavating School Test Pit

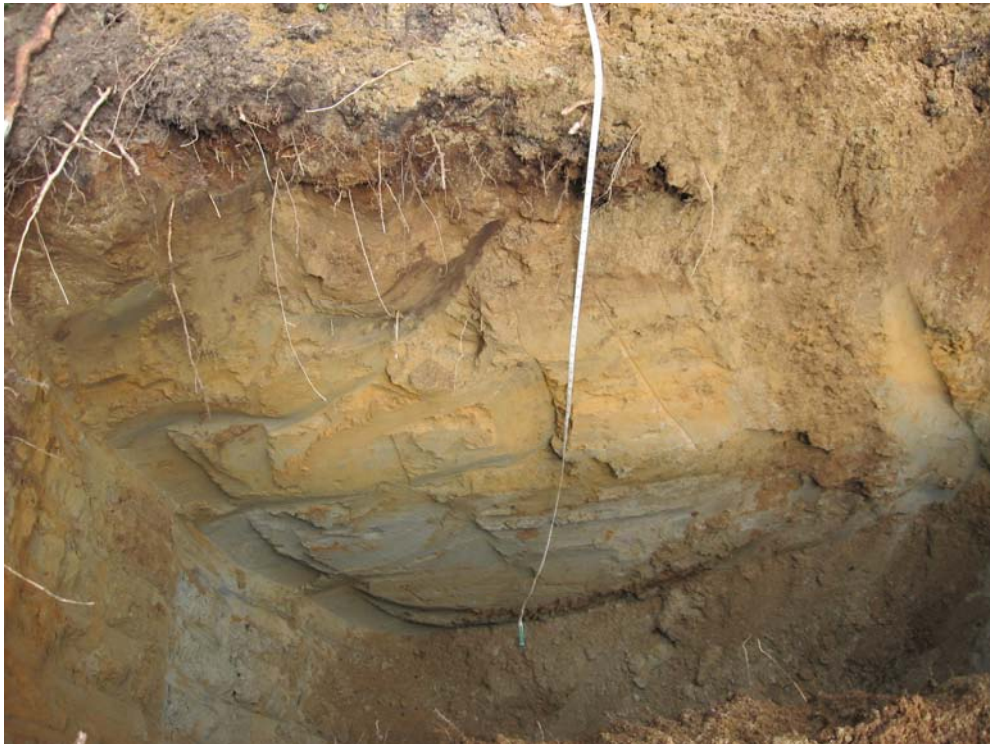
Photo 2- School Test Pit

The subsurface conditions present in the test pit excavated at the school site consists of a thin organic mat, 8 inches thick, which is underlain by brown, silty fine-grained sand, transitioning to gray silty sand at about 5 feet below the surface and extending to the bottom of the test pit, 8 feet deep. The silty sand at the school site is most likely similar to silty sand previously found above the bluff in Ekwok, which is moderately frost susceptible. Marginally frozen ground was observed at 3 feet below the surface and was apparently present to the depth of the test pit. The frozen ground is most likely due to seasonal frost penetration from the previous winter. The site sits on relatively high ground, above the Nushagak River bluffs, and appears to be well-drained.

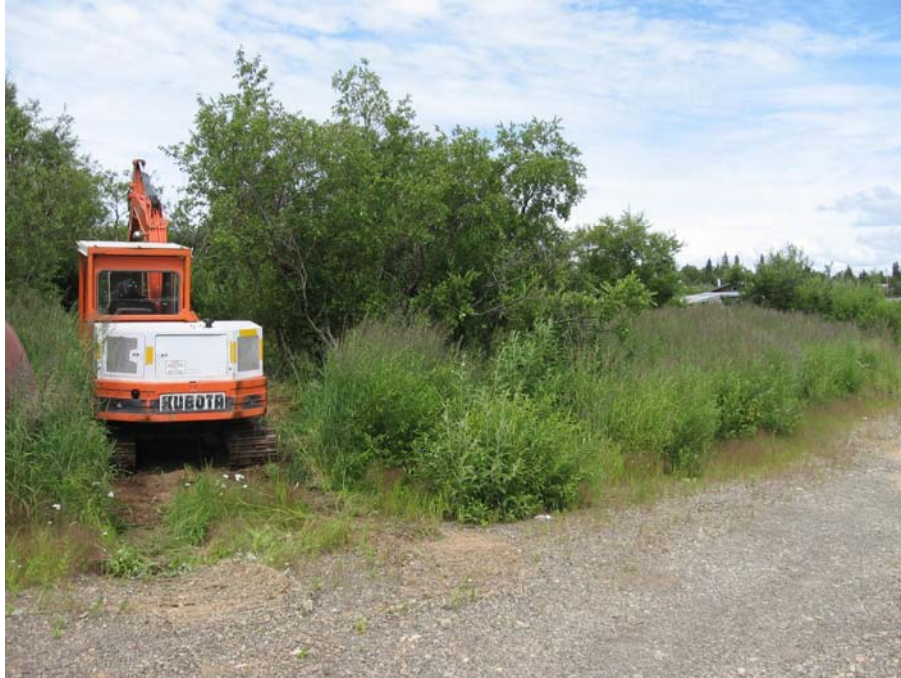
Photo 3- Excavating City Tank Farm Test Pit

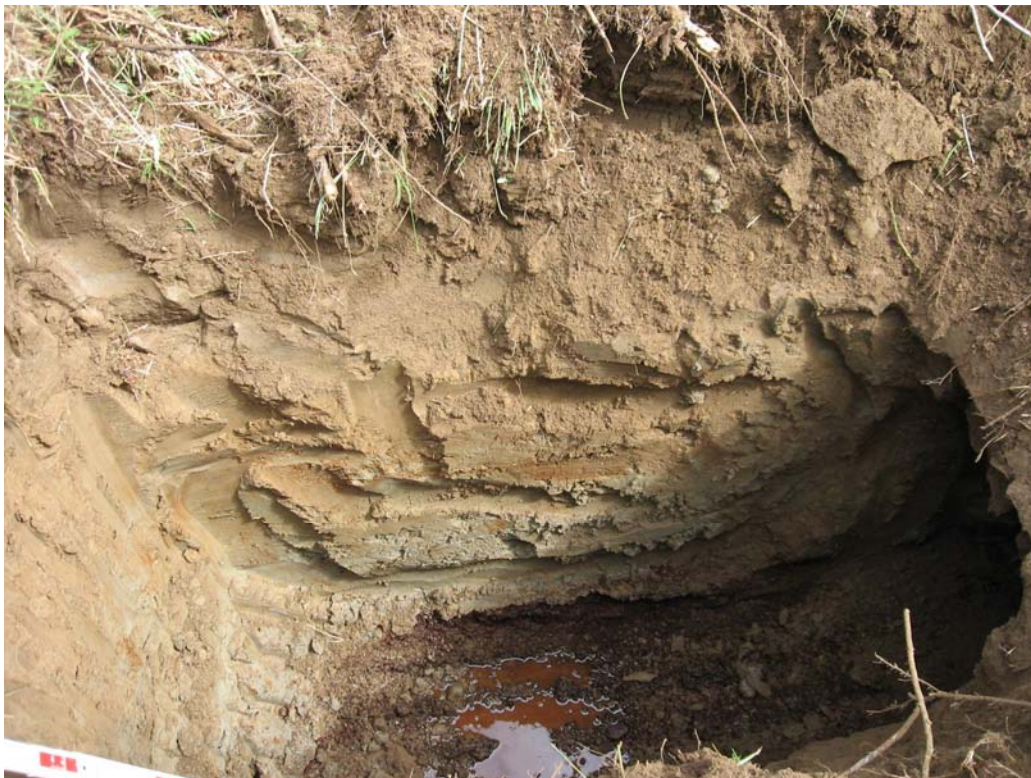
Photo 4- City Tank Farm Test Pit

Site B for the City fuel tank farm is covered with a 1-foot thick organic mat, which is underlain by brown, saturated fine sandy silt to 3 feet below the surface. The brown silt transitions to a light brown-gray, wet, slightly plastic silt with some fine-grained sand. Beneath the silt, orange-brown gravel was encountered at 8 feet below the surface and was present to 9 feet, the depth of the test pit. The silt observed in the test pit is frost susceptible. Marginally frozen ground was reported in the test pit at 4 feet deep and was apparently present to the depth of the pit. The frozen soil is likely due to seasonal frost penetration from the previous winter. Photo 4 (Appendix B) taken during excavation shows groundwater accumulating in the bottom of the test pit at about 8.5 feet below the ground surface. Site B is close to the river (within 100 feet on May 8, 2006, the date of aerial imagery used in Plate 1), and is generally within 10 feet of river elevation.

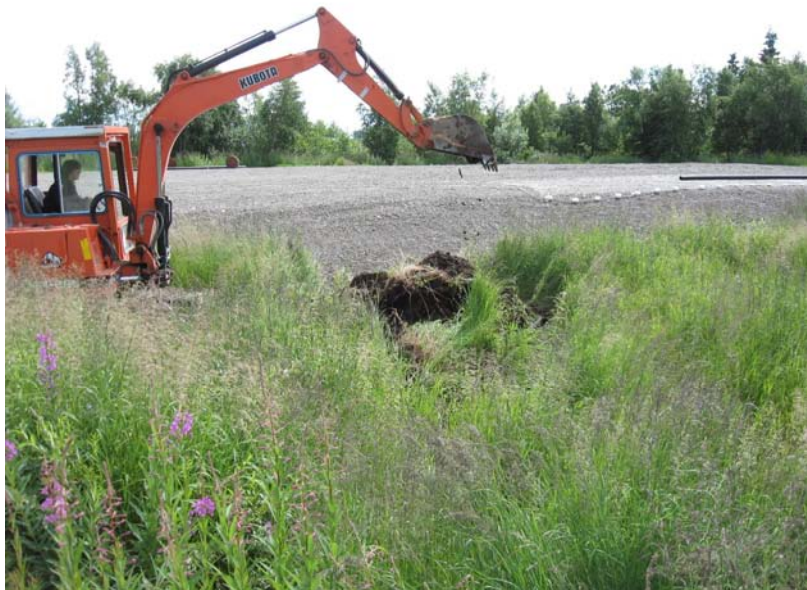
Photo 5- Excavating ADOT Pad Test Pit

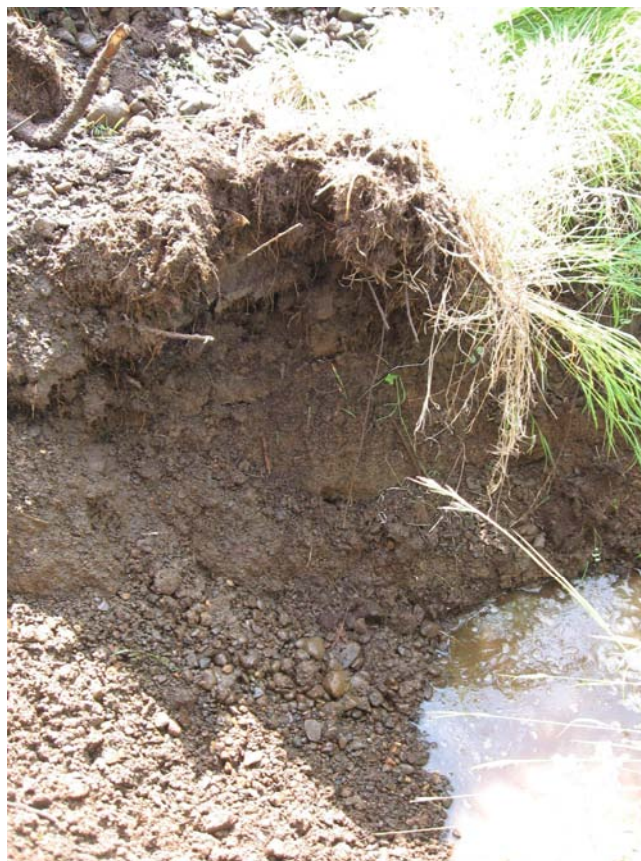
Photo 6- ADOT Pad Test Pit

The test pit at the City Site A was excavated adjacent to the existing gravel pad constructed by ADOT. Subsurface conditions consisted of a thin organic mat, 1 foot deep, underlain by silt to 2.5 feet. Gravel was encountered beneath the silt and was present to the depth of the test pit, 5 feet. Photo 6 (Appendix B) taken during test pit excavation shows significant groundwater ponding in the bottom of the test hole at about 4 feet below the ground surface. The ground surface elevation at the test pit is about 86 feet MSL, within 15 to 20 feet of the river elevation.
