FY 2006  
**FINAL REPORT**

PROJECT #: ACWA-06-10

**Watershed Protection and Recovery for  
Jordan Creek, Juneau, AK**

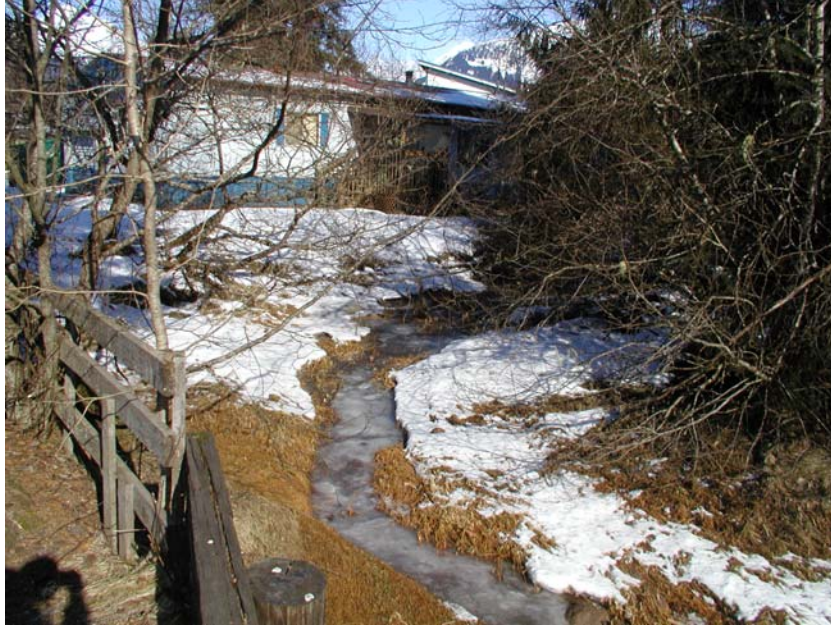
**Figure 3a.** Site JC-A, showing the frozen stream channel on 3/15/06, when the air temperature was  $-15^{\circ}\text{C}$  in Juneau.. Flowing water was present at the site on all other sampling events. Also visible is a house situated within a few meters of the streambank, exemplifying the rising encroachment of urbanization along Jordan Creek.

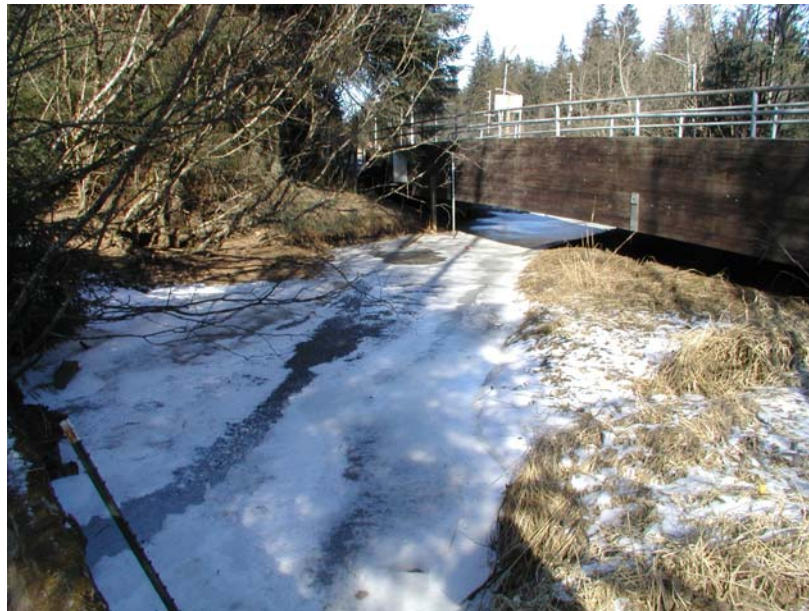
**Figure 3b.** Site JC-B, showing frozen conditions on 3/15/2006. The ice was too thick to break manually.

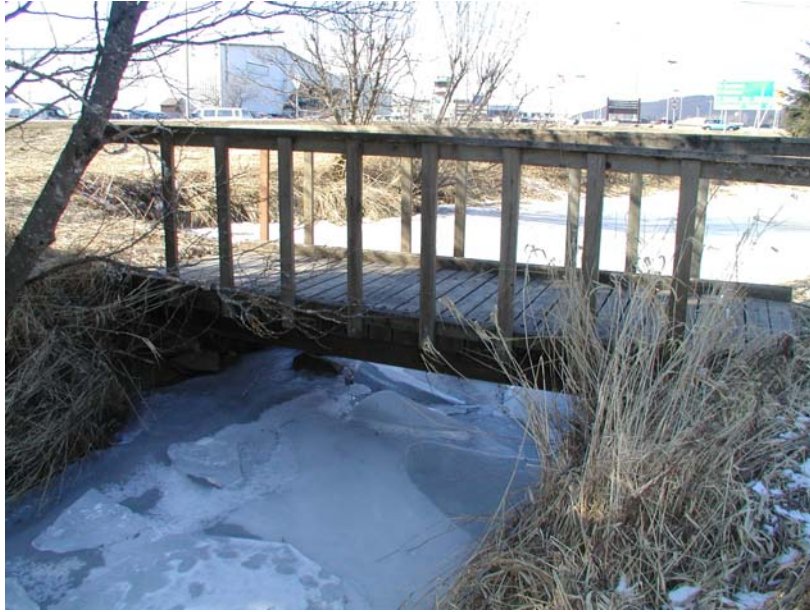
**Figure 3c.** Site JC-C, showing broken ice (with no water underneath), on March 15, 2006 when air temperatures reached  $-15^{\circ}\text{C}$  in Juneau. No flow was observed at the site for approximately 2 months, from late February to late April, 2006. During this no-flow period, the channel was either completely dry or contained disconnected pockets of ice and/or snow.
