# DESIGN ANALYSIS REPORT

## FINAL REVIEW DRAFT

Water Treatment Plant / Washeteria Upgrades, Kongiganak, Alaska  
September 2019

Village Safe Water Program  
(Project #19-VSW-KKH-014)

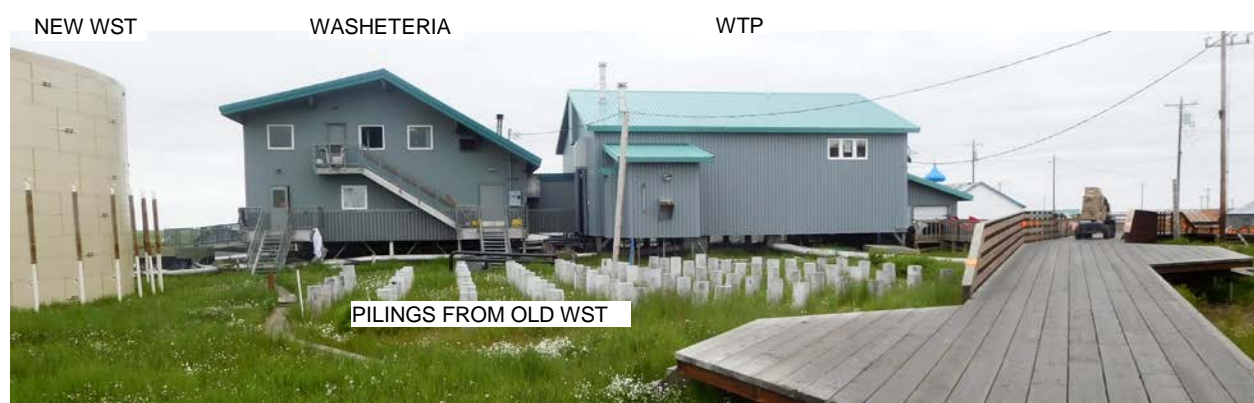
The community WTP building has undergone multiple renovations since its construction in 1978. The WTP was initially a multi-purpose building, including drinking water treatment, wastewater treatment, and laundry facilities. Significant building renovations have included upgrading the drinking water treatment systems (completed in 1999); relocating the laundry facilities to a new Washeteria building addition (completed in 2002); removing the wastewater treatment systems with the construction of a new lagoon system (completed in 2005-2008); and the removal of the original raw WST (572,000 gallons) with the construction of a new raw WST (1.2 million gallons, completed in 2008). An enclosed, coin operated, community watering point was added to the WTP building exterior in 2009.

**Exhibit 2-1: Kongiganak WST, WTP/Washeteria, and old WST pilings (2019).**

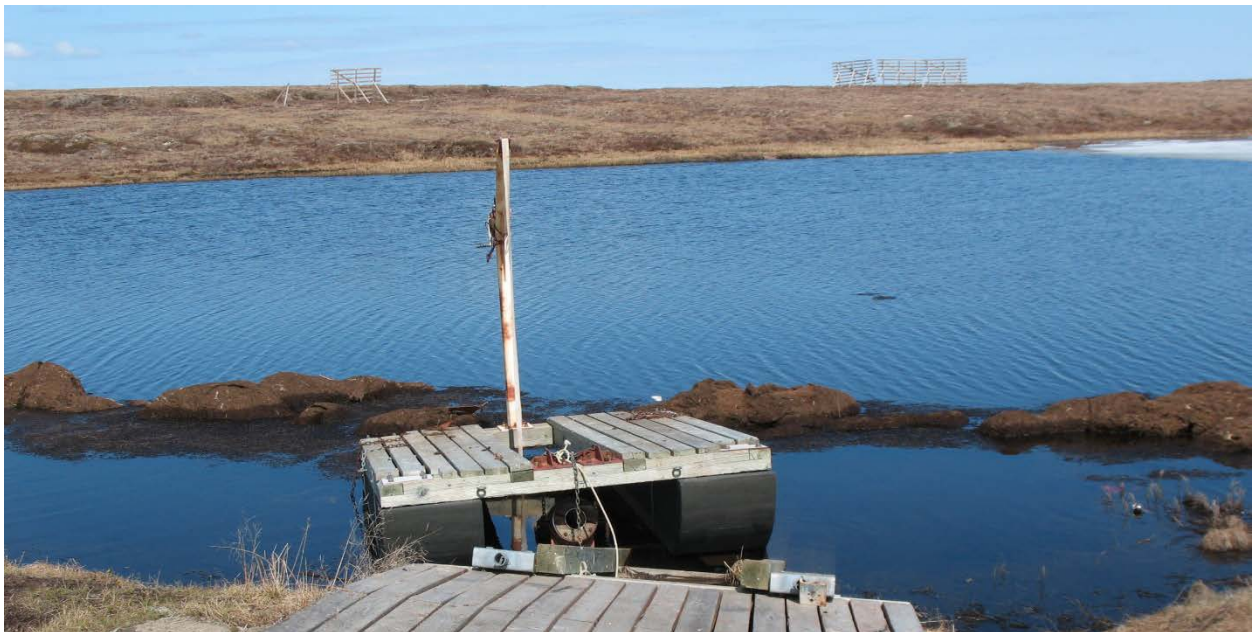
**Exhibit 4-1: Contractor's Lake (2010)**

The 1981 *Design Report, Water Supply and Storage Project, Kongiganak VSW Facility, by Quadra Engineering* estimated that Contractor's Lake could provide approximately 4-5 million gallons of available water, with most of the annual recharge provided by normal precipitation. The Village of Kongiganak currently has water rights with the Alaska Department of Natural Resources (DNR) to withdraw 3,600 gallons per day (issued 2004, LAS 23946, see Appendix B).

An Alaska Native Tribal Health Consortium (ANTHC) report (*A Sanitation Facilities Improvement Project*, Project Nos. AN94-A43 & AN99-MO9, 2004) noted that Contractor’s Lake did not provide a sufficient volume of raw water, requiring the community and the school to supplement raw water supplies with rain water catchment. The report went on further to state: *“Additional water supply will be needed for the ultimate long-term water needs of the community.”* The community population at the time of this report was estimated at 294 people (ANTHC, 2004). The current population is 539, with a 20-year design population of 644 people.

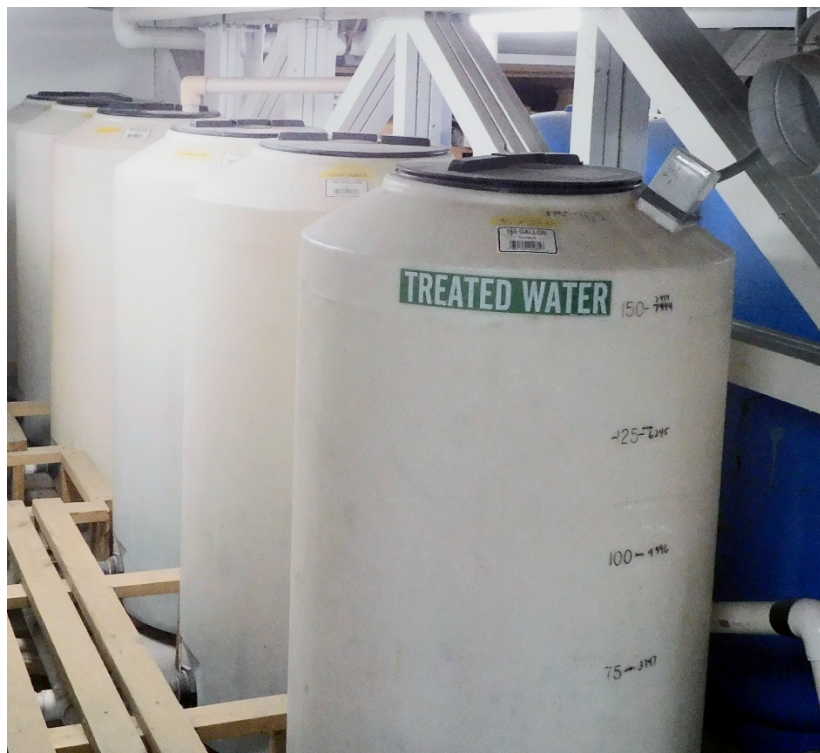
During the water treatment upgrades in 2000, sixty-one 165-gallon, plastic tanks were installed on the lower floor of the original WTP building, as a temporary method of providing treated water storage. However, these tanks are still in use today. The total effective storage (based on volume marks on the containers) is just under 8,000 gallons.

Exhibit 5-2: Current Treated Water Storage

The filtered, chlorinated water is added to one of the tanks, which is part of three storage tank groupings (see Figure 1 in Appendix A). The current piping sends the water from this tank, out to distribution, with no circulation through the other tanks. This results in no reasonable time for chlorine disinfection. There are many dead zones in the existing treated water storage system that never experience chlorination. If replumbed, the existing distribution pump systems would not be sufficient to effectively circulate water through the tanks. This would lead to stored water with a high potential for biofouling. The tanks are currently experiencing excessive algae growth in multiple tanks. However, the most significant issue with the existing storage tanks is the load that they place on the existing building. The existing structure is not capable of safely carrying the load. Since these tanks are on the first floor, failure would be less catastrophic (as compared to the filtration vessels located on the second floor).
