## Waterbody Field Report Pullen Creek, Skagway, Alaska

Prepared by: R.Cash<sup>1</sup>

### Abstract

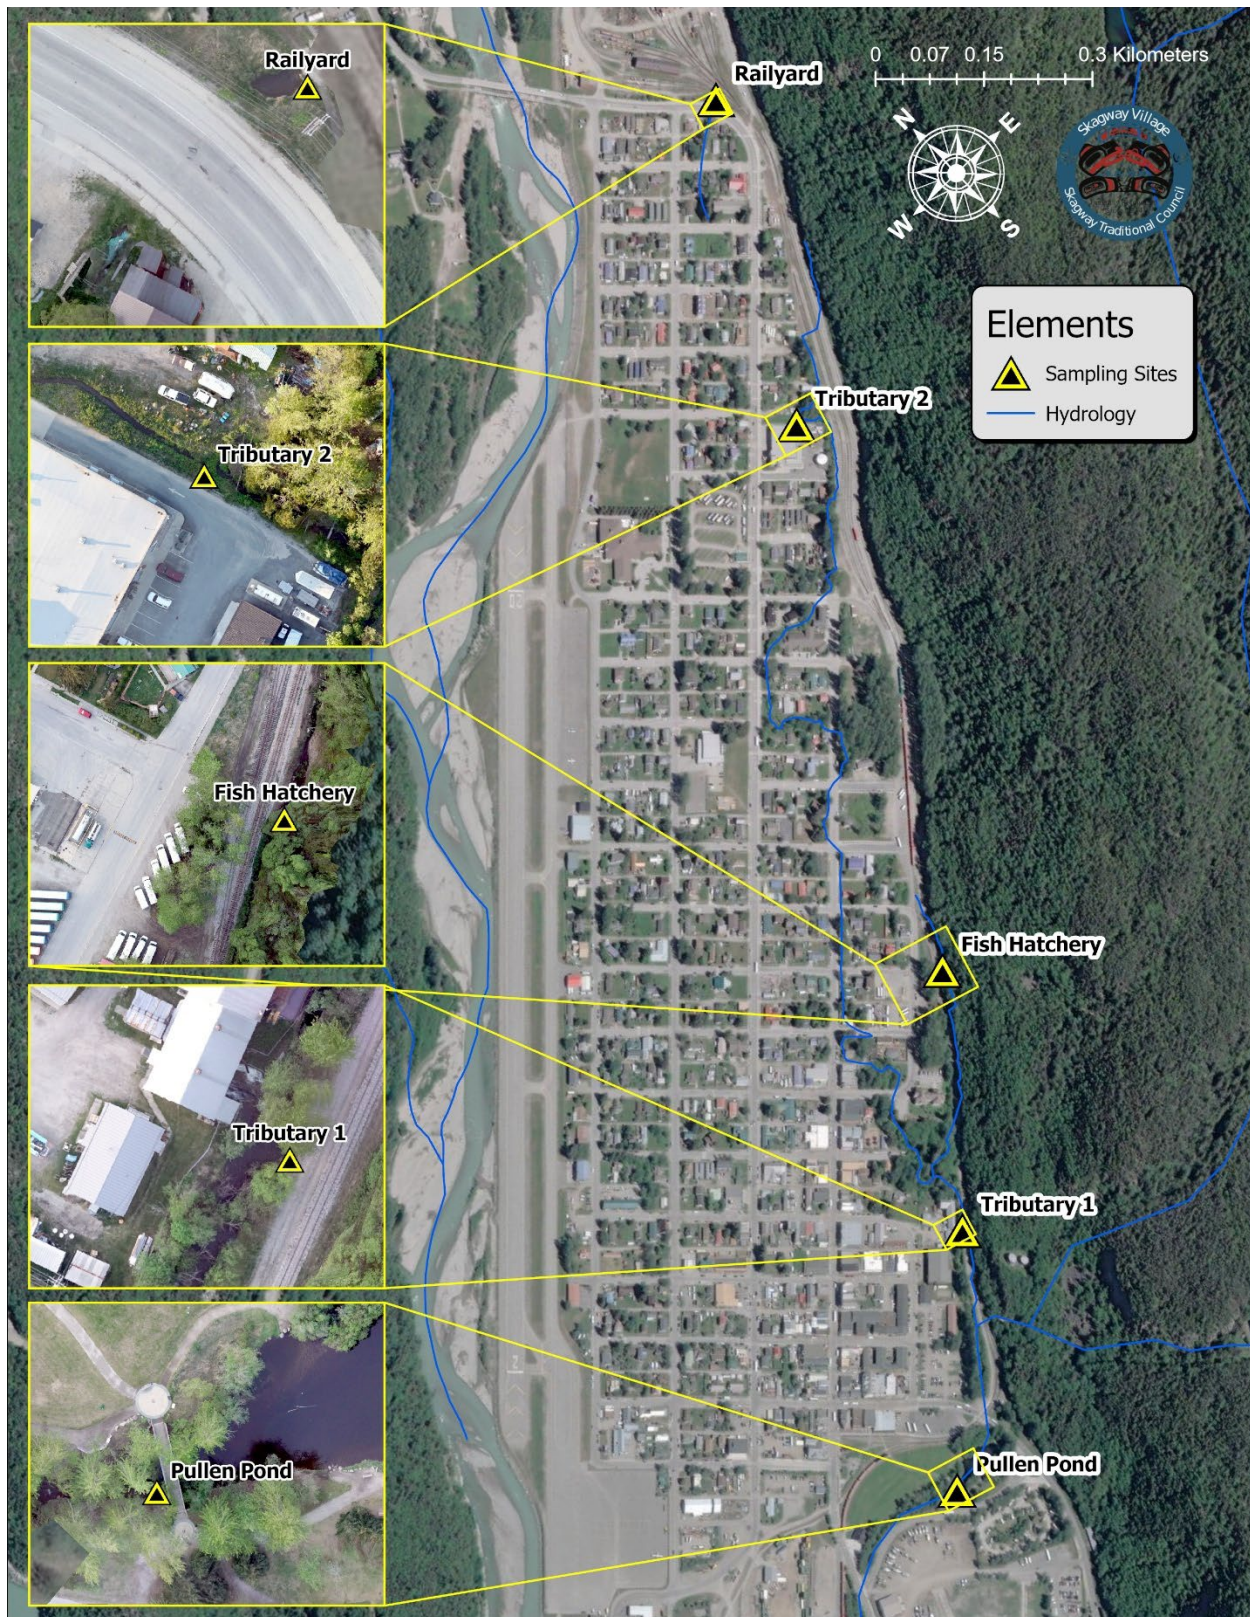
Figure 2. Overview of sampling sites for abiotic and bacteria sampling, with sample sites marked with yellow and black triangles.

STC staff followed all protocols and standard operating procedures (SOPs) as defined by the project QAPP. Sampling was conducted at five sites (Figure 2) in April 2024 with one duplicate for dissolved metals at Pullen Pond, one event was scheduled, and one set of samples was delivered to the lab for a completeness total of 100%. Bacteria sampling took place in July and August 2024, five consecutive events were scheduled, and five sets of samples were delivered to the lab for a completeness total of 100%. Three bacteria sampling sites were selected based on the highest likelihood of representativeness: Pullen Pond, Tributary 1, and Railyard (Figure 2). One rotating duplicate sample for *E. coli* and fecal coliform was

The July/August bacteria samples were collected from a subset of the sampling sites: Pullen Pond, Tributary 1, and Railyard (Figure 2). *E. coli* and fecal coliforms were measured along with the in situ parameters listed above. One set of MST samples was collected during the July 25, 2024, event for analysis of three DNA markers: canine, avian, and human.
