Tuntutuliak Water Treatment Plant/Washeteria

Preliminary Engineering Report

Tuntutuliak, Alaska

FINAL REPORT
May 23, 2019

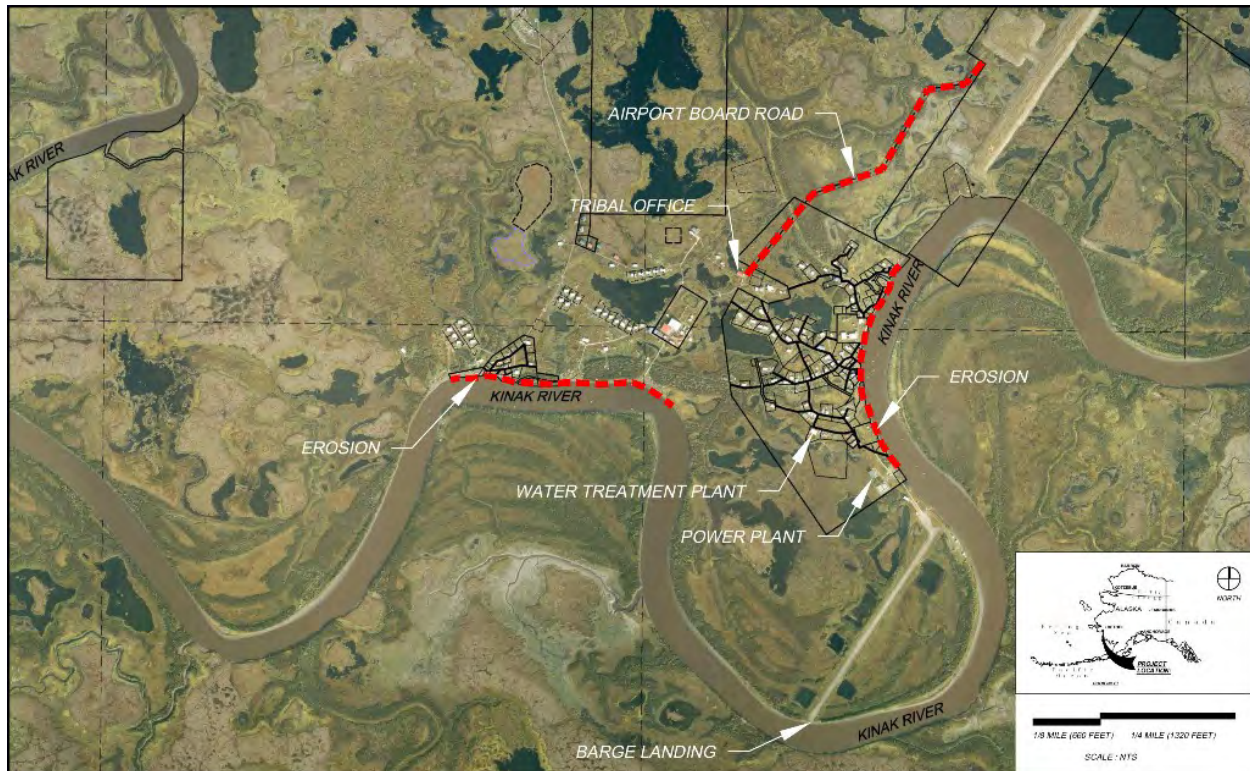
Figure 1.1: Community Map

The WTP/washeteria is located at 60° 20' 24.21" N Latitude and 160° 40' 6.95" W Longitude.

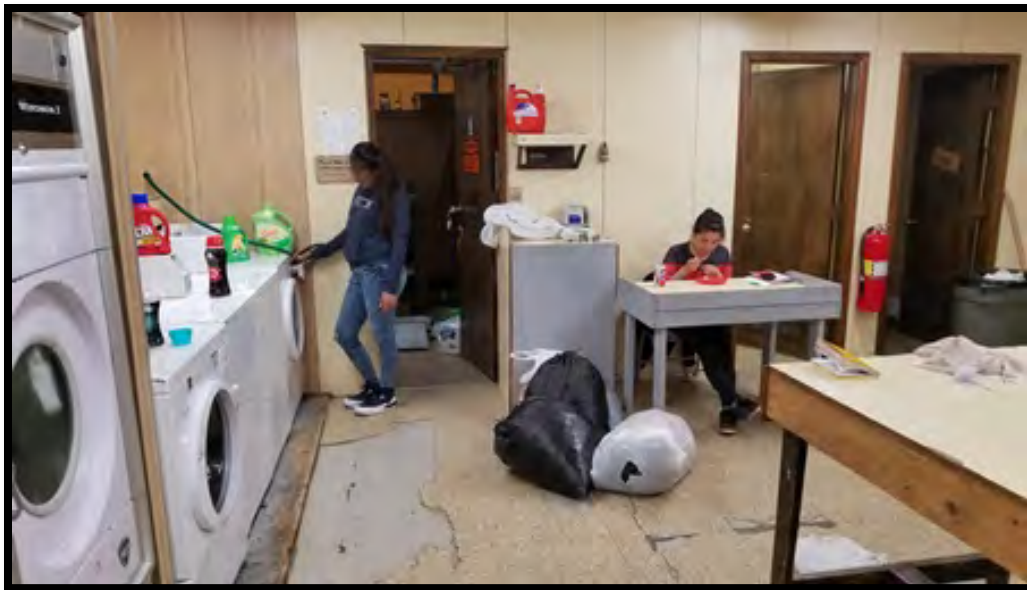
Figure 8: Washer, manual filling with hose.

The washeteria interior is in poor condition. The floor is worn down to the wood structural members. Only one bathroom and one shower are functional. The one functioning bathroom was in poor condition, with a broken mirror, vanity, and door. Mold and rot were observed in the showers and along the baseboards. Only one shower ventilation fan worked, but it is failing and should be replaced. The walls and ceiling have been patched repeatedly due to leaks and breaks. The interior sheetrock is in poor condition and should be replaced. The water fountain doesn't work. The water piping to the washers is non-functioning and washers are filled by hand using a hose.

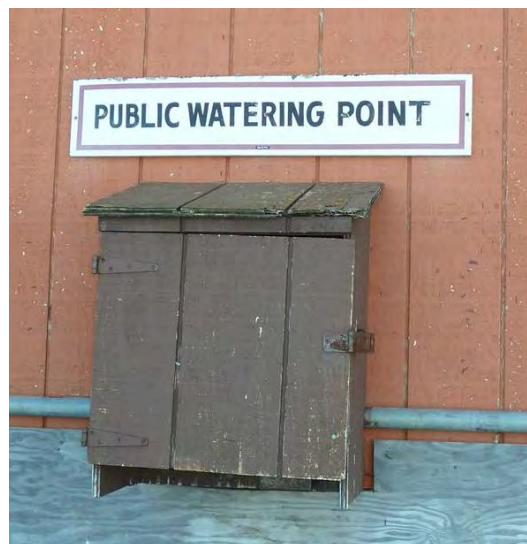
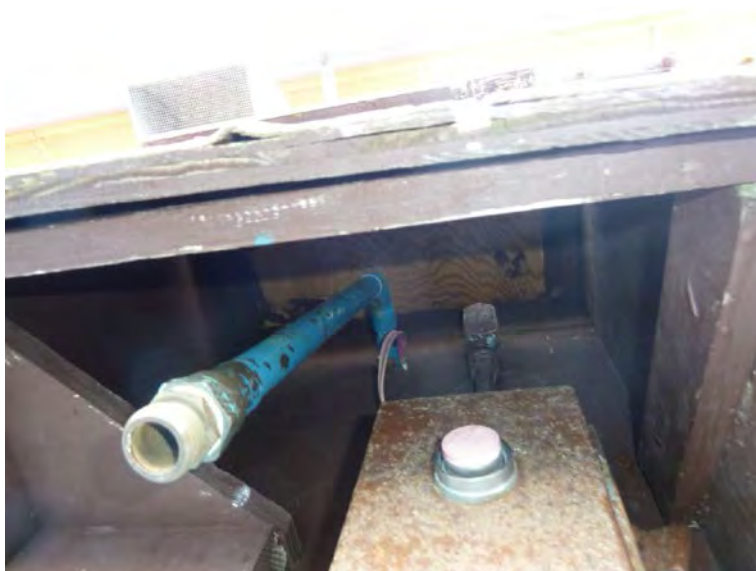
The existing watering point is manually operated using a button-activated solenoid valve in the WTP. The existing watering point control is not working. This configuration does not prevent excessive waste of water nor does it allow for revenue to be collected for water. The watering point does not extend out from the building and does not currently have a flexible hose for the discharge, making it difficult to fill containers on a vehicle. Upgrades are proposed to add a coin operated solenoid to allow revenue collection and prevent excessive wasting of water at the watering point. Watering point piping should also be upgraded by installing an insulated arctic pipe arm with a flexible hose drop pipe to improve accessibility for vehicle haul. This alternative is itemized in Table 2. Due to budget considerations, a second alternative including only the addition of a coin operated dispensing system is presented in Table 3.

Figure 1 - Public Watering Point

Figure 2 - Public Watering Point Piping and Actuator

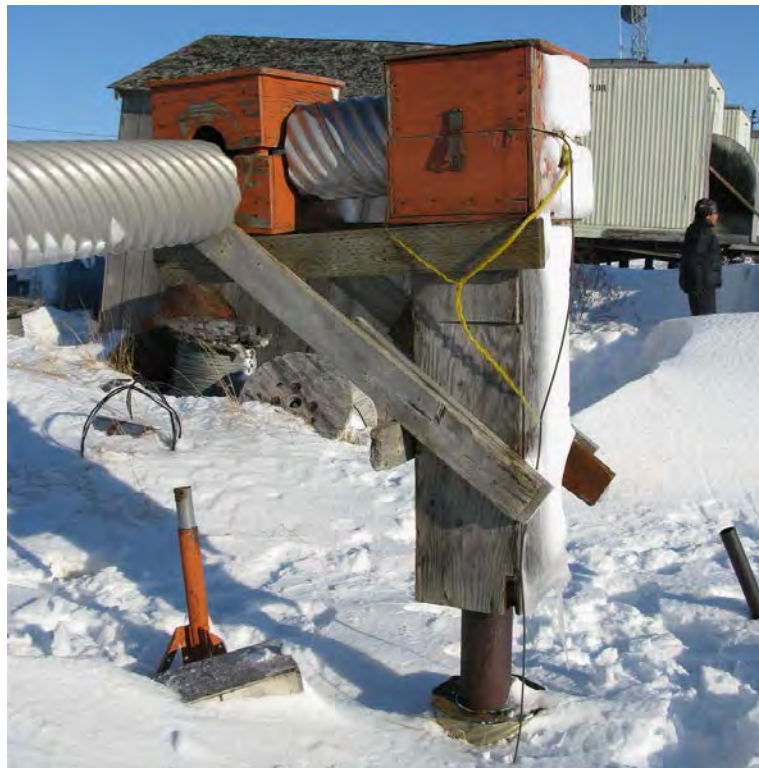
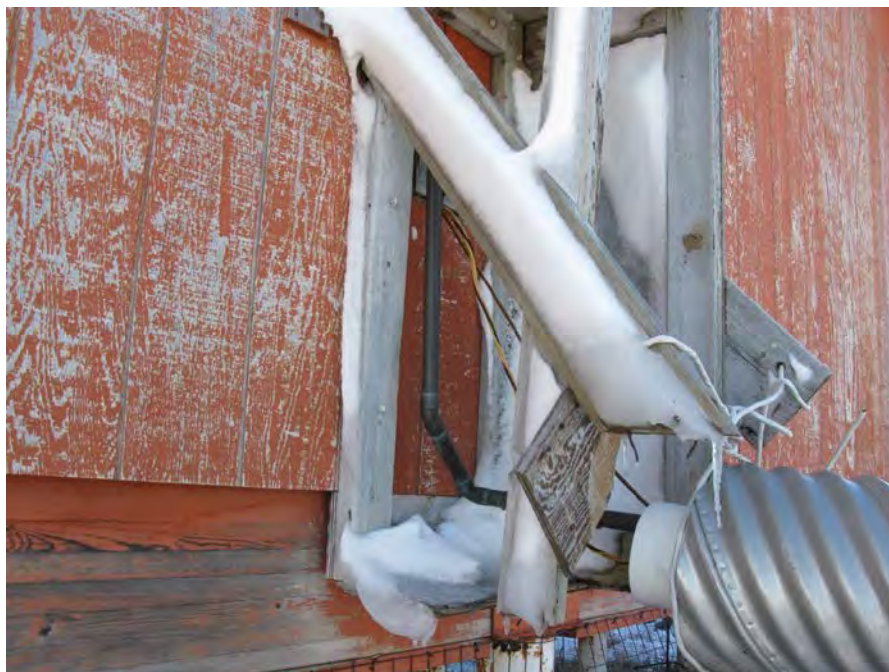
The arctic box on the well head is in need of replacement as it offers minimal thermal protection. The existing transmission line from the well is an approximately 20-foot long copper pipe equipped with heat trace inside an arctic insulated PVC pipe with a CMP jacket. This pipe was supported with 3-legged wooden assemblies with cradles. The supports are now in a state of disrepair, leaving the pipe rigidly supported only at the well end. This also places a strain on the rigid copper water piping. The arctic box at the connection of the raw water pipe to the WTP is partially disassembled resulting in the potential for damage due to freezing. Also, water in the raw water line is forced back into the well using compressed air after the well pump is turned off. This process can be made automatic by installing an air/vacuum valve on the raw water piping in the WTP as record drawings indicate that bleeder valve is already present on the well drop pipe. An air/vacuum valve in the WTP, new arctic boxes at the well head and connection to the WTP, and a new raw water transmission line consisting of a 1-inch or 1.5-inch HDPE carrier pipe with arctic insulation supported by wood cribs are recommended to address these deficiencies.

Figure 3 - Well System and Transmission Line

Figure 4 - Well Head

Figure 5 - Connection to WTP
