## Site Inspection Trip Report Native Village of Kongiganak, Water Treatment Plant Existing Piling Assessment

REPORT DATE:	Tuesday September 08, 2021 - FINAL
INSPECTION DATE:	Wednesday August 11 – Thursday August 12, 2021
PROJECT:	Kongiganak WTP / Washeteria, Bristol # 32190078
LOCATION:	Kongiganak, AK
VSW PROJECT LEAD:	Susan Randlett, PE, VSW
PERFORMED BY:	Richard Mitchells, PE; Kraig Hughes, PE, SE, PLS
OTHERS PRESENT	Joseph Mute <tribal chief>; Sigfrid Kaufman <a href="mailto:sigskimo@yahoo.com">sigskimo@yahoo.com</a> (907) 557-2208 20-year resident of Kong; Roderick Phillip <a href="mailto:Kong6@gmail.com">Kong6@gmail.com</a> (907) 557-2121 Powerplant and ADOT contact
WEATHER:	Partly cloudy, 55 °

### KONGIGANAK FORMER WST FOUNDATION PILES, AUGUST 2021 RECONNAISSANCE SUMMARY

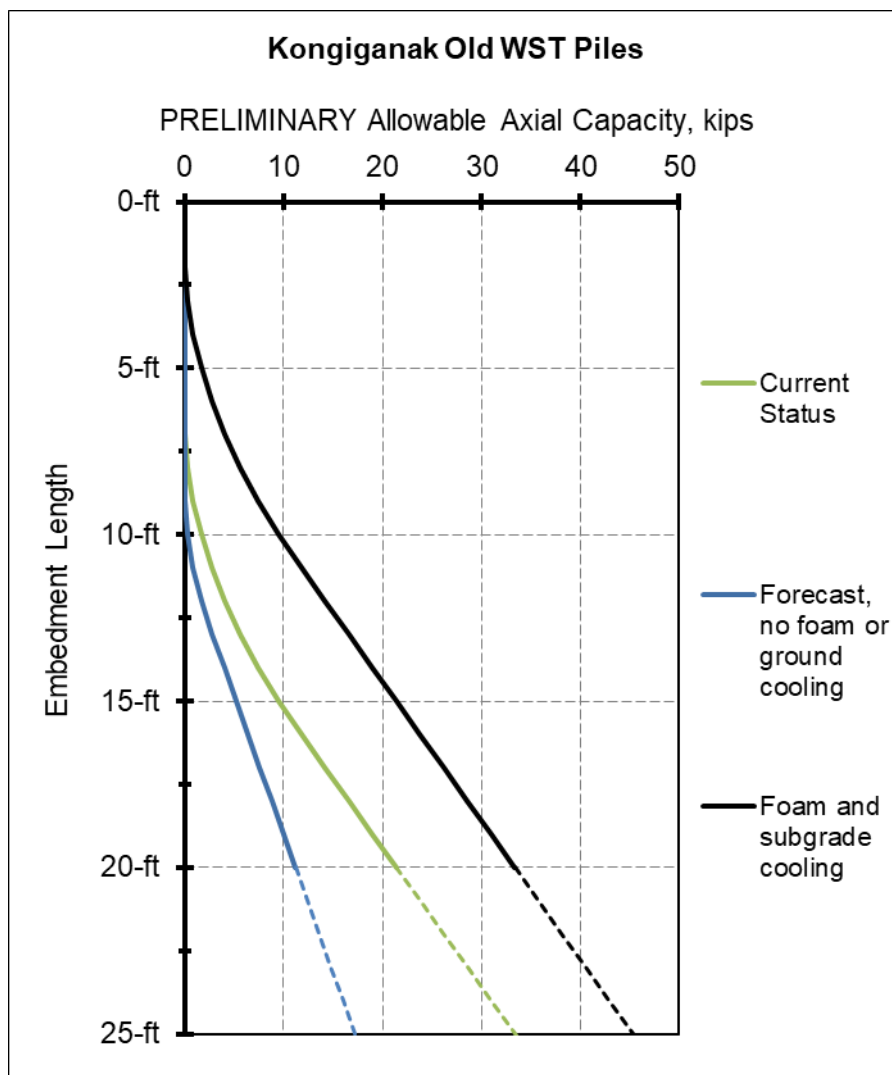
TABLE 1.0 PILE CAPACITY CURVES

The piles are in relatively good condition, considering their age. Their relative alignment is acceptable in the north-south alignment, not as uniform in the east-west direction. Piling shows no signs of decay or rot at the time of inspection. The top relative levelness of the piling is not good, with some piling showing obvious signs of frost jacking (presumably since the tank was removed in 2008). The capacity of the piling is more governed by the deteriorating soil conditions (see Appendix A) than the sizing and placement of the piling. The piles are in an approximately 5.5-foot spacing pattern having a tributary area of approximately 30.25 square feet (SF). The piles are acceptably plumb, but have individually moved some since their original placement. Accumulation of water around the piling was noted, especially on the south and west side of the pile group, and to depths as great as two feet deep.

While the original intent of the inspection and analysis was to determine capacity for two 40,000-gallon tanks with tank heights of 17 feet, and 20-foot diameters, this analysis resulted in a loading that exceeded the projected capacity of the piling at an assumed 20-foot embedment (conservative). See Appendix A. It is assumed that this tank configuration would weigh approximately 19,000 lbs (60 psf) and the water load will be 1,061 psf for a total/tributary area of 35,413 pounds. After a flat loop cooling system and surface insulation is added around the piling, the estimated capacity for each pile will be approximately 33 kips – see Table 1.0 above.

Discussions with the design team for this project allowed for adjustment of the tank capacity and adjustment of their sizing. The new tanks will be 22 feet in diameter and 12 feet high, having a capacity of approximately 34,100 gallons. The resulting load, including the estimated 18,000-pound tank is approximately 26 kips/pile, providing for a 1.27 safety factor above the allowable pile capacity after improvements have successfully been accomplished (subgrade passive cooling system and insulation). The pile capacity curves have an intrinsic geotechnical factor of safety of 2.0.

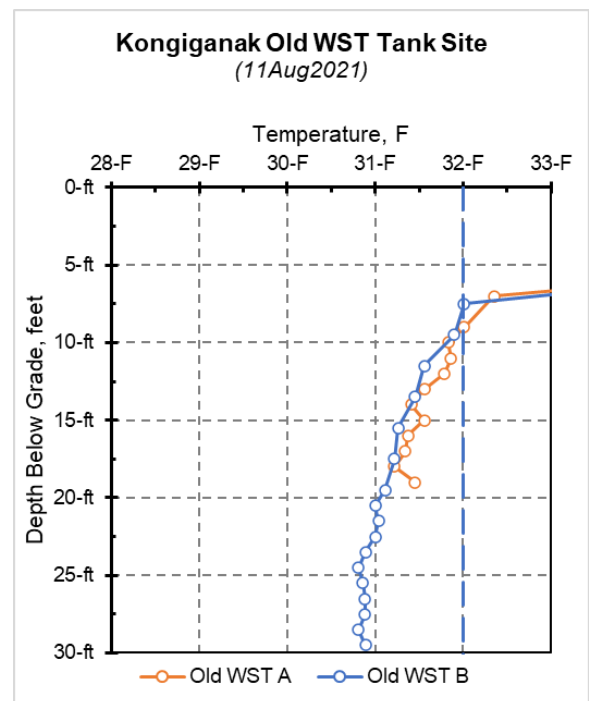
Measured ground temperatures measured during our August reconnaissance along select existing foundation piles are summarized in the adjacent plot. Based on our review of the original QUADRA design data, the August measured ground temperatures are about 2 to 3°F warmer than the ground temperatures reported by QUADRA in the late 1970's and about 0.5°F warmer than the design ground temperatures used in early 1980's by QUADRA for their pile capacity analysis. Based on our August 2021 field findings, the permafrost temperatures at depth have increased about 0.5°F and the depth of seasonal thaw has advanced deeper than the baseline design used by QUADRA.

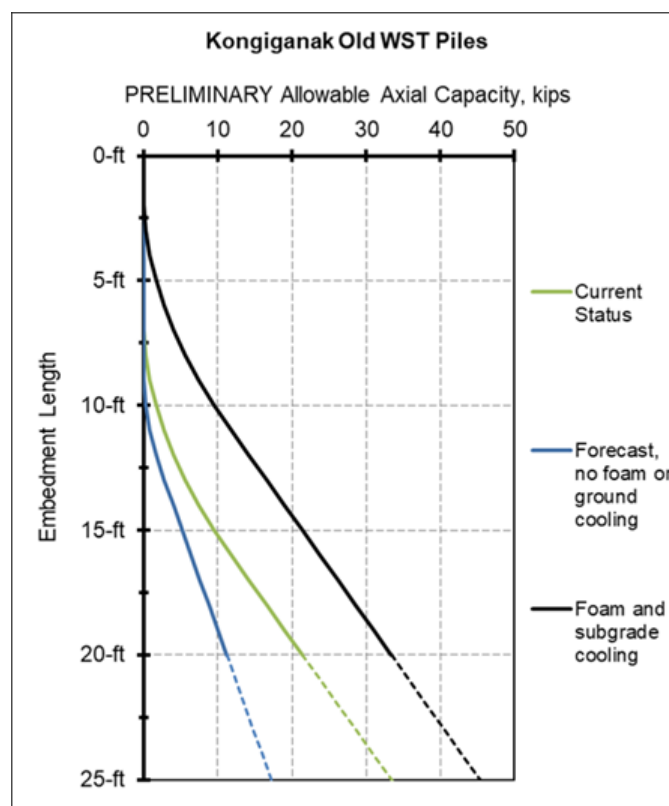
For preliminary adfreeze pile capacities for your planning I assumed an average 14-inch nominal diameter timber piles with silt cuttings used for slurry backfill. I did not include any end bearing contribution, but there is probably some end bearing contribution. I also assumed 20 foot pile embedment. However, the QUADRA report indicates deeper pile embedment, possibly to 28 feet, may have been used. We do not have reliable as-built records to verify the current pile embedment depths. The adjacent Water Treatment Plant (WTP) foundation records indicate 25 foot total embedment for those piles. For a conservative design approach, I applied a 20 foot embedment for the former WST piles but for planning purposes noted the incremental allowable axial capacities for deeper embedment similar to the WST pile foundations. Please note, the attached allowable capacities include a geotechnical Factor of Safety of 2.

In addition, I applied my estimated ground thermal impacts for a 20 year forecast based on historic trends and forecast air temperature warming trends for the area. However, I advise using these estimated allowable capacities with caution as climate impacts in Kong are rapidly accelerating.

Please consider the below allowable capacities as preliminary for your initial planning and design approach.

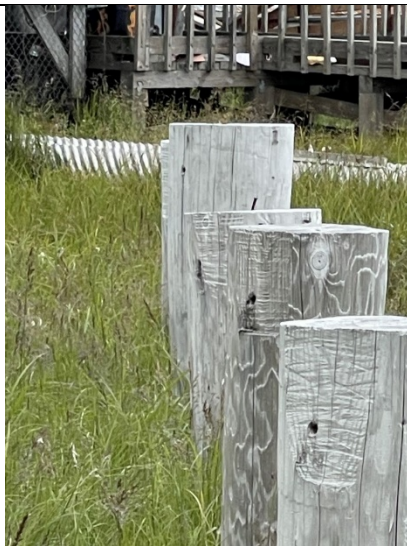
18 – Jacked pile

There is evidence of possible frost heave on a few piles along the western side of the existing pile footprint. Numerous existing piles have deep thaw and subsidence of the slurry around the piles that will need to be properly filled. Also, about 50-percent of the pile footprint area has standing water, some areas over 1 foot deep at the time of our August reconnaissance. This surface water must be removed from the site with the earthwork improvements for my allowable capacities note below. Based on the planned new water storage tank configuration on the site, the currently proposed new tank locations appear to be located in a slightly elevated terrain area that had less standing water when Kraig and I were on-site.

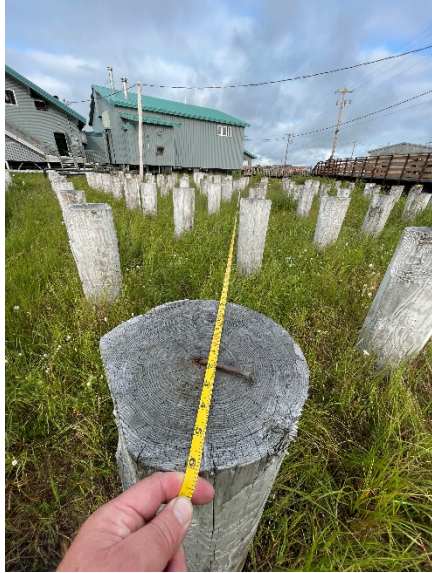
20 – measurements on piling

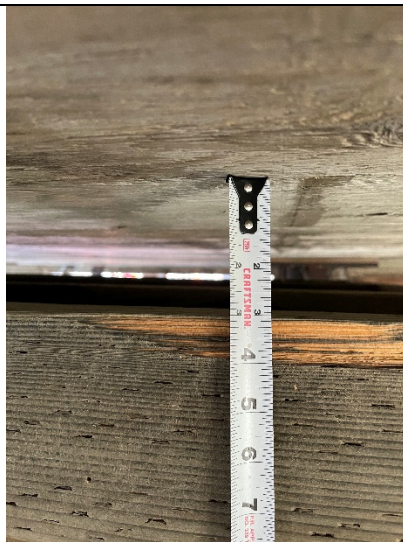
While on site, I inspected the temporary bracing under the Water Treatment Plant that was placed in 2020 to provide a safe load path for the vessels on the second floor to be supported to ground. There is a three-inch gap between the top of the dunnage support and the bottom of the floor fascia under the building – see photos 22 and 23. The dunnage was placed in the winter and it should be monitored in the winter to see if the gap closes in winter conditions. We don't want to shim this in summer to have it push the floor system up in winter if the soils are dynamic. If, during the winter, it is found that the gap persists, then adequate shimming should be installed.

22 - Temp. Support under vessels – 3 inches low

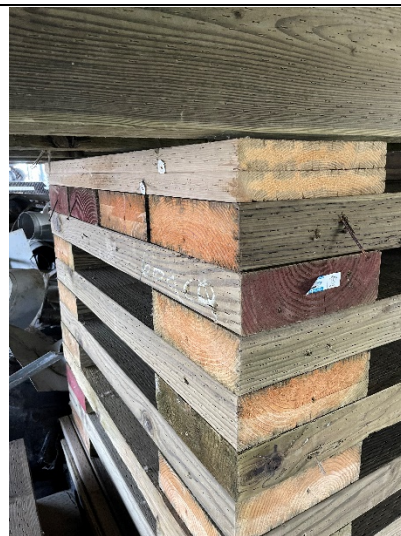
23, Dunnage Support for temporary support under vessel

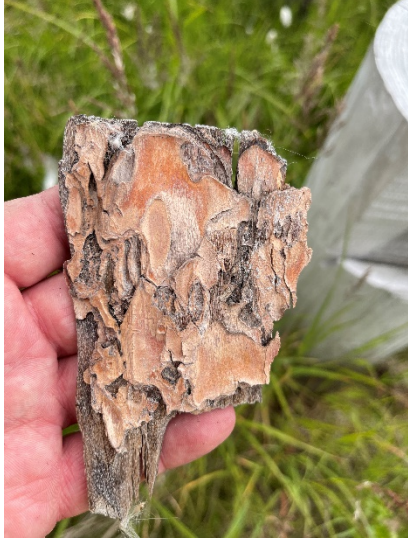
Discussions with Joe Mute during the site inspection provided that the piling were actually constructed from redwood. If the piles are Redwood, it has relatively high mechanical properties, medium weight, low shrinkage, ease of working, and high resistance to decay. Photo 24 shows bark from the pile, removed during the site inspection. Although not definitive, a comparison with known redwood bark images supports that the pile are redwood. A comparison of National Design Specifications for Wood Construction design values for multiple species can be found in **Appendix E**, and shows that redwood has comparable values with other more common species used in Alaska..

24 Bark from pile - redwood
