# DESIGN ANALYSIS REPORT - PHASE I

Water Treatment Plant / Washeteria Upgrades, Kongiganak, Alaska  
September 2019

Village Safe Water Program  
(Project #19-VSW-KKH-014)

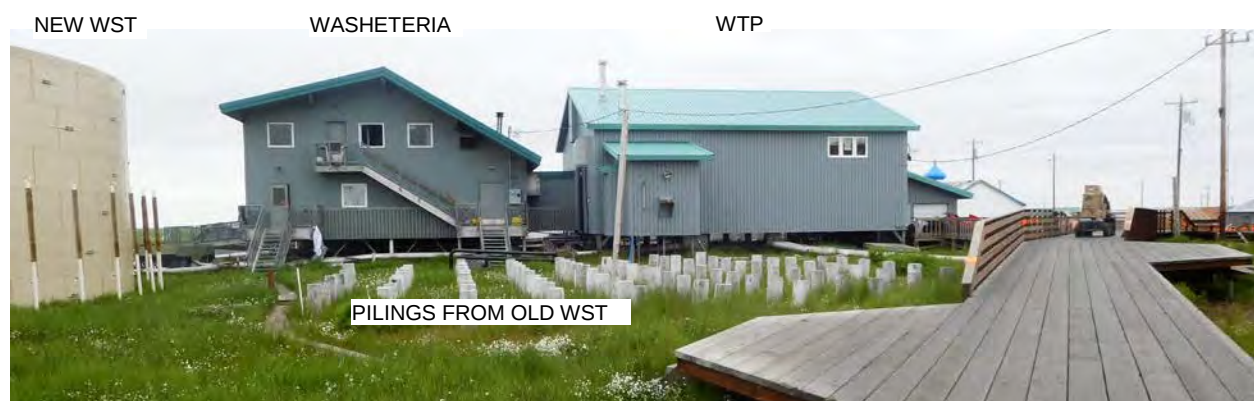
**Exhibit 2-1: Kongiganak WST, WTP/Washeteria, and old WST pilings (2019).**

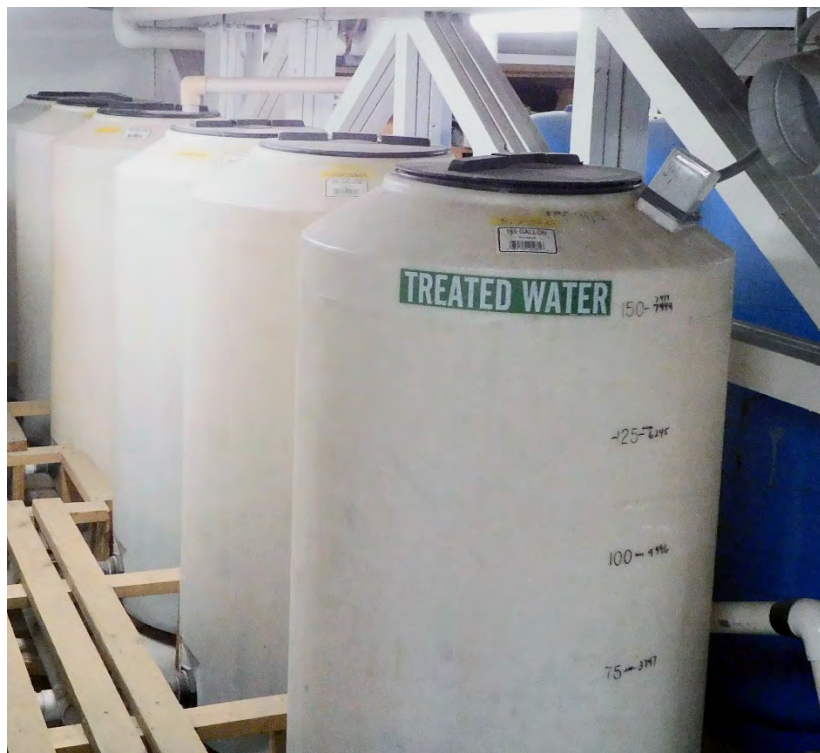
During the water treatment upgrades in 2000, sixty-one 165-gallon, plastic tanks were installed on the lower floor of the original WTP building, as a temporary method of providing treated water storage. However, these tanks are still in use today. The total effective storage (based on volume marks on the containers) is just under 8,000 gallons.

Exhibit 5-2: Current Treated Water Storage

The filtered, chlorinated water is added to one of the tanks, which is part of three storage tank groupings (see Figure 1 in Appendix A). The current piping sends the water from this tank, out to distribution, with no circulation through the other tanks. This results in no reasonable time for chlorine disinfection. There are many dead zones in the existing treated water storage system that never experience chlorination. If replumbed, the existing distribution pump systems would not be sufficient to effectively circulate water through the tanks. This would lead to stored water with a high potential for biofouling. The tanks are currently experiencing excessive algae growth in multiple tanks. However, the most significant issue with the existing storage tanks is the load that they place on the existing building. The existing structure is not capable of safely carrying the load. Since these tanks are on the first floor, failure would be less catastrophic (as compared to the filtration vessels located on the second floor).
