# Lower Jordan Creek Watershed Management Plan

**Stormwater management and riparian restoration  
for sediment, PAH, and metals**

*February 2021*

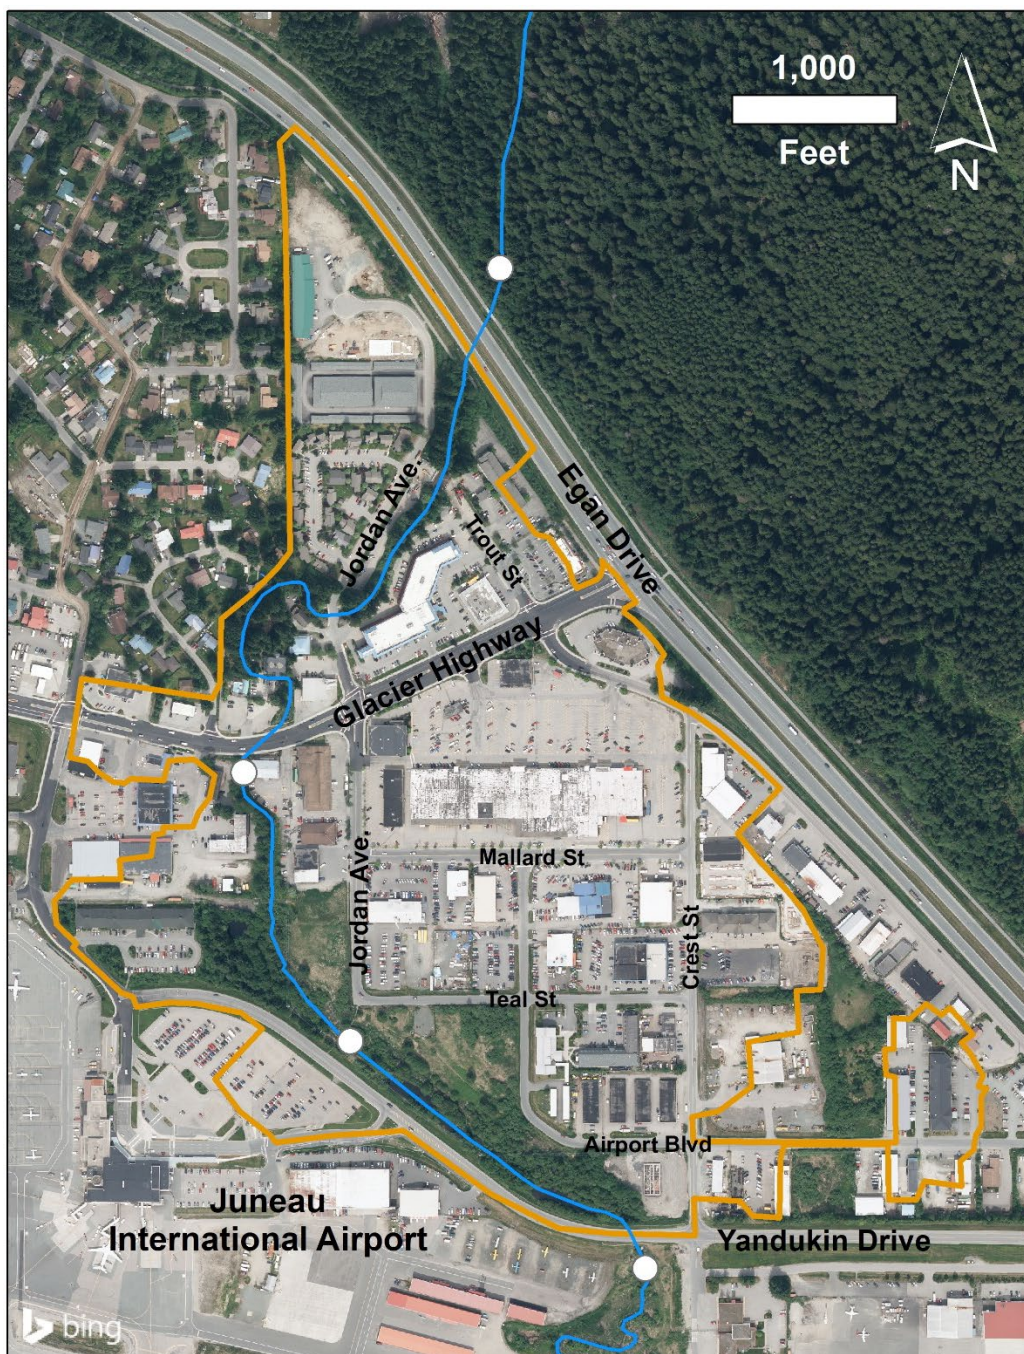
Figure 2. Map of the Lower Jordan Creek watershed. White symbols indicate sampling sites referenced in this document and named for the adjacent crossing road.

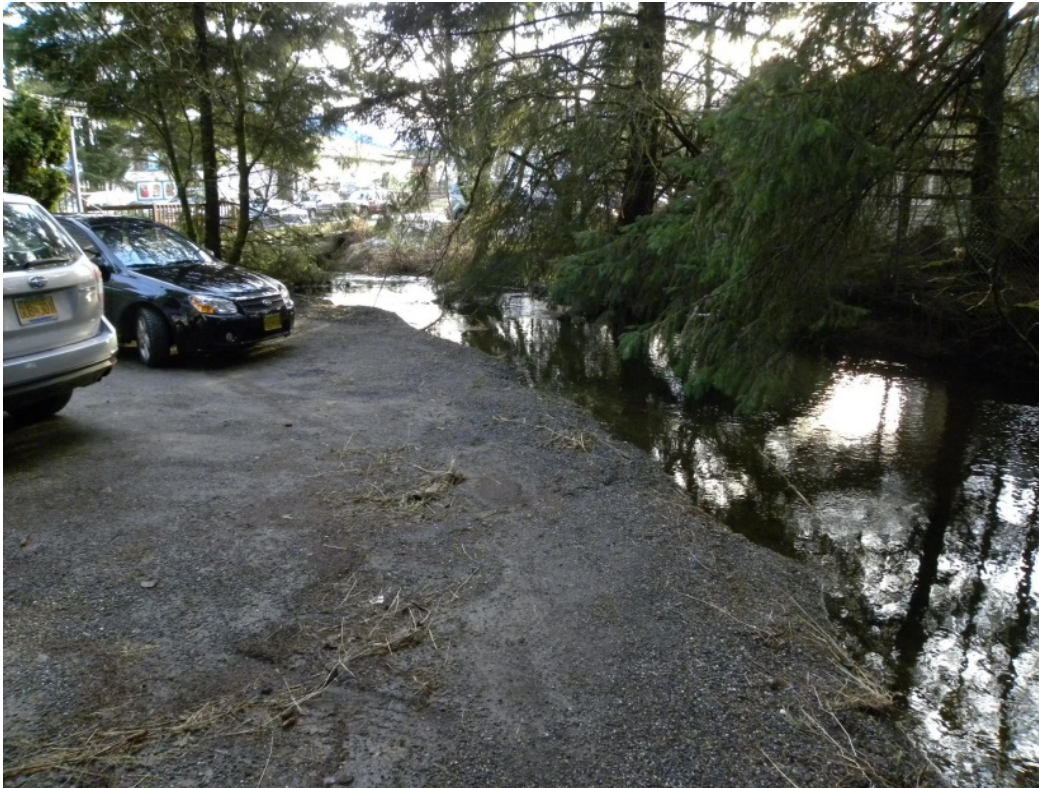
Figure 11. A parking area within the 50-foot riparian buffer along Jordan Creek. (SAWC photo)

**Riparian vegetation:** Development and invasive plant species within the 50-foot riparian buffer next to Jordan Creek have resulted in the loss of over half of the native vegetation (Figure 11). Additionally, existing riparian vegetation is being damaged by disposal of yard waste, snow removal and storage, and parking (Sumner 2018).

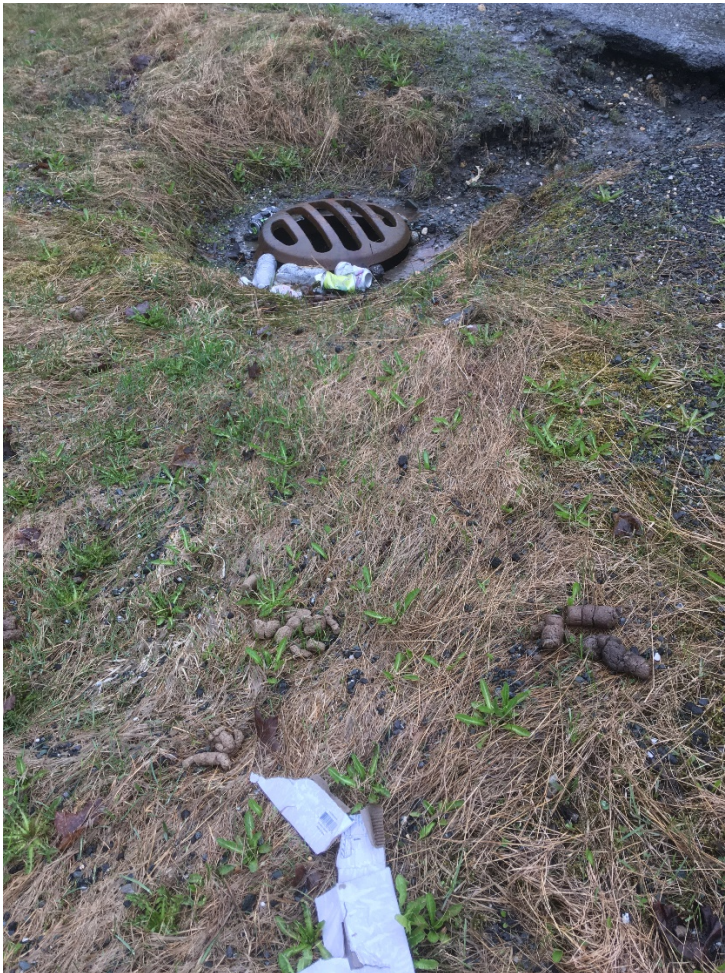
*Figure 12. Pet waste near a catch basin in the Crest Street right-of-way. An example of a bacteria source in the Lower Jordan Creek watershed. (SAWC photo)*

4. **Bacteria:** The exact source(s) of bacteria in Jordan Creek stream water is not known. Wildlife and pets are the likely source upstream of Egan Drive at the reference site. High bacteria levels in water collected from stormwater outfalls in the lower watershed during this project suggest that pet waste is a likely source (Figure 12). We have no information indicating that the sewer system (via leakage) is contributing to elevated concentrations, and there are no septic systems in the area. However, human waste has been observed on the ground and illegal camping occurs near the stream in the lower watershed.

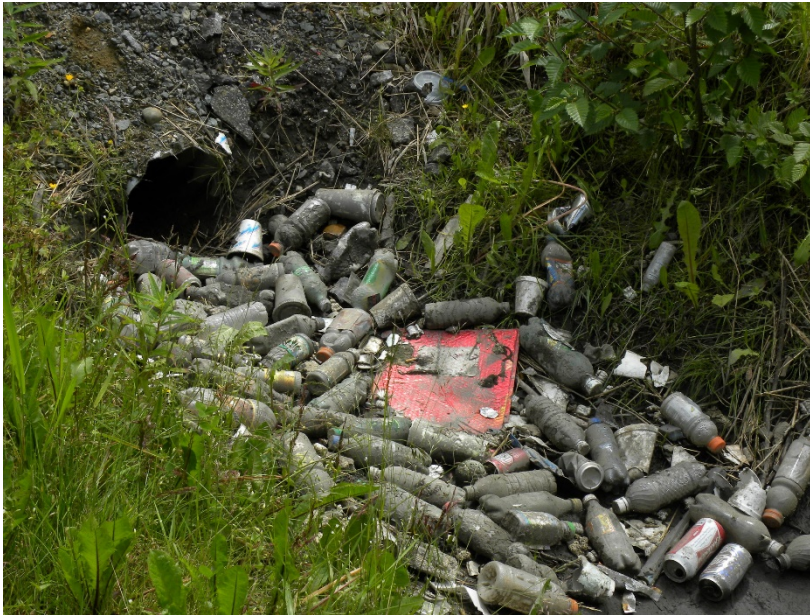
*Figure 13. Litter in a drainage ditch along Trout Street in the Lower Jordan Creek Watershed.*

5. **Litter:** The lower Jordan Creek watershed experiences a high volume of both vehicle and foot traffic which increases the likelihood for debris to be deposited within the watershed (Figure 13). It was noted in the residue TMDL that most debris in and around Jordan Creek appeared to be a product of direct input from residential, commercial, and industrial areas or indirect inputs brought into the creek by wind, snowmelt, runoff, or wildlife (ADEC 2005).

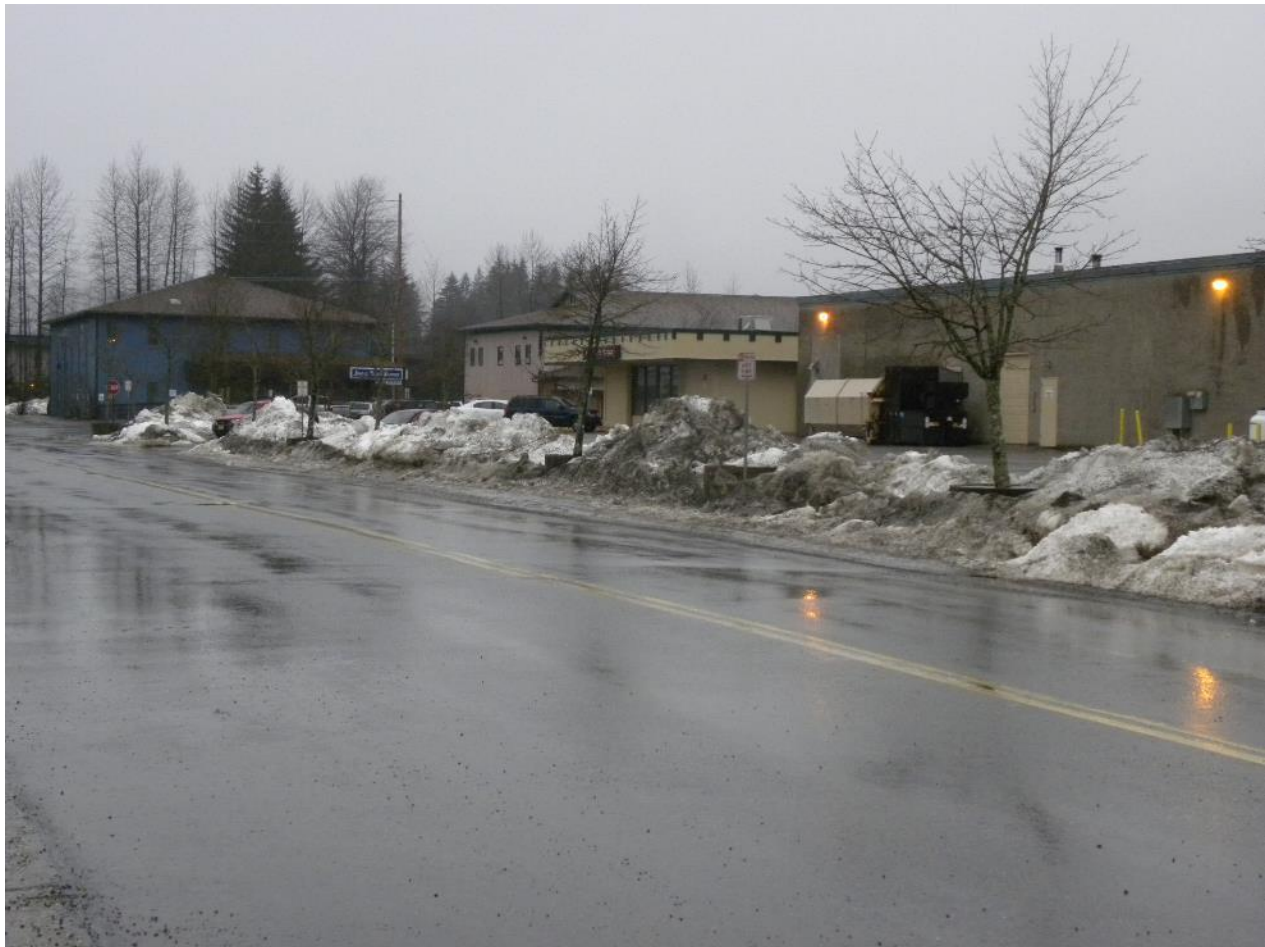
*Stormwater from the west end of Mallard Street drains to stormwater system 9 in the Lower Jordan Creek watershed.*

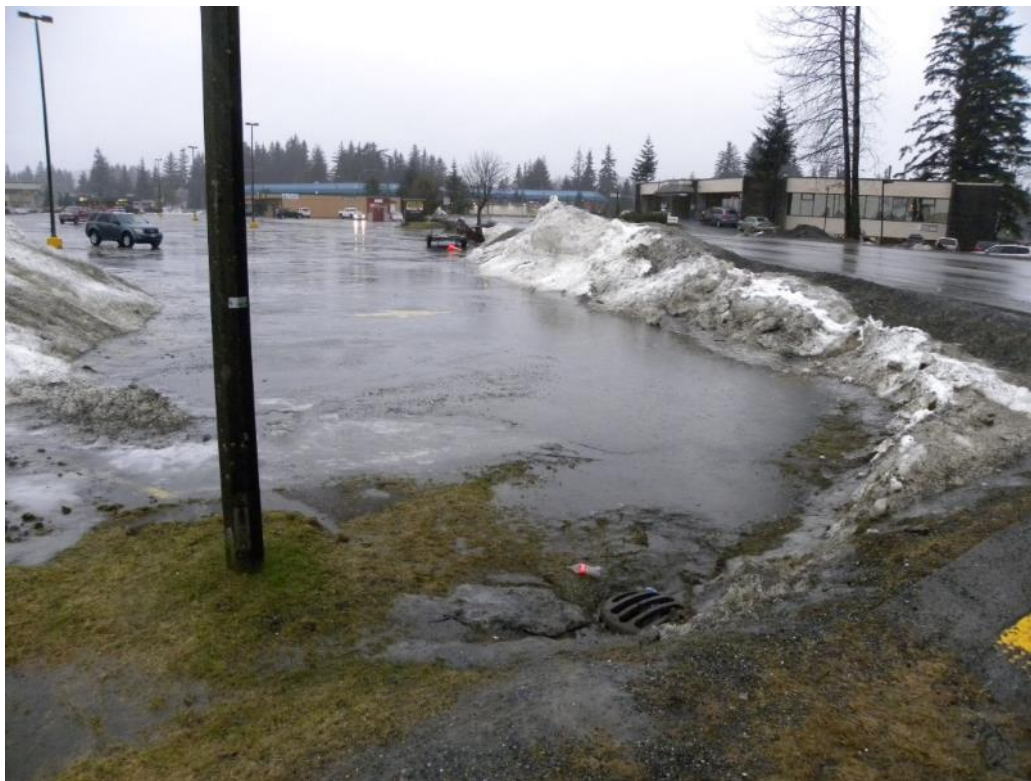
*Figure 1. Rain and melted snow from a parking lot flow into a catch basin at the intersection of Old Dairy Road and Crest Street in the Lower Jordan Creek watershed. January 2013.*

Stormwater is water that originates from rain or melted snow and ice. In urban areas, impervious surfaces such as rooftops, roads, and parking areas accumulate and shed stormwater, which is commonly referred to as runoff (Figure 1). Runoff originating on impervious surfaces often contains pollutants like heavy metals, nutrients, petroleum hydrocarbons, sediment, and bacteria. These pollutants can degrade the quality of surface and groundwater and can be harmful to aquatic life.

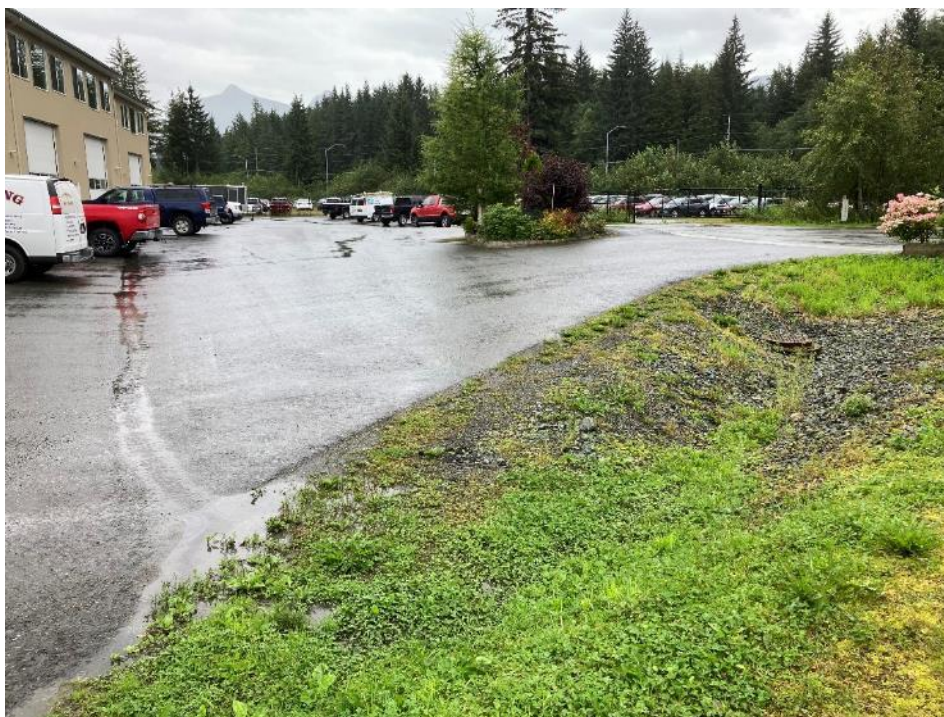
Figure 4. One of 2 infiltration basins near at the end of Jordan Ave. in August 2020.

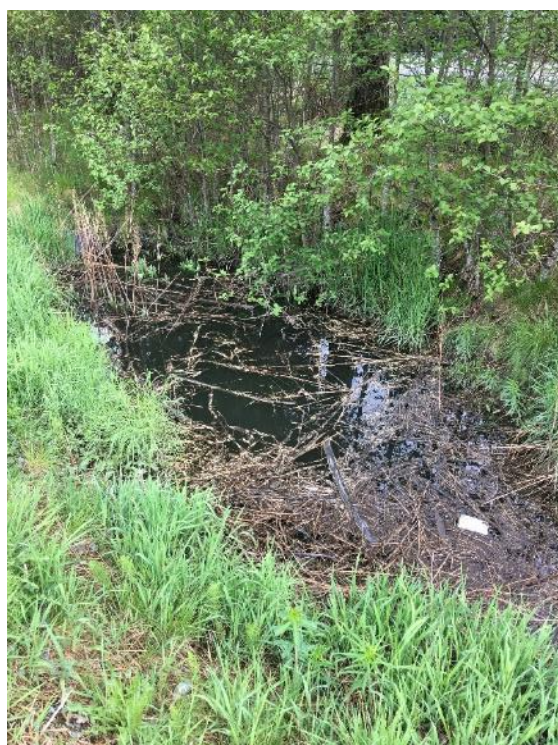
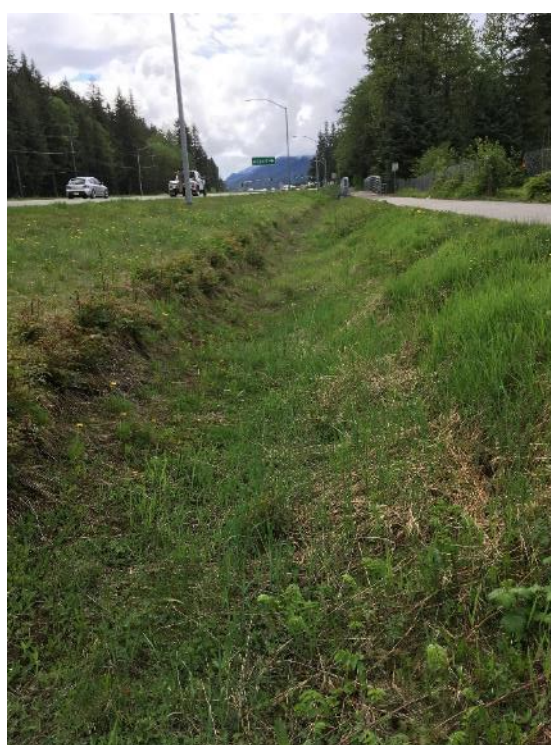
Figure 5. Left: An existing infiltration basin near the downstream end of stormwater system 1. View looking towards inlet pipe (upper right) in May 2020. Right: Runoff from stormwater system 1 flows through a pipe into this ditch on the west side of Egan Drive. The ditch connects to Jordan Creek in the distance. View looking southeast from the pipe outlet. May 2020.

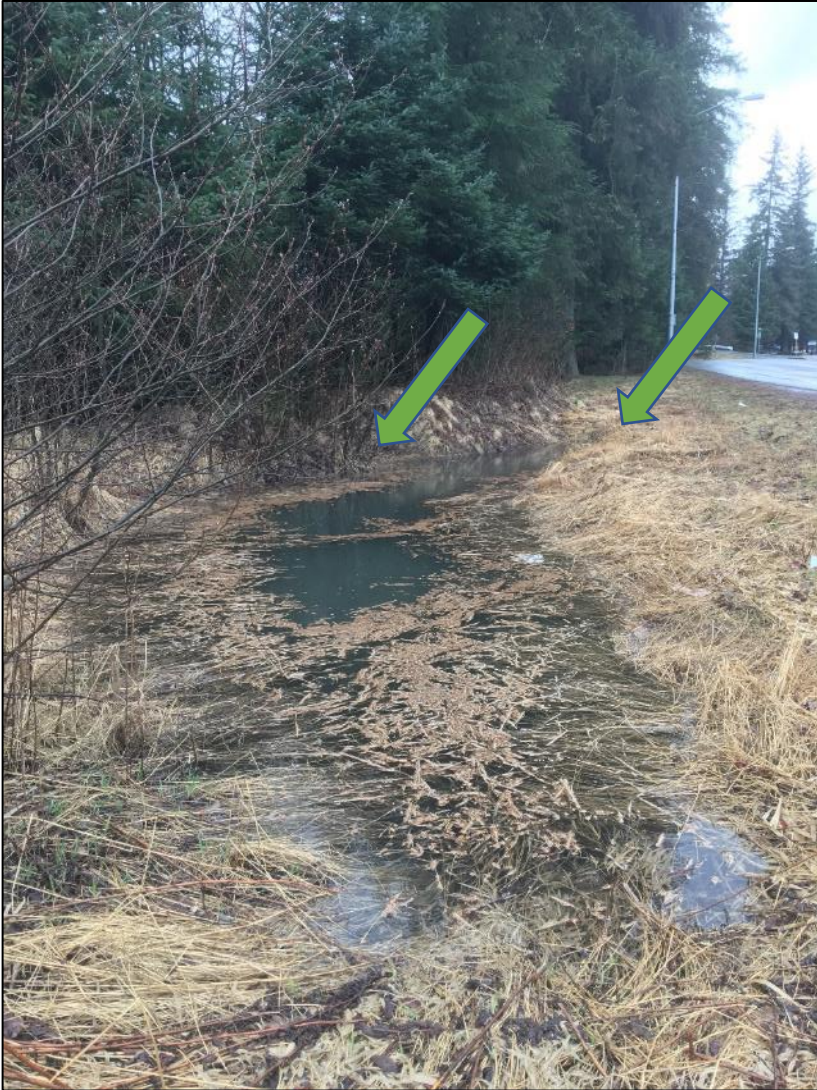
*Figure 7. An infiltration basin at the downstream end of stormwater system 2 in April 2020. Arrows indicate the inlet pipe (right) and outlet trench (left). View from north end of basin looking south in April 2020.*

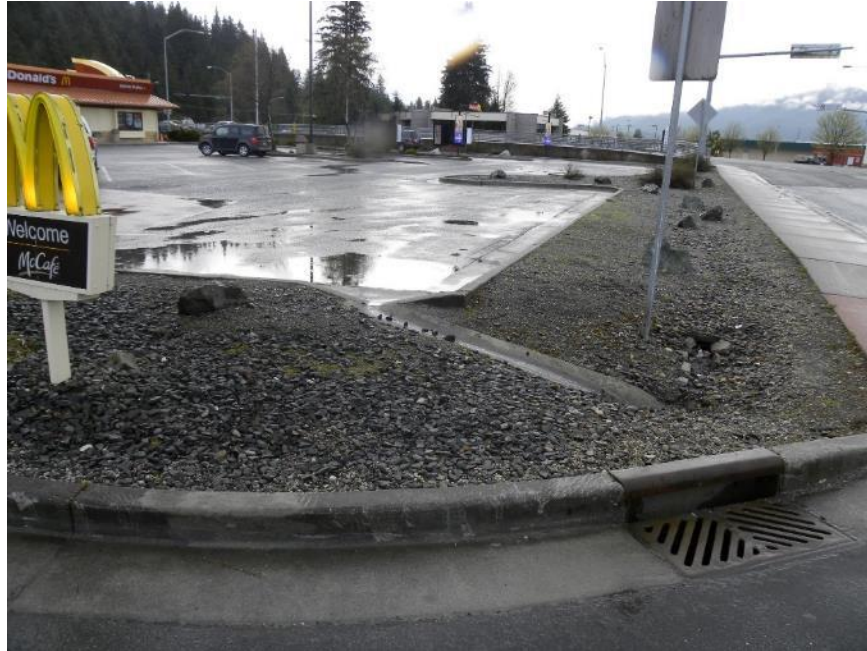
*Figure 9. Stormwater runoff from the west side of the McDonald's parcel enters stormwater system 3 at the entrance driveway. Runoff from the driveway and Trout Street flows into the catch basin. View looking southeast along Trout Street in May 2010.*

The two catch basins in this system are in the Trout Street right-of-way at the entrances to McDonalds (Figure 9) and Breeze In. These catch basins receive runoff from parking lots at the respective businesses as well as runoff from curb and gutter along the south end of Trout Street. Runoff from the basins discharges to a series of grass-lined ditches and driveway culverts along the west edge of the Super 8 parcel. The ditches also receive runoff from the west side of the Super 8 parking lot and the adjacent section of Trout Street. The most downstream culvert discharges runoff into Jordan Creek, immediately upstream of the Trout Street bridge. These ditches, collectively referred to as the "Trout Street Ditch," are commonly filled with litter and vegetation that is coated with an oily black residue (Figure 10). Stormwater runoff originating near the McDonalds dumpster flows into the ditch and has been observed to have an oily surface residue. The ditch likely receives petroleum hydrocarbons and other pollutants from other parts of the contributing area. When the ditch is cleaned, loss of vegetative cover reduces the biofiltration capacity of the ditch and increases soil erosion (Figure 10).

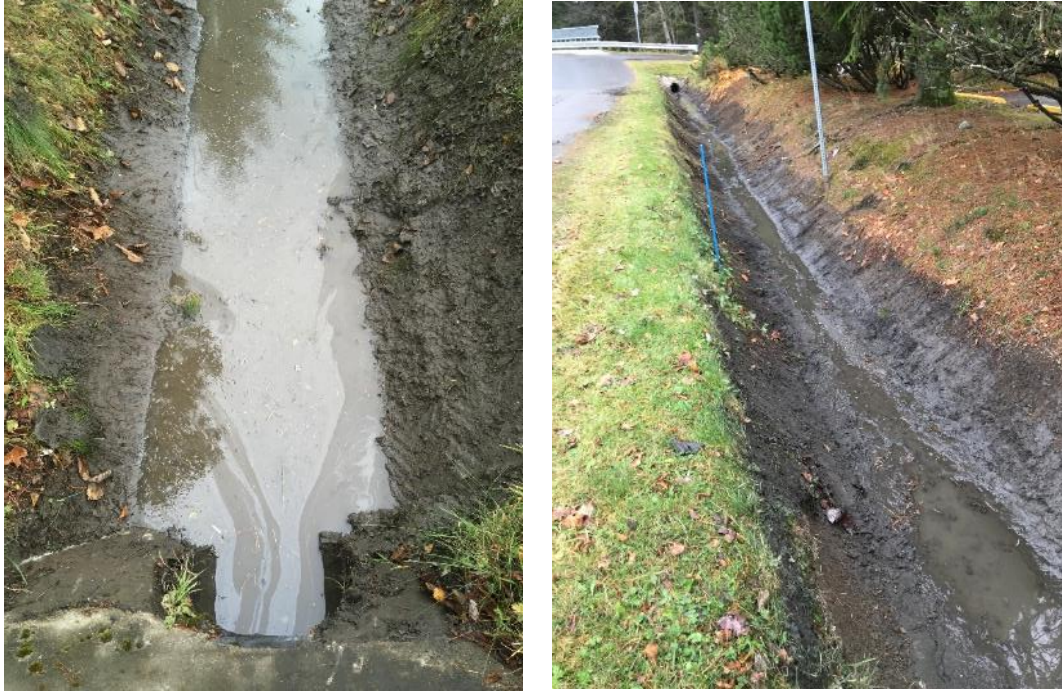
Figure 10. Left: Oil residue on stormwater runoff in the Trout Street Ditch. Right: The Trout Street Ditch following maintenance to remove vegetation and sediment. View looking northwest towards Jordan Creek in October 2018.

- 3.1 Install check dams in a ditch on the north side of Trout Street. The purpose of the dams is to promote runoff storage and infiltration. Establish wetland plants in the ditch to promote sedimentation and stormwater treatment. This project should be considered a low-cost temporary BMP as the ditch is undersized for the contributing area and very high pollutant loads.
- 3.2 Convert landscaped areas in the McDonald's parking lot to bioretention BMPs.
- 3.3 Replace the asphalt parking lot at the Breeze In with permeable pavement.

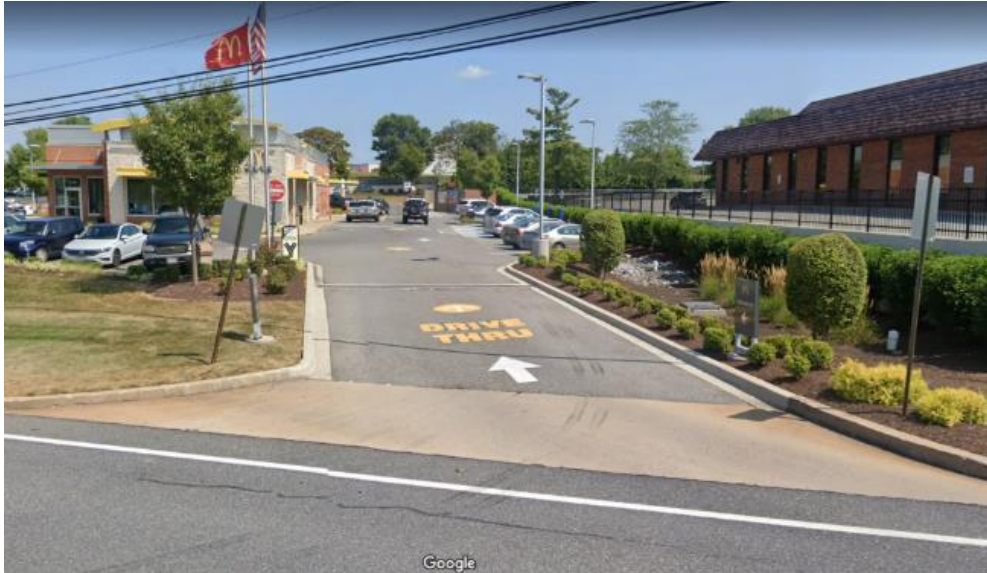
Figure 11. Stormwater runoff from a McDonald's restaurant in Westminster, MD is collected in a trench drain (center) at the drive-through entrance and conveyed to a landscaped infiltration BMP (right). Note the square-shaped raised overflow drain. Google Street View.

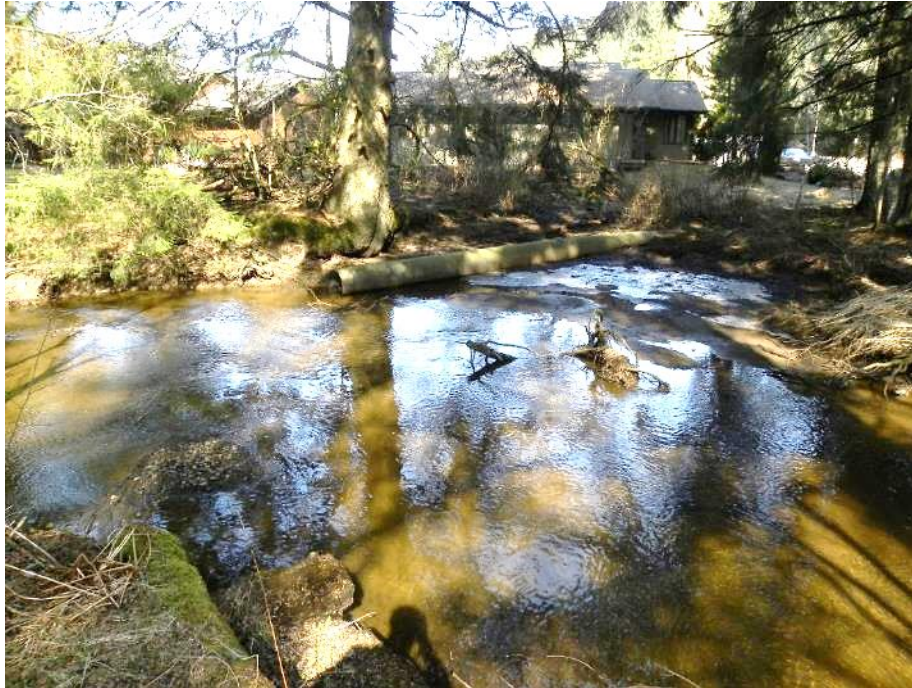
*Figure 14. Stormwater outfall 5. Stream flow is from right to left. View looking north in March 2020.*

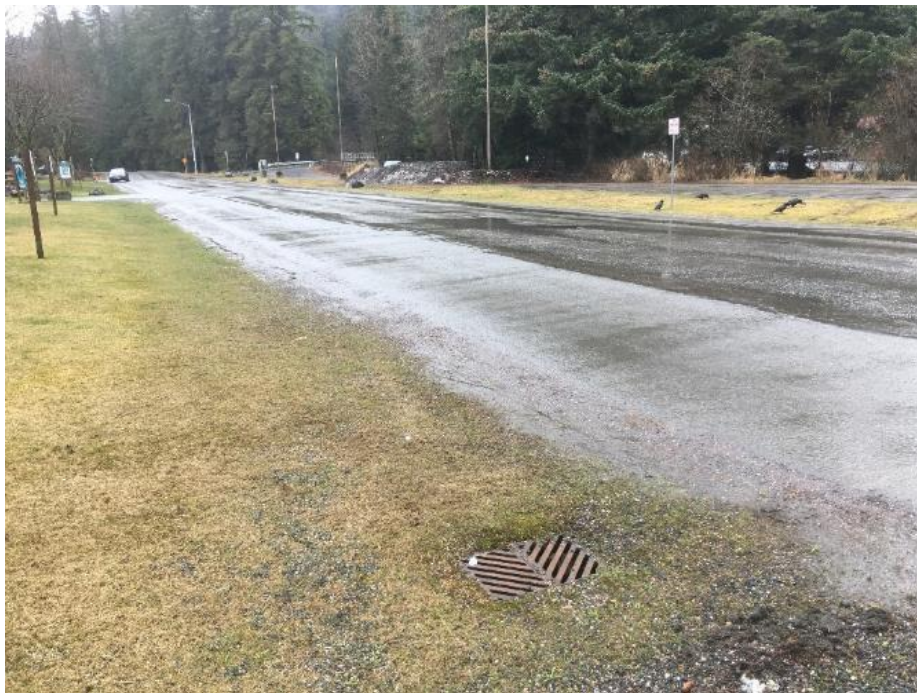
*Figure 15. A catch basin near the intersection of Jordan Ave. and the south entrance to Jordan Creek Condos Loop drive. Biofiltration BMPs that encompass this and 4 other basins in the right-of-way can be constructed to provide flow control and runoff treatment. View looking north along Jordan Ave. in April 2020.*

4. Construct bioretention cells or planters that encompass the catch basins in the Jordan Ave. right-of-way (Figure 15). Use catch basin inlets as overflow structures. Construct the cells in curb extensions if necessary.

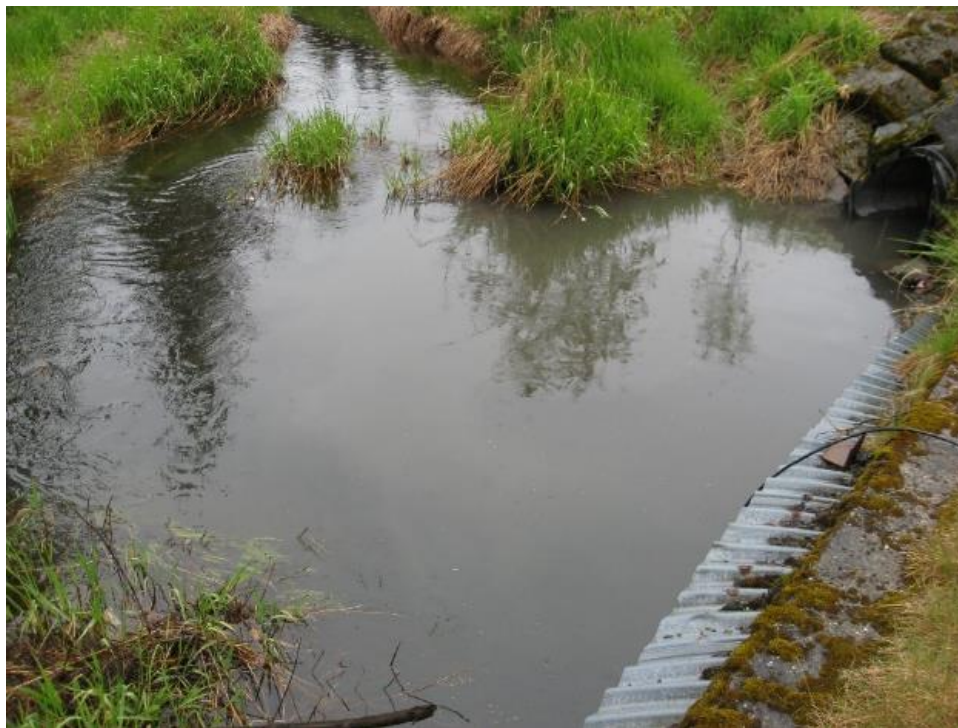
*Figure 17. Stormwater runoff containing suspended sediment flows into Jordan Creek from the stormwater system 6 outfall pipe (upper right) and mixes with clear water in Jordan Creek upstream of Glacier Highway in May 2020.*

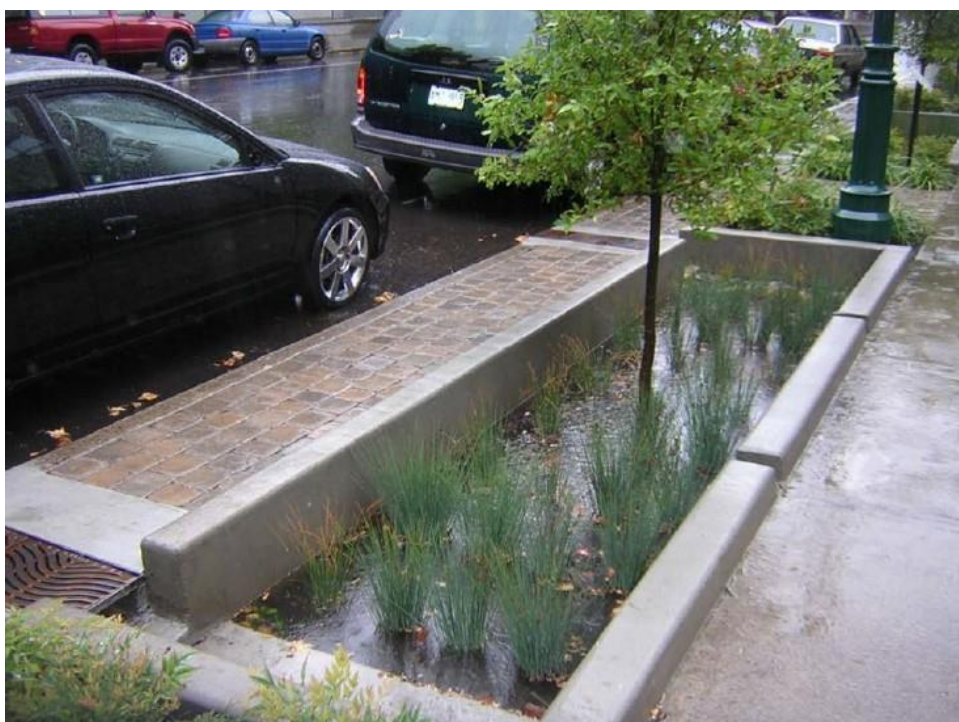
*Figure 18. Trench drains (covered with iron grates) in a pedestrian strip convey stormwater from curb and gutter to a bioretention planter.*

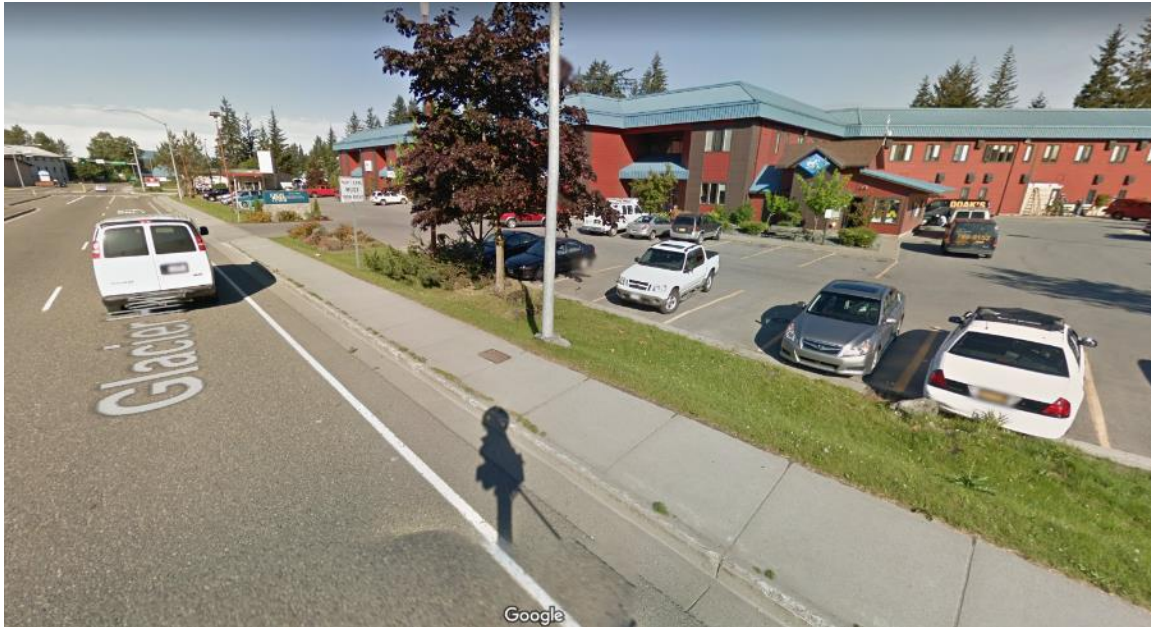
Figure 19. Two grass swales border an entrance drive connecting Jordan Creek Center to Glacier Hwy. Converting the swales into bioretention BMPs would provide treatment and infiltration of runoff from Glacier Highway and the parking area. Google Street View looking southwest in July 2011.

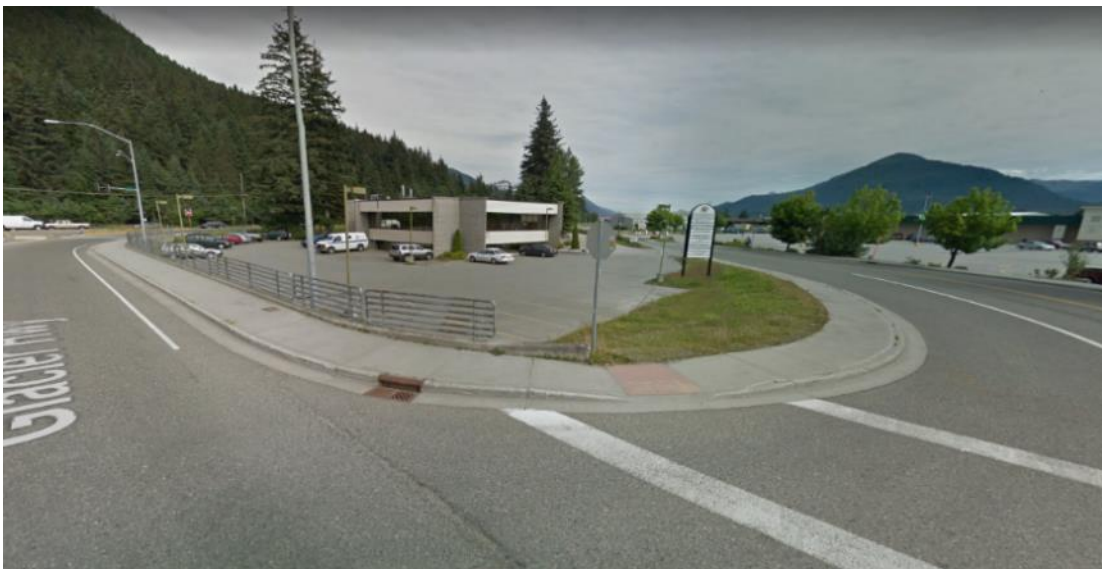
Figure 20. Google Street View of the intersection of Old Dairy Road (right) and Glacier Hwy. (left) in July 2011 (view looking east). Highway runoff could be directed from the curb and gutter to a stormwater BMP constructed in the grass-covered area in the Old Dairy Road right-of-way.

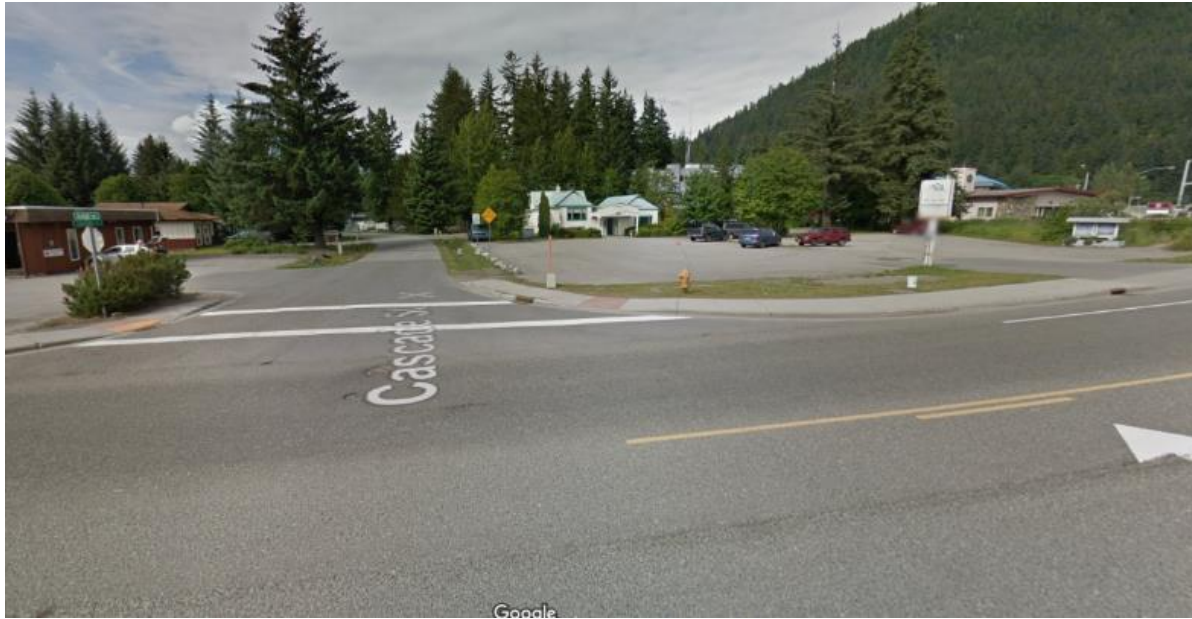
*Figure 22. Google Street View of the north side of Glacier Hwy. at Cascade Street in July 2020. Parking lot and highway runoff could be conveyed into stormwater BMPs constructed in existing grass-covered (photo-right near hydrant) and landscaped (photo-left near stop sign) areas on private parcels that abut the roadways.*

Due to the lack of undeveloped space, and the likely presence of underground utility conflicts, opportunities for installing stormwater BMPs in this system are limited. BMPs will have to be constructed solely on private parcels. Use trench drains to convey stormwater from the highway to stormwater BMPs on adjacent parcels near the back side of sidewalks (Figure 22).

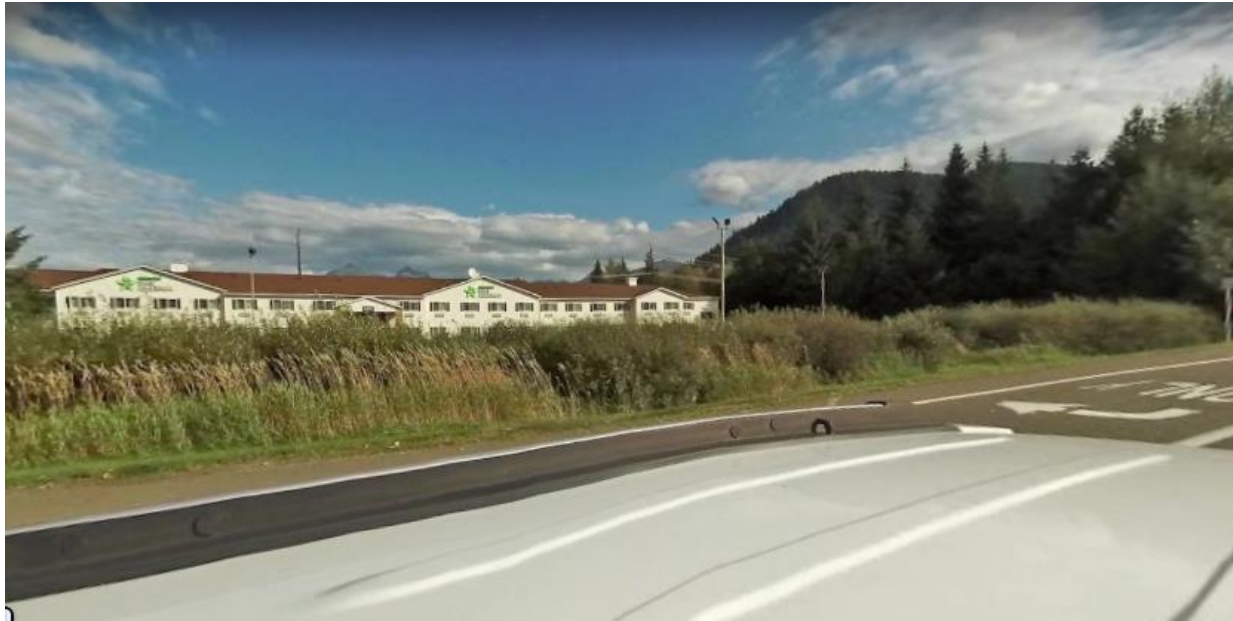
*Figure 24. A hedge of alder and willow shrubs indicates the location of an infiltration trench on the south side of the Extended Stay Hotel in Juneau. Note invasive reed canarygrass in center left of photo. Google Street View in September 2017.*

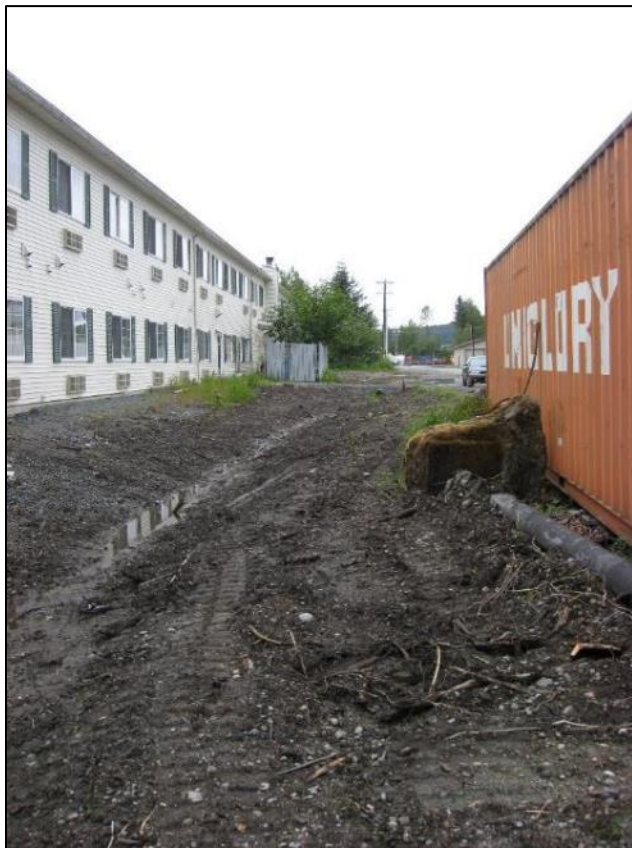
*Figure 26. An infiltration trench on the north side of the Extended Stay Hotel after native vegetation was removed between July 2006 and July 2010. View looking west in July 2010.*

- Replant infiltration trench corridor on the north side of the Extended Stay hotel using native trees and shrubs, as per original 404 permit.
- Install educational signage describing the existing stormwater BMPs.

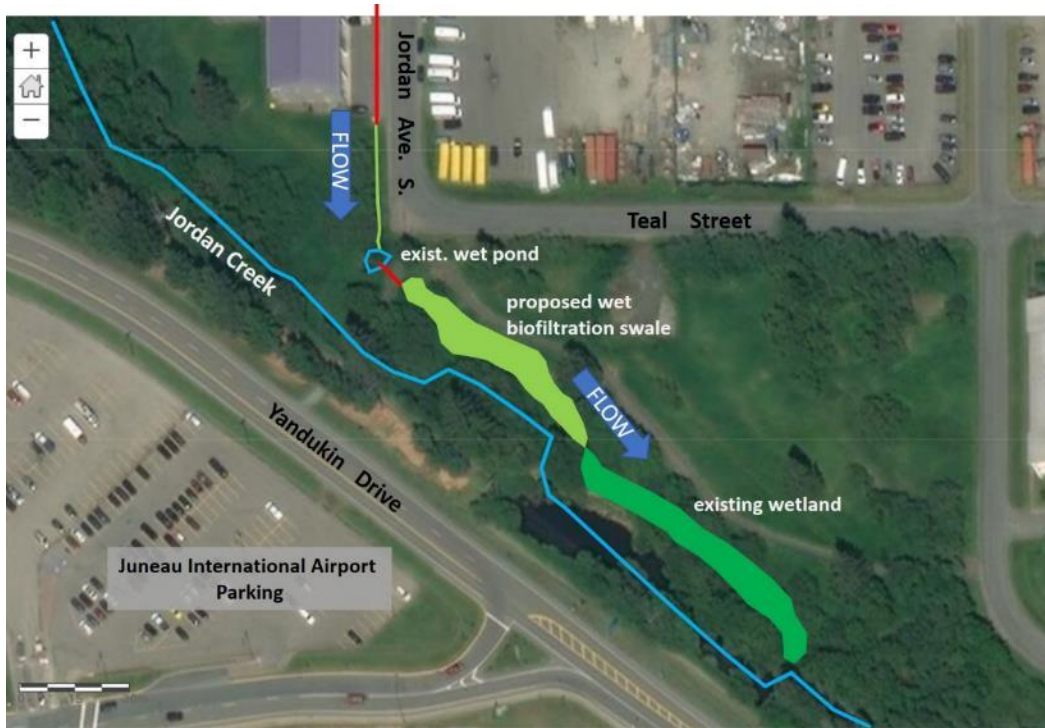
Figure 268. A wet biofiltration swale concept for treating stormwater runoff from the outfall 9 stormwater system. View of the Jordan Creek greenbelt area near the south end of Jordan Ave. World Imagery, June 2019.

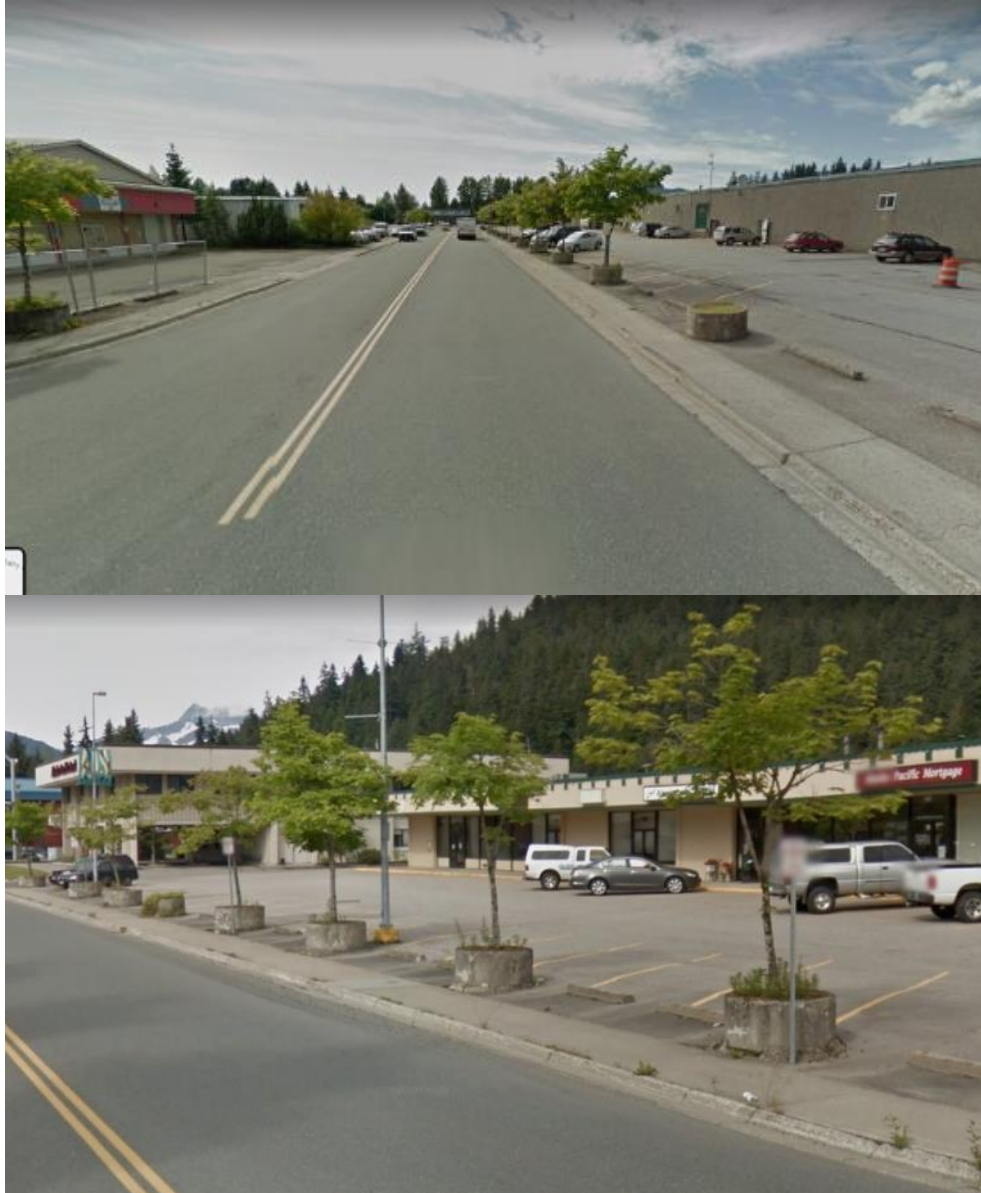
*Figure 2927. Tree planters occupy a narrow strip of right-of-way on the back side of sidewalks bordering Jordan Ave. South (above) and Mallard St. (below). Existing tree planters can be replaced with bioretention planters that receive runoff from the roadway through trench drains installed in the sidewalk and from adjacent parking areas. Google Street View views of Jordan Ave. South looking north near Mallard St. and Mallard St. looking west near Alpine Ave. in July 2011.*

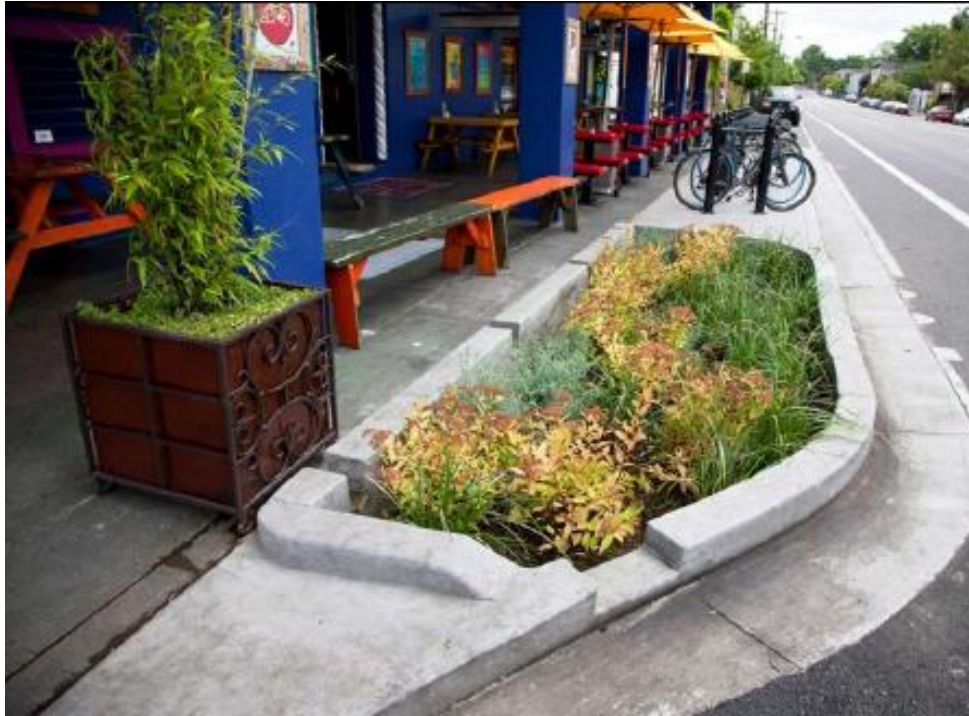
Figure 30. Bioretention planters can be installed in curb extensions where space is limited.

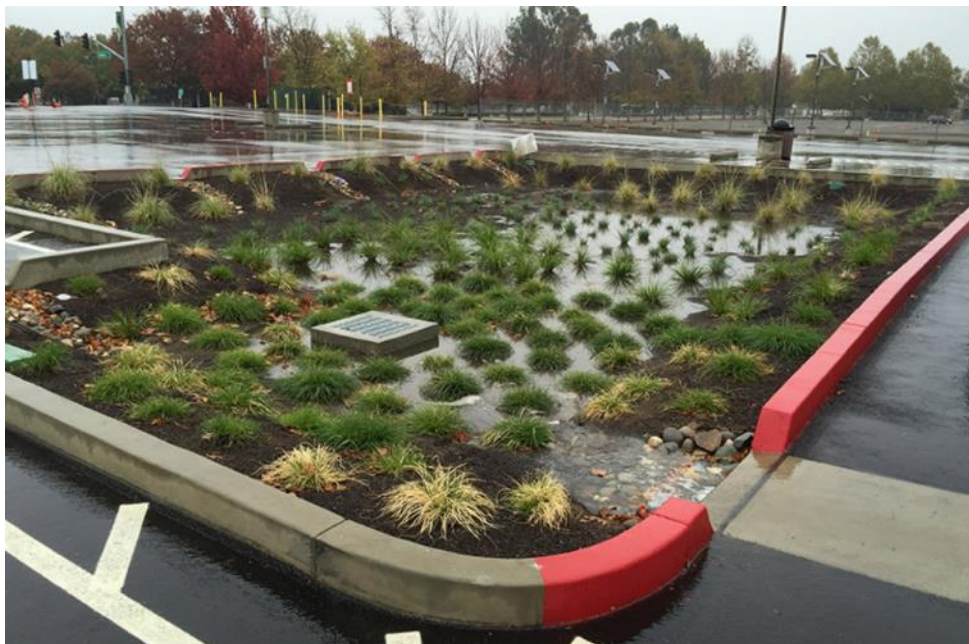
Figure 281. Bioretention planters in parking lots can treat and infiltrate runoff from large contributing areas and provide attractive landscaping for retail properties. An overflow drain (center left) can convey excess runoff to grey stormwater infrastructure or to another stormwater BMP. (credit: <https://www.owp.csus.edu/lid/site/lot-7-bioretention-planter.html>)

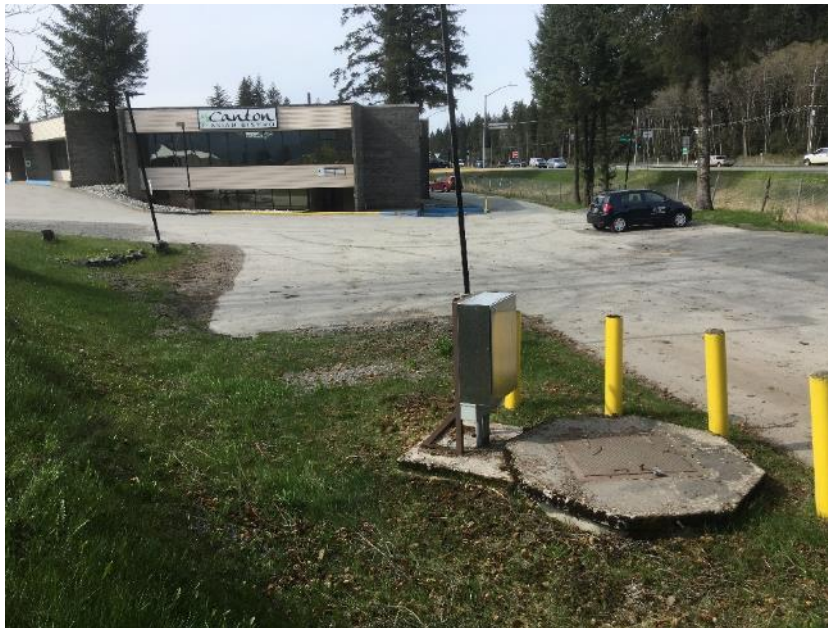
*Figure 35. The Kootznoowoo parcel and building at 8585 Old Dairy Road. Stormwater runoff collected in 5 catch basins on the parcel flows to a sump (lower right of photo) and is then pumped into stormwater system 10.*

This stormwater system contributing area includes a parcel owned by Kootznoowoo, Inc. The parcel is northeast of the Nugget Mall on the north side of Old Dairy Road. Five small catch basins in the parcel collect runoff from the paved parking area surrounding a building. Although the underground connections among basins have not been mapped, runoff flows into a sump on the east side of the parcel (Figure ). Due to the low elevation of the sump, a pump lifts and discharges the stormwater into a vault on the south side of Old Dairy Road west of Crest Street.

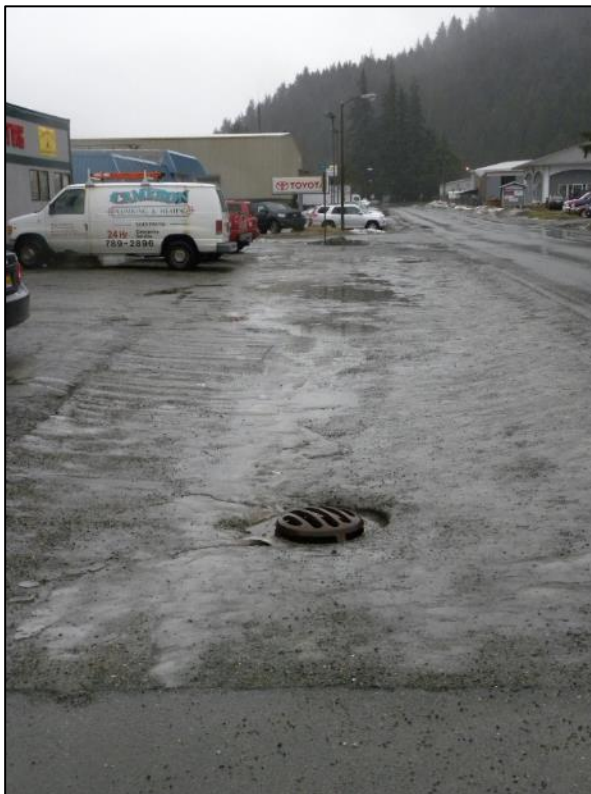
*Figure 30. A stormwater catch basin in a gravel-surfaced area in the Crest Street right-of-way. View looking north towards Teal Street in January 2013.*
