# Lower Jordan Creek Watershed Management Plan

**Stormwater management and riparian restoration  
for sediment, PAH, and metals**

*February 2021*

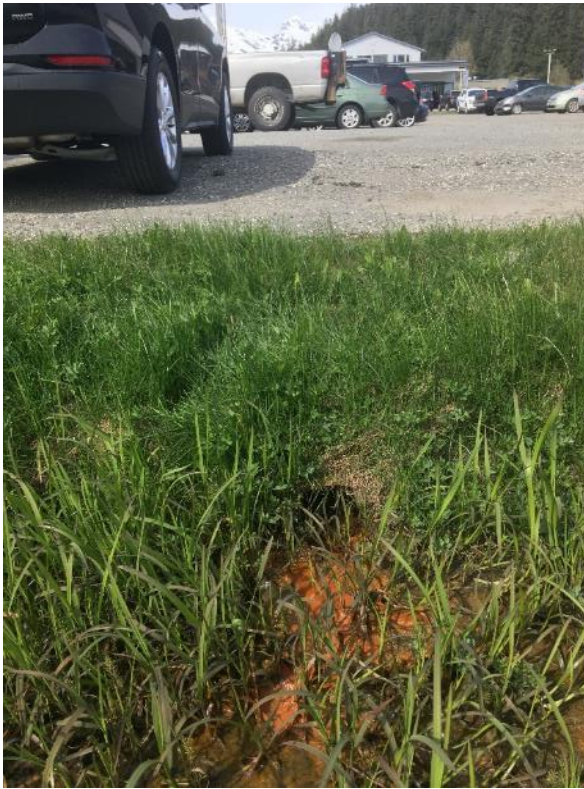
*Figure 31. The outlet of a pipe connected to two catch basins in a parking area on the west side of the Toyota-Honda dealership. The Teal Street ditch is in the foreground and flows to the right. View looking north in June 2020.*

Two catch basins on the west side of this parcel receive runoff from a parking area. The runoff is discharged from a pipe into a ditch on the north side of Teal Street (Figure 36). The Teal Street East ditch system is discussed below. There are 4 additional basins in a drive-through lane on the north side of the dealership parcel; however, the fate of runoff entering these basins could not be determined.

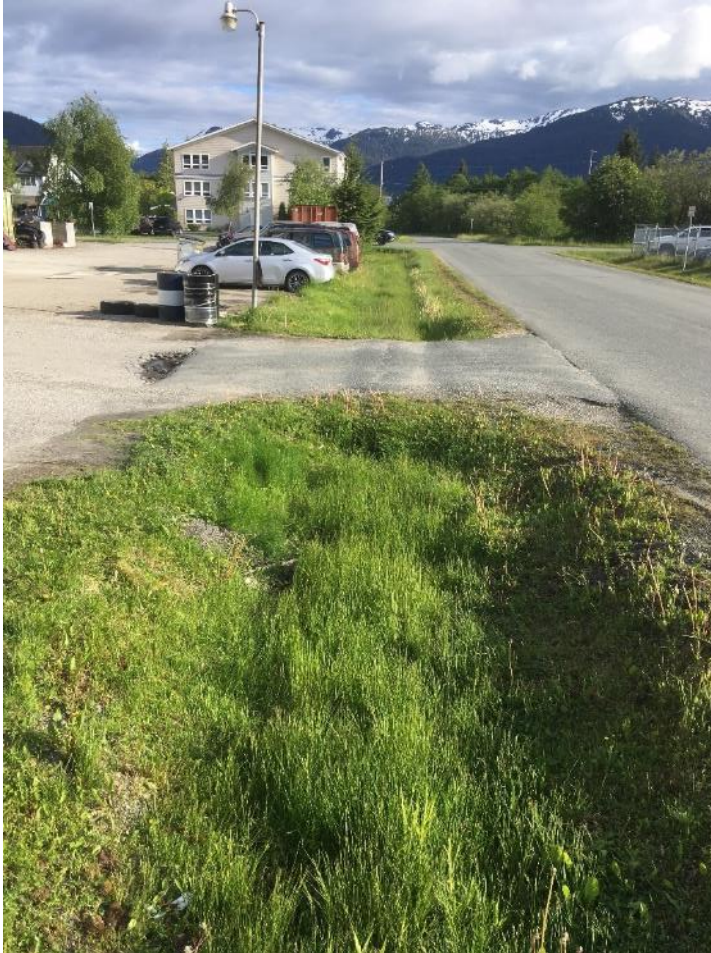
*Figure 32. Stormwater swales on the east side of Alpine Ave. North. View looking south towards the Teal Street intersection in June 2020.*

The north and south sides of Teal Street are bordered by a series of vegetated ditches interconnected by driveway culverts. The ditches, which appear to function as biofiltration swales, receive runoff from the roadway and parking areas on adjacent properties, including runoff collected by two catch basins on the west side of the Toyota-Honda dealership. The west end of the north Teal Street ditch connects to a series of swales on the east side of Alpine Ave. North, between Mallard and Teal Streets (Figure 37). These swales appear to infiltrate all the stormwater they receive from the adjacent roadway and parking areas.

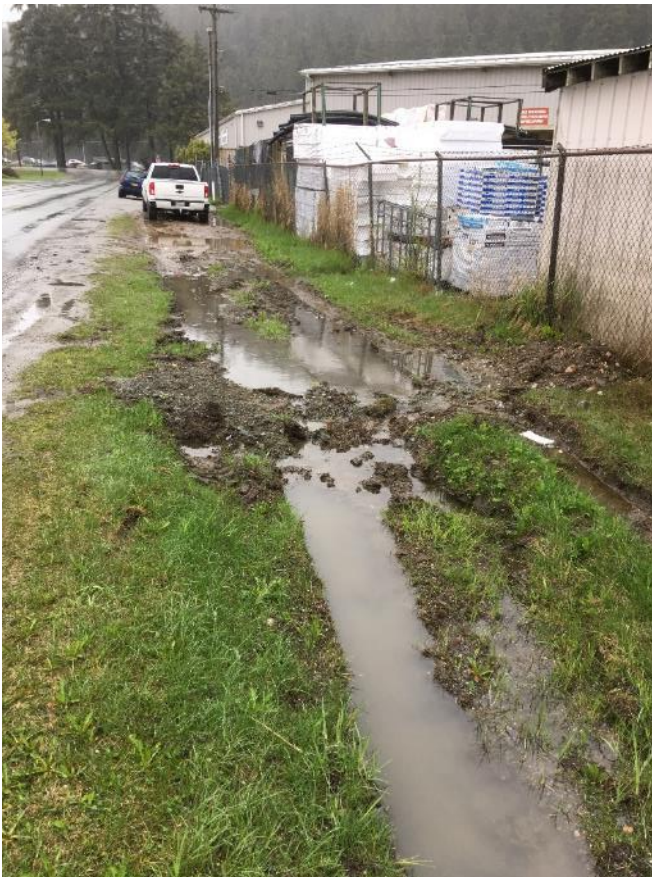
*Figure 33. Vehicles parked in a swale in the Crest Street right-of-way near Valley Lumber. View looking north near the east end of Mallard Street in March 2020.*

- 10.1 Work with Valley Lumber management to avoid parking in a grass swale along the northeast edge of Crest Street. Vehicle use of this area has caused severe rutting, damage to vegetation, and erosion. Runoff from this area carries suspended sediment, and likely pollutants from vehicles, into nearby catch basins.

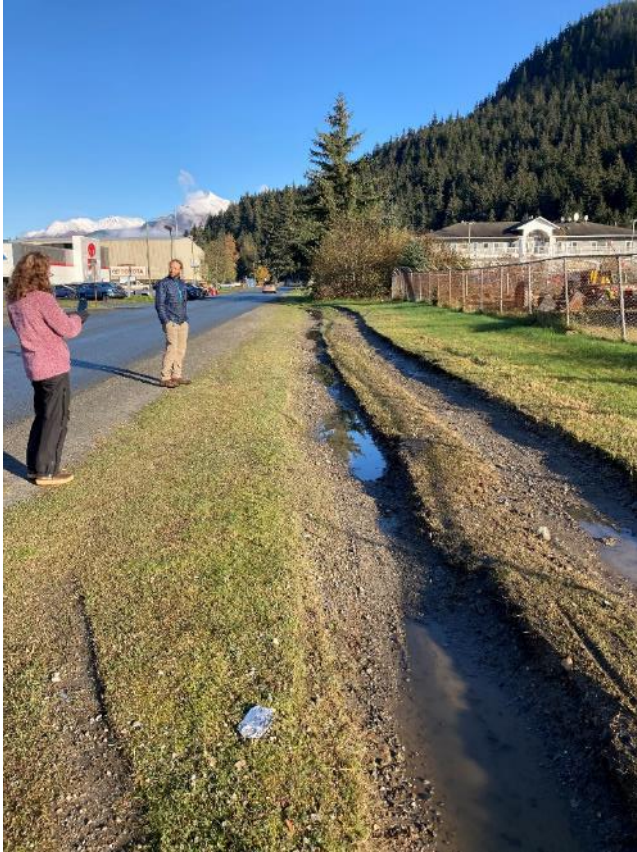
*Figure 34. Ruts left by vehicles driving in the Crest Street right-of-way. View looking north between Teal Street and Airport Blvd. in October 2020.*

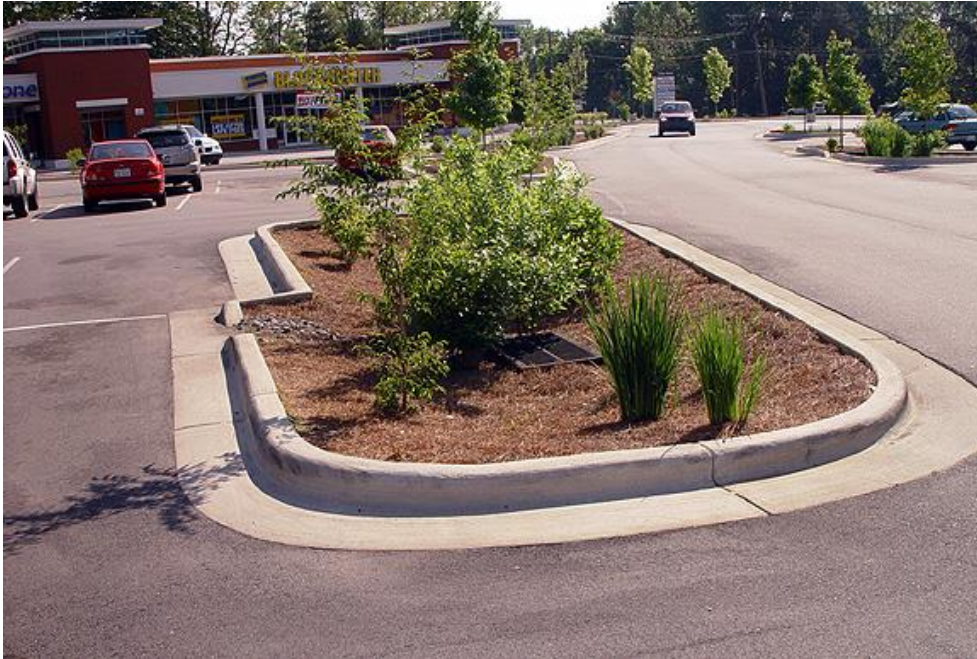
Figure 35. A bioretention planter between a parking area and an access drive (credit: <https://www.hazenandsawyer.com/publications/urban-green-infrastructure-solutions/>)

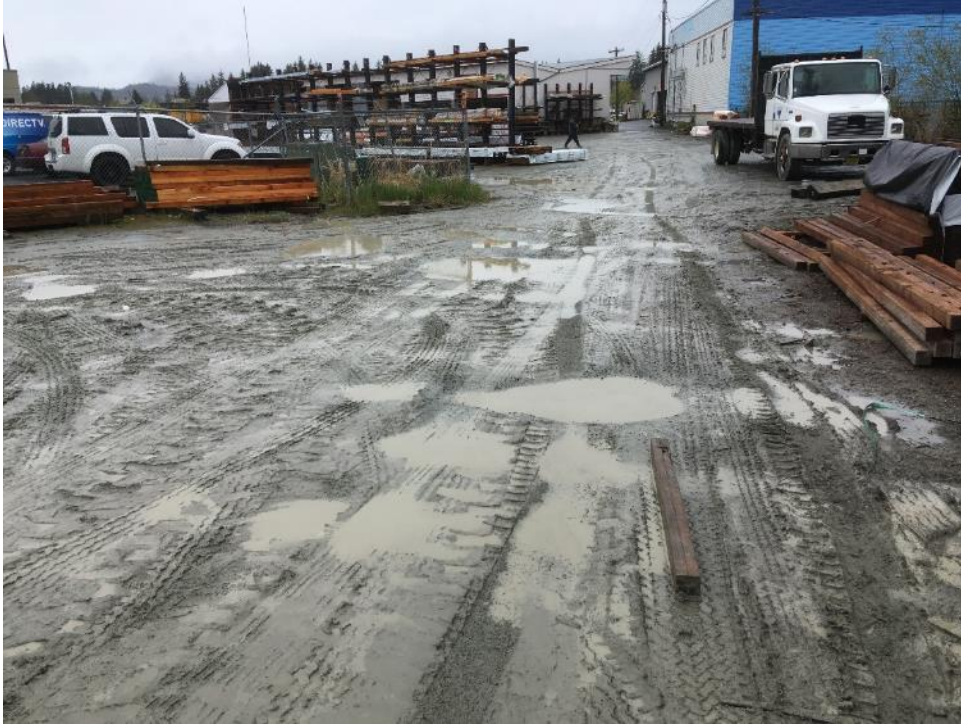
*Figure 36. The Valley Lumber lumberyard produce large quantities of sediment-laden stormwater, some of which enters stormwater system 10. May 2019.*

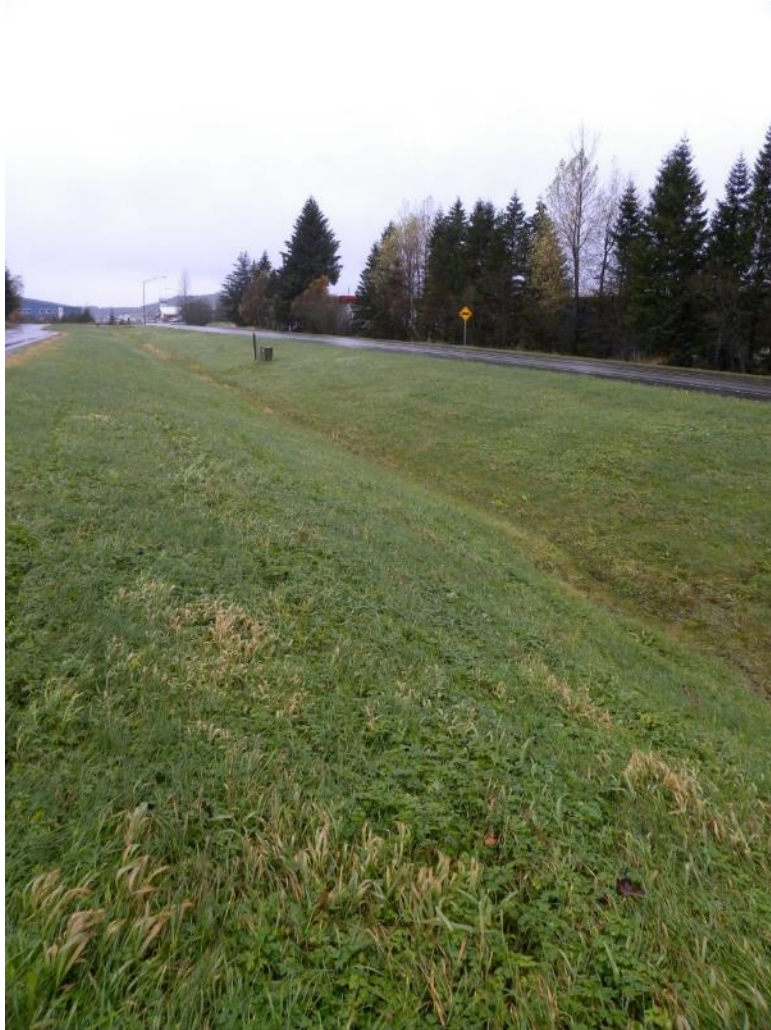
*Figure 38. A grass swale on the south side of Yandukin Drive East. View looking west towards the Crest Street in October 2014.*

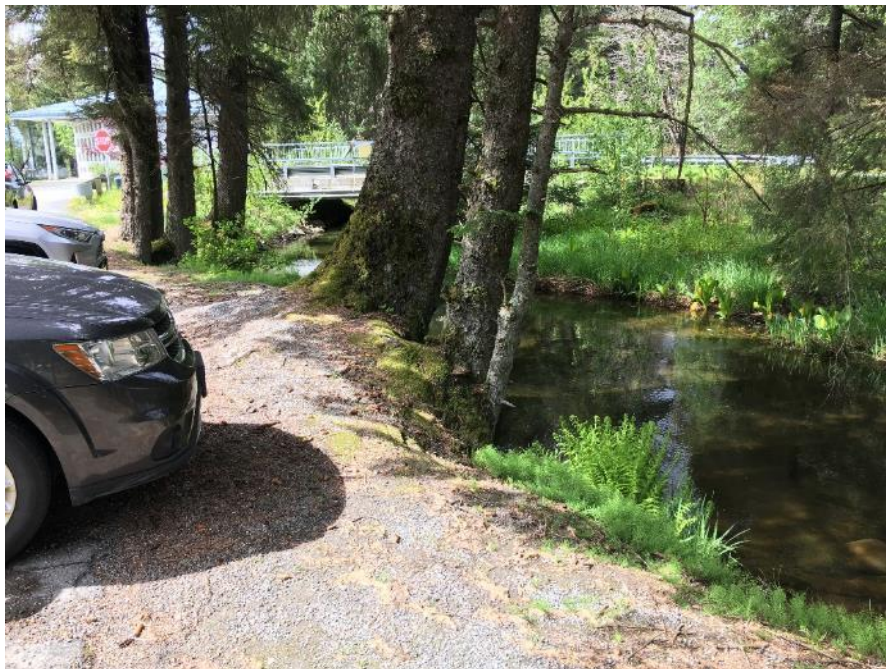
*Figure 40. Only a narrow strip of riparian vegetation exists between parking spaces and Jordan Creek near the west end of the Jordan Creek Center parcel. View looking west from the south side of Jordan Creek in May 2020.*

JCC.2 Parking areas on the east and west sides of Jordan Creek encroach to within a few feet of the stream. Replace asphalt with permeable pavement or install infiltration strips at the edge of the paved areas.

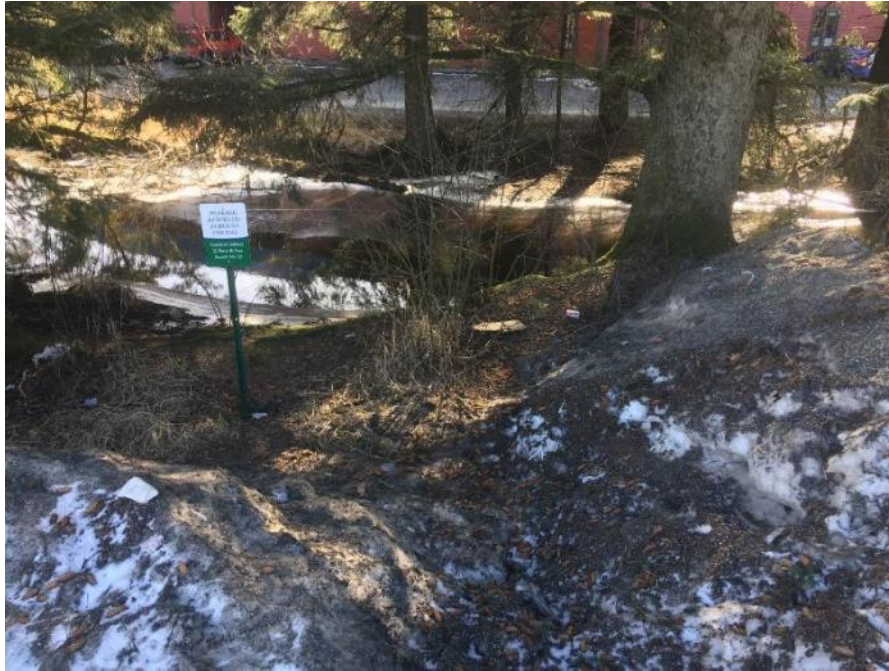
*Figure 41. Plowed snow from a parking lot next to Jordan Creek Center is stored next to Jordan Creek. March 2020.*

- Work with landowner to store snow in areas where meltwater will not flow into the stream and where snow piles will not damage riparian vegetation.

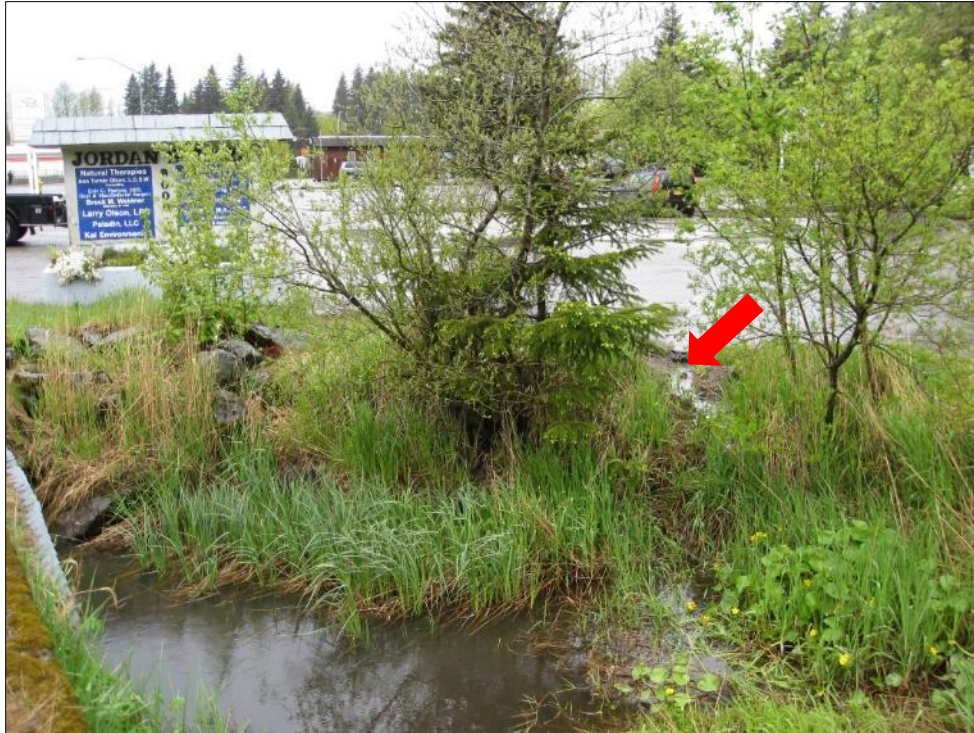
Figure 43. Runoff from a parking area on the south side of the Jordan Square North parcel flows through a narrow strip of vegetation before entering Jordan Creek. View looking west in May 2015.

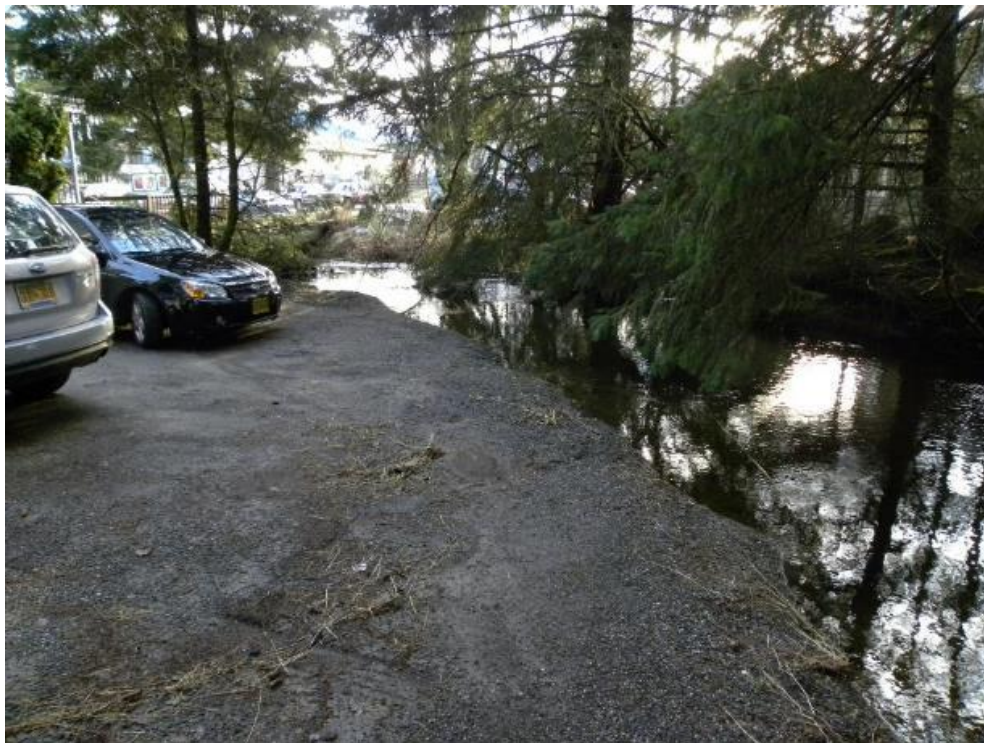
Figure 44. A small parking area next to the Jordan Square North building extends onto the banks of Jordan Creek. View looking southwest /downstream in January 2014.

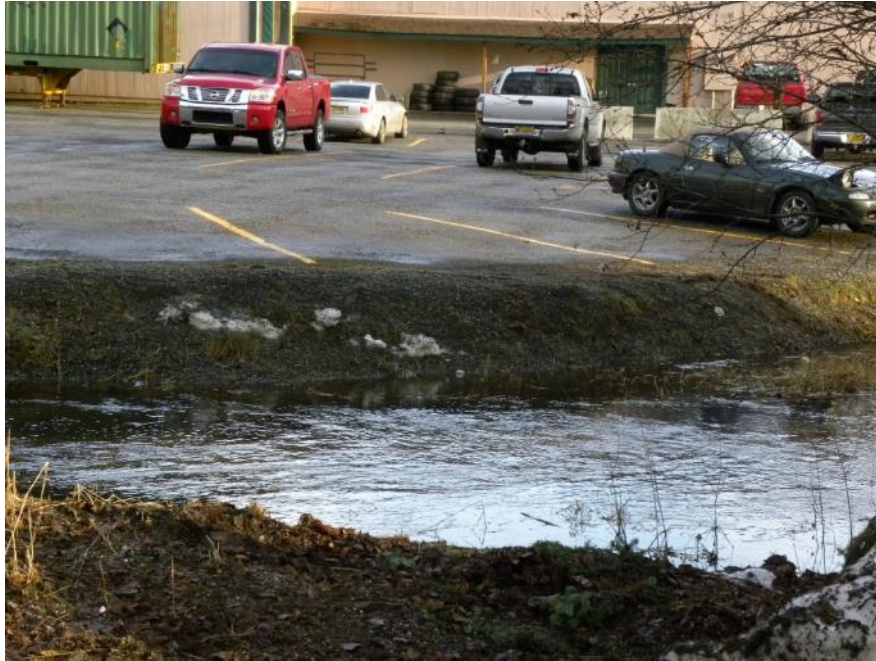
*Figure 46. Plowed snow and gravel cover the banks of Jordan Creek at the edge of a parking area on the Jordan Square South parcel. View looking east from the west side of Jordan Creek in January 2014.*

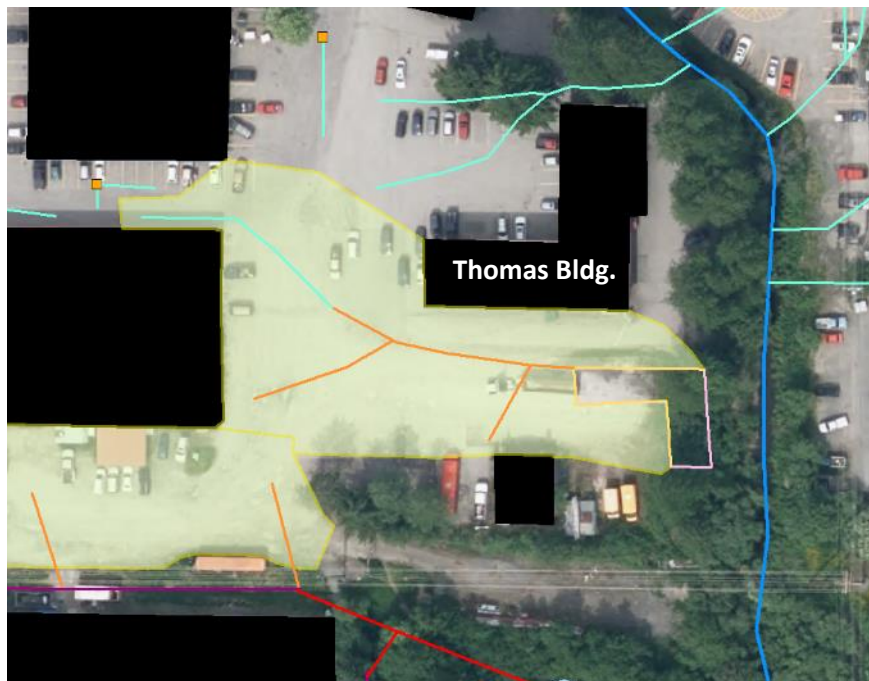
*Figure 47. Runoff from asphalt paved and gravel-surfaced parking areas near the Edward K. Thomas Building flows into an L-shaped infiltration trench constructed next to Jordan Creek in 2015.*

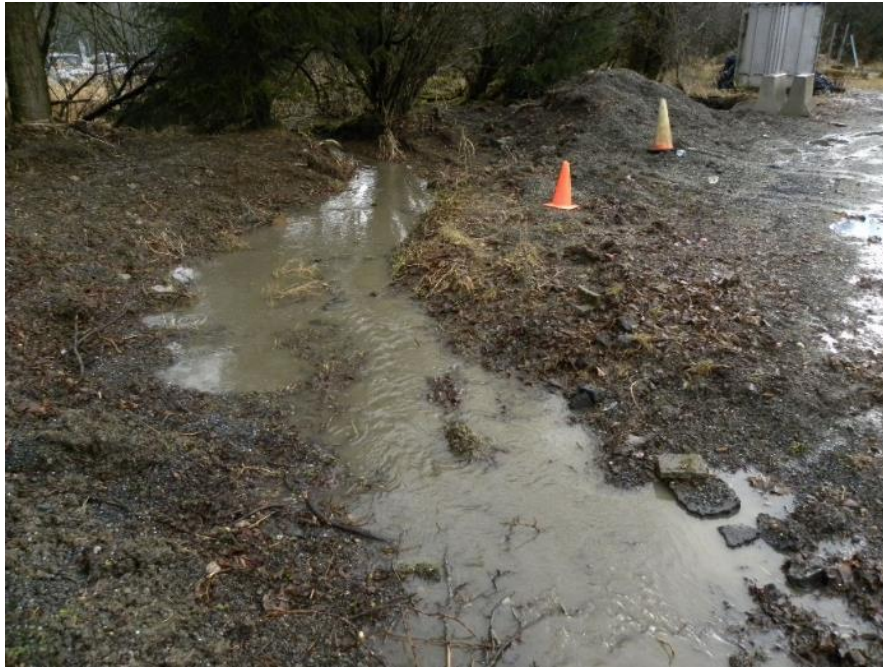
*Figure 48. Stormwater runoff from gravel and paved parking areas near the Edward K. Thomas building flows towards Jordan Creek prior to construction of the infiltration trench. View looking southeast in February 2016.*

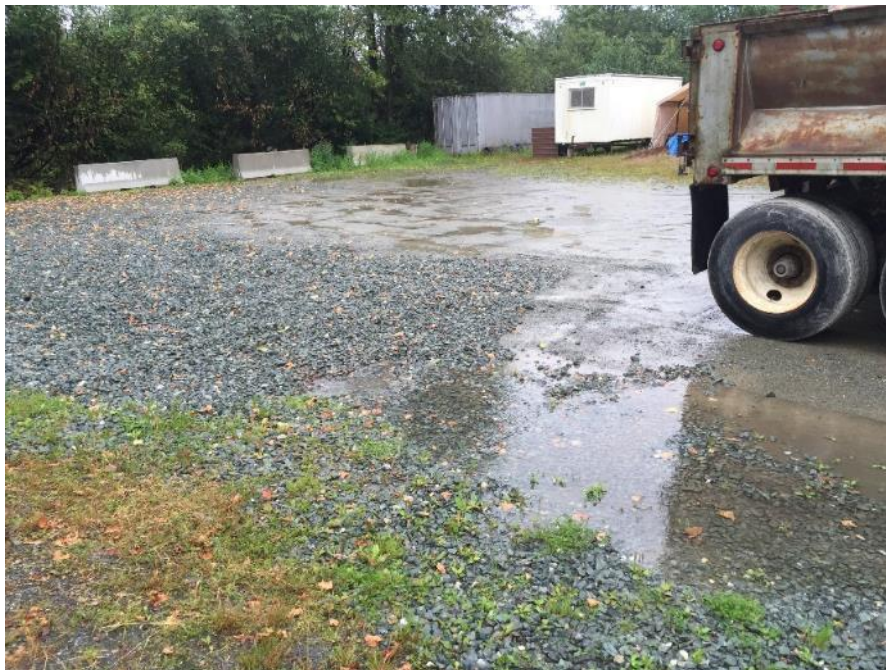
*Figure 49. Stormwater runoff enters an infiltration trench (photo center) on the south side of the Edward K. Thomas building. The vegetated portion of the trench is behind the concrete barriers. View looking southeast in August 2016.*

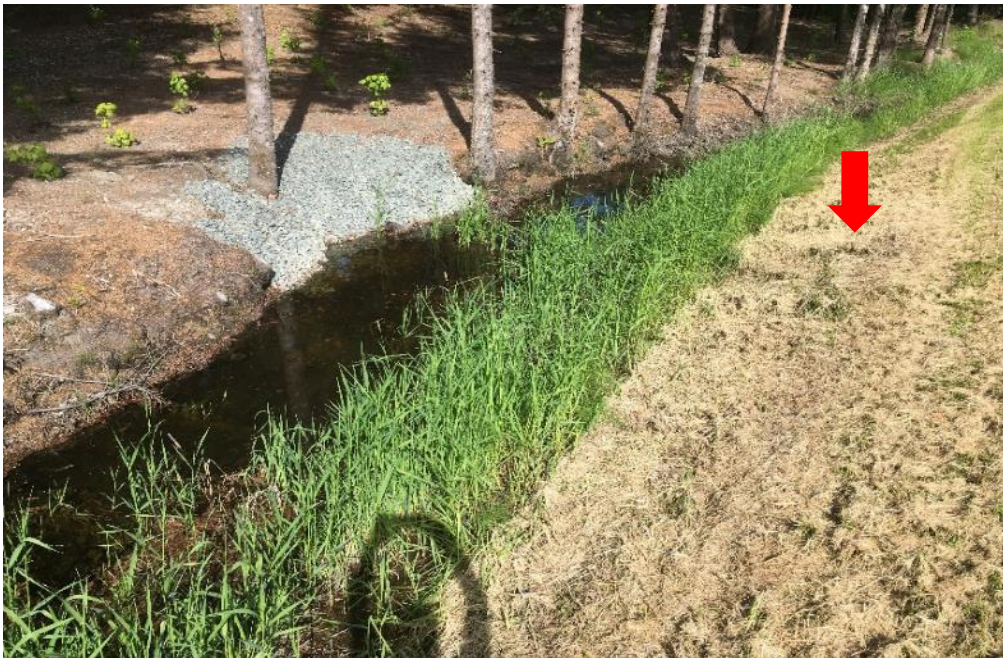
*Figure 51. The outfall area of a small stormwater system at the west end of Yandukin Drive. Runoff from a stormwater outfall pipe (red arrow) collects in the ditch and enters a trench drain. The inlet of the drain is indicated by the gravel-faced embankment above. View looking east in June 2020.*

The Yandukin Drive West stormwater system collects runoff from a 240-ft long section (0.23 acres) of Yandukin Drive (Figure 55). The roadway is owned and maintained by the CBJ. Prior to 2019, this system discharged runoff into a wet pond on land managed by the Juneau International Airport. The pond was connected to Jordan Creek by a ditch, although there was no evidence that surface water flowed from the pond to the stream. In 2019, the Juneau International Airport filled the pond and a portion of the outlet ditch. A 150-ft. long trench drain was constructed in the former pond area; the drain connects the outfall area to a remaining section of ditch. Road runoff discharged from this system collects in a small basin next to the trench inlet and eventually infiltrates the ground, presumably within the trench drain (Figure 56). No improvements to this system are recommended at this time.

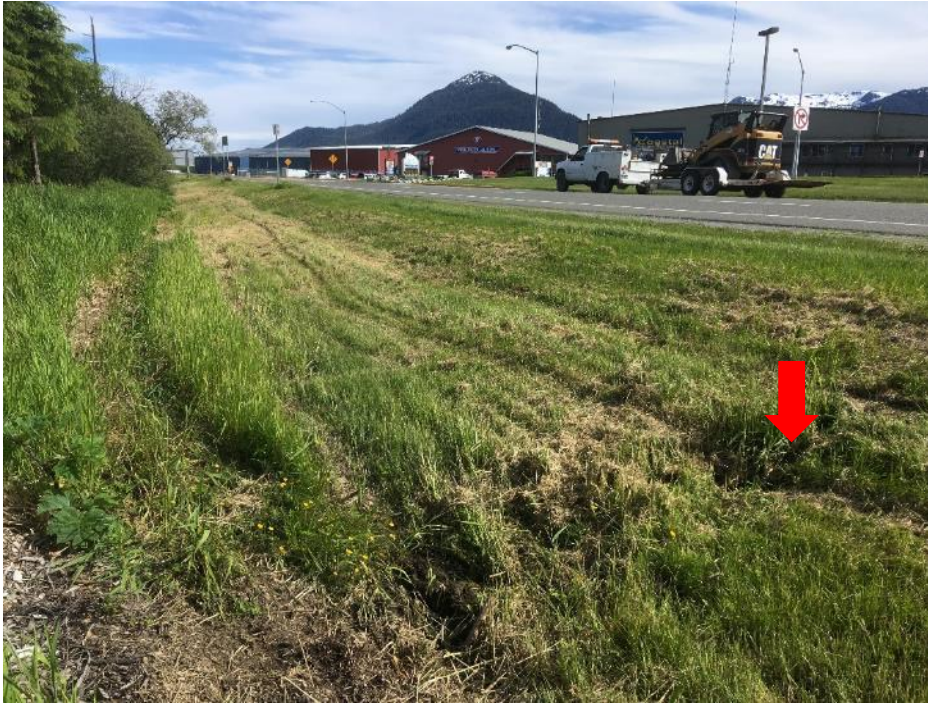
*Figure 52. The Yandukin Drive Middle stormwater system discharges runoff from a pipe (indicated by red arrow) into a grass swale next to Jordan Creek (left of photo). View looking southeast from the north side of Yandukin Drive in June 2020.*

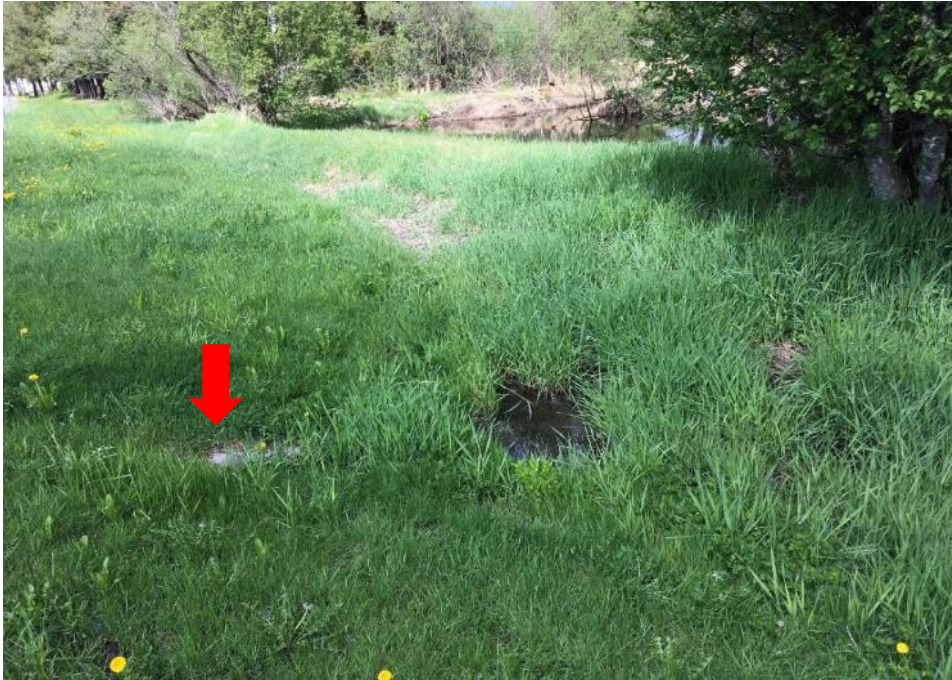
*Figure 53. The Yandukin Drive East stormwater system discharges runoff from a pipe (indicated by red arrow) into a grass swale next to Jordan Creek. Jordan Creek is visible at top of photo. View looking northwest from the north side of Yandukin Drive in May 2020.*

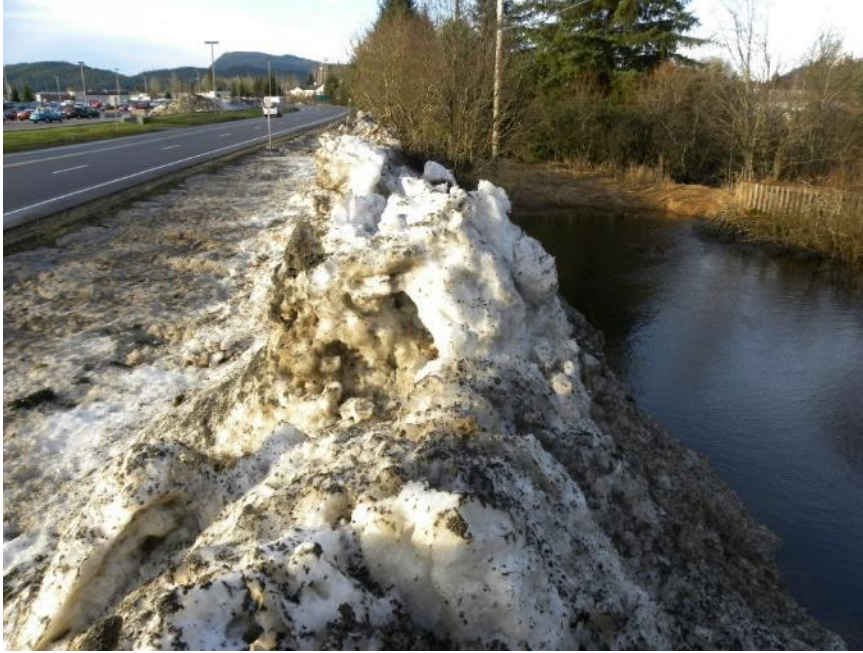
*Figure 54. Plowed snow from Shell Simmons Drive is stored in the Yandukin Drive East stormwater swale and on the bank of an excavated pond in Jordan Creek (right). View looking west from the north side of Yandukin Drive in January 2014.*

Juneau International Airport often stores plowed snow in the swale, on the edge of the pond, and in the pond. The snow damages riparian vegetation and introduces pollutants into the stream. The airport has agreed to avoid this practice as of spring 2020.

1. Monitor the outfall area during large runoff events to ensure adequate runoff storage and infiltration within the swale. Modify the swale to increase infiltration and storage capacity if runoff overflows into the stream.
2. Avoid storing plowed snow in the protected riparian setback area next to the pond (Figure 59). Plant native woody plants on the banks of the pond to provide habitat, improve runoff treatment, and increase transpiration rates from the swale.

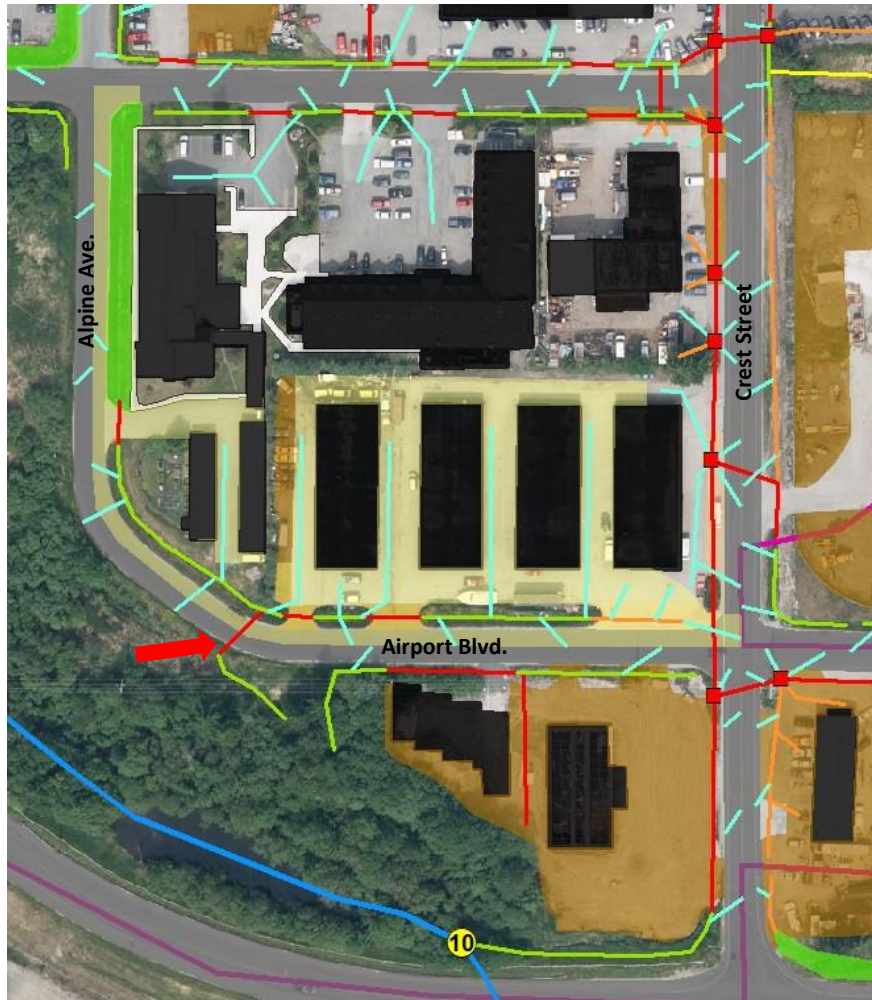
Figure 55. The Alpine Ave. South – Airport Blvd. West stormwater system. The contributing area is shown in yellow; red arrow indicates the outfall pipe.

1. This stormwater system provides complete flow control and runoff treatment in its current state. There is no evidence of surface runoff entering Jordan Creek. If roadways in this contributing area are reconstructed, avoid replacing the grass ditches with stormwater infrastructure that concentrates and accelerates surface runoff conveyance to Jordan Creek, or replace the ditches with BMPs that provide the same flow control and treatment functions.

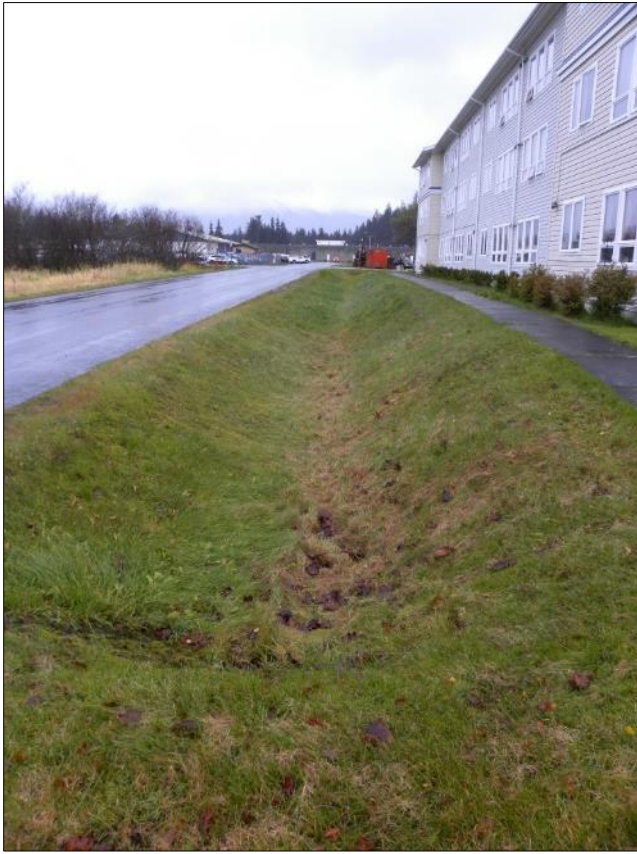
*Figure 56. A grass-lined swale on the east side of Alpine Ave. South. View looking north towards Teal Street in October 2014.*

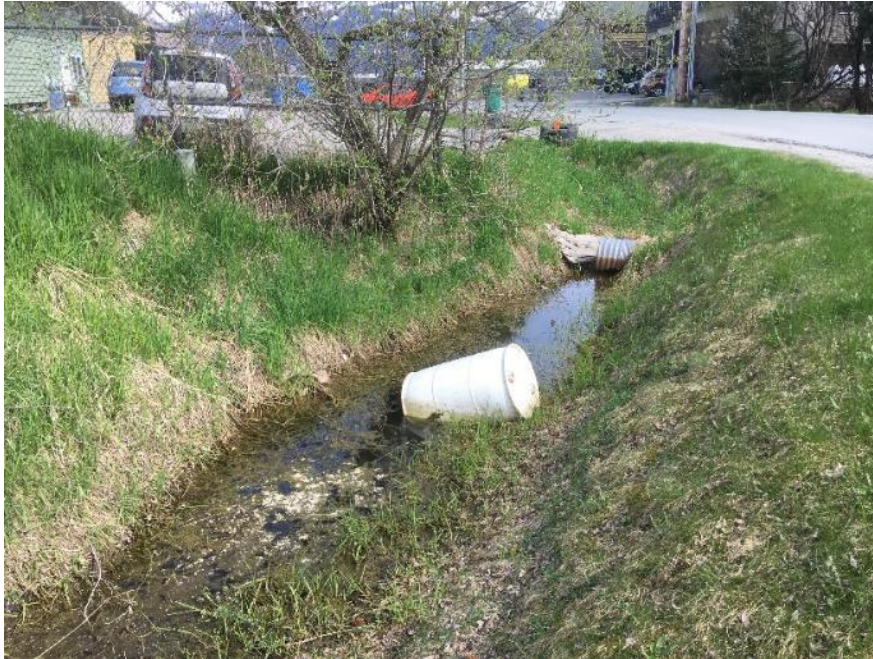
*Figure 57. Stormwater runoff pools in a ditch at the junction of Alpine Ave. and Airport Blvd. View looking southeast in May 2020.*

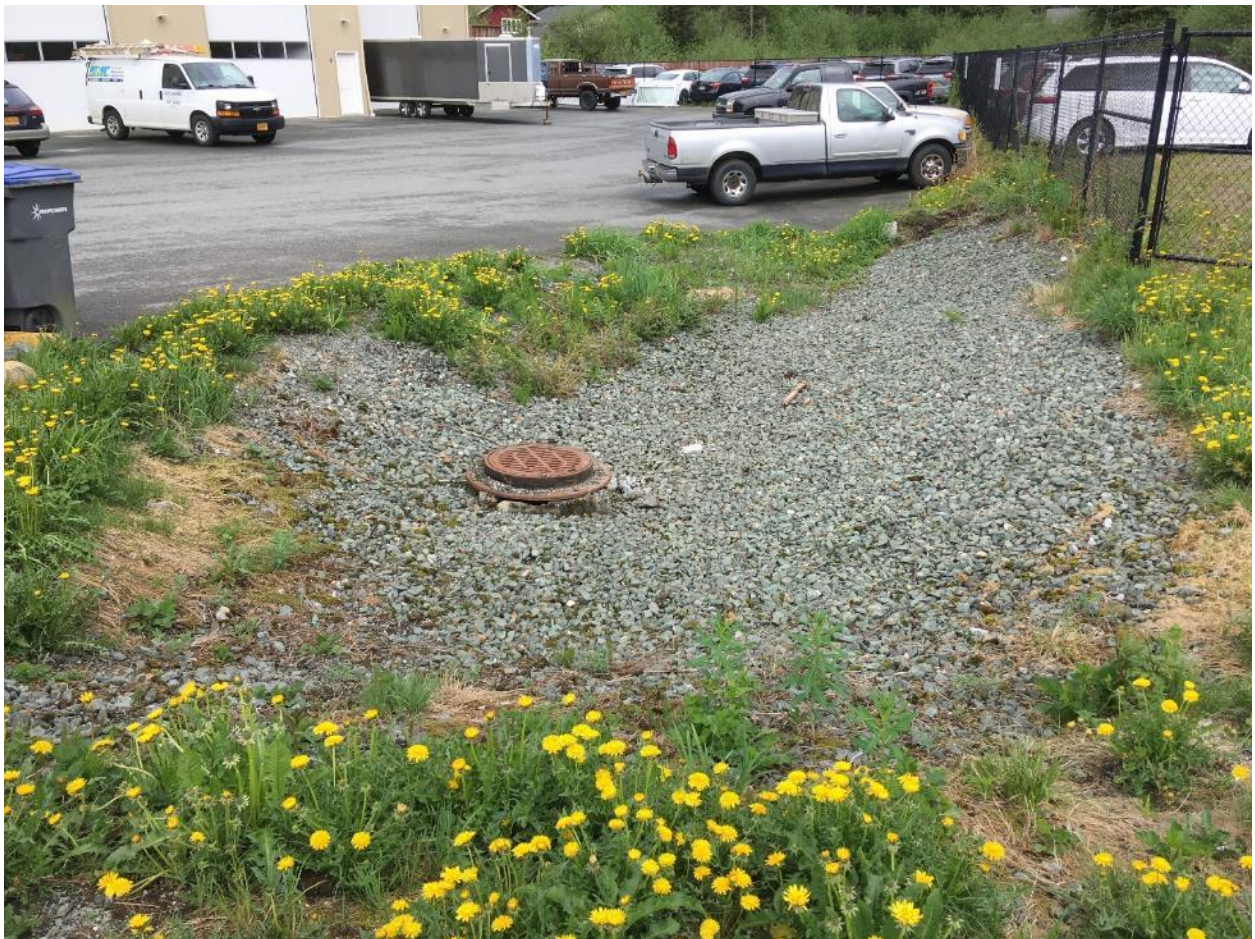
*A stormwater infiltration basin at the north end of Jordan Ave. is designed to receive runoff from a parking lot near Jordan Creek.*

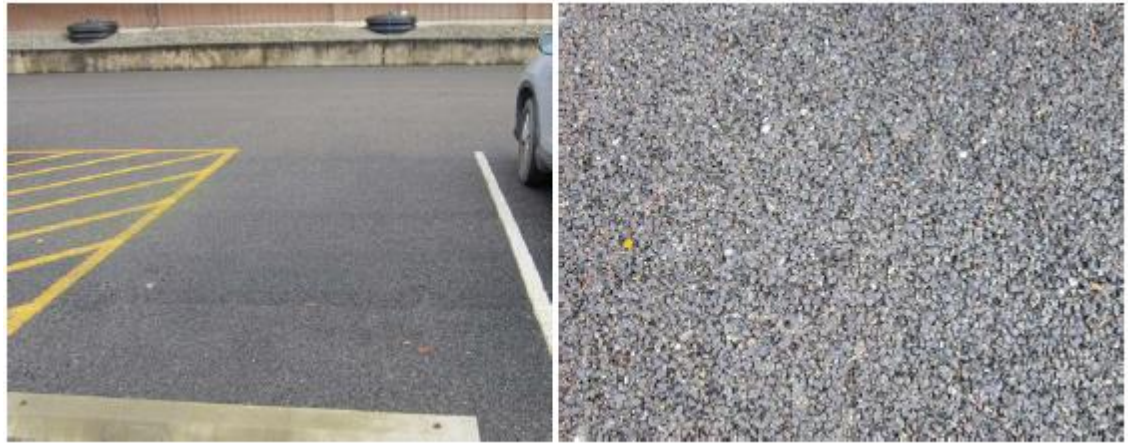
Figure 2. Left: A parking lot paved with porous asphalt. Right: porous asphalt closeup (Washington Stormwater Center LID Training Manual)

*Porous asphalt (Figure 2)*

- a flexible pavement that is similar to conventional asphalt pavement
- produced by reducing or eliminating the amount of fine-grained material in the pavement mix, which creates voids that allow water to flow through the aggregate
- typically used in parking lots

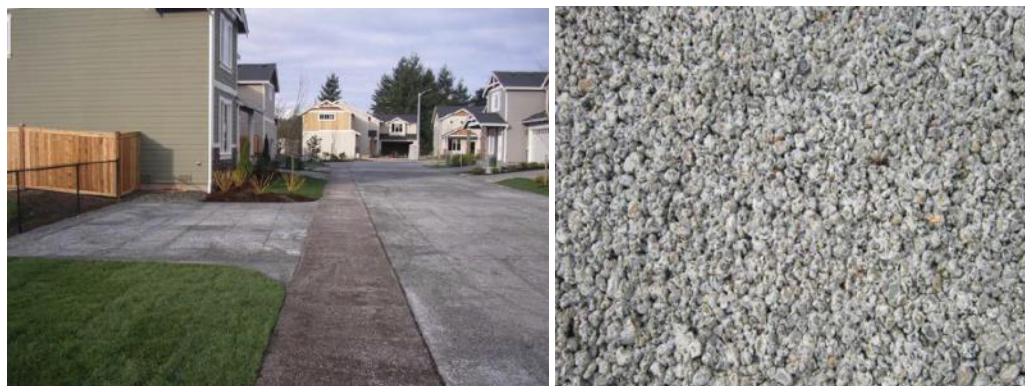
Figure 3. Left: pervious concrete sidewalk, driveways, and a street in a residential setting. Right: pervious concrete closeup. (Washington Stormwater Center LID Training Manual)

*Pervious concrete (Figure 3)*

- similar to conventional concrete pavement
- produced by reducing or eliminating the amount of fine-grained material in the pavement mix, which creates voids that allow water to flow through the aggregate
- the only permeable pavement that is rigid
- suitable for parking lots, bike lanes, sidewalks, and driveways

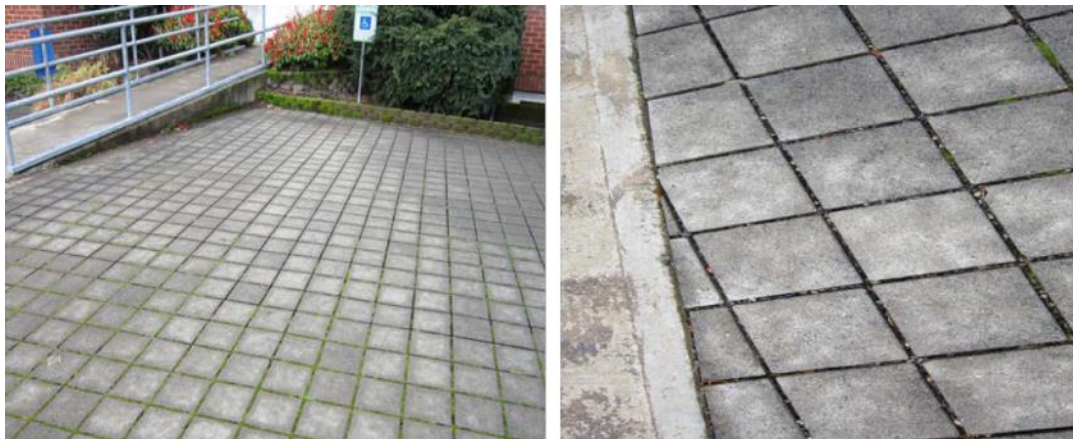
Figure 4. Left: a parking lot paved with PICP. Right: PICP closeup (Washington Stormwater Center LID Training Manual).

Permeable interlocking concrete pavements (PICP) are modular precast impervious pavers made with high-strength Portland cement (Figure 4). PICP can support high vehicle loads at low speeds.

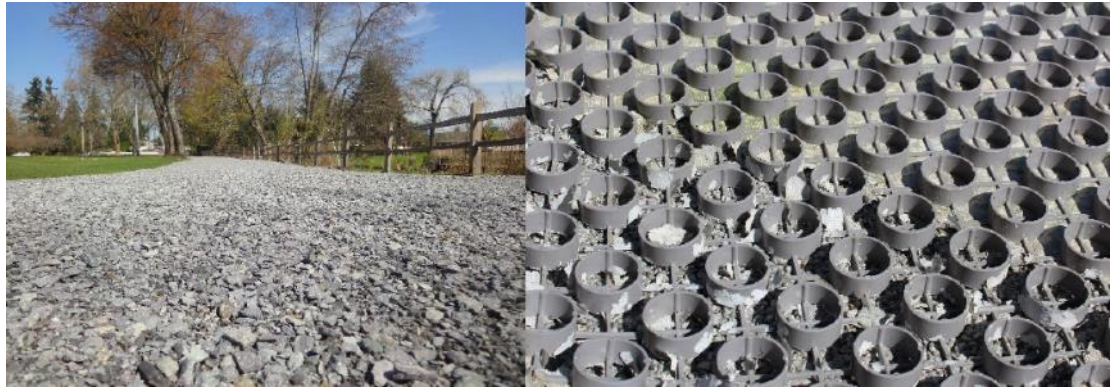
*Figure 5. Left: park access road constructed with plastic grid and gravel. Right: plastic grid system (Washington Stormwater Center LID Training Manual).*

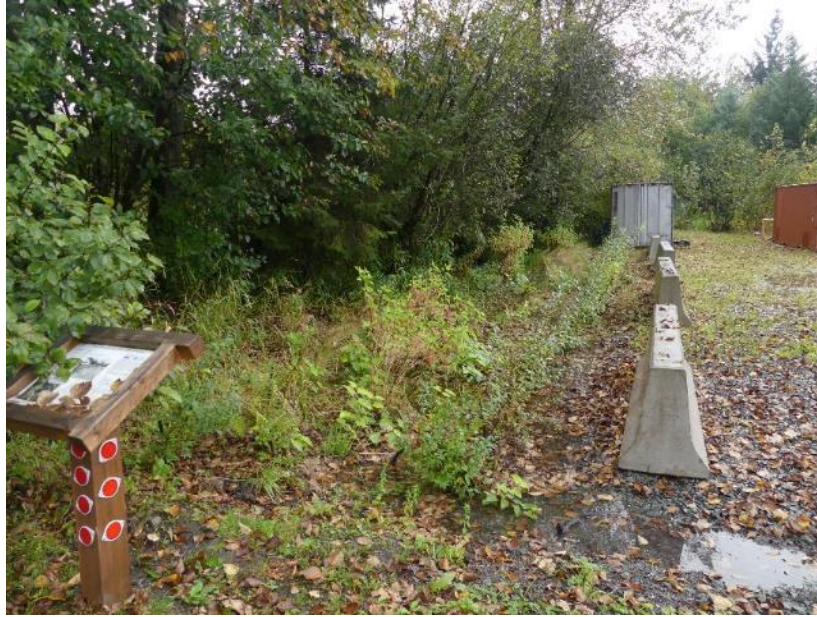
*Figure 8. An infiltration trench (left of barriers) on the west side of Jordan Creek, downstream of Glacier Highway in Juneau. Runoff enters from the lower right of photo; Jordan Creek is left of photo.*

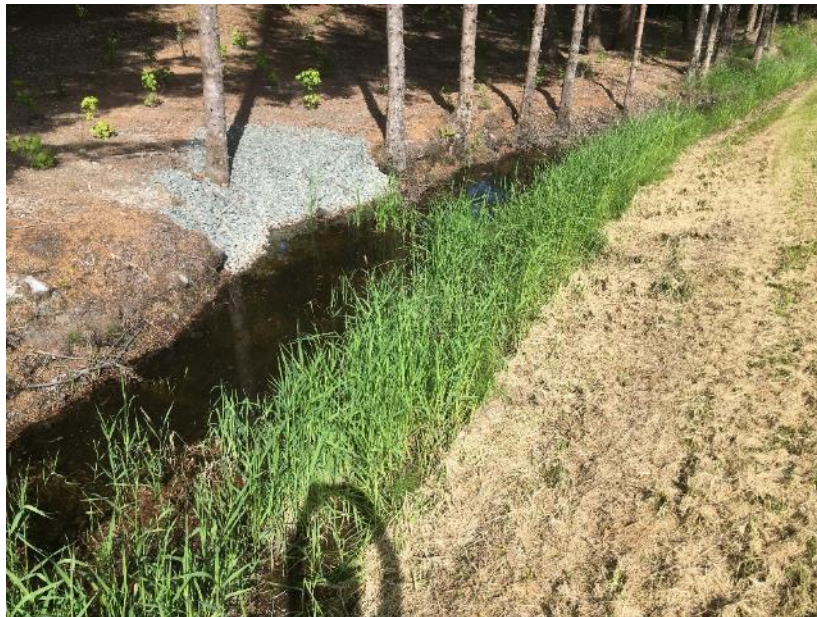
*Figure 9. The inlet end of a 150-foot long infiltration trench that receives runoff from the west end of Yandukin Drive near Jordan Creek.*

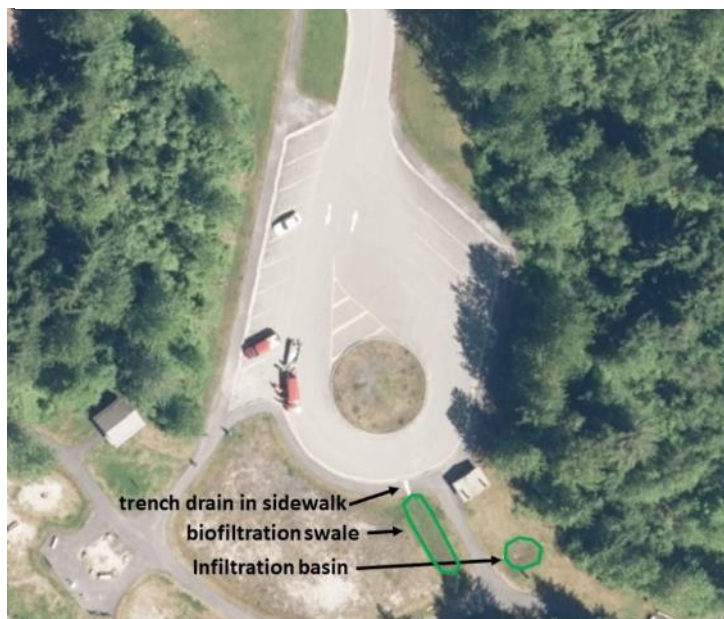
Figure 12. A stormwater BMP next to Eagle River in the Eagle Beach State Recreation Area in Juneau. Runoff flows from the parking lot to a biofiltration swale through a trench drain in the sidewalk. Runoff exiting the swale flows through a buried culvert (not depicted above) into an infiltration basin.

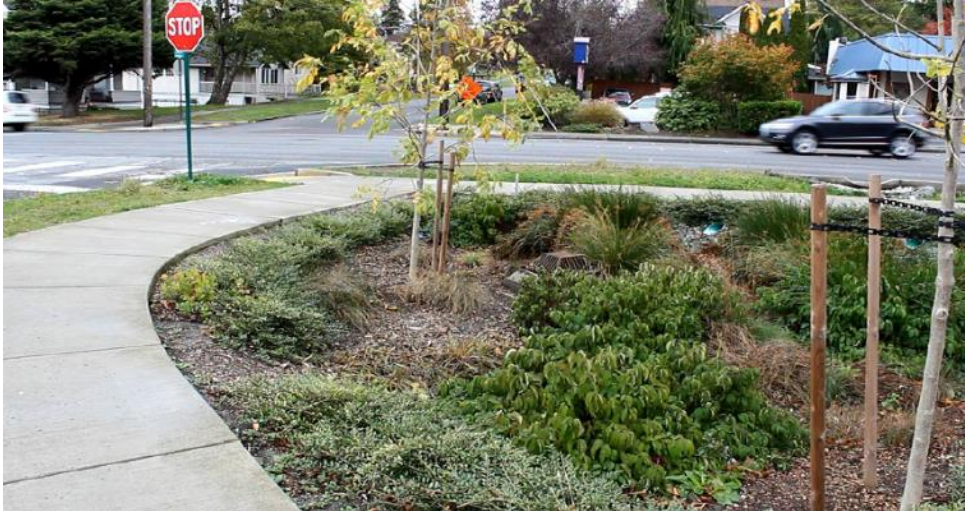
Figure 14. Bioretention cell. Note the overflow drain with beehive grate (center) and the two blue inlet pipes (center right) that convey runoff from the street into the cell (Washington Stormwater Center Training Manual).

Bioretention cells are shallow depressions filled with BSM and plants, including trees, shrubs, grasses, and/or other herbaceous plants (SWMMSW) (Figure 13Figure 14).

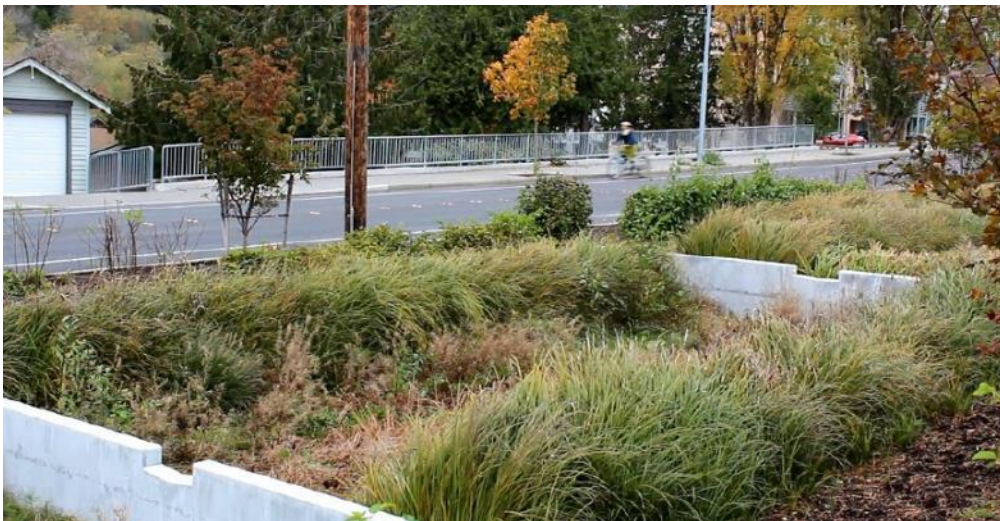
Figure 15. A series of bioretention swales. Check dams between cells impound and convey water to the downstream cell. (Washington Stormwater Center Training Manual)

Bioretention swales use the same design features as bioretention cells. Unlike bioretention cells, bioretention swales are interconnected in a series to allow for conveyance of overflow from one swale to the next (Figure 15).
