# Lower Jordan Creek Watershed Management Plan

**Stormwater management and riparian restoration  
for sediment, PAH, and metals**

*February 2021*

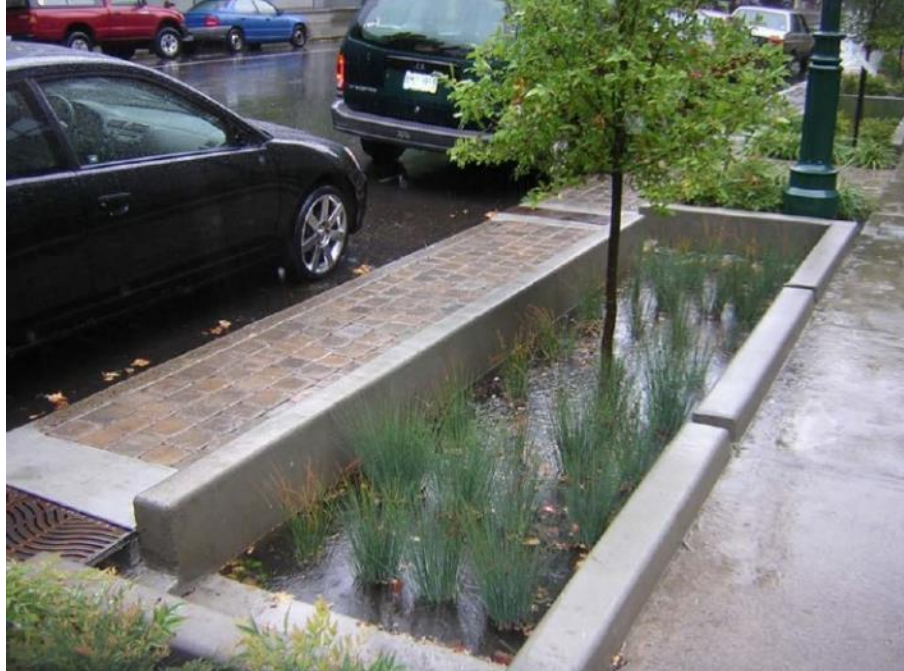
Figure 17. A bioretention planter in Portland, Oregon. Trench drains serve as inlets and outlets for street runoff; curb notches are inlets for sidewalk runoff. (Washington Stormwater Center Training Manual)

*Bioretention planters are stormwater infiltration BMPs with walled vertical sides and flat bottoms designed to capture, store, and treat stormwater runoff from streets (NACTO) (Figure 16, Figure 17Figure 18). Bioretention planters are commonly used where the right-of-way width is constrained. Where the right-of-way does not*

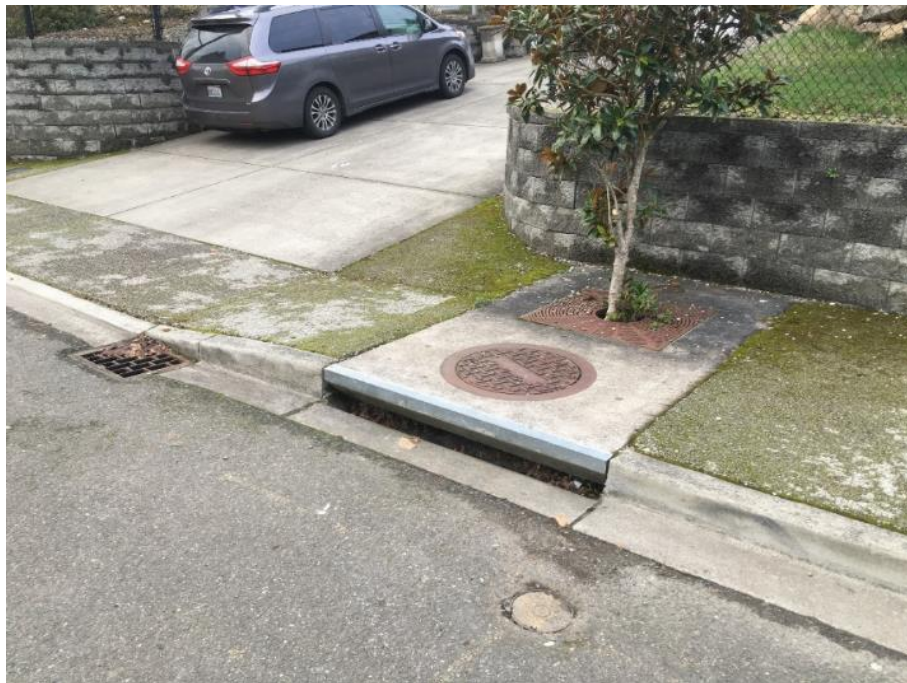
Figure 18. This bioretention planter containing a single tree intercepts runoff from curb and gutter immediately upstream of a catch basin (center left) in Seatac, WA. Note the sidewalk is constructed with pervious concrete.

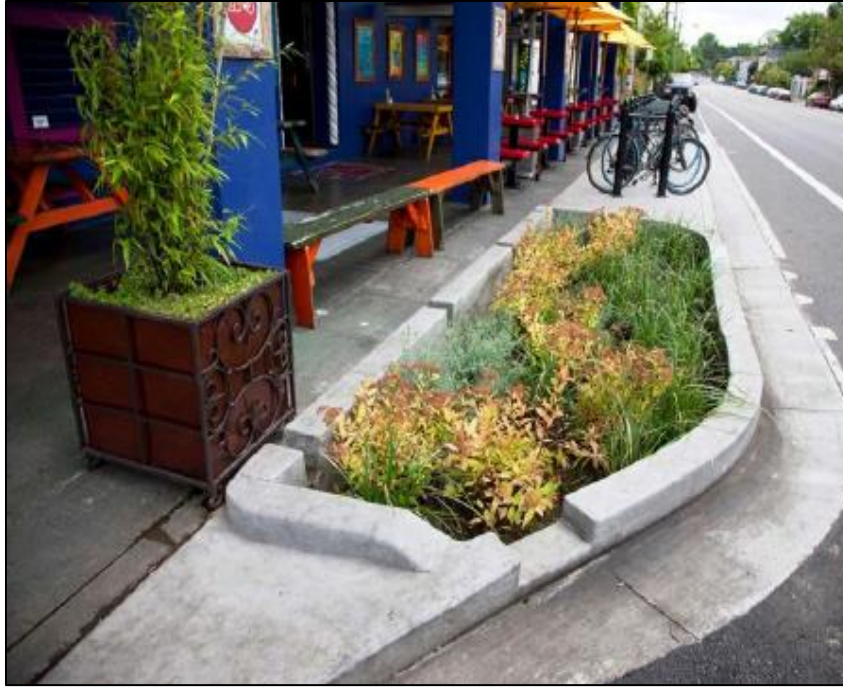
*Figure 19. A bioretention planter in a curb extension designed to receive runoff from the sidewalk and street in Portland, Oregon. Curb extensions provide space for stormwater BMPs where right-of-way space is limited and improve auto, pedestrian, and bicycle safety by shortening the crossing distance for pedestrians, improving sight lines, and providing a visual presence in the roadway to slow vehicles approaching intersections (Washington Stormwater Center Training Manual).*

*provide adequate space, planters can be constructed in curb extensions or medians (Figure 19). Plants and BSM in the planter remove many types of pollutants from the runoff. Planters have an open bottom allowing treated runoff to infiltrate native soils. Bioretention planter boxes are similar to planters but have an impervious bottom and must be equipped with an underdrain. Bioretention planters can be interconnected in series.*

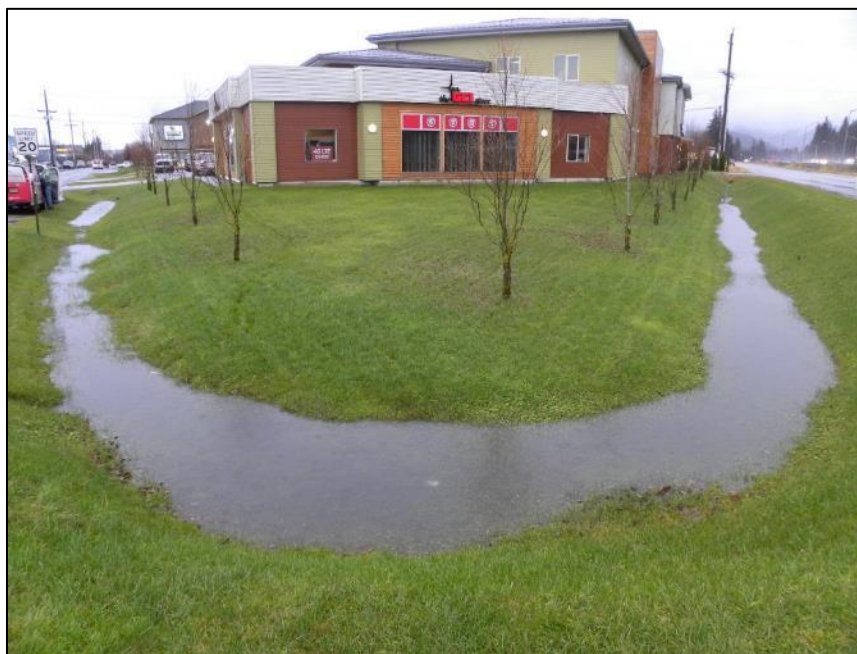
Figure 21. Panoramic photo of a biofiltration swale at the intersection of Airport Blvd. and Old Dairy Road in October 2014. Swale inlet pipes are at top of photo; the outlet pipe is at left edge of photo.

Biofiltration swales are linear, shallow, vegetated, open channels usually with parabola- or trapezoid-shaped cross sections (SWMMWW) (Figure 20, Figure 21, and Figure 22). Due to the high degree of variation in performance among biofiltration swales, it may be desirable to consider another runoff treatment BMP that is appropriate for the site. Biofiltration swales may be designed with longitudinal dividers to ensure an even distribution of flow

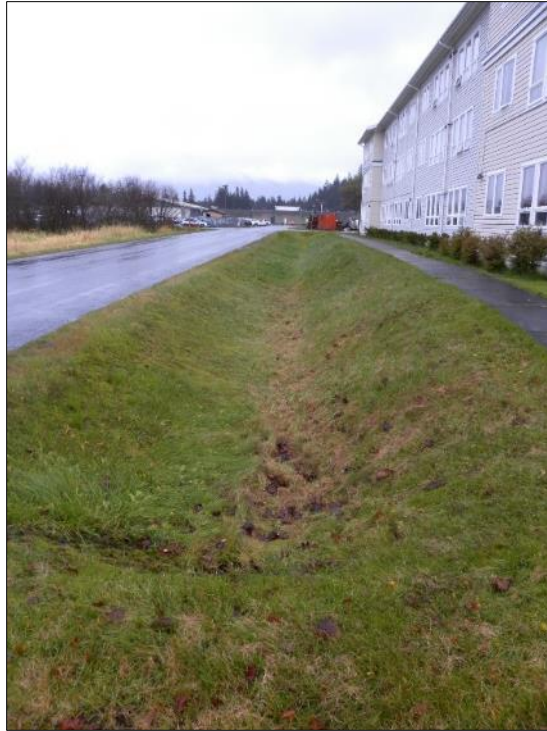
*Figure 22. A biofiltration swale at the southeast end of Alpine Ave. in the lower Jordan Creek watershed in October 2014.*

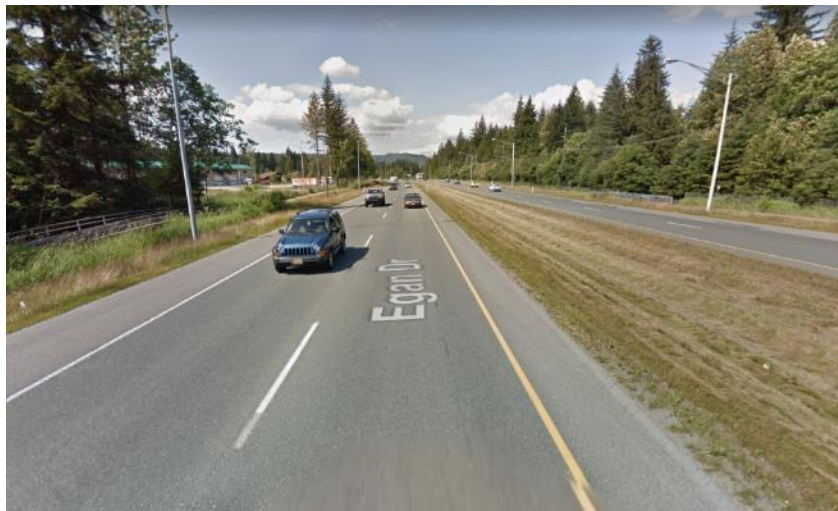
Figure 24. The median and outer margins of Egan Drive function as vegetative filter strips. View looking northwest where the highway crosses Jordan Creek (Google Earth Street View).

A vegetated filter strip is a flat strip of vegetation adjacent to an impervious surface such as a road, driveway, or parking lot (Figure 23, Figure 24, and Figure 25). Runoff enters the strip as sheet flow across the width of the strip. Runoff Treatment is provided by filtration through vegetation and infiltration through the soil. Native soils may be amended with the addition of compost to enhance treatment capability. A flow spreader may be added to a filter strip. The spreader uniformly spreads flow across the edge of the strip next to the impervious surface.

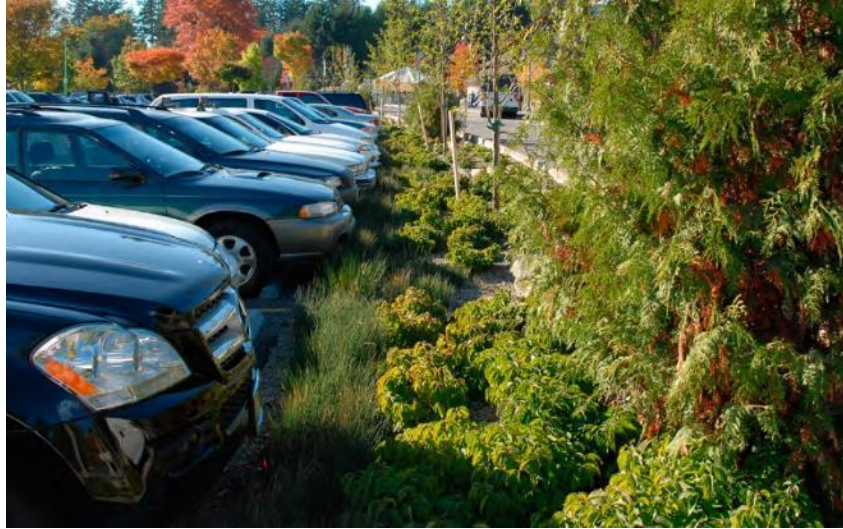
Figure 25. A vegetated filter strip in a parking lot at the Oregon Zoo.
