Brownfield Assessment

PROPERTY ASSESSMENT AND CLEANUP PLAN

Old City Tank Farm and Power Plant Akiak, Alaska

By: SLR International Corp April 2010

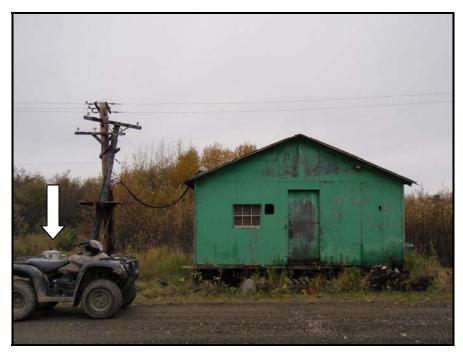
Photograph 1:

Old City Power Plant Generator Building. Power lines run directly above the building and it is unknown if the power line connected to the building is still active. A transformer is visible behind the all-terrain vehicle (September 2009).

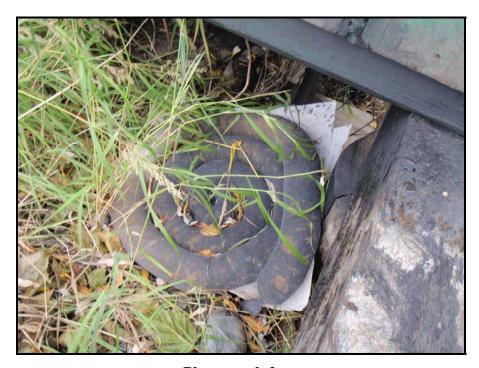
Photograph 2:

Saturated sorbent observed on the ground outside the Old City Power Plant Generator Building (September 2009).

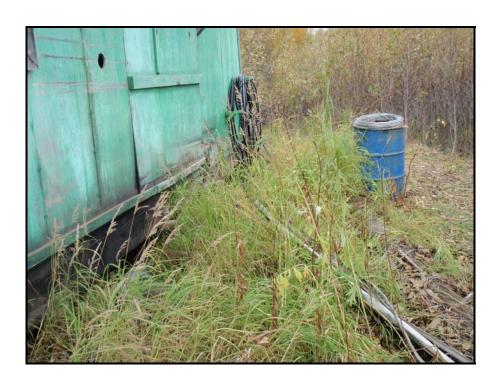
Photograph 3: Unlabeled 55-gallon drum and wiring observed adjacent to the Old City Power Plant Generator Building (September 2009).

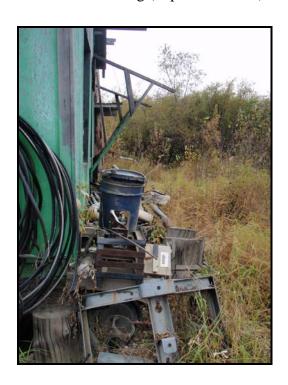
Photograph 4: Waste oil bucket and miscellaneous debris behind the Old City Power Plant and Generator Building (September 2009).

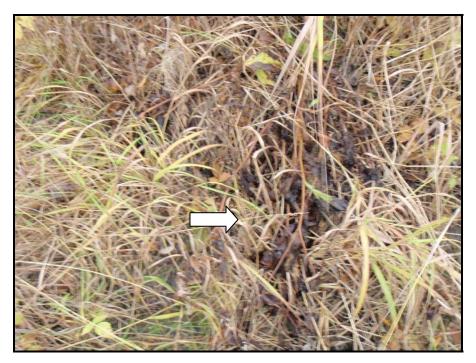
Photograph 5: Stressed vegetation noted behind the Old City Power Plant Generator Building (September 2009).

- The ground beneath and around the ASTs and the fuel pipeline described by Sam Jasper (see Section 2.2.4);
- The west side of the power plant building in the area of a former used-oil storage area where stressed vegetation was observed during SLR's site visit in 2009; and

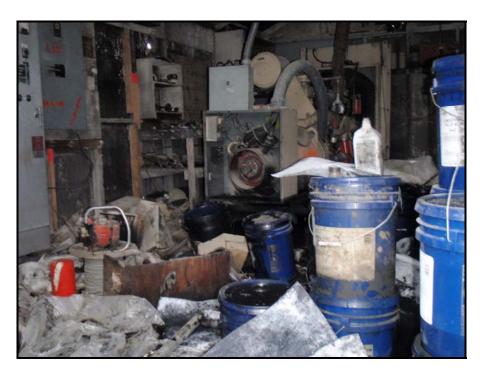
Photograph 6: Interior of the Old City Power Plant Generator Building (September 2009).

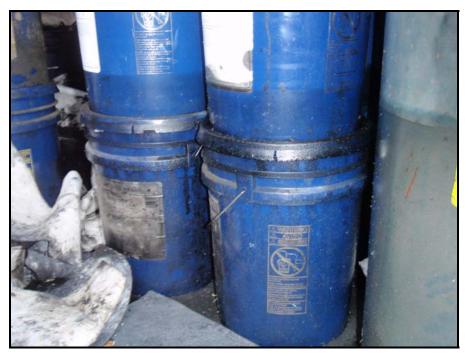
Photograph 7:

High water line from spring flooding is visible on the second row of buckets inside the Old City Power Plant Generator Building (September 2009).

The former power plant building, which remains on the Site, is approximately 25 feet by 30 feet in size and was built in the late 1970s. The building was impacted by flooding in the spring of 2009 with the high water mark approximately 2 feet above the floor of the building, which is elevated on pilings. The floor of the building was heavily stained and approximately 70 5-gallon plastic pails containing waste oil, lead-acid batteries, generators, and transformers are stored in the building.

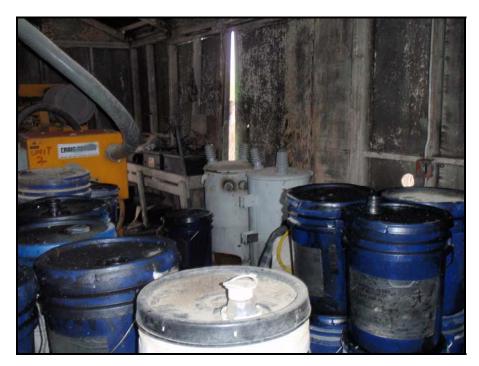
Photograph 8:

One generator, batteries, two transformers, and lots of motor oil buckets inside the Old City Power Plant and Generator Building (September 2009).

- Three generators are present at the Site (two inside the old power plant building and one outside in the brush) It is recommended that the generators be reused within the community, if possible. If reuse of the generators is not feasible they should be disposed of in accordance with state regulations, which may require offsite shipment if they cannot be disposed of in the local landfill.

- Several transformers were observed at the Site. The oil within the transformers should be sampled and analyzed for PCBs or other hazardous substances. Operational equipment should be reused within the community; non-operational equipment should be disposed of in the local landfill, if it does not contain PCBs or other hazardous substances. Any PCB containing transformers should be disposed of properly.

- Lead-acid batteries were observed at the Site. These require special handling and should be disposed of in accordance with all applicable state and federal regulations.

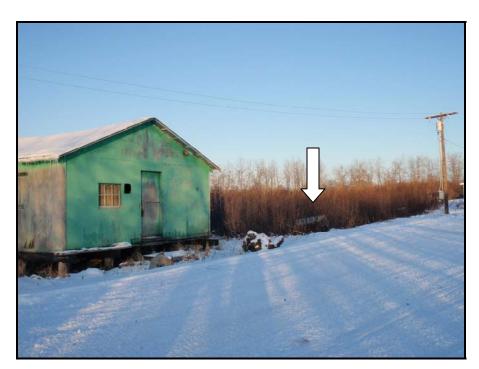
Photograph 10:

Aboveground storage tank (AST) observed in the trees near the Old City Power Plant Generator Building (October 2009). The AST was not noted during SLR's initial site visit in September 2009.

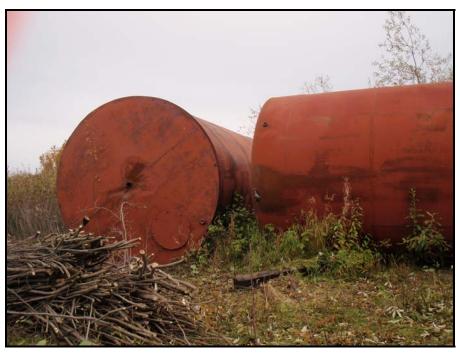
Photograph 11:

Flooding of the Kuskokwim River in spring 2009 toppled the two vertical ASTs. The ASTs were outside of their containment and appeared to be empty at the time the Site was visited by SLR. No stained soil or pooled liquids indicating a recent release were observed, although historical petroleum contamination has been documented at the Site in previous reports and was described in interviews.

Tanks toppled over at the Old City Tank Farm (September 2009). Both top-loading tanks were toppled during the 2009 spring flooding of the Kuskokwim River, located approximately 1,000 feet away.

- Two ASTs associated with the former tank farm are located on the Site; the tanks are no longer in use and appear to be empty. It is recommended that these tanks be decommissioned by a qualified contractor, cut up, and either reused, recycled or disposed of in the local landfill.
- Approximately 70 5-gallon buckets were used inside the old power plant building; interviews indicated these buckets contain motor oil. It is recommended that this used oil be combusted in a waste oil burner for energy recovery. The waste oil would require testing to determine if it complies with state and federal regulations for this purpose, for

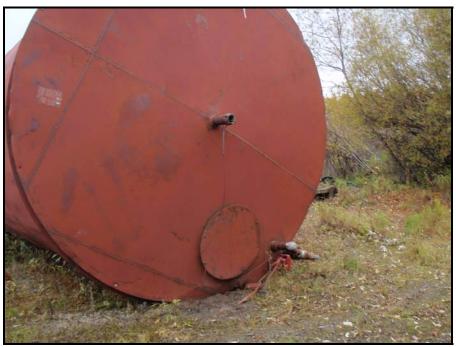
Photograph 12: Close-up of tank top (September 2009).

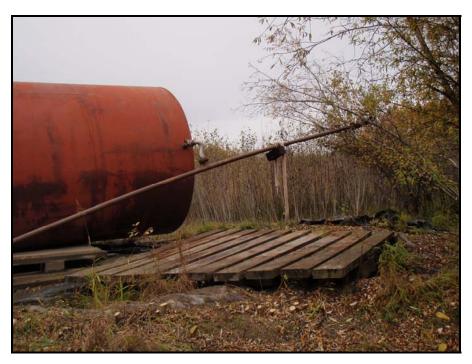
Photograph 13:

Toppled tank and associated fuel line. Also visible in this photograph is one of the wooden platforms the tanks originally sat on, which were removed partially outside of the lined area during the spring flooding. No stained soil was observed (September 2009).
