**FINAL  
PROPERTY ASSESSMENT  
AND CLEANUP PLAN**

*Village of Beaver Old BIA School Tank Farm  
and Burned Generator Building  
Beaver, Alaska*

By:  
SLR International Corp  
May 2010

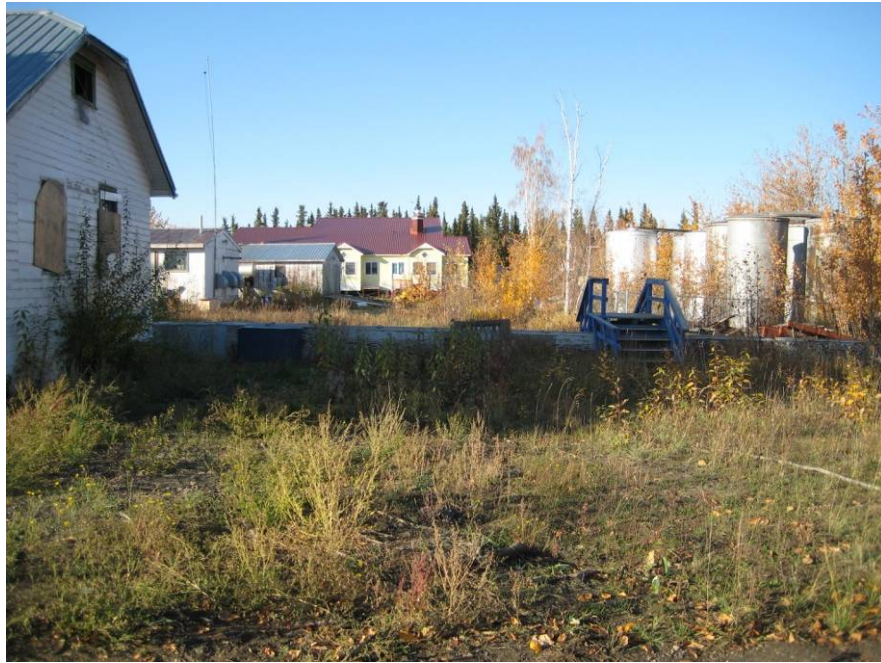
**Photograph 1:**

The Old BIA School Site. The Old School is on the left in the photograph. The generator building and shop building are in the distance on the left. The tank farm is on the right in the photograph. The new school is in the background (September 2009).

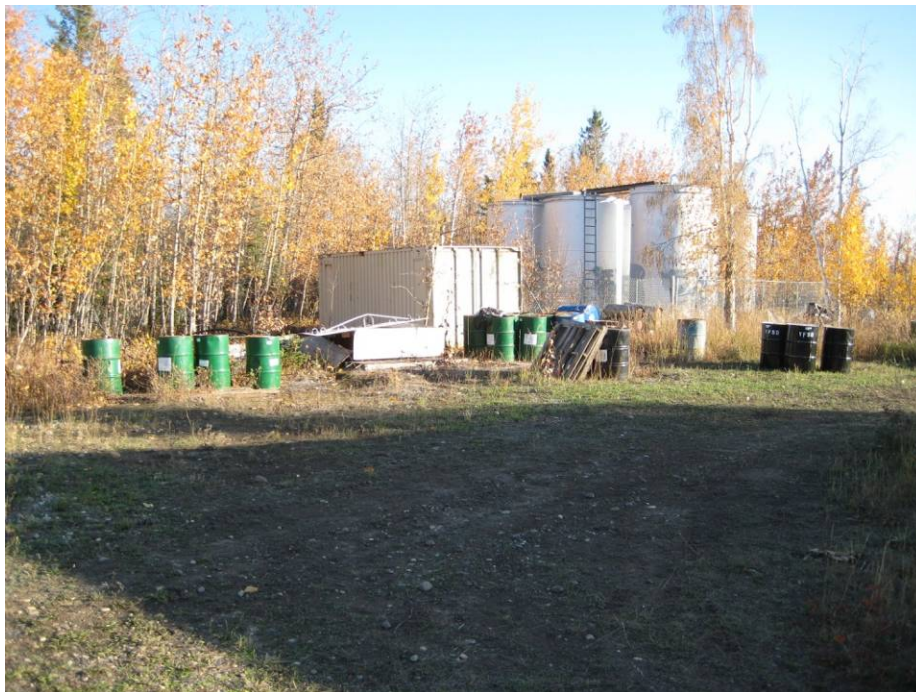
**Photograph 2:**

The tank farm at the Old BIA School. Drums are stored all over the area north west of the tank farm (September 2009).

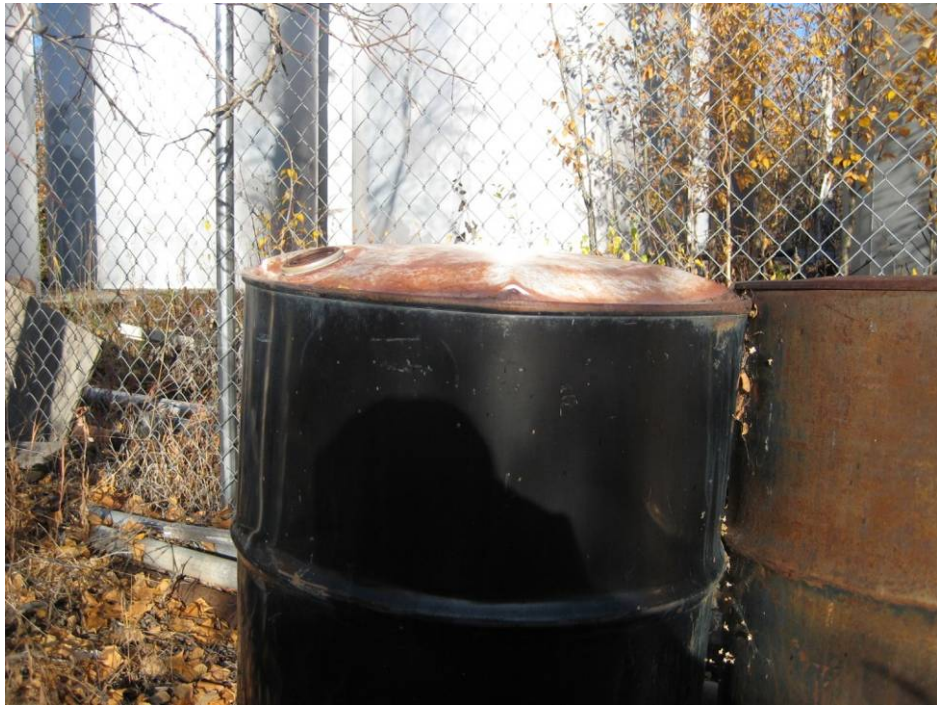
**Photograph 3:**  
Drum conditions at the tank farm (September 2009).

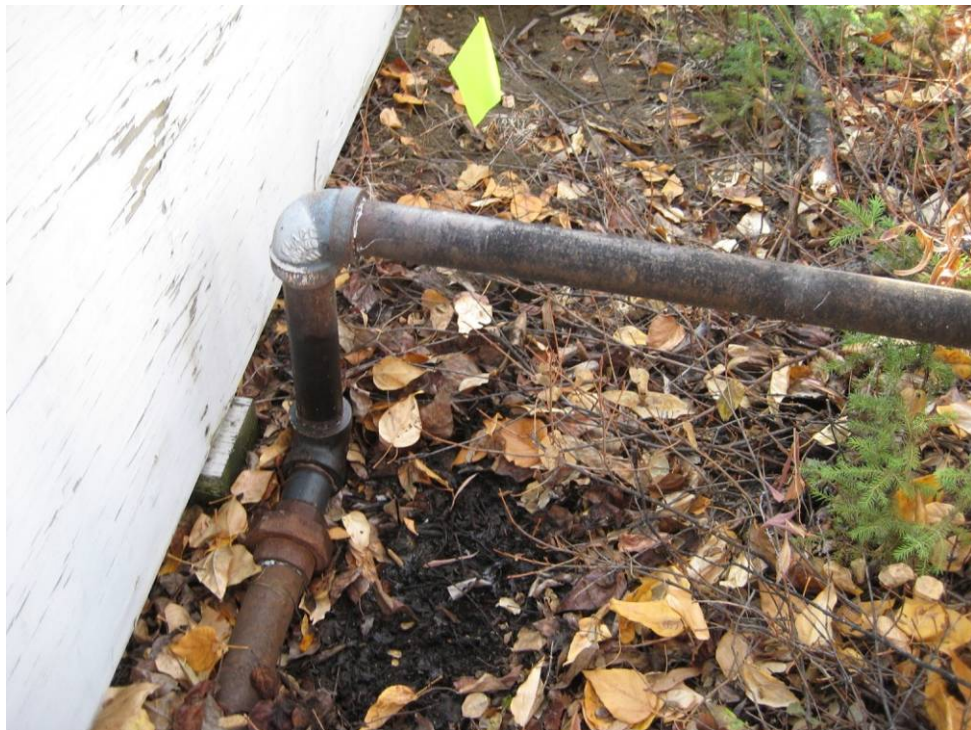
**Photograph 4:**  
Leaking coupling near utilidor east of tank farm (September 2009).

**Old BIA School Tank Farm Area** – There is a wooded area east of the Old BIA School tank farm. A utilidor and fuel lines leading into and out of the tank farm passes through this wooded area (Figure 2). During the visit, a leaking elbow coupling was observed adjacent to the utilidor (north of the location of soil sample B-2, Figure 2 and Appendix E-1, Photograph 4). Beneath the coupling, stained soil was observed with a fuel odor. The locations of test pits from previous investigations were also evident in this area. North of and adjacent to the western fence of the tank farm, 15 to 20 55-gallon drums with antifreeze and unleaded gasoline labels were present (Figure 2 and Appendix E-1, Photograph 2). Some drums were bulged and contained liquid contents during the field investigation. Strong fuel odors were noted throughout the Old BIA School tank farm area.

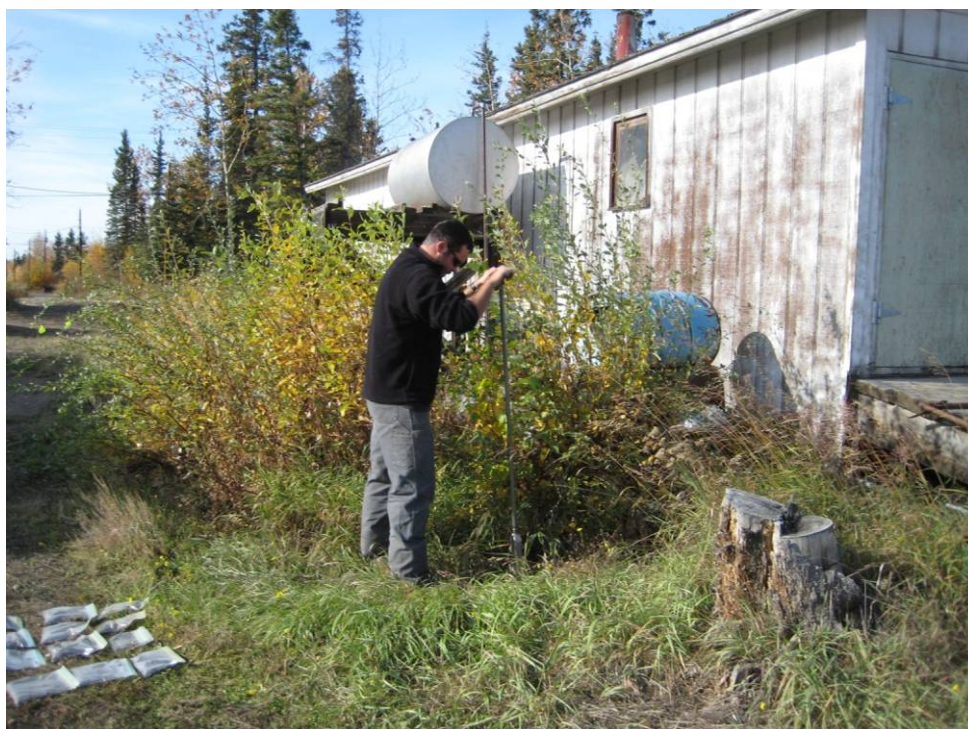
**Photograph 5:**

Hand auguring for field screening sample collection near entrance of shop building. Screening samples are heating up on left side of photograph (September 2009).

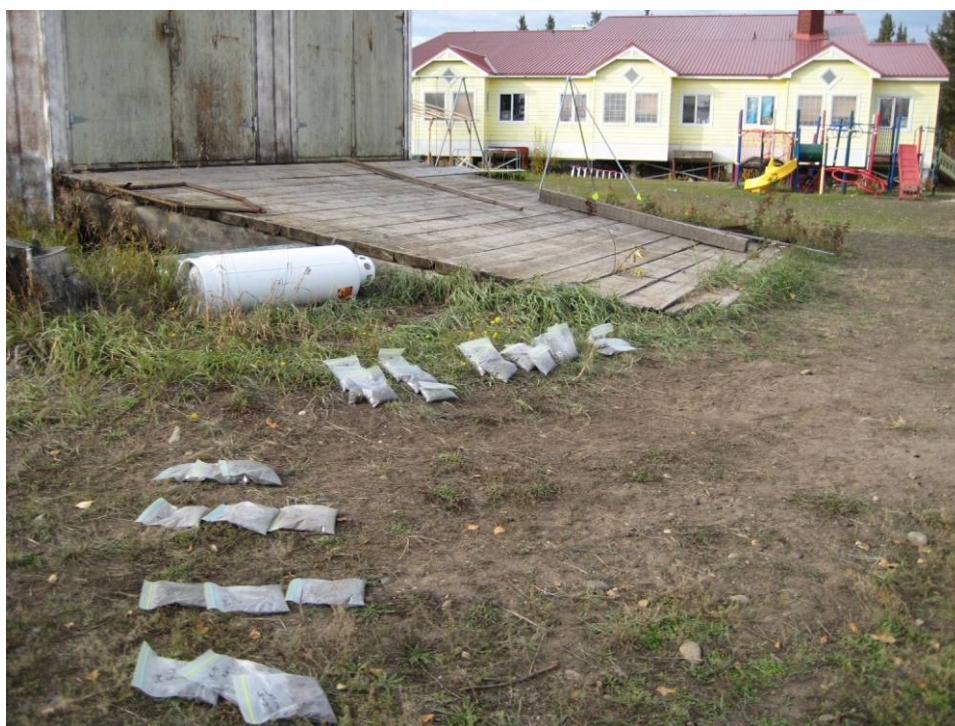
**Photograph 6:**

Vicinity of new school to shop building at Old BIA School Site (September 2009).

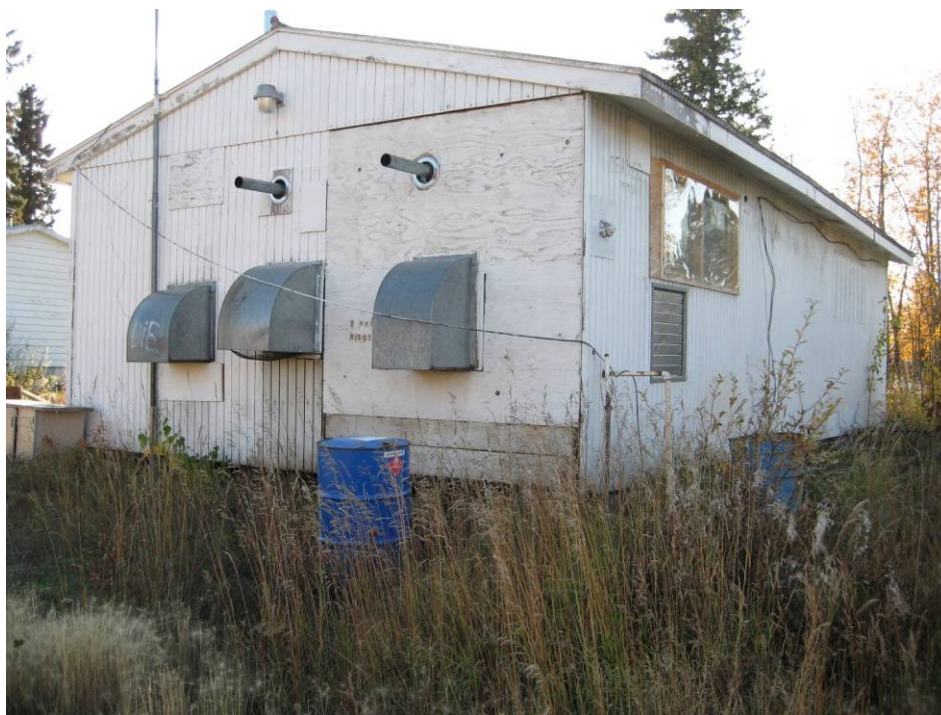
**Photograph 7:**  
Unleaded gasoline drums stored at generator building (September 2009).

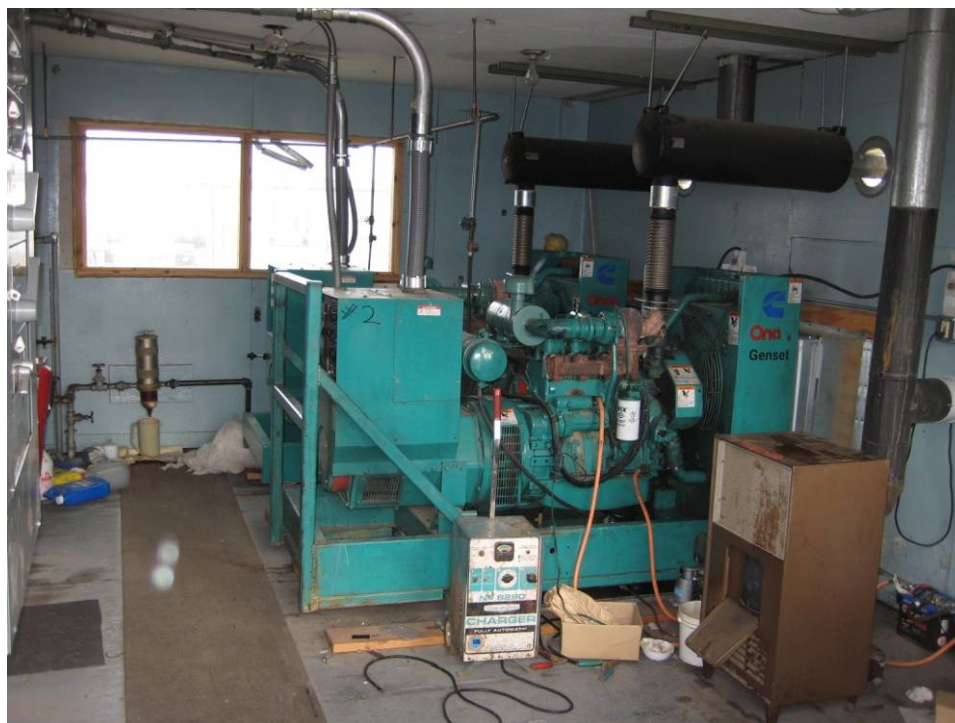
**Photograph 8:**  
Inside generator building (September 2009).

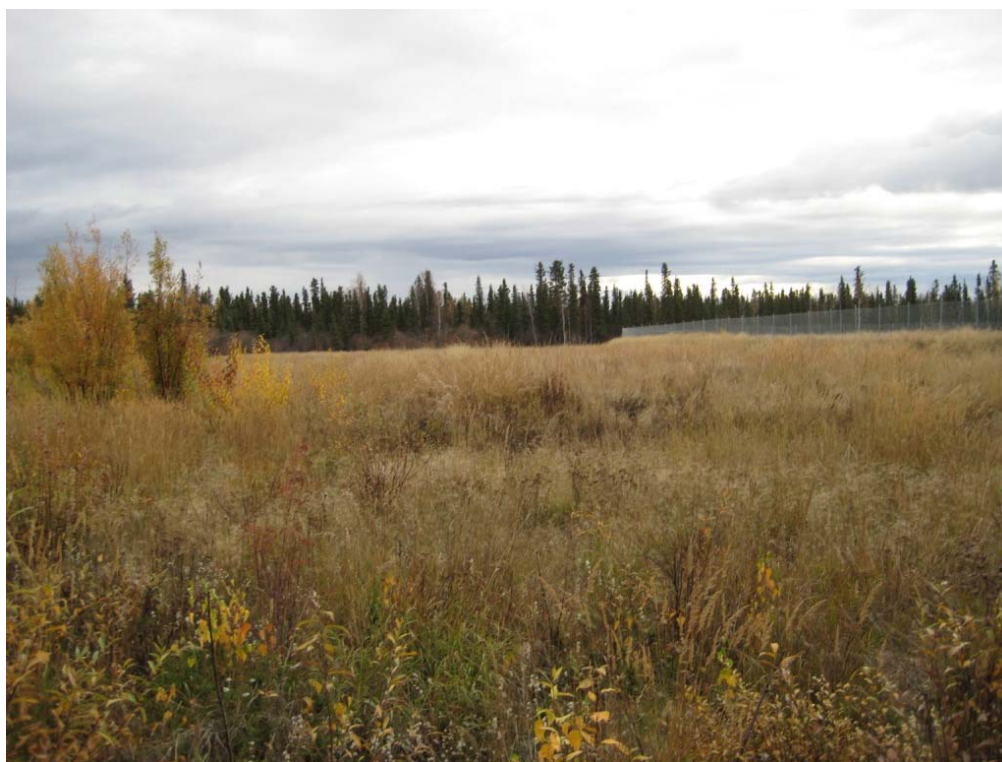
**Photograph 10:**  
Land between landfill and sewage lagoon. Site could be used for long-term storage of contaminated soils (September 2009)

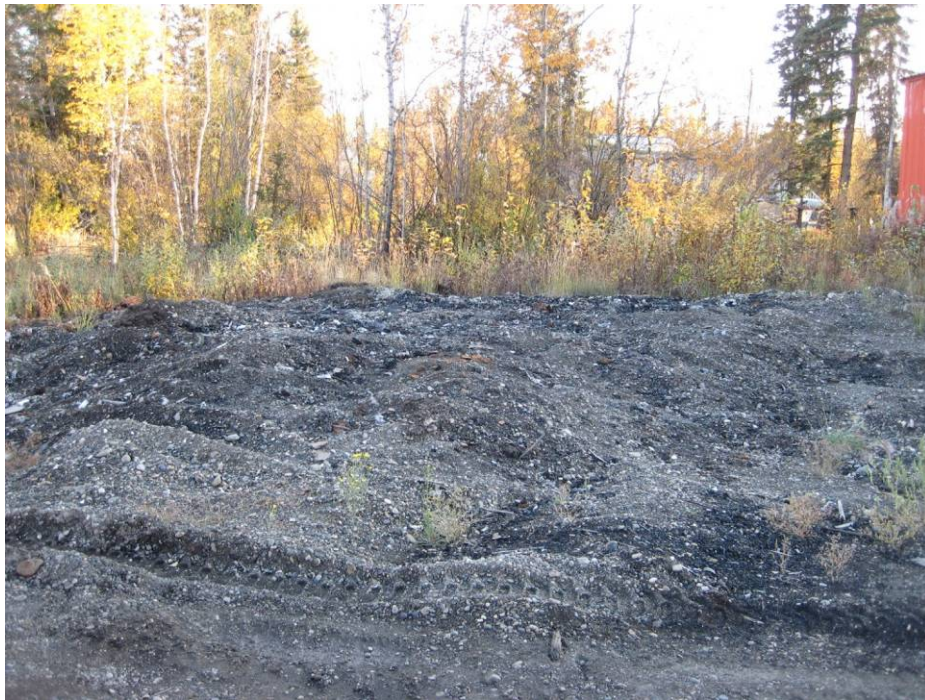
**Photograph 1:**  
The Burned Generator Building Site (September 2009).

**Burned Generator Building Site** – The Burned Generator Building site contained an approximate one-half- to 1-foot-deep layer of burned debris on the ground surface. There were no recognizable construction materials left from the fire (Appendix E-2, Photograph 1). Strong fuel odors were noted in the area.

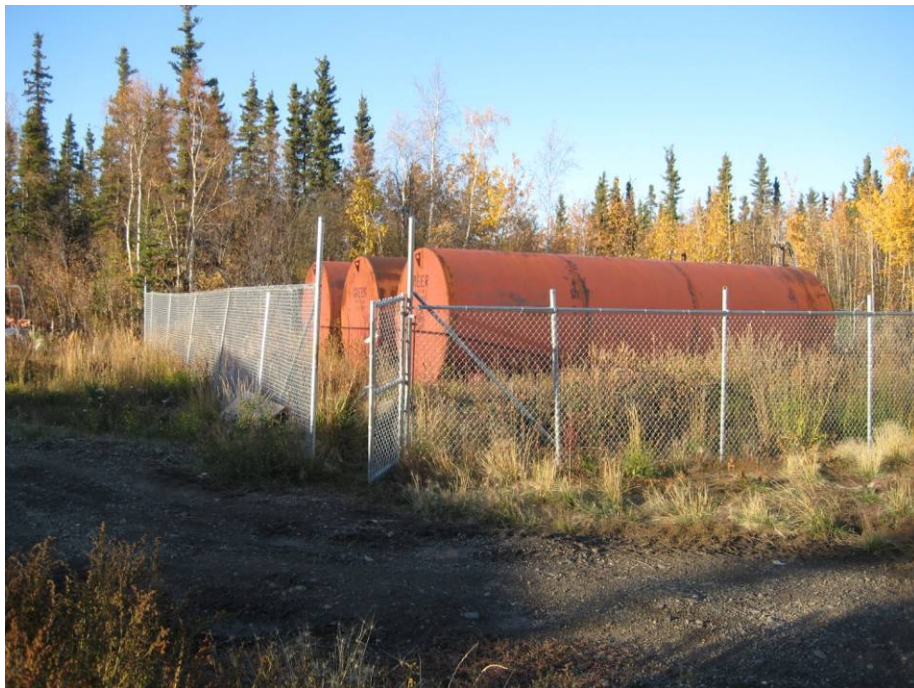
**Photograph 2:**  
The Beaver Joint Utilities (BJU) Tank Farm. The Burned Generator Building Site is left of the fence and tanks, across the path. (September 2009).

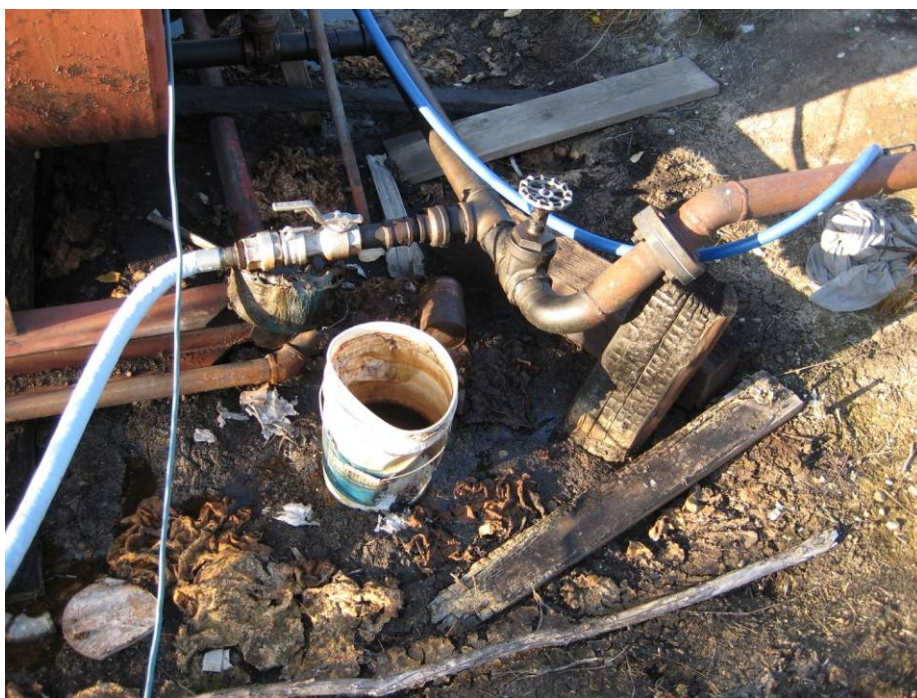
**Photograph 3:**  
Leaking pipe fittings at BJU Tank Farm (September 2009).

**Beaver Joint Utilities Tank Farm Area** – At the BJU tank farm, several potential environmental issues were identified. Strong fuel odors were noted in the area of the tank farm. Although there was containment, leaking valves and couplings were observed. One of the fuel dispensing hoses was a common household garden hose. There were transformers

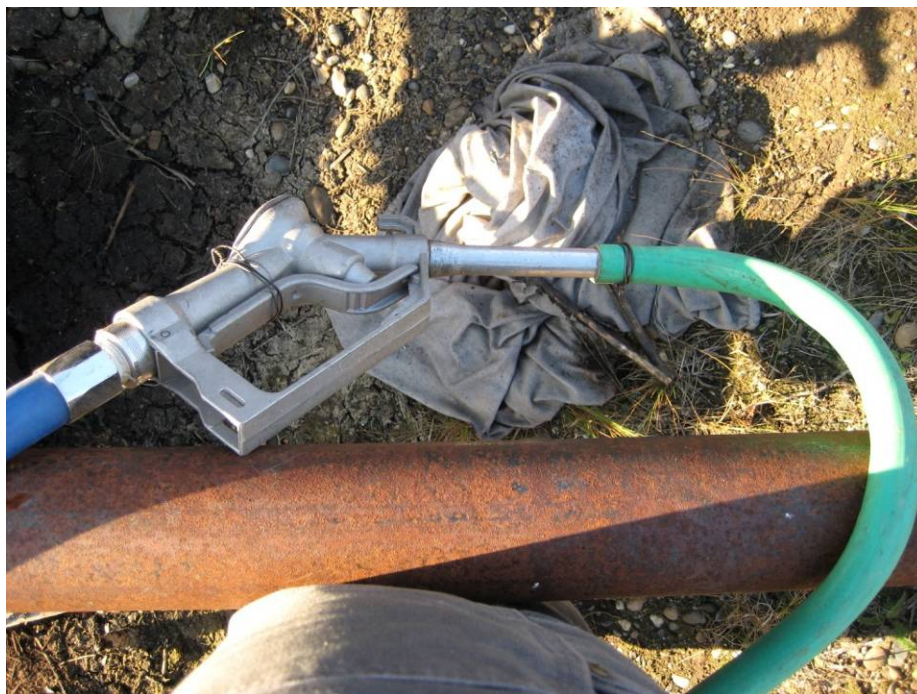
**Photograph 4:**  
Fuel pump with garden hose used for fuel line (September 2009).

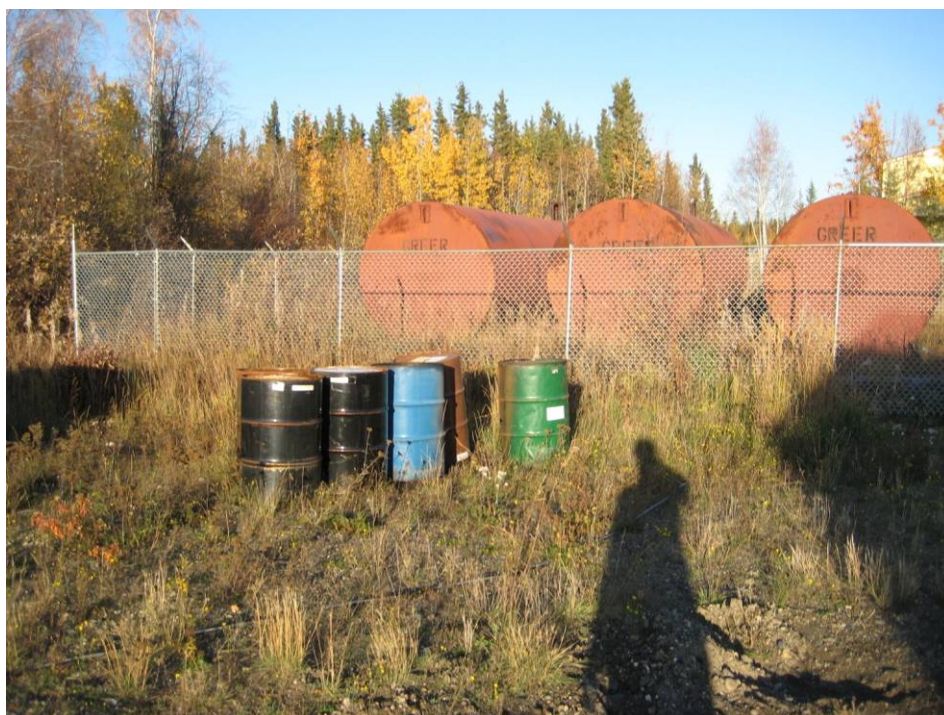
**Photograph 5:**  
Drum storage area west of BJU Tank Farm. Soil sample E-12 was collected at the base of one of the drums (September 2009).

and bulging 55-gallon drums being stored west of the tank farm. Stained soil was observed adjacent to the 55-gallon drums. (Figure 4 and Appendix E-2, Photographs 3-7)

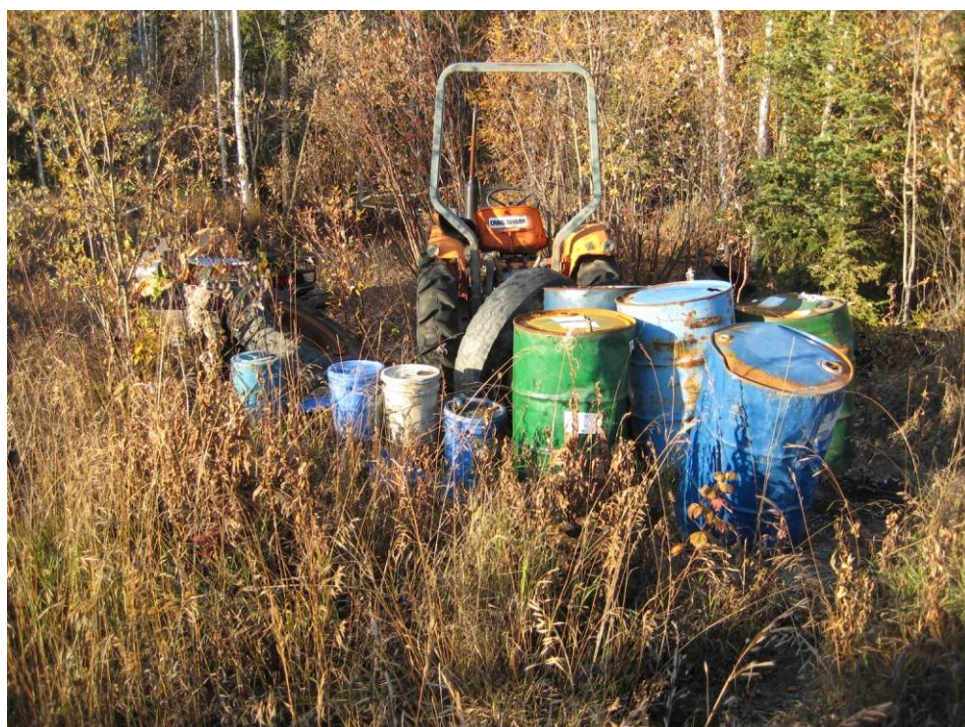
**Photograph 6:**  
Another bucket/drum storage area west of BJU Tank Farm (September 2009).

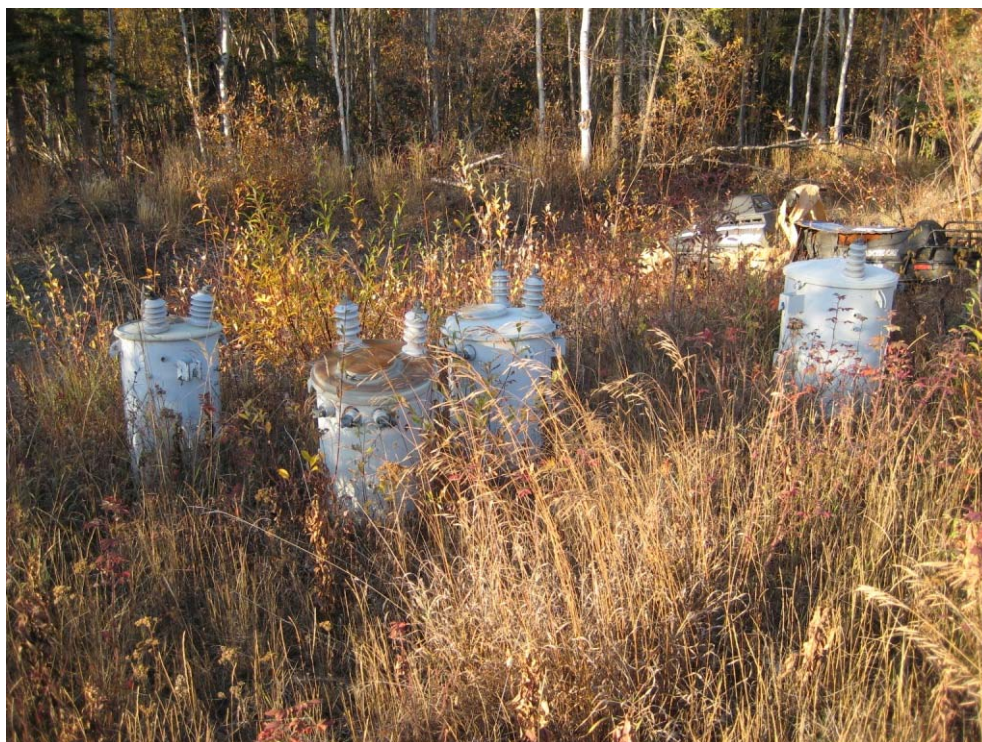
**Photograph 7:**  
Transformer storage west of BJU Tank Farm (September 2009).

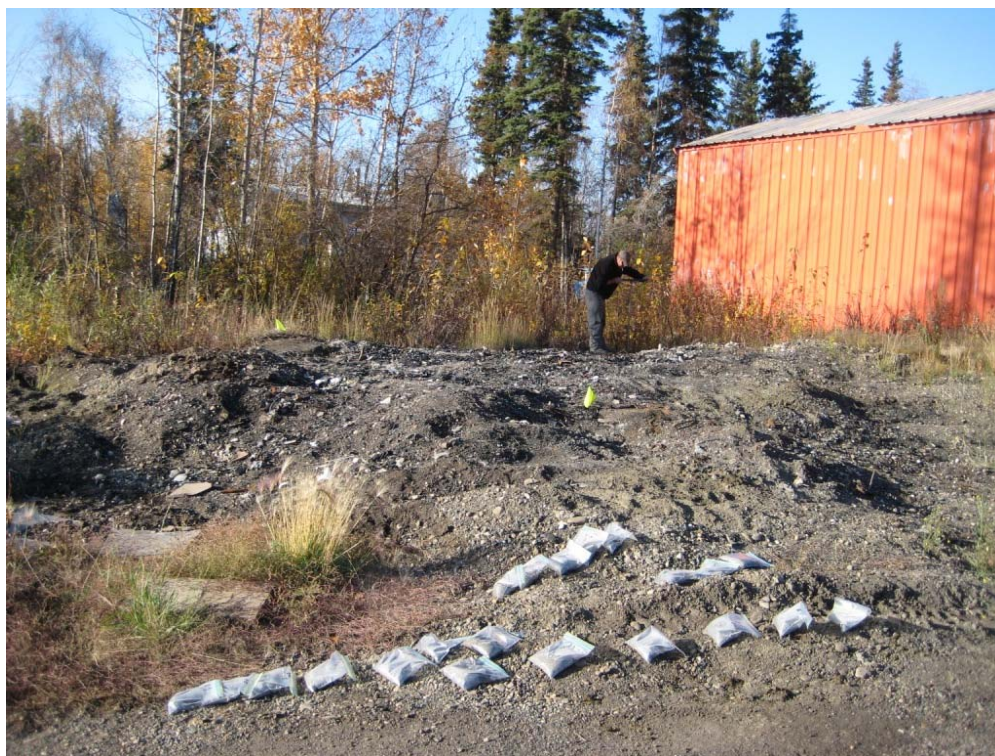
**Photograph 8:**  
Heating up field screening samples prior to taking readings with the photoionization detector. Hand-auguring is taking place in background. (September 2009).
