Brownfield Assessment

Former Chamai Center Assessment
and
Site Restoration Report
McGrath, Alaska

**FORMER CHAMAI CENTER ASSESSMENT
AND
SITE RESTORATION REPORT
MCGRATH, ALASKA**

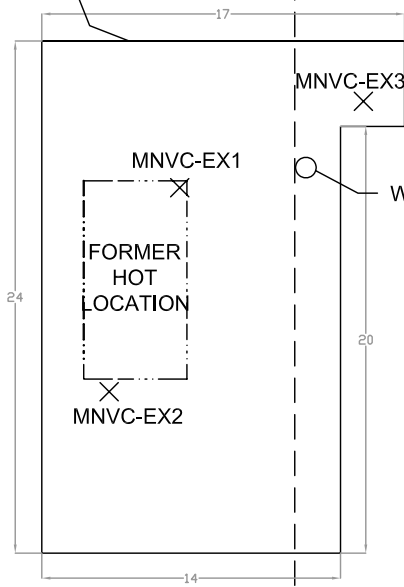
File Name McGrath RP Fig 2

APPROXIMATE EXCAVATION LIMITS

WATER SUPPLY STUB (CITY SUPPLY)

APPROXIMATE LOCATION OF THE FORMER CHAMAI CENTER

The general site layout was mapped, and work included using a hand-held global positioning system (GPS) receiver to locate key site features (Table 1). Facilities that were examined during the reconnaissance included a Quonset hut used for general storage, the HOT and associated stained soil, empty drums, and debris that was present at the site (Figure 2 and Appendix B).

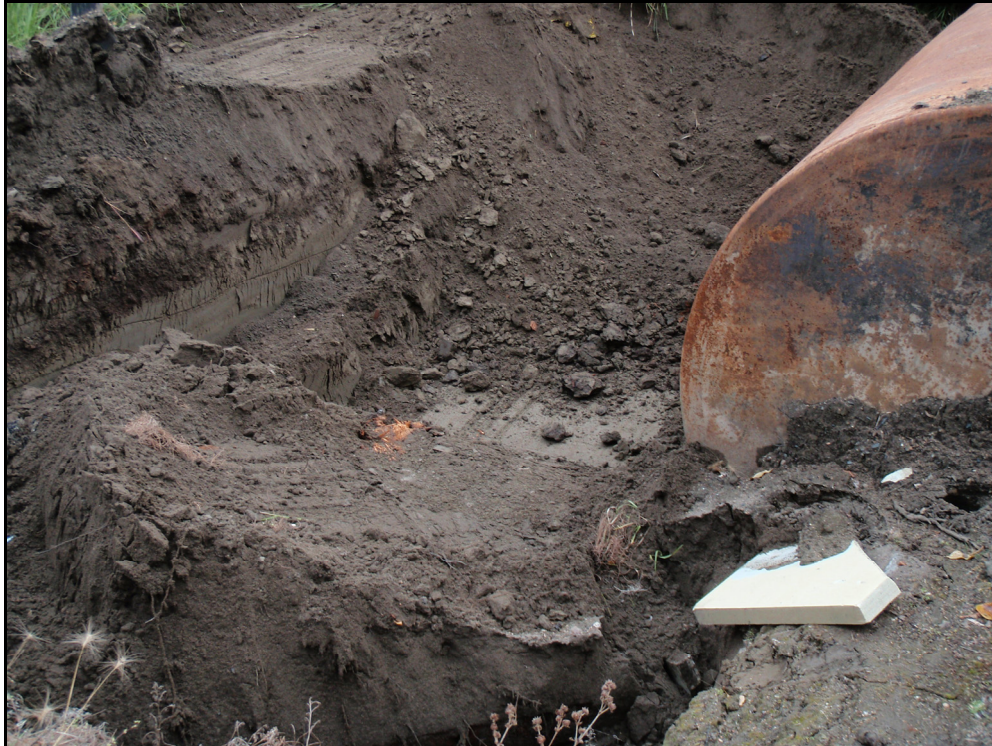
Photograph 1 – View of impacted soil being removed from around tank.

In order to remove the HOT, the soil above the top of the HOT that was visibly impacted by petroleum hydrocarbons, and had previously been disturbed during the building demolition, was excavated and placed directly into an end dump truck and hauled to the landspreading area located at the landfill. The HOT was then removed from the ground by the excavator and placed on the east side of the property. The HOT measured approximately 6.3 feet in diameter and 9.3 feet in length. Upon inspection, the HOT appeared to be in good condition. Surface rusting and some pitting were noted, but there were no holes or other signs of significant deterioration observed.

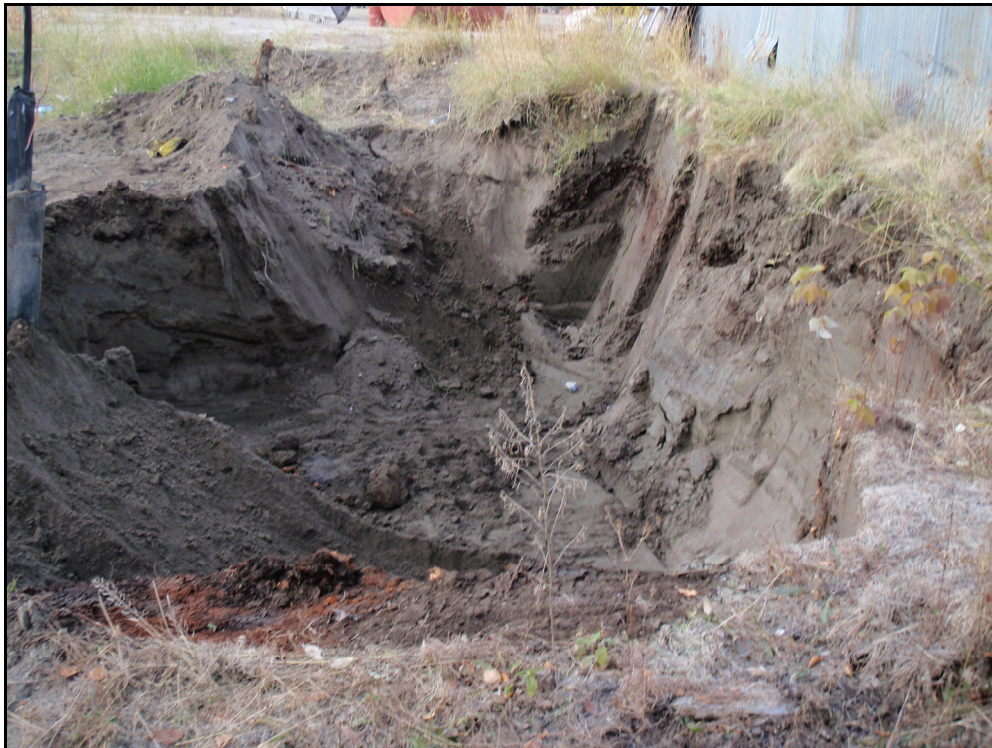
Photograph 2 – Completed excavation with tank removed.

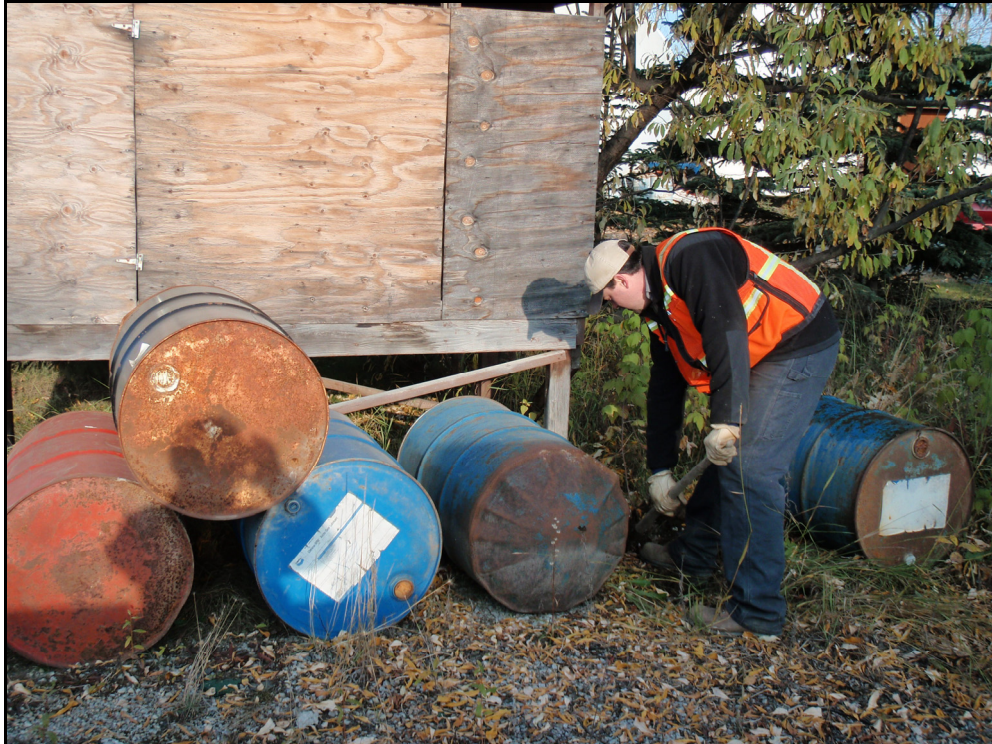
Photograph 3 – Soil sampling activities near empty drums.

One additional area of concern was noted during site characterization activities: five 55-gallon drums stacked near the property boundary (Figure 2). Two PID field screening samples were

collected from beneath the barrels at approximately 6 inches bgs. The PID field screening results did not indicate hydrocarbon impacts to soil, and soil staining was not present. No samples were collected for laboratory analysis from this area.

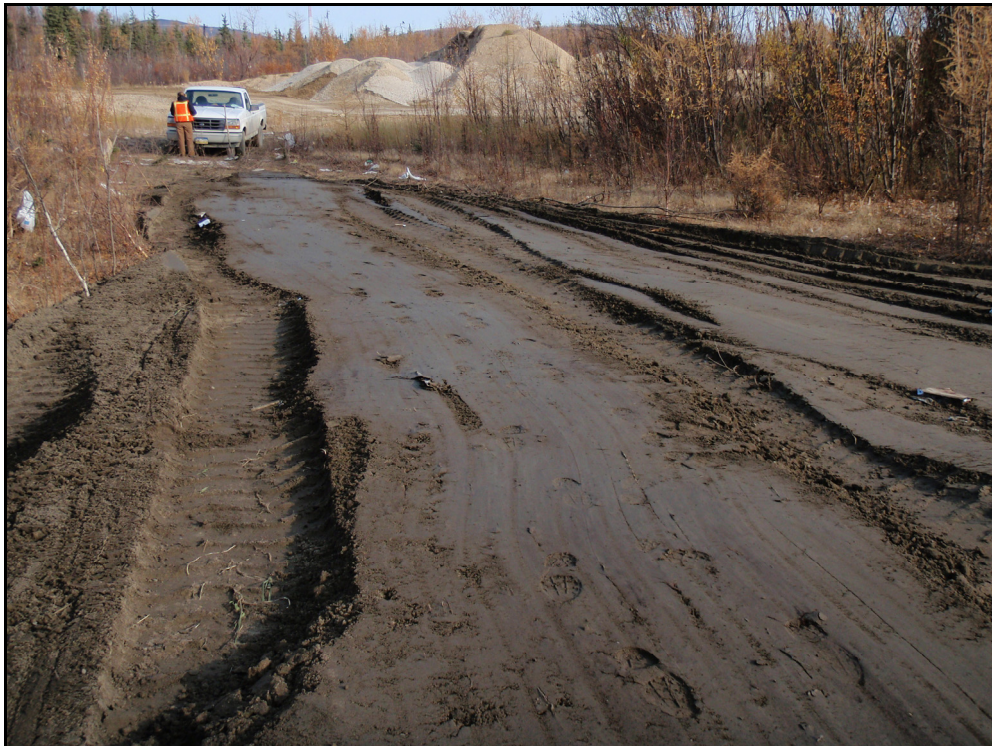
Photograph 4 – View of land spreading area at local landfill.
