FORMER ALASKA PACKERS CANNERY SITE CHARACTERIZATION REPORT

September 30, 2008

Alaska Department of Environmental Conservation

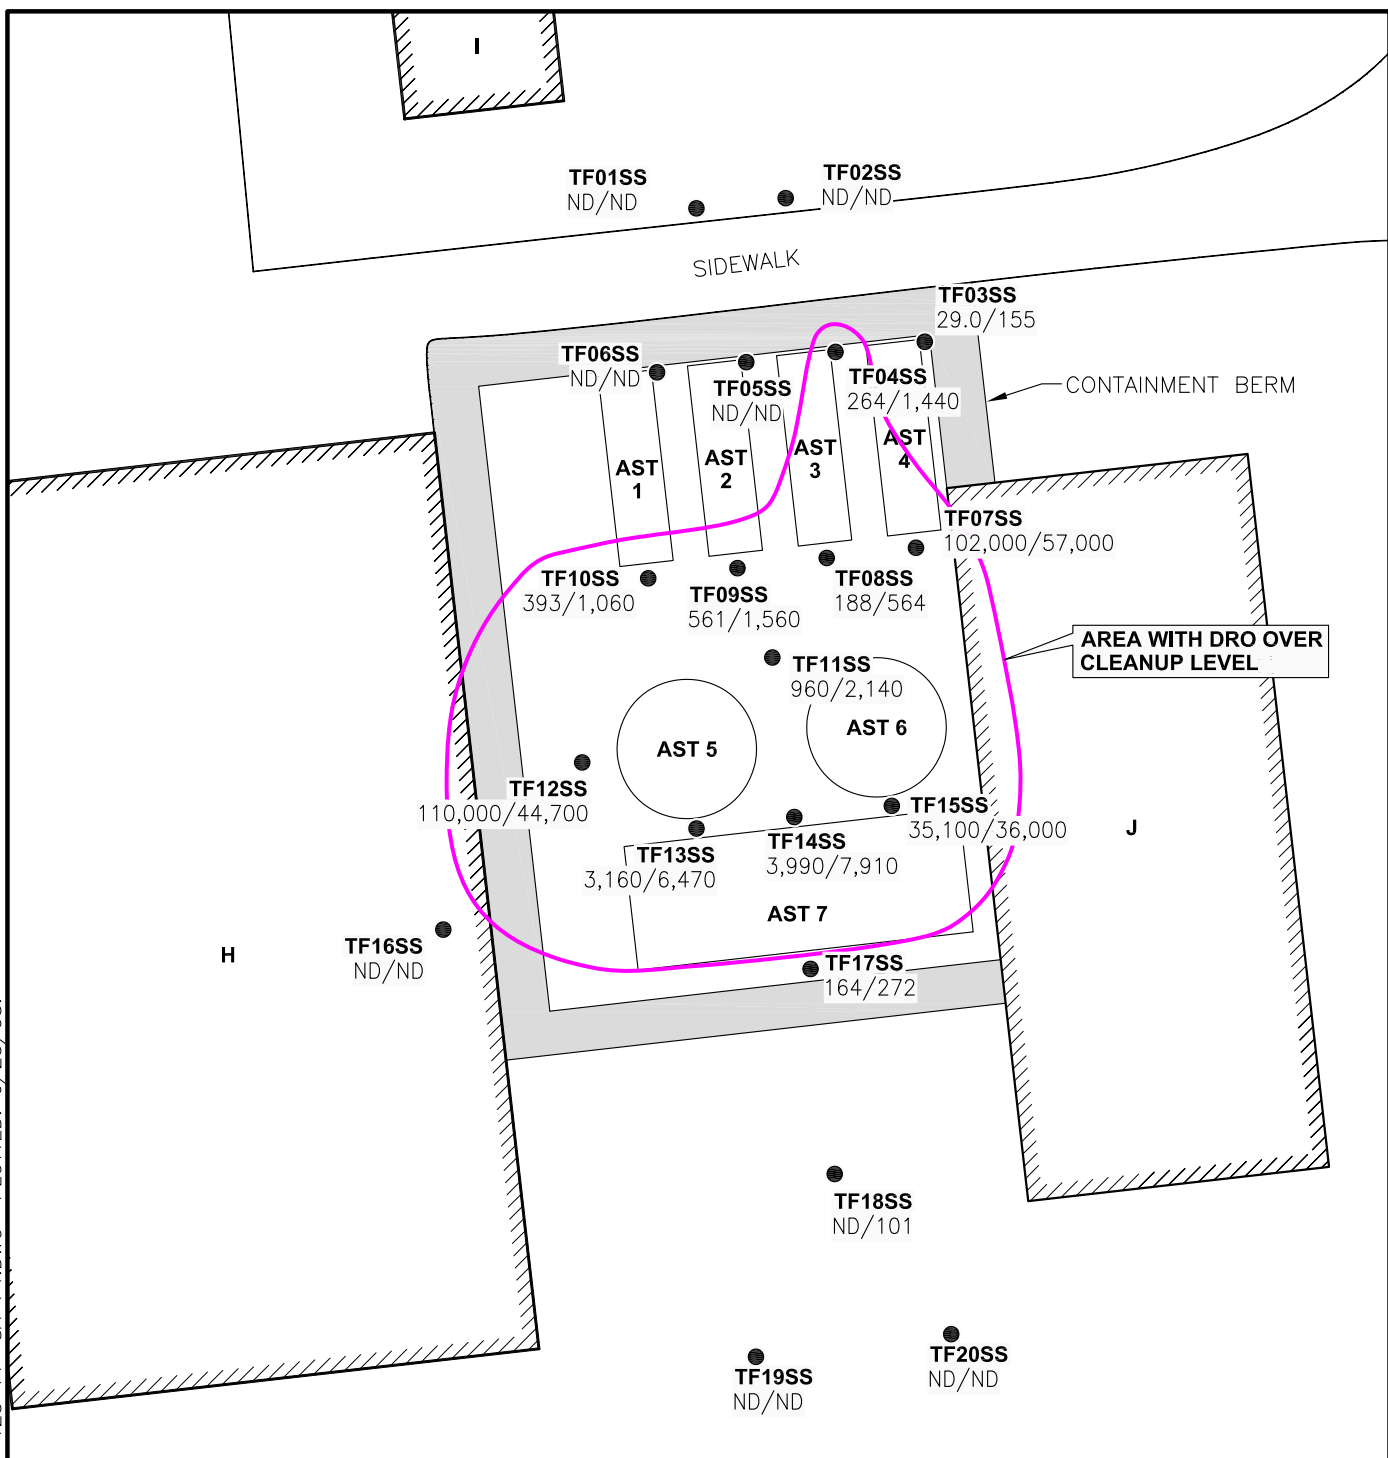
DATE: JUNE 2008	TANK FARM SOIL SAMPLE LOCATIONS	FIGURE 4
	CHKD: N.R.M.		
	DRAWN: C.E.H.		
	PROJ. No.: 14-123	SITE CHARACTERIZATION WORK PLAN Pilot Point, Alaska	
	825 W. 8th Ave., Anchorage, AK 99501, (907) 258-4880

Hydrocarbon contamination was found in various areas of the tank farm. DRO exceeded the ADEC cleanup level of 250 mg/kg at nine locations (Figure 4). Exceeded concentrations ranged from 264 mg/kg in TF04SS to 110,000 mg/kg in TF12SS (Table 2). A duplicate sample taken at this location had a DRO concentration of 134,000 mg/kg. RRO exceeded the ADEC cleanup level of 11,000 mg/kg at three locations: TF07SS, TF12SS, and TF15SS. Concentrations at these locations were 57,000, 44,700, and 36,000 mg/kg, respectively. GRO was not detected above the cleanup level in the tank farm area. Benzene was detected above the ADEC cleanup level of 0.02 mg/kg at nine locations. Exceeded concentrations ranged from 0.153 mg/kg in TF13SS to 0.615 mg/kg in TF07SS. Toluene, ethylbenzene, and total xylenes were not detected above their respective cleanup levels. PAHs were analyzed in TF12SS and TF14SS (Table 2). At TF12SS, naphthalene, acenaphthene, fluorene, benzo(a)anthracene, and benzo(a)pyrene exceeded their respective ADEC cleanup levels (Table 2). At TF14SS, benzo(a)pyrene exceeded the ADEC cleanup level (Table 2).

BUILDINGS WITH IDENTIFIER
TF17SS ●	SOIL SAMPLE LOCATION
164/272 →	RESIDUAL-RANGE ORGANICS (mg/kg)
→	DIESEL-RANGE ORGANICS (mg/kg)

Recommendation: In order to estimate the total volume of soil requiring excavation to meet ADEC cleanup levels, subsurface soil should be sampled to determine the vertical extent of the impacts.

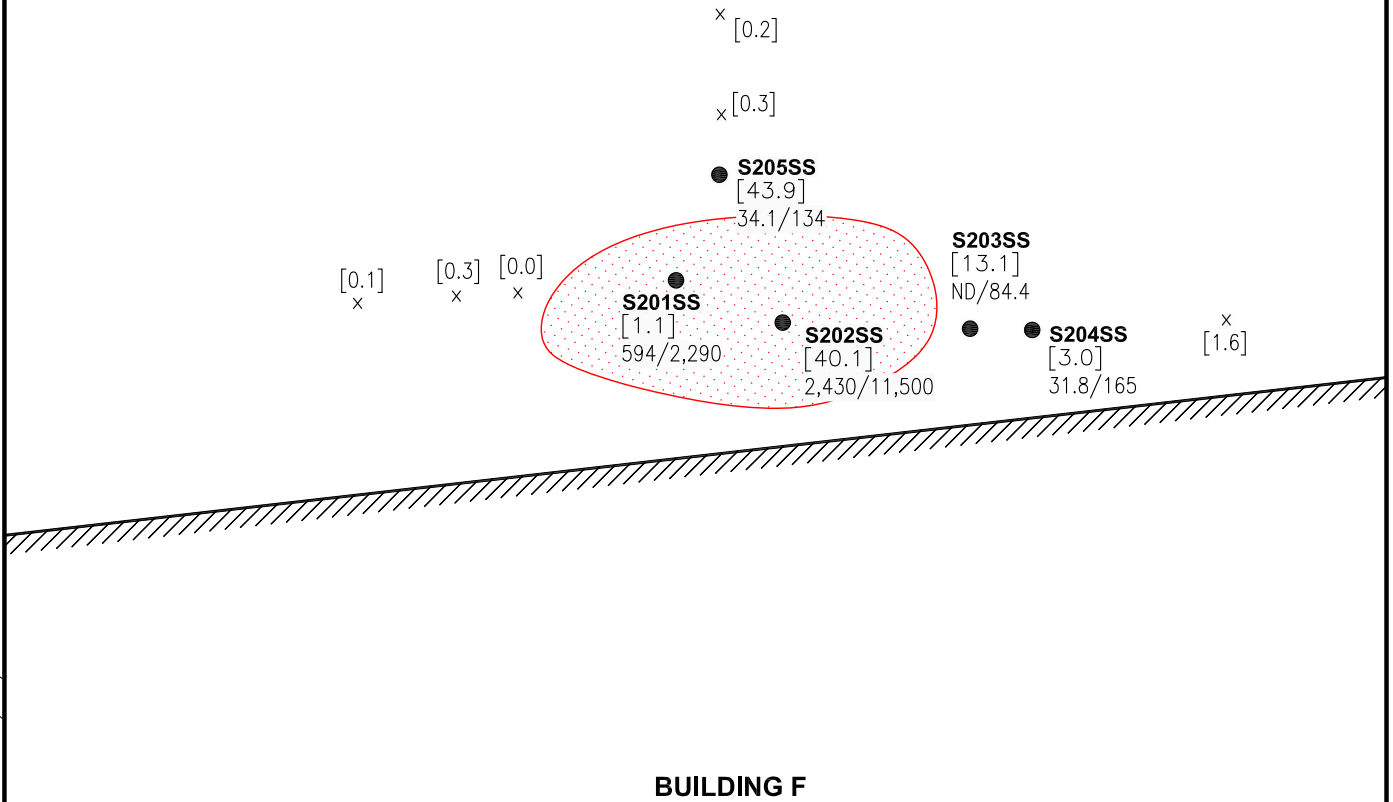
FIGURE
5

Ten surface soil samples were collected at the stained areas. Sample locations were based on high PID screening results. DRO exceeded the cleanup level at six locations. Concentrations ranged from not detected (ND) to 8,570 mg/kg at S101SS. RRO exceeded the cleanup level at five locations. Concentrations ranged from ND to 44,300 mg/kg at S101SS. GRO and BTEX were not detected in the stained areas. PAH was analyzed at S101SS, but none of the constituents exceeded their respective cleanup levels.

EXPLANATION	
	AREAS OF HYDROCARBON STAINING
S204SS ●	SOIL SAMPLE LOCATION
[0.1] x	PHOTOIONIZATION DETECTOR (PID) READING (ppm)
31.8/165	RESIDUAL-RANGE ORGANICS (mg/kg)
←	DIESEL-RANGE ORGANICS (mg/kg)

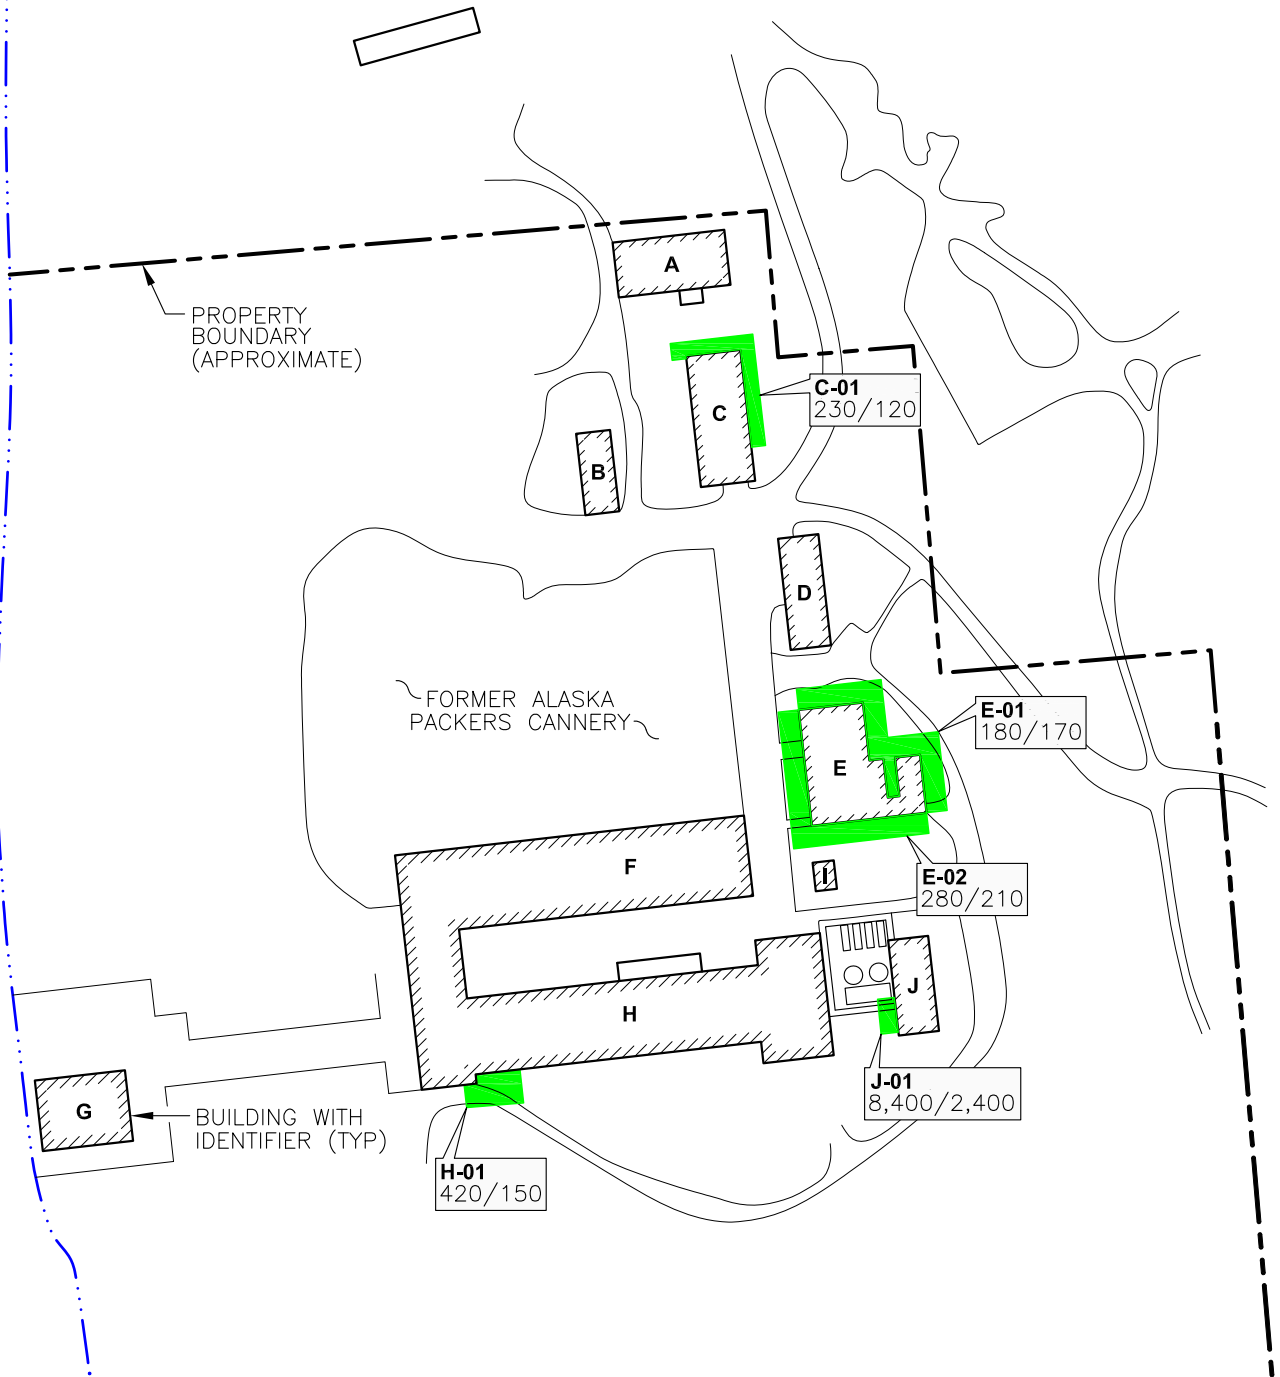
EMI concluded that significantly elevated soil lead levels were found around Buildings C, E, J, and H. Building E was almost entirely coated with LBP and had paint chips under the drip lines and windows. LBP soil samples were collected from the soils around these four buildings. A total of 83 tests were completed.

BUILDINGS WITH IDENTIFIER
	AREA OF COMPOSITE SAMPLING
230/120	← DUPLICATE COMPOSITE SAMPLE RESULT (mg/kg)
←	COMPOSITE SAMPLE RESULT (mg/kg)

Recommendation: Remove of lead contaminated soil at Building H by placing soil in an approved container and shipping to a disposal facility. Assuming that this site would be used as an industrial site, no further action may be needed at Building H.

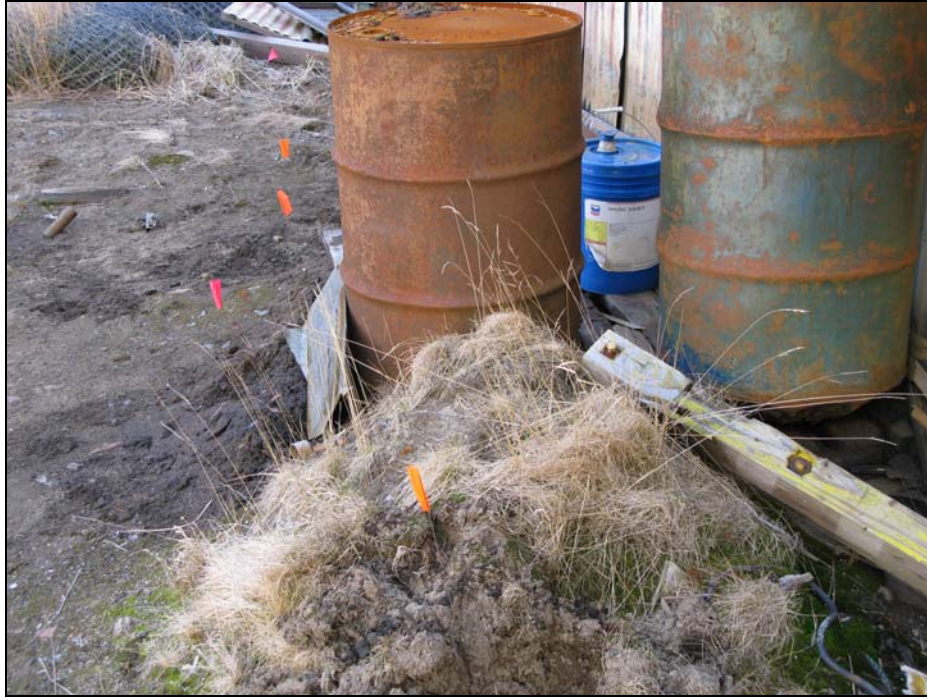
A second area of significant staining was located between Buildings F and H. Two 55-gallon drums and one 5-gallon bucket partially filled with waste oil were observed in the immediate vicinity of the stained soil. Nine PID screening samples were taken to determine horizontal extent of staining (Figure 6). Concentrations ranged from 0.0 to 7.2 ppmv. Five confirmation samples and one duplicate sample were collected for laboratory analysis from locations with the highest PID readings. Soils in this area also consisted of silty sand with some organics.

PHOTOGRAPH 1. TWO 55-GALLON DRUMS AND ONE 5-GALLON BUCKET PARTIALLY FILLED WITH OIL LOCATED BETWEEN BUILDINGS F AND H. RED FLAGS SHOW LOCATIONS OF SOIL SAMPLES.

Recommendations: Drums of known and unknown chemicals should be characterized and removed from the site. Used car batteries should also be disposed of. Leaking oily substances should be contained and cleaned up.

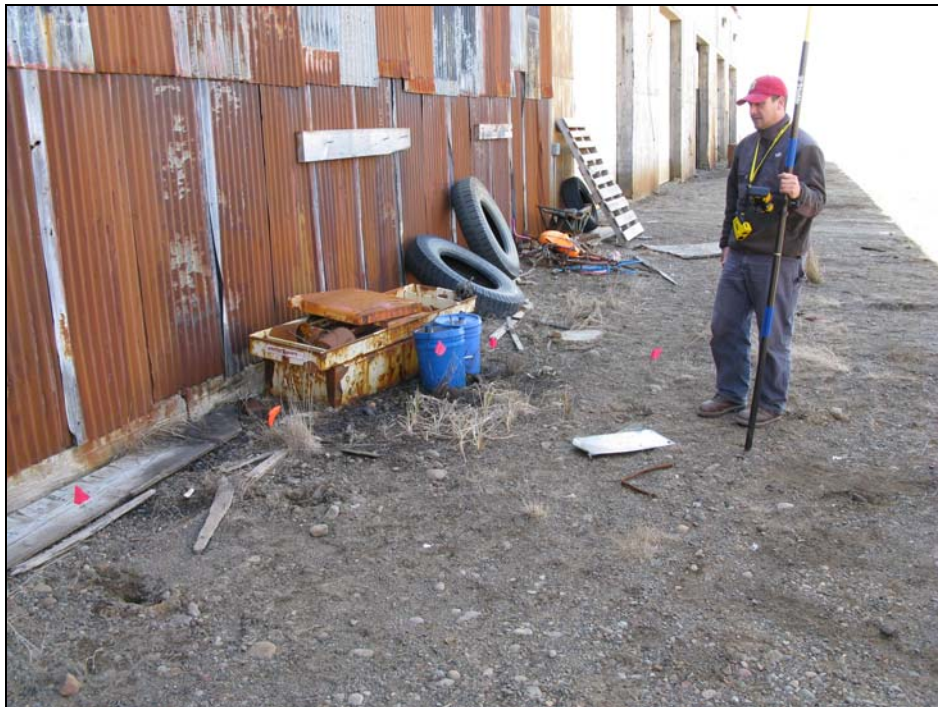
Several areas of hydrocarbon staining were observed on the subject property. One area of hydrocarbon staining was observed adjacent to and north of Building F. OASIS field personnel observed two 5-gallon buckets of waste oil in this area. PID screening samples were taken at 11 locations to determine the horizontal extent of contamination (Figure 5). Concentrations ranged from 0.0 to 43.9 ppmv. Five confirmation samples and one duplicate sample were collected at locations with the highest PID readings for laboratory analysis. Soils in this area consisted of silty sand with some organics.

PHOTOGRAPH 2. TWO 5-GALLON BUCKETS FILLED WITH USED OIL LOCATED NEXT TO TRUCK BED TOOL BOX CONTAINING PARTIALLY FILLED AND EMPTY PAINT CANS. NORTH OF BUILDING F. RED FLAGS SHOW LOCATIONS OF SOIL SAMPLES.

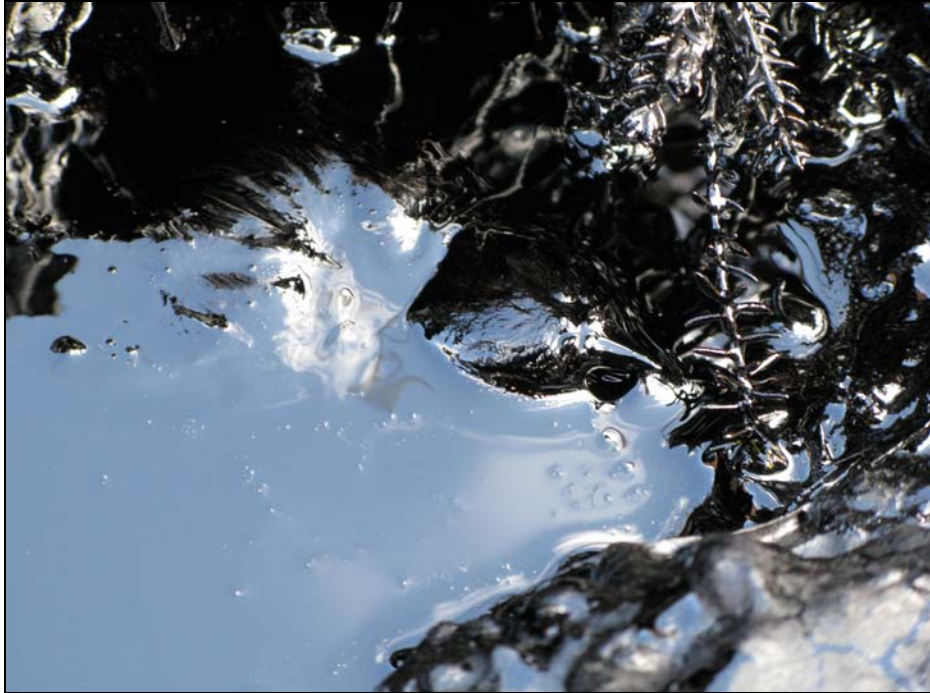
PHOTOGRAPH 3. A RUPTURED AND EXPOSED UST LEAKED HEAVY OIL TO SURROUNDING AREAS. THIS LIVE BIRD WAS FOUND TRAPPED IN THE OIL.

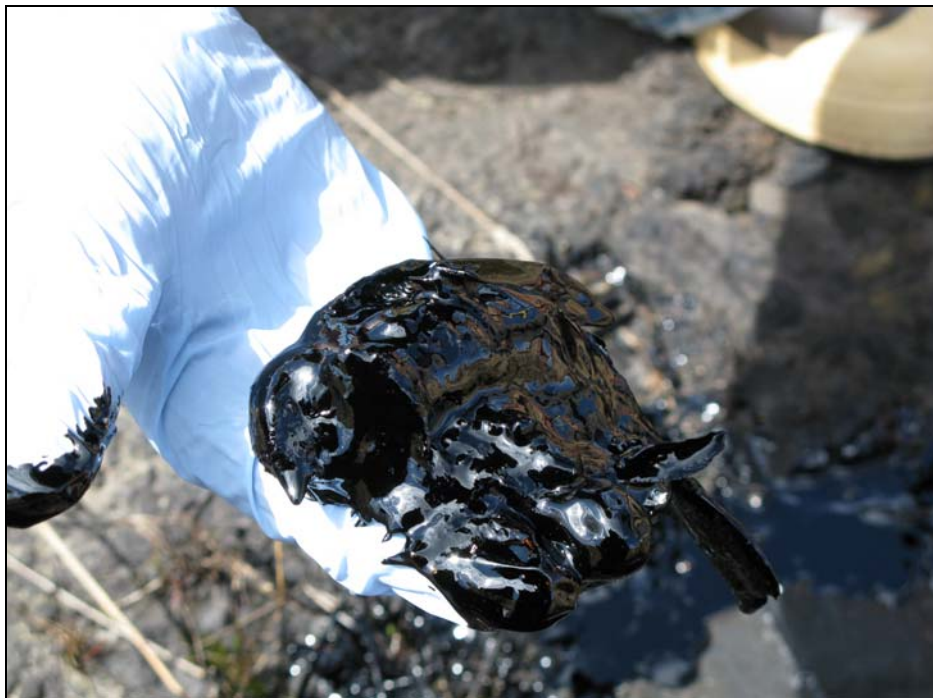
PHOTOGRAPH 4. CLOSE-UP OF LIVE BIRD FOUND IN HEAVY OIL. SPECIES TYPE WAS NOT POSITIVELY IDENTIFIED.

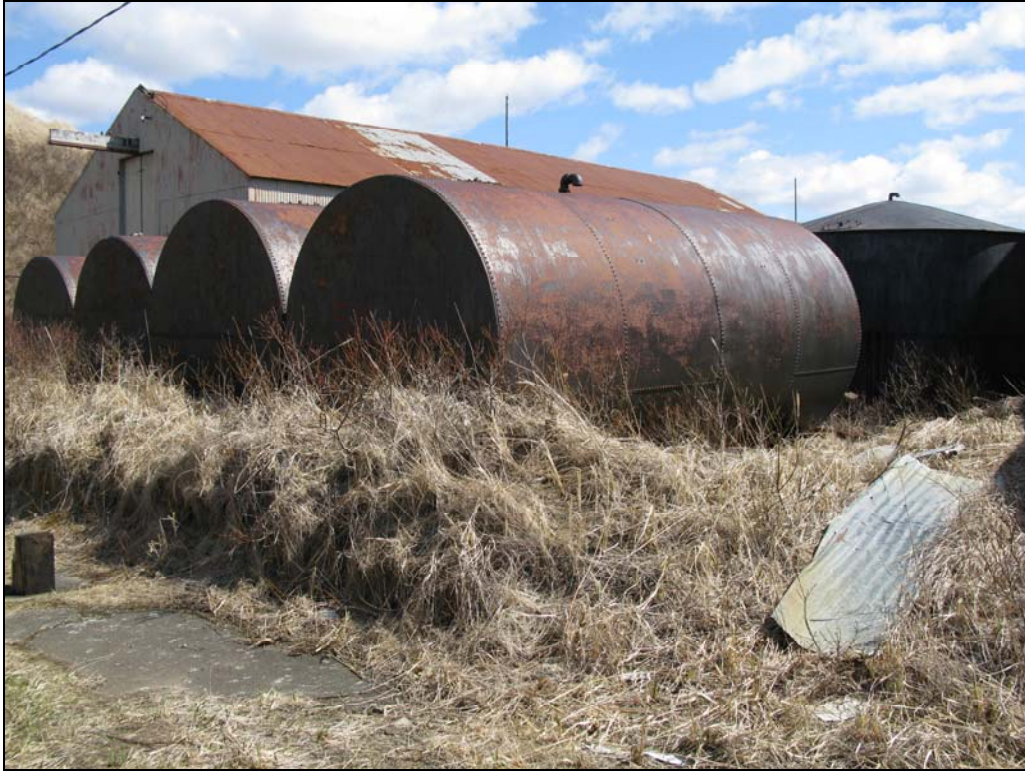
The tank farm area is located between Buildings H and J. Seven aboveground storage tanks (ASTs) exist in this area and are enclosed by a 2- to 3.5-foot-high berm. Heavy hydrocarbon staining was observed within the entire bermed area. OASIS field personnel noticed that several holes exist at the bottom of the horizontally orientated tanks (ASTs 1, 2, 3, and 4) and that all the tanks appeared to be empty. Soils consisted of gravelly sand.

PHOTOGRAPH 5. TANK FARM AREA LOOKING SOUTH AT ASTS 1, 2, 3, AND 4.

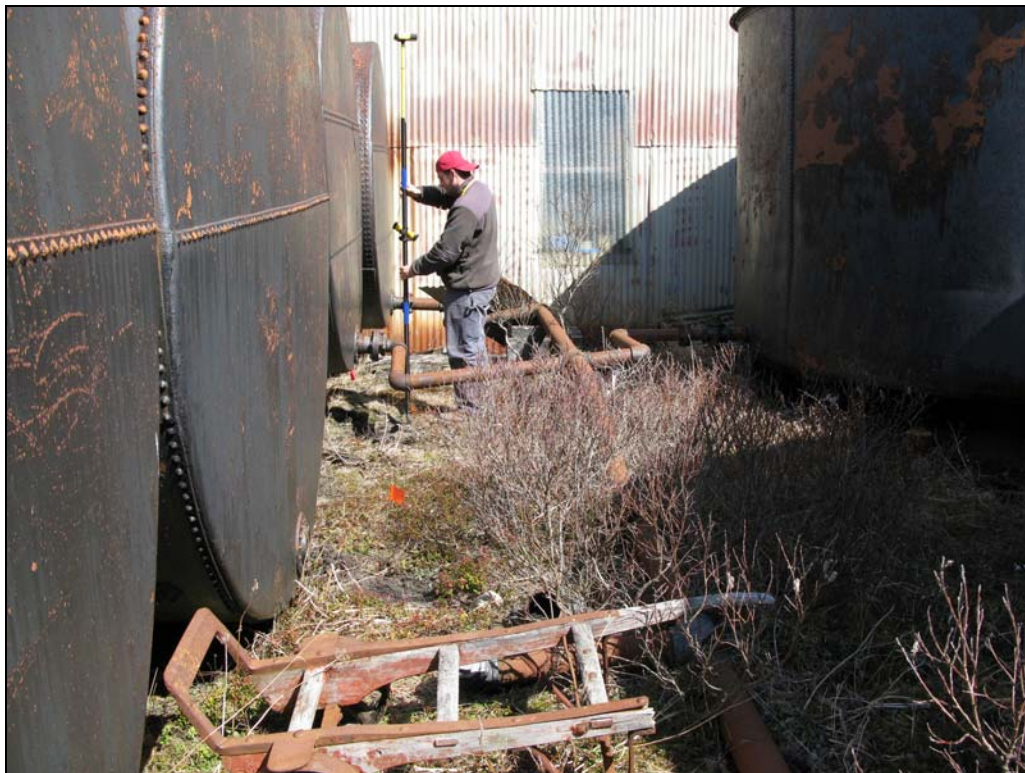
PHOTOGRAPH 6. WITHIN THE TANK FARM AREA BETWEEN ASTS 1, 2, 3, AND 4 ON THE NORTH SIDE (LEFT SIDE OF PICTURE) AND AST 6 ON THE SOUTH SIDE (RIGHT SIDE OF PICTURE). RED FLAGS SHOW LOCATIONS OF SOIL SAMPLES.

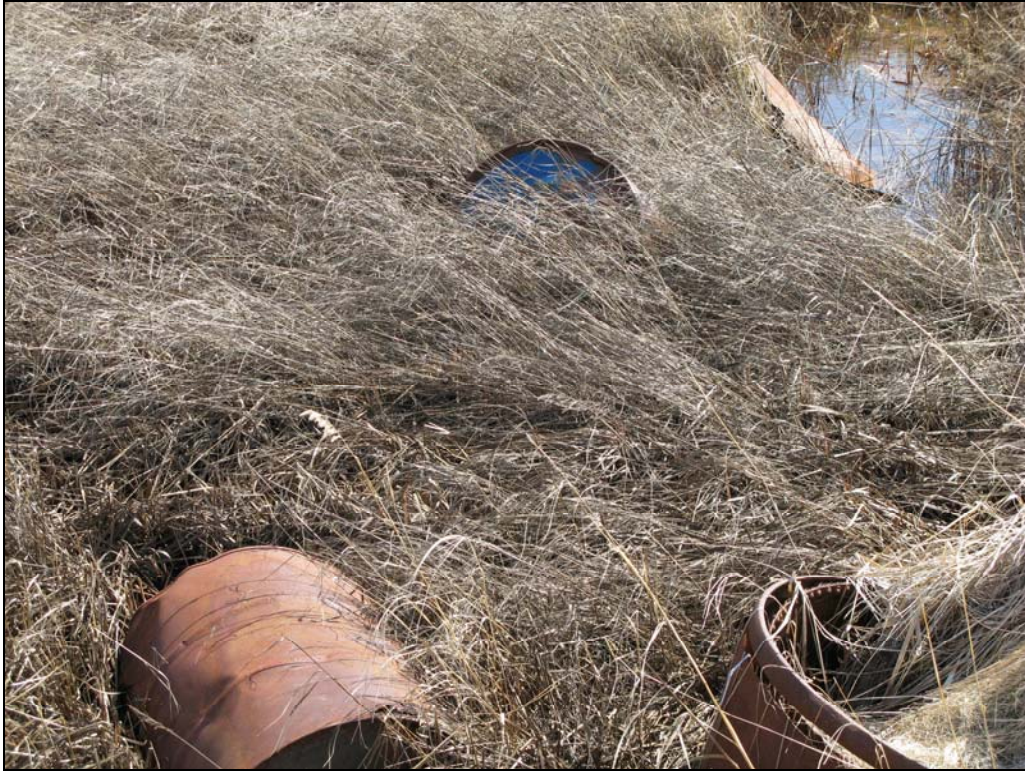
- Several 55-gallon drums in varying stages of decay are located south of Building H in wetland area near a tidal lagoon.
- Waste oil and miscellaneous substance storage was found inside Building H. There is extensive staining on wood plank floor.

PHOTOGRAPH 7. SEVERAL 55-GALLON DRUMS IN VARYING STAGES OF DECAY SOUTH OF BUILDING H.

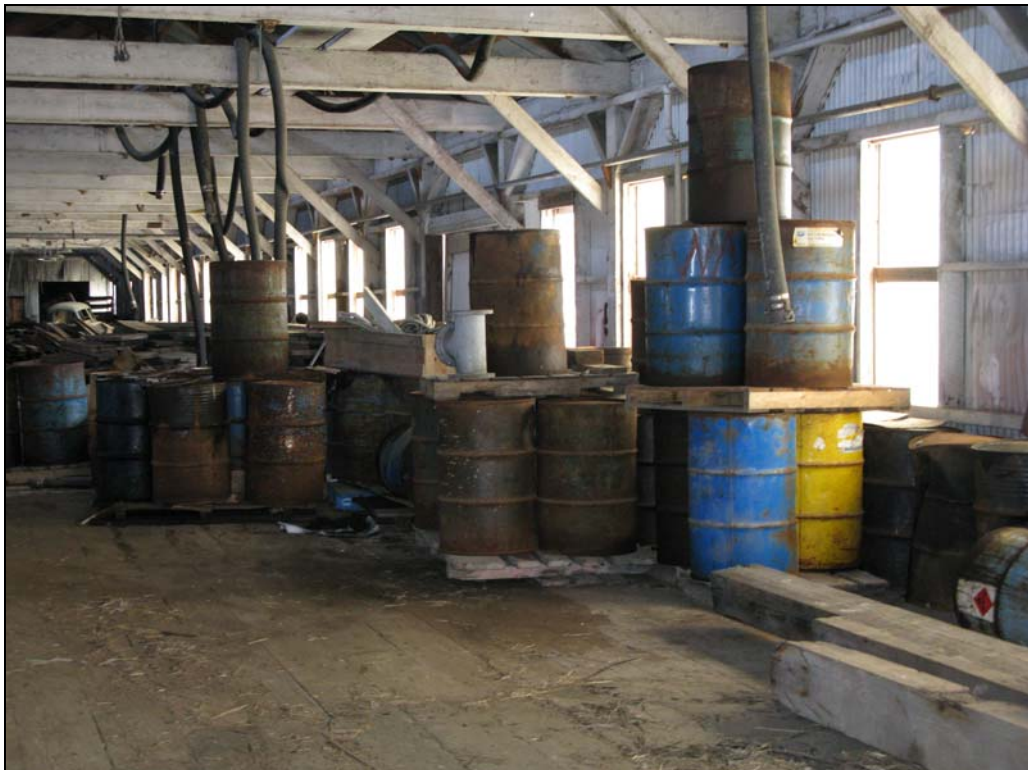
PHOTOGRAPH 8. WASTE OIL AND MISCELLANEOUS SUBSTANCE STORAGE INSIDE BUILDING H.

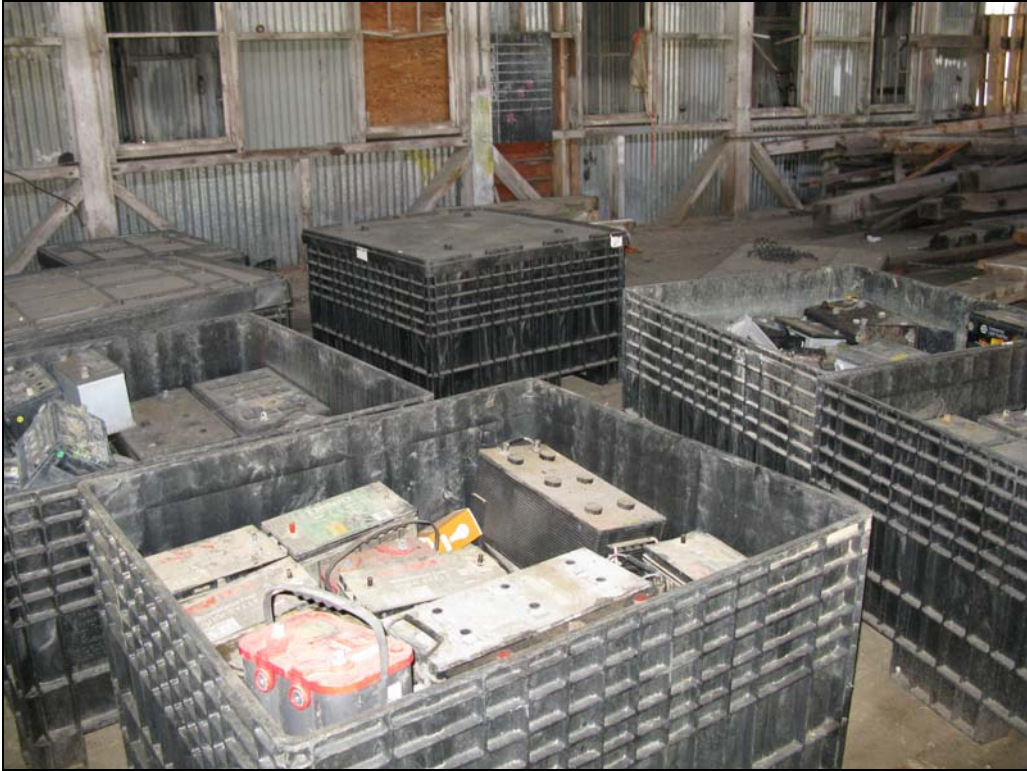
PHOTOGRAPH 9. DISCARDED BATTERY STORAGE IN BUILDING H.

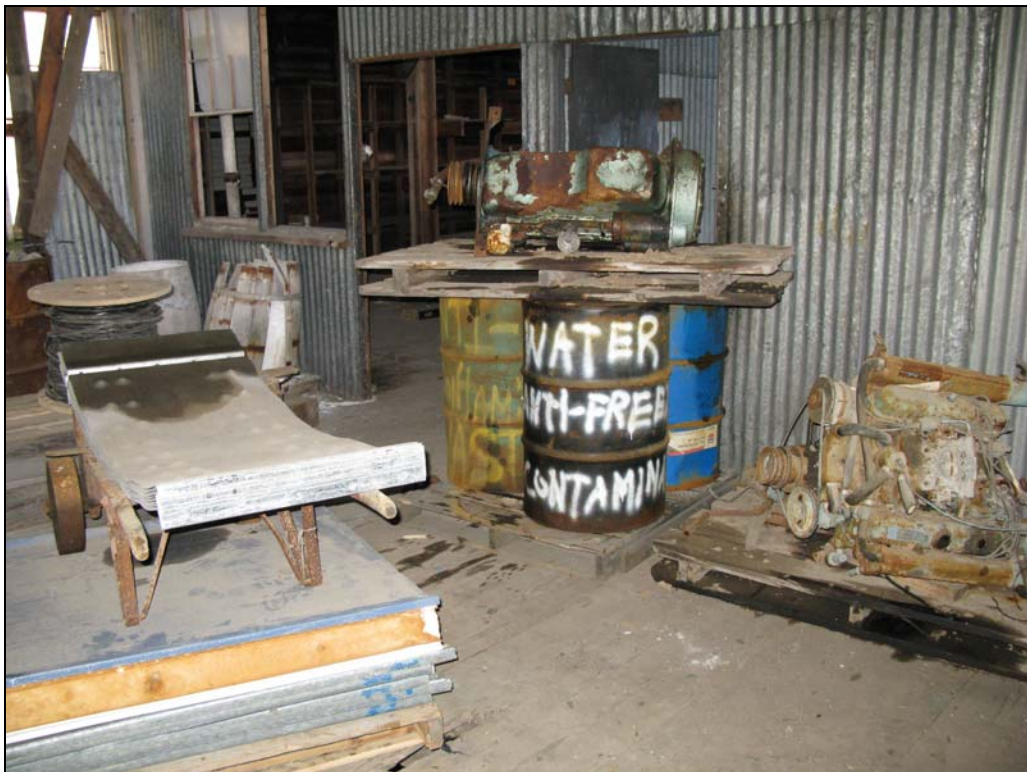
PHOTOGRAPH 10. THREE 55-GALLON DRUMS INSIDE BUILDING H, TWO DRUMS ARE LABELED "WATER, ANTI-FREEZE, CONTAMINATED," AND ONE HAS UNKNOWN CONTENTS.

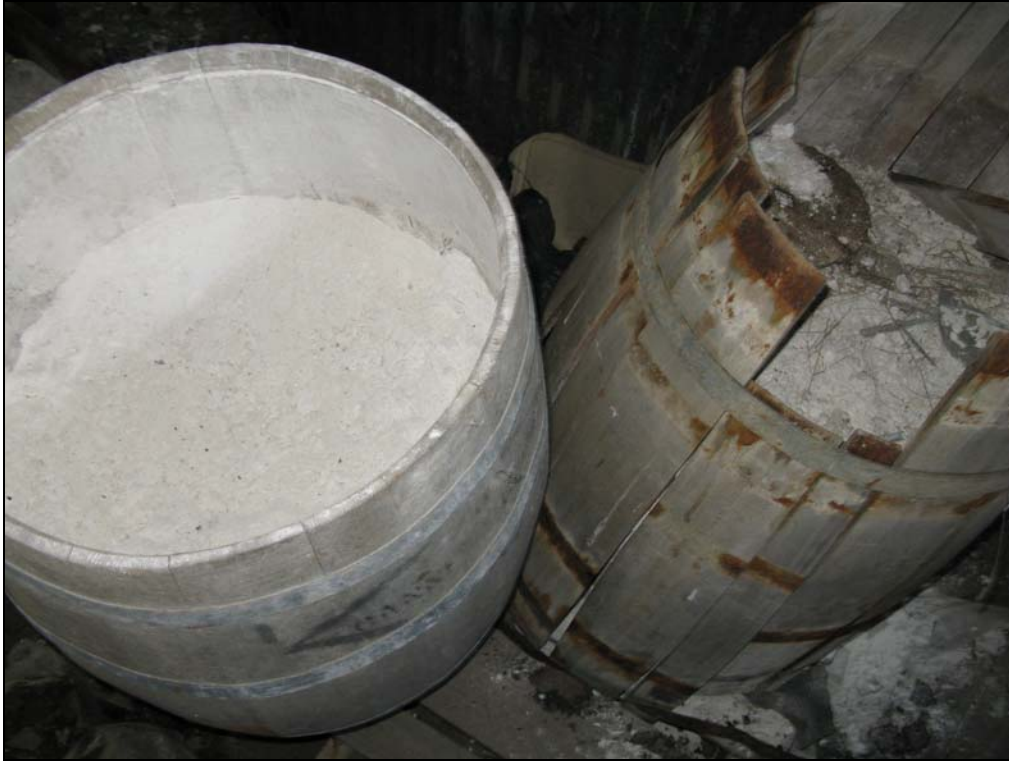
PHOTOGRAPH 11. TWO WOODEN BARRELS LOCATED INSIDE BUILDING H THAT CONTAIN UNKNOWN WHITE SUBSTANCE. ONE OF THE BARRELS IS SEVERELY DETERIORATING AND SPILLING THE WHITE SUBSTANCE ONTO THE FLOOR.

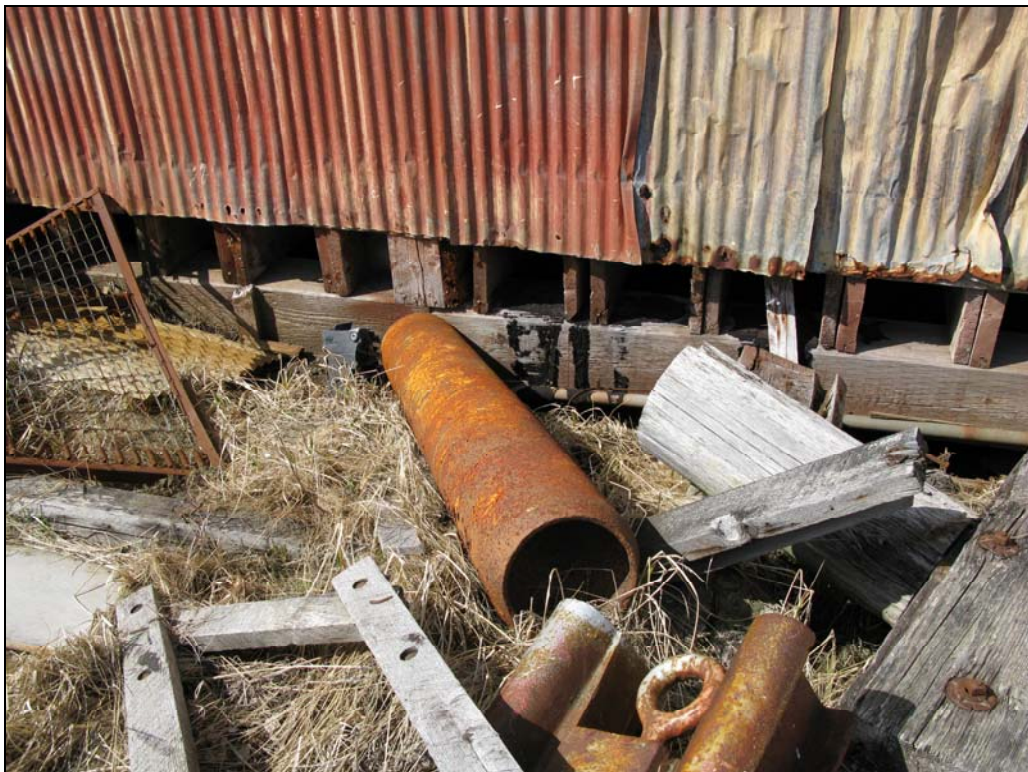
- The boiler/furnace room at the far east side of Building H has 1 to 3 inches of oil on entire floor.
- Oily substances appear to be leaking from Building H onto the ground, possibly originating from similar substances within the building.

PHOTOGRAPH 12. OILY SUBSTANCES LEAKING FROM BUILDING H THAT PROBABLY ORIGINATED FROM WITHIN THE BUILDING.

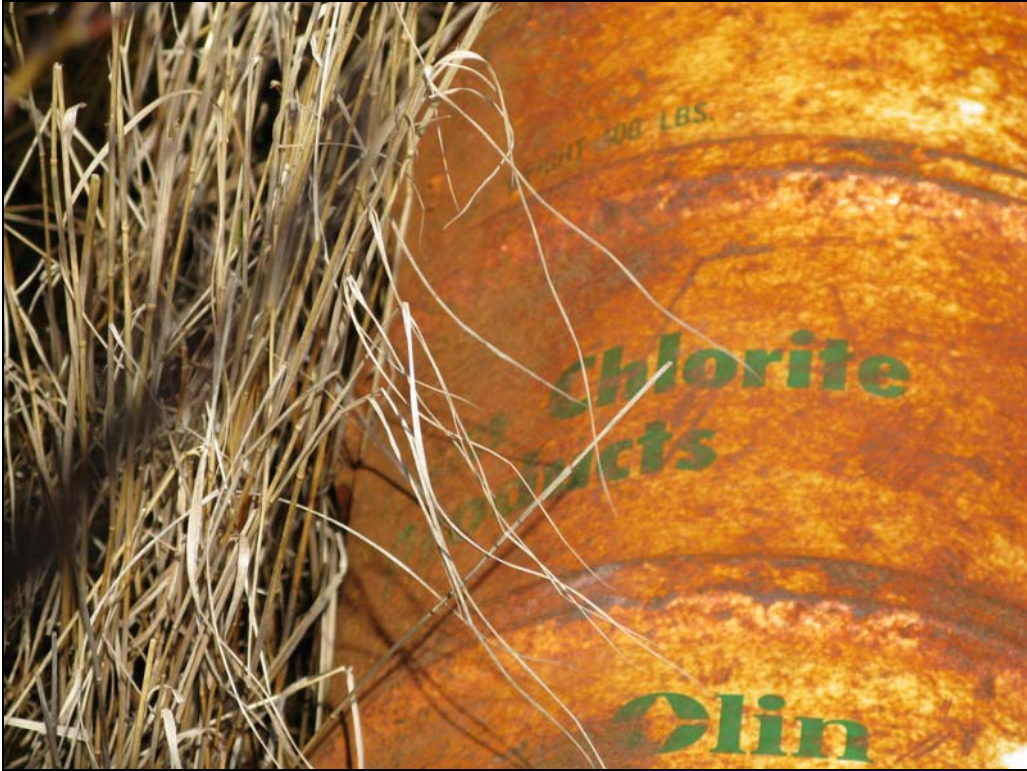
- The tundra/wetland area just south and adjacent to Building H contains 55-gallon drums with unknown volumes of unknown substances. One of the drums was labeled as containing a chlorite product. Several discarded and broken batteries were also observed in this area.

PHOTOGRAPH 13. DRUM LABELED AS CONTAINING CHLORITE PRODUCTS LOCATED WITHIN THE WETLAND AREA SOUTH AND ADJACENT TO BUILDING H.

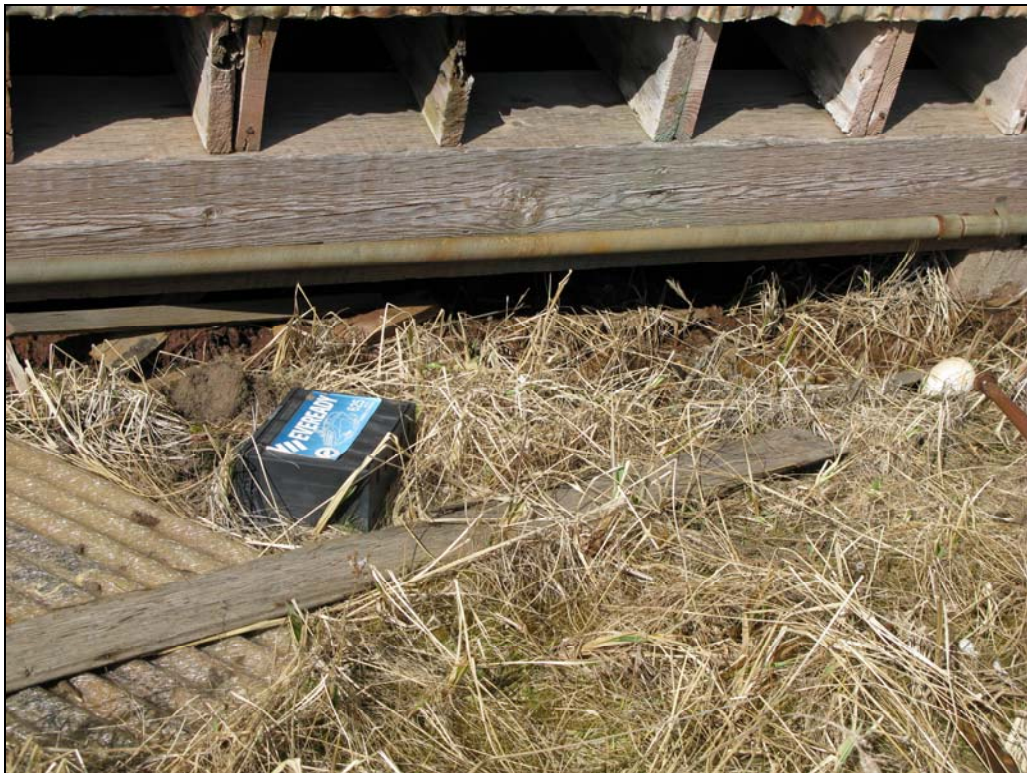
PHOTOGRAPH 14. DISCARDED BATTERY LOCATED ADJACENT TO BUILDING H.
