## Phase I Environmental Site Assessment Report

*Former Alaska Packers Cannery*  
Pilot Point, Alaska

By:  
Hart Crowser, Inc  
June 26, 2007

***June 2007  
8969-03***

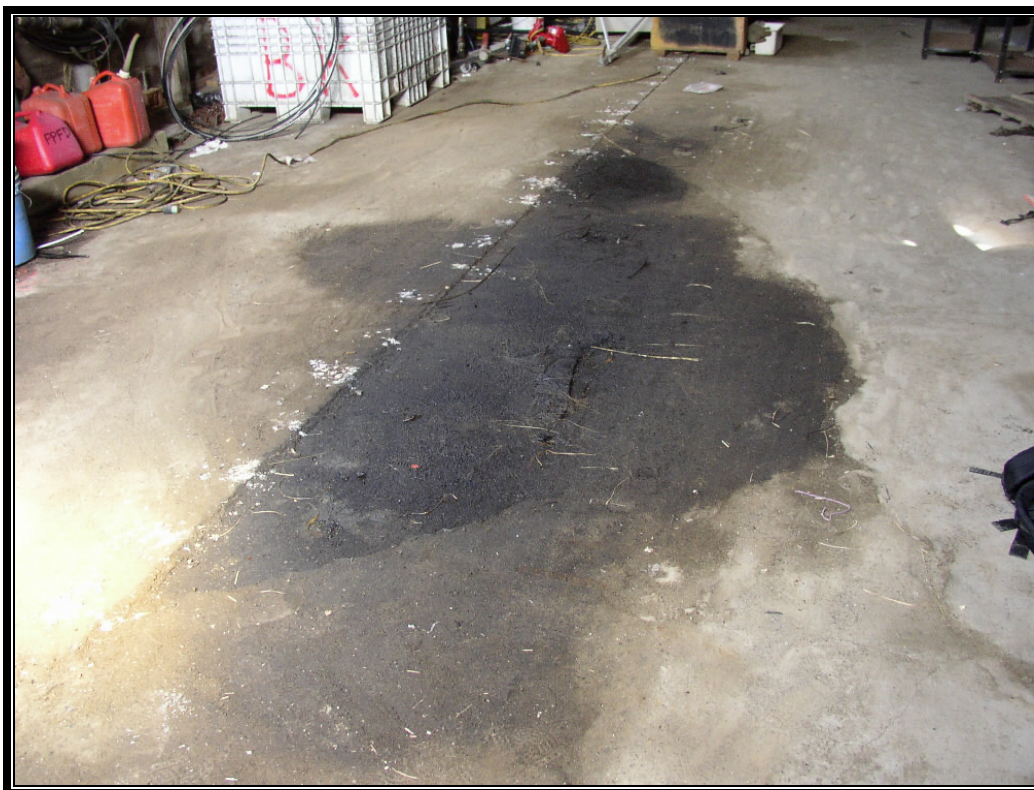
Hydrocarbon staining was also noted on the concrete floor of the Former Provision Warehouse (Building C), the Former North Main Cannery Building (Building F), and the Former South Main Cannery Building (Building H) (Appendix C; Pages C-1 and C-15). The staining on the floor in Building C appears to have traveled down the expansion joint in the concrete.

Photograph 2: Petroleum staining on concrete floor inside the Former Provision Warehouse (Building C).

- Hydrocarbon stains on the concrete floors of several buildings were noted during the site visit. Hart Crowser recommends sampling the soils under the flooring in areas where the petroleum products have obviously migrated down an expansion joint or crack in the concrete floor.

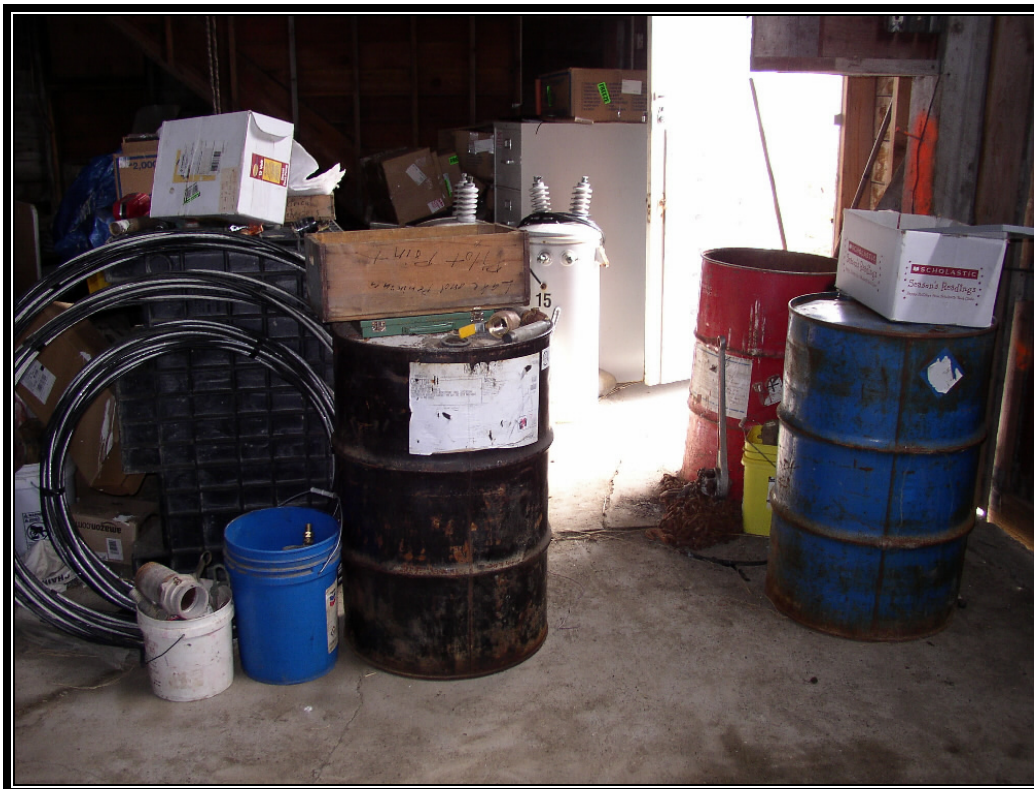
**Miscellaneous 55-Gallon Drums.** Several 55-gallon drums with various contents were noted on the subject property. A partially full drum of mineral spirits (Petroleum Distillates, UN1268) was noted inside the Former Provision Warehouse (Building C). Two partially full drums of oil were also found inside the Former Provision Warehouse, one with approximately 20 gallons of heating oil and the other with approximately 25 gallons of transformer oil that was labeled “does not contain PCBs.” Two empty, rusted drums were noted outside Building I. Stained soils were not noted in the vicinity of these drums. Approximately 20 rusted 55-gallon drums were found in the marsh to the south of the tank farm. Markings or other identifying features were not visible on the drums. It is possible that there are more drums in this area that have been covered by vegetation and were not visible at the time of the site visit. Several 55-gallon drums were found inside both of the main cannery buildings (Building F and Building H). The conditions of these drums varied, some were in good condition and others were rusted, some were empty and others were partially full. Some leaks were noted on the floor in Building F near these drums.

Photograph 3: Fifty-five-gallon drums of various fluids found inside the Former Provision Warehouse (Building C).

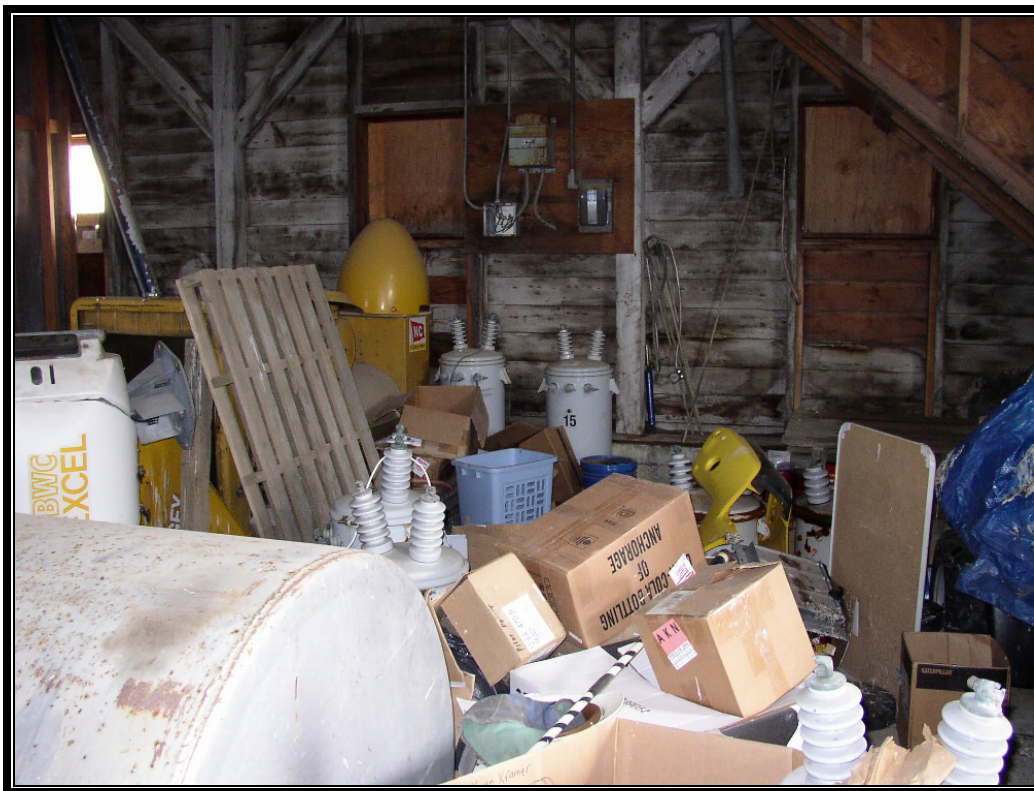
Photograph 4: Electrical transformers, aboveground storage tank, and miscellaneous items stored inside the Former Provision Warehouse (Building C).

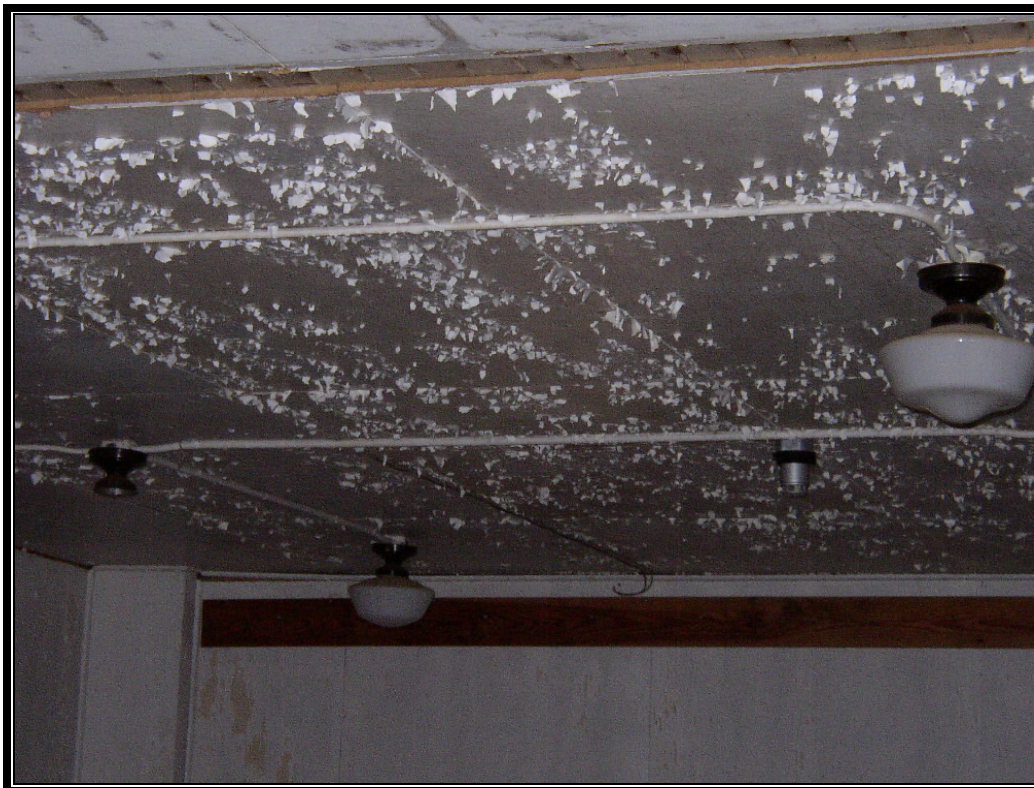
Given the age of the buildings, some original paint could contain lead. We observed that many of the painted surfaces are in poor condition and could

present an exposure risk. The paint on many of the interior painted surfaces was flaking and in poor condition. Exterior paint was severely weathered on most of the buildings and it is likely that soils around the buildings have been impacted by lead.

Photograph 8: Flaking paint on ceiling inside the Former Webloft (Building D).

- Given the age of the buildings on the subject property, it is likely that they contain ACBM and LBP. Hart Crowser recommends conducting a limited hazardous building material (HBM) survey to confirm the presence or absence of these materials. Surface soils in the vicinity of all buildings should be sampled for the presence of lead as part of this survey.

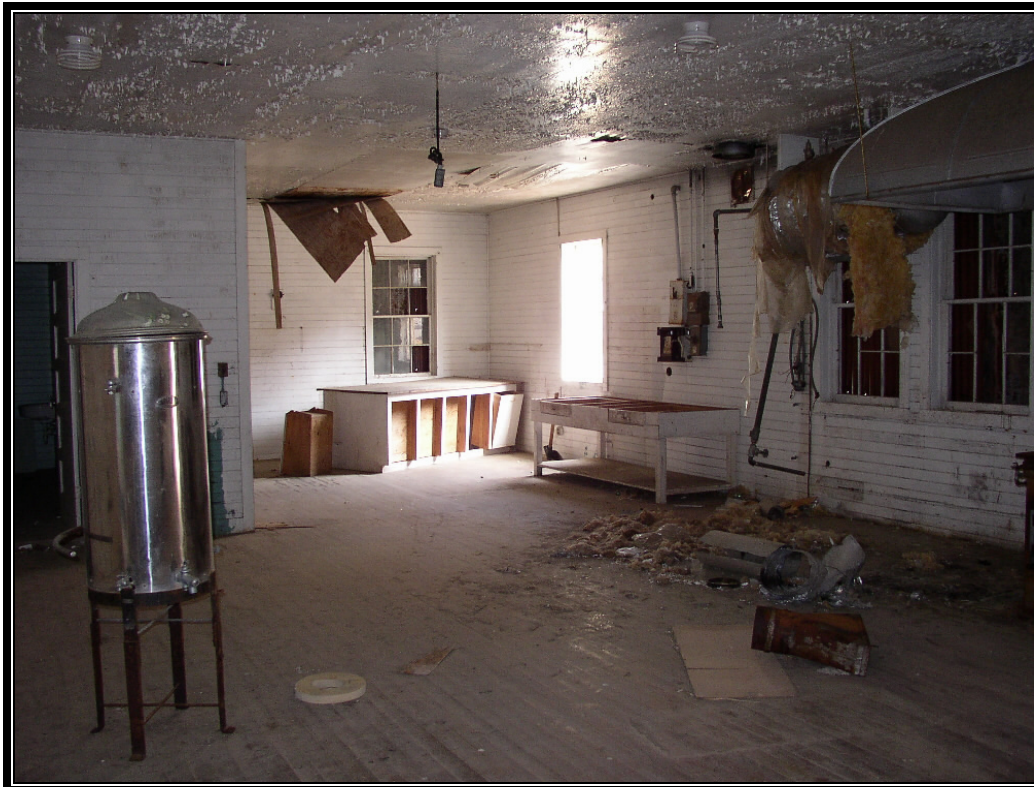
Photograph 11: Interior of the Former Cookhouse (Building E). Note the flaking ceiling paint and shredded insulation.

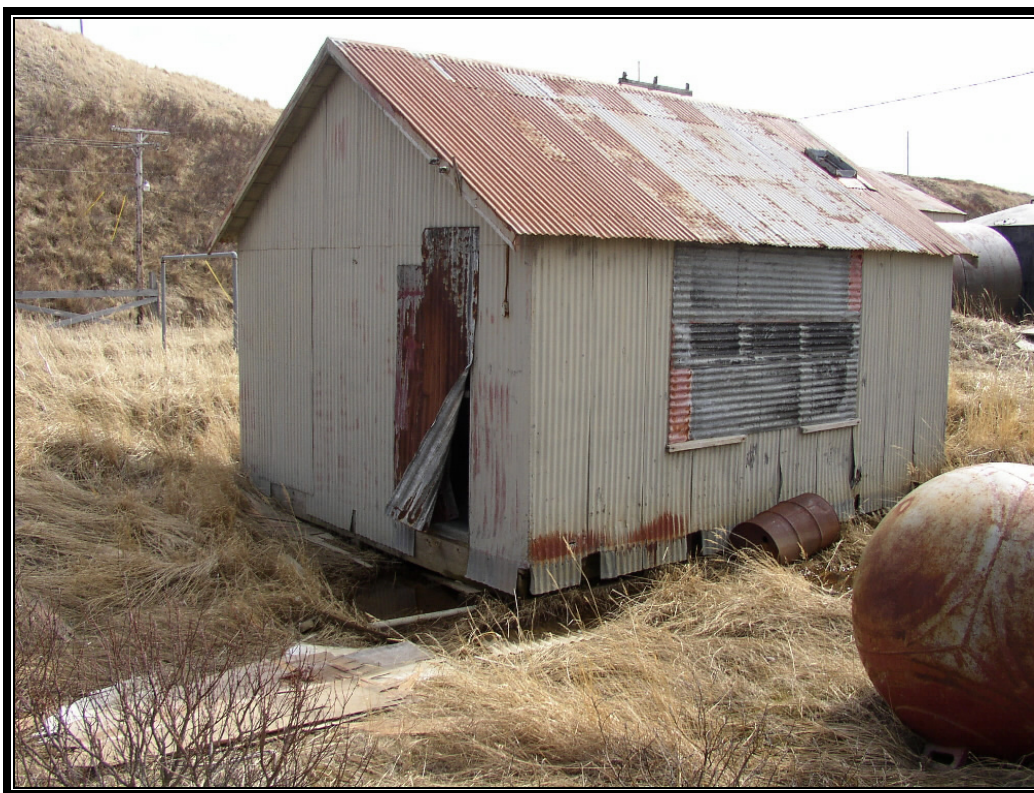
Photograph 14: Northwest side of Building I. This building was boarded up at the time of the site visit and was inaccessible. Note the rusted 55-gallon drum on the west side of the building. The drum appeared empty.

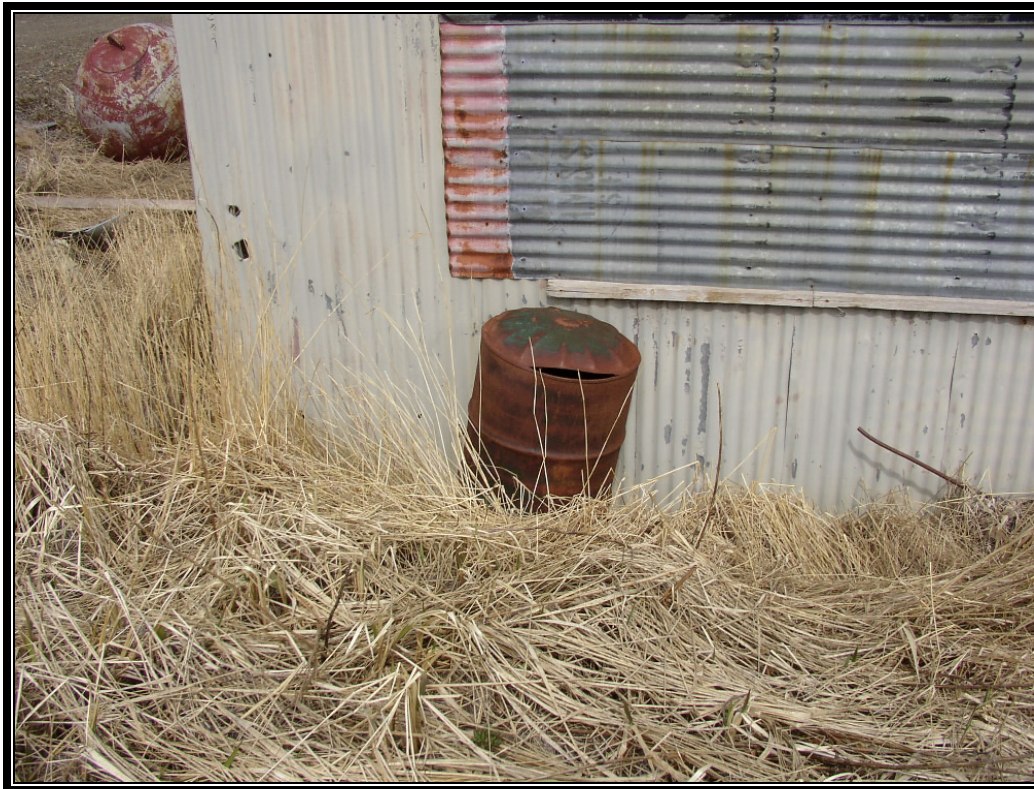
Photograph 15: Rusted, empty 55-gallon drum on south side of Building I.

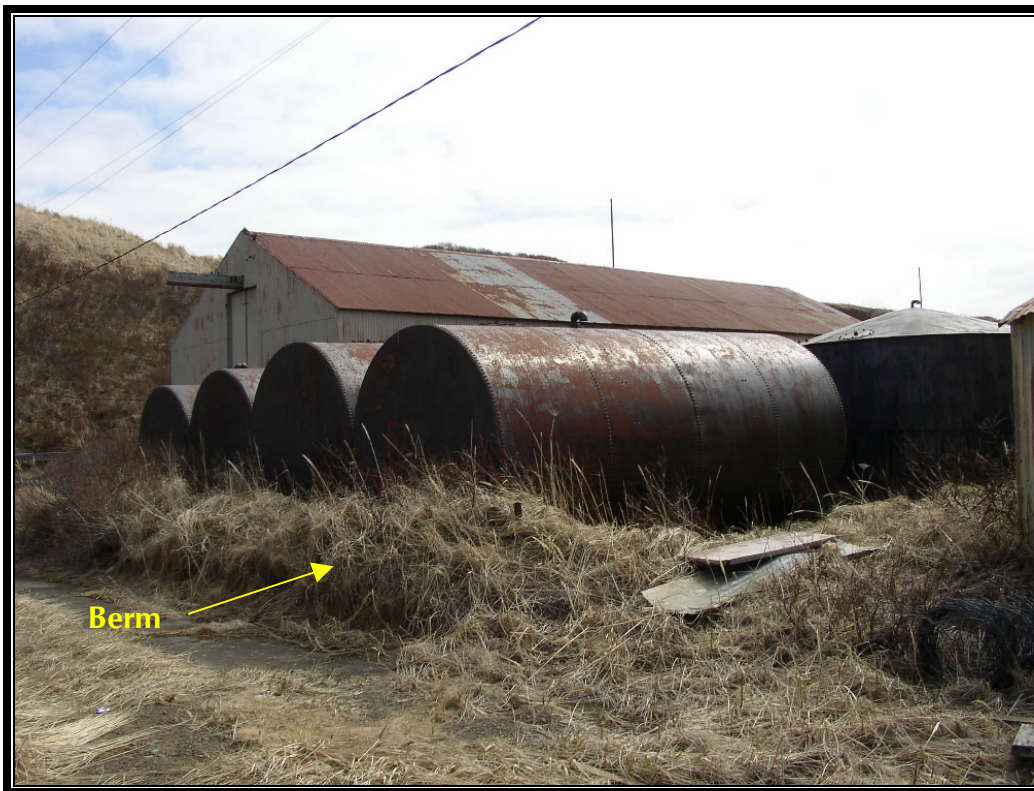
Photograph 16: Tank farm located at south end of subject property. The tanks are surrounded by an earthen berm. There was no liner present in the secondary containment area at the time of the site visit.

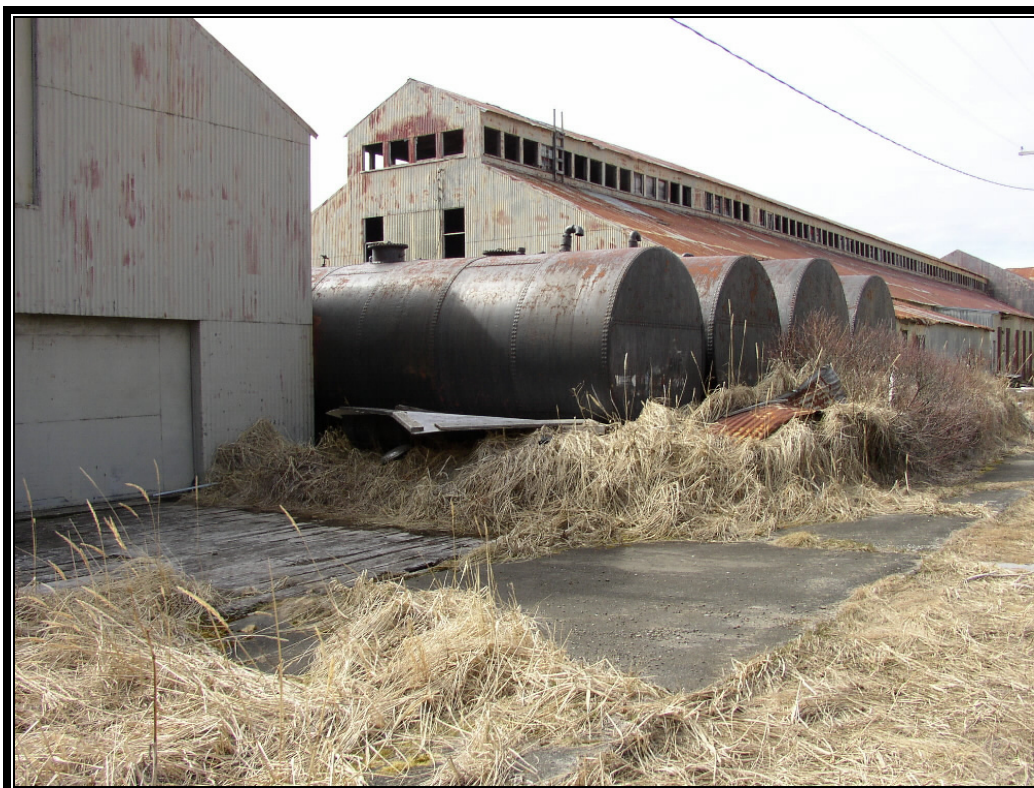
Photograph 17: Northeast side of the tank farm. Some sheet metal debris was located on the berm during the site visit.

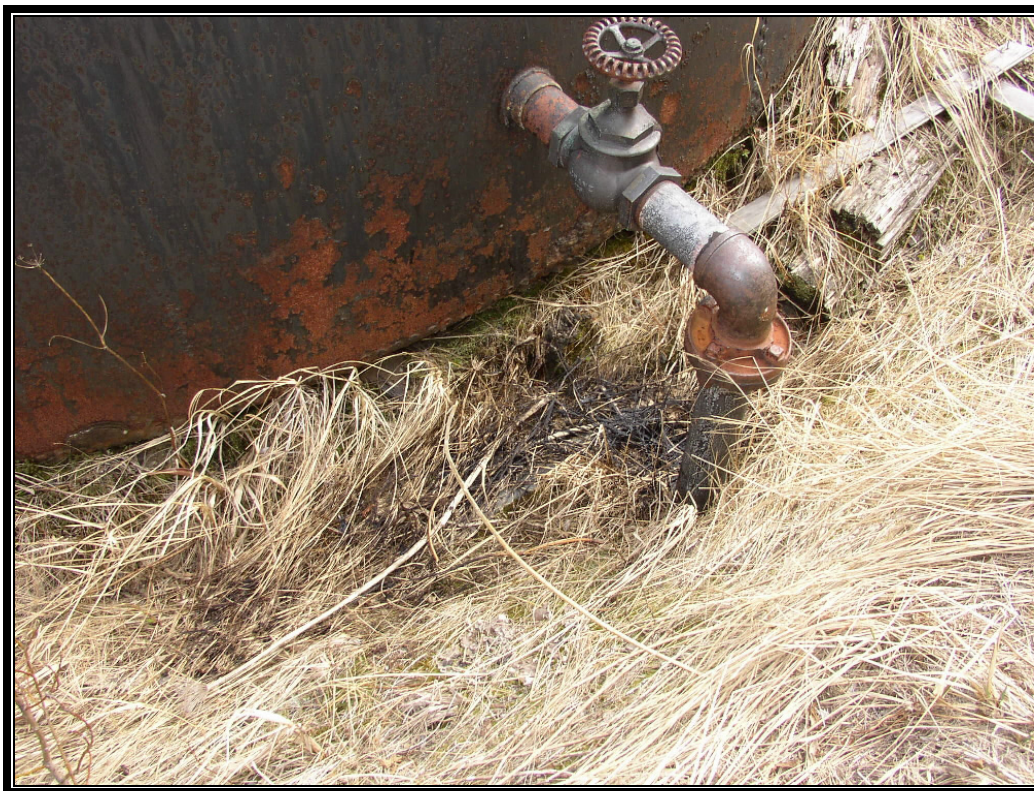
Stained soils were noted in the vicinity of the Tank Farm (Figure 2). Surface staining observed is most likely due to the release of Bunker "C" oil in 1992. Evidence of leakage from one of the ASTs was observed during the site visit (see Appendix C, Page C-9).

Photograph 18: Stain noted near the outlet of one of the aboveground storage tanks during the site visit. This stain was located inside the bermed area and was less than 1 square foot in area.

- Evidence of leakage from the tanks in the tank farm was identified during the site visit. Hart Crowser recommends placement of temporary containment near the source of these leaks and removal of all residual fluids from these tanks as soon as possible. Hart Crowser also recommends limited soil removal in the areas where these leaks have occurred.

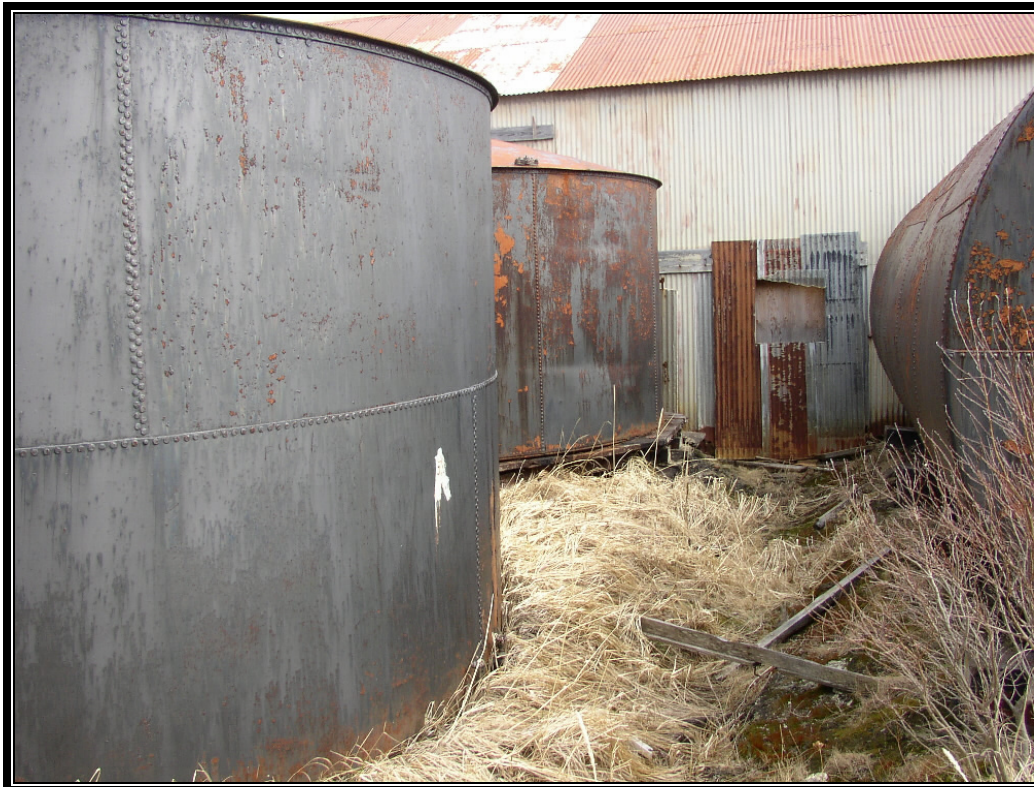
Photograph 19: Wooden debris located within the tank farm. There is visible rust on all of the tanks in the tank farm.

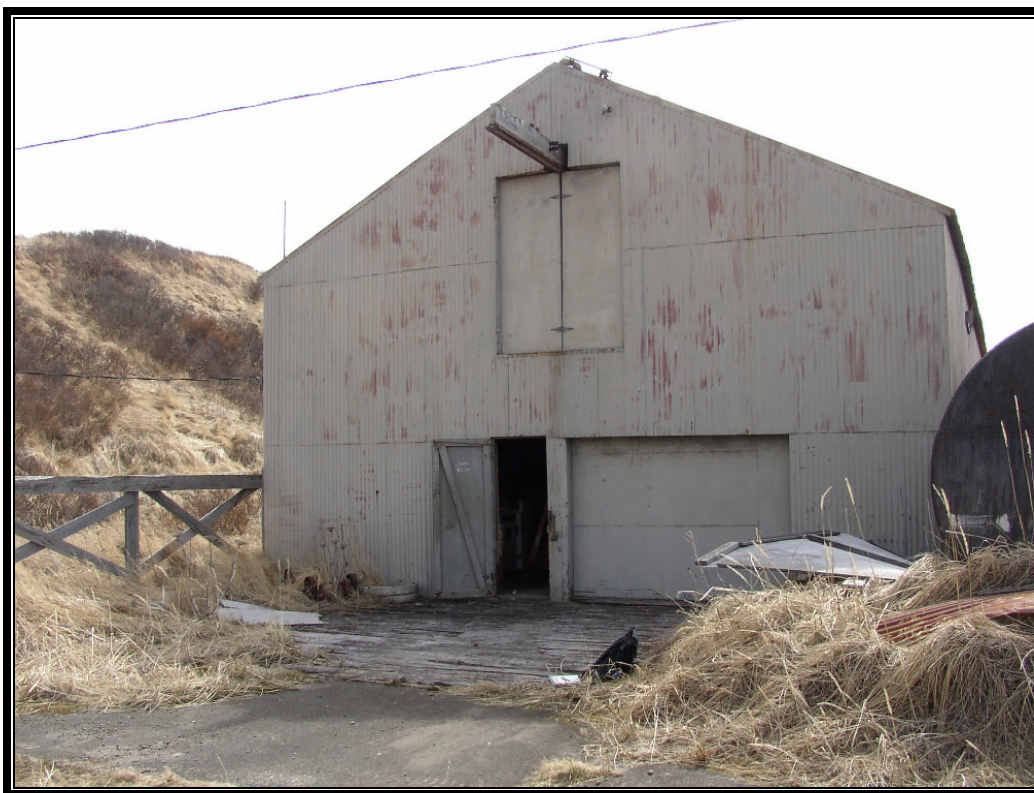
Photograph 24: North end of building J. Some of the original red paint is visible on the building exterior; most of the original paint has peeled off.

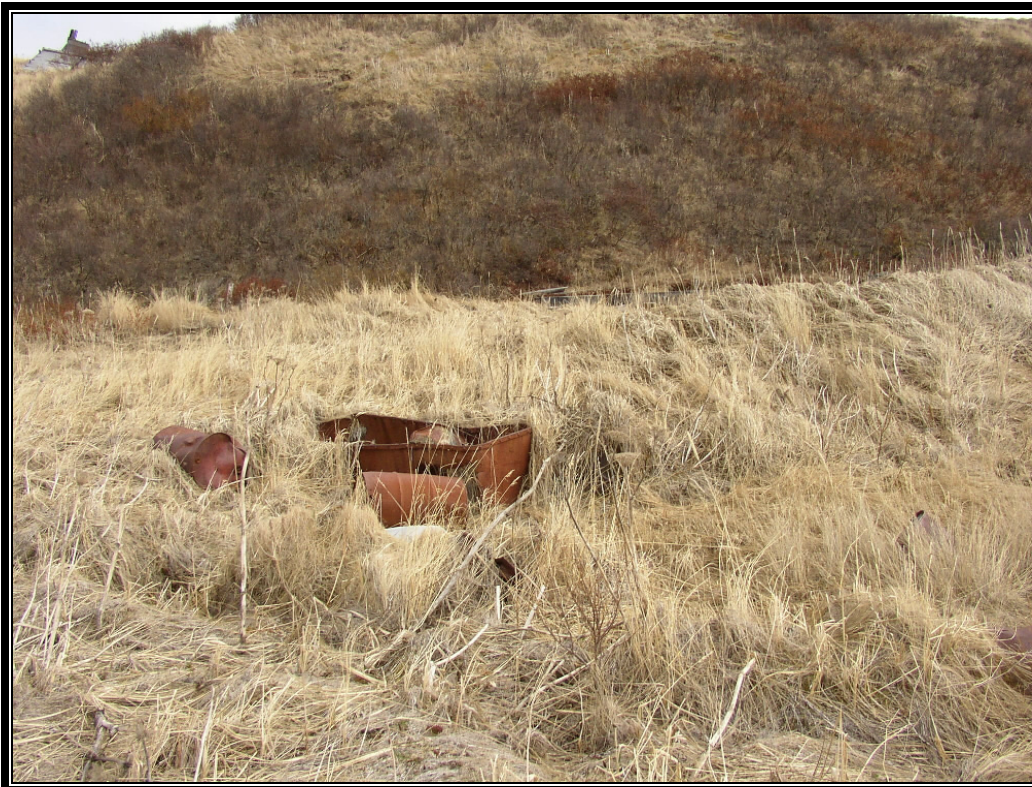
Photograph 25: Fifty-five-gallon drums and metal debris in the undeveloped area to the south of the subject property.

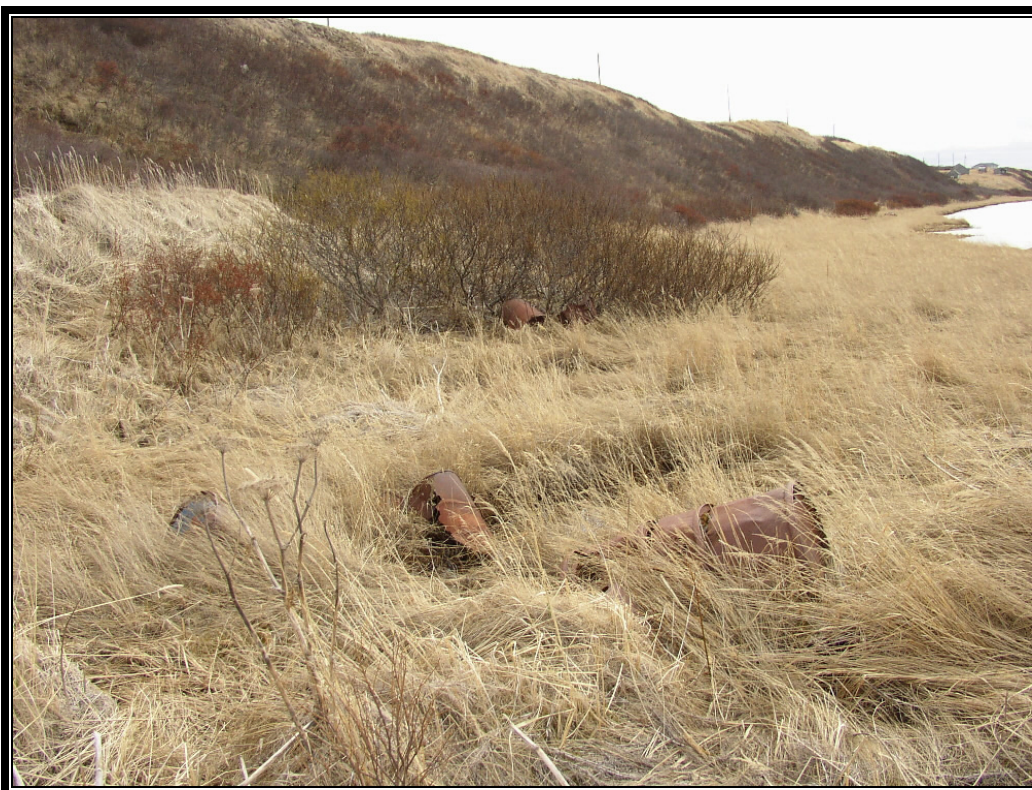
Photograph 26: Fifty-five-gallon drums found in the undeveloped area south of the subject property during the site visit.

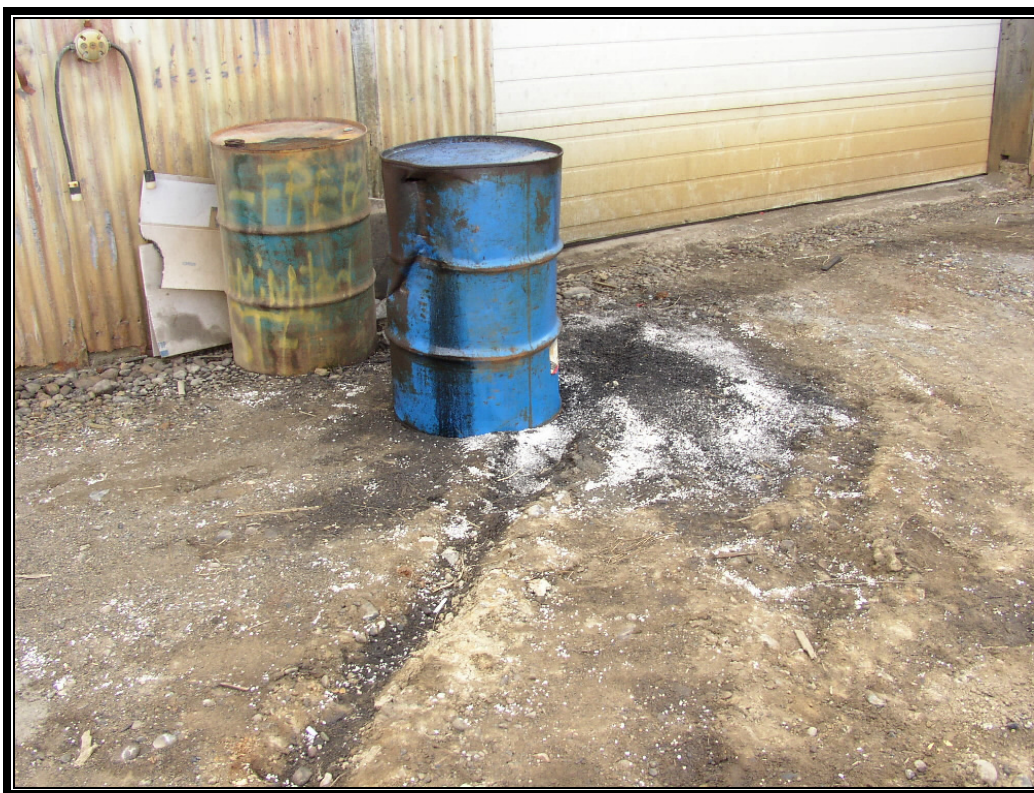
Stained soils were also noted near the Former North Main Cannery Building (Building F) and near the "L" connecting the Former North and South Main Cannery buildings (Buildings F and H; Figure 2). Rusted and partially full 55-gallon drums were noted nearby during the site visit (see Appendix C; Pages C-14 and C-17).

Photograph 28: Fifty-five-gallon drum and stained soils observed on the north side of the Former North Main Cannery Building (Building F).

- Several areas of stained soil were noted on the subject property in the vicinity of 55-gallon drums. Hart Crowser recommends sampling the surface soils in all noted stained areas to determine the nature and extent of contamination from the leaking 55-gallon drums.

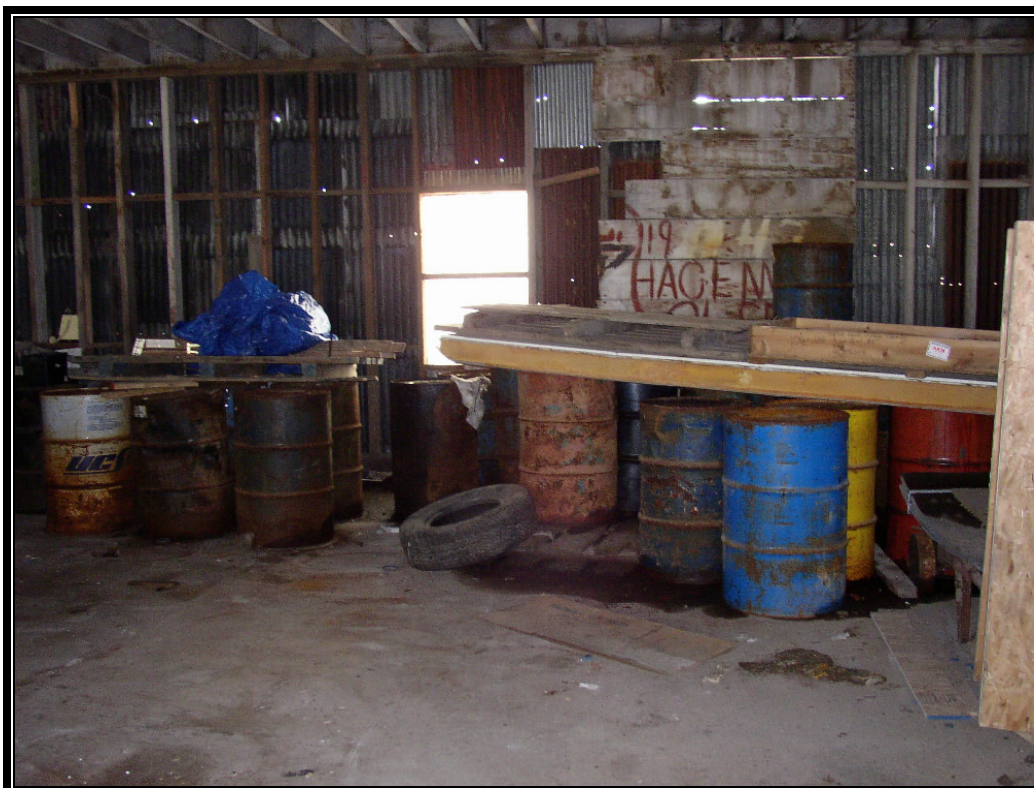
Photograph 29: Fifty-five-gallon drums and stained flooring observed inside the Former North Main Cannery Building (Building F).

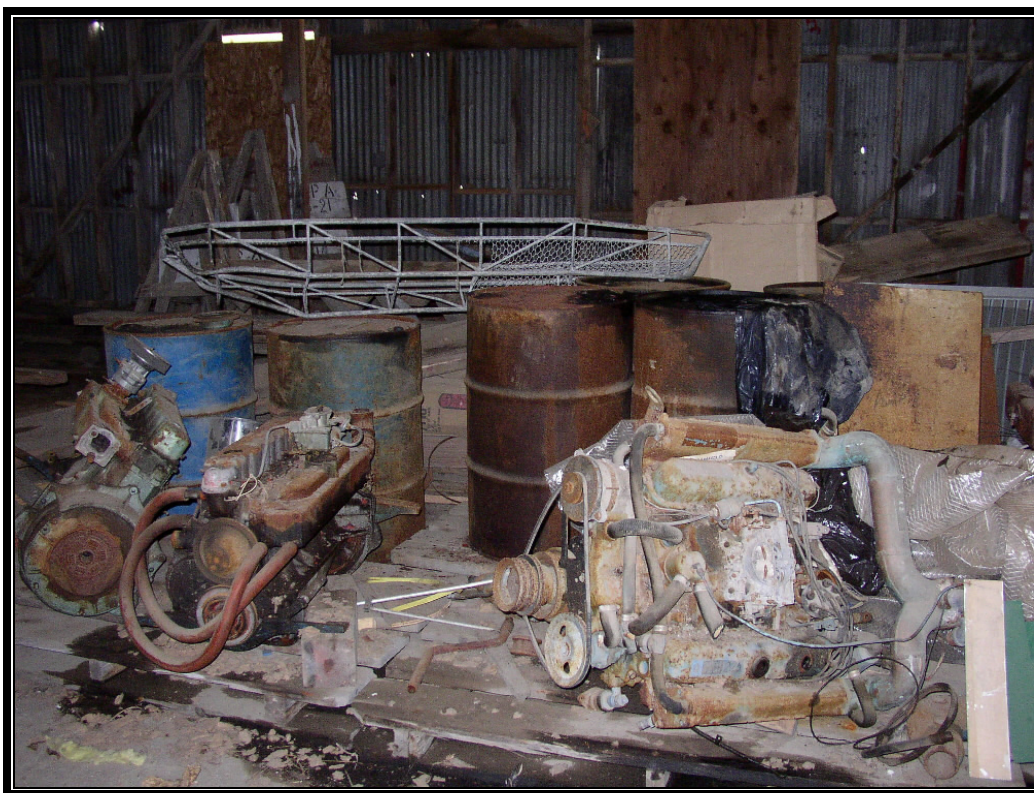
Photograph 30: Fifty-five-gallon drums and miscellaneous automotive parts found in the Former North Main Cannery Building (Building F). Some staining was noted on the flooring in the vicinity of these items.

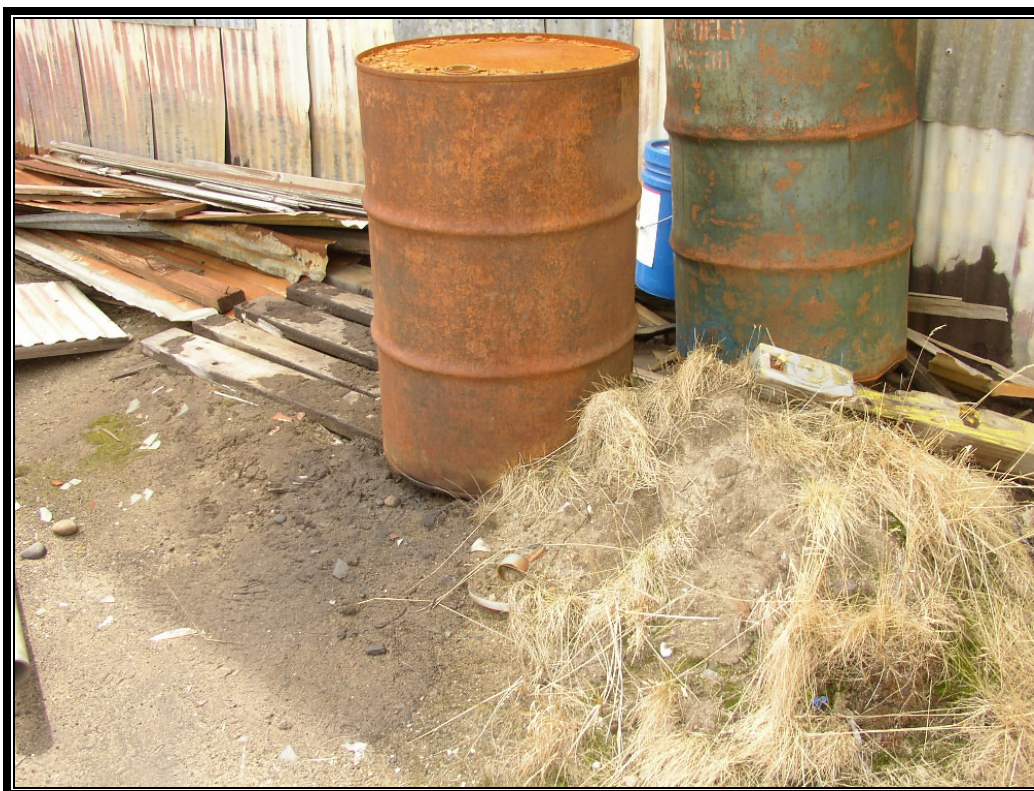
Photograph 34: Fifty-five-gallon drums and stained soils observed along the exterior of the “L” between the Former North and South Main Cannery Buildings (Buildings F and H).

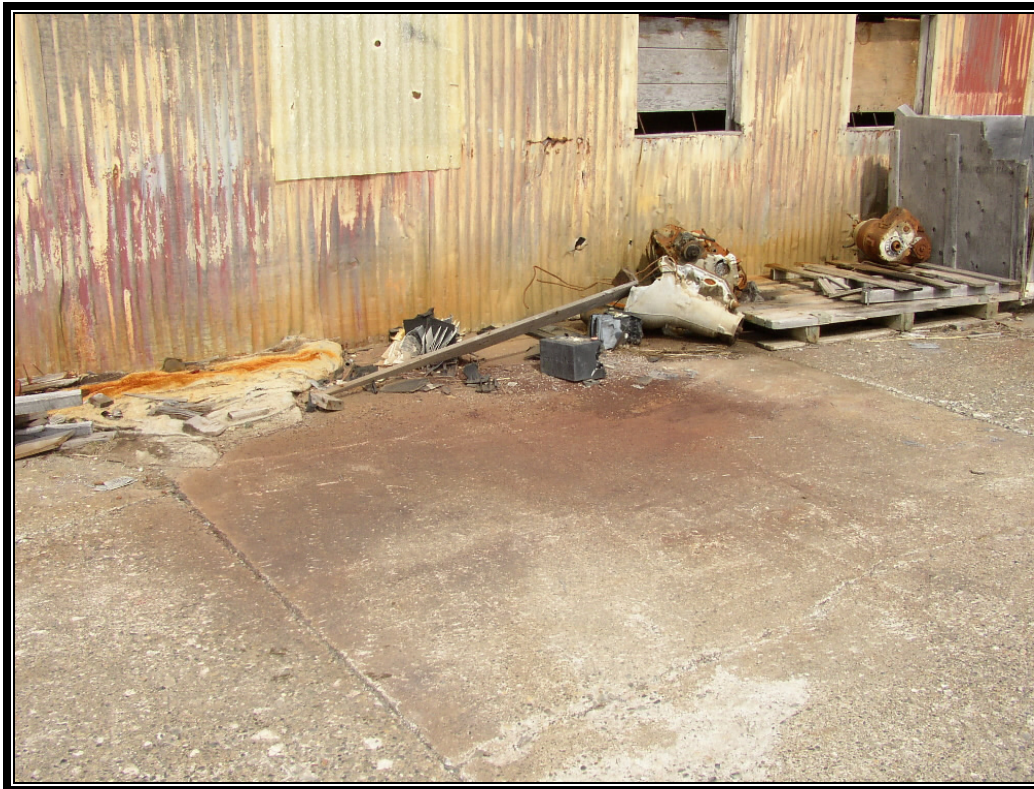
**Automotive Batteries.** Six plastic totes, each approximately 4-feet long by 3-feet wide by 3-feet high, with several used automotive batteries were found inside the Former South Main Cannery Building (Building H). Several batteries were inside each tote and many of the batteries were broken. No leaks or spills were noted in the vicinity of these batteries. Several broken automotive batteries were also observed on the exterior of this building, near the southwest corner (see Appendix C; Page C-18).

Photograph 35: Broken batteries and debris observed on the southwest side of the Former South Main Cannery Building (Building H).

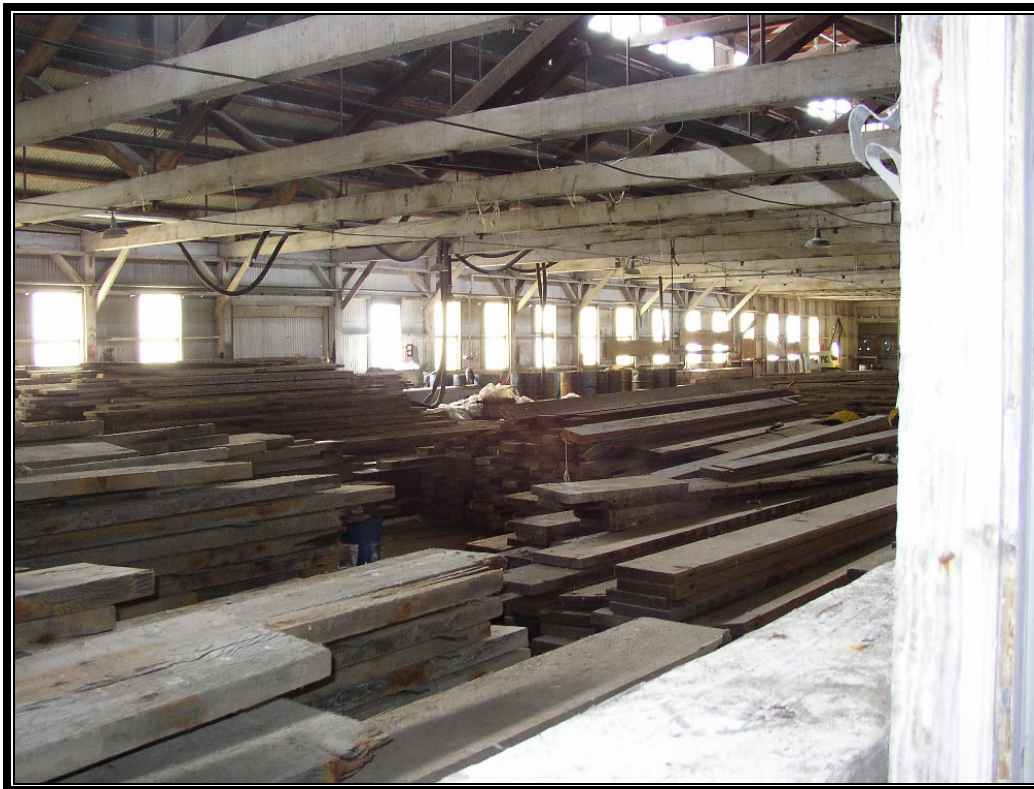
Photograph 36: Building materials and 55-gallon drums stored inside the Former South Main Cannery Building (Building H).

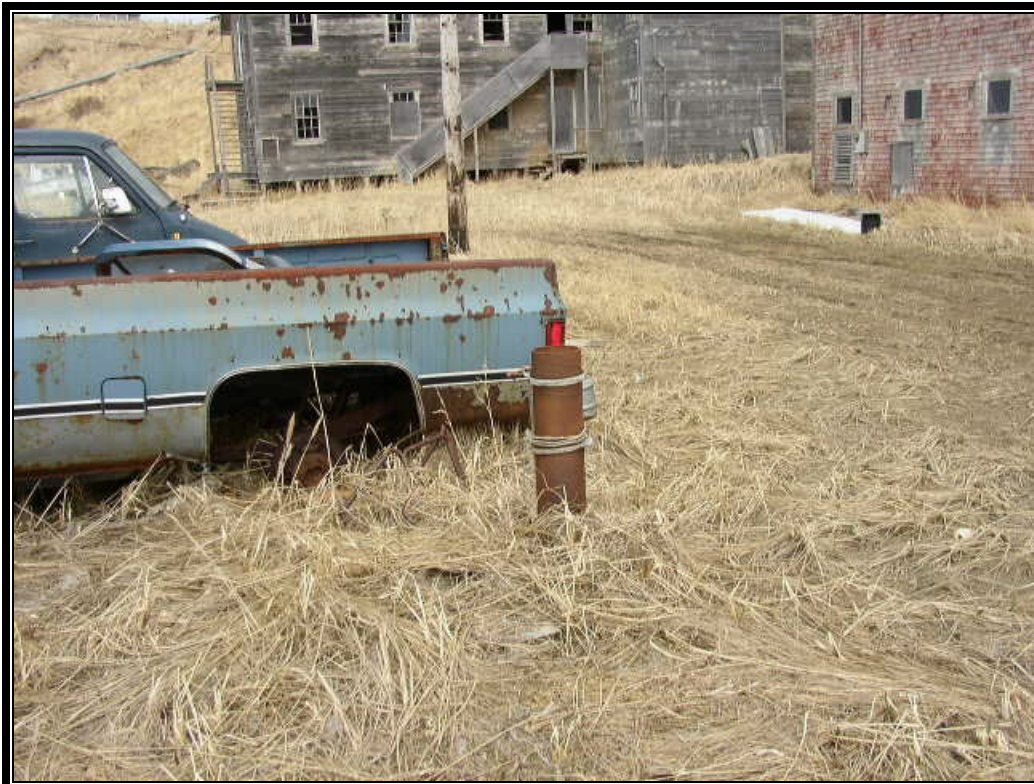
Photograph 39: Drinking water well located near Building B. This well appears to have provided drinking water to Building B, a former residence, and is no longer in use.

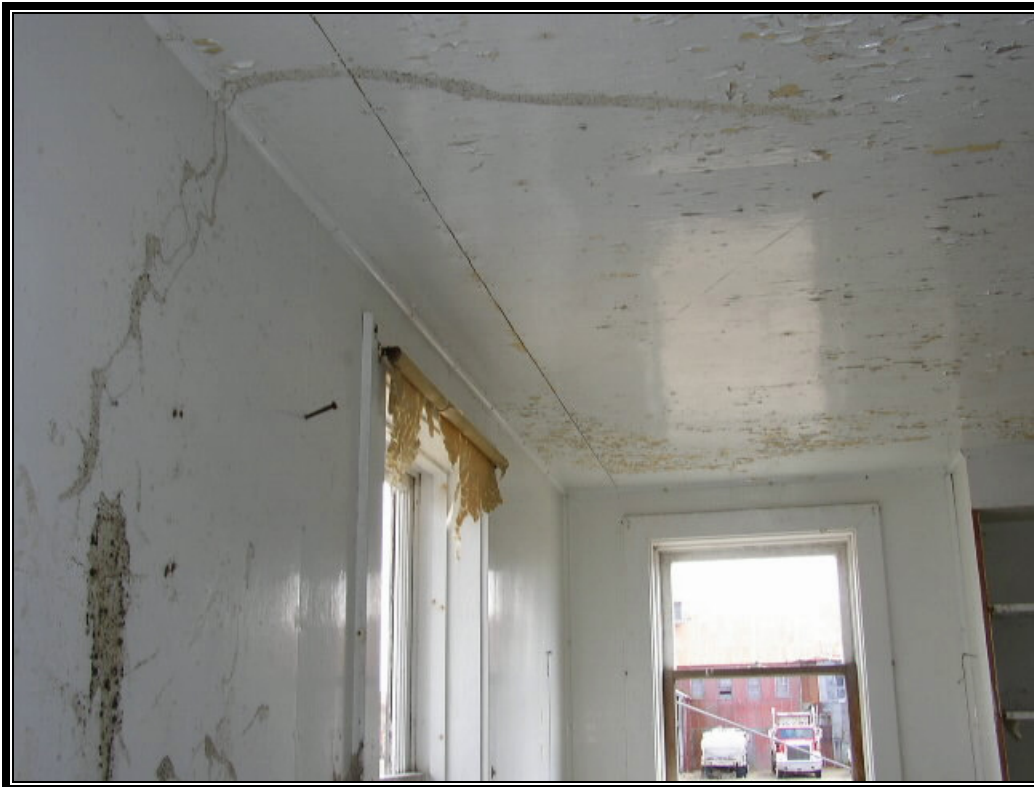
Photograph 41: Peeling paint noted on ceiling inside Building B.

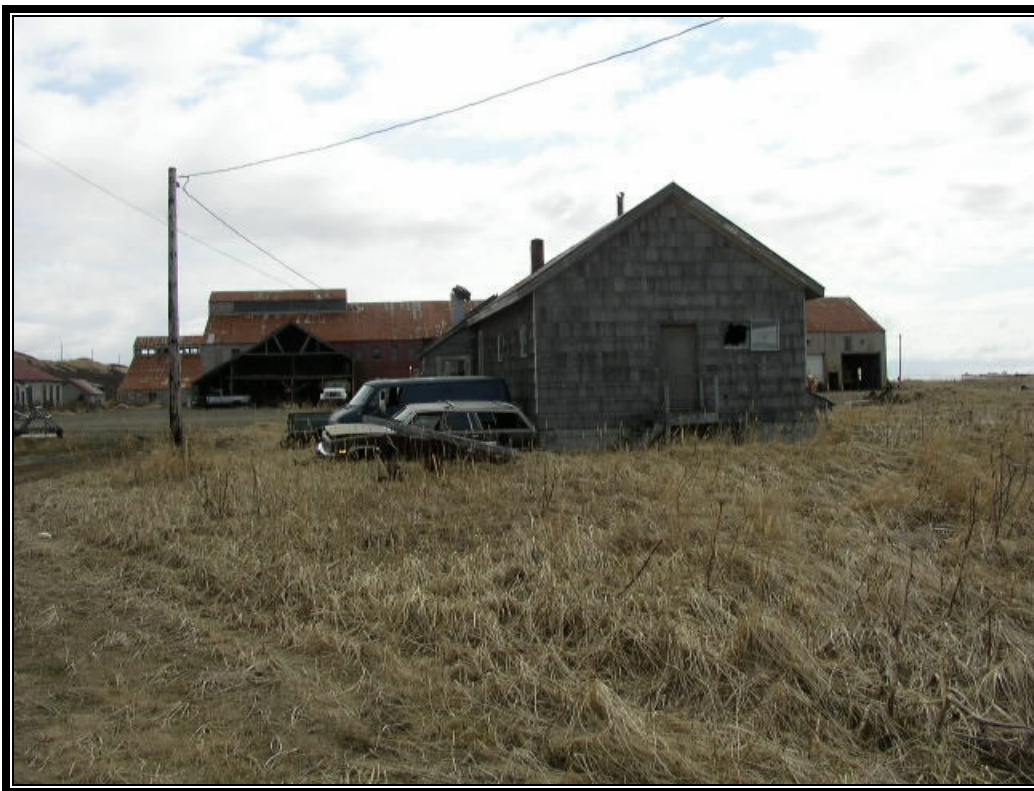
Photograph 42: Exterior of Building B. View is of the north side of the building. Two abandoned vehicles were observed near this building.

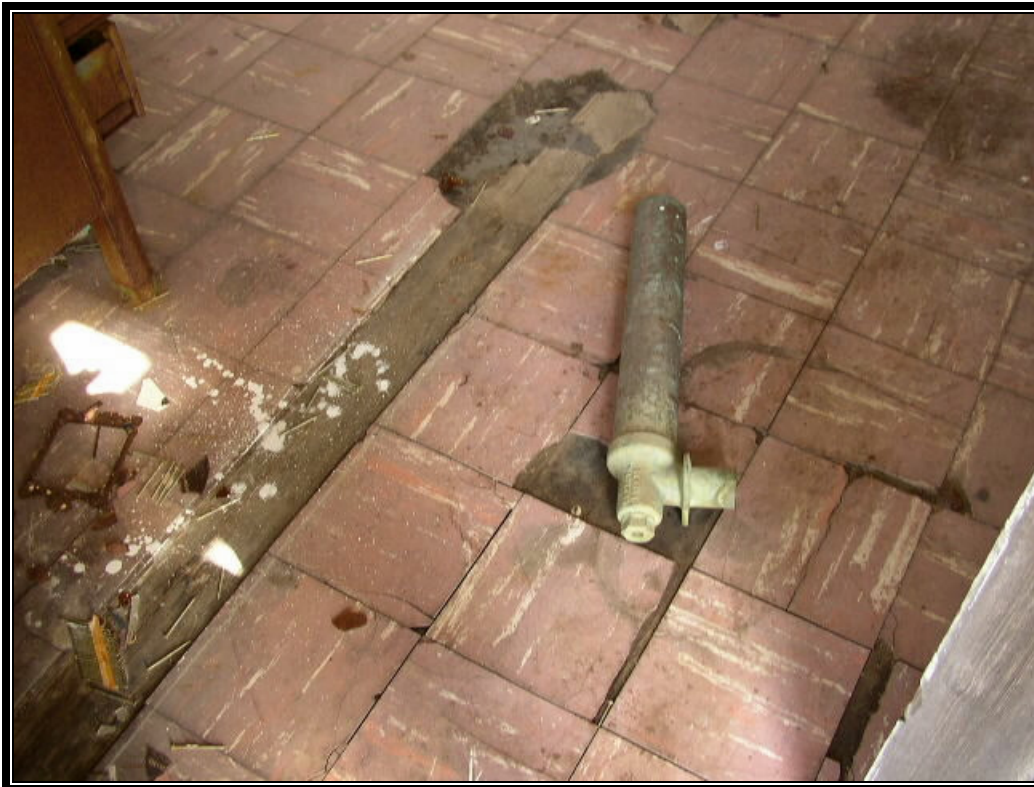
Photograph 43: Tile flooring inside Building A, which appeared to have been a bunkhouse at one time. Much of this building was inaccessible at the time of the site visit due to safety concerns.

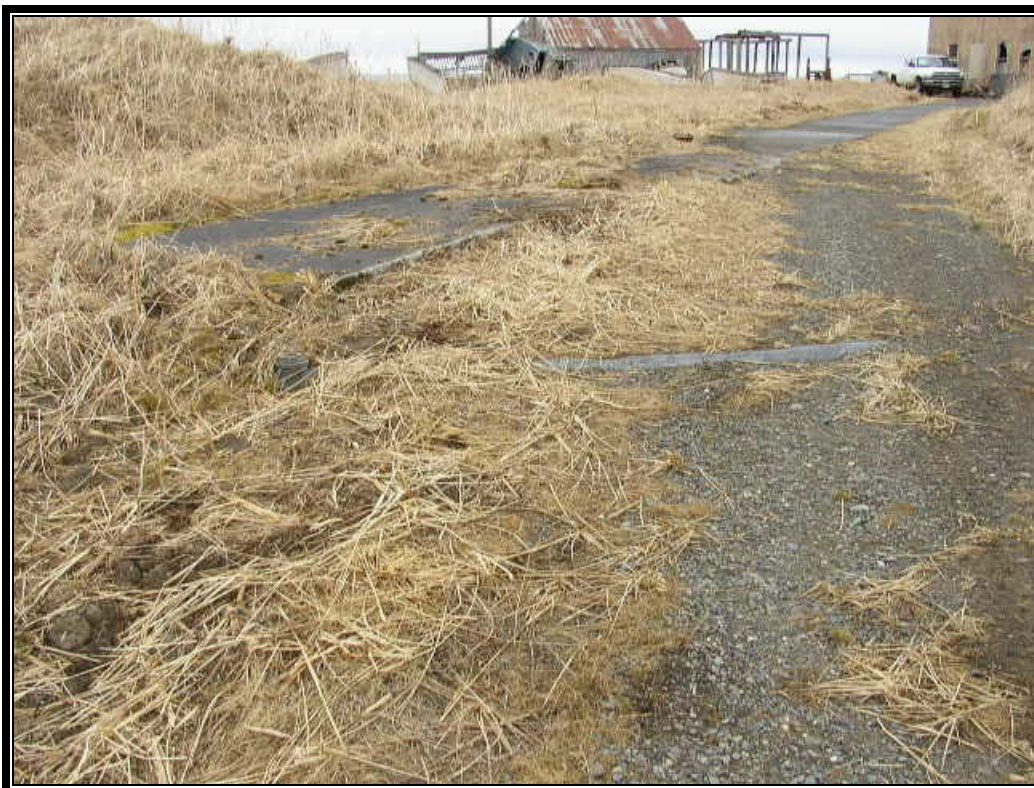
Photograph 44: Partially exposed piping south of the subject property. This piping led to the footprint of a building that is no longer there. The purpose of this piping is unknown.
