# Alaska's 2009 Air Monitoring Network Plan

## Chapter 2 – Monitoring Plan

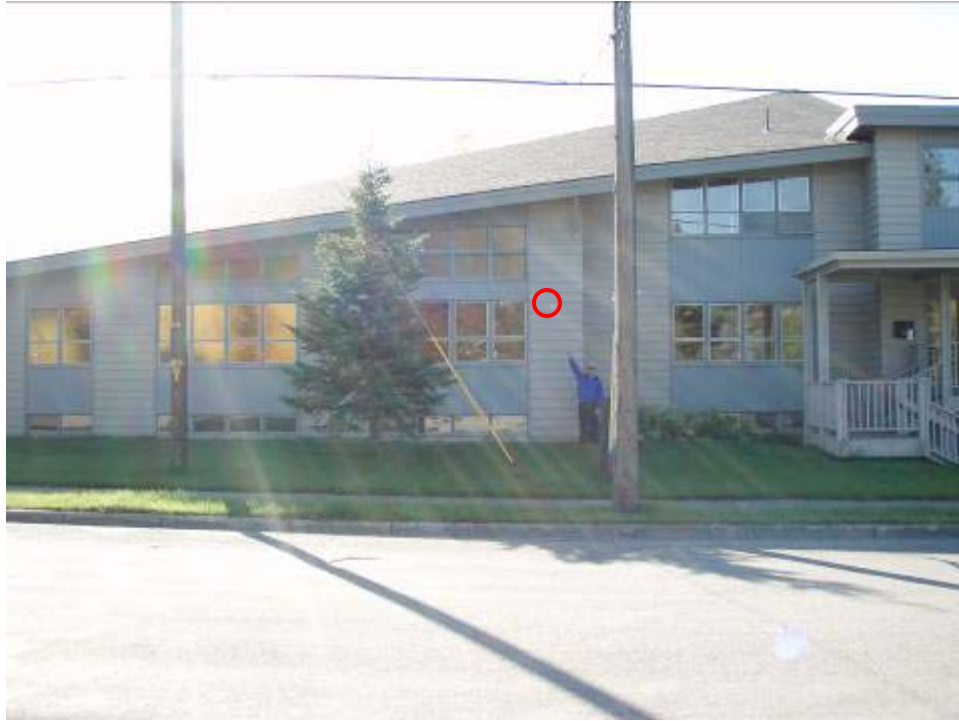
**Figure 3.2:3:** View of CO probe at Garden Site. The red circle indicates where the probe is located.

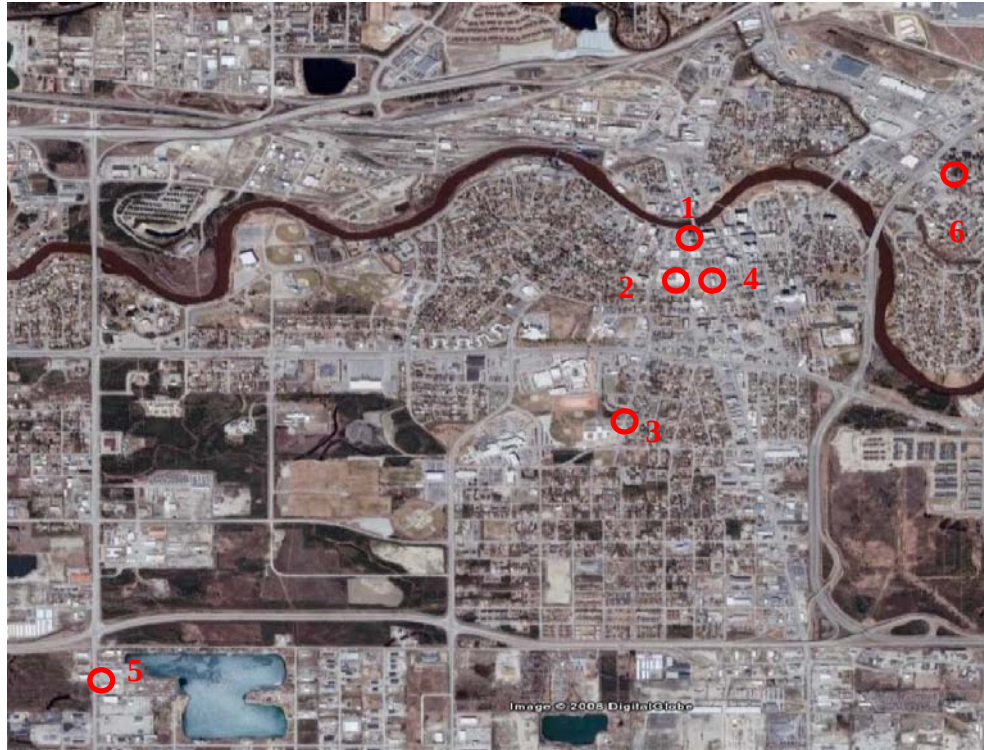
**Figure 4.1:2:** Satellite photo of Fairbanks. Red circles indicate (in order from top down) the (1) Old Post Office, (2) State Office Building, (3) Hunter Elementary School, (4) Sadler, (5) TAC (Peger Rd), and (6) Nordale School sites.
