Draft Final Preliminary Engineering Report Water Treatment Plant and Washeteria Facility Tununak, Alaska

December 26, 2017

DRAFT FINAL PRELIMINARY ENGINEERING REPORT
WATER TREATMENT PLANT AND WASHETERIA FACILITY
TUNUNAK, ALASKA

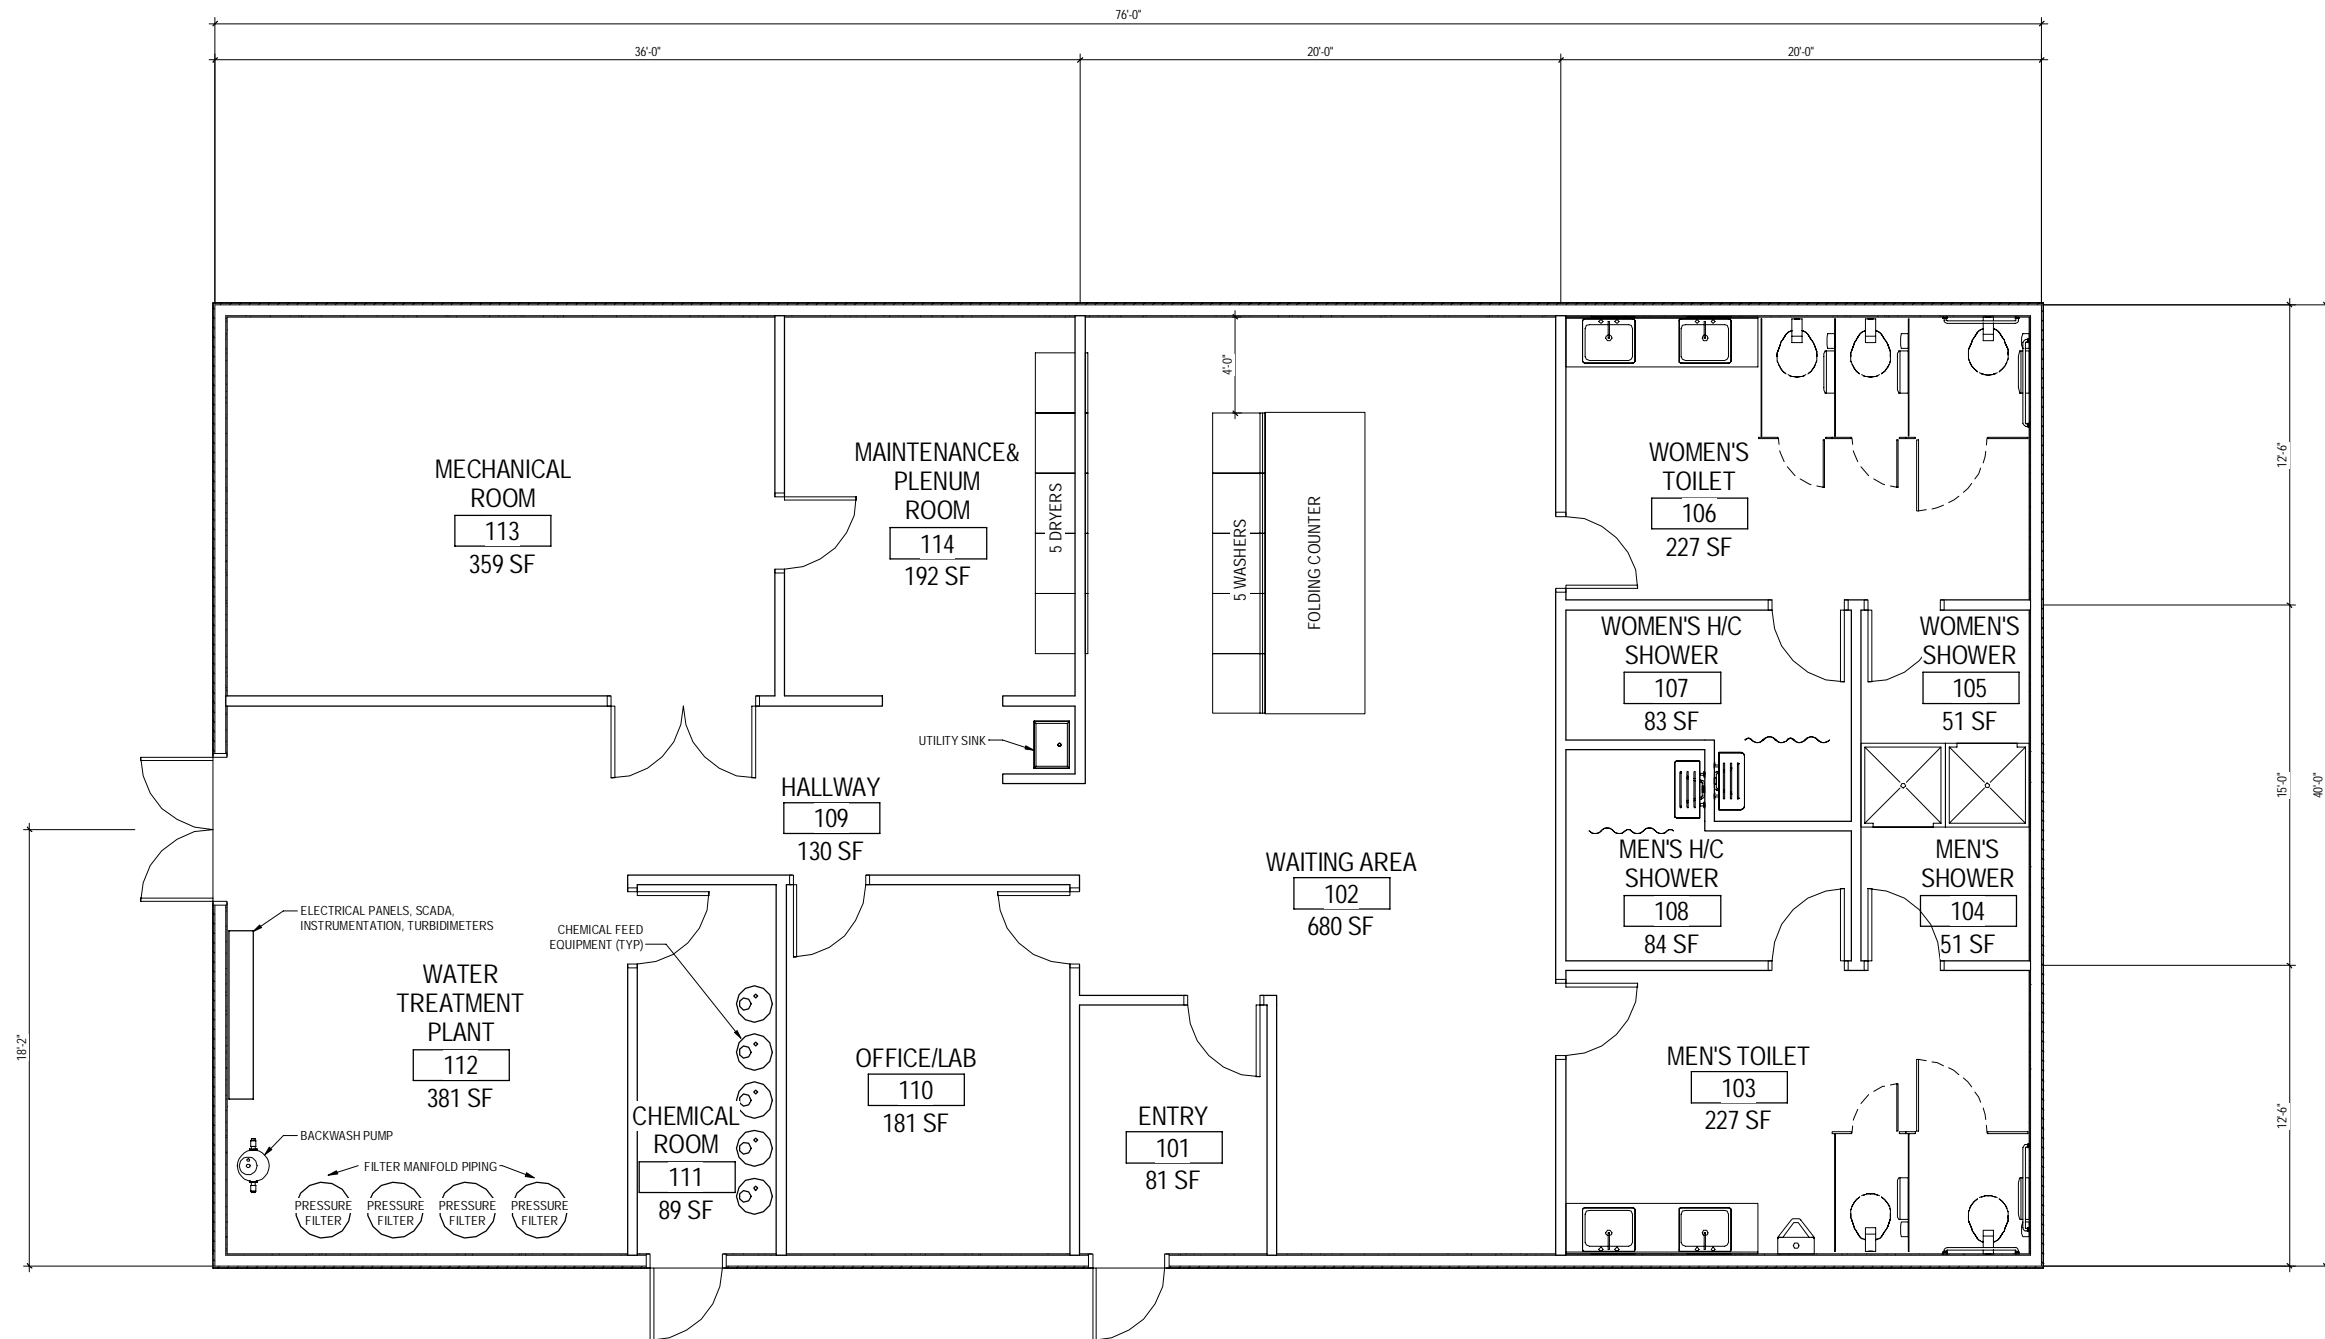
1 **FIGURE 6 - Proposed Floor Plan for Alternative 3 - Modular Washeteria/WTP**
A1 1/4" = 1'-0"

Figure 6 shows the conceptual floor plan for the modular combined washeteria/WTP.

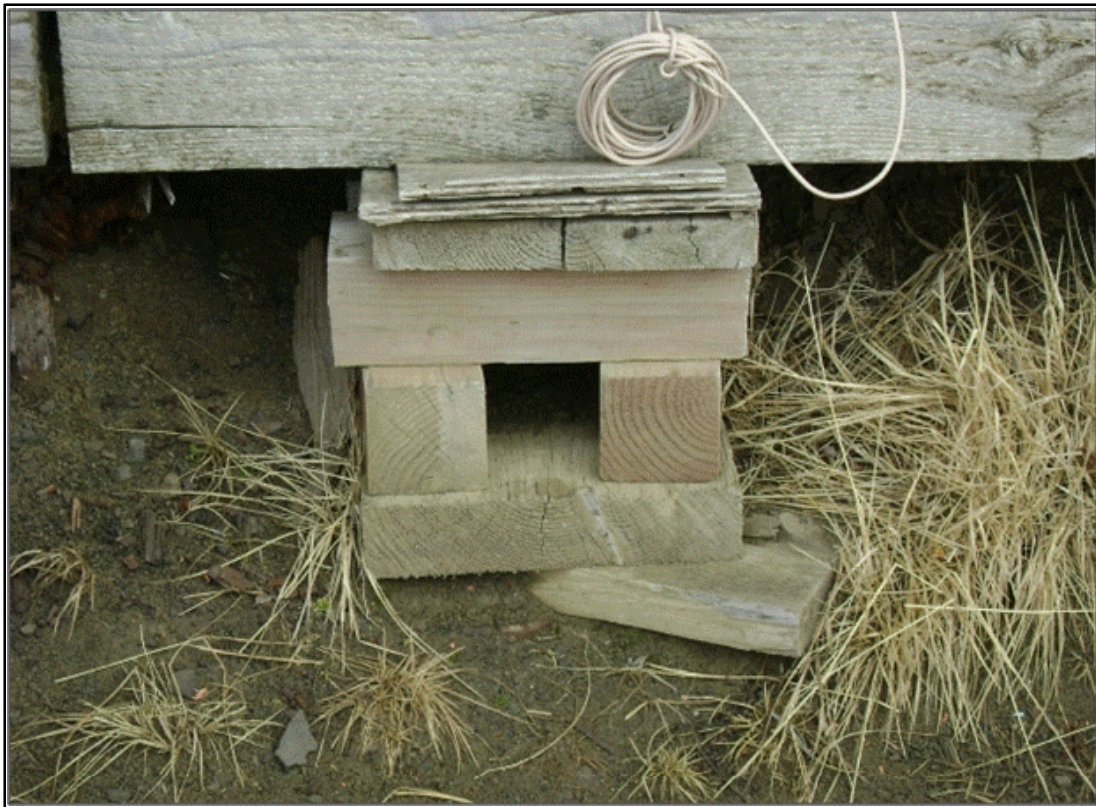
Photo 4: Another footing eroded along south wall of water treatment plant building.

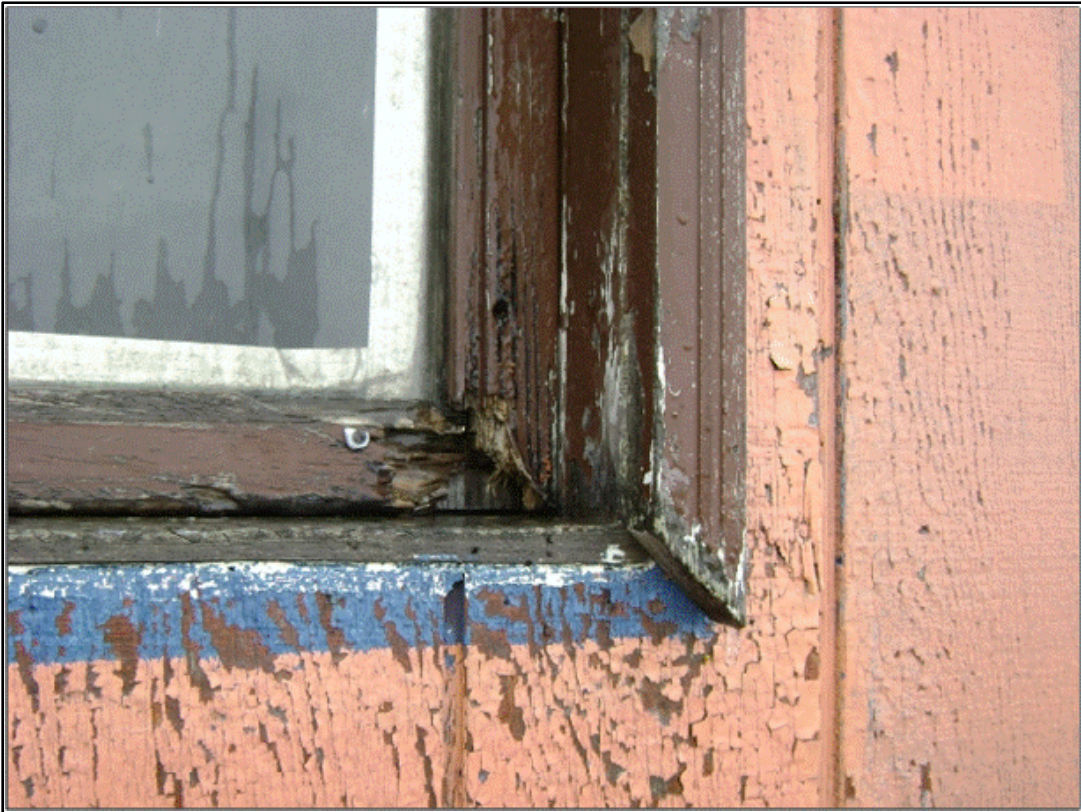
Photo 7: Rotted window frames and replaced glass with single pane Plexiglas or plywood.

- leaking window frames
- broken windows replaced with single panes of Plexiglas or plywood,
- roof leaks around the boiler stacks that have caused deterioration of insulation and finishes

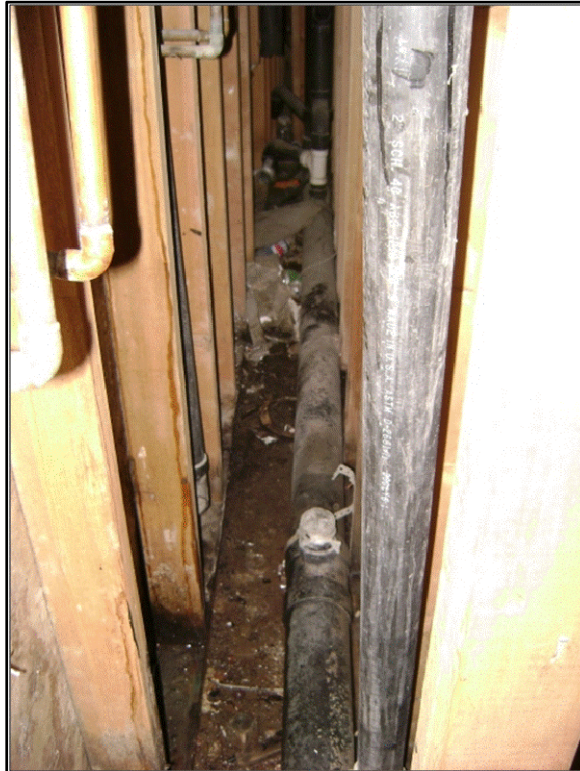
Photo 10: Showing disconnected drainage piping improperly sealed.

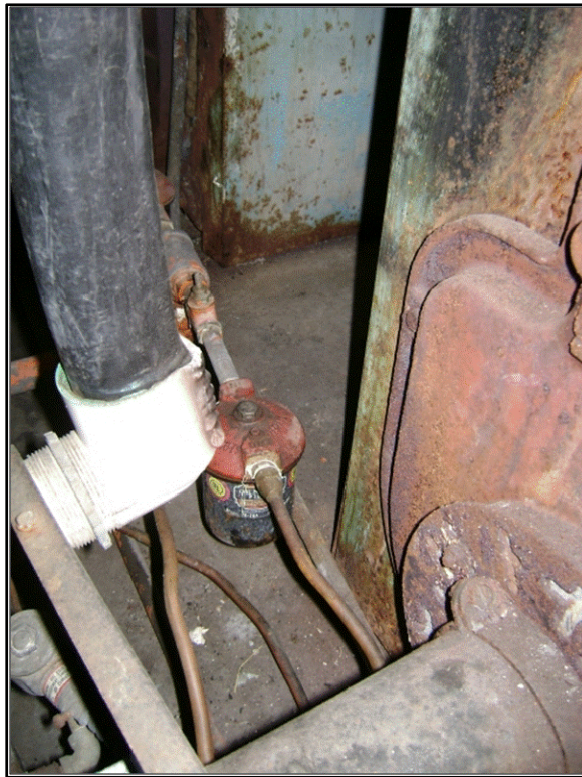
Photo 11: Boiler 2 burner showing firebox leakage and melting of combustion air inlet piping.

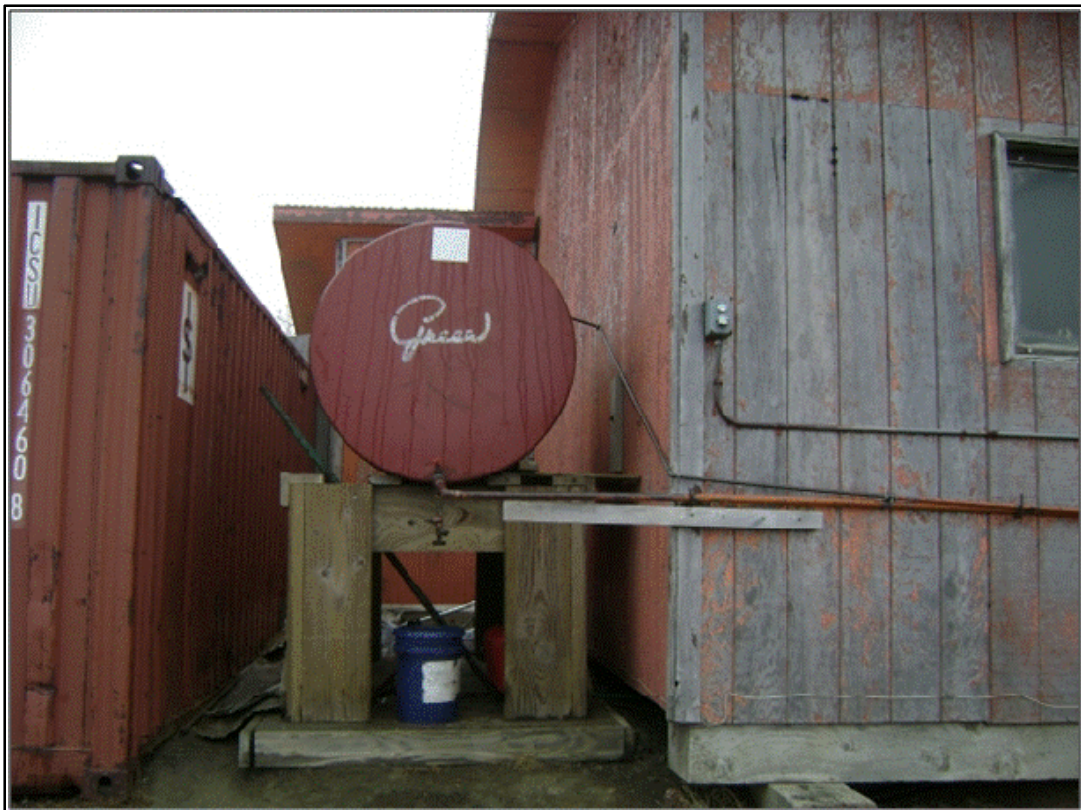
Photo 12: Building fuel supply tank located too close to building. Piping is not properly connected. Fill access is at rear contributes to fuel spill potential.

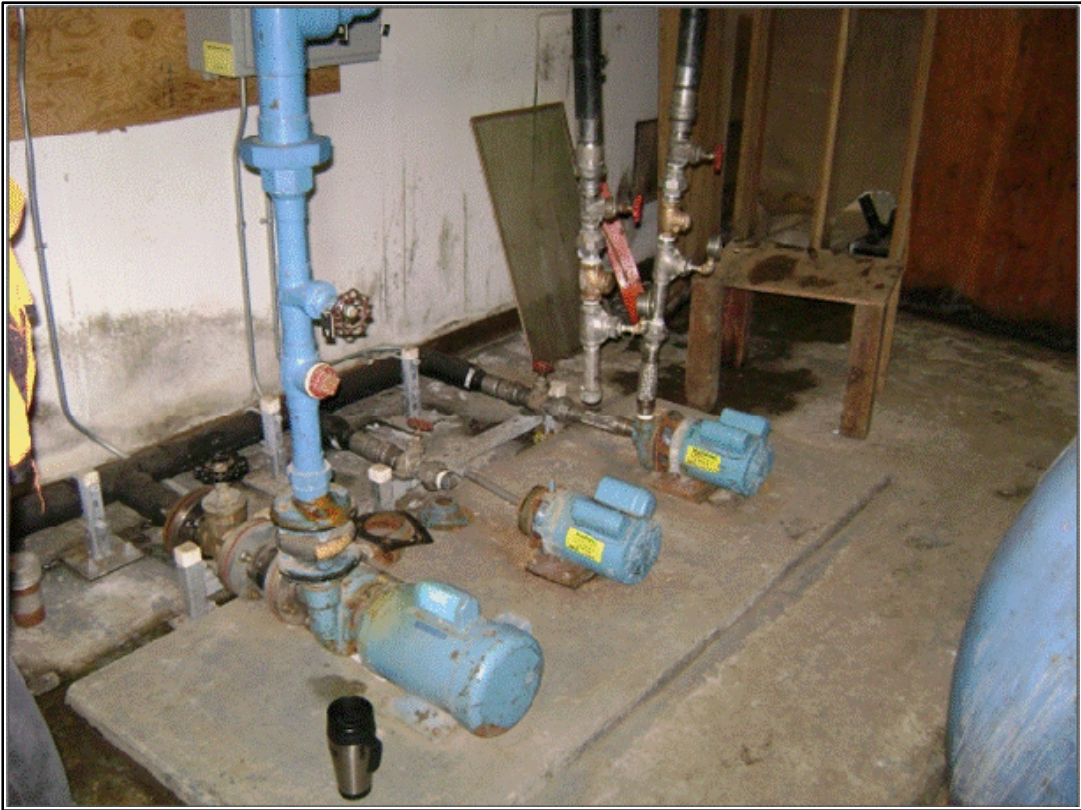
Photo 13: Backwash pump (foreground) and pressure pumps (only one serviceable).

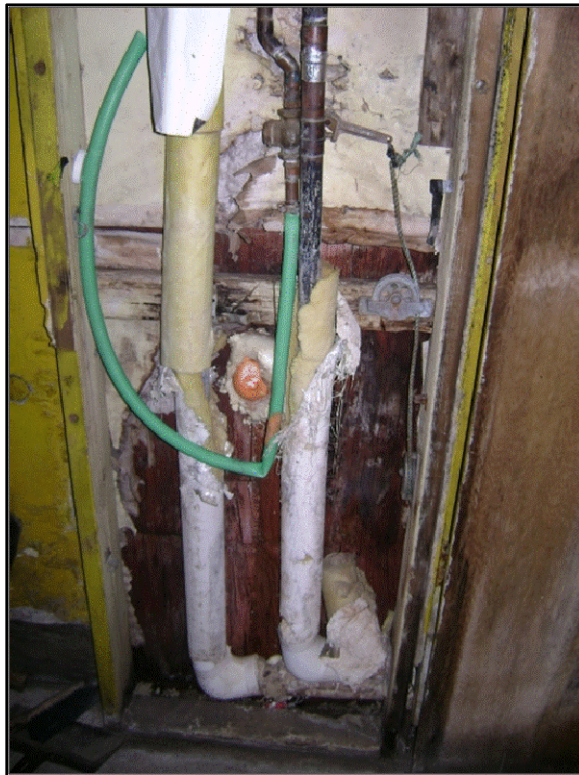
Photo 14: Abandoned watering point at south side of WTP showing deterioration of insulation and building envelope. Exterior siding is visible from building interior.

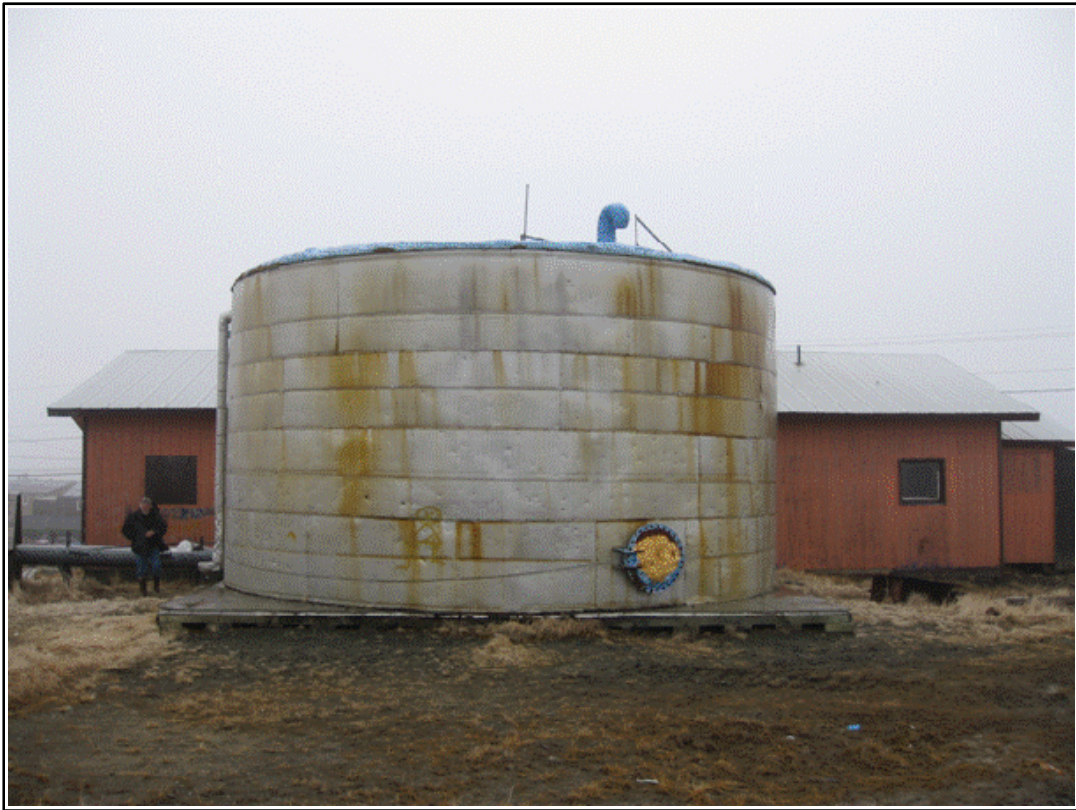
Photo 34: Deteriorated 50,000-gallon bolted steel water storage tank on timber foundation.

Also, the foundation platform for the 50,000 gallon WST is deteriorated and needs to be replaced. However, the WST is reported to be currently operational with no apparent problems. According to the operators, no known significant renovations or repairs have been made to the WST since it was constructed.

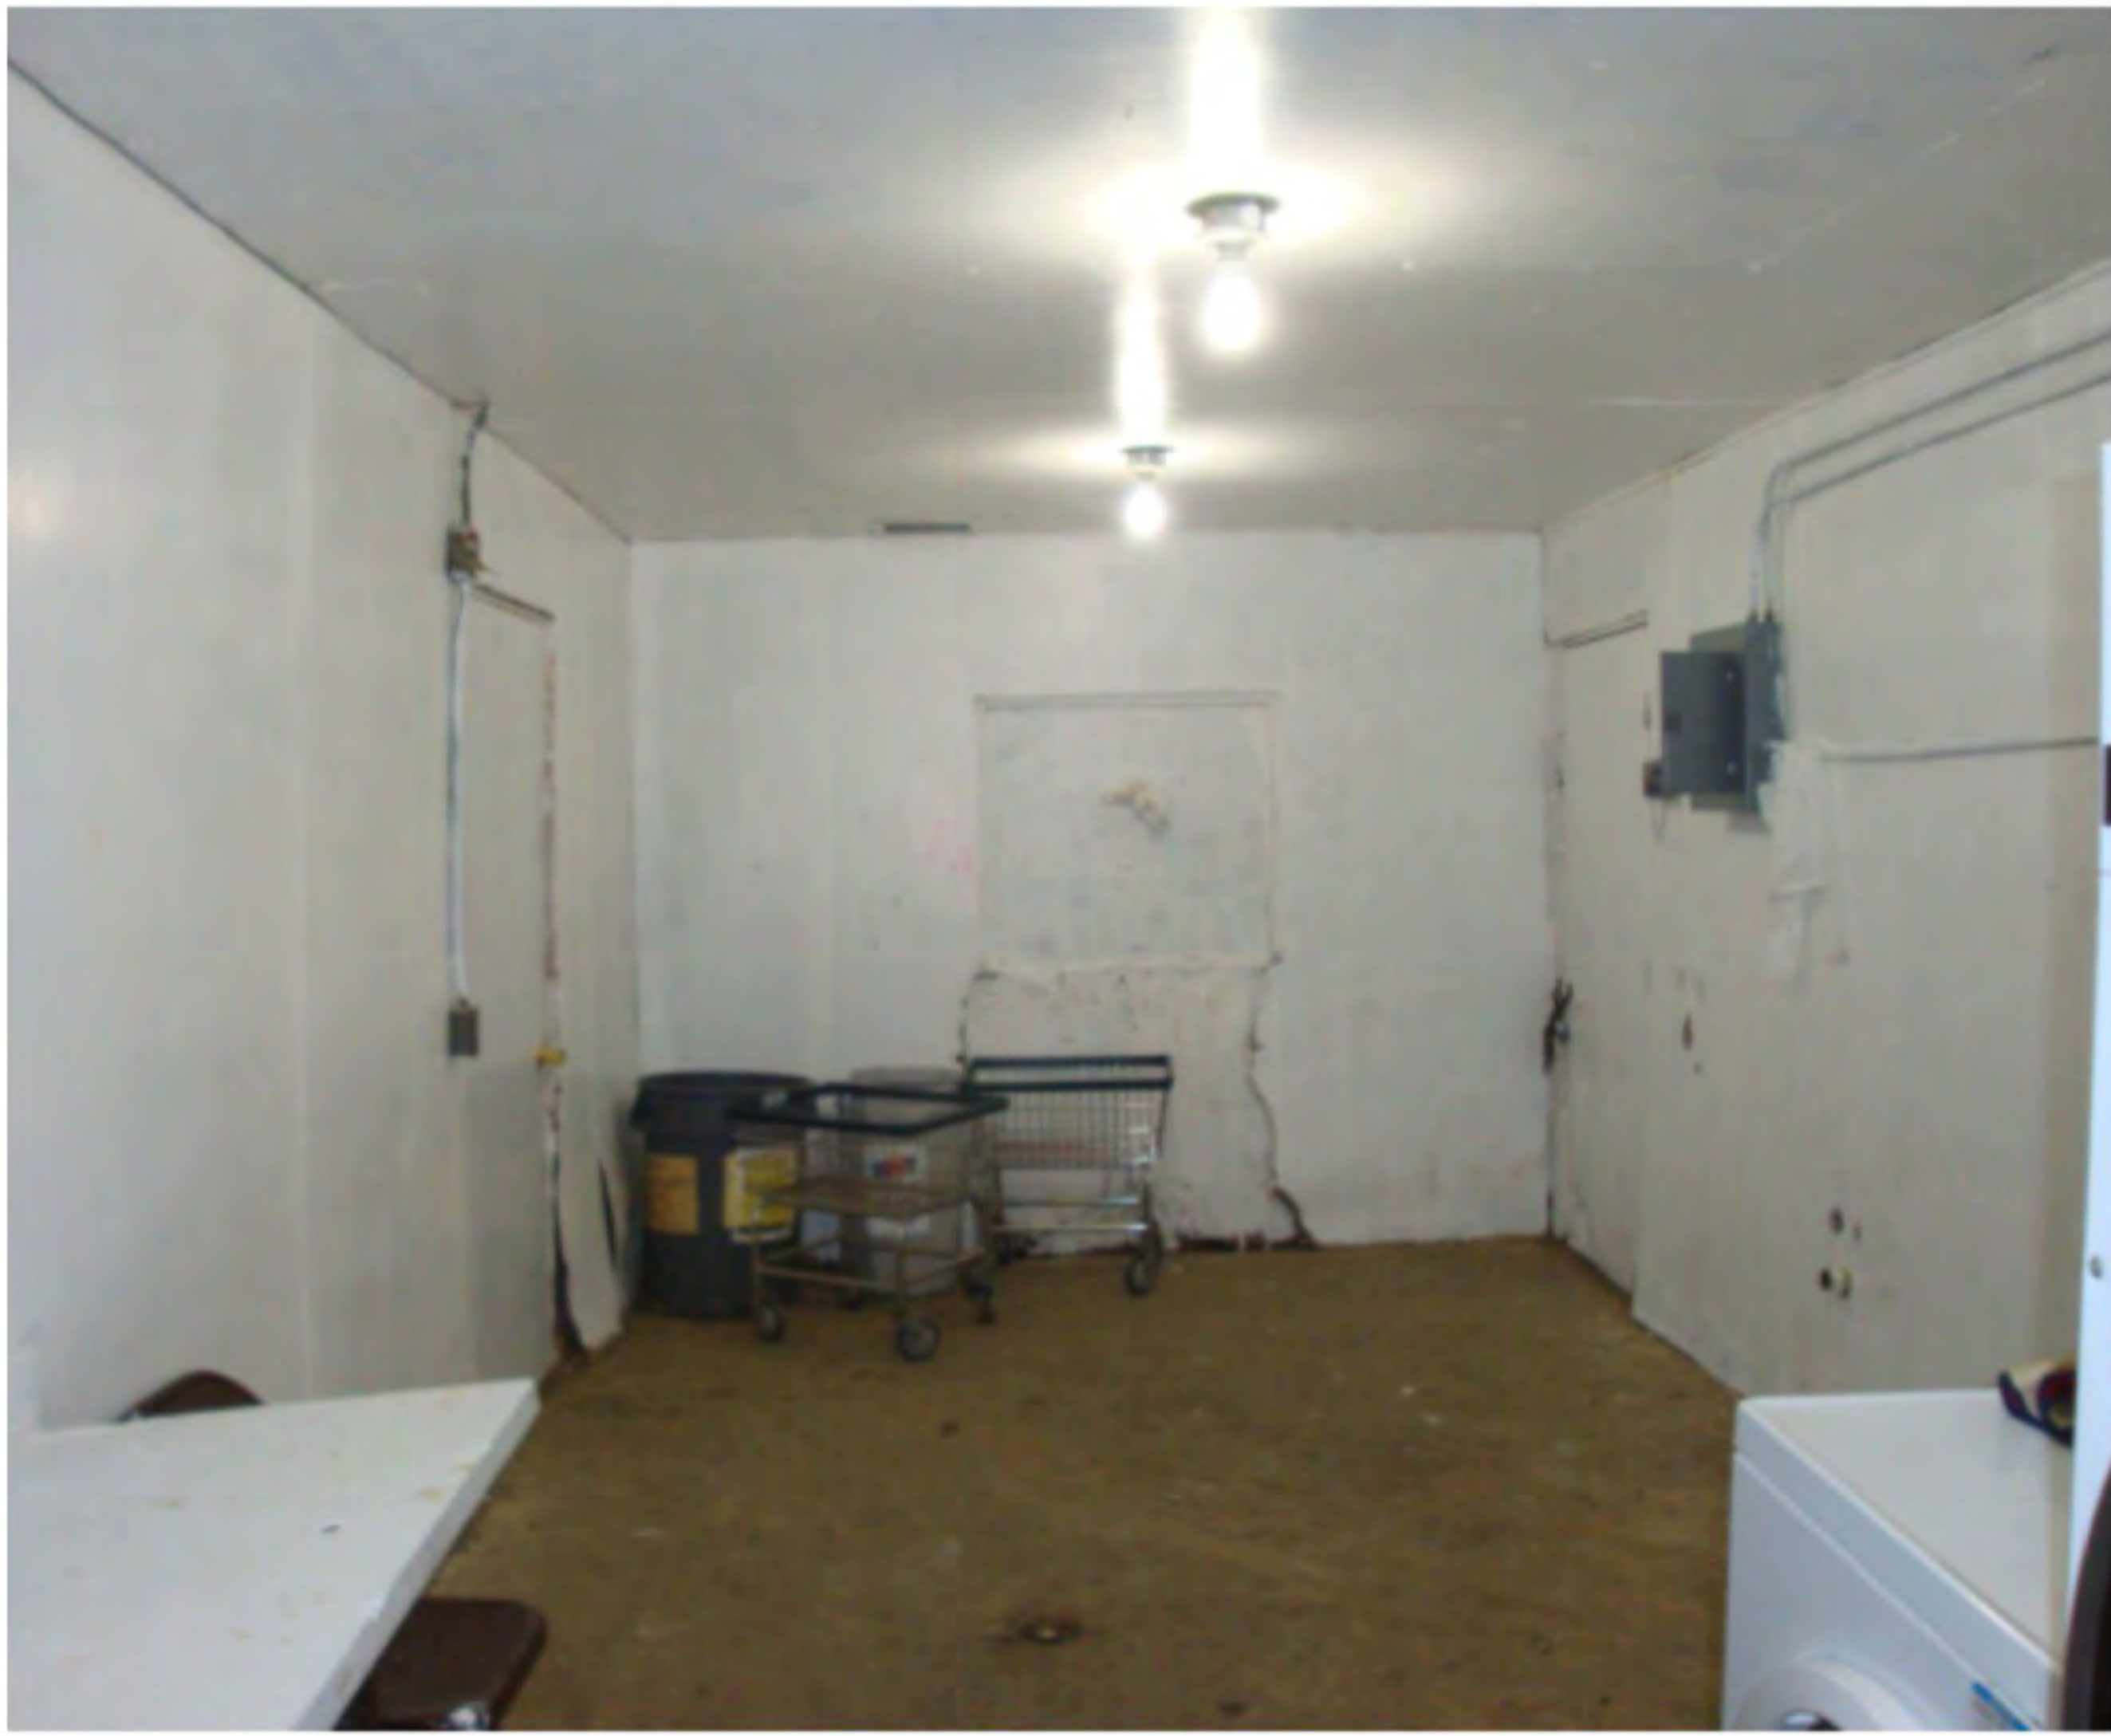
Tununak Washeteria. Photo shows decay of the door and flooring, and peeling of the wall.

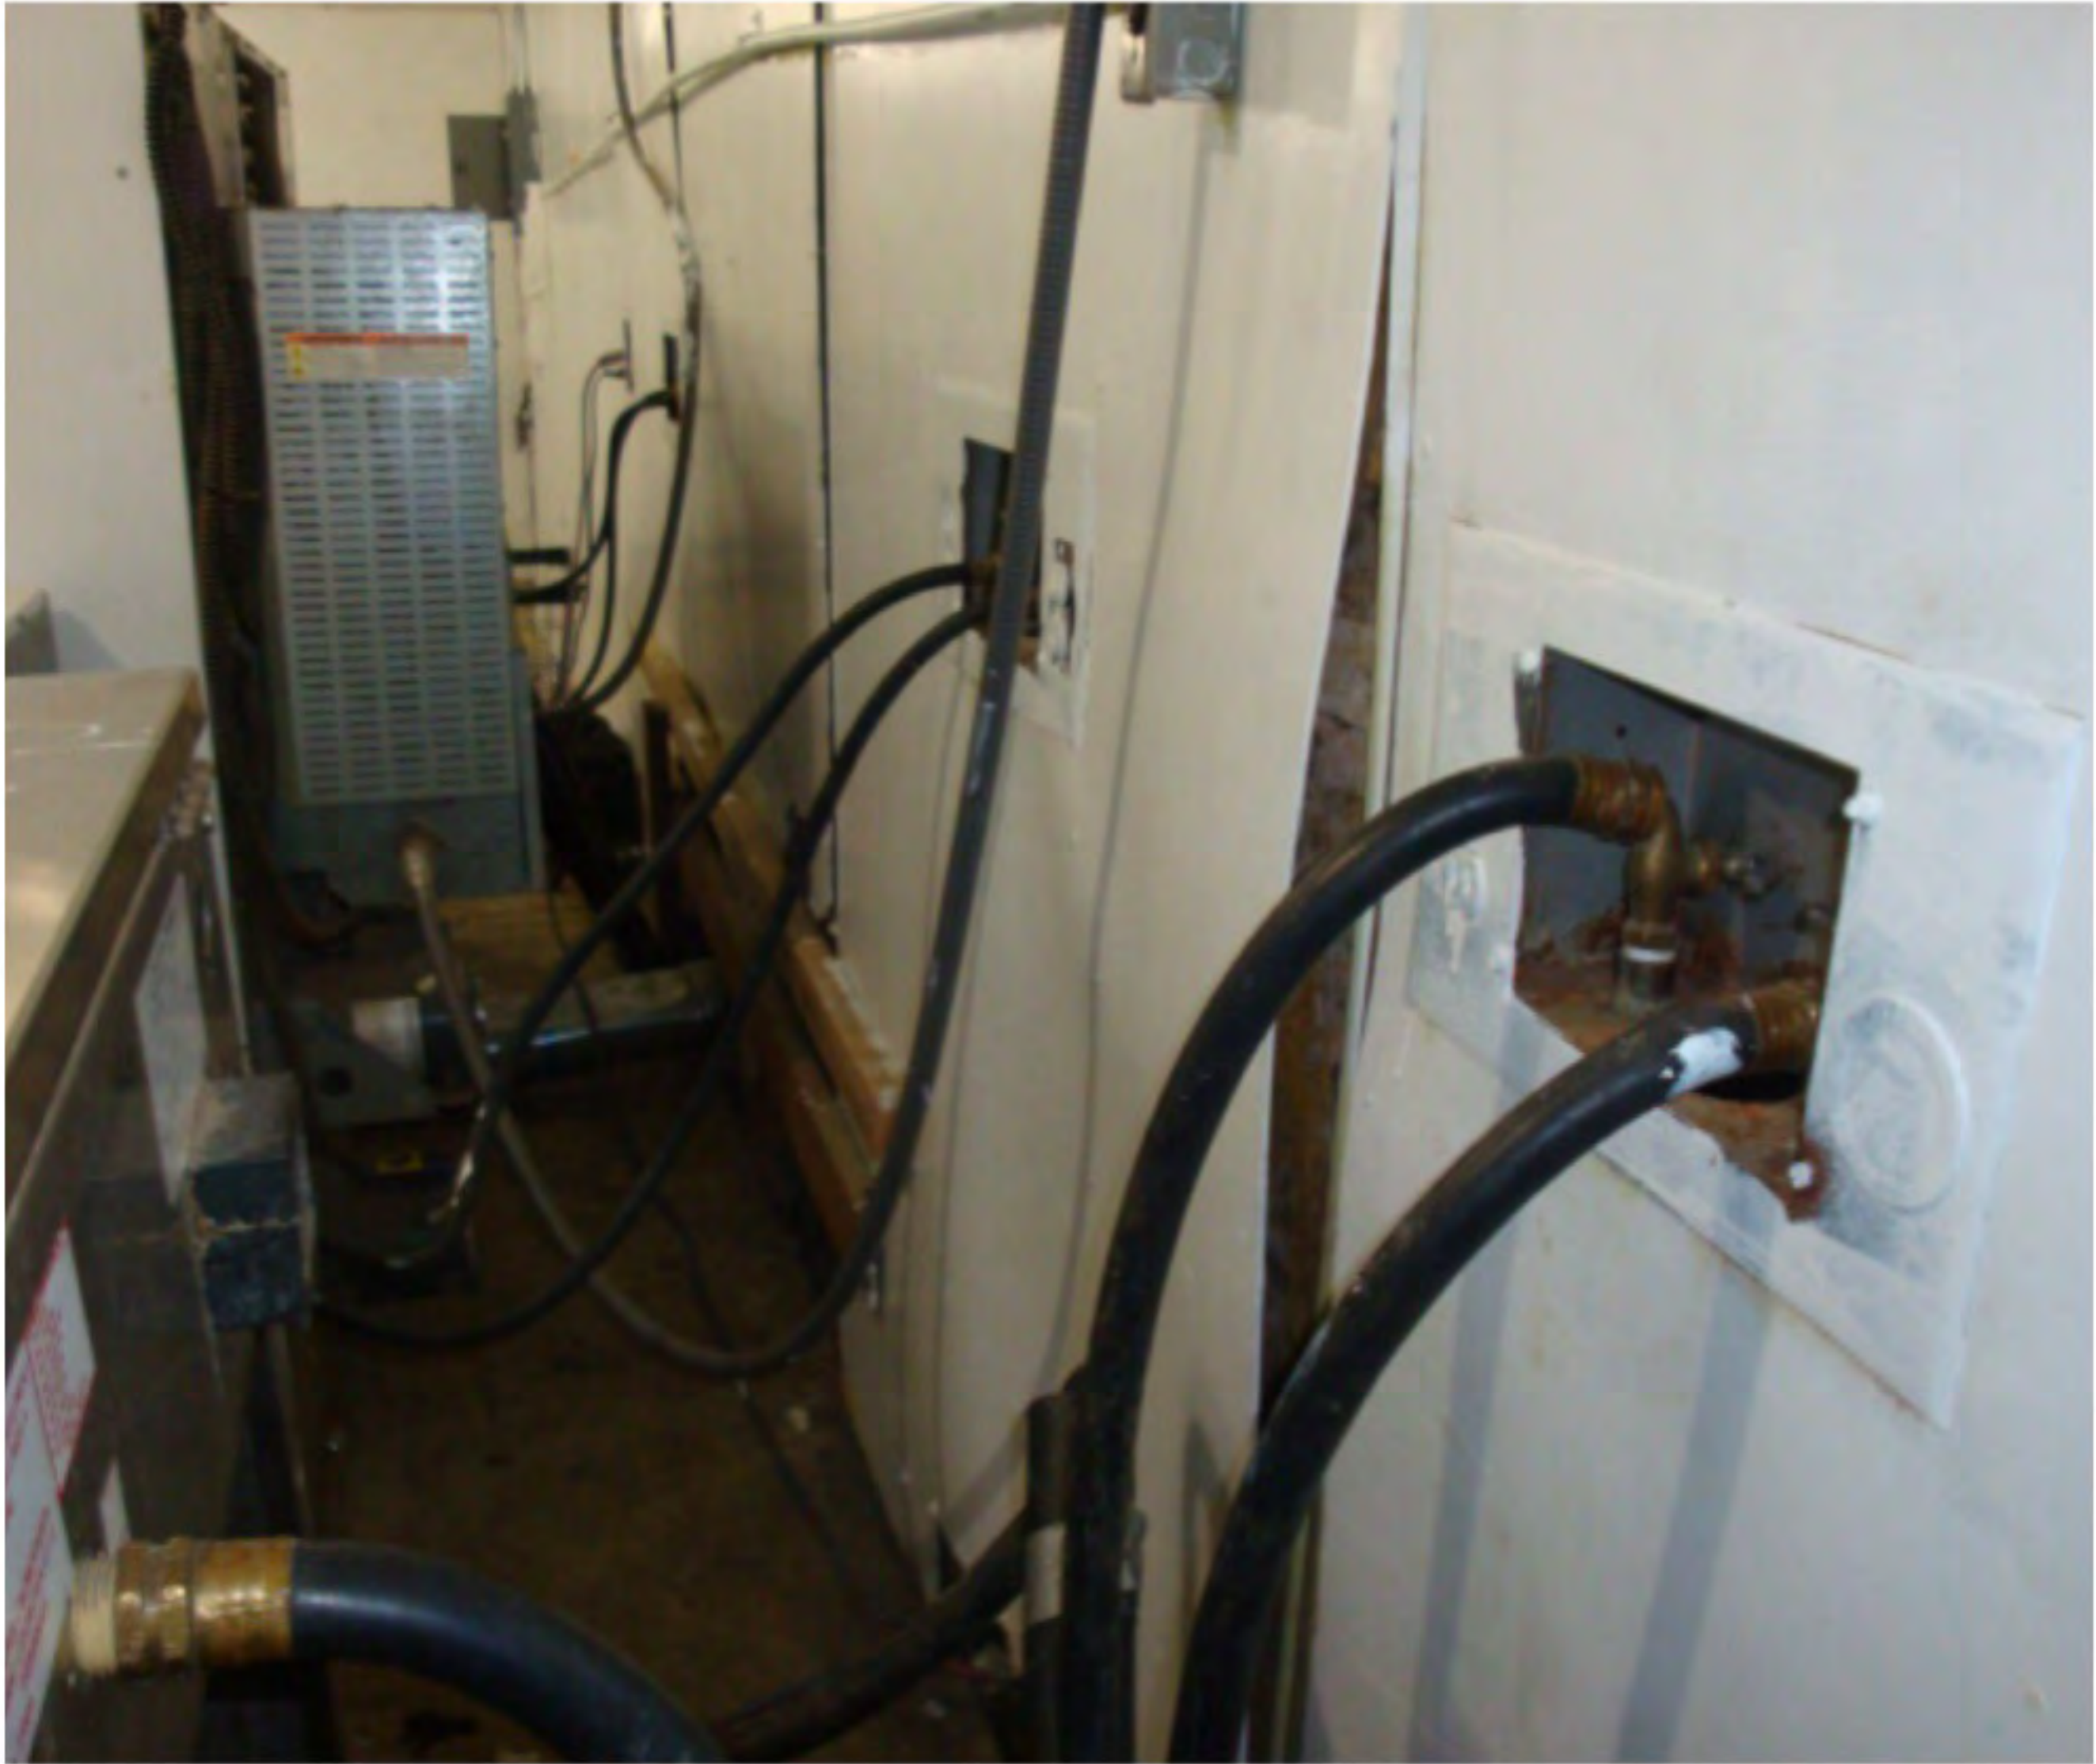
Tununak Washeteria - space behind machines. Note the wall splitting, and corrosion.
